**Underwater Inspection of
Interstate 95 over Christina River
Bridge No. 1-744-059
April 5 and 6, 2016**

Bridge No. 1-744-059
Interstate 95 over Christina River

**Underwater Inspection
Bridge No. 1-744-059
Interstate 95 over Christina River**

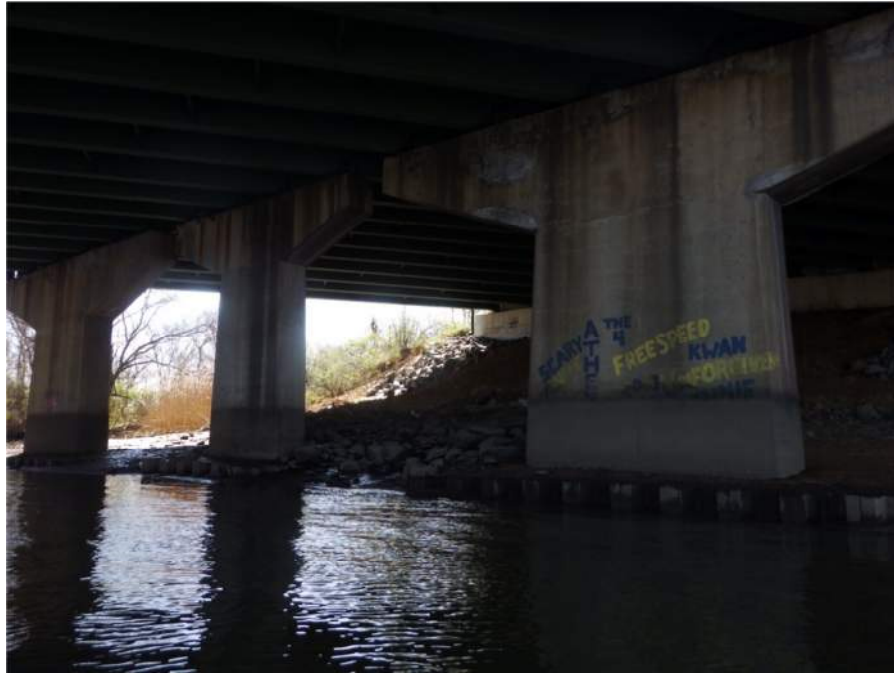
Photograph 3. Typical Configuration of Pier (Pier 1 shown), Looking Southeast.

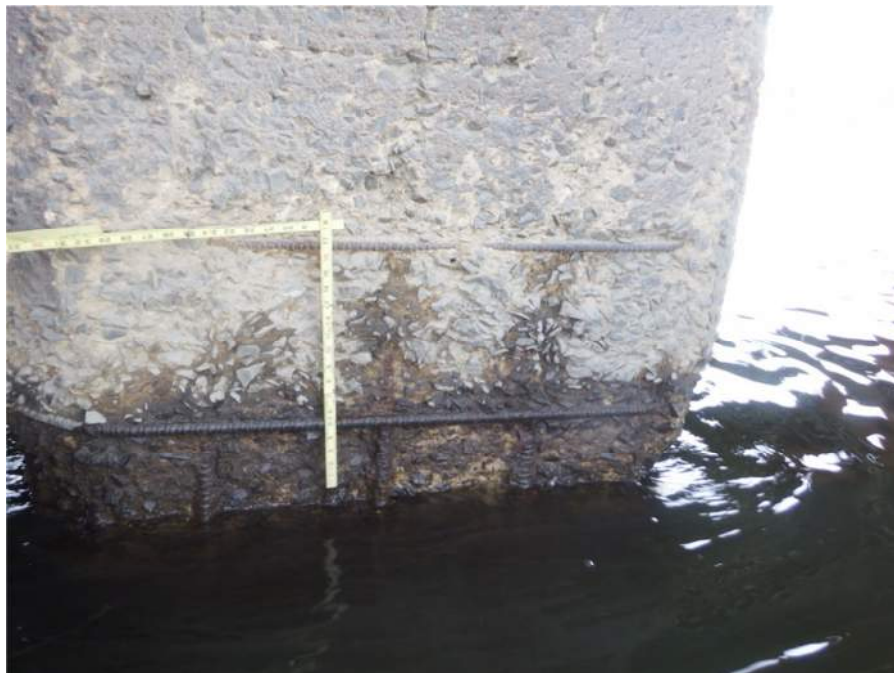
Overall, Pier 5 was in fair condition. The west face of the West Stem exhibits 3' H x full-width x 4" D scaling with exposed corroded steel reinforcement (4 horizontal and 8 vertical steel bars) with up to 90% section loss to the horizontal reinforcement, 4-feet from the mudline that extends 4-feet long onto the north face. The West Stem exhibits 2 1/2' H x up to 2" D scaling along the south, east and north faces with an exposed horizontal steel bar and a vertical steel bar at the southeast chamfer, 3-feet above the mudline. There is map cracking and a 1/32-inch wide vertical crack extending 15-feet up from the band of scaling on the west face of the West Stem. The west face of the East Stem exhibits 3' H x full-width x 3" D scaling with exposed corroded steel reinforcement (3 vertical and 2 horizontal steel bars), 6-feet above the mudline that extends 5-feet long on the north face with one exposed horizontal steel reinforcement bar. Refer to Photographs 4 and 5 in Appendix B for scaling defect. Refer to Figure 6 in Appendix C for detailed inspection notes of Pier 5.

Photograph 4. Pier 5, west face of West Stem, Looking East.
Note: 3' H x full-width x up to 4" D scale with exposed steel reinforcement.

ELEM	DESCRIPTION	UNITS	TOTAL	CS1	CS2	CS3	CS4	COMMENTS
210	RC Pier Wall	LF	39	0	21	18	0	<p>Abrasion CS3: (14 LF) The West Stem exhibits 2 1/2' H x up to 2" D scaling along the south, east and north faces with an exposed horizontal steel bar and a vertical steel bar at the southeast chamfer, 3-feet above the mudline. The west face of the East Stem exhibits 3' H x full-width x 3" D scaling with exposed corroded steel reinforcement (3 vertical and 2 horizontal steel bars), 6-feet above the mudline that extends 5-feet long on the north face with one exposed horizontal steel bar.</p> <p>CS2: (21 LF) The stems exhibit scaling 2'-6" H x up to 1-inch deep throughout the tidal zone</p> <p>Exposed Rebar CS3: (4 LF) The west face of the West Stem exhibits 3' H x full-width x 4" D scaling with exposed corroded steel reinforcement (4 horizontal and 8 vertical steel bars) with up to 90% section loss, 4-feet from the mudline that extends 4-feet long onto the north face (Photos 4 and 5).</p>

The bands of scaling and associated concrete deterioration at Piers 2 through 5 should be repaired. In lieu of traditional concrete patching repairs, which may be short-lived, consideration should be given to installing a fiberglass jacket system (or similar method) around each pier stem to provide a longer-life repair.

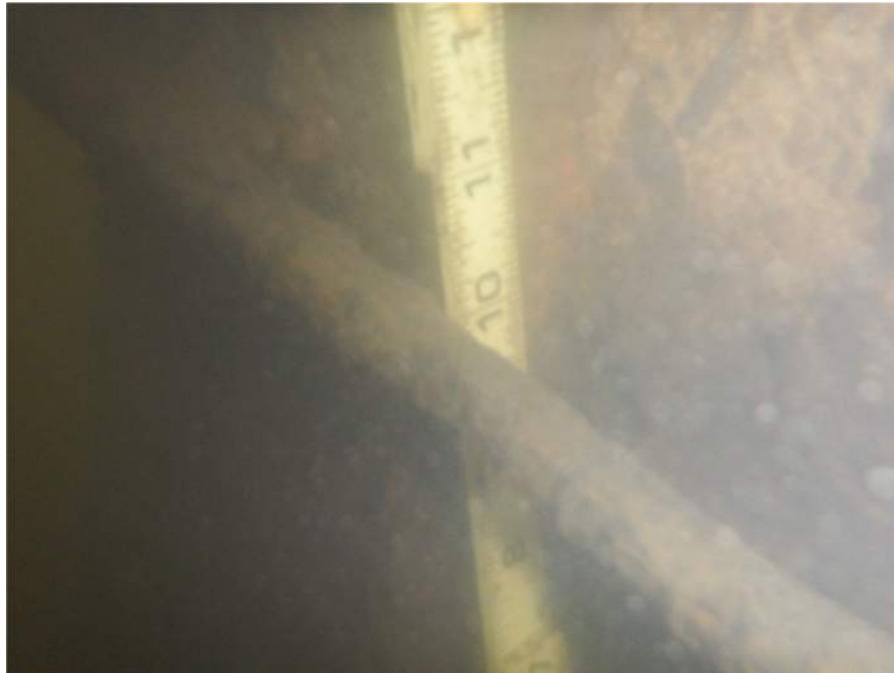
Photograph 5. Pier 5, west face of West Stem, Looking East.
Note: Exposed steel reinforcement with section loss.

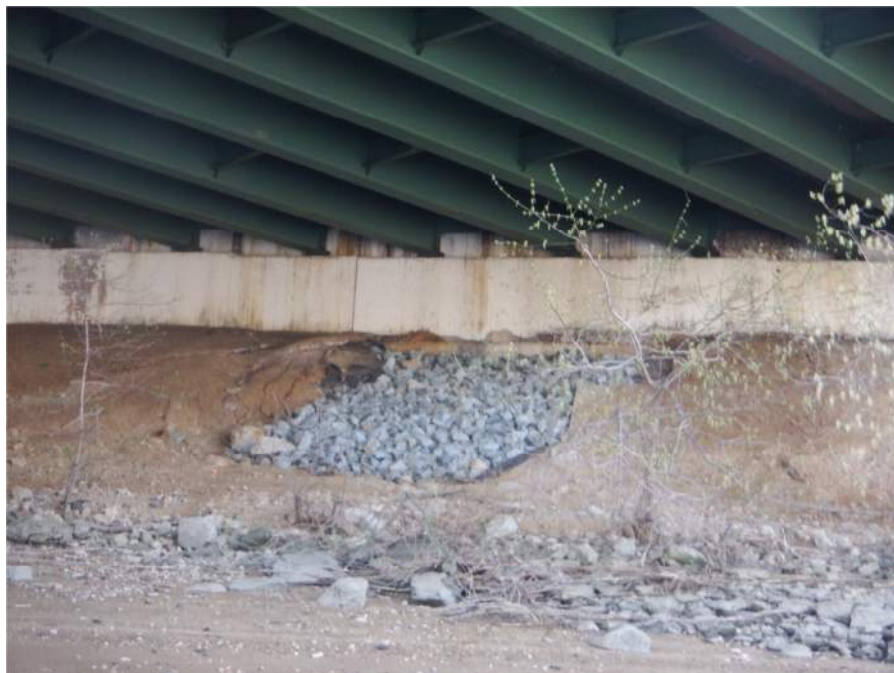
Photograph 6. South Abutment, Looking South.
Note: Previous area of erosion has been filled with riprap.

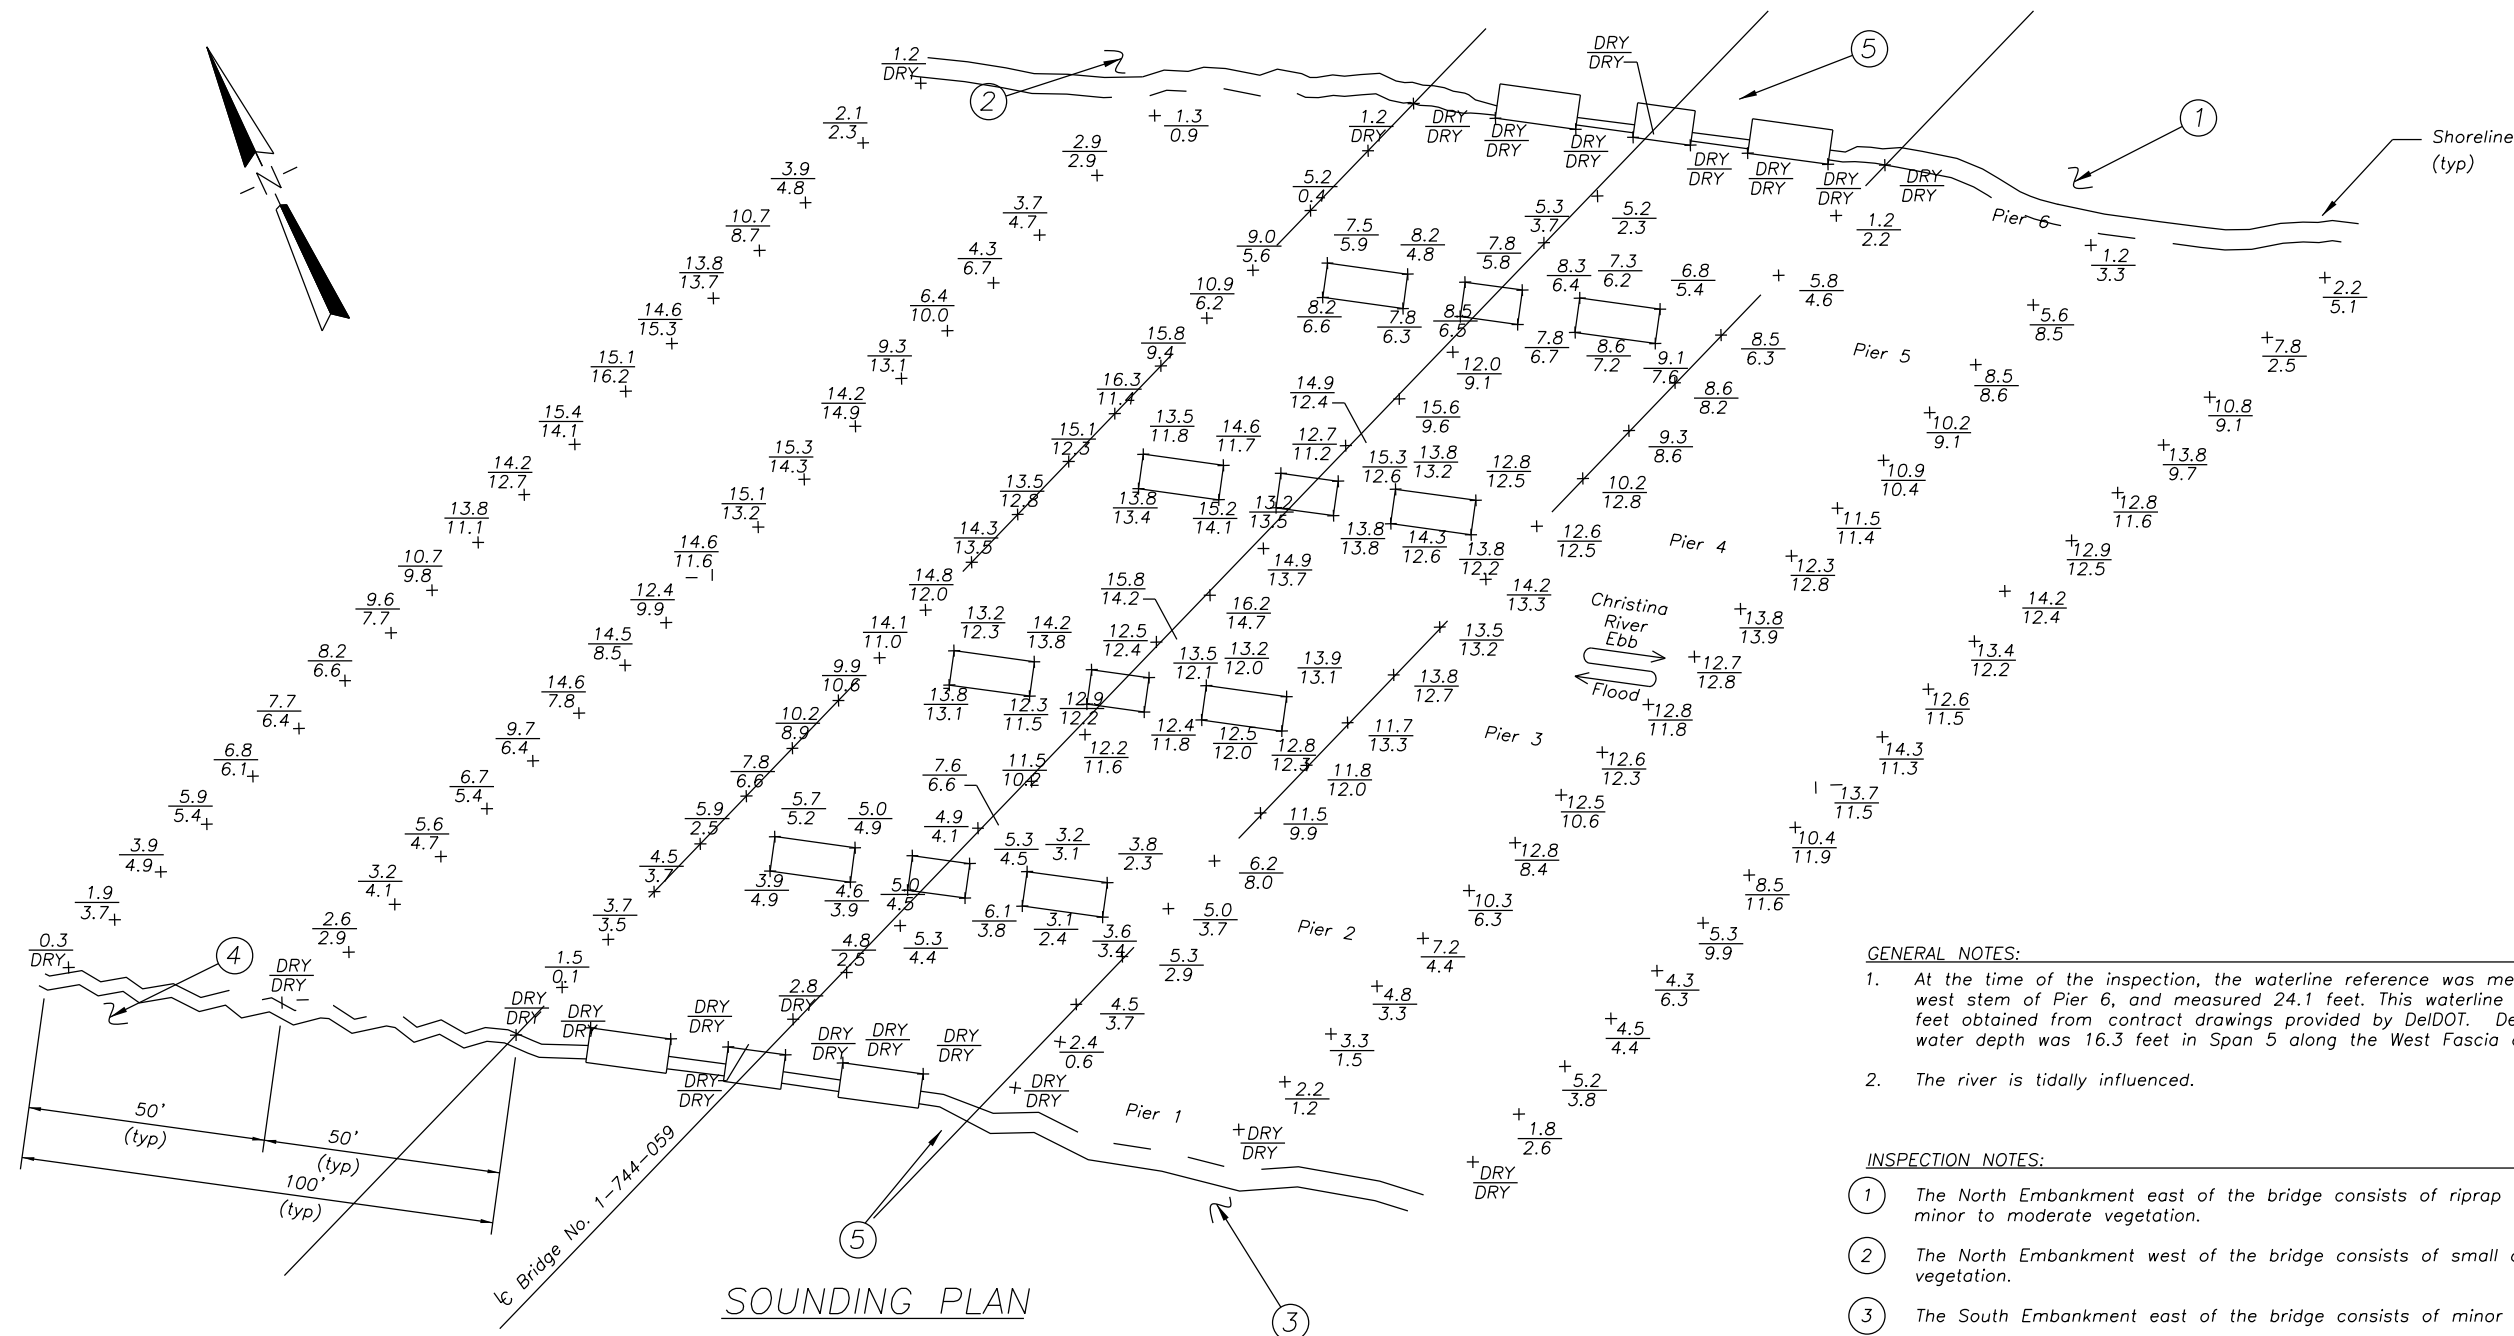
SOUNDING PLAN

- The North Embankment east of the bridge consists of riprap measuring 6 to 12-inches in diameter with minor to moderate vegetation.
- The North Embankment west of the bridge consists of small cobbles up to 4-inches in diameter with minor vegetation.
- The South Embankment east of the bridge consists of minor vegetation.
- The South Embankment west of the bridge consists of riprap measuring 6 to 12-inches in diameter.
- The embankments under the bridge consist of riprap measuring 6 to 12-inches in diameter from the mean high waterline to the mean low waterline.

The channel bottom configuration should continue to be closely monitored during future underwater inspections to ensure that the footing exposure at Pier 2 remains minimal and the footings at Piers 4 and 5 do not get exposed due to scour as previously noted.

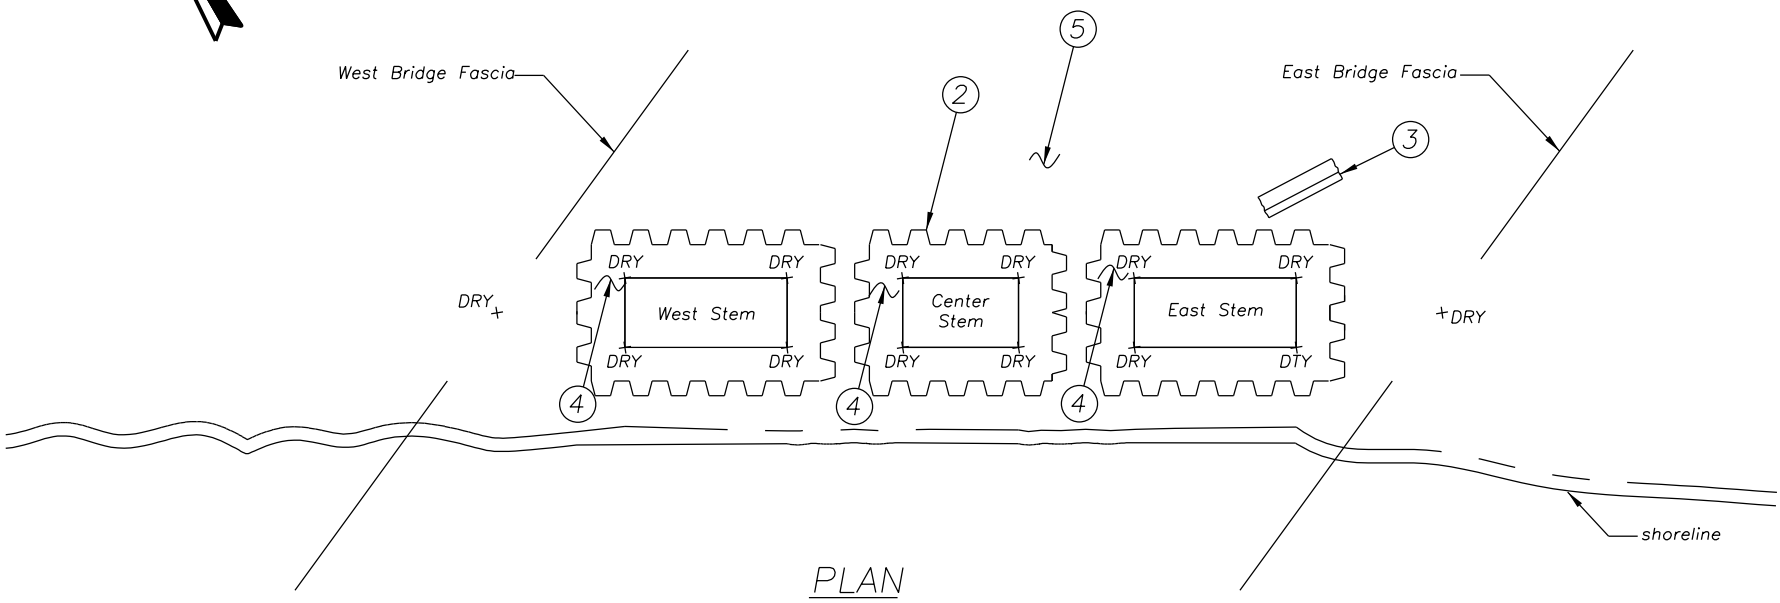
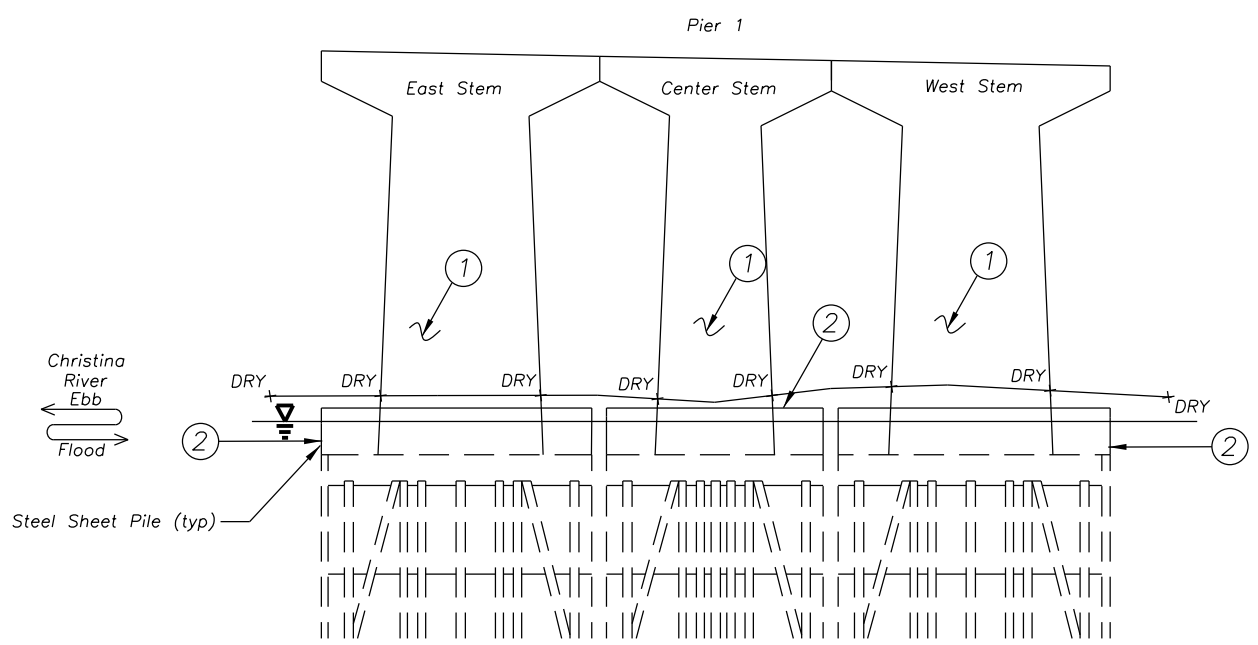
Overall, Piers 1 and 6 are in satisfactory condition. Piers 1 and 6 stems typically exhibit up to 1/2-inch deep scaling from the mean high waterline to the streambed. At Pier 1 a 6-foot long section of steel H-pile is on the channel bottom just north of the steel sheet pile at the East Stem. Refer to Figures 2 and 7, respectively in Appendix C for detailed inspection notes of Piers 1 and 6.

- INSPECTION NOTES:**
- ① The concrete surfaces of all Pier 1 Stems exhibit up to 1/2-inch deep scaling from the mean high waterline to the channel bottom.
 - ② Steel sheet pile is approximately 4.5-feet off the north face of all pier stems and extends to the centerline of the east and west faces of all pier stems. The steel sheet pile extends out of the channel bottom approximately 1.2-feet. The sheeting is in good condition with minor surface corrosion.
 - ③ Section of steel H-pile, 6-feet long, is north of the steel sheet piling at the East Stem.
 - ④ Within the steel sheet pile, gravel with up to 2-inches of probe rod penetration existed.
 - ⑤ The channel bottom outside the steel sheet pile consists of sandy silt with up to 3-feet of probe rod penetration.

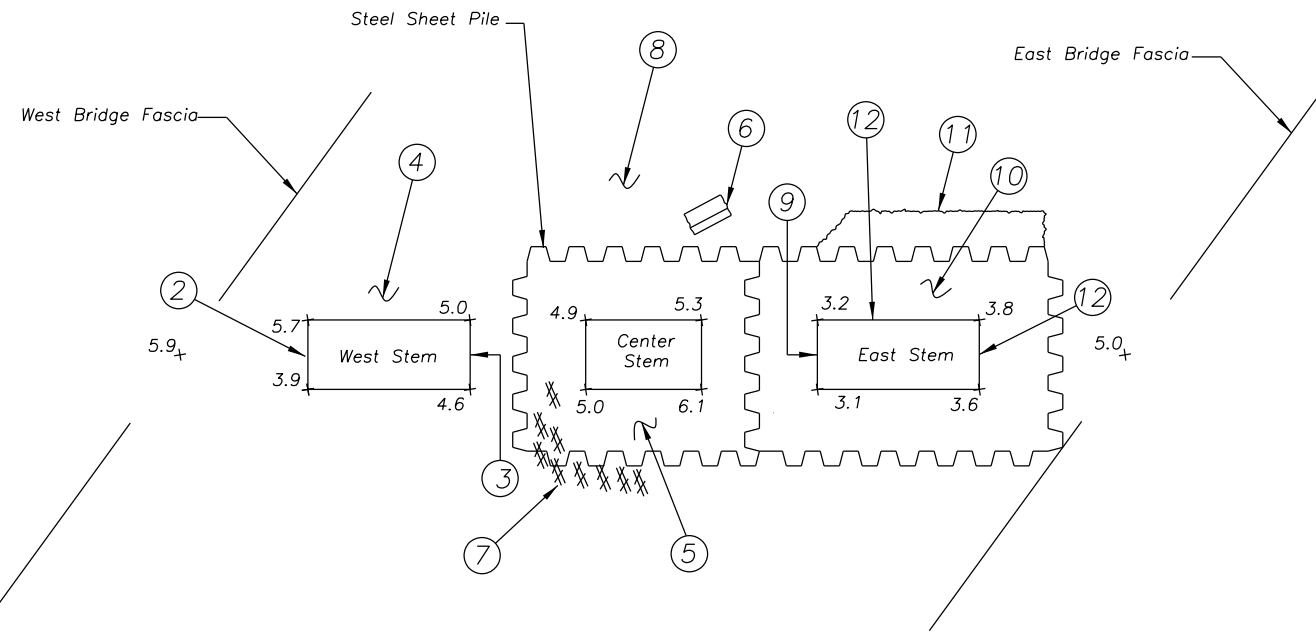
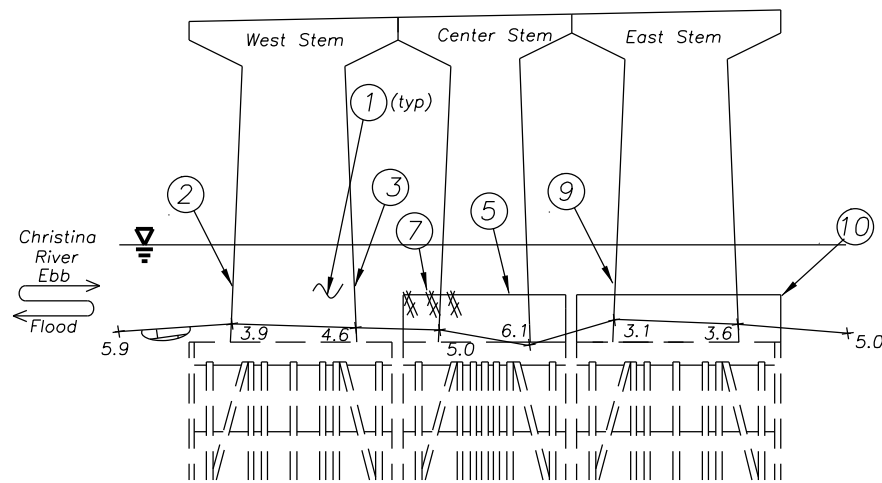
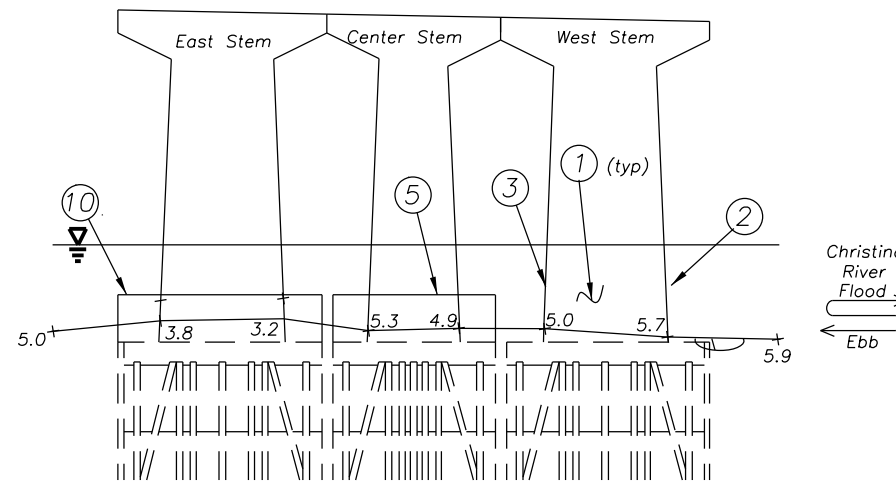
PIER 2 INSPECTION DETAILS

Overall, Pier 2 was in fair condition. The west face of the West Stem exhibits a 6' H x full-width (3'-6") x 3" D area of scaling with exposed corroded steel reinforcement (7 vertical and 3 horizontal steel bars) with 20% section loss on the vertical bars and up to 60% section loss on the horizontal bars, starting 2 feet-6 inches above the mudline. The east face of the West Stem exhibits a 2' H x full-width x 1 1/2" D area of scaling with exposed corroded steel reinforcement (3 horizontal steel bars), 1-foot above the mudline that extends 3-feet onto the north face. The west face of the East Stem exhibits scaling up to 4' H x full-width x up to 2 1/2" D with exposed corroded steel reinforcement (11 vertical and 2 horizontal steel bars) with up to 30% section loss, 6-feet above the

mudline that extends 6-inches on both the north and south faces. The East Stem exhibits 2' H x up to 1 1/2-inch deep scaling/poorly consolidated concrete at the mudline on all faces. The top of the footing is exposed along the north and south faces of the Center Stem inside the steel sheet piling. A 6-foot long section of a steel H-pile is on the channel bottom along the north face of the exposed steel sheet pile at the Center Stem and a 3-foot long section of steel H-pile is at the southwest corner of the steel sheet piling. A 2 to 3-foot concrete overpour exists along the north face of the steel sheet pile from the west quarter point to the northeast corner at the East Stem. Refer to Figure 3 in Appendix C for detailed inspection notes of Pier 2.

- ① The concrete surfaces of all Pier 2 Stems exhibit a band of 2'-6" H x up to 1-inch scaling in the tidal zone.
- ② Scaling on the west nose of the West Stem, measuring 6' H x full-width x 3" D with exposed corroded steel reinforcement (7 vertical and 3 horizontal steel bars) with 20% section loss on the vertical steel bars and up to 60% section loss on the horizontal steel bars, starting 2.5-feet above the mudline.

- ③ Scaling on the east nose of the West Stem, measuring 2' H x full-width x 1 1/2" D with exposed corroded steel reinforcement (3 horizontal steel bars), 1-foot above the mudline that extends 3-feet onto the north face.

- ④ The channel bottom in the vicinity of the West Stem consists of gravel with up to 1-inch of probe rod penetration.
- ⑤ Steel sheet pile was exposed around the Center Stem, the top of the steel sheet pile was 2 to 3-feet from the mudline. The top of the footing was exposed along the north and south faces of the Center Stem inside the steel sheet pile. Within the steel sheet pile along the east and west faces of the Center Stem, sandy gravel with up to 4-inch probe rod penetration exists.

- ⑥ A section of a steel H-pile, 6-feet long, is on the channel bottom along the north face of the exposed steel sheet pile at the Center Stem.
- ⑦ Minor timber debris is present at the west nose of the Center Stem and extends 6-feet east, down the south face of the steel sheet pile.

- ⑧ The channel bottom outside the steel sheet pile consists of sand with up to 4-inches probe rod penetration.
- ⑨ An area of scaling is present on the west nose of the East Stem, measuring 4' H x full-width x 2 1/2" D with exposed corroded steel reinforcement (11 vertical and 2 horizontal rebars) with up to 30% section loss, 6-feet above the mudline that extends 6-inches onto the north and south faces.

- ⑩ Steel sheet pile is exposed around the entire East Stem with the top of the steel sheet pile located 2 to 2.5-feet from the mudline. Within the steel sheet pile, there is gravel with 0-inches of probe rod penetration covering the footing. At the west nose there was a 3-foot long section of steel H-pile on the gravel.

- ⑪ Concrete overpour exists along the north face of the steel sheet pile from the west quarter point to the northeast corner at the East Stem. The overpour extends 2 to 3-feet out from the north face of the steel sheet pile with 6 to 18-inches of vertical exposure.

- ⑫ There is scaling/poorly consolidated concrete in the East Stem on all faces measuring 2' H x 1 1/2" D at the mudline.

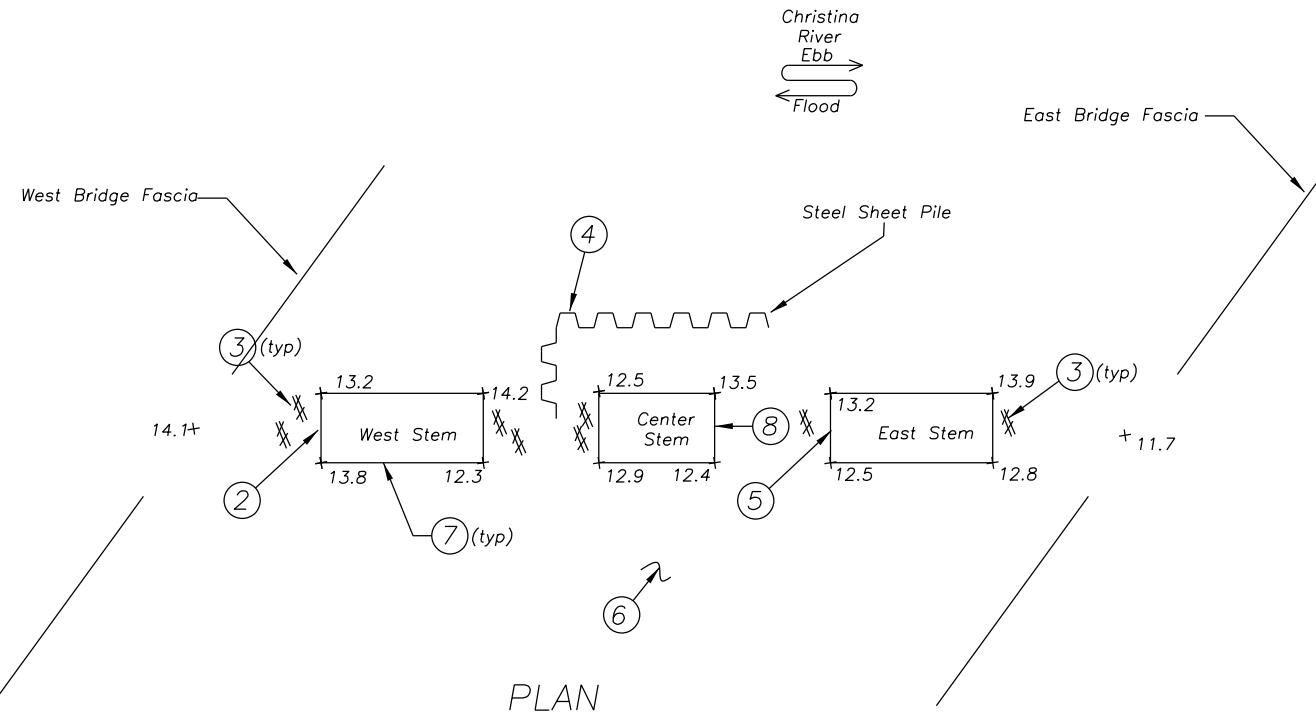
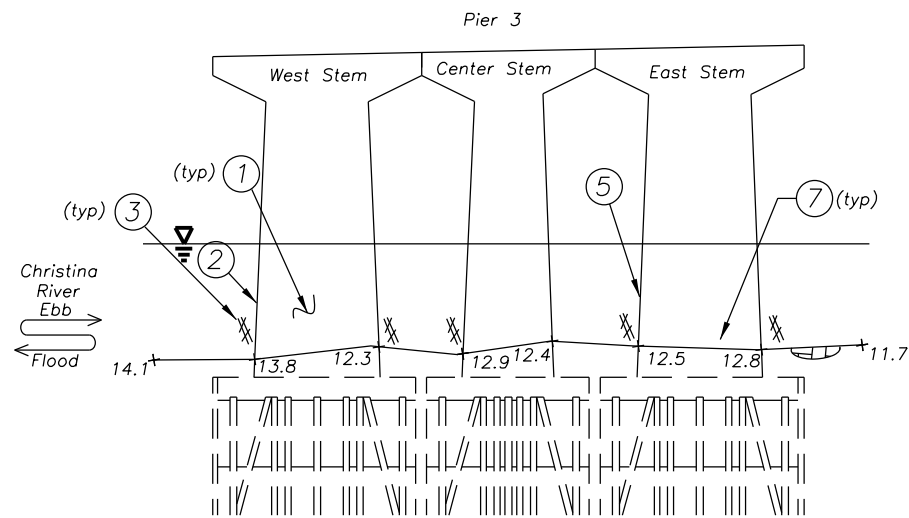
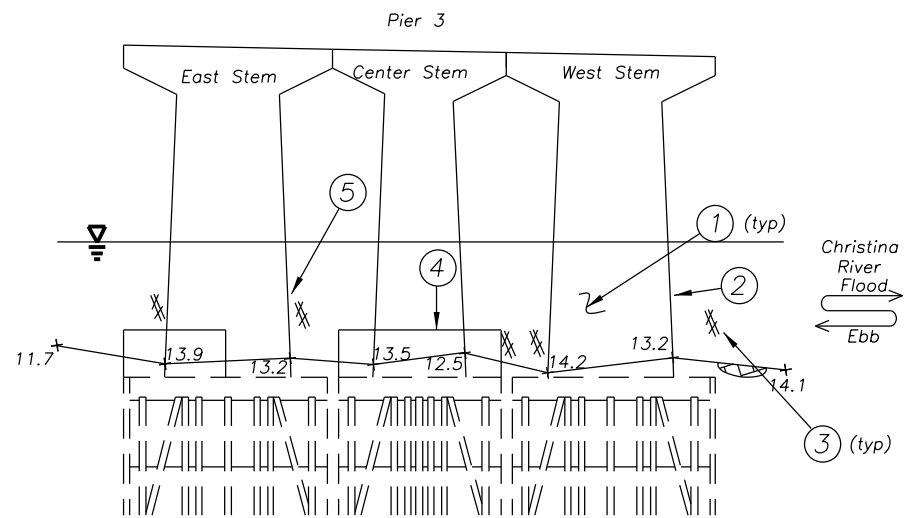
PIER 3 INSPECTION DETAILS

Overall, Pier 3 was in fair condition. The stems exhibit a 2' H x 1 1/2" D area of scaling/poorly consolidated concrete at the mudline on all faces. The west face of the West Stem exhibits a 6' H x full-width x 3" D area of scaling with exposed corroded steel reinforcement (6 vertical and 2 horizontal steel bars) with up to 20% section loss. The west face of the East Stem exhibits a 2'-6" H x full-width x 3" D area of scaling with exposed corroded steel reinforcement (2 vertical and 2 horizontal steel bars) with up to 25% section loss, at the waterline. The previously noted 10' L x 1' D scour depression that extended 3-feet north of the north face of the West Stem; a 3' L x 1' D scour depression that extended 3-feet out from the west face of the Center Stem; and a 3' L x FW x 1' D scour depression that extended 3-feet away from the north face of the East Stem were not observed during the 2016 Inspection; however, around the pier stems there is a minor, up to 6-inches deep, streambed change. There is a 14' H x up to 1/16" W vertical crack on the east face of the Center Stem that terminates 4 feet below the waterline. Refer to Figure 4 in Appendix C for detailed inspection notes of Pier 3.

- ① The concrete surfaces of all Pier 3 Stems exhibits a band of 2'-6" H x up to 1" D scaling within the tidal zone.
- ② Area of scaling on the west nose of the West Stem measuring 6' H x full-width x 3" D with exposed corroded steel reinforcement (6 vertical and 2 horizontal steel bars) with 20% section loss.

- ③ Minor accumulations of timber debris measuring up to 12-inches in diameter exists at the east and west faces of the West and East Stems and the west face of the Center Stem, along the streambed.

- ④ Steel sheet pile is exposed 12-feet below the waterline from the northeast corner of the Center Stem, along the north face, and terminated into the channel bottom at the centerline of the west face.

- ⑤ An area of scaling on the west nose of the East Stem measuring 2'-6" H x full-width x 3" D with exposed corroded steel reinforcement (2 vertical and 2 horizontal steel bar) with up to 25% section loss.

- ⑥ The channel bottom in the vicinity of the pier consists of sand and minor gravel with up to 6-inches of probe rod penetration.
- ⑦ There is a band of scaling/poorly consolidated concrete measuring 2' H x 1 1/2" D on all faces of the pier stems at the mudline.

- ⑧ There is a 14' H x up to 1/16" W vertical crack on the east face of the Center Stem, starting at 4 feet below the waterline and extending up.

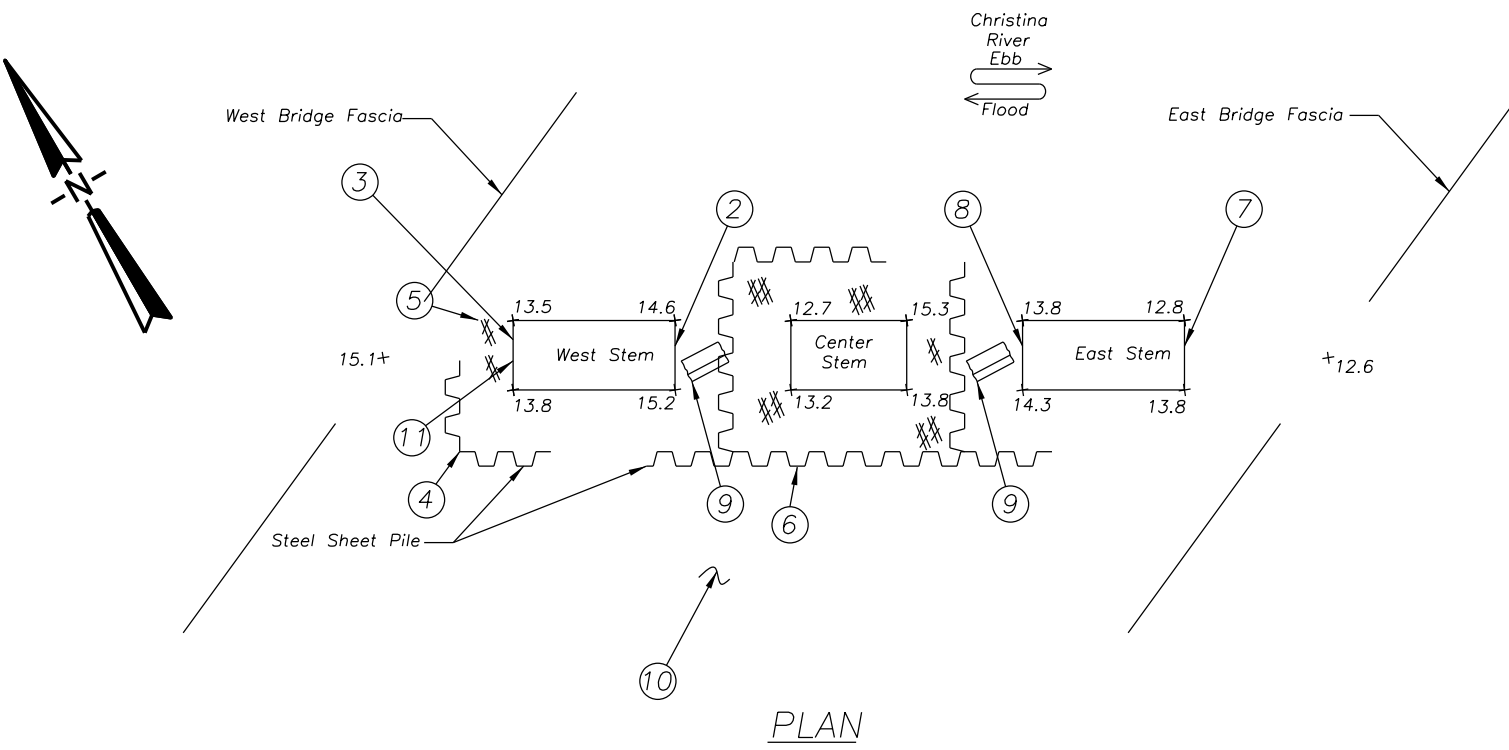
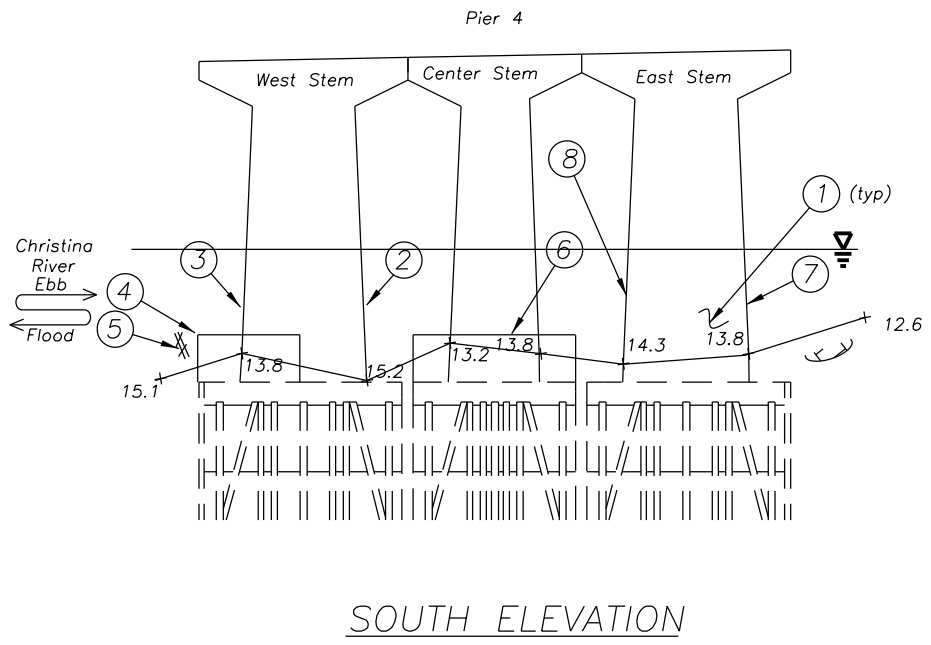
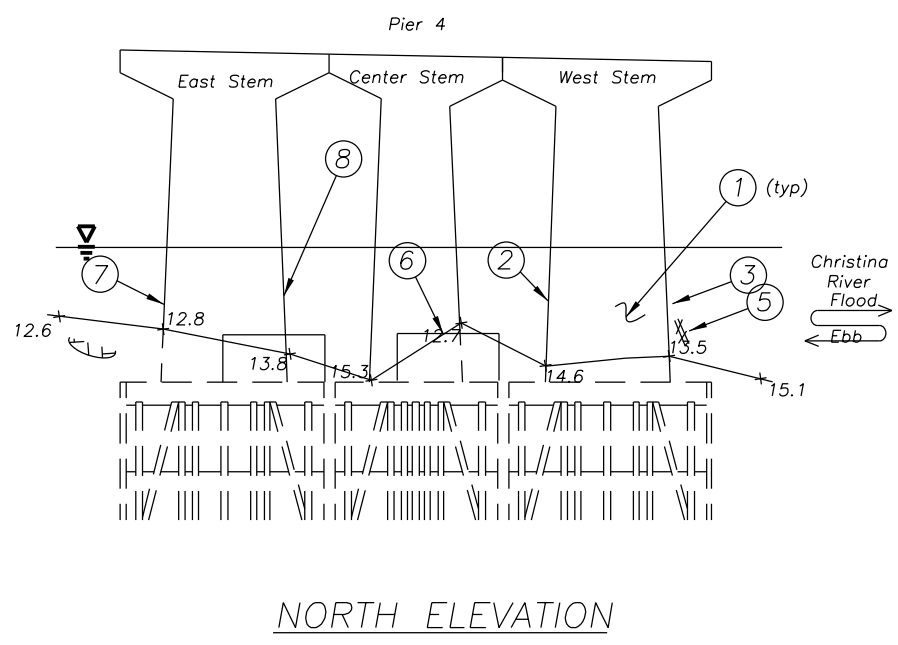
Overall, Pier 4 was in satisfactory condition. The west face of the West Stem exhibits 5' H x full-width x 4" D scaling with exposed corroded steel reinforcement (1 vertical and 1 horizontal steel bar), at the waterline that extends 1-foot on the north and south faces. The east face of the West Stem exhibits 1'-4" H x full-width x 4" D scaling with exposed corroded steel reinforcement (with one horizontal steel bar) at the waterline. At the center of the west face of the West Stem is a vertical crack up to 30' H x up to 1/16" W that terminates 5-feet below the waterline. The east face of the East Stem exhibits 1'-6" H x full-width x 4" D scaling with exposed corroded steel reinforcement (1 vertical and 2 horizontal steel bars), starting 3-feet above the mudline. The west face of the East Stem exhibits 3' H x full-width x 4" D scaling with exposed corroded steel reinforcement (5 vertical and 4 horizontal steel bars), starting 3-feet above the mudline. Steel debris, up to 4-feet long, is on the channel bottom at the west face of the East Stem. Refer to Figure 5 in Appendix C for detailed inspection notes of Pier 4.

- INSPECTION NOTES:
- ① The concrete surfaces of all Pier 4 Stems exhibits a band of 2'-6" H x up to 1" D scaling in the tidal zone.
 - ② Area of scaling on the east nose of the West Stem measuring 1'-4' H x full-width x 4" D with one exposed corroded horizontal steel reinforcement.

- ③ Area of scaling on the west nose of the West Stem measuring 5' H x full-width x 4" D with exposed corroded steel reinforcement (1 vertical and 1 horizontal steel bar), that extends 1-foot onto the north and south faces.

- ④ Steel sheet pile is exposed from the centerline of the west nose of the West Stem extending to the southwest corner of the pier and extended 6-feet east on the south face of the pier. The steel sheet pile extended approximately 3-feet out of the channel bottom.

- ⑤ Moderate accumulations of timber debris consisting of branches measuring 6 to 12-inches in diameter exists at the west nose of the West Stem.
 - ⑥ Steel sheet pile is exposed at the Center Stem along the south face, east face, west face, and extended 15-feet east along the north face from the northwest corner. The steel sheet pile extended approximately 2-feet out of the channel bottom.

- ⑦ Scaling on the east face of the East Stem, measuring 1'-6" H x full-width x 4" D with exposed corroded steel reinforcement (1 vertical and 2 horizontal), starting 3-feet above the mudline.

- ⑧ Scaling on the west face of the East Stem, measuring 3' H x full-width x 4" D with exposed corroded steel reinforcement (5 vertical and 4 horizontal), starting 3-feet above the mudline.

- ⑨ Steel debris measuring approximately 4-feet long exists on the channel bottom at the west face of the East Stem and the east face of the West Stem.

- ⑩ The channel bottom in the vicinity of the pier consists of sand and gravel with up to 2-inches of probe rod penetration.
 - ⑪ There is a 30' H x 1/16" W vertical crack starting 5-feet below the waterline, extending up the center of the west face of the West Stem.

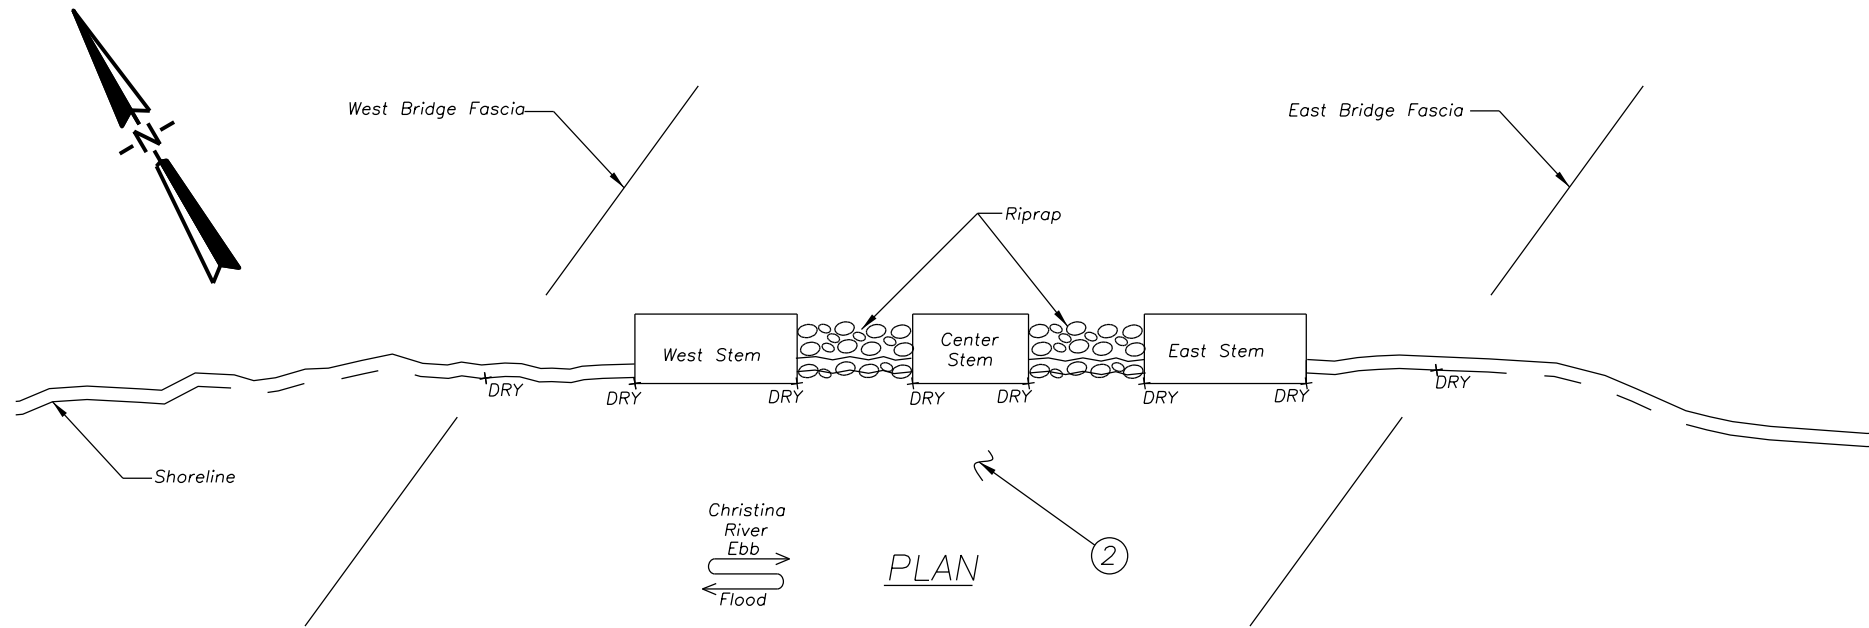
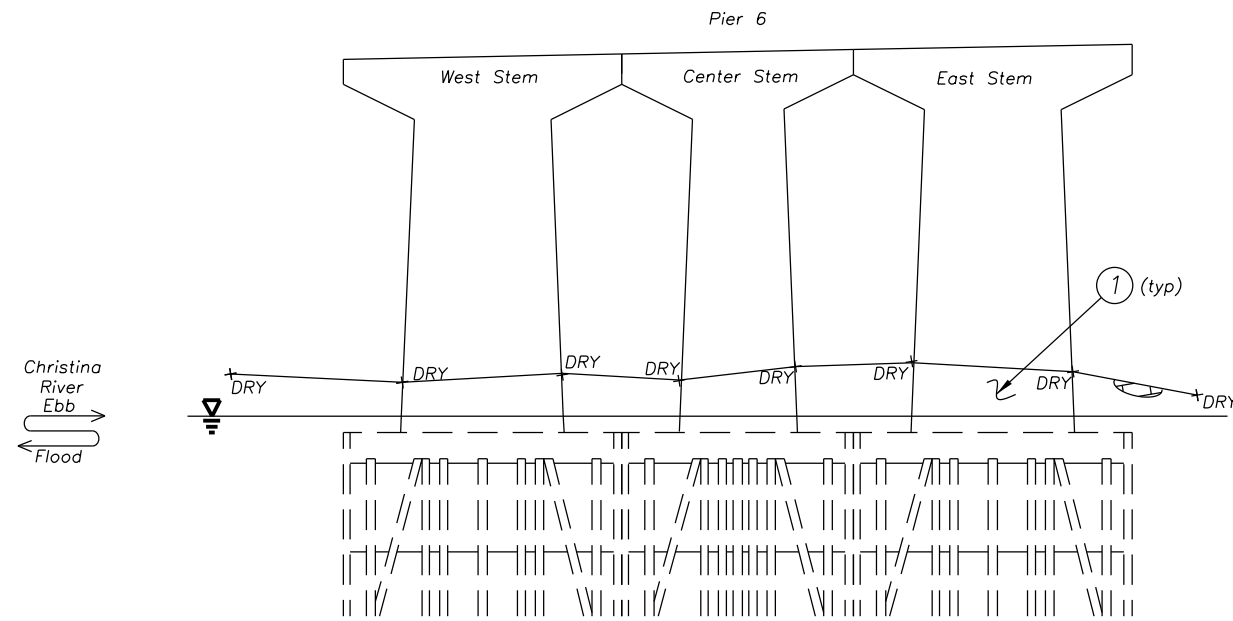
PIER 6 INSPECTION DETAILS

Overall, Pier 6 was in satisfactory condition. The stem exhibits a band of up to 1/2-inch deep scale from the mean high waterline to the mudline. The channel bottom in the vicinity of the pier consists primarily of gravel and concrete debris with riprap placed between each stem. Refer to Figure 7 in Appendix C for detailed inspection notes of Pier 6.

- INSPECTION NOTES:**
- ① The concrete surfaces of all Pier 6 Stems exhibits a band of up to 1/2-inch deep scaling from the mean high waterline to the mudline.
 - ② The channel bottom in the vicinity of the pier consists of gravel and concrete debris measuring 3 to 8-inches in diameter with riprap between pier stems.
