**Underwater Inspection of
Interstate 95 over Christina River
Bridge No. 1-744-059
April 5 and 6, 2016**

Bridge No. 1-744-059
Interstate 95 over Christina River

**Underwater Inspection
Bridge No. 1-744-059
Interstate 95 over Christina River**

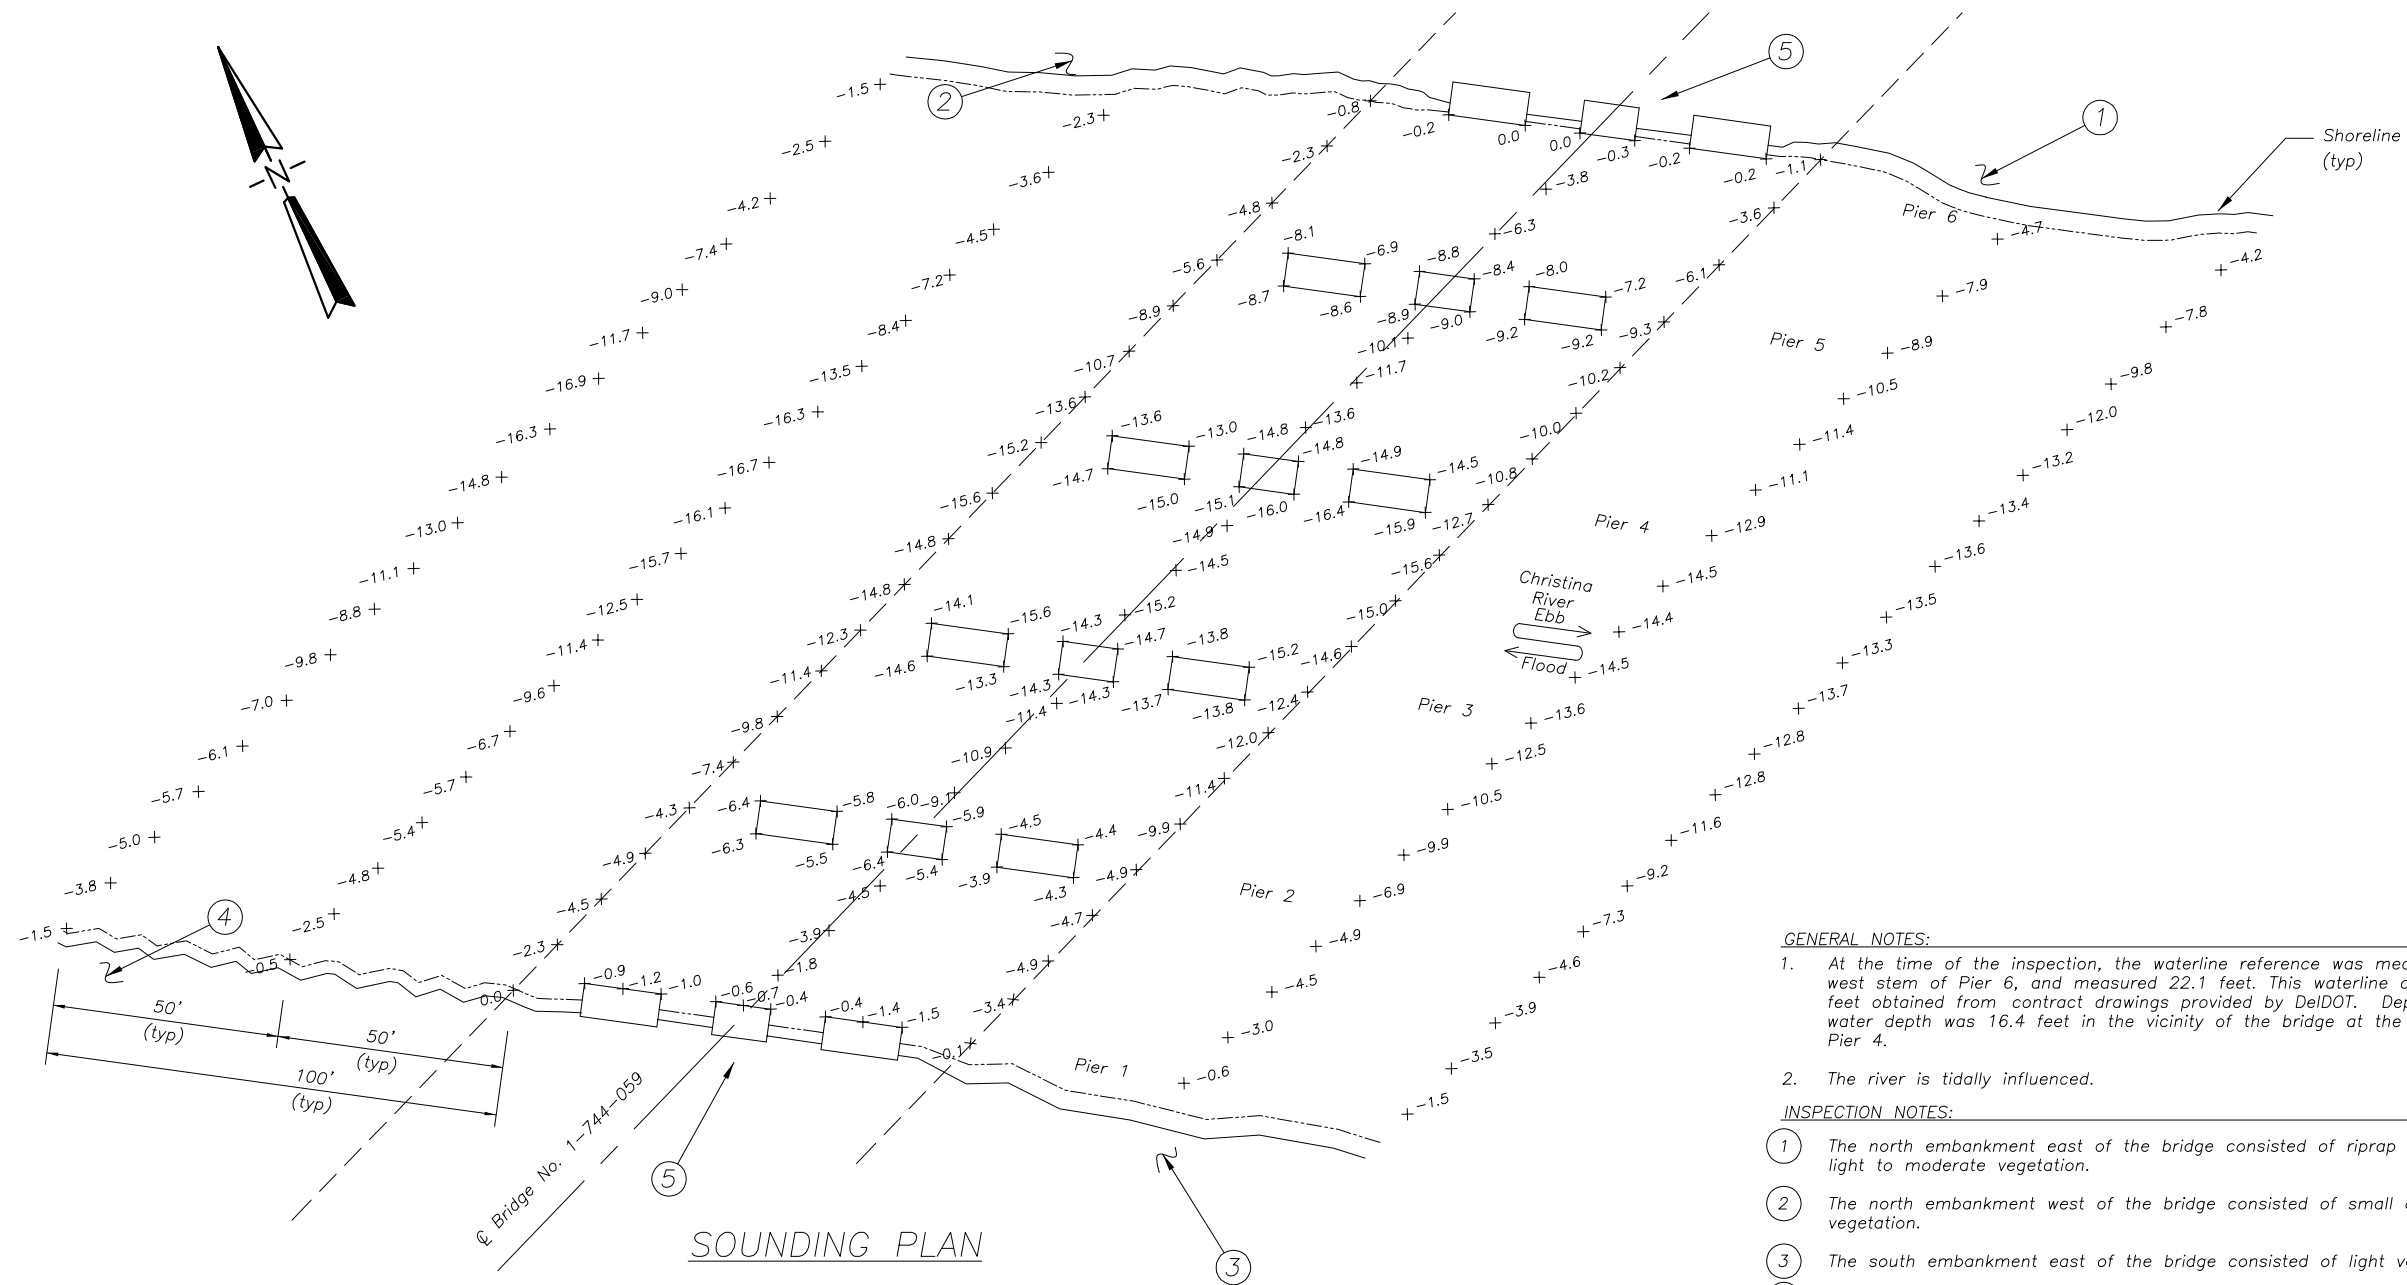
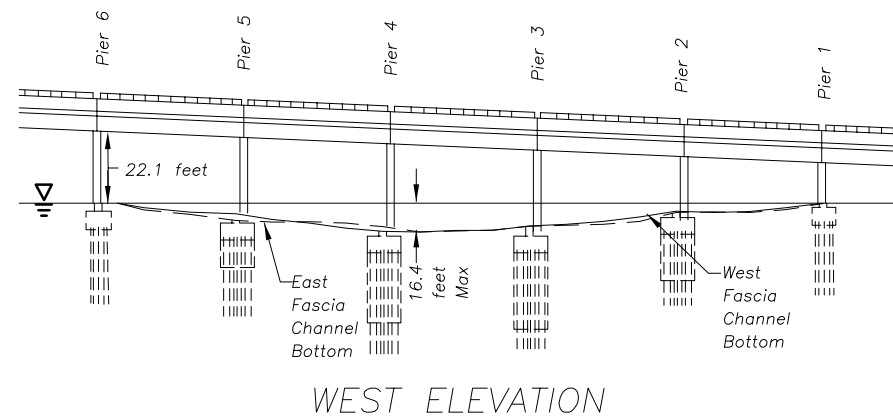
BASE YEAR SOUNDING PLAN

- ① The north embankment east of the bridge consisted of riprap measuring 6 to 12 inches in diameter with light to moderate vegetation.
- ② The north embankment west of the bridge consisted of small cobble up to 4 inches in diameter with light vegetation.
- ③ The south embankment east of the bridge consisted of light vegetation.
- ④ The south embankment west of the bridge consisted of riprap measuring 6 to 12 inches in diameter.
- ⑤ The embankments under the bridge consisted of riprap measuring 6 to 12 inches in diameter from the mean high waterline to the mean low waterline.
