## **SIGNIFICANT FINDINGS SUMMARY**

A special underwater inspection of Bridge No. 1-744-059 was performed on January 19 and 20, 2015. The underwater substructure units were generally in Fair condition. The reinforced concrete stems typically exhibit scaling up to 1-inch deep. Areas of moderate scaling up to 3-inches deep are present at isolated locations with and without exposed steel reinforcement with moderate section loss. The West Stem of Pier 5 exhibits up to 6-inch deep scaling with exposed steel reinforcement with up to 90% section loss. The top of the footings are exposed at Piers 2, 4 and 5. Steel sheet piling is present at Piers 1 through 5; the sheet piling typically protrudes up to 3-feet from the mudline. In accordance with the National Bridge Inspection Standards, DelDOT Underwater Bridge Inspection Guidelines, and based on the inspection findings it is recommended that the submerged substructure units of Bridge No. 1-744-059 be placed on an accelerated routine underwater inspection interval of 24 months.

DelDOT Bridge No. 1-744-059 carries Interstate 95 over the Christina River in New Castle County, Delaware. On January 19 and 20, 2015, Pennoni Associates Inc. perf

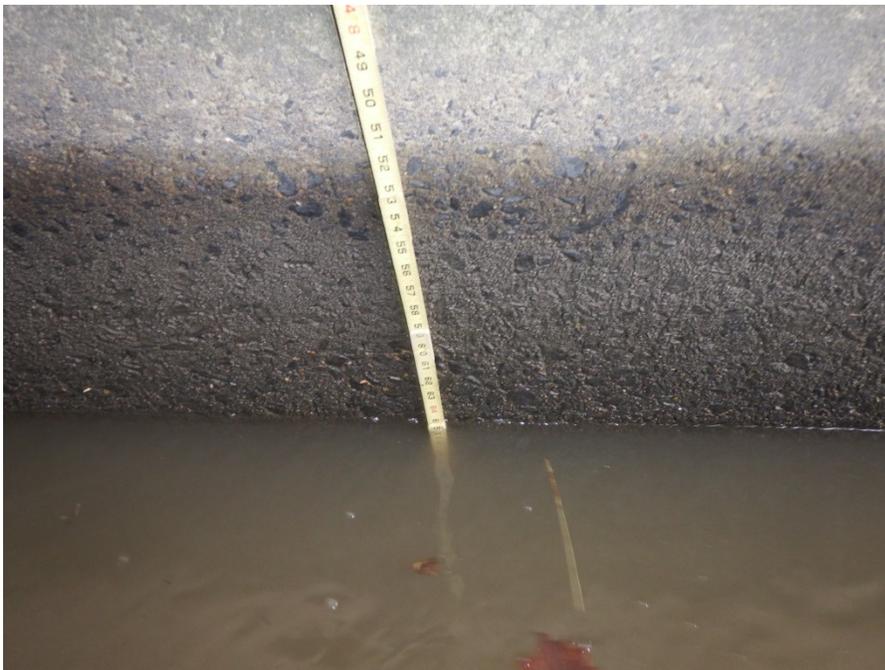
The reinforced concrete stems typically exhibit scaling up to 1-inch deep from the mean high waterline to the channel bottom. The stems typically exhibit steel sheet piling that protrude from the mudline up to 3-feet high; the sheet piling typically exhibits minor to moderate surface corrosion. The top of the footing is exposed at Piers 2, 4 and 5. Timber debris up to 12-inch Diameter is typical around the stems of all piers. The channel bottom consisted of sand and silty sand with up to 3-feet of probe rod penetration outside the steel sheet piling and predominately gravel with up to 4 inches of probe rod penetration inside the steel sheet piling. Refer to Photographs 3 and 4 in Appendix B for a view of a typical pier and typical scale.

**Photograph 4. View of Pier 4, South Face, Looking North.**  
**Note: Typical 1/4" Deep Scale along the waterline.**

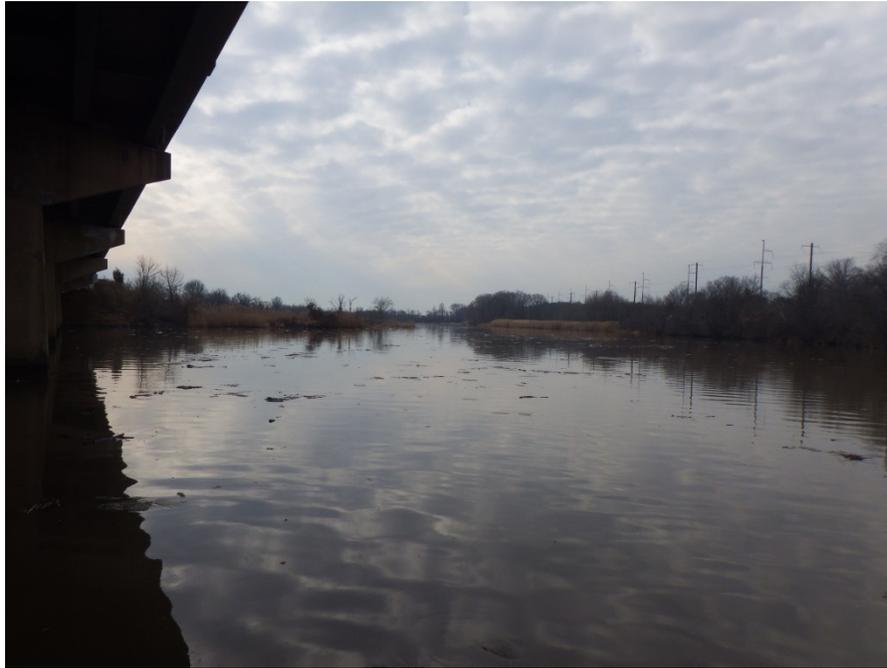
The north embankment west of the bridge consisted of small cobbles up to 4 inches in diameter with minor vegetation. The South Embankment east of the bridge consisted of minor vegetation. Refer to Photographs 5 and 6 for channel views. Refer to Figure 1 in Appendix C for detailed inspection results of the embankments.

Photograph 5. Tidal View, Looking West.

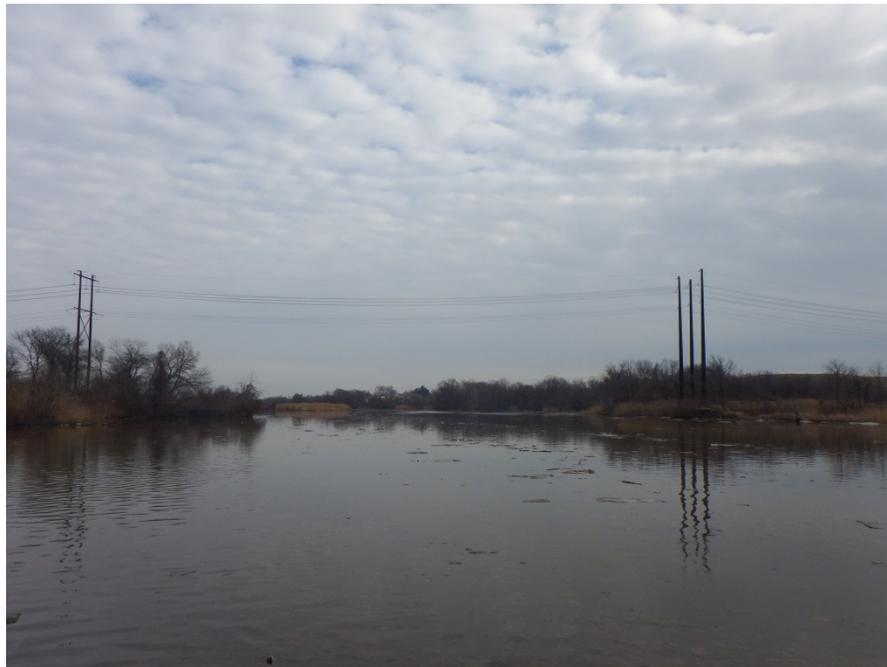
Photograph 6. Tidal View, Looking East.

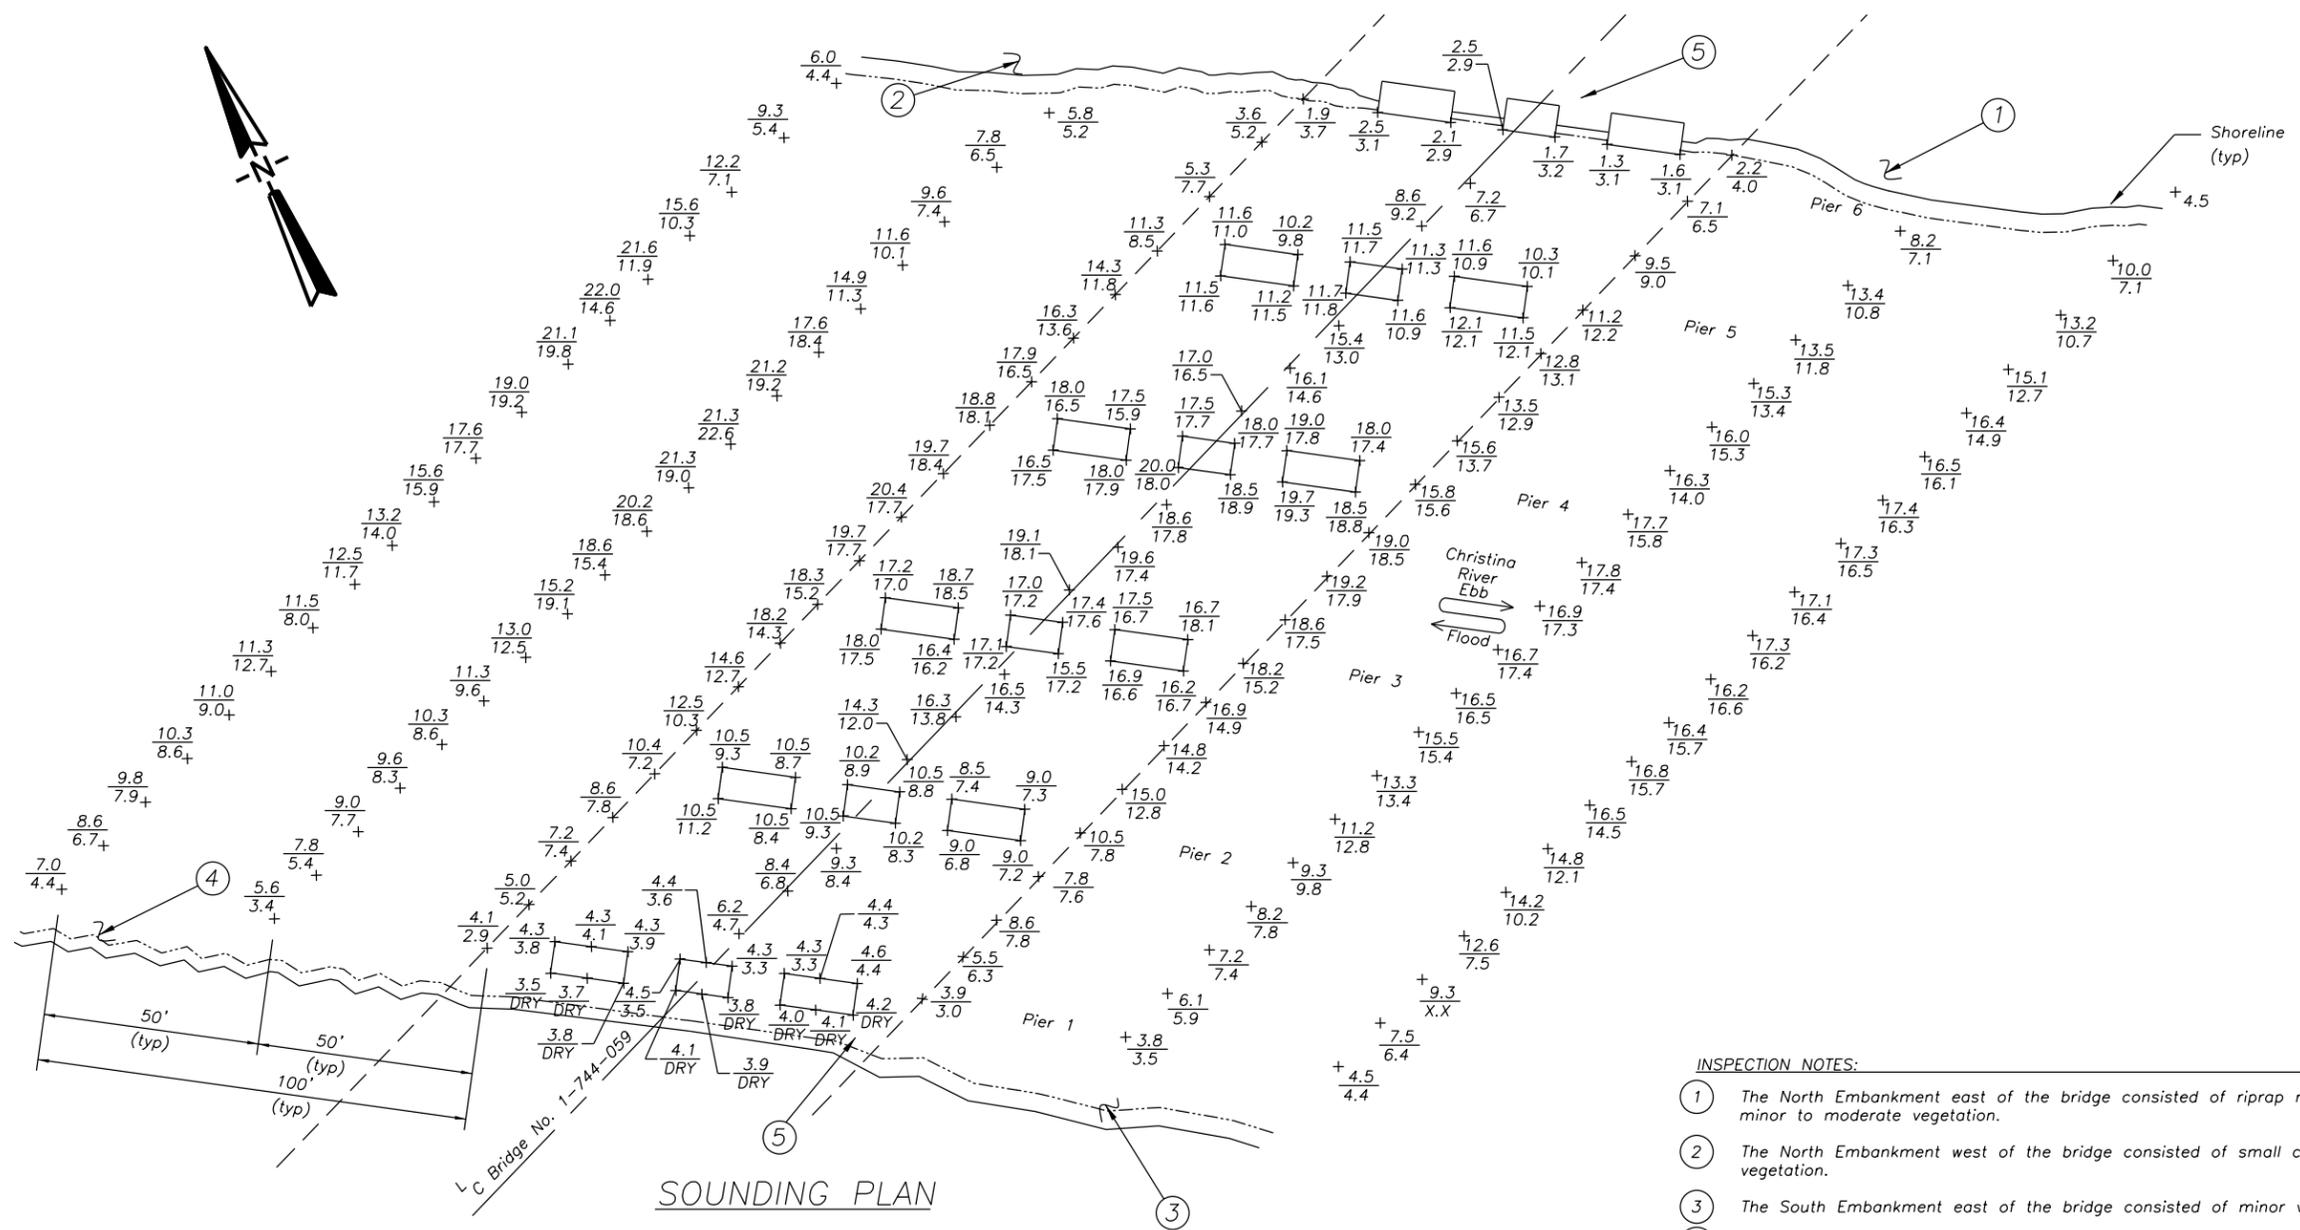
SOUNDING PLAN

measured to be 18.0-feet. Depth soundings indicated that the maximum water depth at the bridge structure was 20.0 feet at the southwest corner of the Center Stem of Pier 4. Refer to Figure 1 in Appendix C for a Sounding Plan of the bridge. At the time of inspection, there were less than 6 inches of visibility and a water velocity of approximately 0 to 2.0 feet per second. The river is tidally influenced and has a tidal swing of approximately 6 feet.

- ① The North Embankment east of the bridge consisted of riprap measuring 6 to 12-inches in diameter with minor to moderate vegetation.
- ② The North Embankment west of the bridge consisted of small cobbles up to 4-inches in diameter with minor vegetation.
- ③ The South Embankment east of the bridge consisted of minor vegetation.
- ④ The South Embankment west of the bridge consisted of riprap measuring 6 to 12-inches in diameter.
- ⑤ The embankments under the bridge consisted of riprap measuring 6 to 12-inches in diameter from the mean high waterline to the mean low waterline.

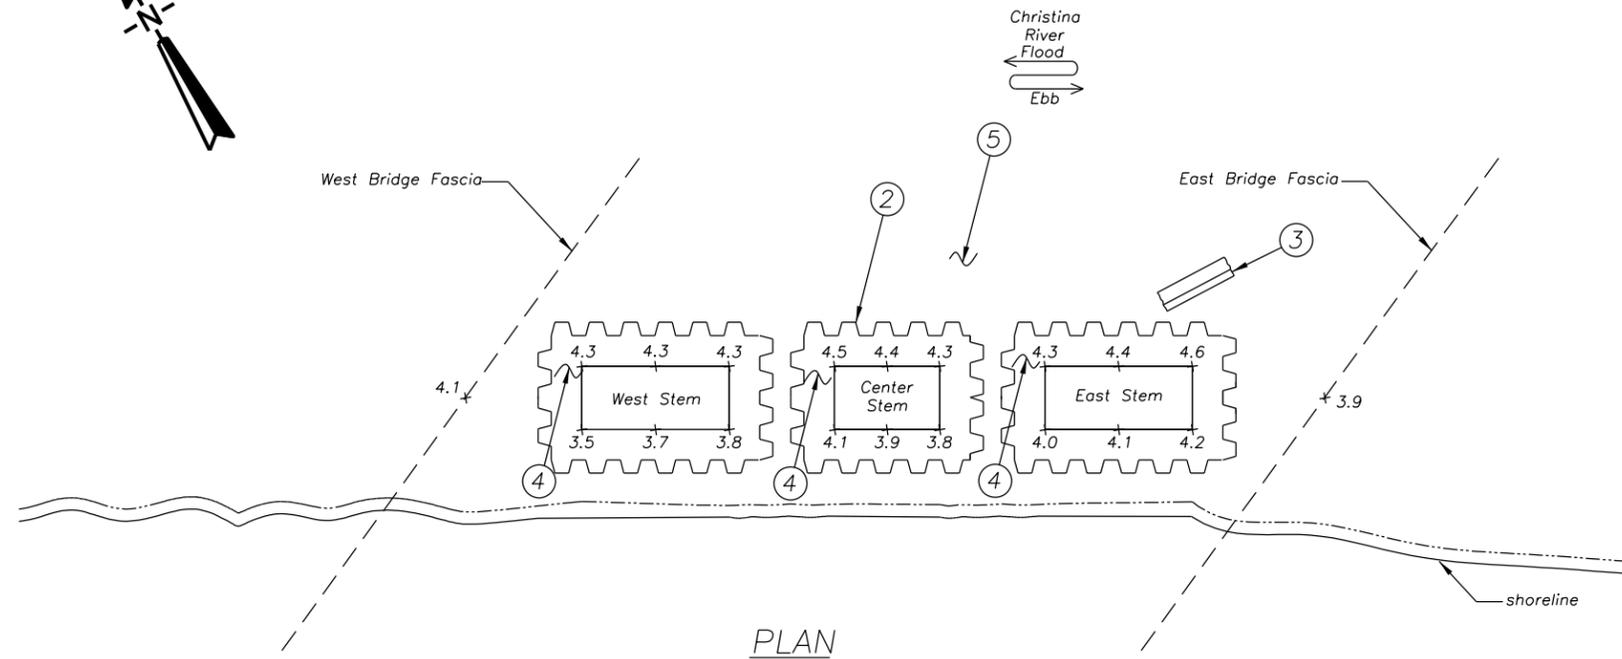
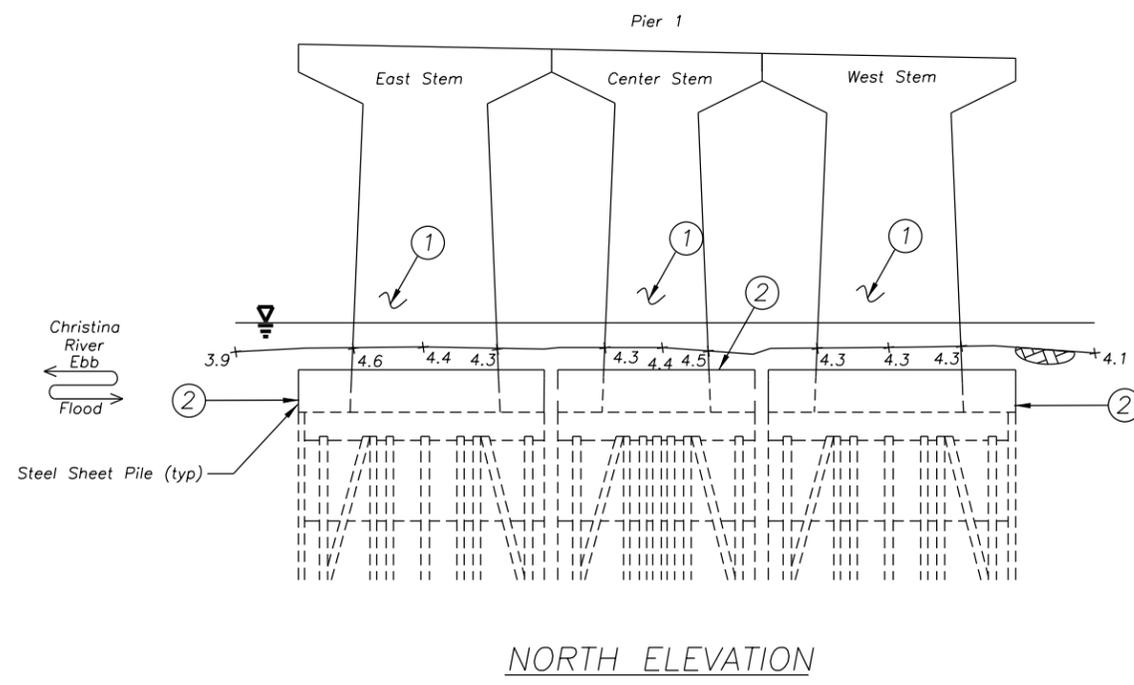
Overall, Pier 1 was in satisfactory condition. The previously noted area of riprap (stones measuring 1 to 3 feet in diameter) between the West Stem and the Center Stem was not observed. A 6-foot long section of steel H-pile is on the channel bottom just north of the steel sheet pile at the East Stem. Refer to Figure 2 in Appendix C for detailed inspection notes of Pier 1.

- INSPECTION NOTES:**
- ① The concrete surfaces of all Pier 1 Stems exhibit up to 1/2-inch deep scaling from the mean high waterline to the channel bottom.
  - ② Steel sheet pile is approximately 4.5-feet off the north face of all pier stems and extends to the centerline of the east and west faces of all pier stems. The steel sheet pile extends out of the channel bottom approximately 1.2-feet. The sheeting is in good condition with minor surface corrosion.
  - ③ Section of steel H-pile, 6-feet long, is north of the steel sheet piling at the East Stem.
  - ④ Within the steel sheet pile, gravel with up to 2-inches of probe rod penetration existed.
  - ⑤ The channel bottom outside the steel sheet pile consists of sandy silt with up to 3-feet of probe rod penetration.

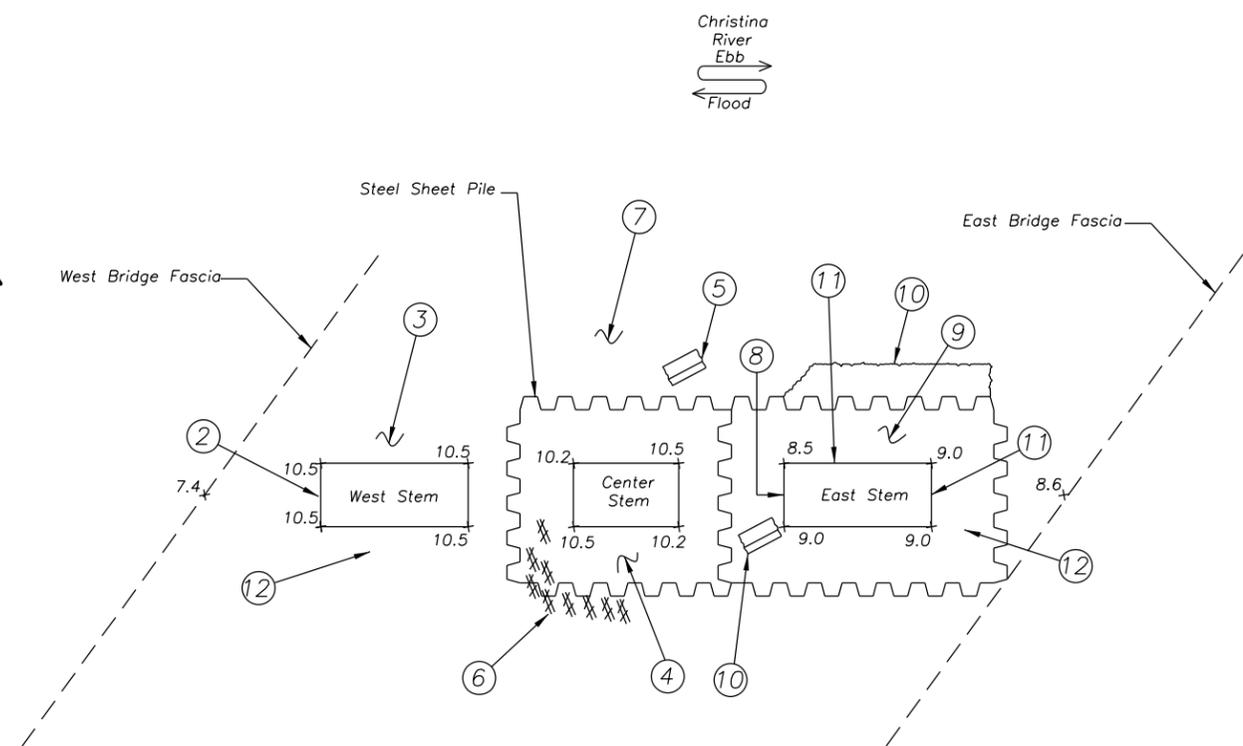
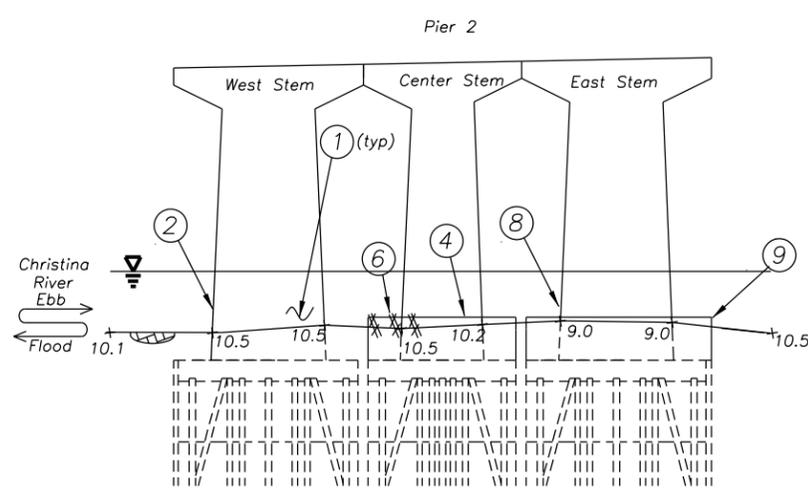
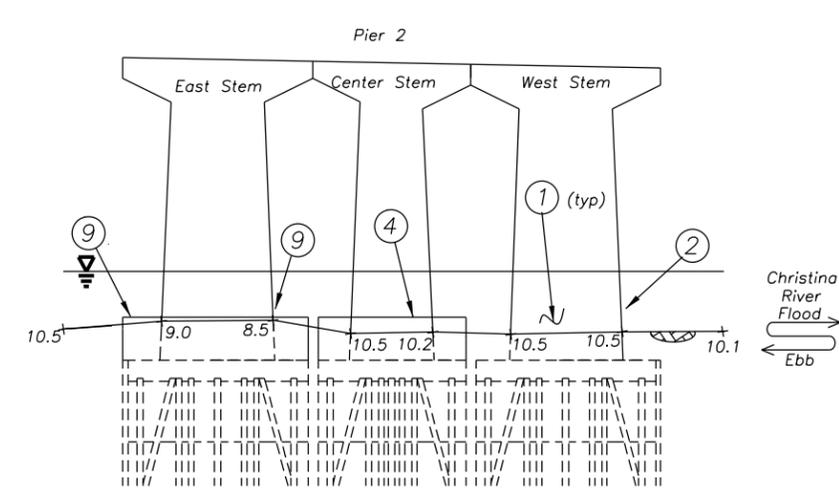
PLAN

Overall, Pier 2 was in fair condition. The east and west ends of the Cent and East Stem's typically exhibit scaling up to 2-inches deep. The west face of the West Stem exhibits a 2' H x 3'-6" W x 3" D area of scaling with exposed corroded steel reinforcement (5 vertical and 3 horizontal steel bars) with up to 60% section loss at the waterline. The west end of the East Stem exhibits scaling up to 2'-6" H x 3'-6" W x up to 2 1/2" D with exposed corroded steel reinforcement (6 vertical and 2 horizontal steel bars) with up to 30% section loss at the waterline. The East Stem exhibits up to 1 1/2-inch deep scaling at the bottom 2-feet of stem on all faces. The top of the footing is exposed along the north and south faces of the Center Stem inside the steel sheet piling. A 6-foot long section of a steel H-pile is on the channel bottom along the north face of the exposed steel sheet pile at the Center Stem and a 3-foot long section of steel H-pile is at the southwest corner of the steel sheet piling. A 2 to 3-foot concrete overpour exists along the north face of the steel sheet pile from the west quarter point to the northeast corner at the East Stem. Refer to Figure 3 in Appendix C for detailed inspection notes of Pier 2.

- ① The concrete surfaces of all Pier 2 Stems exhibit a band of up to 3/4-inch scaling from 1-foot up from the mudline to 5-feet above the mudline.
- ② Spalling on the west nose of the West Stem, extending from the waterline to 2-feet below the waterline measuring 3.5' W x 3" D with exposed corroded steel reinforcement (5 vertical and 3 horizontal steel bars) with up to 60% section loss.

- ③ The channel bottom in the vicinity of the West Stem consists of gravel with up to 1-inch of probe rod penetration.
- ④ Steel sheet pile was exposed around the Center Stem, the top of the steel sheet pile was 2 to 2.5-feet from the mudline. The top of the footing was exposed along the north and south faces of the Center Stem inside the steel sheet pile. Within the steel sheet pile along the east and west faces of the Center Stem, sandy gravel with up to 1-foot probe rod penetration exists.

- ⑤ A section of a steel H-pile, 6-feet long, is on the channel bottom along the north face of the exposed steel sheet pile at the Center Stem.
- ⑥ Minor timber debris is present at the west nose of the Center Stem and extends 6-feet east, down the south face of the steel sheet pile.

- ⑦ The channel bottom outside the steel sheet pile the stems consists of sand with up to 4-inches probe rod penetration.
- ⑧ An area of spalling is present on the west nose of the East Stem extending from the waterline to 2.5-feet below the waterline measuring 3.5' W x 2.5" D with exposed corroded steel reinforcement (6 vertical and 2 horizontal rebars) with up to 30% section loss.

- ⑨ Steel sheet pile is exposed around the entire East Stem with the top of the steel sheet pile located 2 to 2.5-feet from the mudline. Within the steel sheet pile, there is gravel with 0-inches of probe rod penetration covering the footing. At the west nose there was a 3-foot long section of steel H-pile on the gravel.

- ⑩ Concrete overpour exists along the north face of the steel sheet pile from the west quarter point to the northeast corner at the East Stem. The overpour extends 2 to 3-feet out from the north face of the steel sheet pile with 6 to 18-inches of vertical exposure.

- ⑪ There is scaling in the East Stem measuring 2' H x 1 1/2" D. The scaling starts at gravel inside sheeting and extends around the perimeter.
- ⑫ The West and East Stem footings are exposed around the full perimeter.

The bands of scaling and associated concrete deterioration at Piers 2 through 5 should be repaired. In lieu of traditional concrete patching repairs, which may be short-lived, consideration should be given to installing a fiberglass jacket system (or similar method) around each pier stem to provide a longer-life repair.

The channel bottom configuration should continue to be closely monitored during future underwater inspections to ensure that the footing exposure at Piers 2, 4, and 5 remains minimal and the scour depressions at Piers 2 and 3 are not increasing.

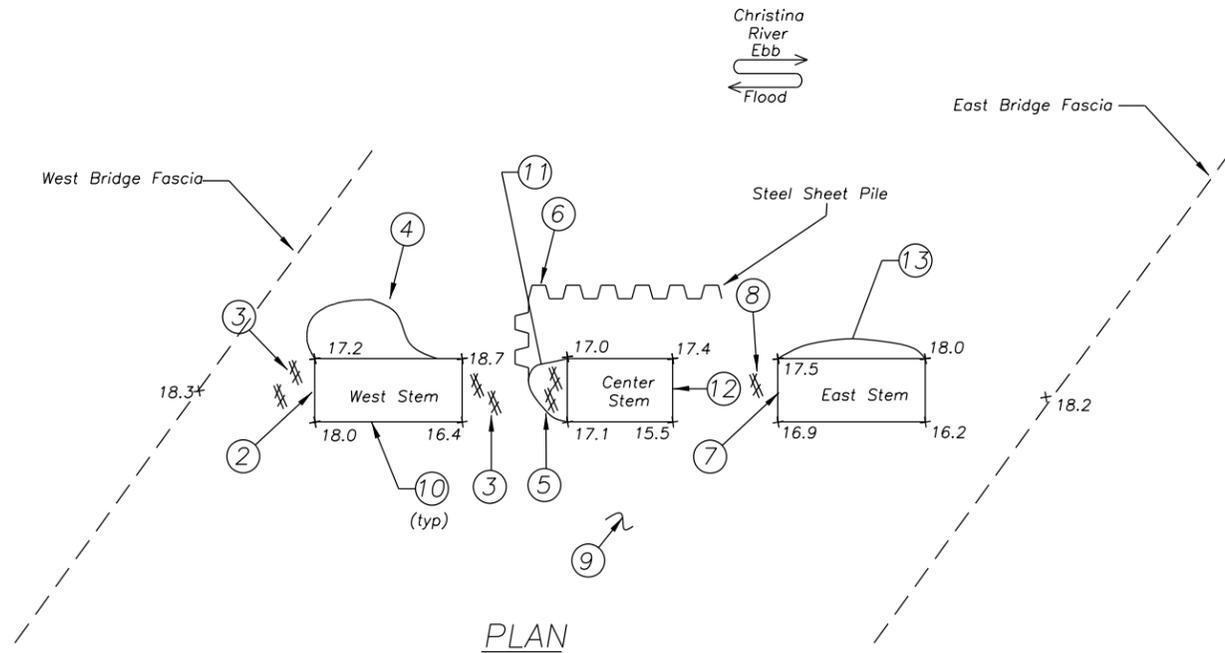
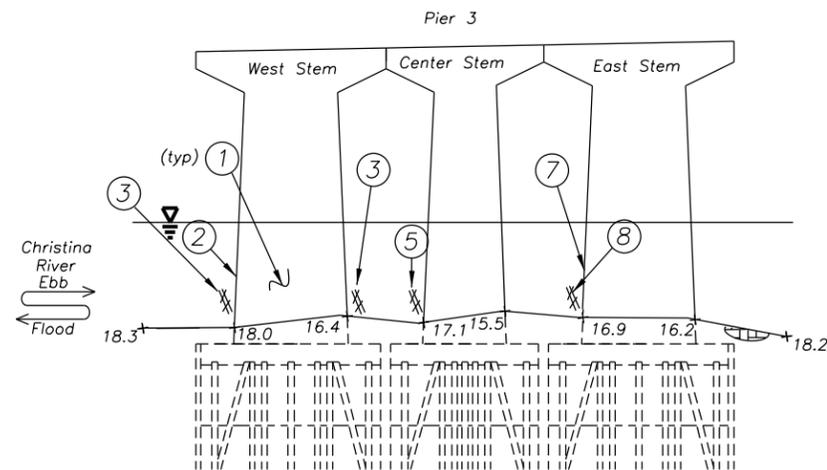
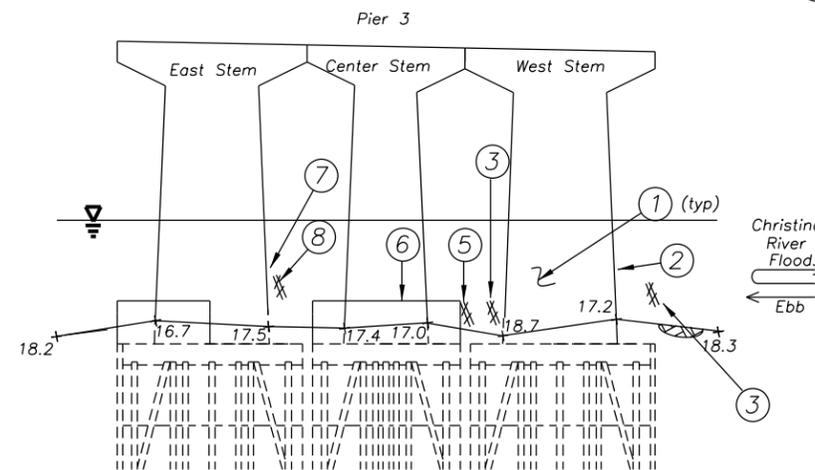
Overall, Pier 3 was in fair condition. The stems typically exhibit a 2' H x 1 1/2" D band of scaling on all faces, 6-feet below the waterline. The west end of the West Stem exhibits a 5' H x 3'-6" W x 3" D area of scaling with exposed corroded steel reinforcement (3 vertical and 2 horizontal steel bars) with up to 20% section loss at the waterline. The west face of the East Stem exhibits a 2'-6" H x 3'-6" W x 3" D area of scaling with exposed corroded steel reinforcement (one horizontal bar with only the outer surface of the steel reinforcement exposed) at the waterline. A 10' L x 1' D scour depression extends 3-feet north of the north face of the West Stem; a 3' L x 1' D scour depression extended 3-feet out from the west face of the Center Stem; a 3' L x FW x 1' D scour depression extended 3-feet away from the north face of the East Stem. There is a 14' H x up to 1/16" W vertical crack on the east face of the Center Stem that terminates 4 feet below the waterline. Refer to Figure 4 in Appendix C for detailed inspection notes of Pier 3.

- ① The concrete surfaces of all Pier 3 Stems exhibits a band of up to 1-inch deep scaling from the high water mark to the waterline.
- ② Area of spalling on the west nose of the West Stem extending from the waterline to 5-feet below the waterline measuring 3.5' W x 3" D with exposed corroded steel reinforcement (3 vertical and 2 horizontal steel bars) with 20% section loss.

- ③ Minor accumulations of timber debris measuring 2 to 6-inches in diameter exists at the east and west noses of the West Stem at the channel bottom.
- ④ A 10-foot long scour depression extended 3-feet off the north face of the West Stem and was 1-foot deep.

- ⑤ Minor accumulations of timber debris measuring 3 to 12-inches in diameter exists at the west nose of the Center Stem.
- ⑥ Steel sheet pile is exposed 14-feet below the waterline from the northeast corner of the Center Stem, along the north face, and terminated into the channel bottom at the centerline of the west face.

- ⑦ An area of scaling/spalling on the west nose of the East Stem extending from the waterline to 2.5-feet below the waterline measuring 3.5' W x 3" D with exposed corroded steel reinforcement (1 horizontal bar).

- ⑧ Minor accumulations of timber debris consisting of branches measuring up to 12-inches in diameter exists at the west nose of the East Stem.
- ⑨ The channel bottom in the vicinity of the pier consists of sand and gravel with up to 6-inches of probe rod penetration.

- ⑩ There is a band of deterioration 6-feet below the waterline measuring 2' H x 1 1/2" D on all faces of the pier stems.
- ⑪ A 3-foot wide scour depression extended 3-feet off the west face of the Center Stem and was 1-foot deep.

- ⑫ There is a 14' H x up to 1/16" W vertical crack on the east face of the Center Stem, starting at 4 feet below the waterline and extending up.
- ⑬ A full-width scour depression extended 3-feet off the north face of the East Stem and was 1-foot deep.

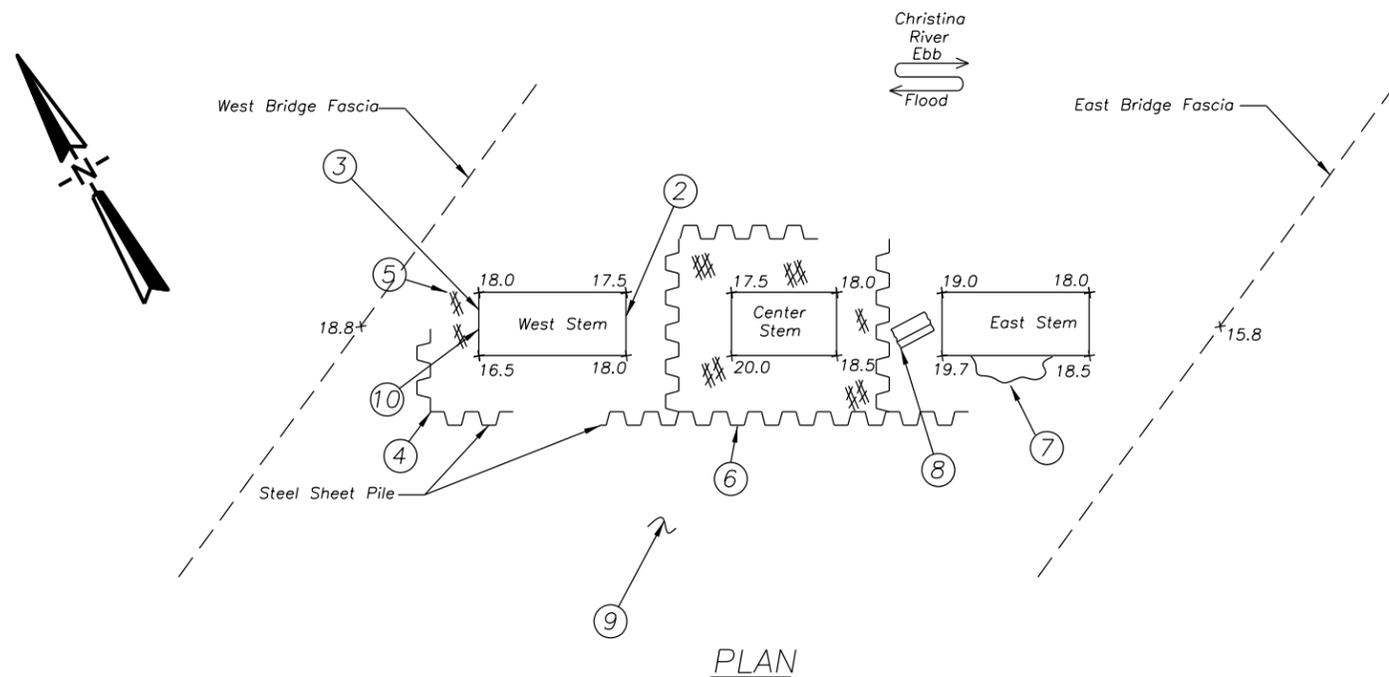
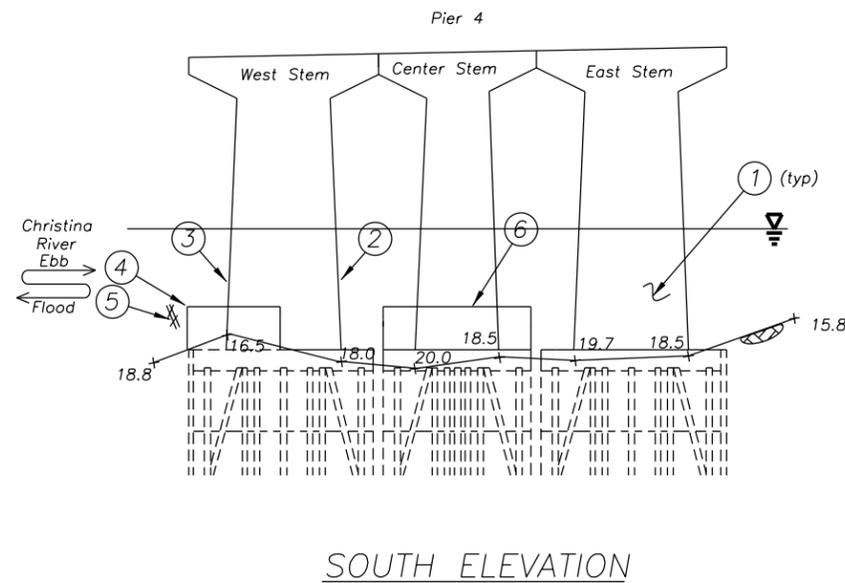
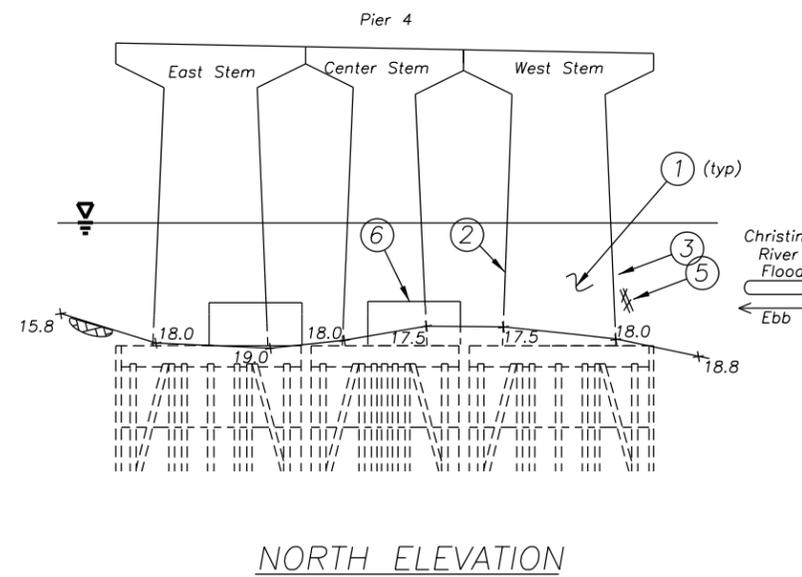
Overall, Pier 4 was in satisfactory condition. The east face of the West Stem exhibits 2' H x 3'-6" W x 3" D scaling with exposed corroded steel reinforcement (with 1 horizontal steel bar) at the waterline. The west face of the West Stem exhibits 2' H x 3'-6" W x 3" D scaling with exposed corroded steel reinforcement (1 vertical and 1 horizontal steel bar) at the waterline. At the center of the west face of the West Stem is a vertical crack up to 30' H x up to 1/16" W that terminates 5-feet

below the waterline. The previously reported area of scaling with exposed corroded steel reinforcement on the east and west faces of the East Stem 2-feet above the mudline was not observed. The top of the footing was exposed along the south face of the East Stem. Steel debris, up to 4-feet long, is on the channel bottom at the west face of the East Stem. Refer to Figure 5 in Appendix C for detailed inspection notes of Pier 4.

- ① The concrete surfaces of all Pier 4 Stems exhibits a band of up to 1-inch deep scaling, 3 to 5-feet high, 3-feet below the waterline.
- ② Area of spalling on the east nose of the West Stem extending from 1 to 2.5 feet below the waterline measuring 3.5' W x 3" D with exposed corroded steel reinforcement.

- ③ Area of spalling on the west nose of the West Stem extending from 1 to 2.5 feet below the waterline measuring 3.5' W x 3" D with exposed corroded steel reinforcement (1 vertical and 1 horizontal steel bar).

- ④ Steel sheet pile is exposed from the centerline of the west nose of the West Stem extending to the southwest corner of the pier and extended 6-feet east on the south face of the pier. The steel sheet pile extended approximately 3-feet out of the channel bottom.

- ⑤ Moderate accumulations of timber debris consisting of branches measuring 6 to 12-inches in diameter exists at the west nose of the West Stem.
- ⑥ Steel sheet pile is exposed at the Center Stem along the south face, east face, west face, and extended 15-feet east along the north face from the northwest corner. The steel sheet pile extended approximately 2-feet out of the channel bottom. The top of the footing is exposed along the south face and west face inside the steel sheet pile.

- ⑦ The top of the footing at the East Stem is exposed along the south face of the pier and extended 2 to 4-feet off the pier stem.
- ⑧ Steel debris measuring approximately 4-feet long exists on the channel bottom at the west face of the East Stem.

- ⑨ The channel bottom in the vicinity of the pier consists of sand and gravel with up to 2-inches of probe rod penetration.
- ⑩ There is a 30' H x 1/16" W vertical crack starting 5-feet below the waterline, extending up the center of the west face of the West Stem.

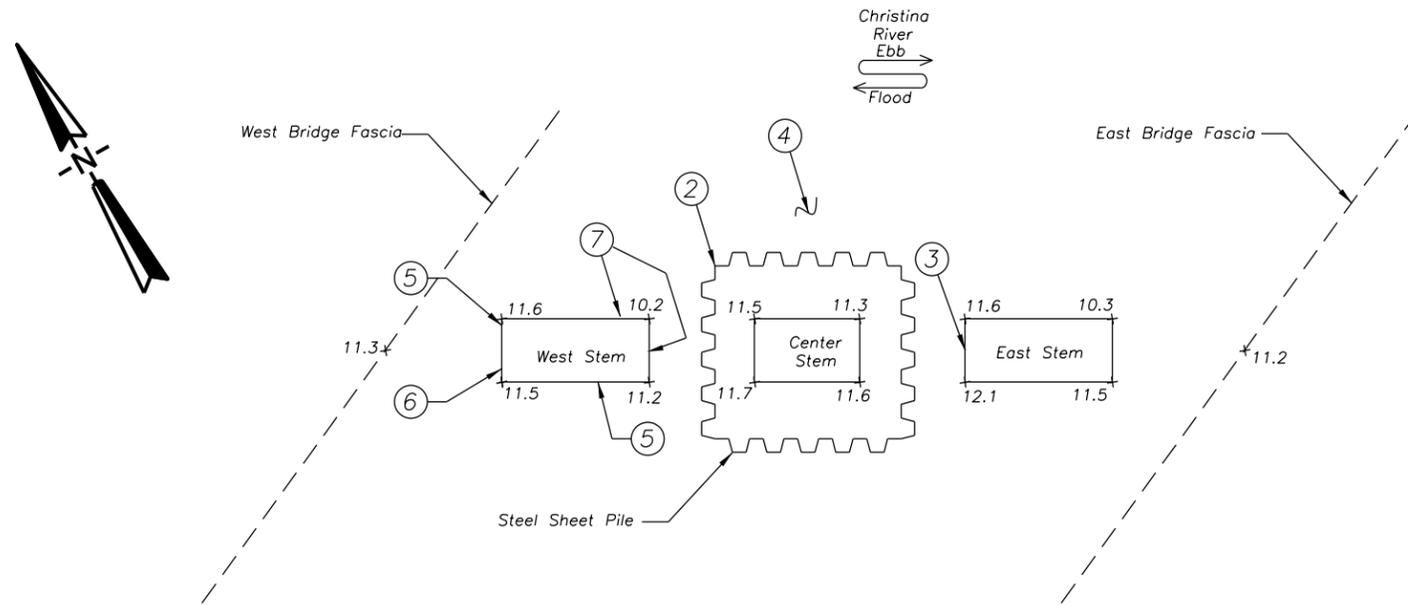
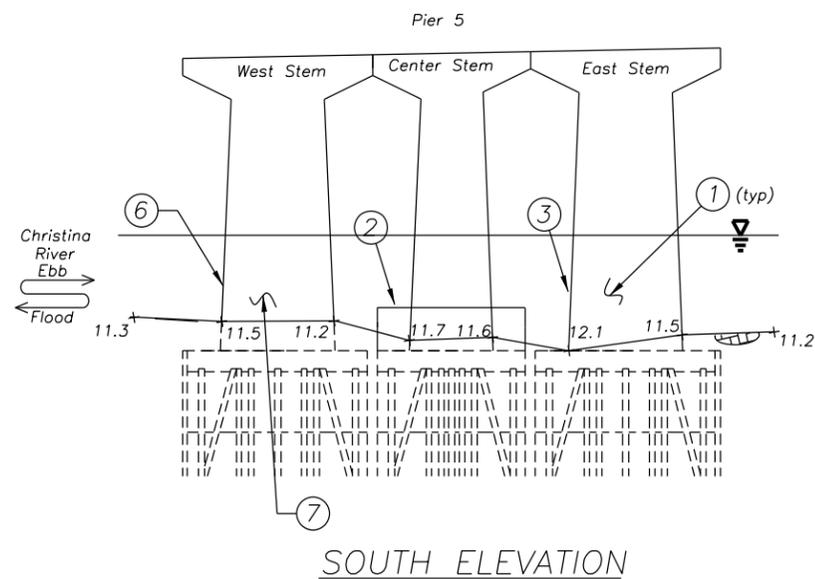
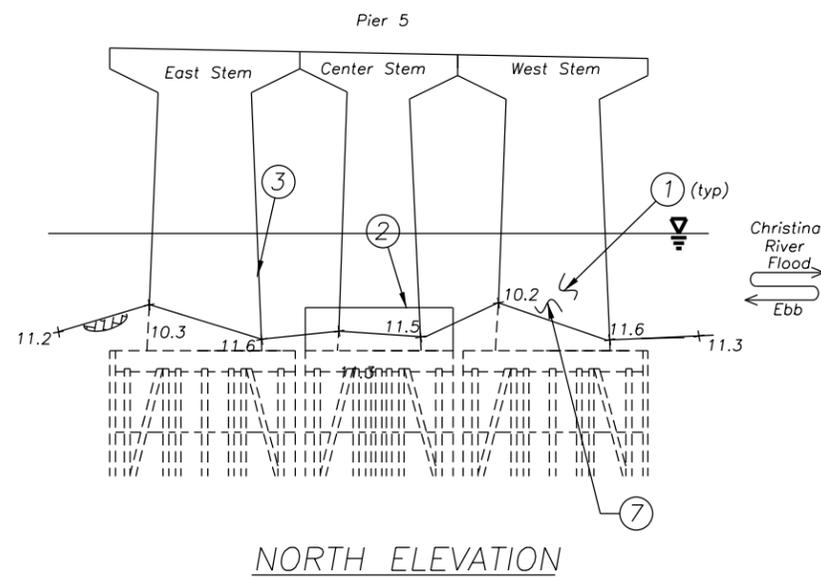
PLAN

Overall, Pier 5 was in fair condition. The West Stem exhibits scaling, up to 2' H x FW x 6" D with exposed corroded steel reinforcement (4 horizontal and 5 vertical steel bars) with up to 90% section loss, 4-feet from the mudline on the west face. The West Stem exhibits 4' H x FW x up to 3" D scale with one horizontal steel bar exposed on the south, east and north faces, 2-feet from the mudline. The top of the footing was exposed around the entire Center Stem. There is map cracking and a 1/32-inch wide vertical crack extending 15-feet up from the band of scaling on the west face of the West Stem. The East Stem exhibits scaling up to 2' H x 8' L x 3" D with one exposed horizontal steel bar on the north face and 2' H x FW x 3" D with an exposed horizontal and vertical steel bar on the west face. Refer to Figure 6 in Appendix C for detailed inspection notes of Pier 5.

- ① The concrete surfaces of all Pier 5 Stems exhibits a band of 1up to 1-inch deep scaling from the low water mark to 6-feet below the waterline.
- ② Steel sheet pile is exposed around the Center Stem and extended approximately 3.5-feet out from the channel bottom. The top of the footing is exposed within the steel sheet pile.

- ③ Area of scaling at the north and west faces of the East Stem measuring 2' H x 8' L x 3" D and 2' H x FW x 3" D, respectively, with exposed corroded vertical and horizontal steel reinforcement, 4-feet off the mudline.

- ④ The channel bottom in the vicinity of the pier consists of gravel and concrete debris measuring 3 to 8-inches in diameter.
- ⑤ There is map cracking and a 1/32-inch wide vertical crack extending 15-feet up from the band of scaling on the west face of the West Stem.

- ⑥ The scaling on the west face of the West Stem is 2' H x FW x 6" D with exposed corroded steel reinforcement (4 horizontal and 5 vertical steel bars) with up to 90% section loss, 4-feet off the mudline.

- ⑦ The scaling on the north, south, and east faces of the West Stem is 4' H x FW x 3" D with exposed steel reinforcement (1 horizontal steel bar), 2-feet off the mudline.

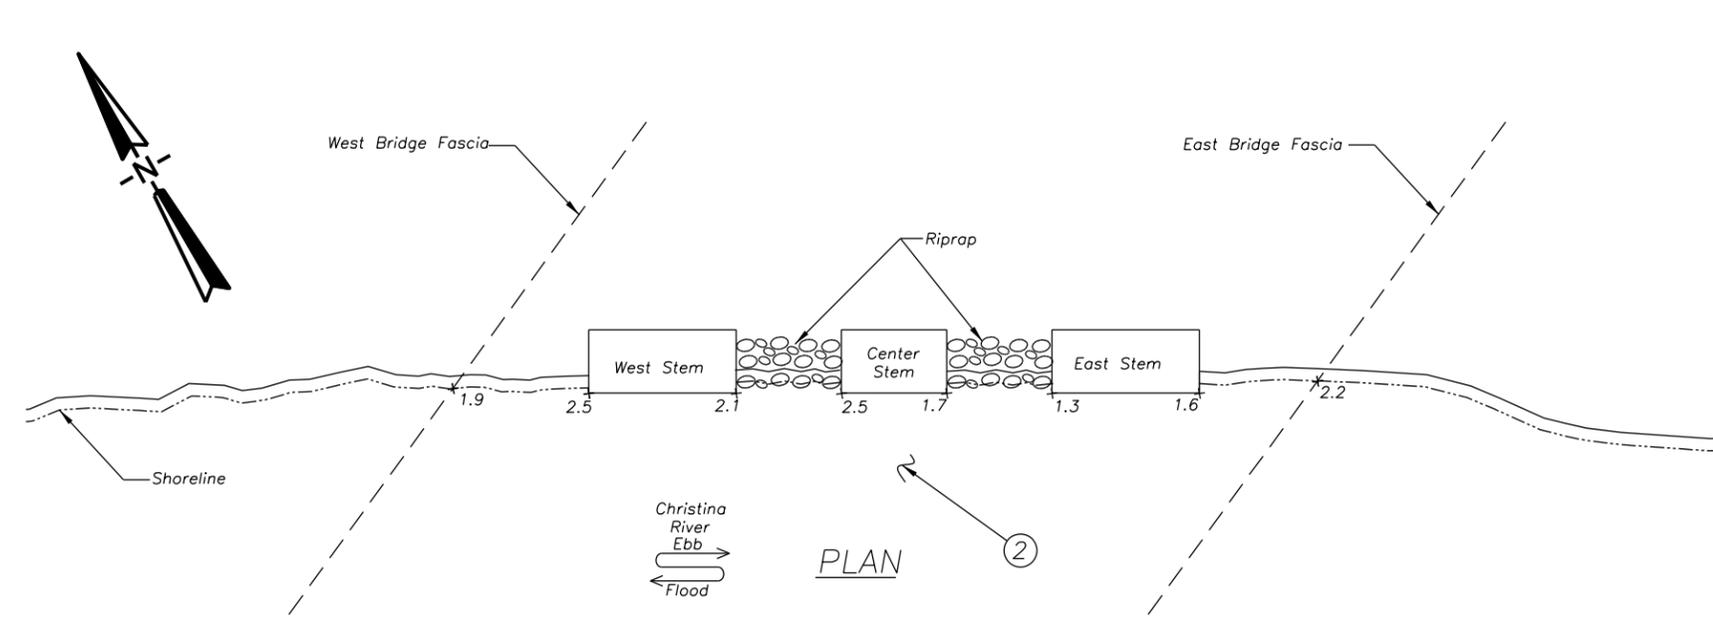
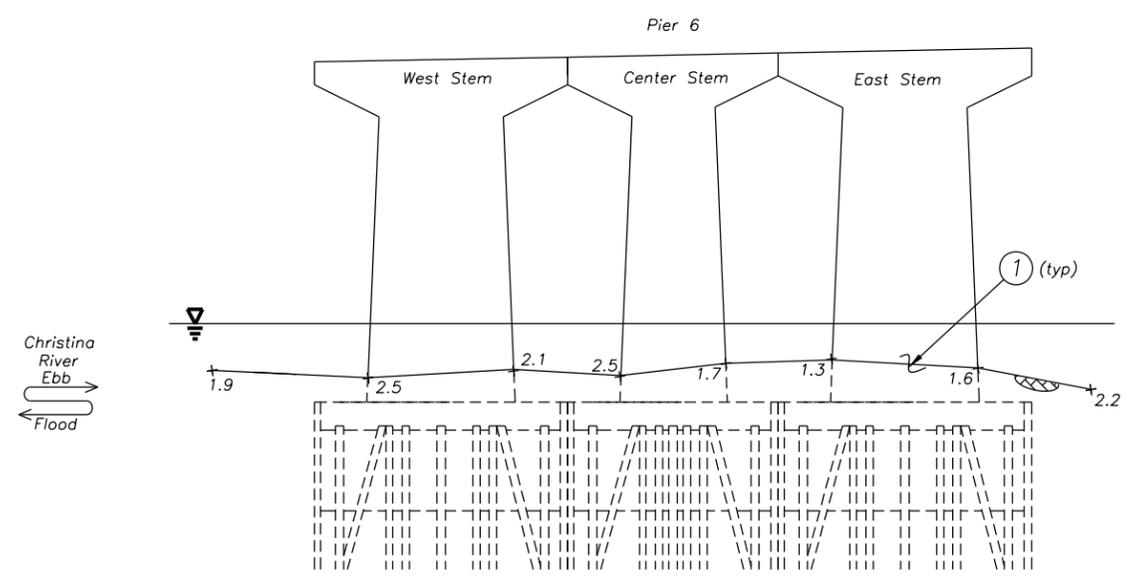
Overall, Pier 6 was in satisfactory condition. Refer to Figure 7 in Appendix C for detailed inspection notes of Pier 6.

- INSPECTION NOTES:**
- ① The concrete surfaces of all Pier 6 Stems exhibits a band of up to 1/2-inch deep scaling from the mean high waterline to the mudline.
  - ② The channel bottom in the vicinity of the pier consists of gravel and concrete debris measuring 3 to 8-inches in diameter with riprap between pier stems.
