Delaware Department of
Transportation

**Underwater Inspection of
Interstate 95 over Christina River
Bridge No. 1-744-059
April 10, 2018**

Bridge No. 1-744-059
Interstate 95 over Christina River

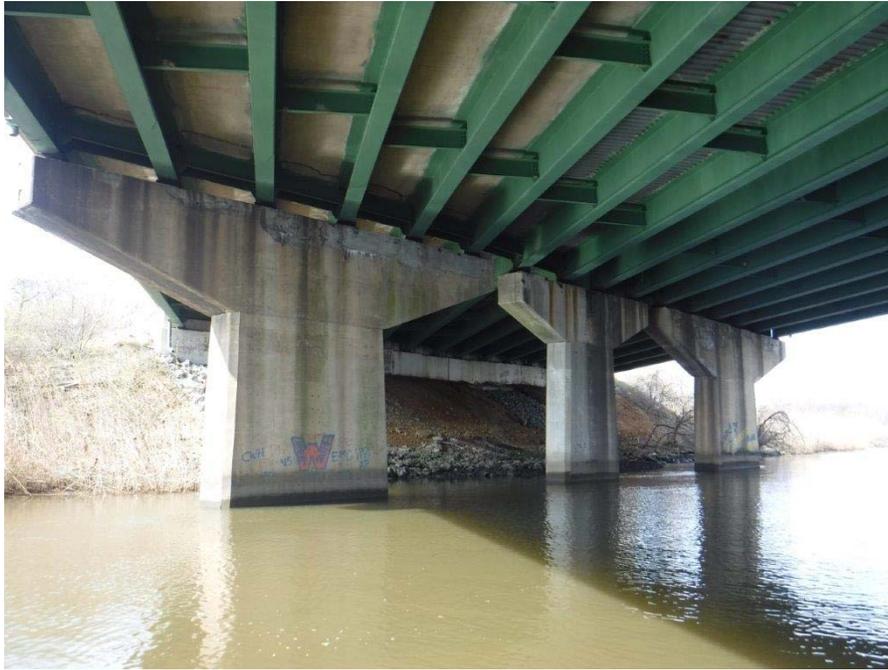
The reinforced concrete stems at Piers 2 through 5 typically exhibit scaling 2.5 feet high x up to 1 inch deep throughout the tidal zone. Around the piers there is typically steel sheet piling that protrudes up to 3.5 feet high from the mudline; the sheet piling typically exhibits minor to moderate surface corrosion. The top of the footing was exposed at Pier 2. Timber debris was observed around the stems of all piers. The channel bottom consisted of sand, gravel, and silty sand with up to 3 feet of probe rod penetration outside the steel sheet piling and predominately hard packed sand with up to 4 inches of probe rod penetration inside the steel sheet piling. Refer to Photograph 3 in Appendix B for a view of a typical pier.

**Photograph 3. Typical Configuration of Pier (Pier 1 shown),
Looking Southwest.**

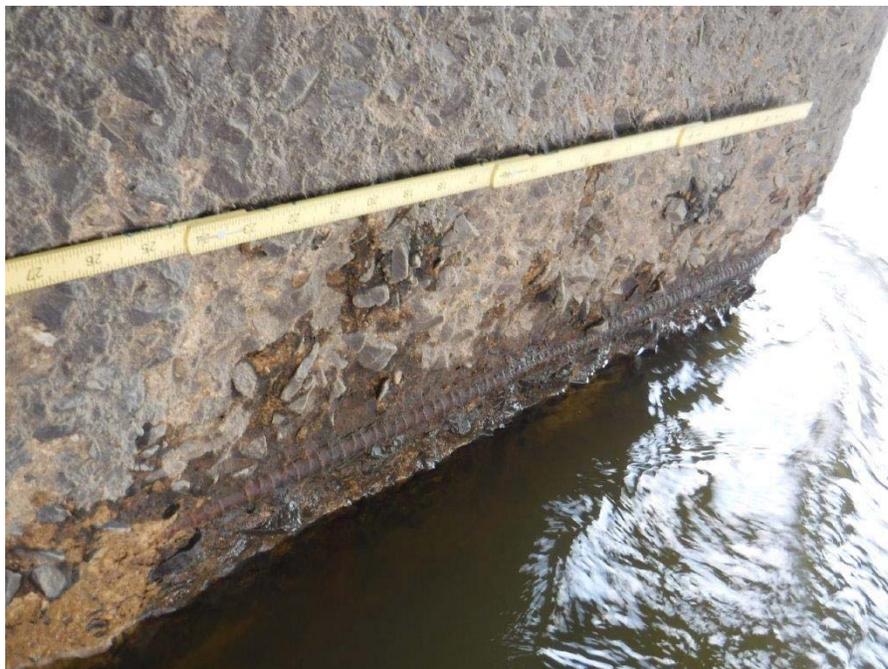
Overall, Pier 4 was in fair condition. The west face of the West Stem exhibits 5 foot high x full-width x 4 inch deep scaling with exposed corroded steel reinforcement (5 vertical and 1 horizontal steel bars), at the waterline that extends 1-foot onto the north and south faces. The east face of the West Stem exhibits 3 foot high x full-width x 4 inch deep scaling with exposed corroded steel reinforcement (2 horizontal steel bars) at low waterline. At the center of the west face of the West Stem is a vertical crack, up to 30 feet high x up to 1/16 inch wide that terminates 5 feet below the waterline. The east face of the East Stem exhibits 3 foot high x full width x 4 inch deep scaling with exposed corroded steel reinforcement (1 vertical and 2 horizontal steel bars), starting at the low waterline. The west face of the East Stem exhibits 3 foot high x full width x 4 inch deep scaling with exposed corroded steel reinforcement (5 vertical and 4 horizontal steel bars), starting at the low waterline. One of the horizontal steel bars is broken. Steel debris, up to 4 feet long, is on the channel bottom at the west face of the East Stem and at the east face of the West Stem. Refer to Photograph 4 in Appendix B for scaling defect. Refer to Figure 6 in Appendix C for detailed inspection results of Pier 4.

**Photograph 4. Pier 4, west face of East Stem, Looking East.
Note: 3' H x full-width x up to 4" D scale with exposed steel
reinforcement.**

The bands of scaling and associated concrete deterioration at Piers 2 through 5 should be repaired. In lieu of traditional concrete patching repairs, which may be short-lived, consideration should be given to installing a fiberglass jacket system (or similar method) around each pier stem to provide a longer-life repair.

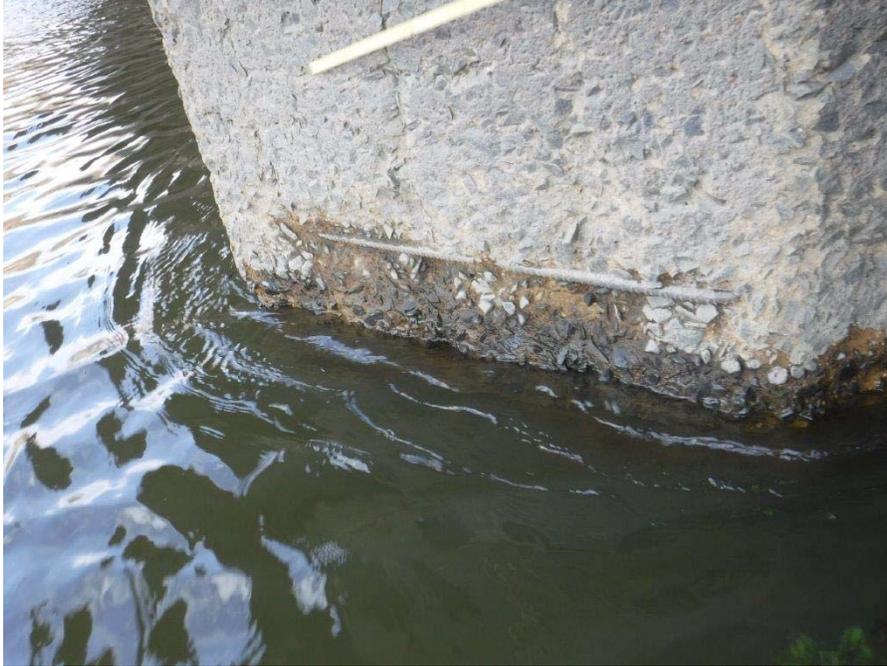
Overall, Pier 5 was in fair condition. The west face of the West Stem exhibits 3 foot high x full width x 4 inch deep scaling with exposed corroded steel reinforcement (4 horizontal and 8 vertical steel bars) with up to 90% section loss to the horizontal reinforcement, 4 feet from the mudline that extends 4-feet long onto the north face. The West Stem exhibits 2.5 foot high x up to 3 inch deep scaling along the south, east and north faces with an exposed horizontal steel bar and a vertical steel bar at the southeast chamfer, 3 feet above the mudline. There is map cracking and a 1/32 inch wide vertical crack extending 15 feet up from the band of scaling on the west face of the West Stem. The west face of the East Stem exhibits 3 foot high x full width x 3 inch deep scaling with exposed corroded steel reinforcement (3 vertical and 2 horizontal steel bars), 6 feet above the mudline that extends 5 feet long on the north face with one exposed horizontal steel reinforcement bar at the low waterline. The northeast corner of the East Stem has one foot high x 2 inch deep scale with exposed corroded steel reinforcement (1 horizontal steel bar). Refer to Photograph 5 in Appendix B for scaling defect. Refer to Figure 7 in Appendix C for detailed inspection results of Pier 5.

Photograph 5. Pier 5, west face of West Stem, Looking East.
Note: Exposed steel reinforcement.

ELEM	DESCRIPTION	UNITS	TOTAL	CS1	CS2	CS3	CS4	COMMENTS
210	RC Pier Wall	LF	41	0	23	18	0	<p>Abrasion CS3: (14 LF) The West Stem exhibits 2'-6" H x up to 3" D scaling along the south, east and north faces with an exposed horizontal steel bar and a vertical steel bar at the southeast chamfer, 3-feet above the mudline. The west face of the East Stem exhibits 3' H x full-width x 3" D scaling with exposed corroded steel reinforcement (3 vertical and 2 horizontal steel bars), 6-feet above the mudline that extends 5-feet long on the north face with one exposed horizontal steel bar at the low waterline.</p> <p>CS2: (23 LF) The stems exhibit scaling 2'-6" H x up to 1-inch deep throughout the tidal zone. The NE corner of the East Stem has 1' H x 2" D scale with exposed corroded steel reinforcement (1 horizontal steel bar). There is a 15' H x up to 1/32" W vertical crack and map cracking on the west face of the West Stem.</p> <p>Exposed Rebar CS3: (4 LF) The west face of the West Stem exhibits 3' H x full-width x 4" D scaling with exposed corroded steel reinforcement (4 horizontal and 8 vertical steel bars) with up to 90% section loss, 4-feet from the mudline that extends 4-feet long onto the north face (Photo 5).</p>

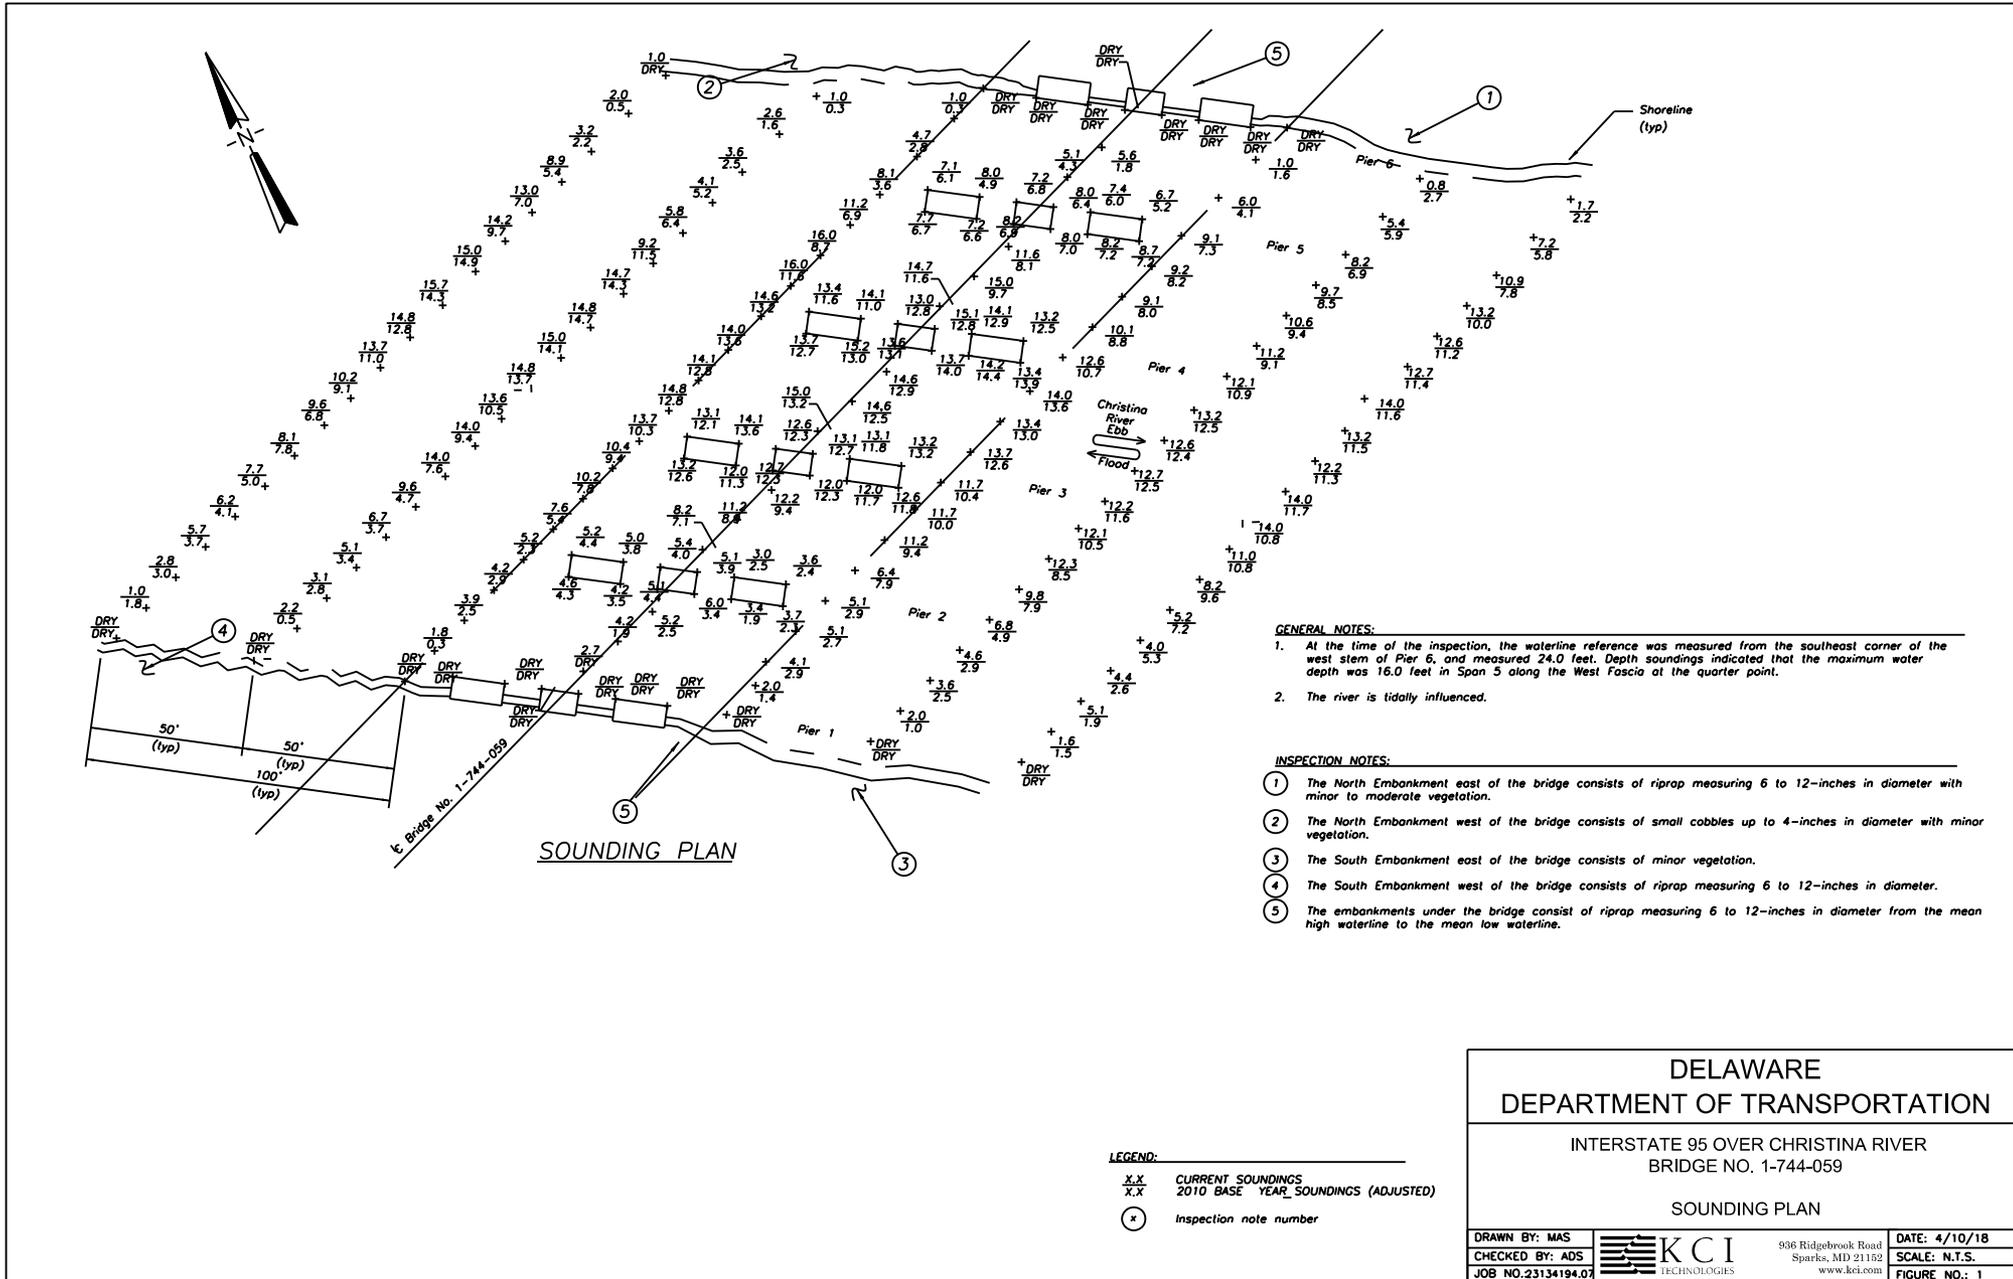
DELAWARE DEPARTMENT OF TRANSPORTATION		
INTERSTATE 95 OVER CHRISTINA RIVER BRIDGE NO. 1-744-059		
SOUNDING PLAN		
DRAWN BY: MAS		DATE: 4/10/18
CHECKED BY: ADS		SCALE: N.T.S.
JOB NO. 23134194.07		FIGURE NO.: 1

Overall, the submerged substructure units of Structure No.1-744-059 are in fair condition. A comparison of the 2010 Base Year Soundings and the soundings taken during this inspection revealed minor scour along the west fascia of the structure. The footing exposure at Pier 2 is not of concern at this time given that the bottom of the footing was embedded below the current channel bottom, restrained within the steel sheet pile walls, and the footing is supported by piles.

- The North Embankment east of the bridge consists of riprap measuring 6 to 12-inches in diameter with minor to moderate vegetation.
- The North Embankment west of the bridge consists of small cobbles up to 4-inches in diameter with minor vegetation.
- The South Embankment east of the bridge consists of minor vegetation.
- The South Embankment west of the bridge consists of riprap measuring 6 to 12-inches in diameter.
- The embankments under the bridge consist of riprap measuring 6 to 12-inches in diameter from the mean high waterline to the mean low waterline.

The channel bottom configuration should continue to be closely monitored during future underwater inspections to ensure that the footing exposure at Pier 2 remains minimal.

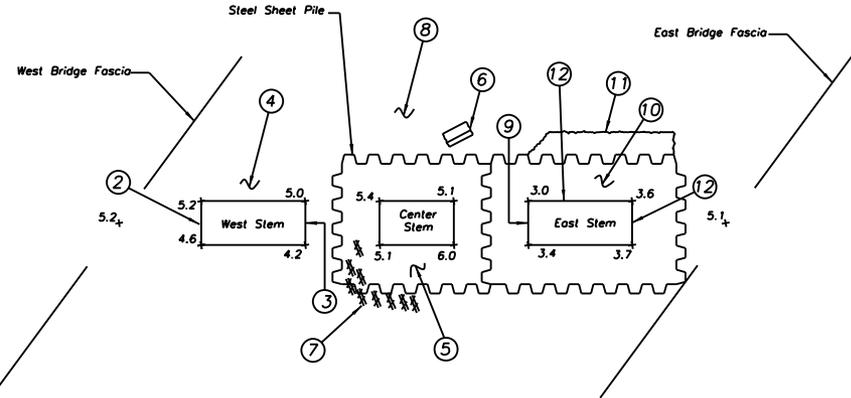
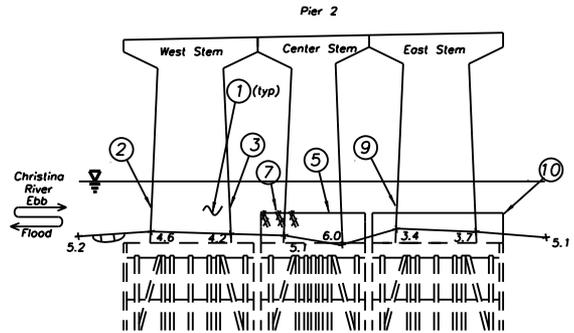
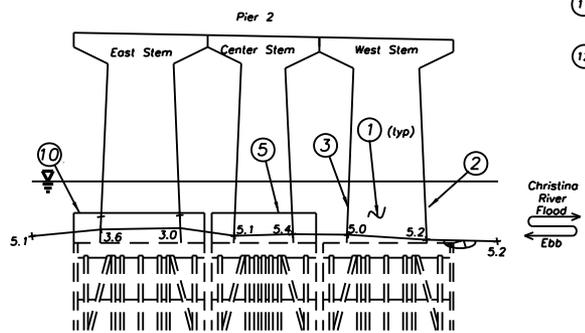
DELAWARE DEPARTMENT OF TRANSPORTATION	
INTERSTATE 95 OVER CHRISTINA RIVER BRIDGE NO. 1-744-059	
PIER 2 INSPECTION DETAILS	
DRAWN BY: MAS CHECKED BY: ADS JOB NO.: 23134194.07	121 Continental Drive Suite 207 Newark, DE 19713 www.penmon.com DATE: 4/10/2018 SCALE: N.T.S. FIGURE NO.: 4

Overall, Pier 2 was in fair condition. The west face of the West Stem exhibits a 6 foot high x full width (3'-6") x 3 inch deep area of scaling with exposed corroded steel reinforcement (2 vertical and 3 horizontal steel bars) with 20% section loss on the vertical bars and up to 60% section loss on the horizontal bars, starting 2.5 feet above the mudline. The east face of the West Stem exhibits a 3 foot high x full-width x 2 inch deep area of scaling with exposed corroded steel reinforcement (3 horizontal and 2 vertical steel bars), 1 foot above the mudline that extends 5 feet onto the north face. The west face of the East Stem exhibits scaling up to 4 foot high x full-width x up to 2.5 inch deep with exposed corroded steel reinforcement (11 vertical and 2 horizontal steel bars) with up to 30% section loss, 6 feet above the mudline that extends 18 inches on both the north and south faces. The East Stem

exhibits 4 foot high x up to 2 inch deep scaling/poorly consolidated concrete at the mudline on all faces. The top of the footing is exposed along the north and south faces of the Center Stem inside the steel sheet piling. A 6 foot long section of a steel H-pile is on the channel bottom along the north face of the exposed steel sheet pile at the Center Stem and a 3 foot long section of steel H-pile is at the southwest corner of the steel sheet piling. A 2 to 3 foot concrete overpour with 6 to 18 inches of vertical exposure exists along the north face of the steel sheet pile from the west quarter point to the northeast corner at the East Stem. Refer to Figure 4 in Appendix C for detailed inspection results of Pier 2.

- 1 The concrete surfaces of all Pier 2 Stems exhibit a band of 2'-6" H x up to 1-inch scaling in the tidal zone.
- 2 Scaling on the west nose of the West Stem, measuring 6' H x full-width x 3" D with exposed corroded steel reinforcement (2 vertical and 3 horizontal steel bars) with 20% section loss on the vertical steel bars and up to 60% section loss on the horizontal steel bars, starting 2.5-feet above the mudline.

- 3 Scaling on the east nose of the West Stem, measuring 3' H x full-width x 2" D with exposed corroded steel reinforcement (3 horizontal steel bars and 2 vertical steel bars), 1-foot above the mudline that extends 5-feet onto the north face.

- 4 The channel bottom in the vicinity of the West Stem consists of gravel with up to 1-inch of probe rod penetration.
- 5 Steel sheet pile was exposed around the Center Stem, the top of the steel sheet pile was 2 to 3-feet from the mudline. The top of the footing was exposed along the north and south faces of the Center Stem inside the steel sheet pile. Within the steel sheet pile along the east and west faces of the Center Stem, sandy gravel with up to 4-inch probe rod penetration exists.

- 6 A section of a steel H-pile, 6-feet long, is on the channel bottom along the north face of the exposed steel sheet pile at the Center Stem.
- 7 Minor timber debris is present at the west nose of the Center Stem and extends 6-feet east, down the south face of the steel sheet pile.

- 8 The channel bottom outside the steel sheet pile consists of sand with up to 4-inches probe rod penetration.
- 9 An area of scaling is present on the west nose of the East Stem, measuring 4' H x full-width x 2 1/2" D with exposed corroded steel reinforcement (11 vertical and 2 horizontal rebars) with up to 30% section loss, 6-feet above the mudline that extends 18-inches onto the north and south faces.

- 10 Steel sheet pile is exposed around the entire East Stem with the top of the steel sheet pile located 2 to 3 feet from the mudline. Within the steel sheet pile, there is gravel with 0-inches of probe rod penetration covering the footing. At the west nose there was a 3-foot long section of steel H-pile on the gravel.

- 11 Concrete overpour exists along the north face of the steel sheet pile from the west quarter point to the northeast corner of the East Stem. The overpour extends 2 to 3-feet out from the north face of the steel sheet pile with 6 to 18-inches of vertical exposure.

- 12 There is scaling/poorly consolidated concrete in the East Stem on all faces measuring 4' H x 2" D at the mudline.

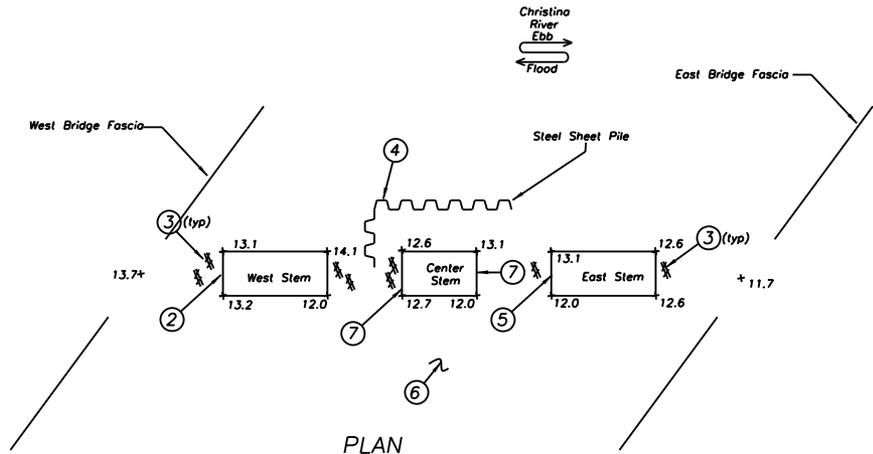
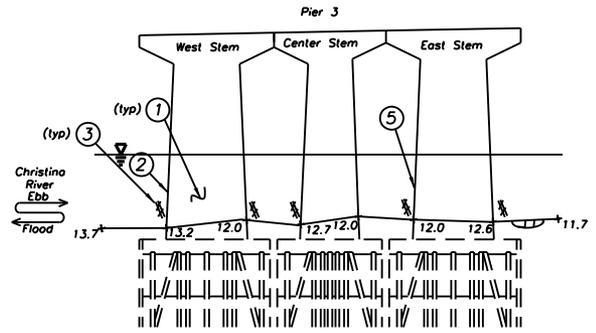
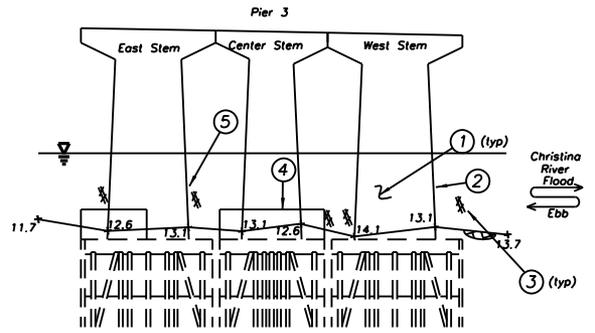
DELAWARE	
DEPARTMENT OF TRANSPORTATION	
INTERSTATE 95 OVER CHRISTINA RIVER BRIDGE NO. 1-744-059	
PIER 3 INSPECTION DETAILS	
DRAWN BY: MAS	DATE: 4/10/18
CHECKED BY: ADS	SCALE: N.T.S.
JOB NO.: 23134194.07	FIGURE NO.: 5

Overall, Pier 3 was in fair condition. The west face of the West Stem exhibits a 6 foot high x full width x 3 inch deep area of scaling with exposed corroded steel reinforcement (6 vertical and 2 horizontal steel bars) with up to 20% section loss at the low waterline. The west face of the East Stem exhibits a 2.5 foot high x full width x 3 inch deep area of scaling with exposed corroded steel reinforcement (3 vertical and 2 horizontal steel bars) with up to 25% section loss, at the low waterline. There is a 14 foot high x up to 1/16 inch wide vertical crack on the east and west faces of the Center Stem that terminates 4 feet below the waterline. Refer to Figure 5 in Appendix C for detailed inspection results of Pier 3.

- ① The concrete surfaces of all Pier 3 Stems exhibits a band of 2'-6" H x up to 1" D scaling within the tidal zone.
- ② Area of scaling on the west nose of the West Stem measuring 6' H x full-width x 3" D with exposed corroded steel reinforcement (6 vertical and 2 horizontal steel bars) with 20% section loss. Scaling starts 8' above the mudline.

- ③ Minor accumulations of timber debris measuring up to 12-inches in diameter exists at the east and west faces of the West and East Stems and the west face of the Center Stem, along the streambed.

- ④ Steel sheet pile is exposed 12-feet below the waterline from the northeast corner of the Center Stem, along the north face, and terminated into the channel bottom at the centerline of the west face.

- ⑤ An area of scaling on the west nose of the East Stem measuring 2'-6" H x full-width x 3" D with exposed corroded steel reinforcement (3 vertical and 2 horizontal steel bar) with up to 25% section loss. Scaling starts 8' above the mudline.

- ⑥ The channel bottom in the vicinity of the pier consists of sand and minor gravel with up to 6-inches of probe rod penetration.
- ⑦ There is a 14' H x up to 1/16" W vertical crack on the east and west face of the Center Stem, starting at 4 feet below the waterline and extending up.

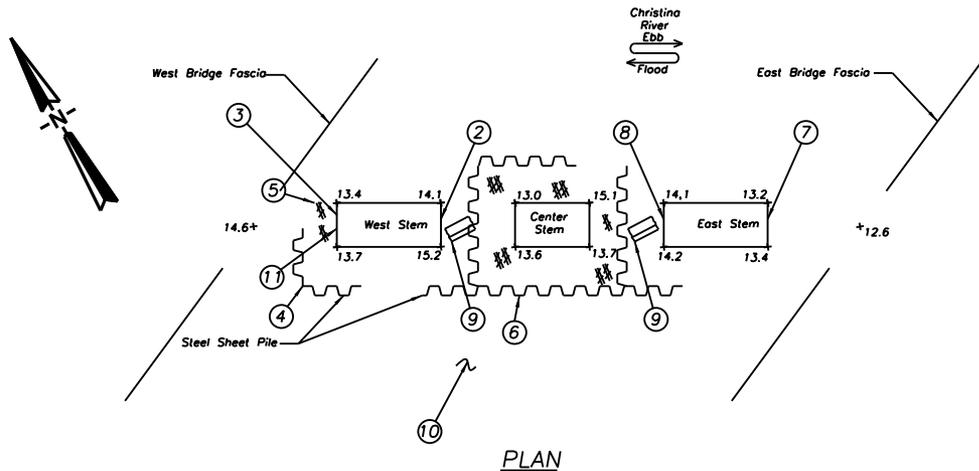
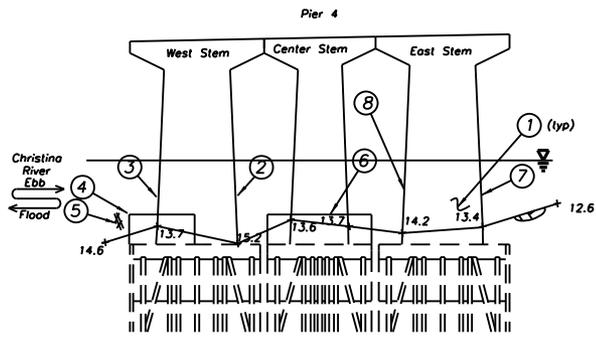
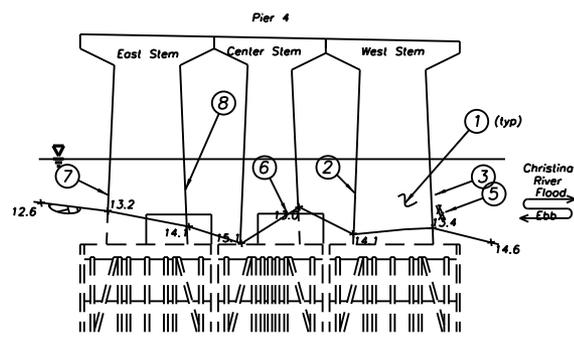
DELAWARE DEPARTMENT OF TRANSPORTATION			
INTERSTATE 95 OVER CHRISTINA RIVER BRIDGE NO. 1-744-059			
PIER 4 INSPECTION DETAILS			
DRAWN BY: MAS		936 Ridgebrook Road Sparks, MD 21152 www.kci.com	DATE: 4/10/18
CHECKED BY: ADS			SCALE: N.T.S.
JOB NO.: 23134194.07			FIGURE NO.: 6

- 1 The concrete surfaces of all Pier 4 Stems exhibits a band of 2'-6" H x up to 1" D scaling in the tidal zone.
- 2 Area of scaling on the east nose of the West Stem measuring 3' H x full-width x 4" D with two exposed corroded horizontal steel reinforcement bars at the low waterline.

- 3 Area of scaling on the west nose of the West Stem measuring 5' H x full-width x 4" D with exposed corroded steel reinforcement (5 vertical and 1 horizontal steel bar), that extends 1-foot onto the north and south faces of the low waterline.

- 4 Steel sheet pile is exposed from the centerline of the west nose of the West Stem extending to the southwest corner of the pier and extended 6-feet east on the south face of the pier. The steel sheet pile extended approximately 3-feet out of the channel bottom.

- 5 Moderate accumulations of timber debris consisting of branches measuring 6 to 12-inches in diameter exists at the west nose of the West Stem.
- 6 Steel sheet pile is exposed at the Center Stem along the south face, east face, west face, and extended 15-feet east along the north face from the northwest corner. The steel sheet pile extended approximately 2-feet out of the channel bottom.

- 7 Scaling on the east face of the East Stem, measuring 3' H x full-width x 4" D with exposed corroded steel reinforcement (1 vertical and 2 horizontal), starting at the low waterline.

- 8 Scaling on the west face of the East Stem, measuring 3' H x full-width x 4" D with exposed corroded steel reinforcement (5 vertical and 4 horizontal), starting at the low waterline. One exposed horizontal bar is broken.

- 9 Steel debris measuring approximately 4-feet long exists on the channel bottom at the west face of the East Stem and the east face of the West Stem.

- 10 The channel bottom in the vicinity of the pier consists of sand and gravel with up to 2-inches of probe rod penetration.
- 11 There is a 30' H x 1/16" W vertical crack starting 5-feet below the waterline, extending up the center of the west face of the West Stem.

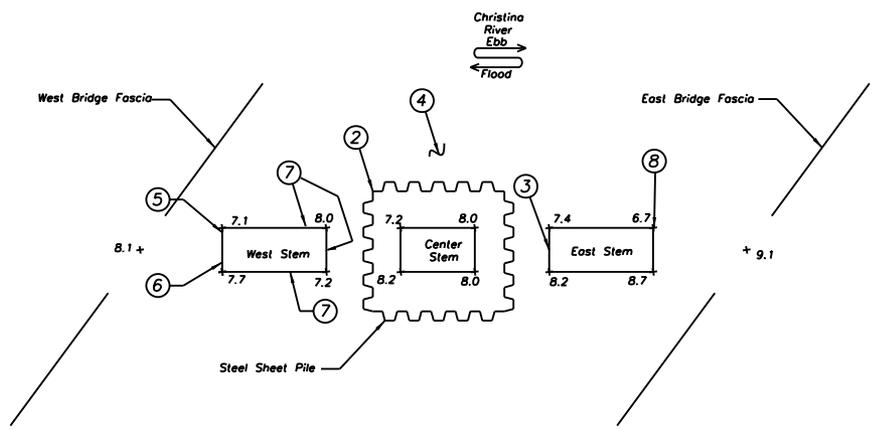
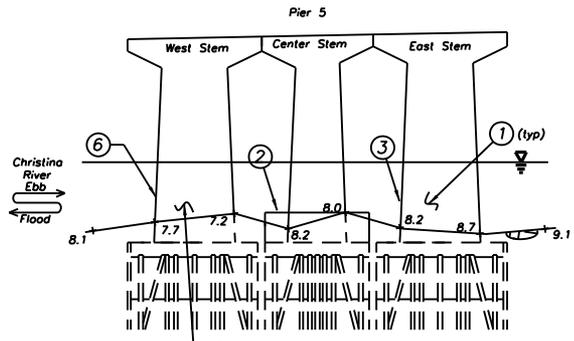
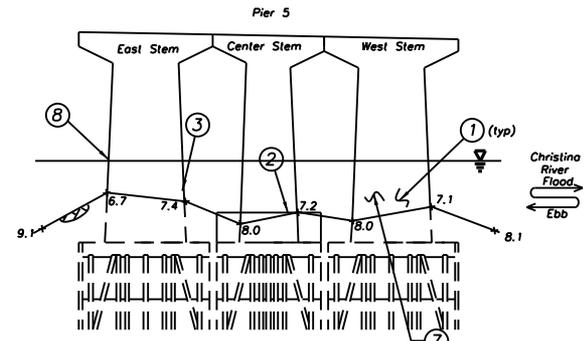
DELAWARE DEPARTMENT OF TRANSPORTATION			
INTERSTATE 95 OVER CHRISTINA RIVER BRIDGE NO. 1-744-059			
PIER 5 INSPECTION DETAILS			
DRAWN BY: MAS		936 Ridgebrook Road Sparks, MD 21152 www.kci.com	DATE: 4/10/18
CHECKED BY: ADS		SCALE: N.T.S.	
JOB NO.: 23134194.07		FIGURE NO.: 7

- 3 Area of scaling at the west face of the East Stem measuring 3' H x full-width x 3" D with exposed corroded steel reinforcement (3 vertical and 2 horizontal steel bars), 6-feet above the mudline that extends 5-feet long onto the north face. There is one exposed steel reinforcement bar (horizontal) exposed on the north face at the low waterline.

- 4 The channel bottom in the vicinity of the pier consists of gravel and concrete debris measuring 3 to 8-inches in diameter.
- 5 There is map cracking and a 1/32-inch wide vertical crack extending 15-feet up from the band of scaling on the west face of the West Stem.

- 6 The scaling on the west face of the West Stem is 3' H x full-width x 4" D with exposed corroded steel reinforcement (4 horizontal and 8 vertical steel bars) with up to 90% section loss, at the waterline.

- 7 The scaling on the north, south, and east faces of the West Stem is 2'-6" H x 3" D with exposed corroded steel reinforcement (1 horizontal steel bar and 1 vertical bar at the southeast corner), 3-feet above the mudline.

- 8 Area of scaling 1' H x 2" D on the northeast corner of the East Stem with one exposed horizontal steel reinforcing bar at the low waterline

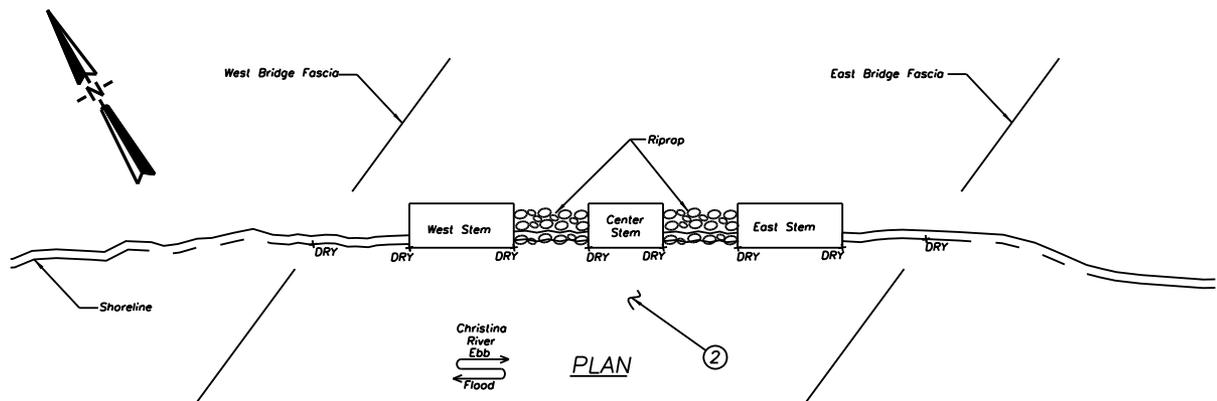
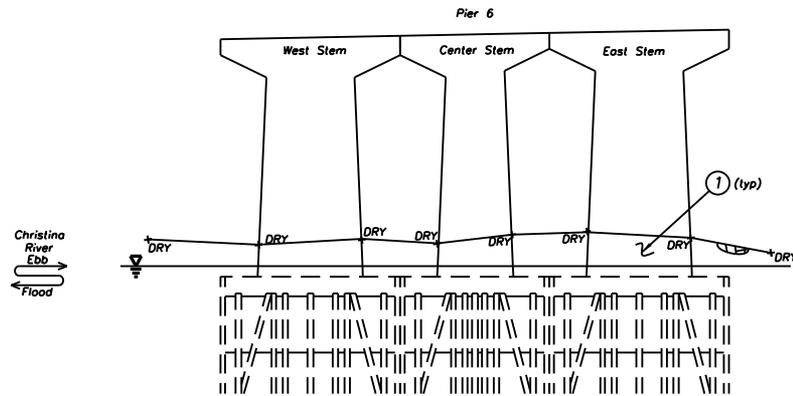
Overall, Pier 6 was in satisfactory condition. The stem exhibits a band of up to ½ inch deep scale from the mean high waterline to the mudline. The channel bottom in the vicinity of the pier consists

primarily of gravel and concrete debris with riprap placed between each stem. Refer to Figure 8 in Appendix C for detailed inspection results of Pier 6.

- ① The concrete surfaces of all Pier 6 Stems exhibits a band of up to 1/2-inch deep scaling from the mean high waterline to the mudline.
- ② The channel bottom in the vicinity of the pier consists of gravel and concrete debris measuring 3 to 8-inches in diameter with riprap between pier stems.
