SIGNIFICANT FINDINGS SUMMARY

DelDOT Bridge No. 1-744-059 carries Interstate 95 over the Christina River in New Castle County, Delaware. On January 19 and 20, 2015, Pennoni Associates Inc. performed a special underwater inspection at the bridge to verify the condition of all substructure units from the high water mark to the channel bottom. This report includes a description of the structure, the method of investigation, and a detailed description of the conditions noted. In addition, this report contains a condition assessment of the bridge components evaluated and presents recommendations for follow-up actions. River depth soundings were obtained around the substructure units, along the centerline of the bridge, along each fascia, and at cross sections of the channel at 50 and 100 feet upstream and downstream of the bridge.

DELAWARE DEPARTMENT OF TRANSPORTATION		
INTERSTATE 95 OVER CHRISTINA RIVER BRIDGE NO. 1-744-059 LOCATION MAP		
CREATED BY: ATF	121 Continental Drive, Suite 207 Newark, DE 19713 www.pennoni.com	DATE: 1/20/2015
CHECKED BY: NRW		SCALE: N.T.S.
PROJECT NO.: WTRQ1402		Appendix A

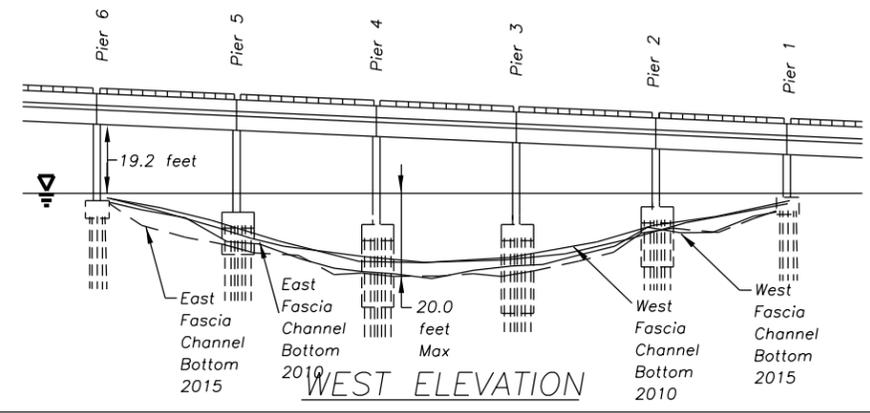
SOUNDING PLAN

measured to be 18.0-feet. Depth soundings indicated that the maximum water depth at the bridge structure was 20.0 feet at the southwest corner of the Center Stem of Pier 4. Refer to Figure 1 in Appendix C for a Sounding Plan of the bridge. At the time of inspection, there were less than 6 inches of visibility and a water velocity of approximately 0 to 2.0 feet per second. The river is tidally influenced and has a tidal swing of approximately 6 feet.

Overall, the submerged substructure units of Structure No. 1-744-059 are in fair condition. A comparison of the soundings recorded during the previous inspection on April 3, 2014 and the soundings taken during this inspection revealed no significant change in the channel bottom profile in the vicinity of the structure. The footing exposure at Piers 2, 4, and 5 are not of concern at this time given that the bottom of the footing was embedded below the current channel bottom, restrained within the steel sheet pile walls, and the footings are supported by piles. The scour depressions observed at Piers 2 and 3 are also not of concern at this time given that the bottom of the footing is embedded below the current channel bottom.

- INSPECTION NOTES:**
- ① The North Embankment east of the bridge consisted of riprap measuring 6 to 12-inches in diameter with minor to moderate vegetation.
 - ② The North Embankment west of the bridge consisted of small cobbles up to 4-inches in diameter with minor vegetation.
 - ③ The South Embankment east of the bridge consisted of minor vegetation.
 - ④ The South Embankment west of the bridge consisted of riprap measuring 6 to 12-inches in diameter.
 - ⑤ The embankments under the bridge consisted of riprap measuring 6 to 12-inches in diameter from the mean high waterline to the mean low waterline.

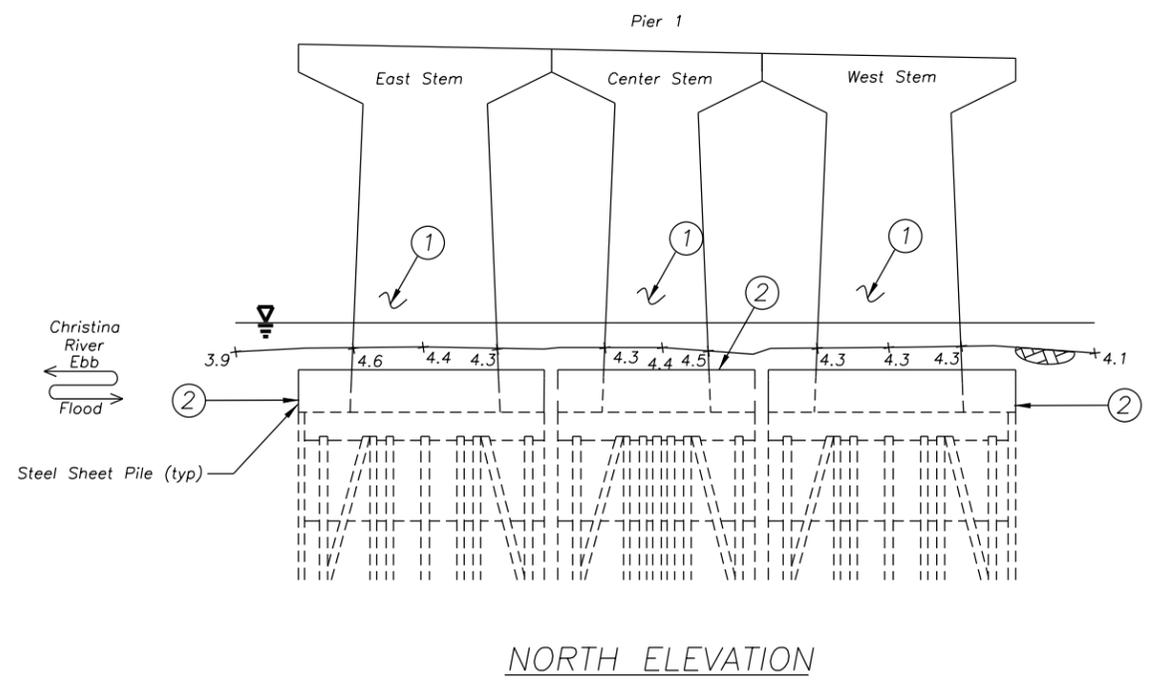
DELAWARE DEPARTMENT OF TRANSPORTATION		
INTERSTATE 95 OVER CHRISTINA RIVER BRIDGE NO. 1-744-059		
PIER 1 INSPECTION DETAILS		
DRAWN BY: ATF		DATE: 1/20/15
CHECKED BY: NRW		SCALE: N.T.S.
JOB NO.: WTR01402		FIGURE NO.: 2
		121 Continental Drive, Suite 207 Newark, DE 19713 www.pennoni.com

Overall, Pier 1 was in satisfactory condition. The previously noted area of riprap (stones measuring 1 to 3 feet in diameter) between the West Stem and the Center Stem was not observed. A 6-foot long section of steel H-pile is on the channel bottom just north of the steel sheet pile at the East Stem. Refer to Figure 2 in Appendix C for detailed inspection notes of Pier 1.

- ① The concrete surfaces of all Pier 1 Stems exhibit up to 1/2-inch deep scaling from the mean high waterline to the channel bottom.
- ② Steel sheet pile is approximately 4.5-feet off the north face of all pier stems and extends to the centerline of the east and west faces of all pier stems. The steel sheet pile extends out of the channel bottom approximately 1.2-feet. The sheeting is in good condition with minor surface corrosion.
- ③ Section of steel H-pile, 6-feet long, is north of the steel sheet piling at the East Stem.
- ④ Within the steel sheet pile, gravel with up to 2-inches of probe rod penetration existed.
- ⑤ The channel bottom outside the steel sheet pile consists of sandy silt with up to 3-feet of probe rod penetration.

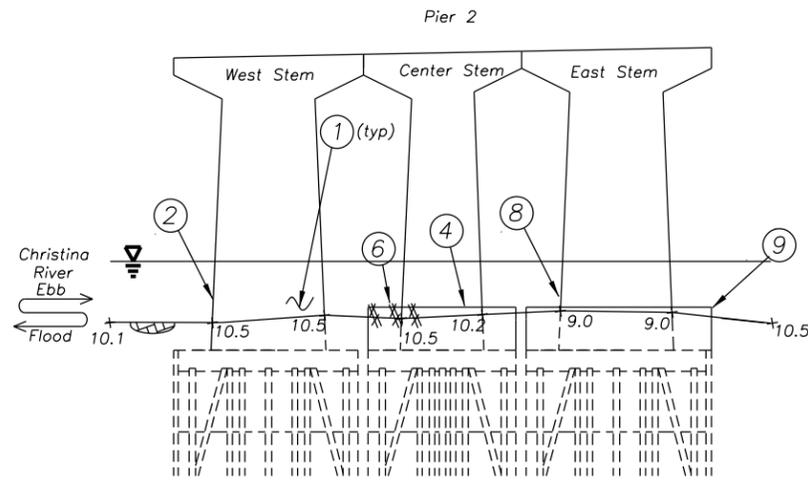
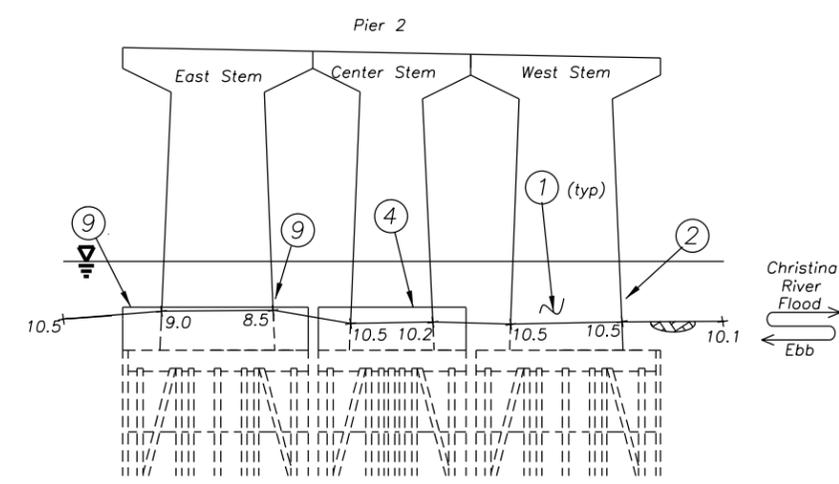
DELAWARE DEPARTMENT OF TRANSPORTATION		
INTERSTATE 95 OVER CHRISTINA RIVER BRIDGE NO. 1-744-059		
PIER 2 INSPECTION DETAILS		
DRAWN BY: ATF		121 Continental Drive, Suite 207 Newark, DE 19713 www.pennoni.com
CHECKED BY: NRW		DATE: 1/20/15
JOB NO.: WTRQ1402		SCALE: N.T.S. FIGURE NO.: 3

Overall, Pier 2 was in fair condition. The east and west ends of the Cent and East Stem's typically exhibit scaling up to 2-inches deep. The west face of the West Stem exhibits a 2' H x 3'-6" W x 3" D area of scaling with exposed corroded steel reinforcement (5 vertical and 3 horizontal steel bars) with up to 60% section loss at the waterline. The west end of the East Stem exhibits scaling up to 2'-6" H x 3'-6" W x up to 2 1/2" D with exposed corroded steel reinforcement (6 vertical and 2 horizontal steel bars) with up to 30% section loss at the waterline. The East Stem exhibits up to 1 1/2-inch deep scaling at the bottom 2-feet of stem on all faces. The top of the footing is exposed along the north and south faces of the Center Stem inside the steel sheet piling. A 6-foot long section of a steel H-pile is on the channel bottom along the north face of the exposed steel sheet pile at the Center Stem and a 3-foot long section of steel H-pile is at the southwest corner of the steel sheet piling. A 2 to 3-foot concrete overpour exists along the north face of the steel sheet pile from the west quarter point to the northeast corner at the East Stem. Refer to Figure 3 in Appendix C for detailed inspection notes of Pier 2.

- ① The concrete surfaces of all Pier 2 Stems exhibit a band of up to 3/4-inch scaling from 1-foot up from the mudline to 5-feet above the mudline.
- ② Spalling on the west nose of the West Stem, extending from the waterline to 2-feet below the waterline measuring 3.5' W x 3" D with exposed corroded steel reinforcement (5 vertical and 3 horizontal steel bars) with up to 60% section loss.

- ③ The channel bottom in the vicinity of the West Stem consists of gravel with up to 1-inch of probe rod penetration.
- ④ Steel sheet pile was exposed around the Center Stem, the top of the steel sheet pile was 2 to 2.5-feet from the mudline. The top of the footing was exposed along the north and south faces of the Center Stem inside the steel sheet pile. Within the steel sheet pile along the east and west faces of the Center Stem, sandy gravel with up to 1-foot probe rod penetration exists.

- ⑤ A section of a steel H-pile, 6-feet long, is on the channel bottom along the north face of the exposed steel sheet pile at the Center Stem.
- ⑥ Minor timber debris is present at the west nose of the Center Stem and extends 6-feet east, down the south face of the steel sheet pile.

- ⑦ The channel bottom outside the steel sheet pile the stems consists of sand with up to 4-inches probe rod penetration.
- ⑧ An area of spalling is present on the west nose of the East Stem extending from the waterline to 2.5-feet below the waterline measuring 3.5' W x 2.5" D with exposed corroded steel reinforcement (6 vertical and 2 horizontal rebars) with up to 30% section loss.

- ⑨ Steel sheet pile is exposed around the entire East Stem with the top of the steel sheet pile located 2 to 2.5-feet from the mudline. Within the steel sheet pile, there is gravel with 0-inches of probe rod penetration covering the footing. At the west nose there was a 3-foot long section of steel H-pile on the gravel.

- ⑩ Concrete overpour exists along the north face of the steel sheet pile from the west quarter point to the northeast corner at the East Stem. The overpour extends 2 to 3-feet out from the north face of the steel sheet pile with 6 to 18-inches of vertical exposure.

- ⑪ There is scaling in the East Stem measuring 2' H x 1 1/2" D. The scaling starts at gravel inside sheeting and extends around the perimeter.
- ⑫ The West and East Stem footings are exposed around the full perimeter.

The bands of scaling and associated concrete deterioration at Piers 2 through 5 should be repaired. In lieu of traditional concrete patching repairs, which may be short-lived, consideration should be given to installing a fiberglass jacket system (or similar method) around each pier stem to provide a longer-life repair.

The channel bottom configuration should continue to be closely monitored during future underwater inspections to ensure that the footing exposure at Piers 2, 4, and 5 remains minimal and the scour depressions at Piers 2 and 3 are not increasing.

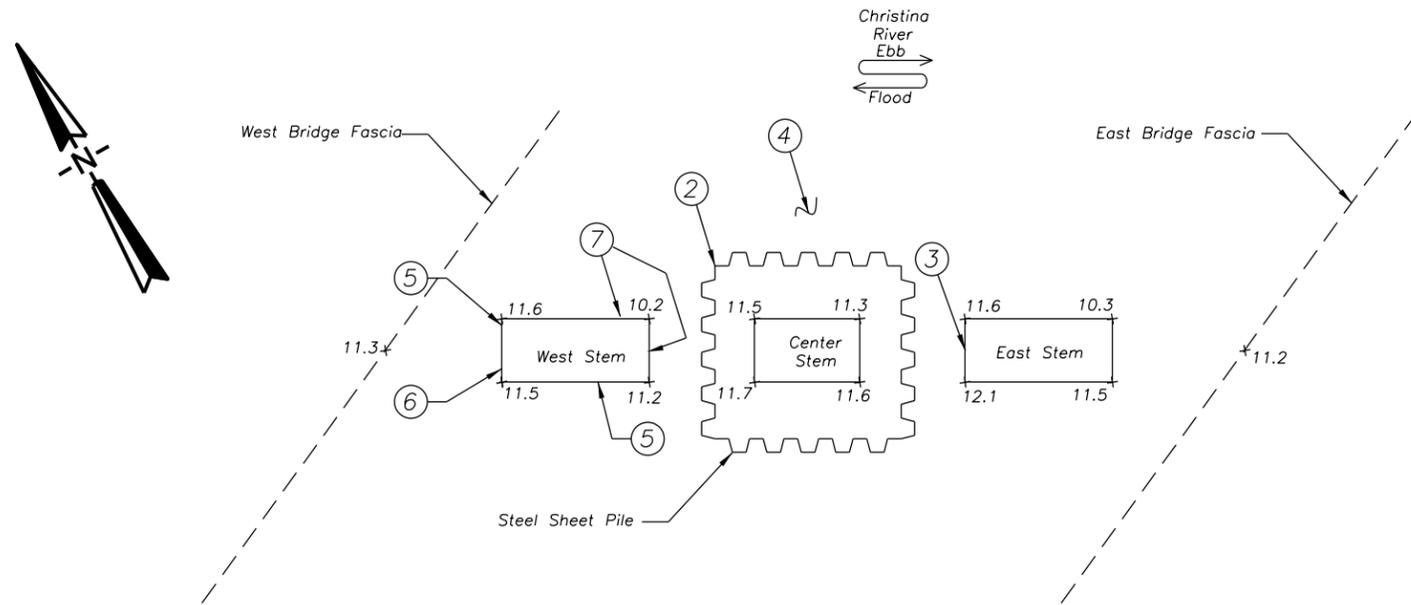
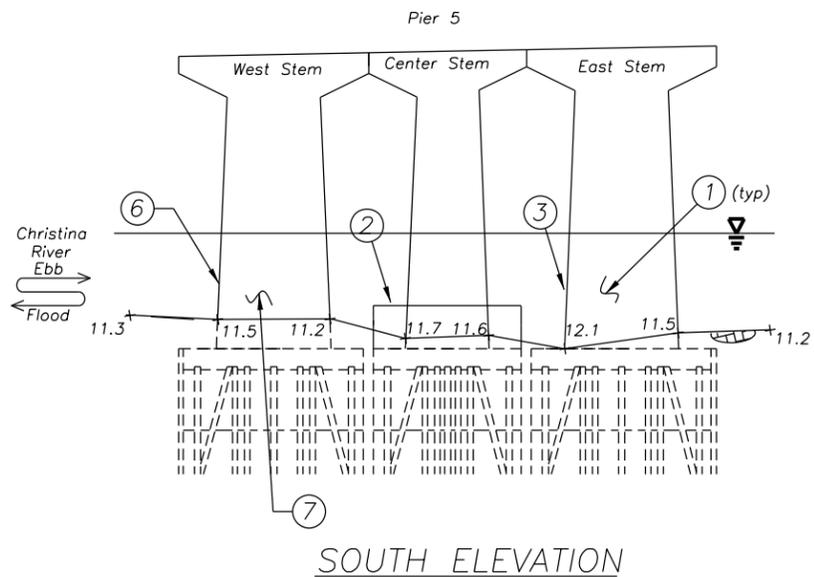
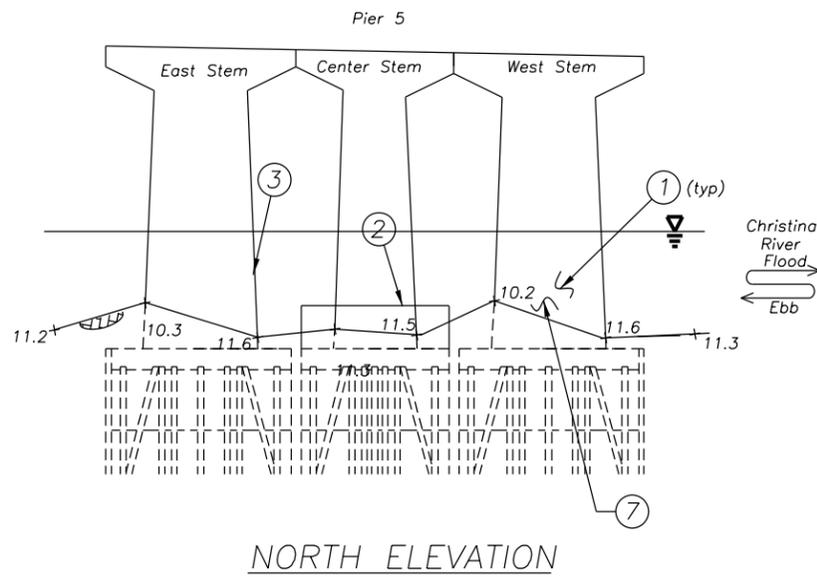
PIER 5 INSPECTION DETAILS

Overall, Pier 5 was in fair condition. The West Stem exhibits scaling, up to 2' H x FW x 6" D with exposed corroded steel reinforcement (4 horizontal and 5 vertical steel bars) with up to 90% section loss, 4-feet from the mudline on the west face. The West Stem exhibits 4' H x FW x up to 3" D scale with one horizontal steel bar exposed on the south, east and north faces, 2-feet from the mudline. The top of the footing was exposed around the entire Center Stem. There is map cracking and a 1/32-inch wide vertical crack extending 15-feet up from the band of scaling on the west face of the West Stem. The East Stem exhibits scaling up to 2' H x 8' L x 3" D with one exposed horizontal steel bar on the north face and 2' H x FW x 3" D with an exposed horizontal and vertical steel bar on the west face. Refer to Figure 6 in Appendix C for detailed inspection notes of Pier 5.

- ① The concrete surfaces of all Pier 5 Stems exhibits a band of 1up to 1-inch deep scaling from the low water mark to 6-feet below the waterline.
- ② Steel sheet pile is exposed around the Center Stem and extended approximately 3.5-feet out from the channel bottom. The top of the footing is exposed within the steel sheet pile.

- ③ Area of scaling at the north and west faces of the East Stem measuring 2' H x 8' L x 3" D and 2' H x FW x 3" D, respectively, with exposed corroded vertical and horizontal steel reinforcement, 4-feet off the mudline.

- ④ The channel bottom in the vicinity of the pier consists of gravel and concrete debris measuring 3 to 8-inches in diameter.
- ⑤ There is map cracking and a 1/32-inch wide vertical crack extending 15-feet up from the band of scaling on the west face of the West Stem.

- ⑥ The scaling on the west face of the West Stem is 2' H x FW x 6" D with exposed corroded steel reinforcement (4 horizontal and 5 vertical steel bars) with up to 90% section loss, 4-feet off the mudline.

- ⑦ The scaling on the north, south, and east faces of the West Stem is 4' H x FW x 3" D with exposed steel reinforcement (1 horizontal steel bar), 2-feet off the mudline.

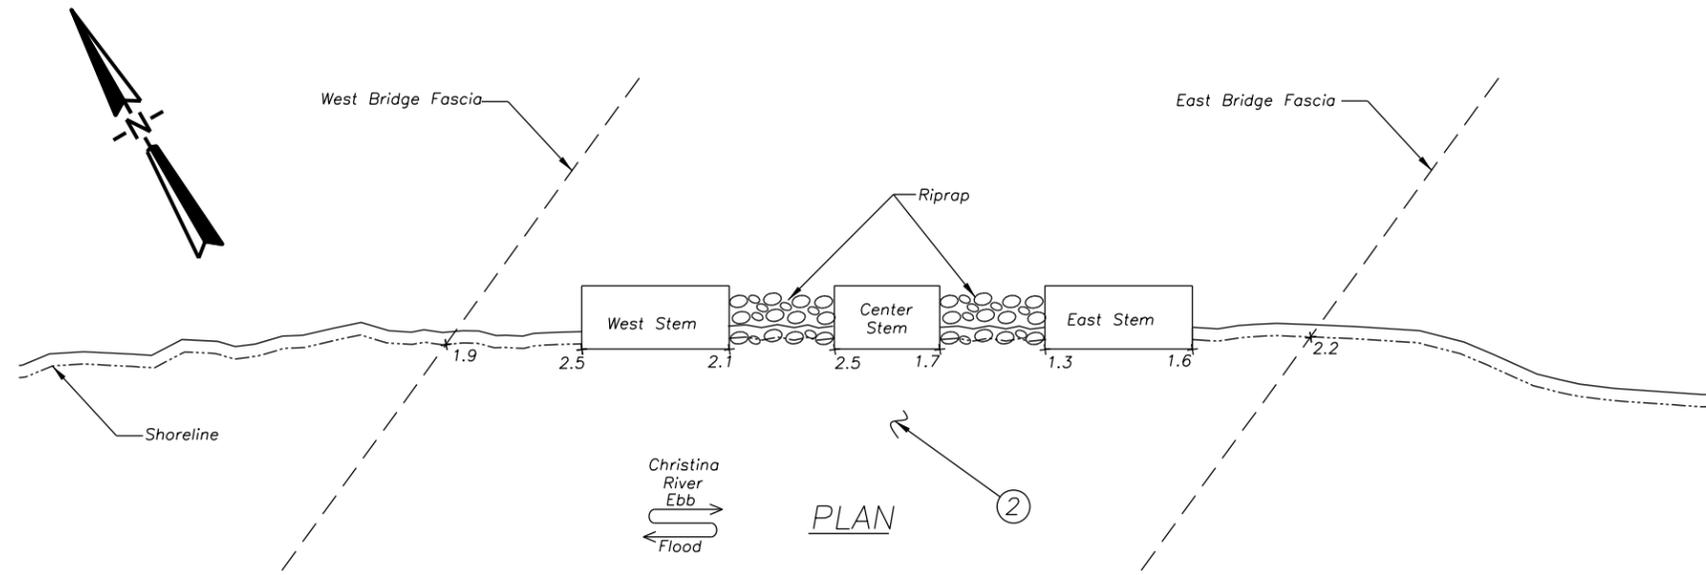
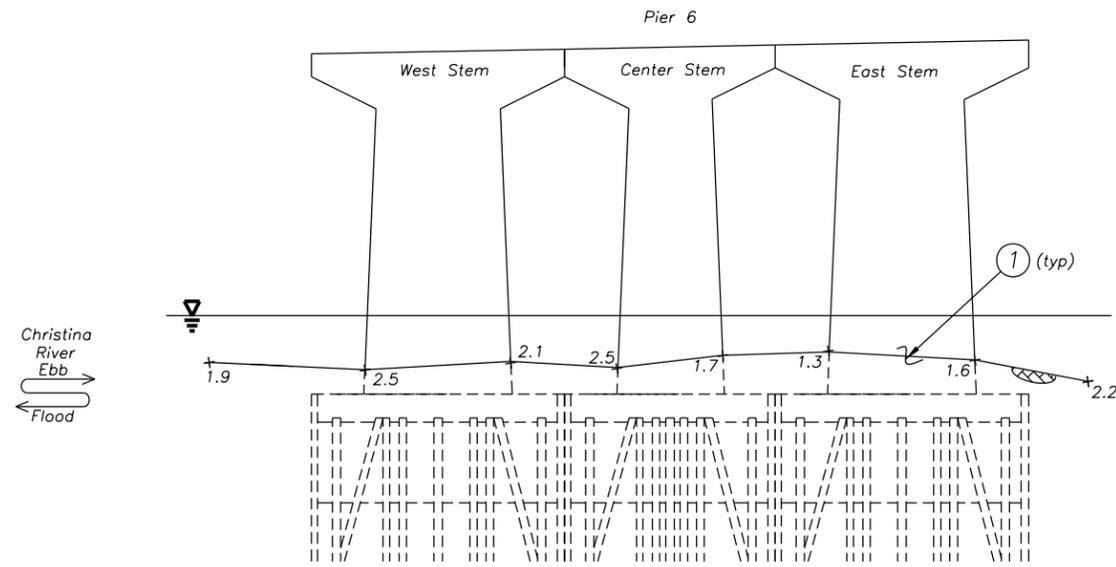
PIER 6 INSPECTION DETAILS

Overall, Pier 6 was in satisfactory condition. Refer to Figure 7 in Appendix C for detailed inspection notes of Pier 6.

- ① The concrete surfaces of all Pier 6 Stems exhibits a band of up to 1/2-inch deep scaling from the mean high waterline to the mudline.
- ② The channel bottom in the vicinity of the pier consists of gravel and concrete debris measuring 3 to 8-inches in diameter with riprap between pier stems.
