DELAWARE DEPARTMENT OF TRANSPORTATION

PRE-MONITORING INSPECTION REPORT

THE MILL BUILDING AT HEARNS POND DAM, SUSSEX COUNTY , DE

**PRE-MONITORING INSPECTION REPORT
MILL BUILDING AT HEARNS POND DAM
CITY OF SEAFORD
SUSSEX COUNTY, DE**

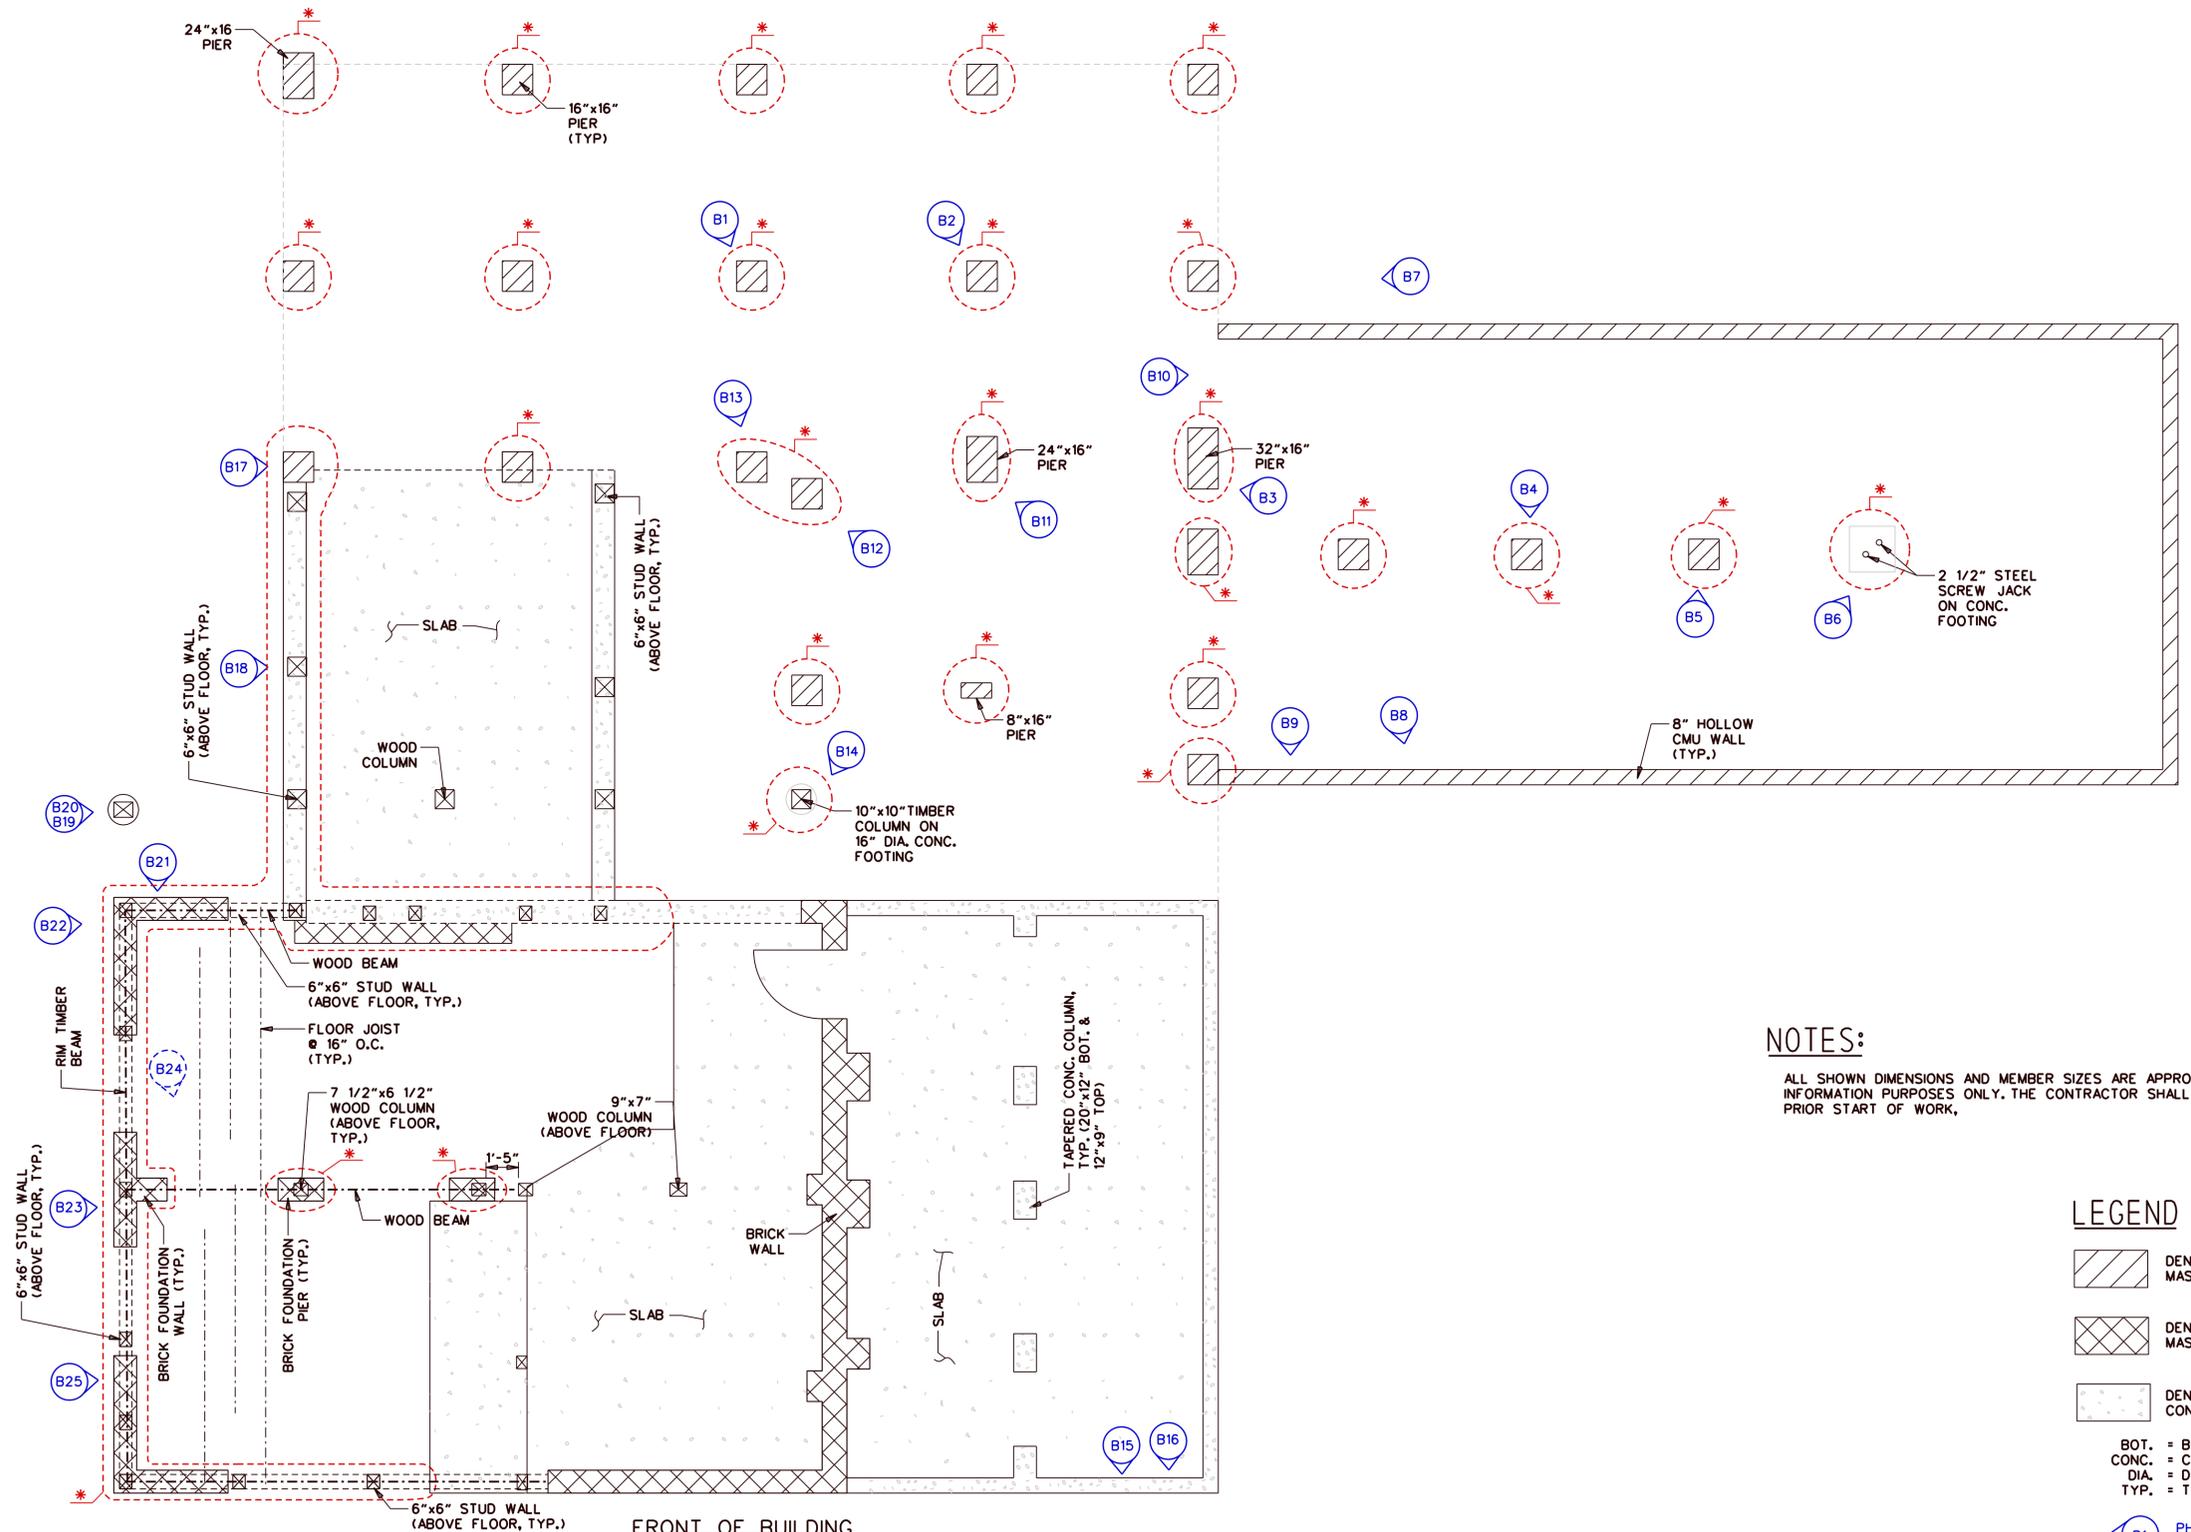
FIGURE 4

- Foundation/Ground Level (see *Figure 4* for locations):
 - Brick masonry walls and piers.
 - Concrete wall foundation along building north.
 - All CMU and timber piers.
- Second Level (see *Figure 6* for locations):
 - Exterior awning at the front of the building.

* APPROXIMATE LIMITS OF FOUNDATION THAT IS TO BE REPAIRED OR ADDITIONAL SUPPORT PROVIDED PRIOR TO PILE DRIVING OPERATION FOR SPILLWAY AND ALL OF ITS COMPONENTS IN NEARBY VICINITY.

The Contractor should pay attention to the above generalized area of concerns and perform a repair or provide additional load bearing support to maintain the overall structural integrity of the building during the pile driving operation. The means and methods of the repair or additional support should be determined by the Contractor and submitted to the Department for their review and acceptance.

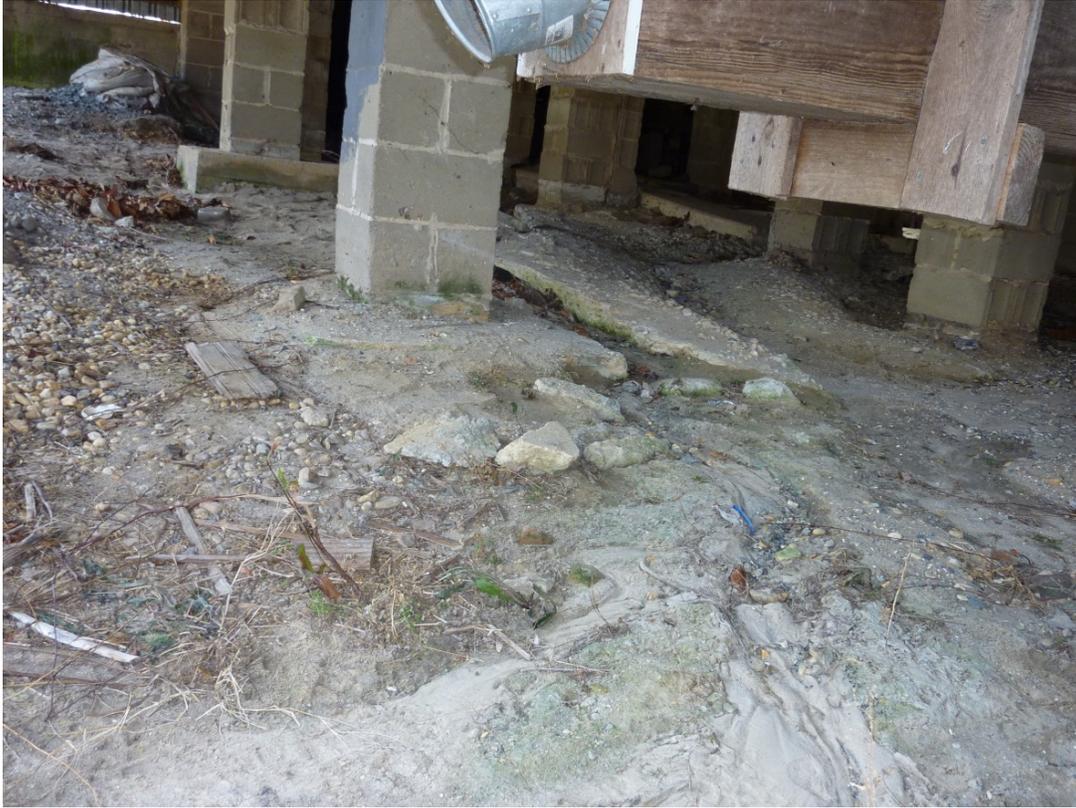
- Several CMU column footings are exposed and bottom of footing appears to be located above the required 36" frost line depth (see Photos B1 & B2).
- Several CMU columns are shifted out of vertical plane (see Photo B13).
- Several CMU columns are constructed without footings (see Photos B3 & B4). Columns exhibiting undermining and few columns are shifted off their base (see Photos B4 & B5).
- Approximately 50% of cross sectional area was removed near the top of CMU column to accommodate the utility pipe (see Photo B12).
- Two timber columns appear to be installed out of plumb. Both columns are unsecured at their base (see Photos B14 & B19).

Photo B1: View of CMU pier foundation on the east side of the building. Note exposed pier footings and soil erosion due to improper drainage in building vicinity.

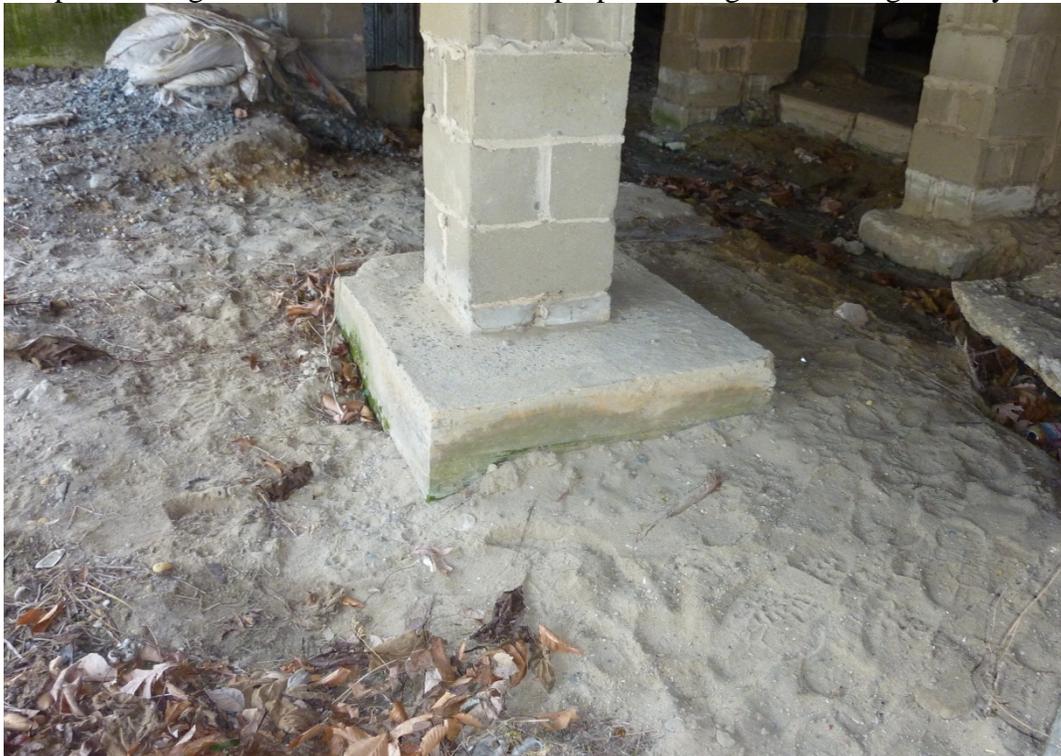
Photo B2: Typical view of the exposed footing supporting CMU pier. Note soil erosion pier vicinity.

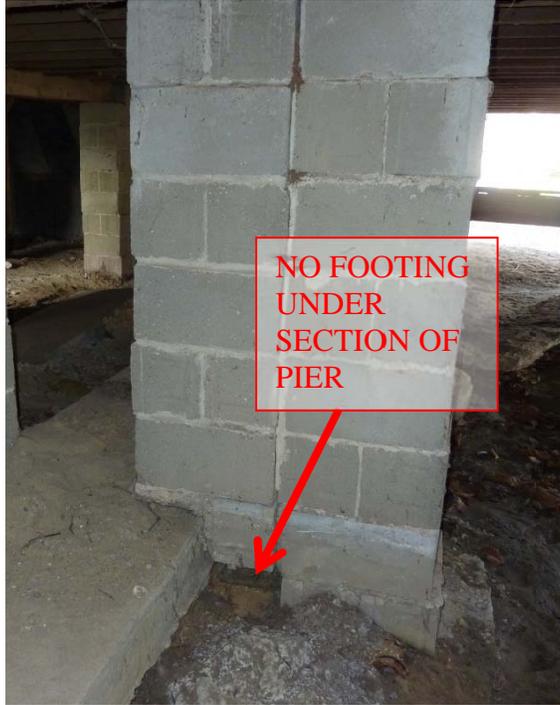
Photo B3: View of the CMU pier under south section of the building. Note void underneath pier. Only one half of pier is supported by footing.

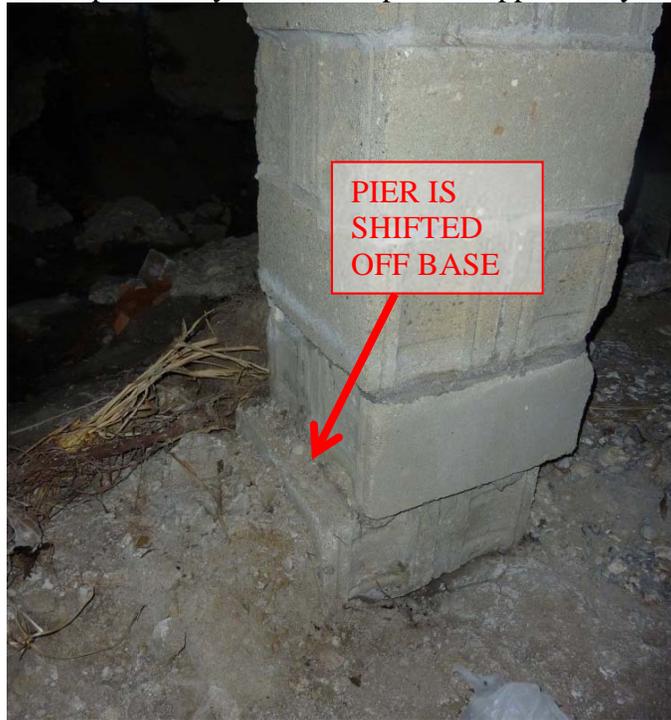
Photo B4: View of the CMU pier under south section of the building. Note that there is no pier footing and pier is shifted approximately 2'' of its base.

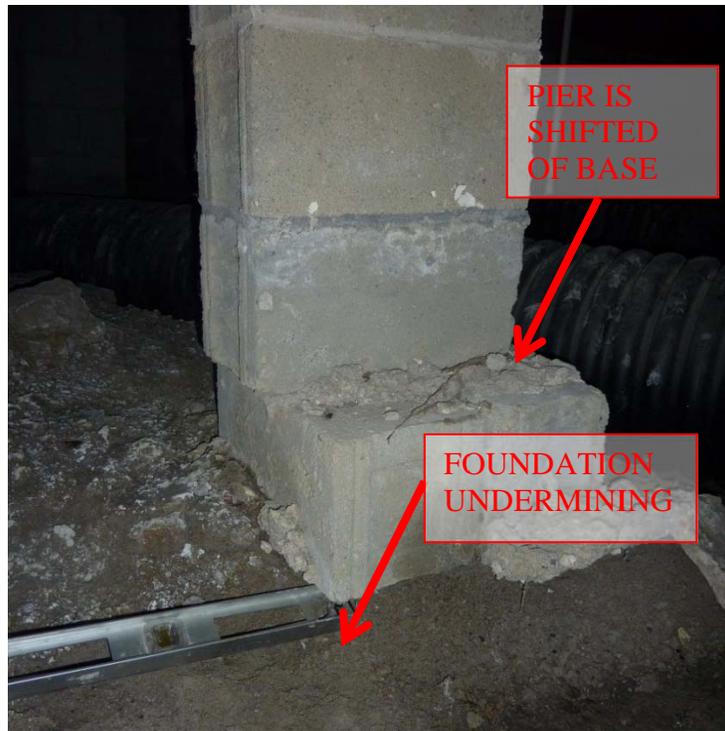
Photo B5: View of the CMU pier under south section of the building. Note that there is no pier footing and pier is shifted approximately 5" of its base. Note approximately 3" void under corner of pier.

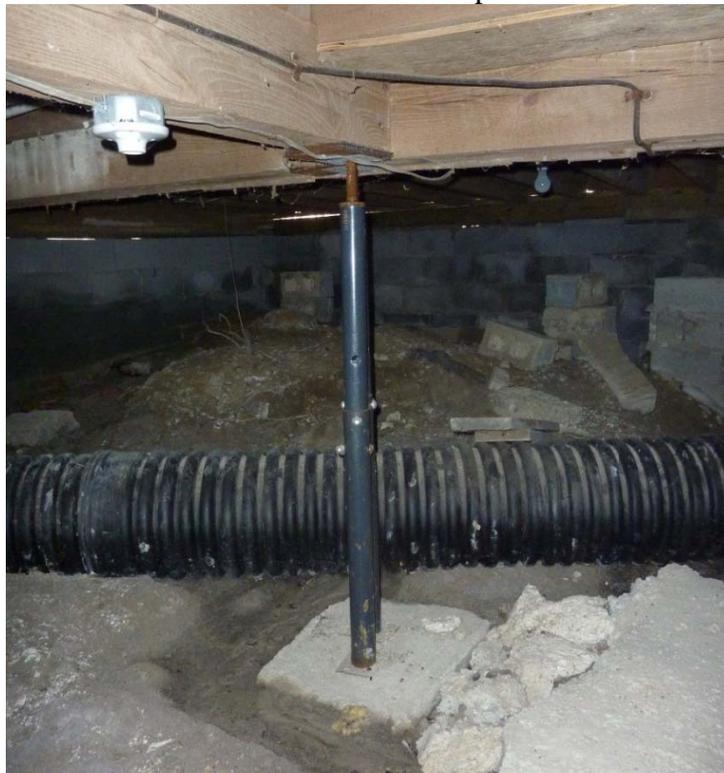
- One steel floor screw jack supports floor beams at the south end of the building. Floor jack is unsecured at top and bottom (see Photo B6). It should be noted that the screw jacks are designed to be a temporary support column rather than a permanent feature.
- Brick column exhibits a full height vertical crack in the column adjacent to the exterior brick foundation wall (see Photo B24).

Photo B6: View of 2 1/2" steel screw jacks on concrete footing at the building south end. Note that jacks are unsecured at top and bottom.

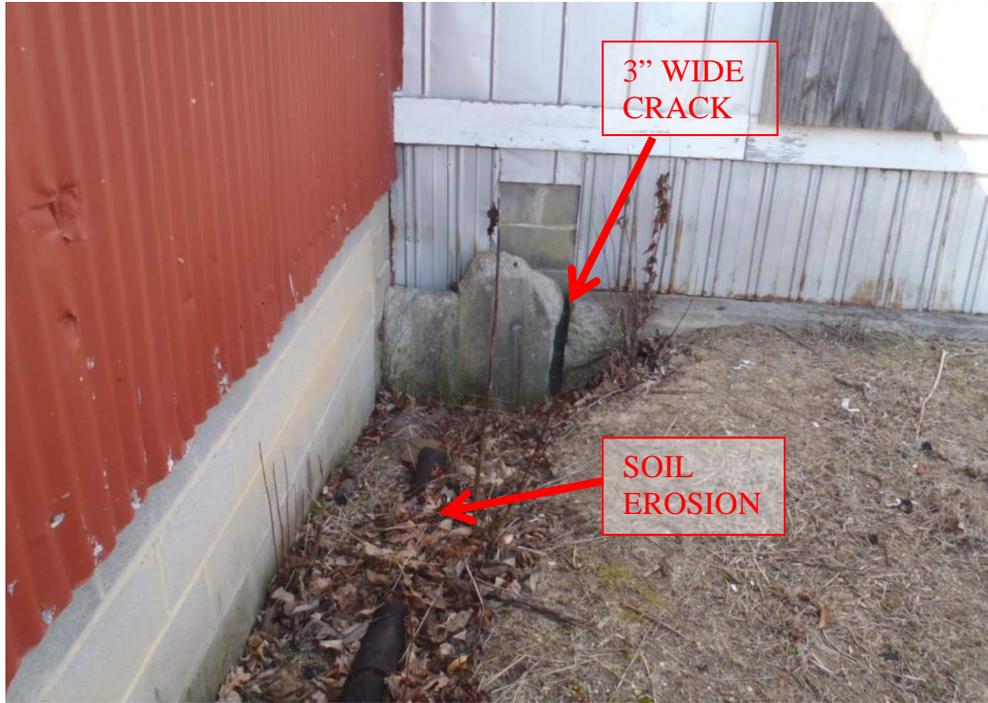
- Severe soil erosion near outside face of the northeast foundation walls and approximately 3” wide vertical crack in the wall (see Photo B7).
- Concrete footing supporting CMU wall exhibits undermining at various locations (see Photos B8, B9 and B10).

Photo B7: View of northeast corner of CMU foundation (looking from outside). Note severe soil erosion near foundation walls and approximately 3" vertical separation in concrete wall.

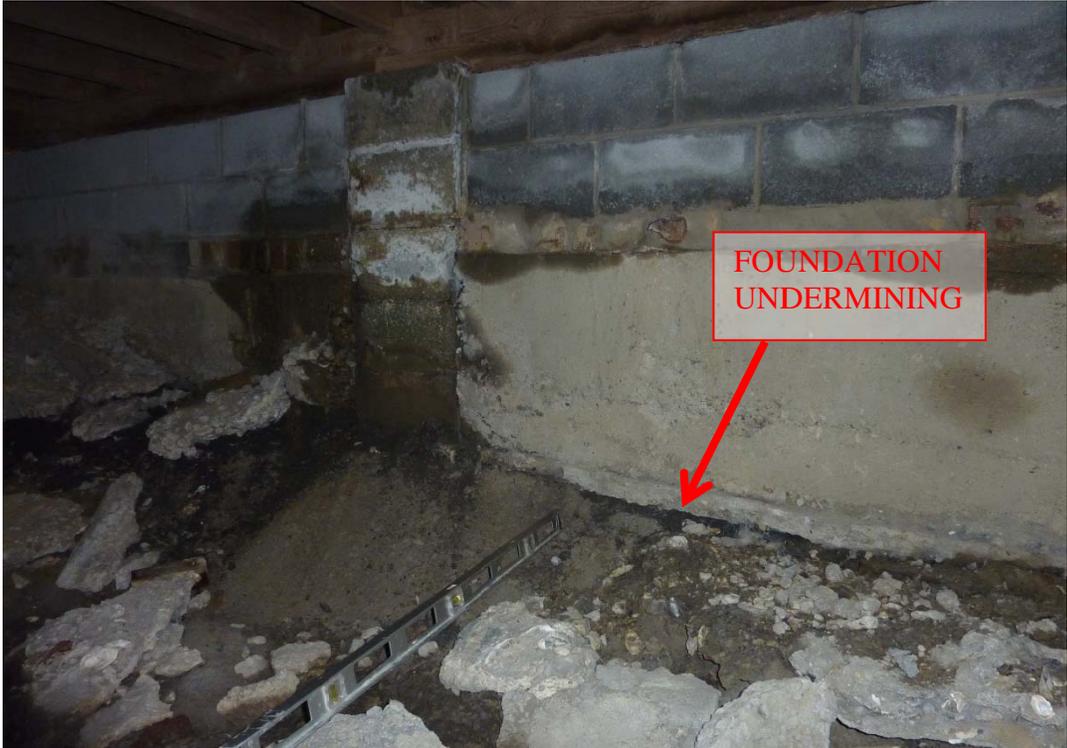
Photo B8: View of the CMU southwest foundation wall. Note undermining of foundation due to water infiltration. Note broken slab and soil erosion in vicinity of the wall.

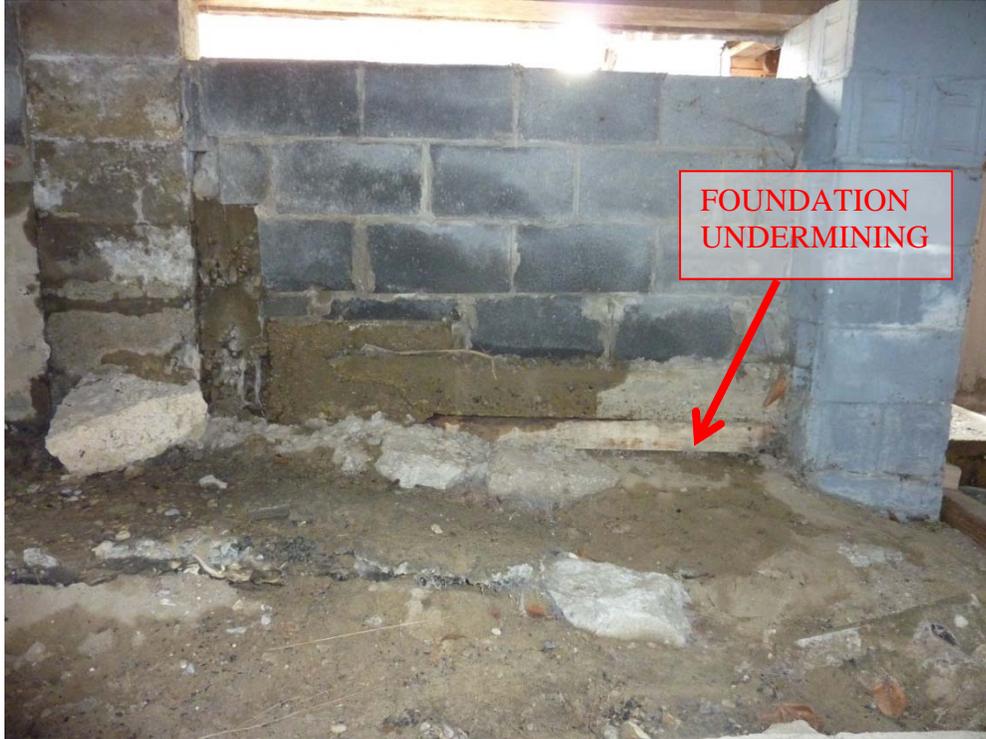
- Bottom of footing appears to be located above the required 36” frost line depth (see Photos B9 and B10).
- Front (west side) concrete wall exhibits water infiltration at the joint with an adjacent wall (see Photo B15). Timber sill above concrete wall shows severe damage due to the termite infestation (see Photos B15 & B16).

Photo B9: View of the CMU southwest foundation wall. Note undermining of foundation due to water infiltration. Note broken slab and soil erosion in vicinity of the wall.

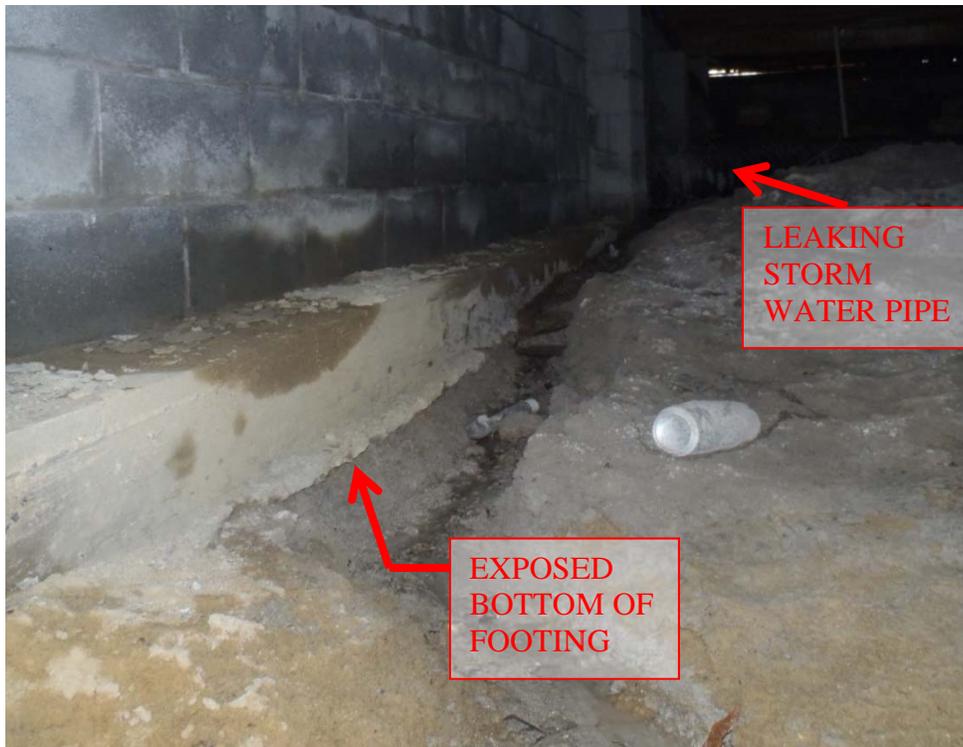
Photo B10: View of the CMU southeast foundation wall. Note undermining of foundation due to leaky storm pipe and soil erosion in vicinity of the wall.

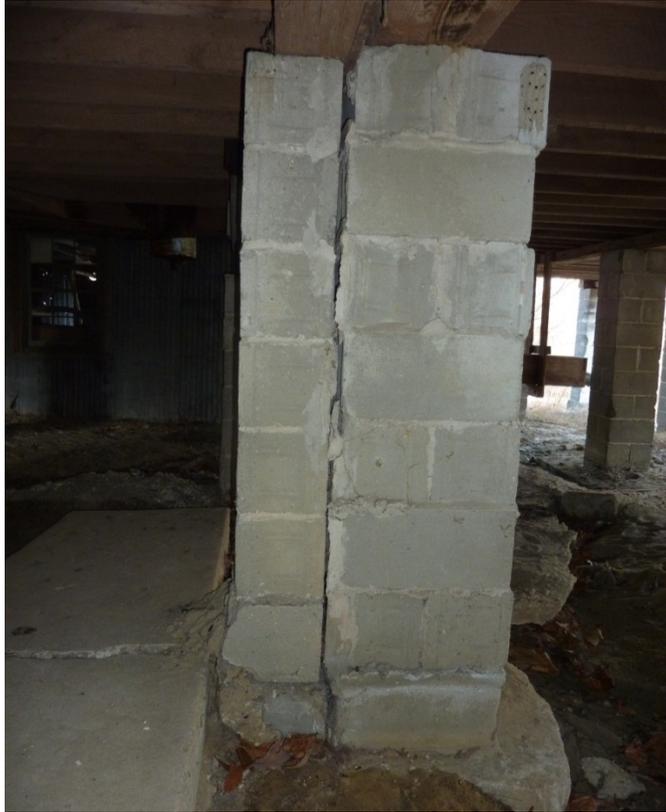
Photo B11: View of the CMU pier near center of the pier foundations. Note that CMU piers are separated vertically along mortar joint.

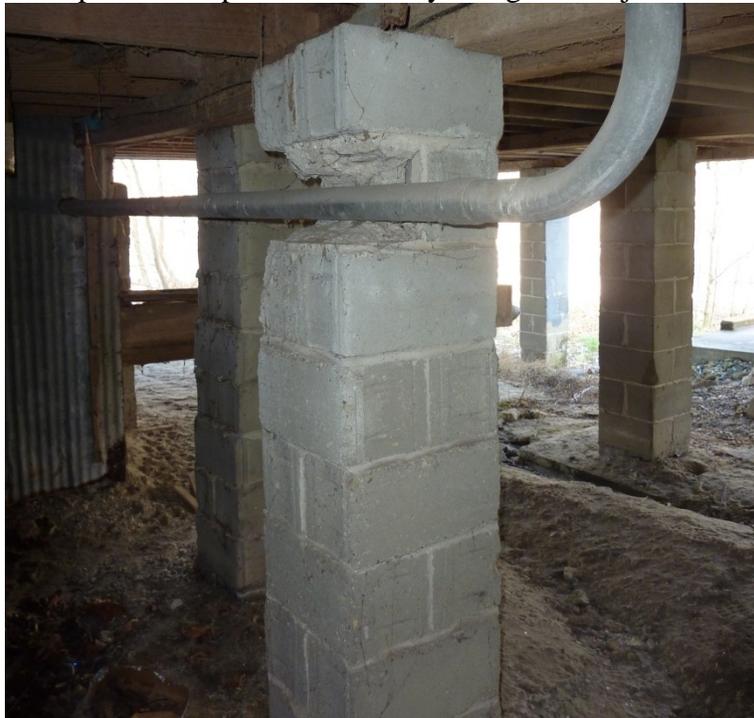
Photo B12: View of the CMU pier near center of the pier foundations. Note missing large section of the pier at the utility pipe location.

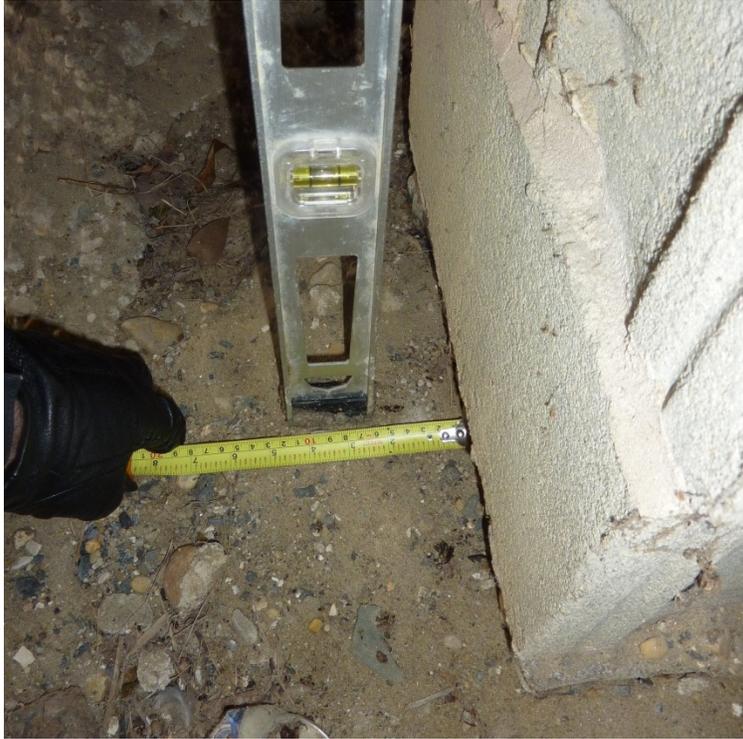
Photo B13: View of the CMU pier located near the center of the building. Pier is out of plumb by 2 1/4" over 4'.

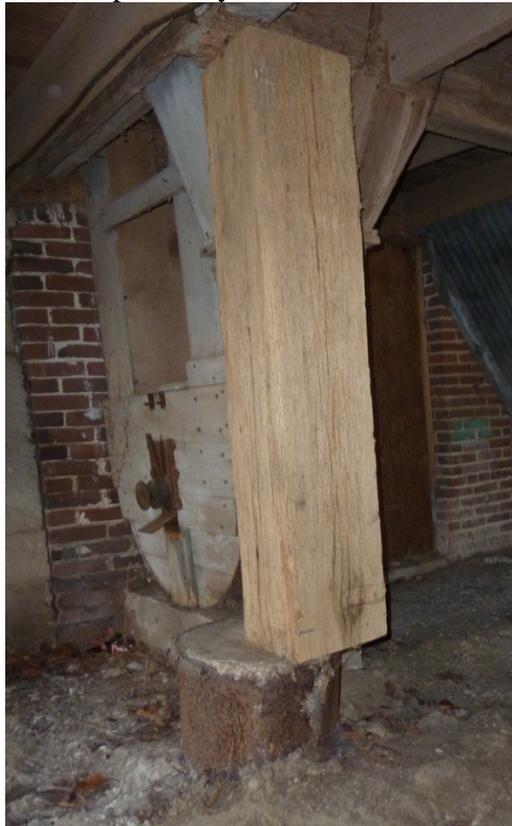
Photo B14: View of 10"x10" timber column on 16" diameter concrete footing. Note that column is out of vertical plumb and its base is only partially supported by footing.

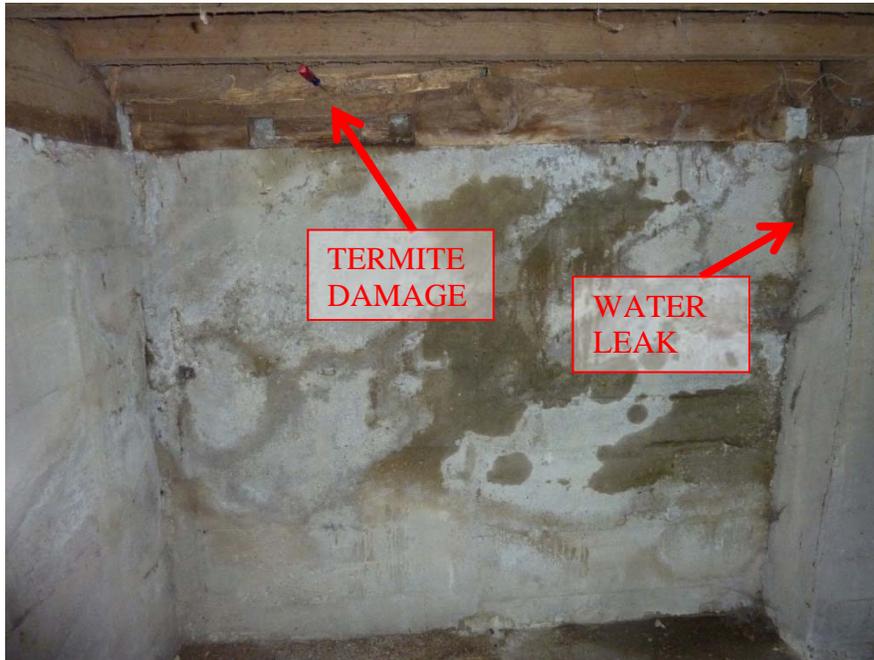
Photo B15: View of front concrete foundation wall (looking from inside). Note water infiltration through the vertical joint near adjoining wall. Also, timber sill above the wall exhibits severe damage due to the termite infestation.

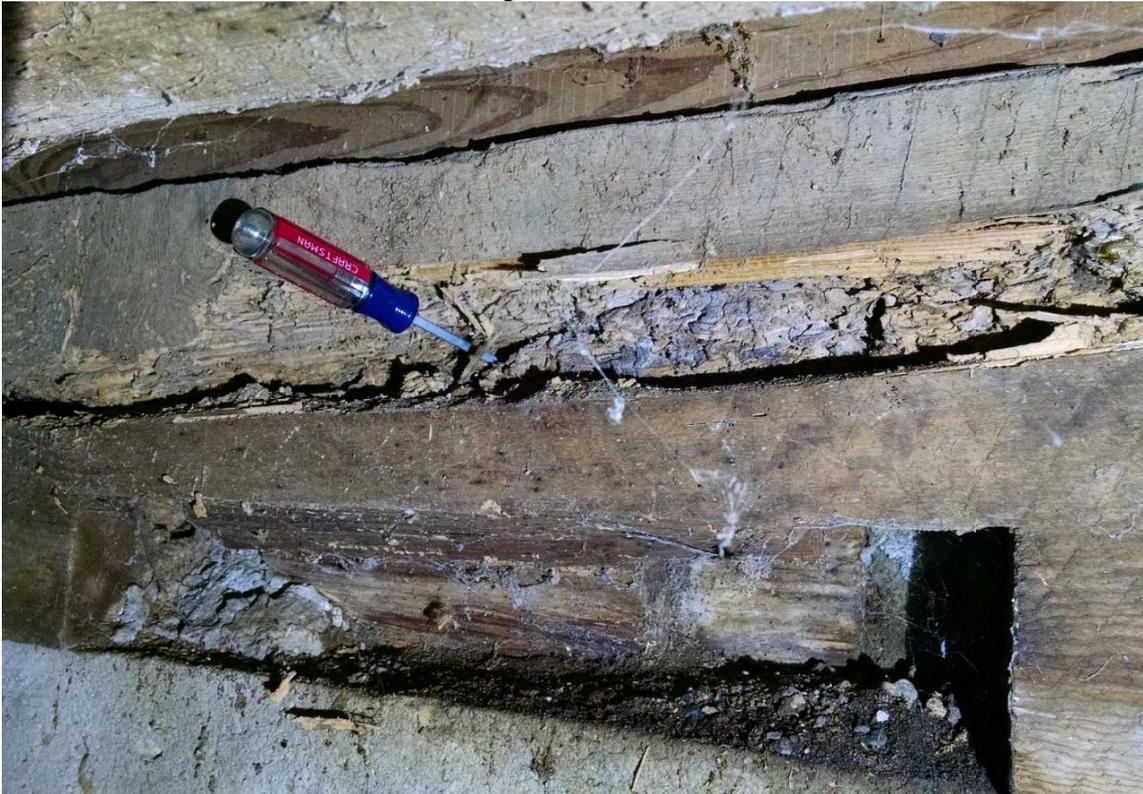
Photo B16: Timber sill above front concrete wall. Note damage in timber due to due to the termite infestation.

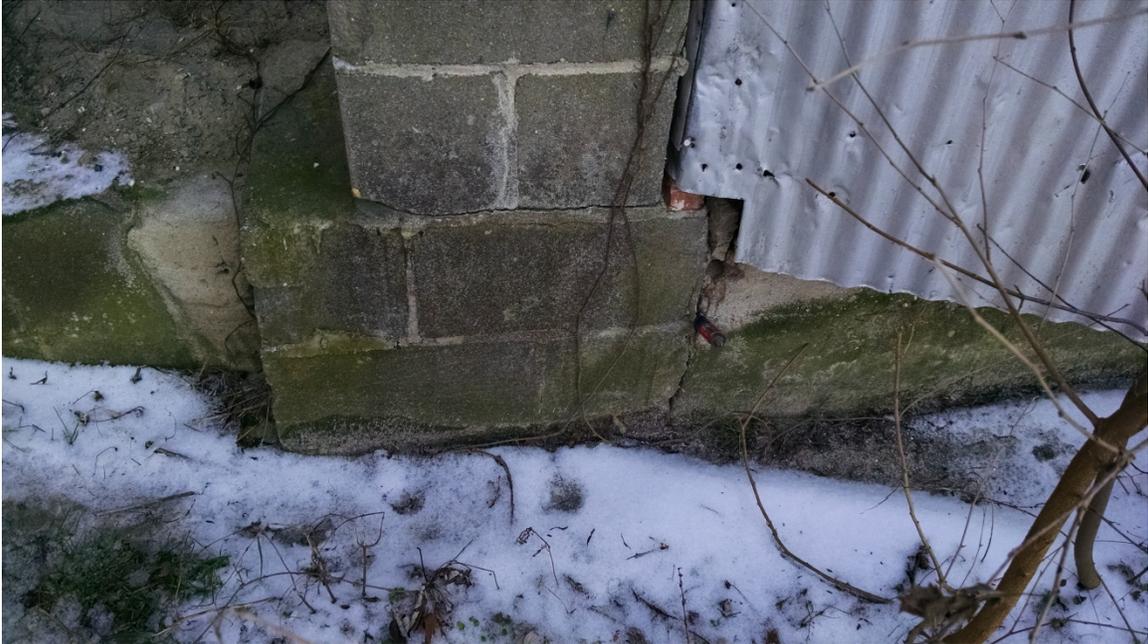
- Concrete foundation exhibits wide vertical crack near adjoining CMU wall and at approximately its mid-span (see Photos B17 & B18).
- Brick foundation wall exhibits vertical and diagonal cracks through mortar joint at the foundation’s east corner (see Photos B21 & 22).

Photo B17: North concrete foundation wall adjacent to CMU piers. Note horizontal crack along mortar joint in CMU pier near its base. Note separation (in vertical plane) between CMU and concrete foundation.

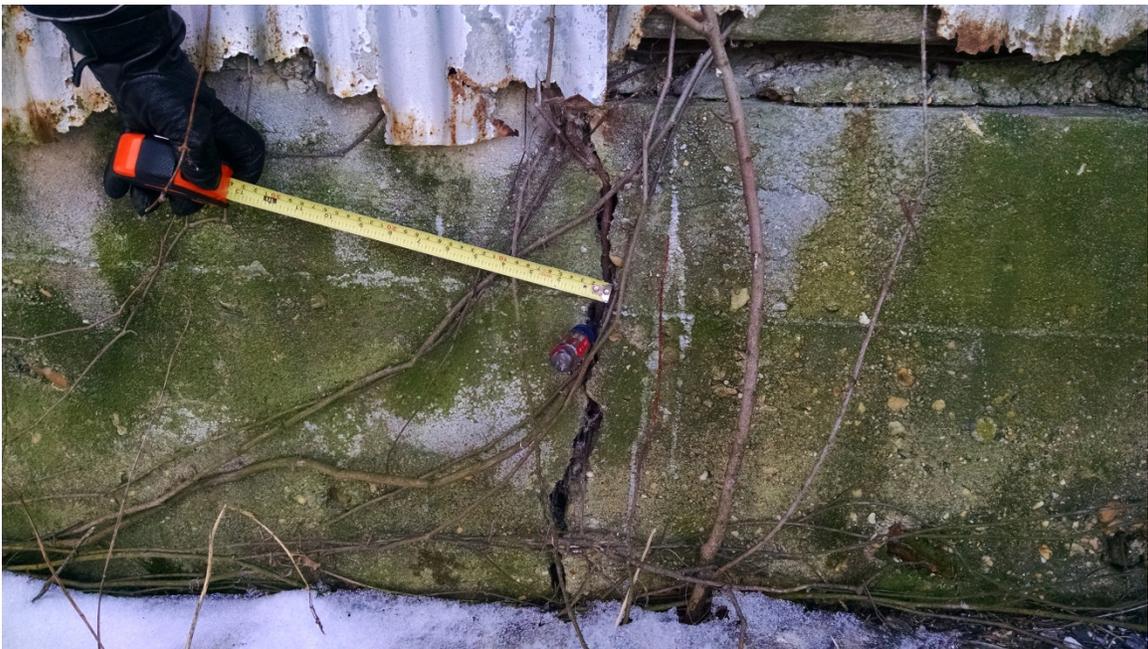
Photo B18: North concrete foundation wall (between piers and brick foundation). Note approximately $\frac{1}{2}$ " wide by 2' long vertical crack. Crack is located approximately at wall mid-span.

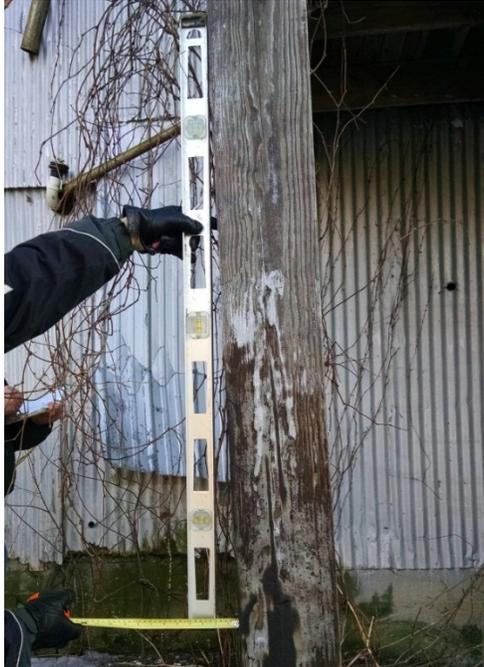
Photo B19: View of 8"x10" timber column located on the north end of the building. Column is out of plumb by approximately 2" over 4'.

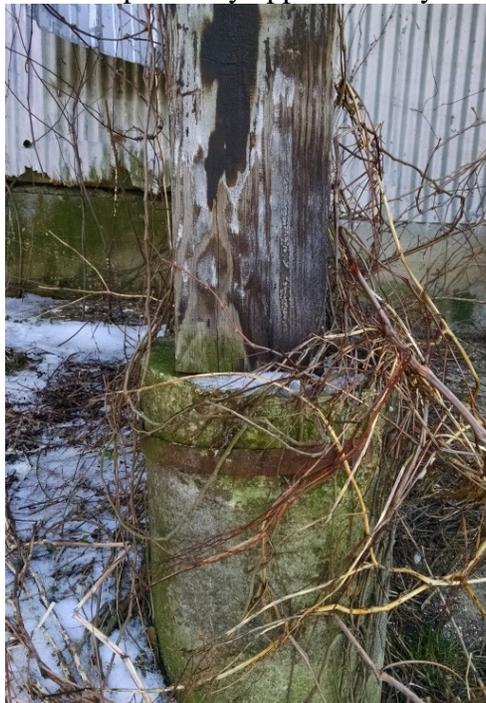
Photo B20: View of 8"x10" timber column on 16" diameter concrete footing. Note missing column to footing attachment.

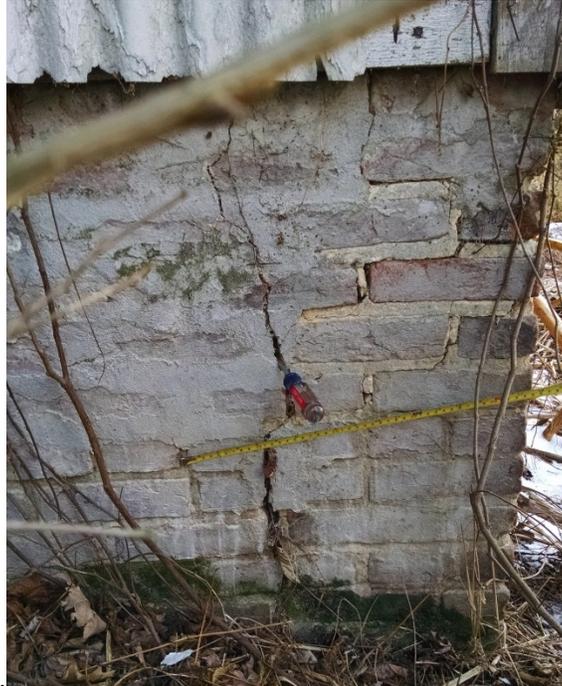
Photo B21: View of northeast corner of brick masonry foundation. Note vertical and diagonal cracking. Vertical crack measures to be approximately 1/4" wide and 3' long.

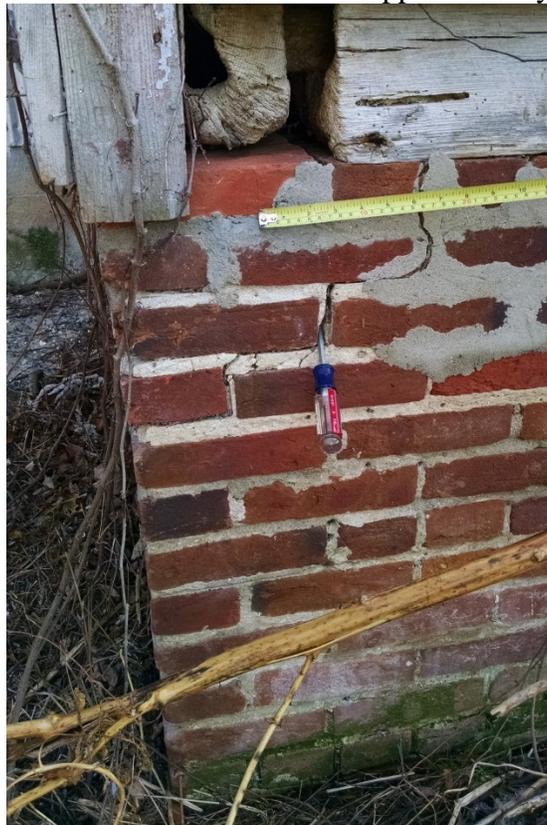
Photo B22: View of northeast corner of brick masonry foundation. Note 1/8" wide by 1' long diagonal crack in foundation. Note that crack reappeared through previously repaired mortar joint.

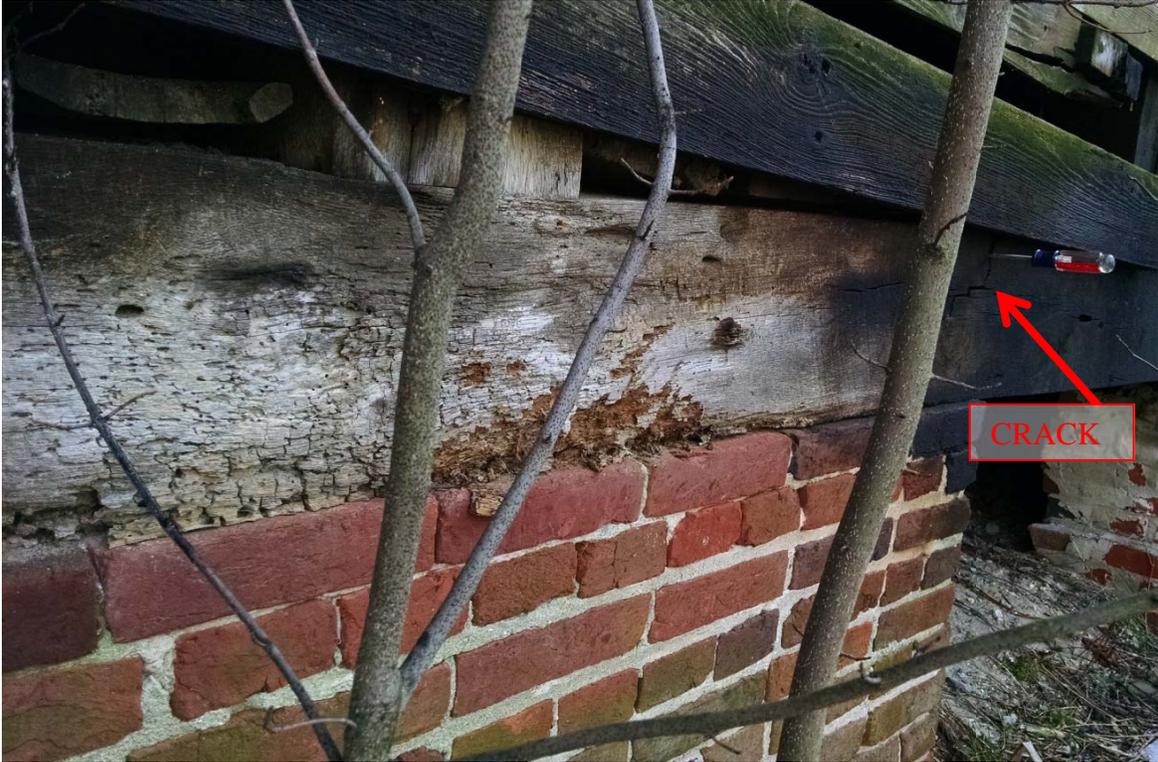
- Portion of the brick foundation at the west corner exhibits complete separation and rotation due to settlement (see Photo B25).
- Timber rim beam over mid-section of a brick foundation exhibits diagonal checks and rotting due to sustained water damage (see Photo B23).

Photo B23: View of masonry brick foundation and rim timber beam. Note significant rotting due to water damage and crack near edge of foundation.

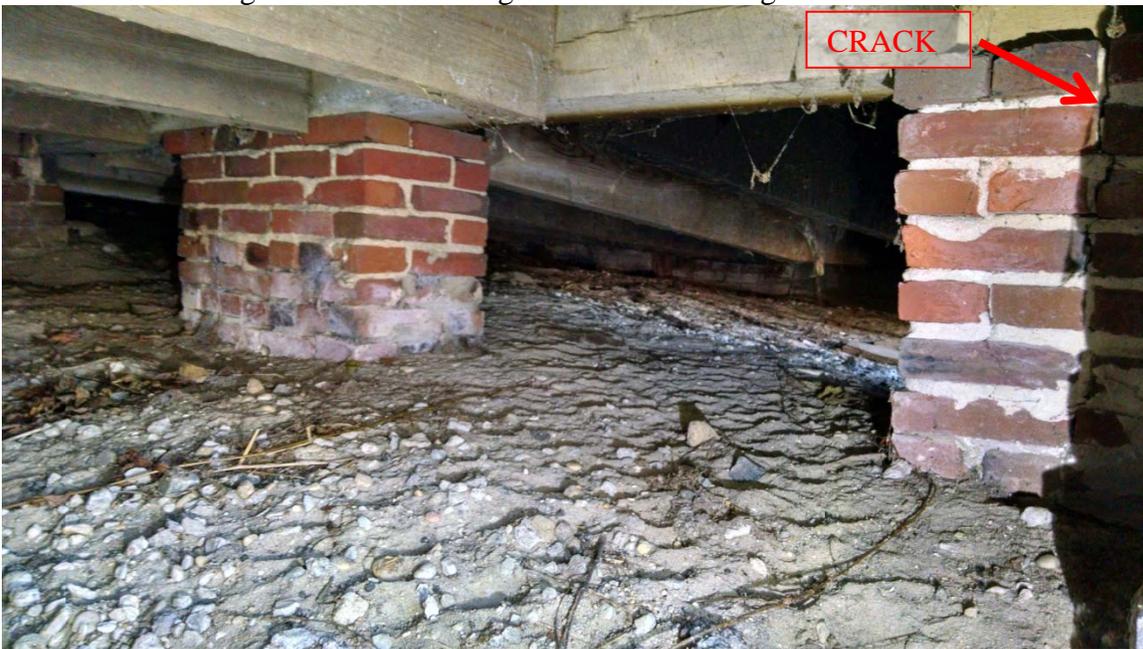
Photo B24: View of brick masonry columns. Note full height vertical crack in the column adjacent to the exterior brick foundation wall.

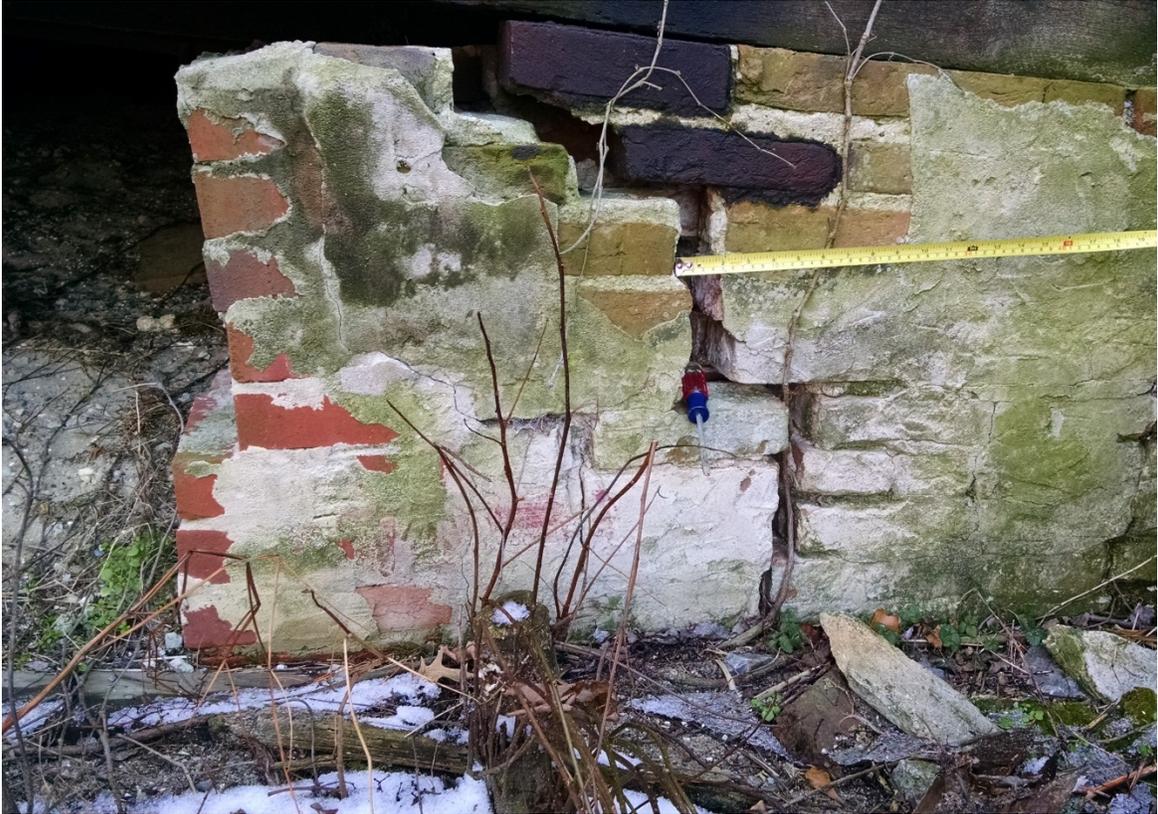
Photo B25: View of northwest corner of brick masonry foundation wall. Note approximately 2" separation in foundation due to differential settlement.

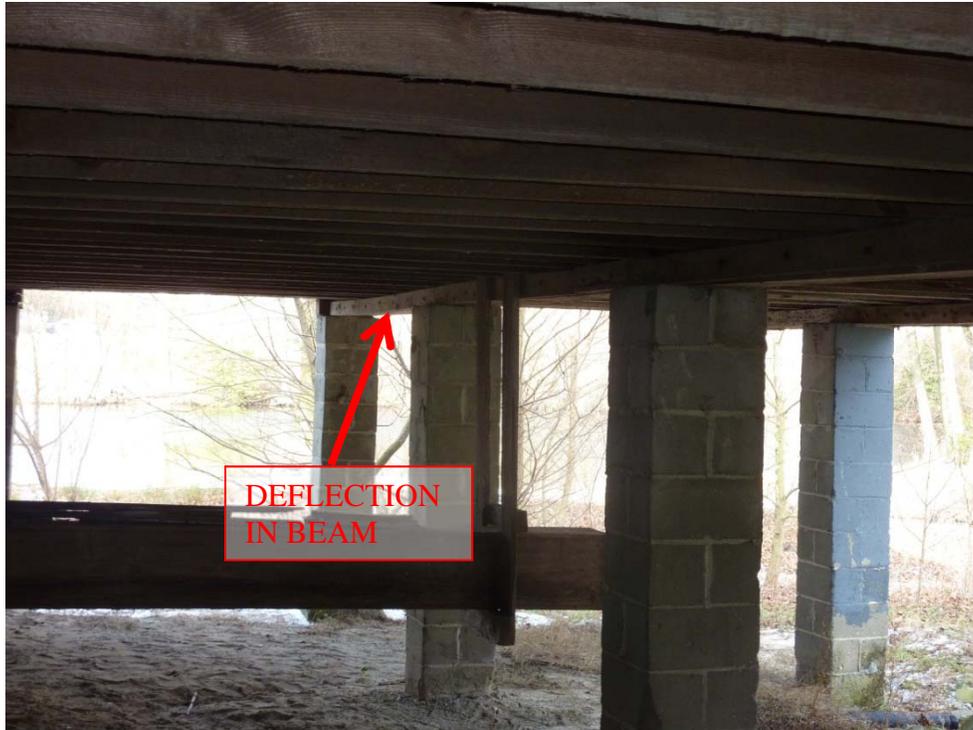
- Did not observe anchoring connection between the timber structure and the foundation below.
- Visible deflection in timber beams supporting floor joist (see Photo F1).
- Various size checks are typical for most timber beams, floor joists and posts (see Photo F2).
- Few of floor joists have cutouts that appear to accommodate other cross members in the past (see Photo F3).
- Temporary screw jacks are improperly installed below second level floor joists with deep cutouts and where floor joist is not secured to adjoining beam (see Photo F3).
- One of the beam-post connection exhibits separation (see Photo F4).
- Section of the floor is damaged due to water leaking from the second floor (see Photo F5).
- One timber column exhibit bowing (see Photo F6).

Photo F1: View of timber floor supporting members (looking north). Note floor beams exhibiting deflection between supporting columns.

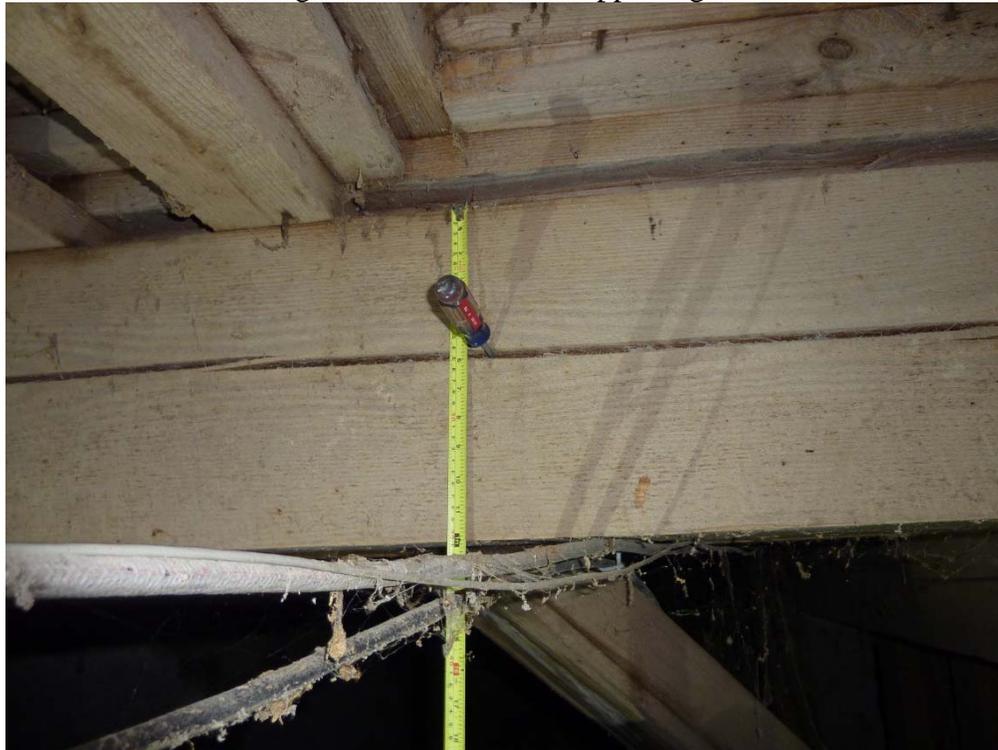
Photo F2: View of timber floor beam. Note wide and long check in the beam. This picture is a typical representation of most timber beams, joists and columns supporting first level.
