DELAWARE DEPARTMENT OF TRANSPORTATION

PRE-MONITORING INSPECTION REPORT

THE MILL BUILDING AT HEARNS POND DAM, SUSSEX COUNTY , DE

**PRE-MONITORING INSPECTION REPORT
MILL BUILDING AT HEARNS POND DAM
CITY OF SEAFORD
SUSSEX COUNTY, DE**

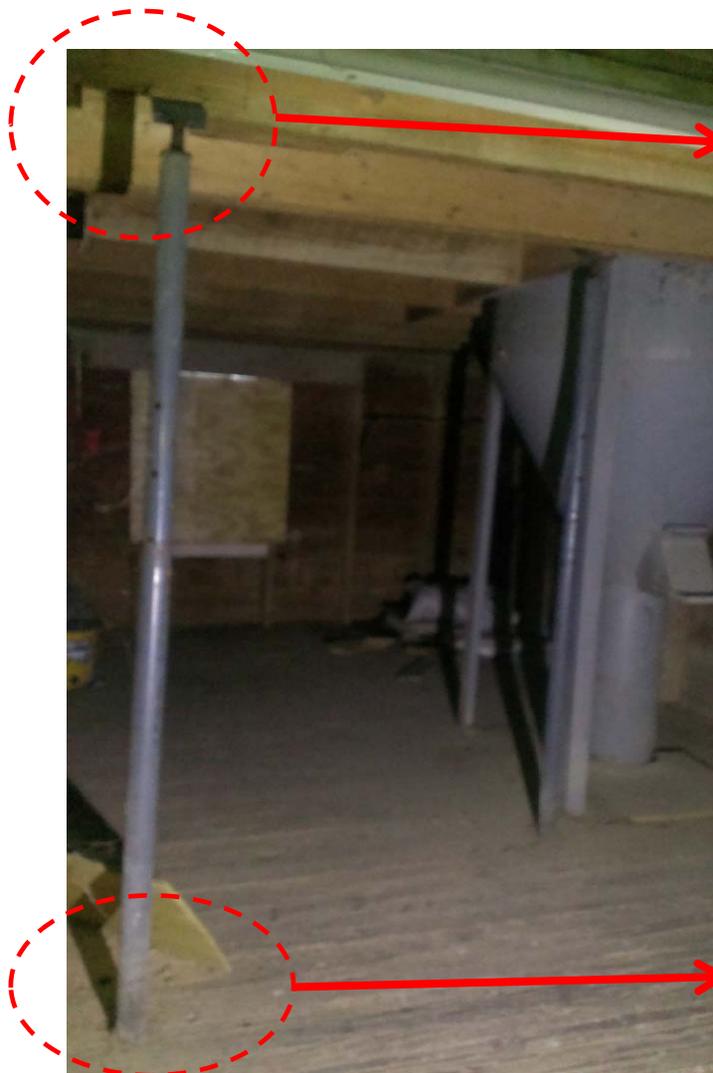
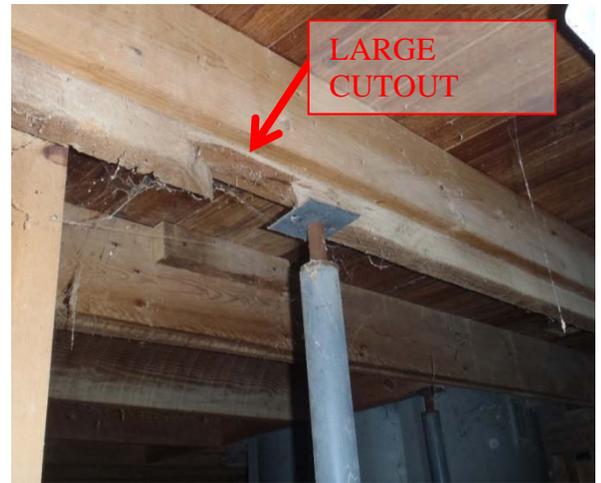
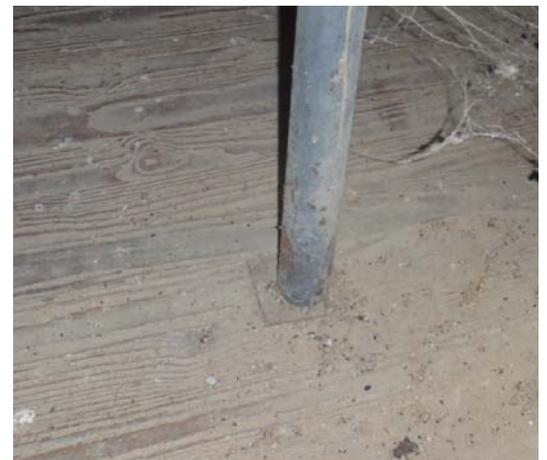
Photo F3: View of 2 1/2" diameter steel screw jacks supporting floor joists. Jacks are unsecured at top and bottom and load distribution plate is not used at the bottom. Note cutout section and sister joist in the supported floor joist.

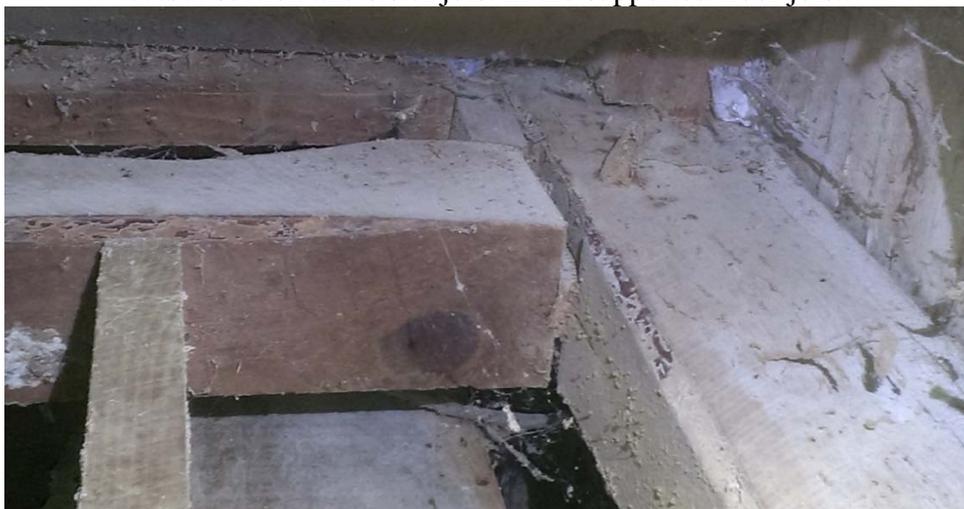
Photo F4: View of timber post to beam connection (looking up). Note approximately 1/2" separation at the joint location.

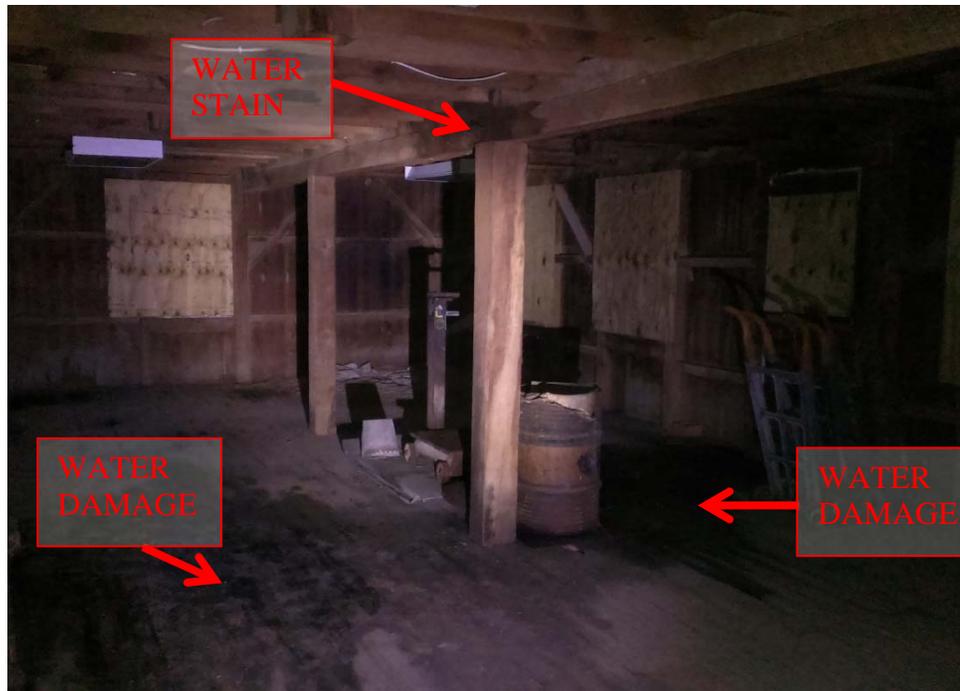
- Did not observe anchoring connection between the timber structure and the foundation below.
- Visible deflection in timber beams supporting floor joist (see Photo F1).
- Various size checks are typical for most timber beams, floor joists and posts (see Photo F2).
- Few of floor joists have cutouts that appear to accommodate other cross members in the past (see Photo F3).
- Temporary screw jacks are improperly installed below second level floor joists with deep cutouts and where floor joist is not secured to adjoining beam (see Photo F3).
- One of the beam-post connection exhibits separation (see Photo F4).
- Section of the floor is damaged due to water leaking from the second floor (see Photo F5).
- One timber column exhibit bowing (see Photo F6).

Photo F5: General view of the room. Note water stains and rotted floor due to water damage infiltrating through 2nd level floor.

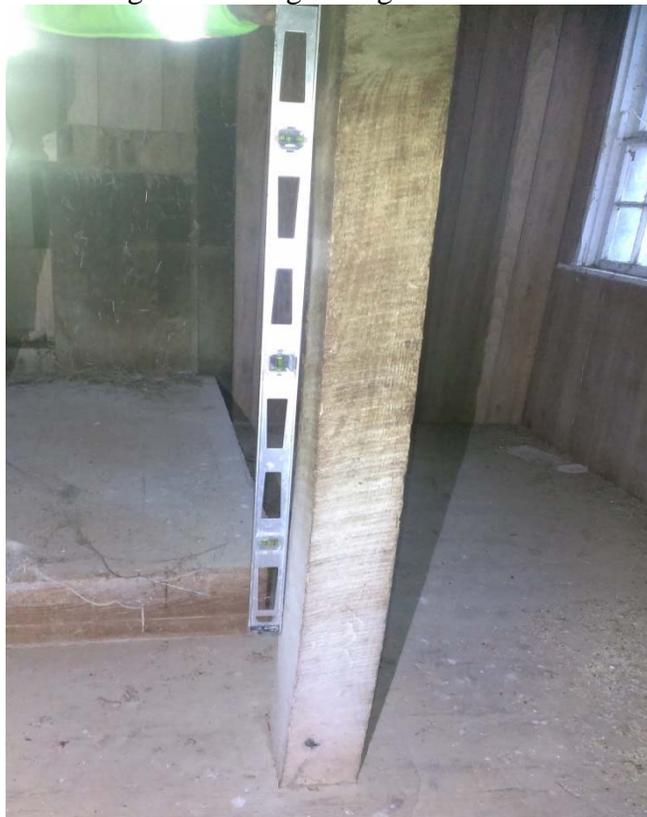
Photo F6: View of 8"x7" timber column. Note approximate 1/2" sideways column deflection.

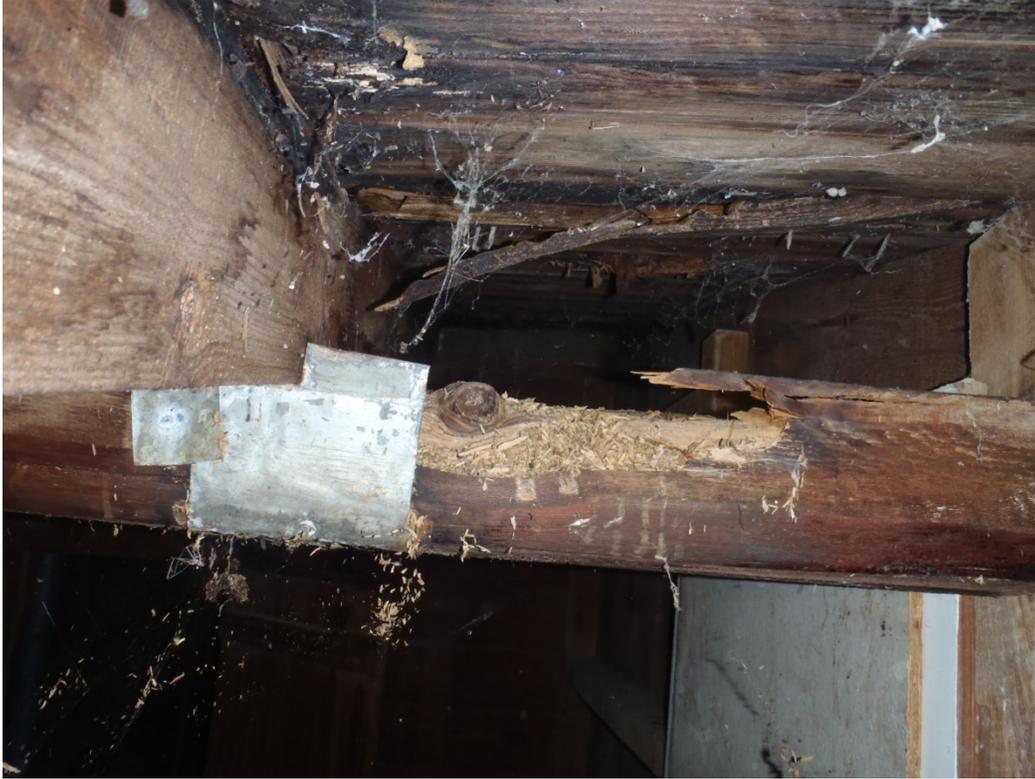
- Sections of the floor and roof exhibit severe damage with 100% section loss due to water leakage and termite infestation (see Photos S1 through S6).
- Section of the load bearing wall supporting roof structure has been removed (see Photo S9).
- Approximately 50% of structural timber members exhibit various length and depth checks (see Photo S7).
- Several studs in non-load bearing wall and post lateral braces exhibit excessive cutouts (see Photos S8 and S10).
- Timber beams supporting attic load bearing walls exhibits severe deflection (see Photo S12). Excessive beam deflection causing beam end to rotate and separate from the supporting post (see Photo S11).
- Wood framing supporting the outside awning shows evidence of deterioration caused by water (see Photo S13).

Photo S1: View of 4 ½”x4 ½” timber beam supporting ceiling joists. Note significant damage to beam due to the termite infestation.

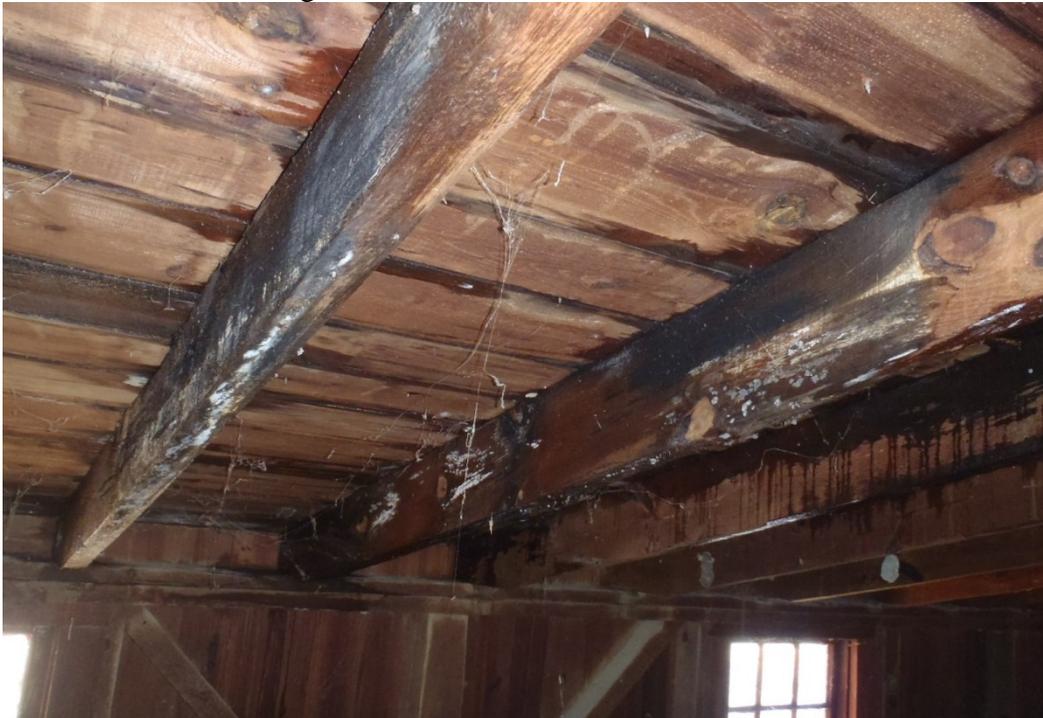
Photo S2: View of ceiling joists. Note significant water damage to the roof rafters due to leaking roof.

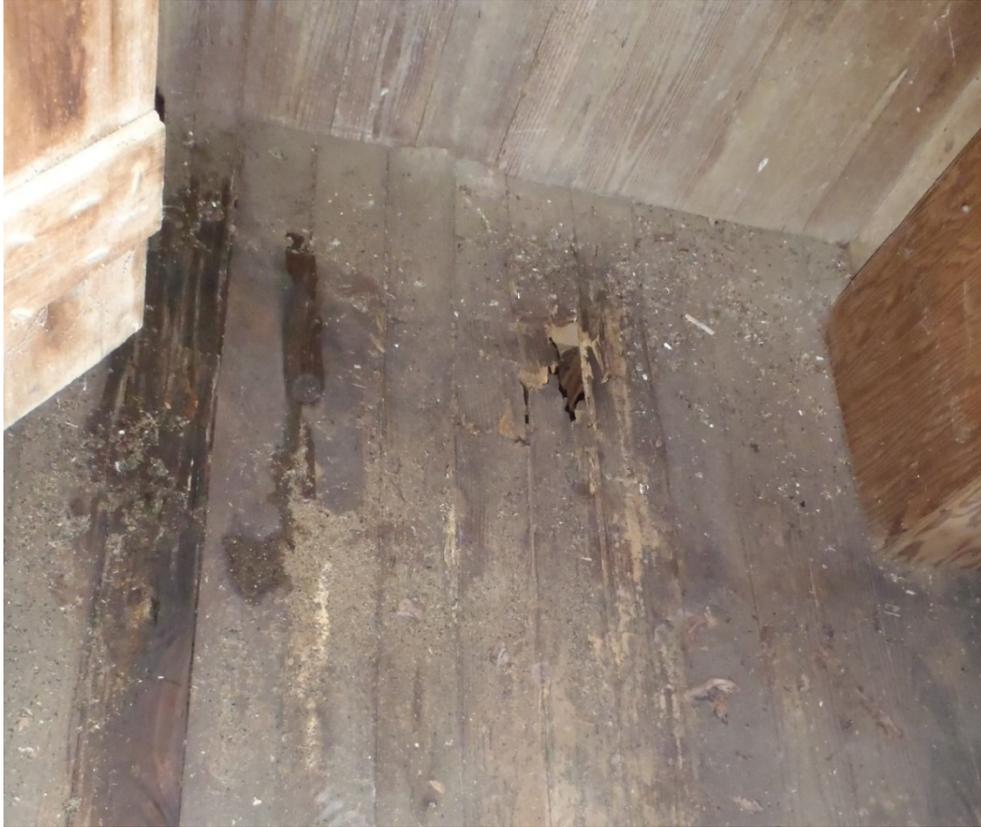
Photo S3: View of 2nd level floor. Note 100% loss of floor section due to the termite infestation.

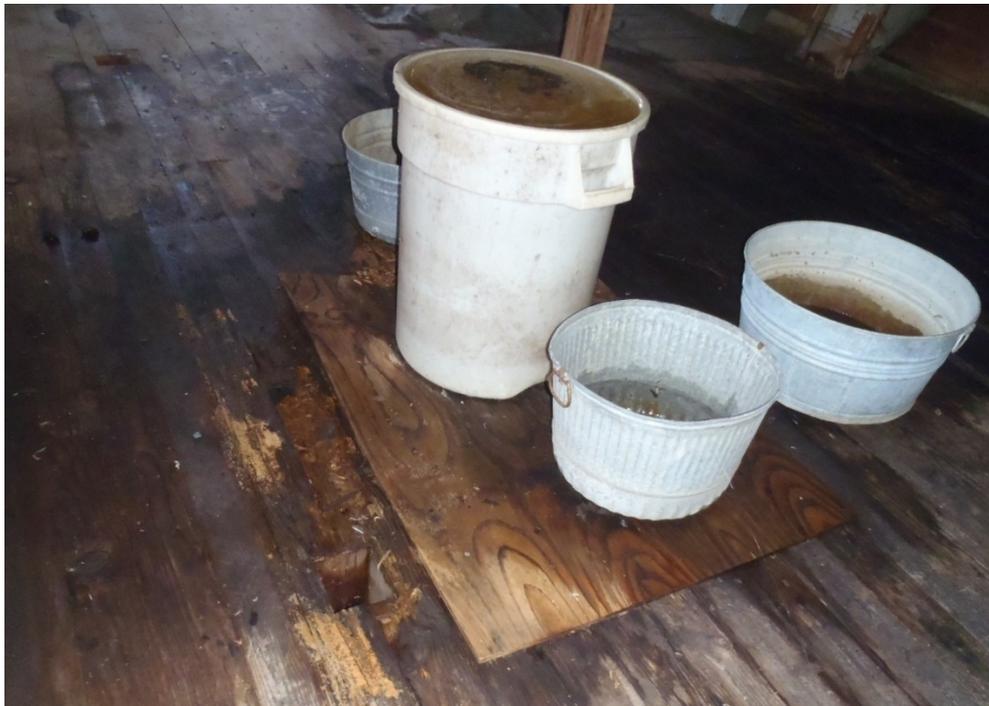
Photo S4: View of the 2nd level floor. Note containers collecting water from roof leak. Containers were overflowing at time of inspection and the floor was sagging significantly.

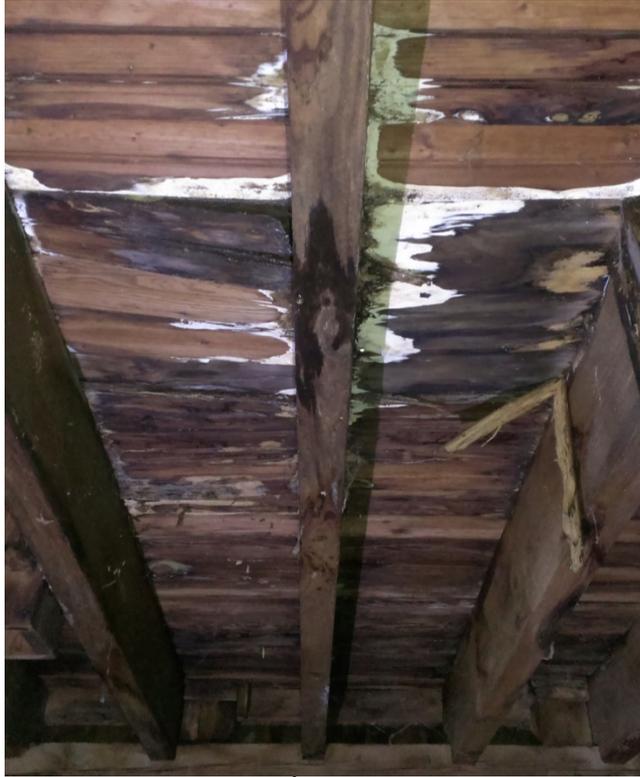
Photo S4: View of joists supporting 2nd level. Note severe damage to floor joist and development of efflorescence due to leaking roof above.

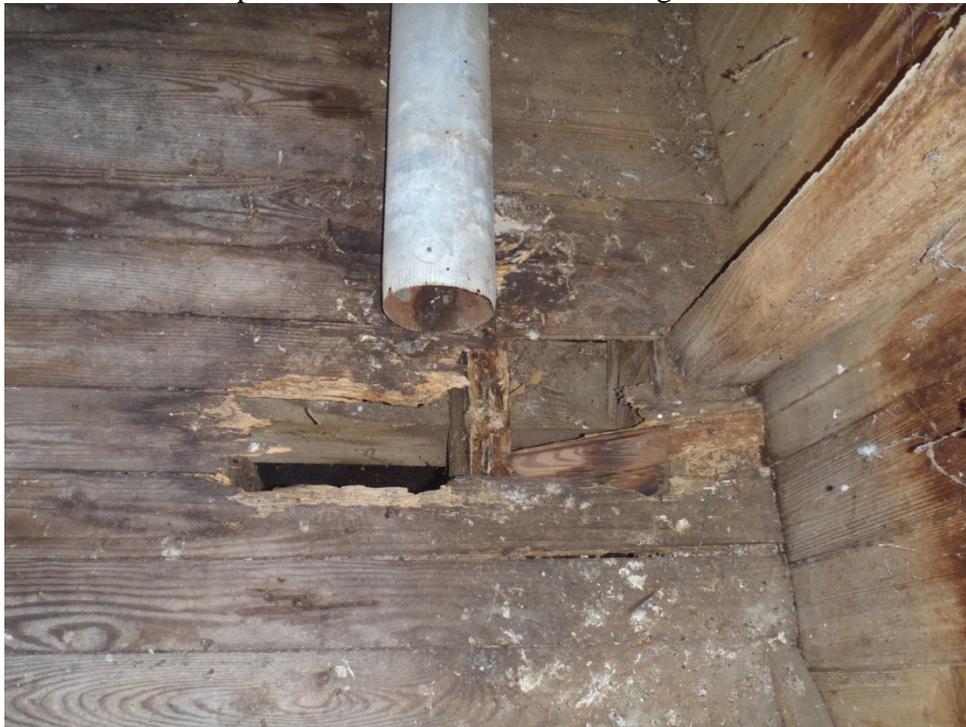
Photo S6: View of the 2nd level floor. Note 100% loss of floor section due to water damage.

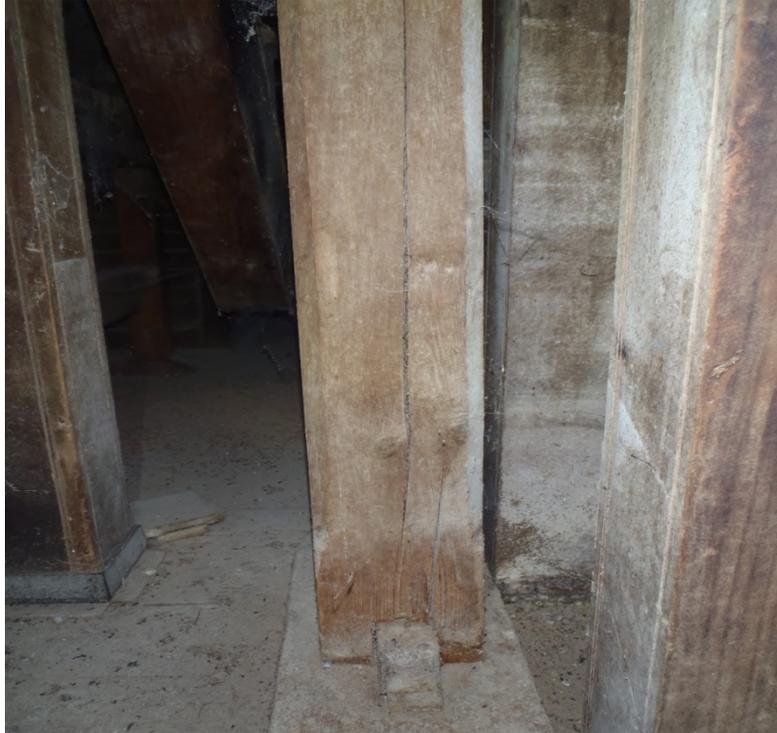
Photo S7: View of timber post. Note long vertical check that represents typical appearance of the 2nd floor timber support members.

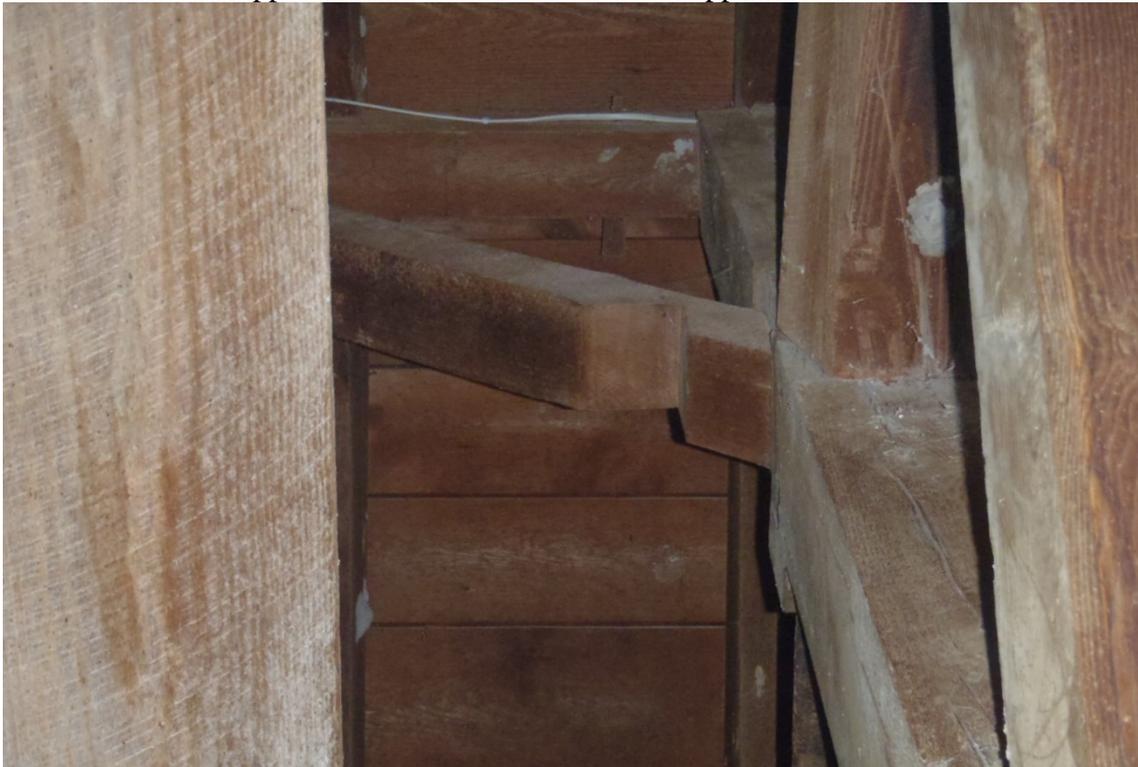
Photo S8: Partial view of post lateral bracing member (looking up). Note deep cutout in lateral bracing member.

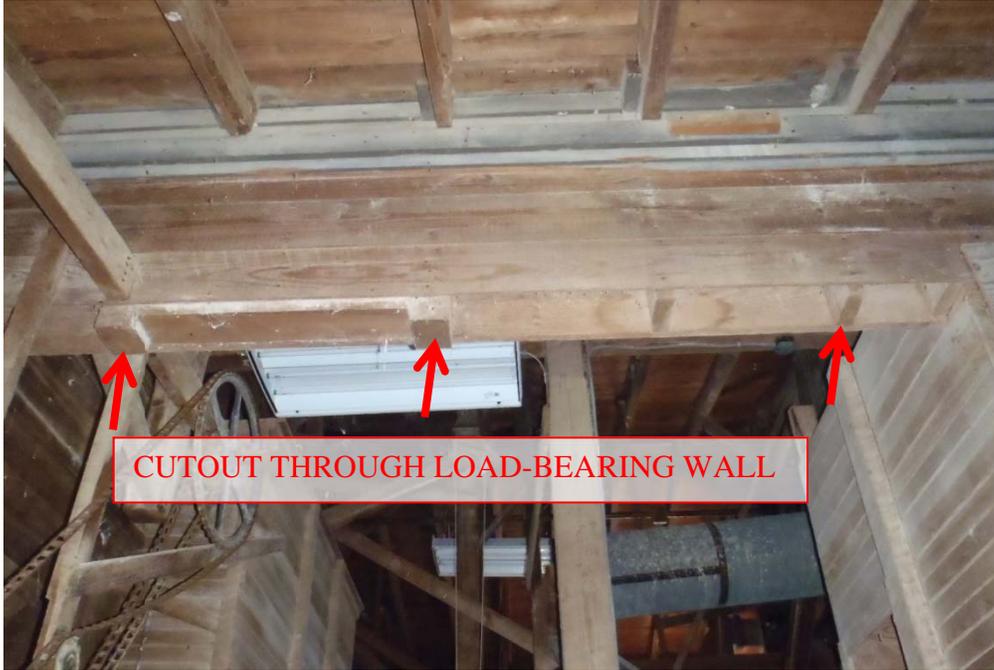
Photo S9: View of cutout through load bearing wall supporting roof structure.

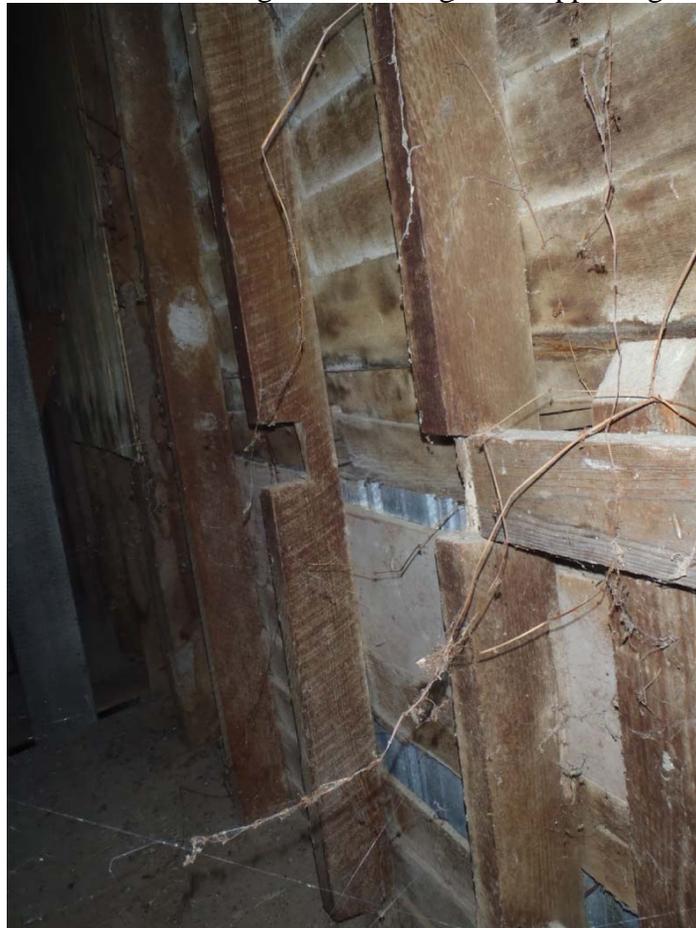
Photo S10: View of exterior non-load bearing stud wall. Note deep cutouts in studs.

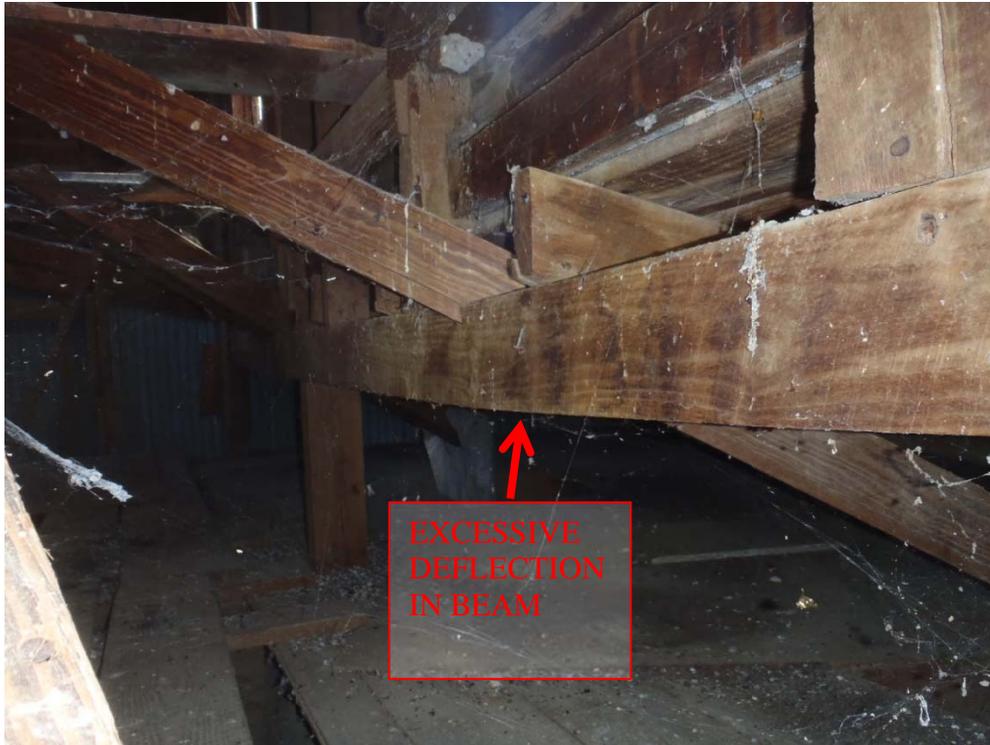
Photo S11: View of timber beam in attic at front side of building. Note significant beam deflection.

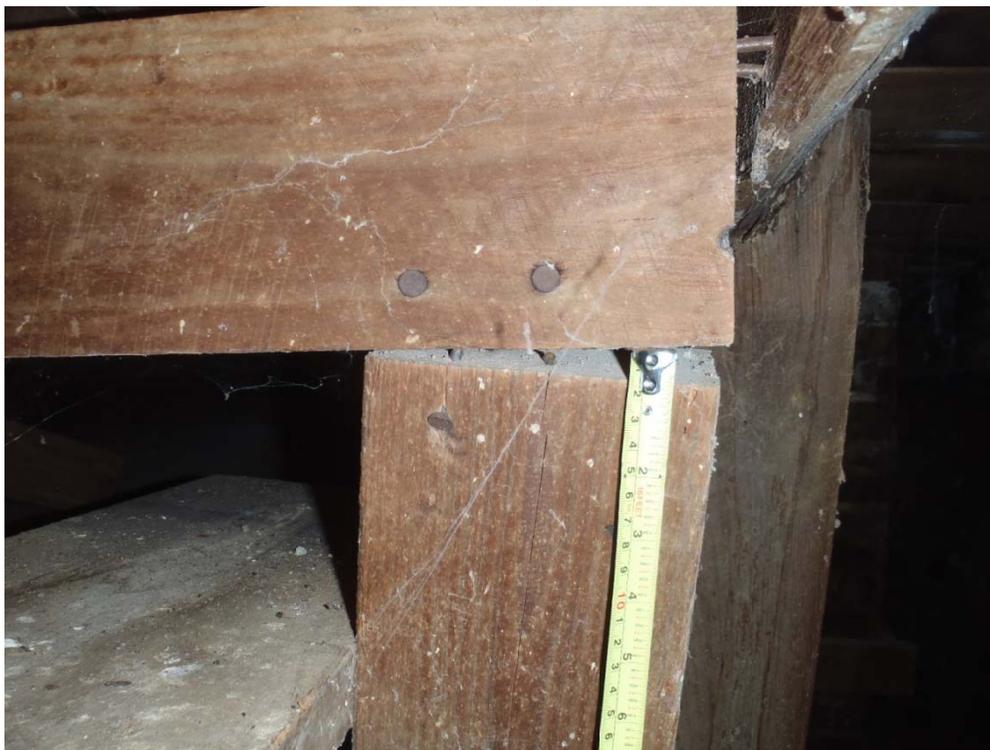
Photo S12: View of timber beam with $\frac{1}{2}$ " gap between bottom of beam and supporting column. Gap is due to significant beam deflection causing beam ends to rotate.

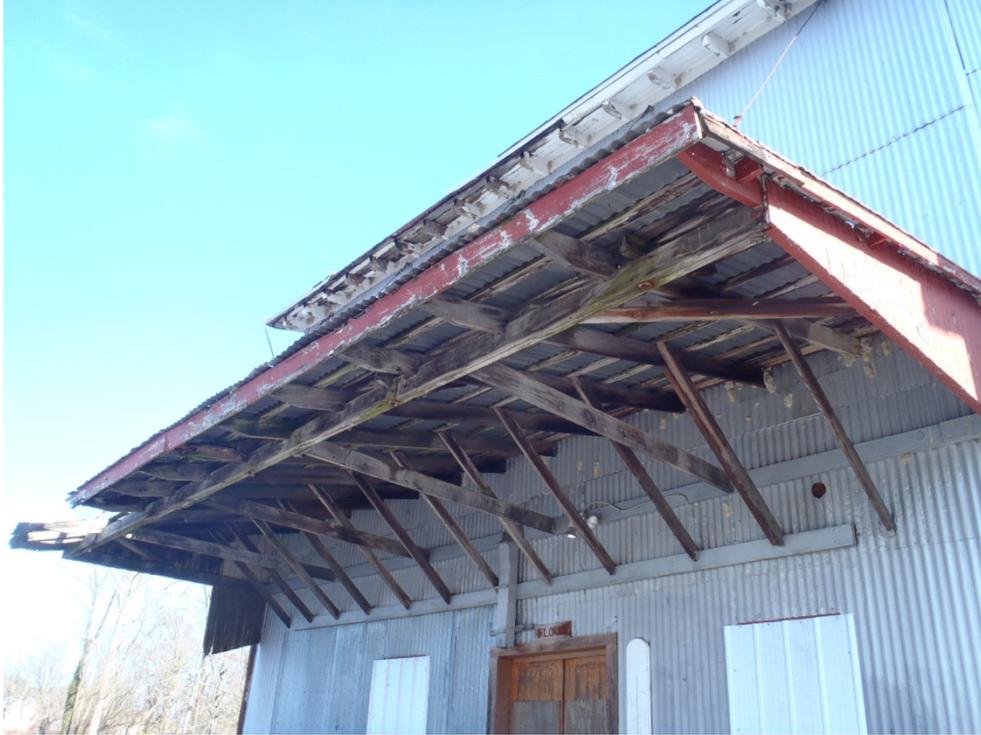
- Foundation/Ground Level (see *Figure 4* for locations):
 - Brick masonry walls and piers.
 - Concrete wall foundation along building north.
 - All CMU and timber piers.
- Second Level (see *Figure 6* for locations):
 - Exterior awning at the front of the building.

Photo S13: View of awning at front of building. Note deterioration of support framing.

The Contractor should pay attention to the above generalized area of concerns and perform a repair or provide additional load bearing support to maintain the overall structural integrity of the building during the pile driving operation. The means and methods of the repair or additional support should be determined by the Contractor and submitted to the Department for their review and acceptance.
