# ASBESTOS-CONTAINING MATERIALS SURVEY AND QUANTITY ESTIMATION REPORT

**“Hanger” Building**  
**Asbestos Agreement 1542 \*Task 27\***  
**800 Bay Road**  
**Dover, Delaware**  
**Agreement 1542**  
**Task No. 27 – Asbestos Management**

September 2012

**BrightFields File: 2680.27.74**

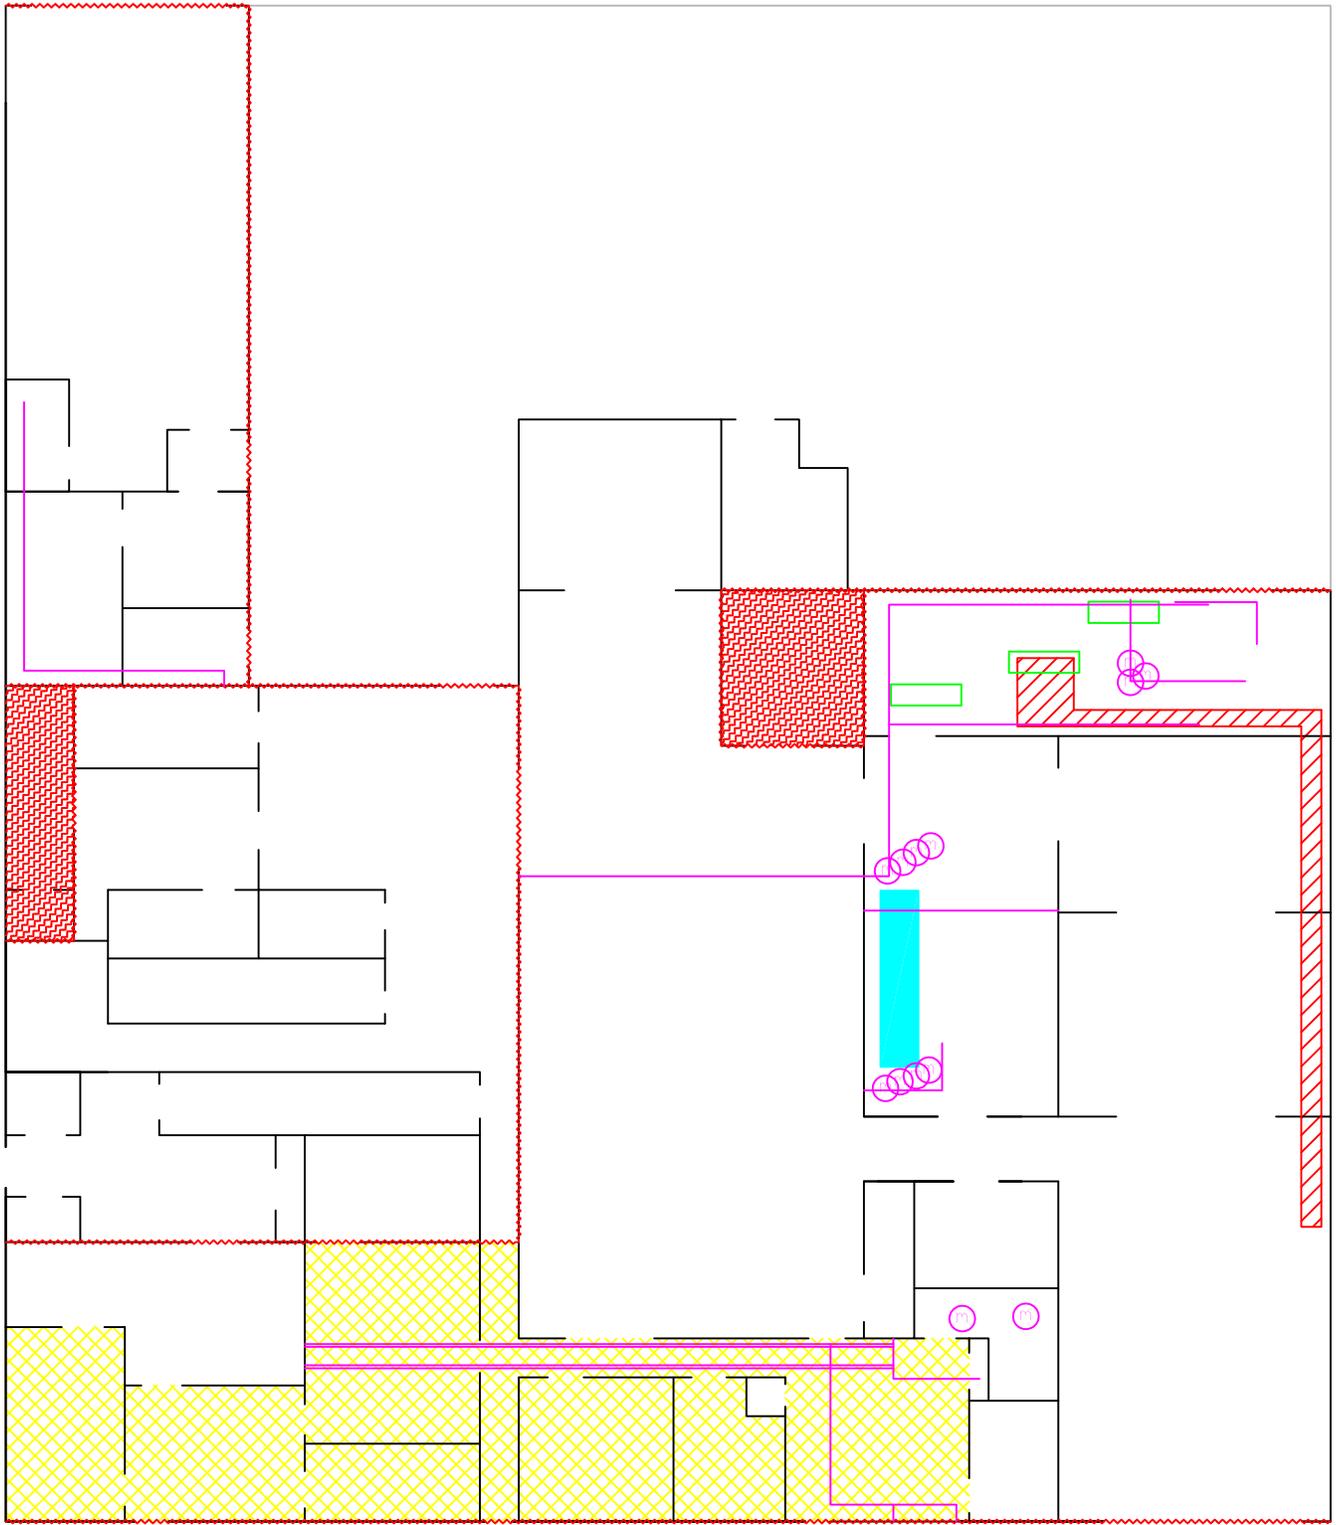
Asbestos-containing Cementitious Panels
-

Asbestos-containing Ventilation Hood includes panels, duct, joint caulk and rope gasket
-

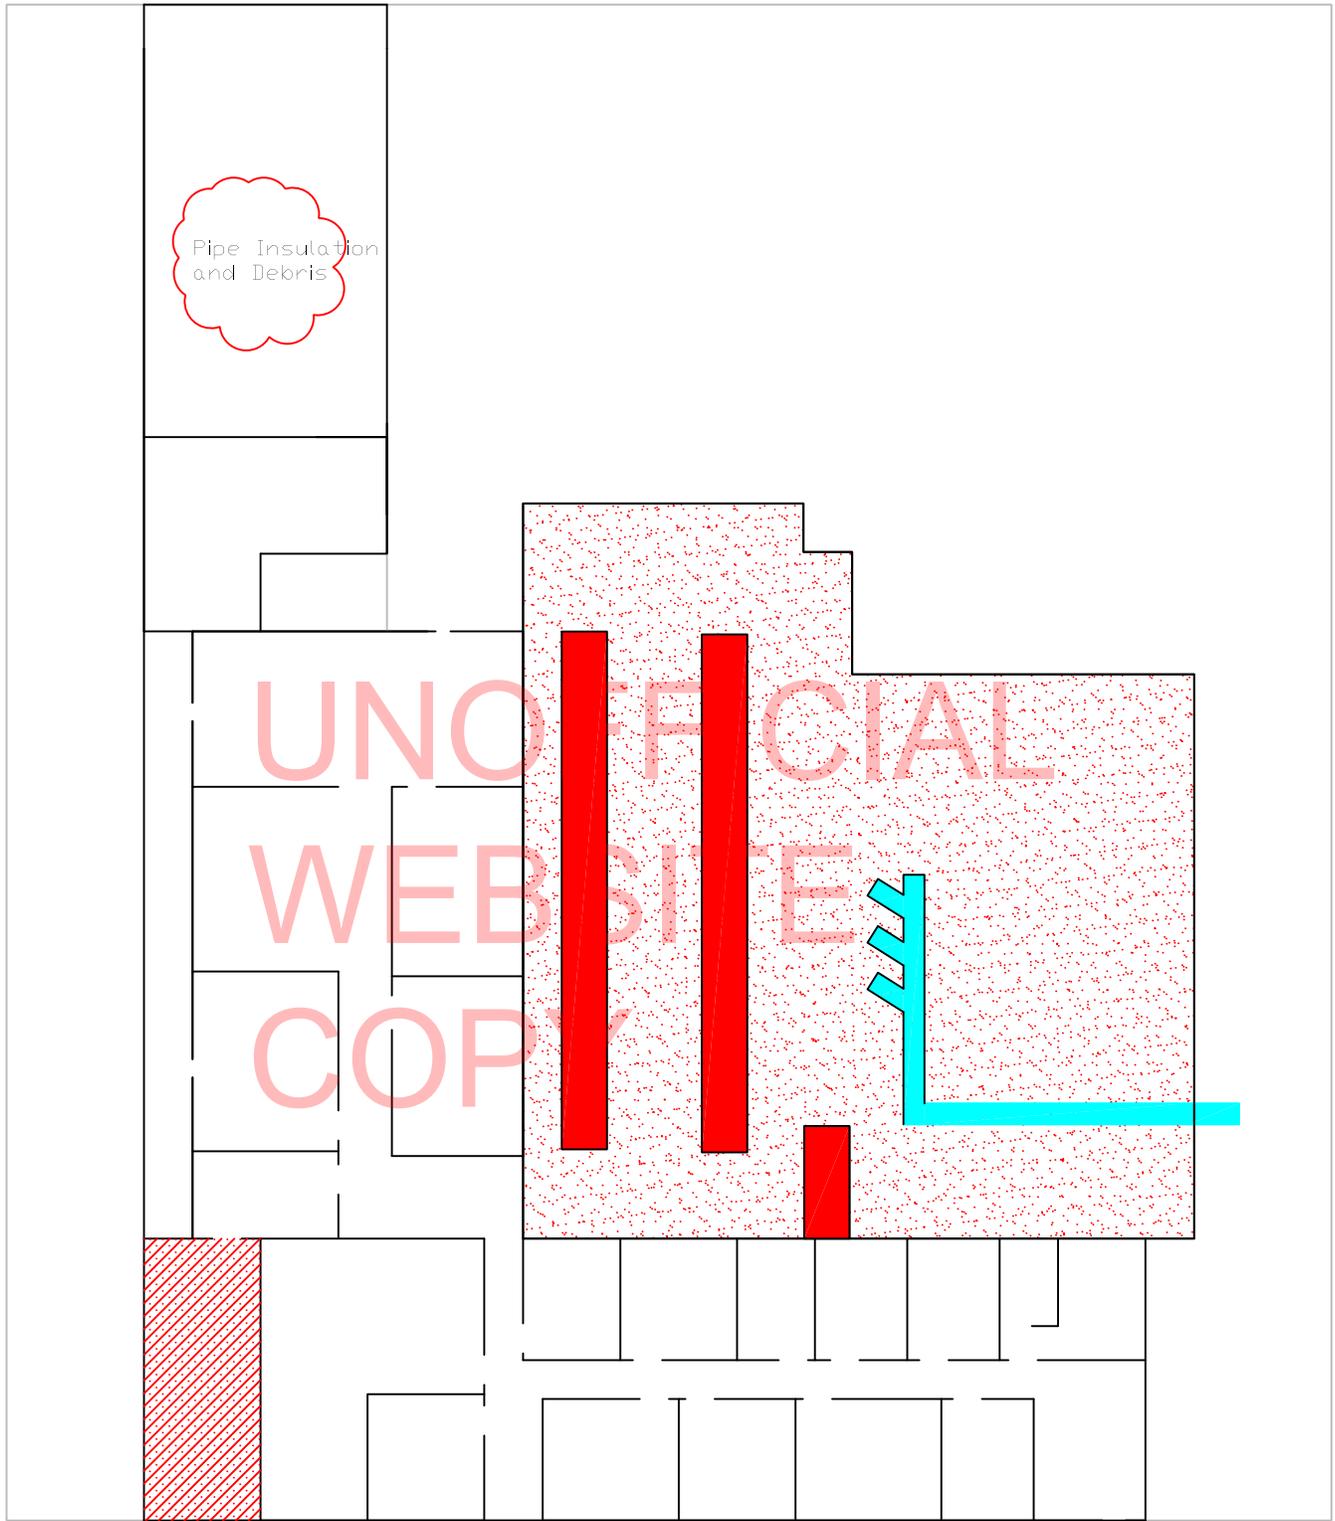
Pipe Insulation  
and Debris

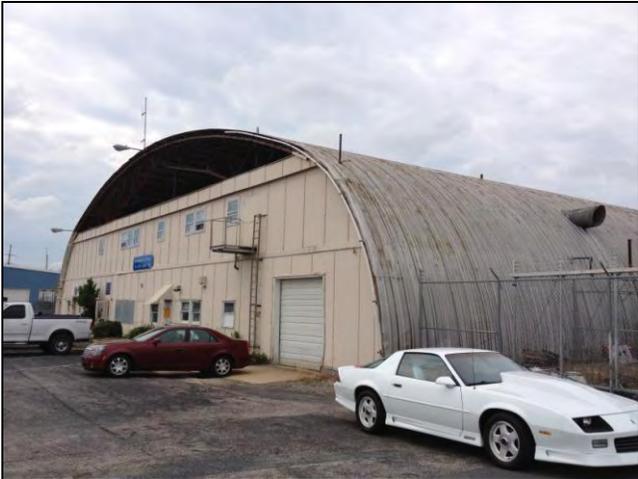
1. Asbestos-containing cementitious siding panels (gray) as exterior and interior walls and as ceilings in room 122 and chase areas adjacent to rooms 113 and 113A – estimated 14,870 square feet (15% Chrysotile).
2. Asbestos-containing sheet good (white with small multi-color squares pattern) located in the 1<sup>st</sup> floor front office area under carpet – estimated 2,000 square feet (8% Chrysotile).

Asbestos-containing cementitious panels along front of building.

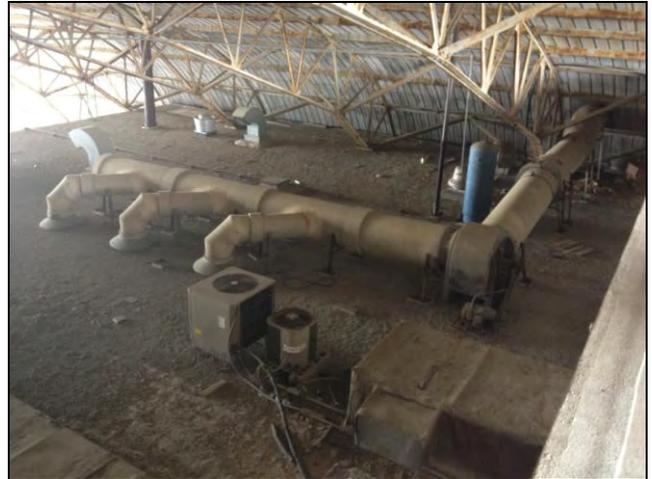
Asbestos-containing ventilation duct, HVAC duct coating, and roofing material.

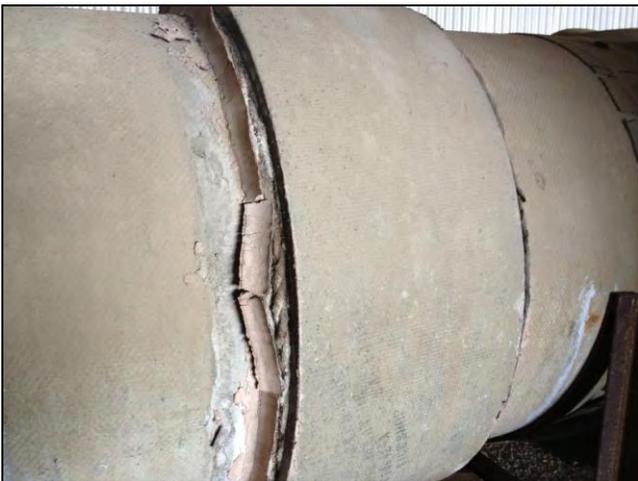
2. Asbestos-containing joint caulk associated with ventilation system duct and vent hood joint connections located in the screening room and across the second level flat roof – estimated 140 linear feet (8% Chrysotile).

3. Asbestos-containing rope gasket associated with ventilation system duct and vent hood joint connections located in the screening room and across the second level flat roof – estimated 140 linear feet (15% Chrysotile).

Asbestos-containing ventilation duct, caulking, and rope gasket.

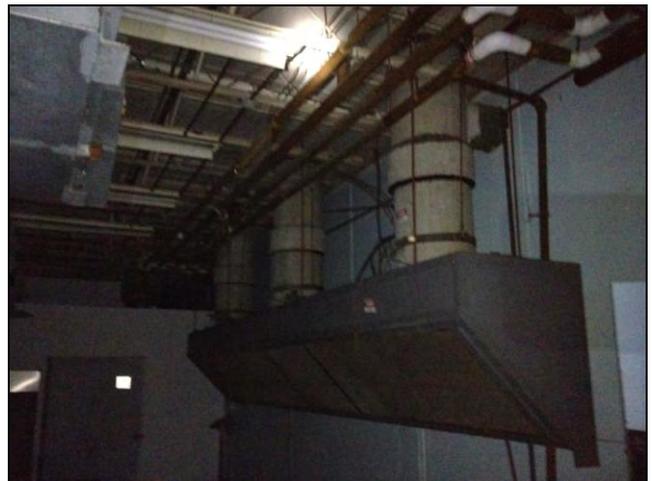
1. Asbestos-containing cementitious ventilation system duct and vent hood located in the screening room and across the 2<sup>nd</sup> Level flat roof – estimated 65 linear feet of 2' diameter duct, 45 linear feet of 1.5' diameter duct, and 68 square feet on vent hood (15 Chrysotile and 15% Crocidolite).

Asbestos-containing ventilation duct and hood in screening room.

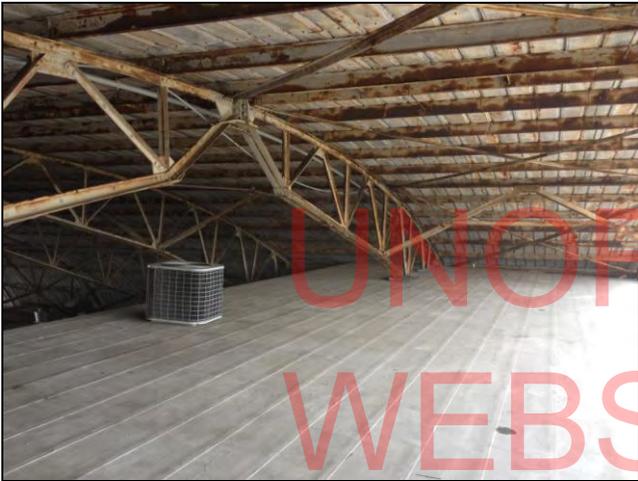
6. Asbestos-containing silver roof coat associated with the third level flat roof over the second level office space – estimated 4,967 square feet (3% Chrysotile).
7. Asbestos-containing asphalt rolled roofing associated with the third level flat roof over the second level office space – estimated 4,967 square feet (6% Chrysotile).

Asbestos-containing silver roof coat and rolled asphalt roof on third level.

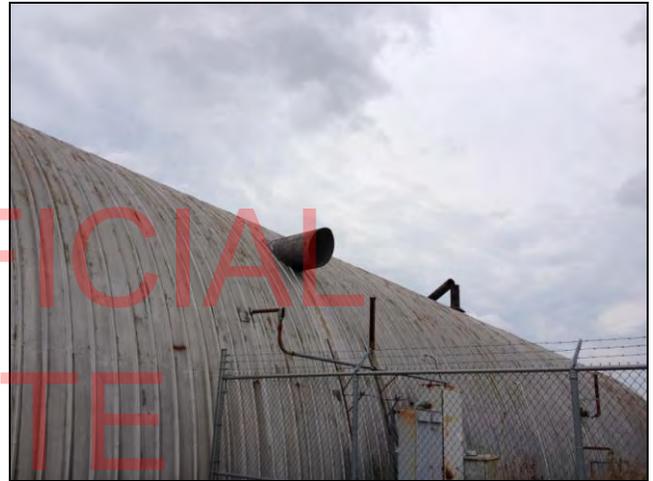
1. Asbestos-containing silver roof coat associated with the main arched metal roof – estimated 23,000 square feet (2% Chrysotile).
2. Asbestos-containing roofing tar and associated felt backing (black) associated with small isolated flat roof accessed from office 214 or the southern HVAC chase located on the second floor – estimated 348 square feet (5% Chrysotile).

Asbestos-containing ventilation duct and silver roof coat on arched roof.

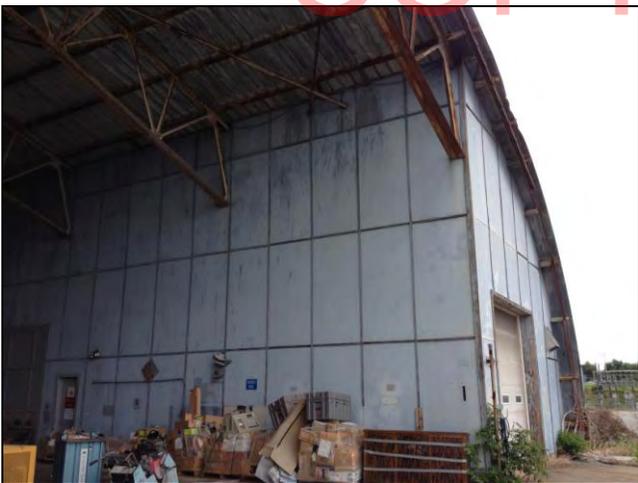
Asbestos-containing cementitious panels along rear of building.

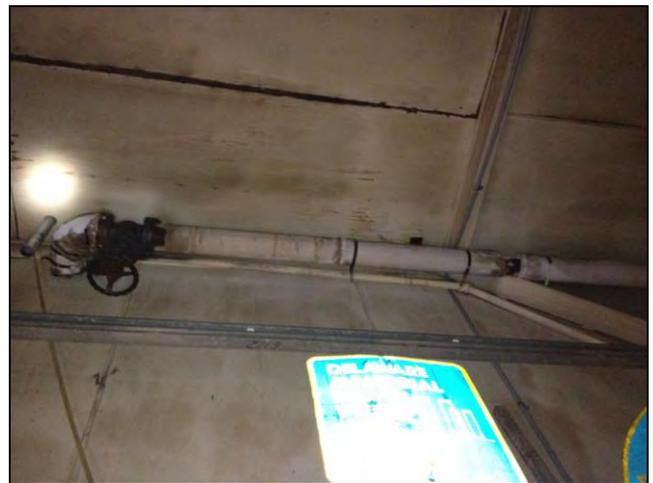
6. Asbestos-containing 4" cement pipe insulation located in maintenance shop, office and storage area, above the drop and wood ceiling in the sign fabrication room, through a portion of the screening room, and in the boiler room – estimated 250 linear feet (15% Chrysotile and 8% Amosite).

4" cement pipe thermal system insulation in maintenance shop.

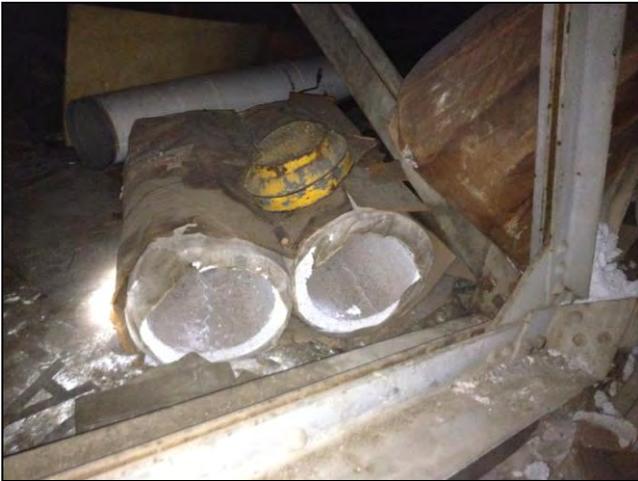
5. Asbestos-containing unused pipe insulation and associated debris located in the attic space above the rear maintenance shop – estimated 800 square feet (15% Chrysotile and 8% Amosite). Please note that two unused 4 foot sections of the pipe insulation were observed with damage debris scattered across the attic floor and on items stored in the attic.

Asbestos-containing unused pipe insulation and debris in maintenance garage attic.

- If asbestos debris is disturbed and/or observed on the floor prior to the commencement of abatement activities, it should never be dry swept, but instead cleaned up by trained/certified personnel using either an approved asbestos high efficiency particulate air (HEPA) vacuum or wet-cleaning methods.

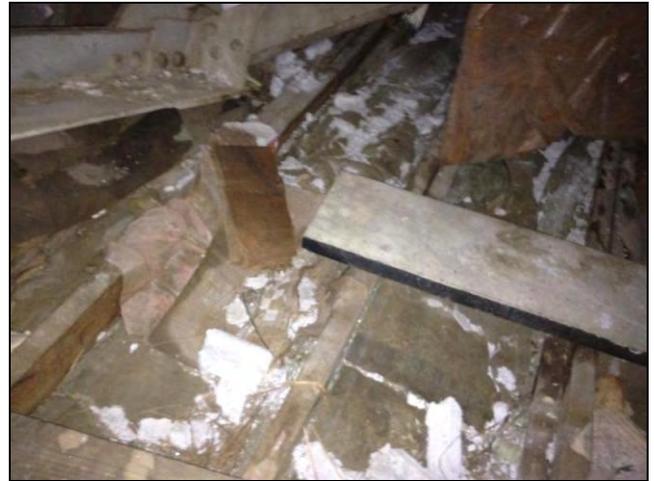
Asbestos-containing unused pipe insulation debris in maintenance garage attic.

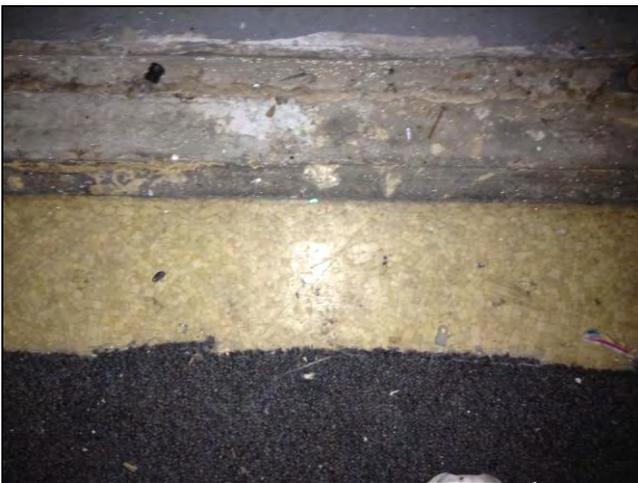
Asbestos-containing sheetgood under carpet in front first level office area.

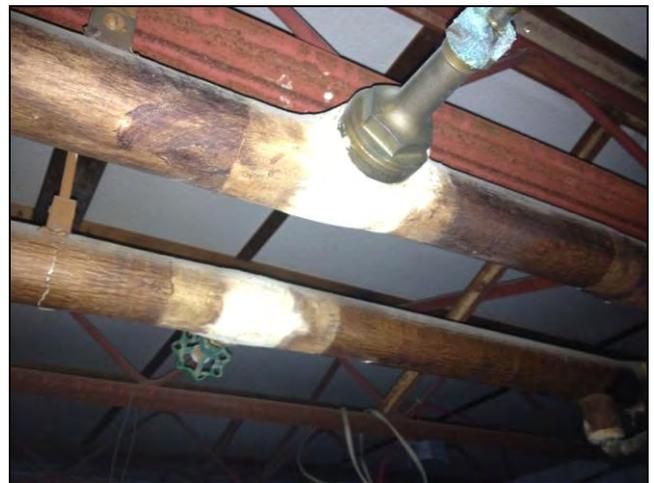
8. Asbestos-containing mudded elbows and valves associated with the brown paper wrapped fiberglass pipe insulation located in front office area, portions of the screening room, and in the boiler room – estimated 25 linear feet (5% Chrysotile).

Asbestos-containing mudded elbow/joint associated with brown wrap fiberglass pipe insulation.

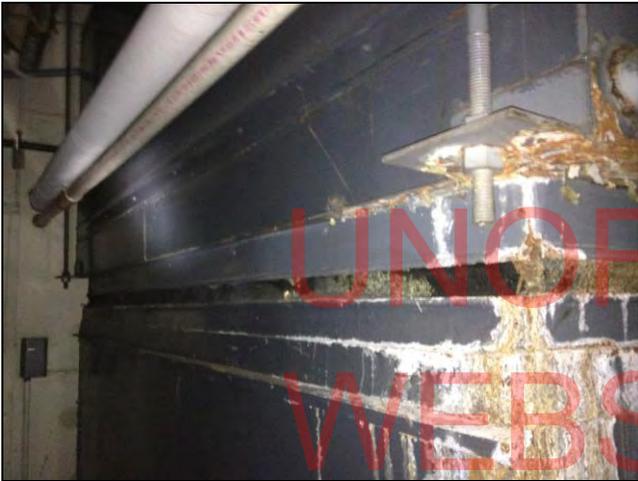
12. Asbestos-containing vibration damper cloth associated with two large air handling units located in the boiler room – estimated 20 square feet (80% Chrysotile).

Asbestos-containing vibration damper cloth associated with large air handling unit in boiler room.

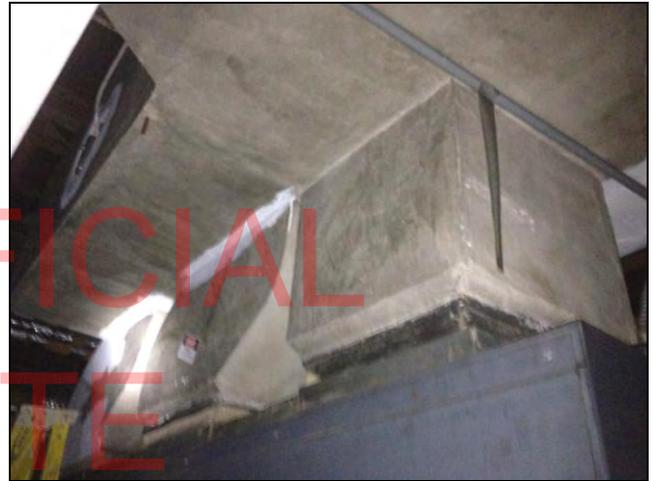
13. Asbestos-containing vibration damper cloth associated with three connections of the 2' x 2' metal box duct to the centrally located large air handling unit located in the boiler room – estimated 24 square feet (80% Chrysotile).

Asbestos-containing vibration damper cloth and 2'x2' duct board coating in boiler room.

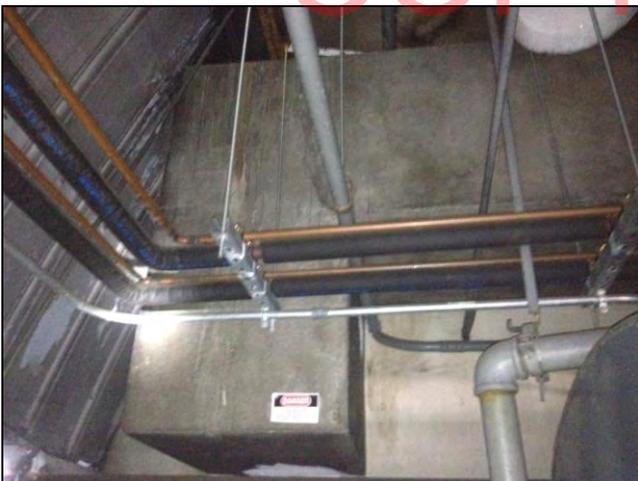
11. Asbestos-containing duct coating associated with the interior 2' x 2' metal box duct located along the northern wall of the metal room and in the boiler room – estimated 450 square feet (10% Chrysotile).

Asbestos-containing 2'x2' duct board coating in boiler room.

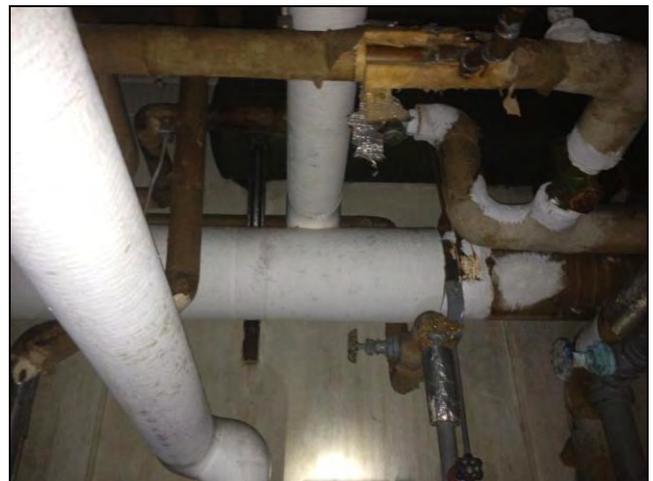
7. Asbestos-containing 2" corrugated pipe insulation located in front office area, portions of the screening room, and in the boiler room – estimated 400 linear feet (15% Chrysotile).

Typical asbestos-containing pipe thermal system insulation in boiler room.
