Contract No.: T201707005

Title: Statewide Movable Bridge Preventative Maintenance  
Location: Bridges 1-687, 1-688, 1-693, 2-021A, 3-151, 3-153, 3-154, 3-164  
County: Statewide

Bridge 1-688

T201707005	SOUTH MARKET STREET
615606 - INITIAL REPAIRS AT BRIDGE 1-688	
REPAIRS S1 & S2

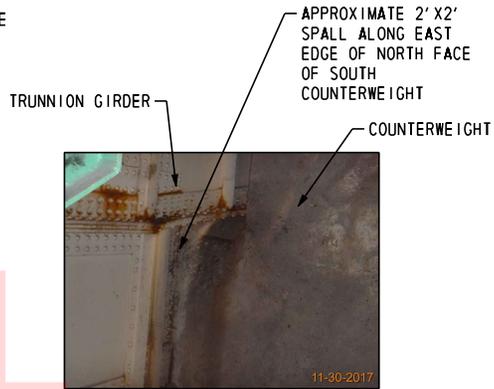
**SPALL IN THE SOUTH COUNTERWEIGHT**

**DEEP SPALL REPAIR**

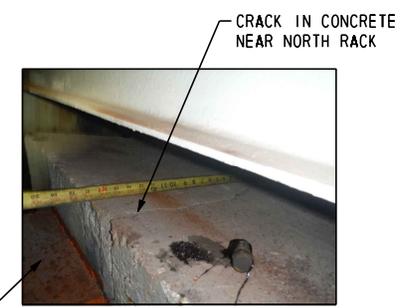
**TYPICAL CRACKS IN THE CONCRETE NEAR THE RACK SUPPORT**

**CRACK REPAIR**

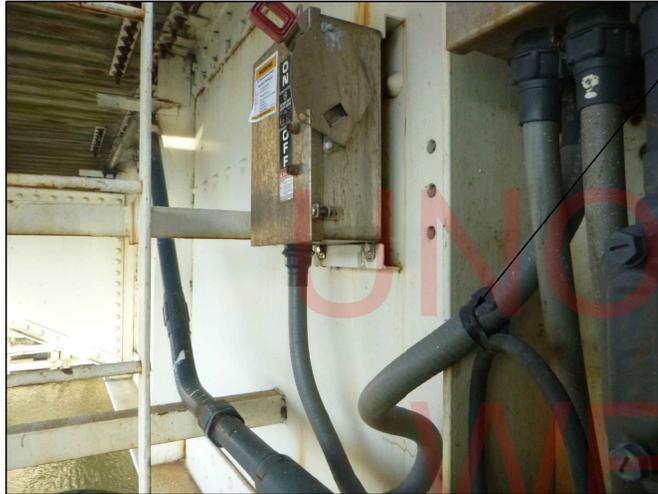
**DAMAGED CONDUIT ON WEST  
SPAN LOCK PLATFORM - FRONT VIEW**

FURNISH AND INSTALL NEW  
LIQUID TIGHT FLEXIBLE  
CONDUIT FROM JUNCTION BOX  
TO DISCONNECT SWITCH

REMOVE EXISTING WIRING FROM  
CONDUIT AND RE-INSTALL IN  
NEW CONDUIT SECTION

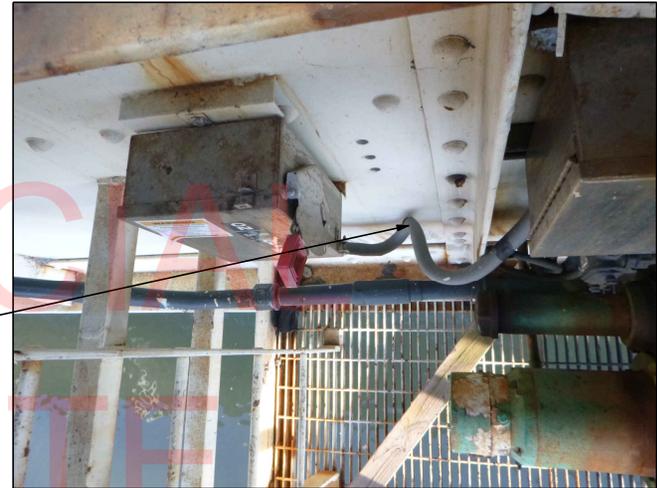
**DAMAGED CONDUIT ON WEST  
SPAN LOCK PLATFORM - PLAN VIEW**

1. REPLACE BOXES ON DAMAGED CONDUIT AND ASSOCIATED CONDUIT HUBS CONNECTING FLEXIBLE CONDUIT TO RIGID CONDUIT.
2. REFER TO THE SPECIAL PROVISIONS FOR REQUIREMENTS.

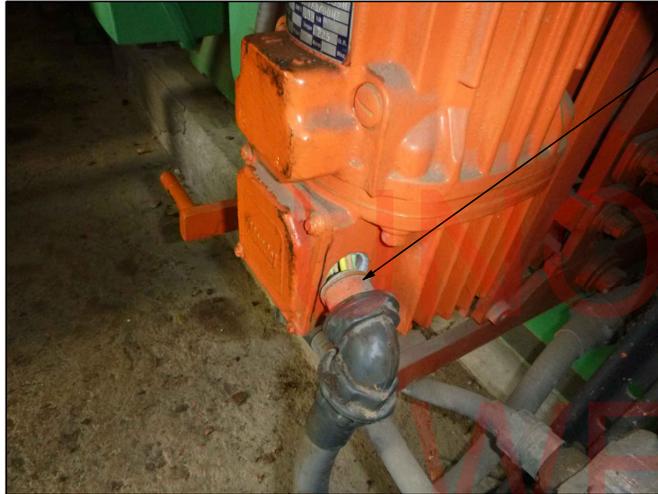
DISCONNECTED CONDUIT TO  
SOUTH BRAKE NO. 1

FURNISH AND INSTALL NEW  
CONDUIT HUB, BUSHING AND  
LOCK WASHERS FOR THE  
SOUTH BRAKE NO. 1 MOTOR  
CONDUIT CONNECTION

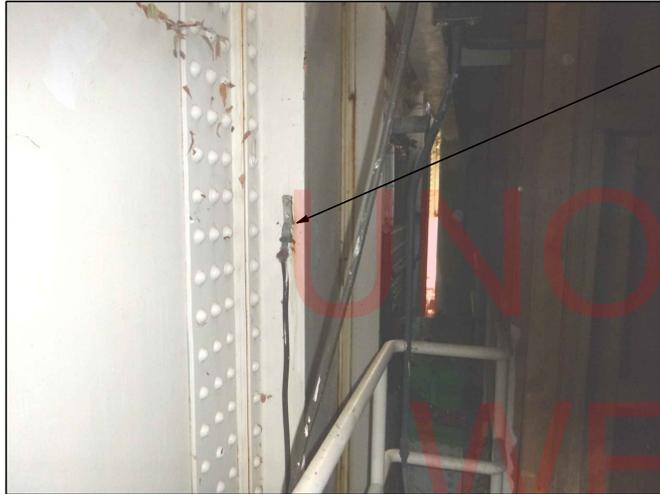
**NORTHEAST DAMAGED FLEXIBLE GROUND BOND  
CONNECTION**

REPLACE/REPAIR EXISTING  
FRAYING GROUND BOND  
CONNECTION TO MOVABLE  
SPAN
