Contract No.: T201707005

Title: Statewide Movable Bridge Preventative Maintenance
Location: Bridges 1-687, 1-688, 1-693, 2-021A, 3-151, 3-153, 3-154, 3-164
County: Statewide

T201707005	THIRD STREET
615613 - INITIAL REPAIRS AT BRIDGE 1-693	
REPAIR S1

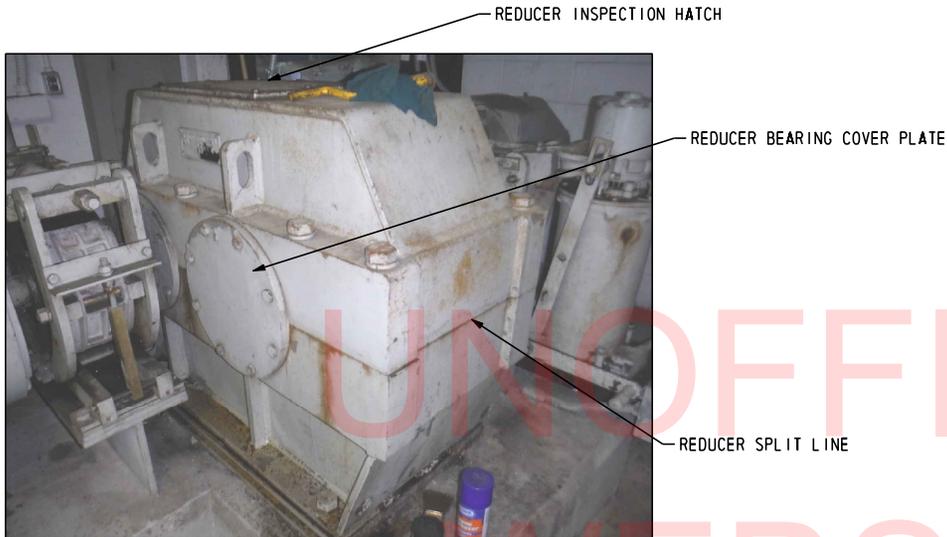
NORTH LEAF REDUCER

M3 SEAL OIL LEAKS AT THE HOUSING SPLIT LINE, COVER PLATES, AND INSPECTION HATCH AT BOTH SPAN DRIVE SPEED REDUCERS.

SPEED REDUCER REPAIR PROCEDURE (SUGGESTED)

1. CONSULT WITH THE REDUCER MANUFACTURER TO PROVIDE A PROCEDURE FOR SEALING THE OIL LEAKS FROM THE SPEED REDUCERS IN THE FIELD. SUBMIT PROCEDURE TO THE ENGINEER FOR REVIEW. A REPRESENTATIVE OF THE MANUFACTURER SHALL BE ON-SITE TO PERFORM THIS WORK.

2. BEFORE DISASSEMBLY OF THE REDUCER, DRAIN OIL FROM THE REDUCER HOUSING AND AS PER THE MANUFACTURER'S RECOMMENDATION FLUSH THE INTERNAL SURFACES TO REMOVE ANY SLUDGE OR DEBRIS FROM WITHIN THE HOUSING. VISUALLY INSPECT INTERNAL SURFACES FOR DEBRIS WITHIN THE HOUSING.

3. WITH THE MACHINERY MOTORS LOCKED OUT/TAGGED OUT FOR OPERATION, RELEASE ANY RESIDUAL TORQUE FROM THE MACHINERY BY RELEASING THE BRAKES.
4. UNBOLT REDUCER AT THE BEARING COVER PLATES AND AT THE HOUSING SPLIT LINE. RAISE THE TOP HALF OF REDUCER HOUSING TO CLEAN THE MATING SURFACES WITH SOLVENT TO PREPARE THE REDUCER FOR NEW GASKET SEALANT.

5. REMOVE EXISTING GASKET SEALANT AT THE SPLIT LINE AS DIRECTED BY THE REDUCER MANUFACTURER.
6. CLEAN THE MATING SURFACES AT THE SPLIT LINE AND BETWEEN THE BEARING COVER PLATES AND HOUSING WITH SOLVENT.

7. APPLY GASKET SEALANT TO THE SPLIT LINE AND BEARING COVER PLATES AS DIRECTED BY THE REDUCER MANUFACTURER.
8. REINSTALL THE TOP HALF OF THE REDUCER HOUSING AND BEARING COVER PLATES.

9. TORQUE REDUCER FASTENERS AS SPECIFIED BY THE MANUFACTURER.
10. FLUSH THE INTERNAL SURFACES AGAIN AFTER ASSEMBLY TO REMOVE ANY DEBRIS FROM WITHIN THE HOUSING. VISUALLY INSPECT INTERNAL SURFACES FOR DEBRIS WITHIN THE HOUSING BEFORE ADDING NEW OIL.

11. FILL REDUCER HOUSING WITH NEW OIL.
12. PERFORM 5 TEST OPERATIONS AND VERIFY OIL DOES NOT LEAK FROM THE HOUSING SPLIT LINE OR BEARING COVER PLATES. REPEAT STEPS 2 THROUGH 11 IF OIL LEAKAGE IS OBSERVED.

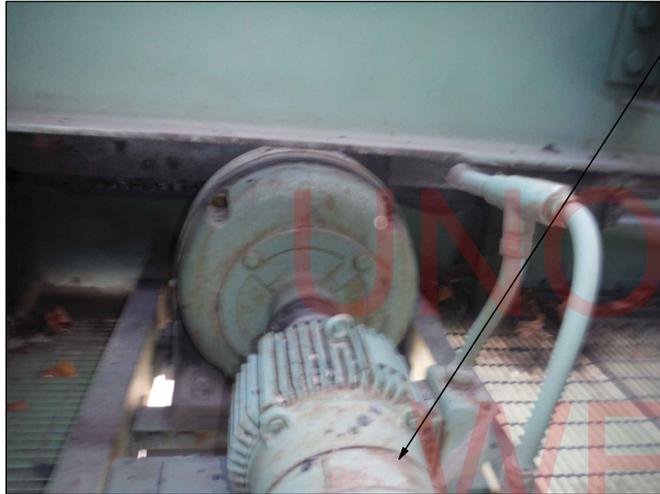
TYPICAL SPAN LOCK MOTOR WITH CORROSION

CLEAN ALL SIDES OF MOTOR,
SCRAPE WITH WIRE BRUSH AND
PAINT AS SPECIFIED

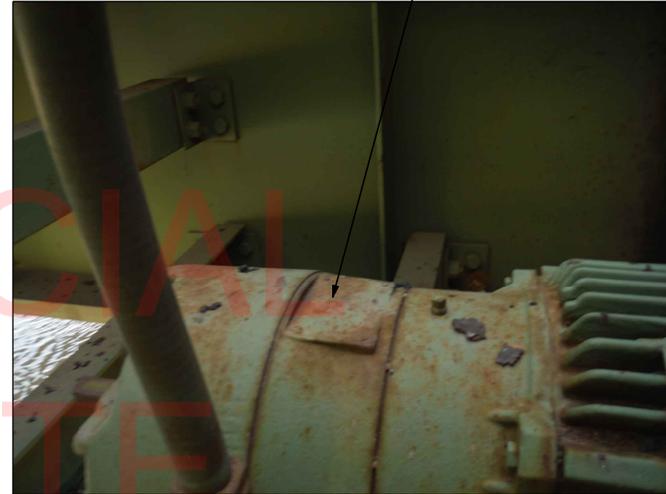
**TYPICAL SPAN LOCK MOTOR
WITH PAINT COVERING BRAKE NAMEPLATE**

CLEAN EXISTING NAMEPLATES
WITH WIRE BRUSH OR SAND
PAPER BEFORE AND AFTER
PAINTING

1. PROVIDE NEW NAMEPLATE IF EXISTING CANNOT BE CLEANED AND MADE LEGIBLE.
2. REFER TO THE SPECIAL PROVISIONS FOR REQUIREMENTS. REFER TO "COMMON PROVISIONS FOR MECHANICAL WORK" SPECIAL PROVISION FOR PAINTING REQUIREMENTS.

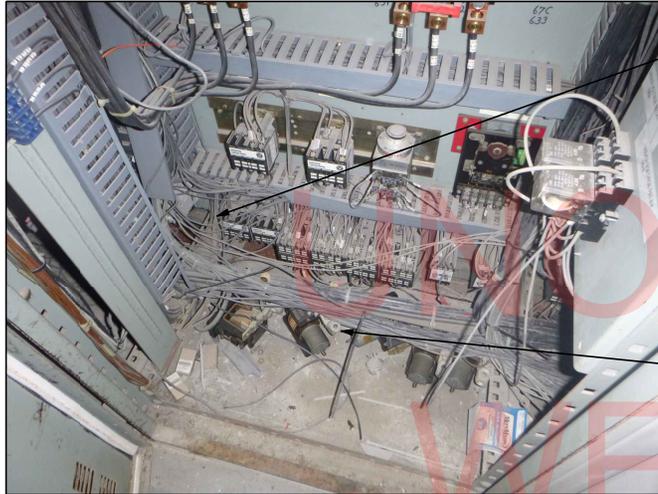
TYPICAL MOTOR CONTROL CABINET WITH UNORGANIZED WIRING

SECURE LOOSE WIRING WITHIN EXISTING WIRING DUCTS, USE PLASTIC TIES AND STRAPS TO BUNDLE CABLES

FURNISH AND INSTALL MISSING WIRING DUCT COVERS, REROUTE CONDUCTORS WHERE POSSIBLE TO REDUCE WIRE DUCT FILL

REMOVE AND DISPOSE EXISTING PARTS AND DEBRIS

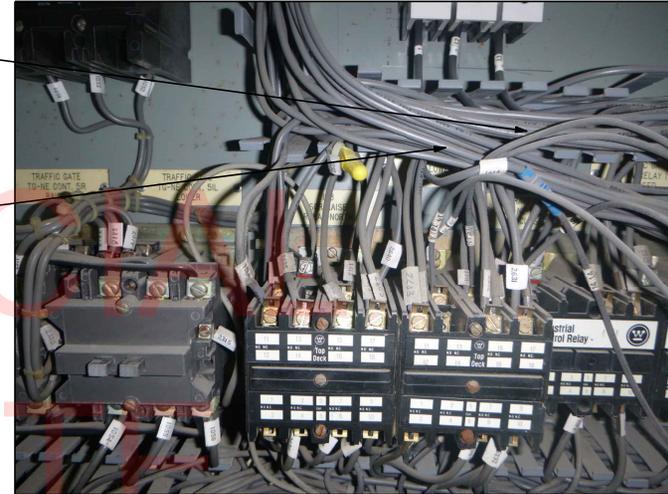
TYPICAL MOTOR CONTROL CABINET WITH UNORGANIZED WIRING

1. FURNISH AND INSTALL NEW WIRE TAGS WHERE MISSING, ILLEGIBLE OR HAND-WRITTEN.
2. REFER TO THE SPECIAL PROVISIONS FOR REQUIREMENTS.

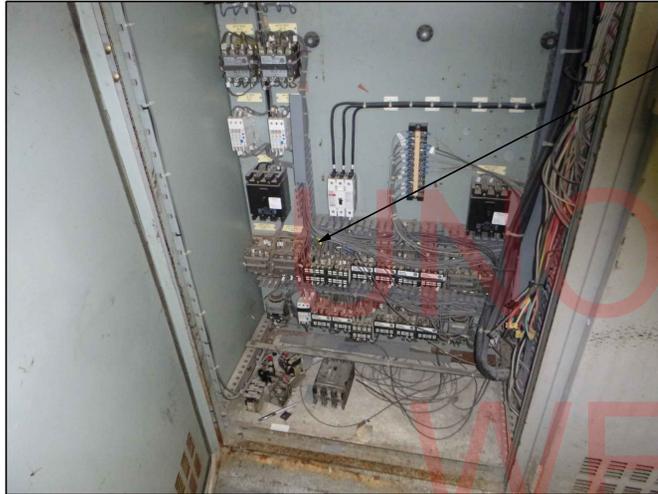
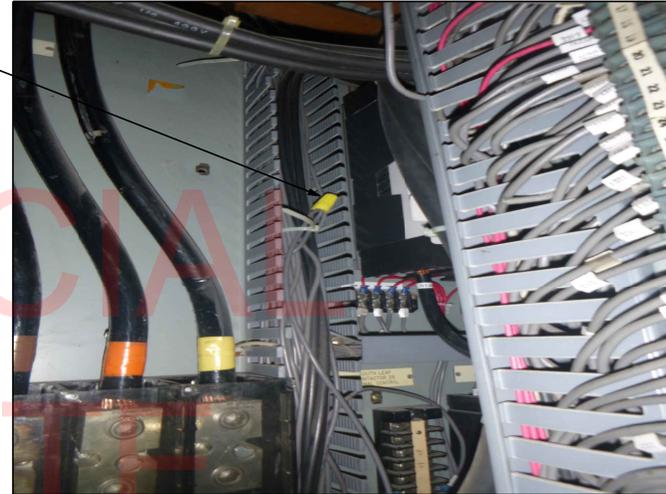
**TYPICAL WIRE NUT SPLICE
IN MOTOR CONTROL CABINET**

REMOVE WIRE NUT SPLICE
AND TERMINATE TO A
TERMINAL BLOCK OR AS
OTHERWISE SPECIFIED

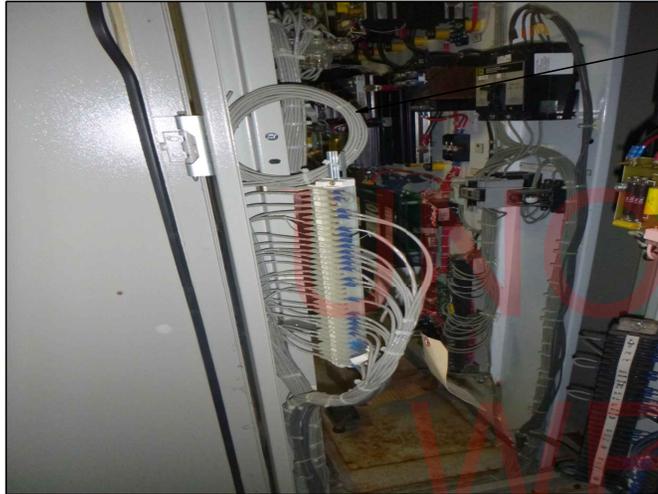
TYPICAL DRIVE CABINET
LOOSE SPARE CONDUCTORS

CONNECT SPARE CONDUCTORS
IN DRIVE CABINET TO NEW
TERMINAL BLOCK MOUNTED
SIMILAR TO EXISTING

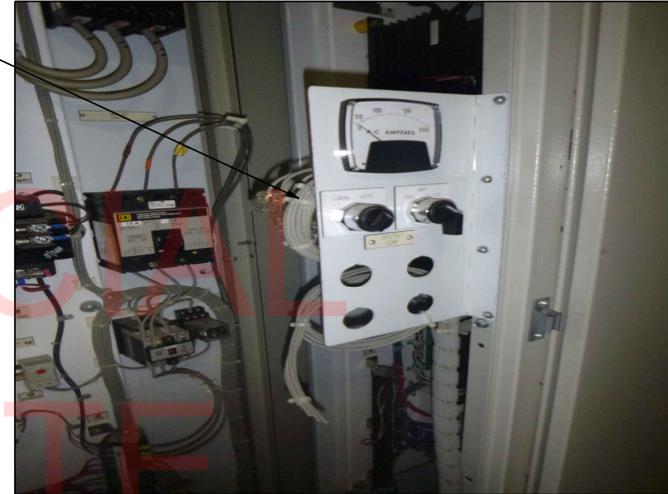
TYPICAL DRIVE CABINET
LOOSE CONDUCTORS

1. FOR WIRING THAT CANNOT BE ROUTED TO A NEW OR EXISTING TERMINAL BLOCK, THE CONTRACTOR SHALL USE AN INLINE COMPRESSION SPLICE WITH HEAT SHRINK.
2. REFER TO THE SPECIAL PROVISIONS FOR REQUIREMENTS.

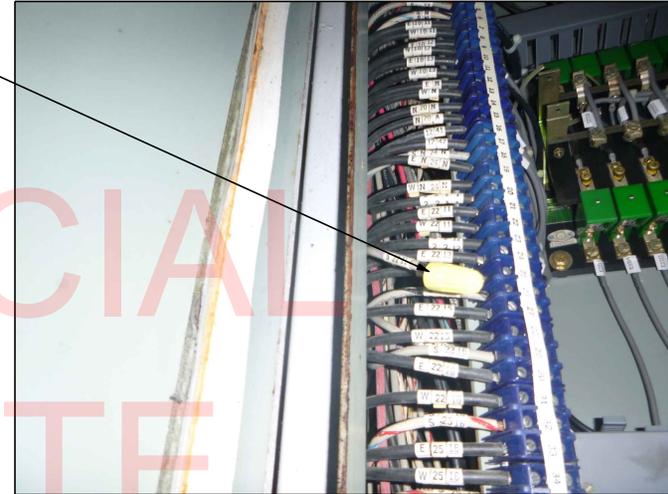
**DISCONNECTED CONDUCTOR IN THE SOUTH
SUBMARINE CABLE TERMINATION CABINET**

1. FOR WIRING THAT CANNOT BE ROUTED TO A NEW OR EXISTING TERMINAL BLOCK, THE CONTRACTOR SHALL USE AN INLINE COMPRESSION SPLICE WITH HEAT SHRINK.
2. TRACE EXISTING WIRE NO. S2211 IN THE SUBMARINE CABLE CABINET AND RELABEL.
3. REFER TO THE SPECIAL PROVISIONS FOR REQUIREMENTS.

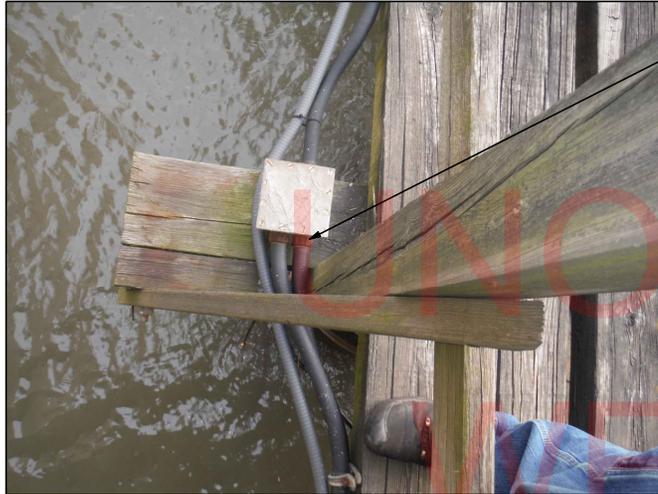
**TYPICAL FENDER JUNCTION BOX
WITH CORROSION ON CONDUIT FITTINGS**

FURNISH AND
INSTALL NEW S. S.
CONDUIT FITTINGS

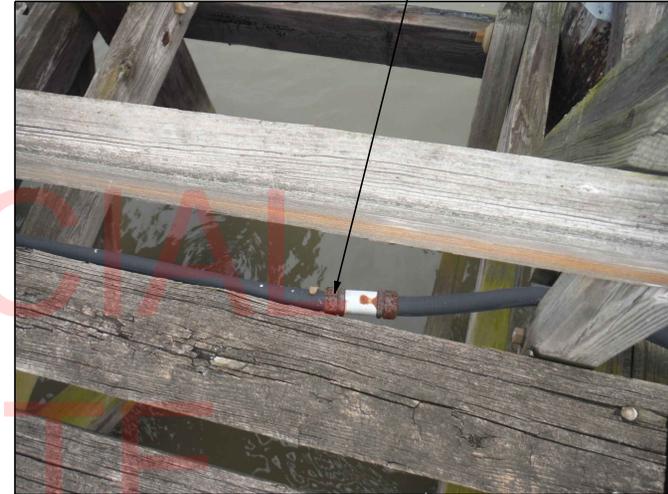
**TYPICAL FENDER CABLE
WITH CORROSION ON CONDUIT FITTINGS**

FURNISH AND INSTALL
NEW S. S. CONDUIT
AND CABLE
FITTINGS

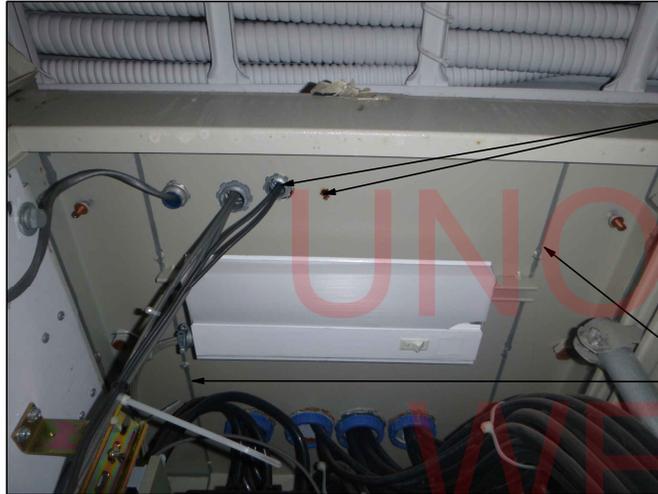
CONTACTOR CABINET INTERIOR WITH SEALANT AND EVIDENCE OF WATER INFILTRATION

SEAL ALL CONDUIT ENTRANCES AND OPENINGS TO PREVENT WATER INFILTRATION

FURNISH AND INSTALL DEBRIS/RAIN SHIELD OVER TOP OF DRIVE AND CONTACTOR CABINETS

REPLACE EXISTING SEALANT ON ENCLOSURE ROOF

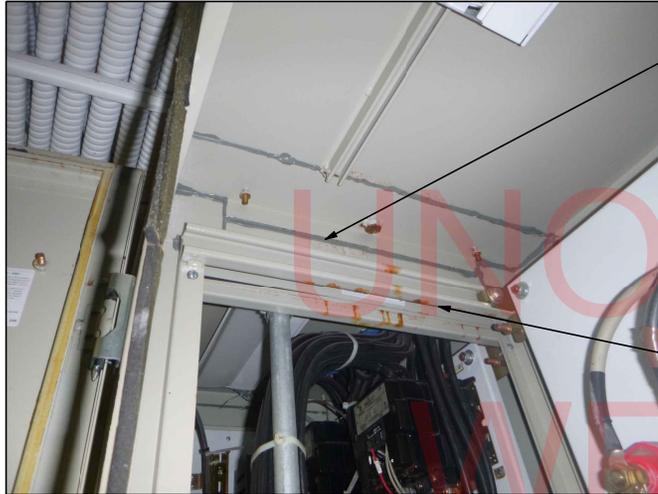
DRIVE CABINET INTERIOR WITH LEAK AT SEAL

REPLACE EXISTING SEALANT ON ENCLOSURE ROOF

CLEAN AND SPOT PAINT AREAS OF CORROSION OR WATER INFILTRATION

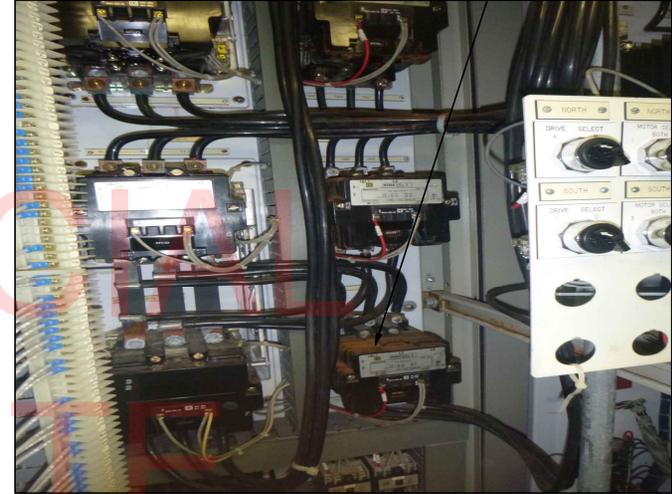
CONTACTOR CABINET INTERIOR WITH CORROSION ON CONTACTOR AND OTHER COMPONENTS

CLEAN CORROSION AND DEBRIS FROM COMPONENTS INSIDE CONTACTOR CABINET

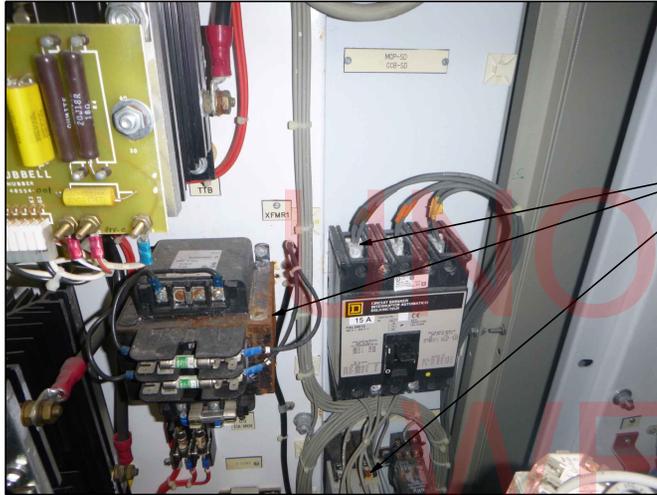
TYPICAL DRIVE CABINET INTERIOR WITH CORROSION ON COMPONENTS

CLEAN CORROSION AND DEBRIS FROM COMPONENTS INSIDE DRIVE CABINET, REPLACE HARDWARE LUGS, AND CONNECTORS WITH CORROSION

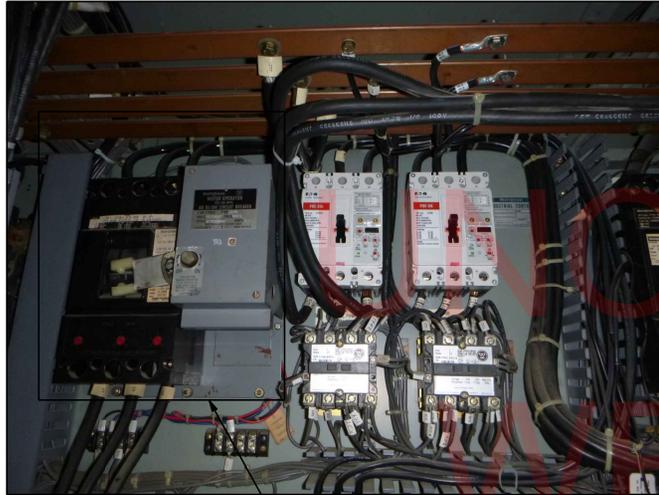
EXISTING MOTOR CONTROL CABINET
MODIFICATIONS FOR MAIN CIRCUIT BREAKERS

EXISTING CB AND
MOTOR OPERATORS
TO BE REPLACED

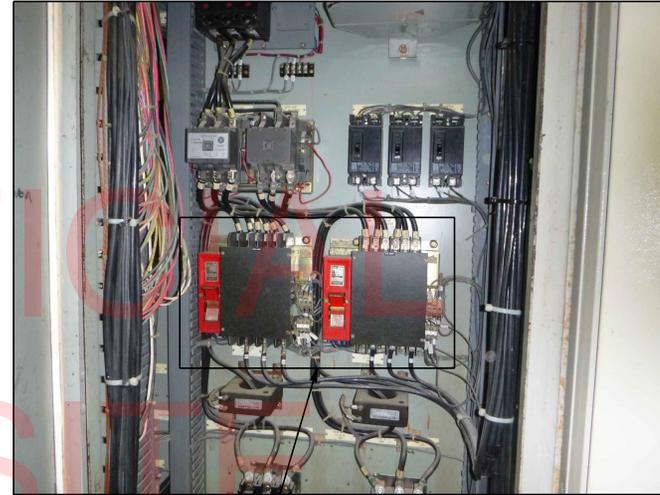
EXISTING MOTOR CONTROL CABINET
MODIFICATIONS FOR REMOTE CONTACTORS

TYPICAL REMOTE
CONTACTORS TO
BE REPLACED
