Contract No.: T201707005

Title: Statewide Movable Bridge Preventative Maintenance  
Location: Bridges 1-687, 1-688, 1-693, 2-021A, 3-151, 3-153, 3-154, 3-164  
County: Statewide

Bridge 2-021A

T201707005	REHOBOTH BOULEVARD
615619 - INITIAL REPAIRS AT BRIDGE 2-021A	
REPAIR S1

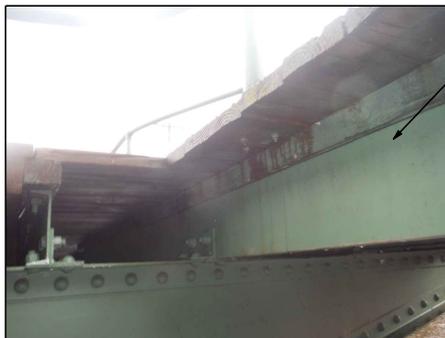
**EXISTING POST CONNECTION TO SIDEWALK**

NEW L8X8X1/2 TO CONNECT TO EXISTING DECKING AND SUPPORTING CHANNEL AT THE NORTH END OF THE BASCULE SIDEWALK

1. ALL WORK INVOLVING STRENGTHENING THE SIDEWALK POST CONNECTION SHALL BE PERFORMED IN ACCORDANCE WITH SPECIAL PROVISION 615619 - INITIAL REPAIRS AT BRIDGE 2-021A. PAID UNDER "615619 - INITIAL REPAIRS AT BRIDGE 2-021A."
2. NEW ANGLE AND BOLTS TO BE PAINTED TO MATCH EXISTING STEEL.

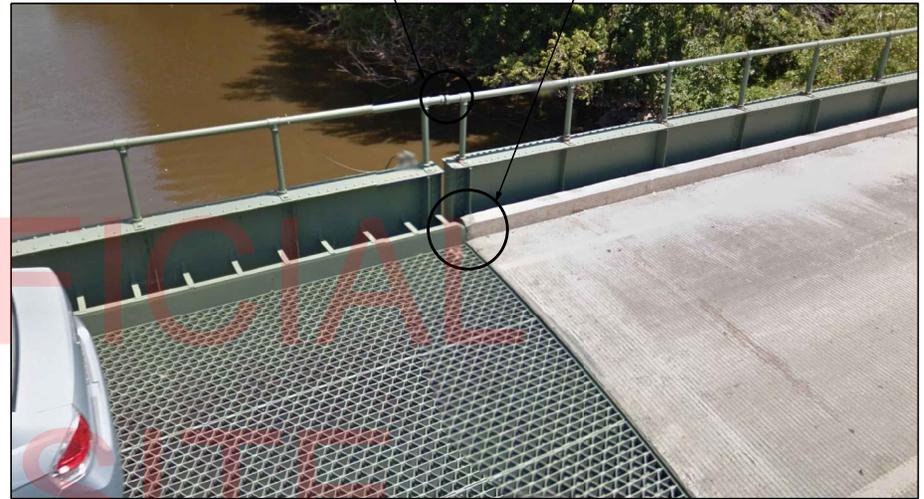
LOCATION OF  
HANDRAIL  
INTERFERENCE

LOCATION OF  
CHANNEL  
INTERFERENCE

**LOCATION OF INTERFERENCES  
AT EAST BASCULE GIRDER TOE JOINT**  
LOOKING SOUTHEAST

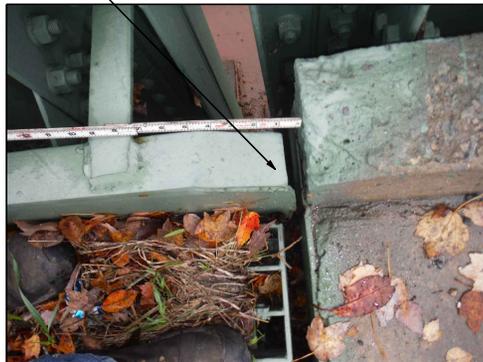
**CHANNEL INTERFERENCE AT TOE JOINT**

TRIM THE 10C15.3 BACK  
FLUSH WITH ROADWAY  
GRATING

1. ALL WORK INVOLVING TRIMMING THE CURB CHANNEL SHALL BE PERFORMED IN ACCORDANCE WITH SPECIAL PROVISION 615619 - INITIAL REPAIRS AT BRIDGE 2-021A. PAID UNDER "615619 - INITIAL REPAIRS AT BRIDGE 2-021A."
2. GRIND SMOOTH ANY ROUGH AREAS ON THE 10C15.3 AFTER TRIMMING IS COMPLETE.
3. APPLY TOUCH UP PAINT TO REPAIRED AREA. PAINT TO MATCH EXISTING.

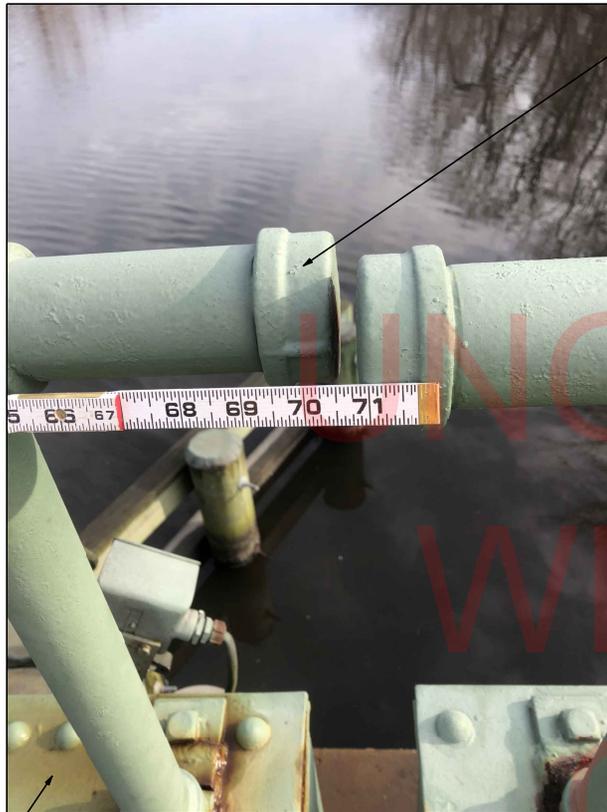
**EAST SIDE HANDRAIL INTERFERENCE AT TOE JOINT**

CUT EXISTING CAP COVER FROM HANDRAIL. CONTRACTOR TO FURNISH AND INSTALL NEW WELDABLE UNTHREADED PIPE CAP COVER IN PLACE. CONTRACTOR TO PROVIDE 1" GAP BETWEEN THE EXISTING HANDRAIL AND THE REPAIRED HANDRAIL.

CUT EXISTING POST 1'-0" FROM TOP FLANGE. FURNISH NEW 2" DIA. PIPE WITH NEW ATTACHMENT PLATE WELDED TO BOTTOM OF PIPE USING 1/4" FILLET WELD.

REMOVE EXISTING BOLTS (2) AND PLATE FROM TOP FLANGE OF BASCULE GIRDER. CLEAN AREA USING MECHANICAL MEANS. FURNISH NEW ATTACHMENT PLATE TO MATCH EXISTING SIZE. NEW BOLTS TO BE SIZED TO FIT EXISTING HOLES.

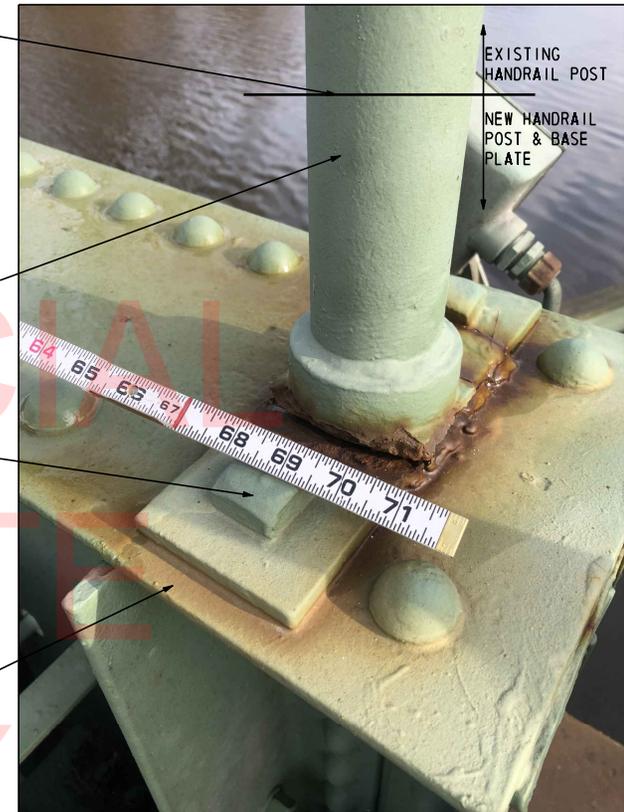
**EAST SIDE HANDRAIL POST DETACHMENT AT THE TOE JOINT**

EXISTING HANDRAIL POST  
NEW HANDRAIL POST & BASE PLATE

1. ALL WORK INVOLVING REPAIRS TO THE HANDRAIL AND HANDRAIL POST SHALL BE PERFORMED IN ACCORDANCE WITH SPECIAL PROVISION 615619 - INITIAL REPAIRS AT BRIDGE 2-021A. PAID UNDER "615619 - INITIAL REPAIRS AT BRIDGE 2-021A."
2. NEW PIPE CAP COVER TO BE PAINTED TO MATCH EXISTING COLOR. APPLY TOUCH UP PAINT AS NEEDED ON ADJACENT CAP COVER TO MATCH EXISTING.
3. CLEANING OF THE HANDRAIL POST SHALL BE IN ACCORDANCE WITH SSPC-SP3 SPECIFICATIONS.
4. ALL WELDING SHALL BE DONE WITH E70 ELECTORDE.
5. APPLY TOUCH UP PAINT TO REPAIRED POST AREA UPON COMPLETION. PAINT TO MATCH EXISTING COLOR.
6. ALTERNATIVELY, CONTRACTOR MAY REPLACE ENTIRE HANDRAIL POST AND BASE PLATE. NEW POST SHALL BE EQUAL TO AND COMPATIBLE WITH THE EXISTING SYSTEM. HANDRAIL SHALL BE PAINTED TO MATCH EXISTING COLOR.

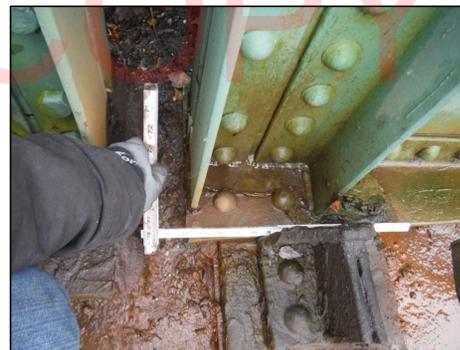
**CRACK IN BOTTOM FLANGE OF EAST  
 BASCULE GIRDER AT LIVE LOAD BEARING  
 (TYP.)**

2. CONTRACTOR TO FIELD VERIFY ALL DIMENSIONS AND ADJUST LIMITS OF REMOVAL AS NECESSARY IN ORDER TO COVER THE LIMITS OF THE CRACK AS WELL AS ANY DEFORMATION IN THE ANGLE.

3. REMOVAL OF EXISTING RIVETS IS TO BE PERFORMED BY MECHANICAL METHODS. BURNING, ARC-GOUGING OR OXYGEN LACING METHODS ARE PROHIBITED.
4. CONTRACTOR SHALL MAINTAIN STRUCTURAL INTEGRITY OF THE BASCULE GIRDER DURING RIVET REMOVAL AND SHALL EXHIBIT EXTREME CAUTION WHILE REMOVING THE EXISTING ANGLES AS TO NOT DAMAGE THE BASCULE GIRDER WHICH REMAINS.

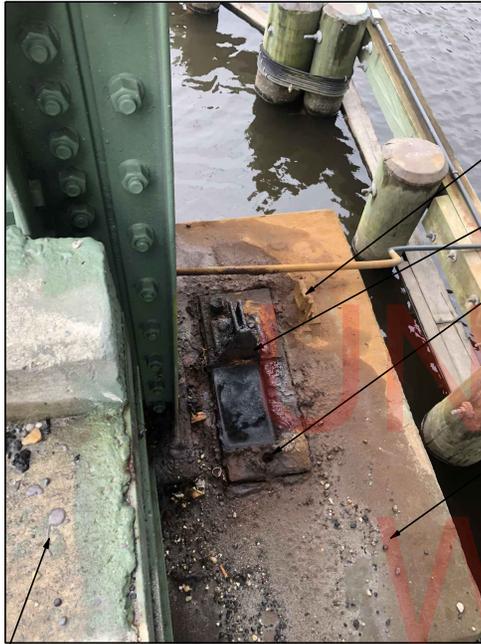
**WEST LIVE LOAD BEARING MASONRY PLATE**

- FULLY SEATED LIMIT SWITCH TARGET (WEST L.L. BEARING LOCATION ONLY. SEE NOTE 5)
- EXISTING CENTERING GUIDE
- MISSING ANCHOR BOLT IN LIVE LOAD BEARING MASONRY PLATE. TWO NEW 1" DIA. ADHESIVE ANCHORS TO BE INSTALLED

2. CONTRACTOR TO FIELD VERIFY EXISTING ANCHOR LOCATIONS. NEW ADHESIVE ANCHORS TO BE INSTALLED ON THE INBOARD SIDE ONLY FOR BOTH EAST AND WEST LIVE LOAD BEARING MASONRY PLATES.

3. ADHESIVE ANCHORS SHALL BE HILTI HAS-R STAINLESS STEEL ANCHOR USED WITH HILTI HIT-HY ADHESIVE. THE STAINLESS STEEL SHALL CONFORM TO ASTM F593 GRADE 316 SPECIFICATIONS.

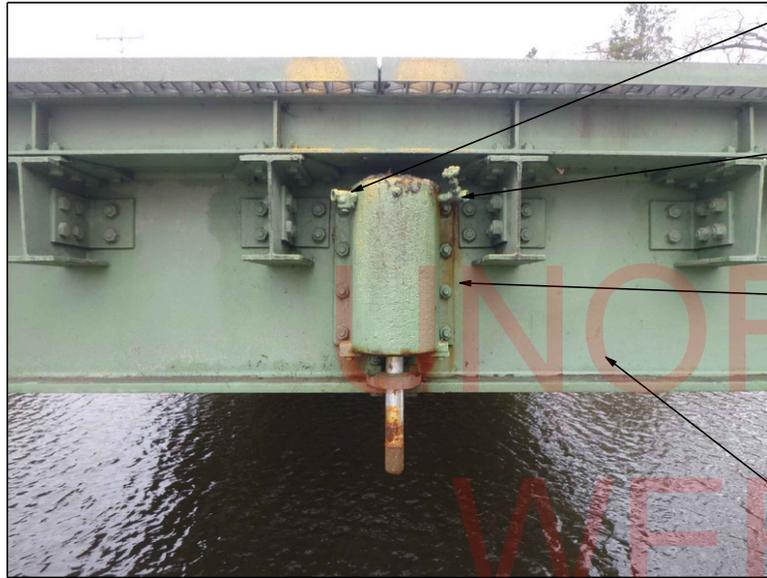
### AIR BUFFER ASSEMBLY - FRONT ELEVATION

REPLACE 1/2" DIA. CHECK VALVE (SEE NOTES 3 & 4)

REPLACE 1/2" DIA. NEEDLE VALVE (SEE NOTES 3 & 4)

M1 REHABILITATE THE AIR BUFFER.

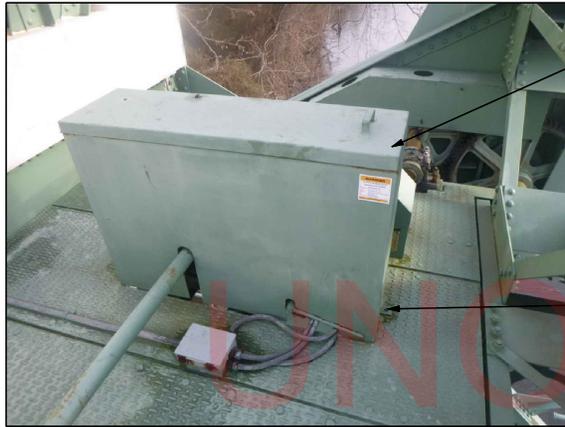
**EXISTING MACHINERY BRAKE COVER**

INSPECT MACHINERY BRAKE HAND  
RELEASE LEVER LINKAGE FOR  
DAMAGE AND ADJUST FOR PROPER  
OPERATION OF THE HAND  
RELEASE MECHANISM

REMOVE EXISTING TABS WELDED TO  
BRAKE COVER

M3 MODIFY THE MACHINERY BRAKE COVER. INSPECT AND ADJUST THE HAND RELEASE LINKAGE.

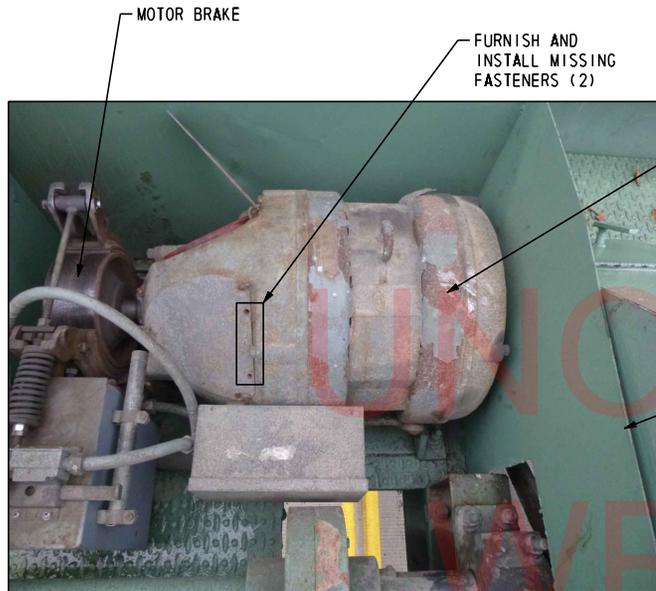
**SPAN MOTOR AND MOTOR BRAKE WITH CORROSION AND PEELING PAINT**

REMOVE CORROSION AND DEBRIS WITH WIRE BRUSH AND PAINT THE MOTOR. CLEAN AND PAINT THE BRAKE FRAME.

CLEAN WITH A WIRE BRUSH AND APPLY PAINT

FURNISH AND INSTALL MISSING FASTENERS (2)

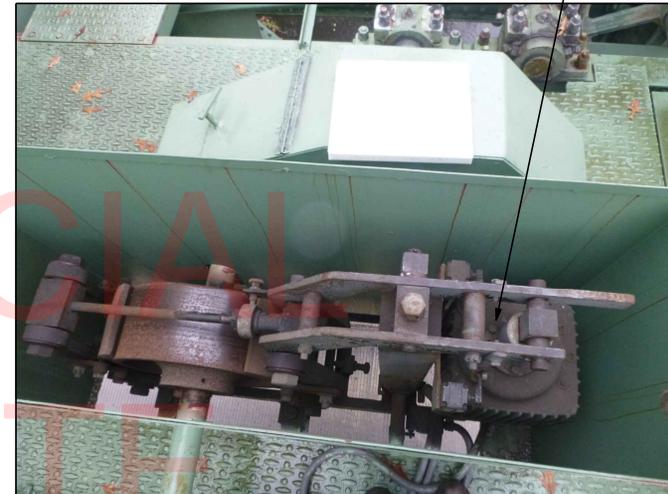
**CORROSION AND DEBRIS ON THE MACHINERY BRAKE**

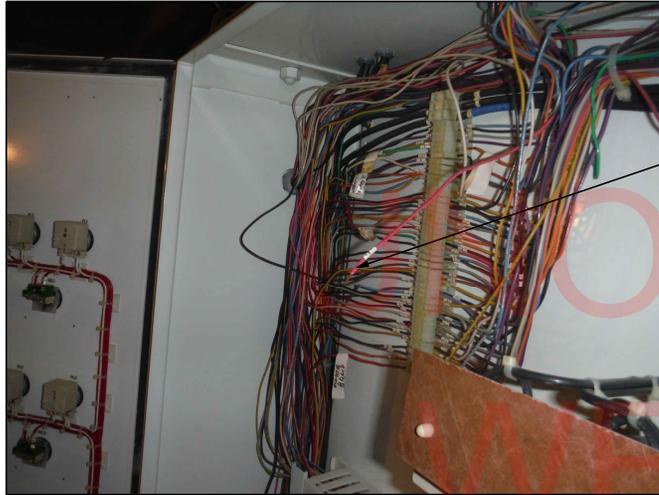
UNCAPPED/UNTERMINATED CONDUCTORS INSIDE  
THE MOTOR CONTROL PANEL

TERMINATE  
LOOSE/DISCONNECTED  
CONDUCTORS TO  
EXISTING TERMINAL  
BLOCK

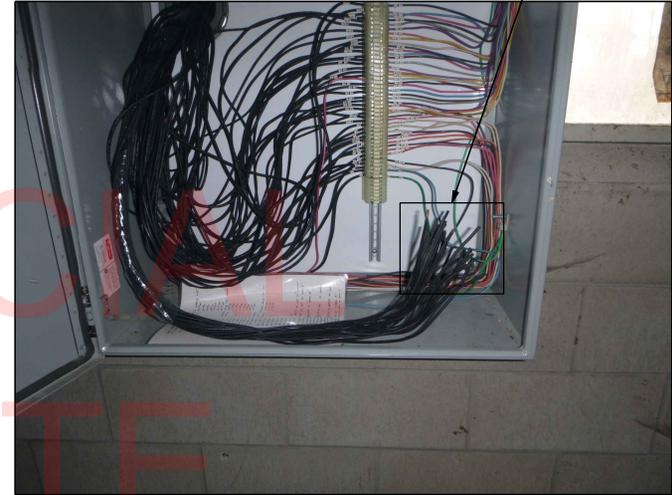
UNCAPPED/UNTERMINATED CONDUCTORS INSIDE  
THE NORTH (NEAR SIDE) SUBMARINE TERMINAL  
BOX

FURNISH & INSTALL  
NEW TERMINAL BLOCK  
AND TERMINATE ALL  
LOOSE CONDUCTORS

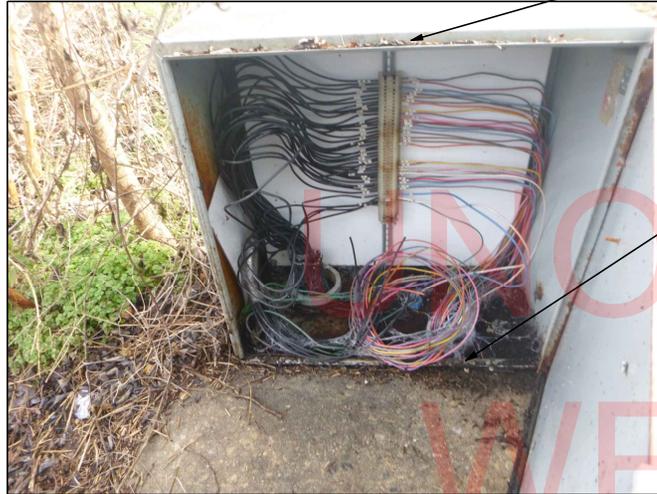
**UNCAPPED/UNTERMINATED CONDUCTORS INSIDE  
THE SOUTH SUB CABLE TERMINAL BOX**

FURNISH & INSTALL  
NEW SUBMARINE  
TERMINAL BOX WITH  
BACK PANEL

FURNISH AND INSTALL NEW  
SUPPORT TO ELEVATE FROM  
GROUND OR PROVIDE  
EXTENDED CONCRETE PAD

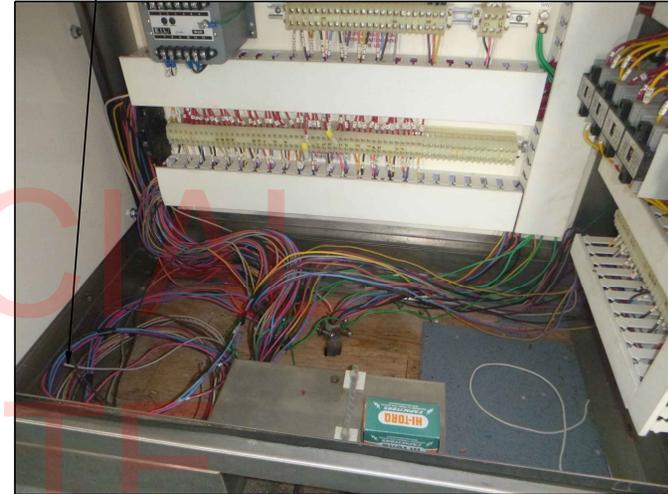
**UNCAPPED/UNTERMINATED CONDUCTORS INSIDE  
THE CONTROL DESK**

TERMINATE LOOSE  
CONDUCTORS TO  
TERMINAL BLOCK

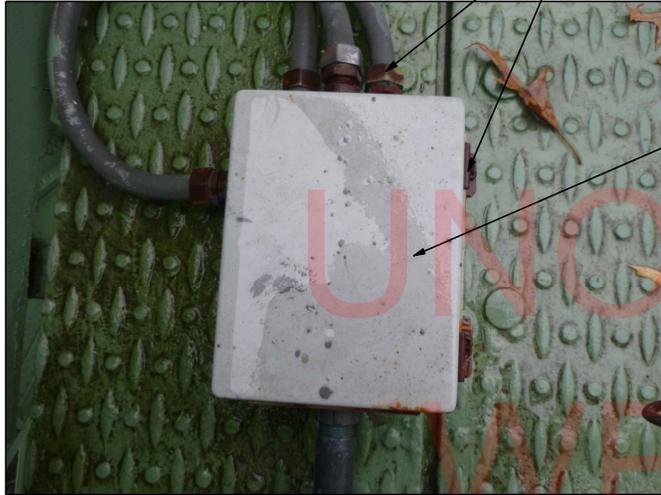
JUNCTION BOX ADJACENT TO THE MACHINERY BRAKE WITH CORROSION ON THE ENCLOSURE, LATCHES AND CONDUIT FITTINGS

REPLACE CORRODED FITTINGS AND HARDWARE

FURNISH AND INSTALL A NEW JUNCTION BOX

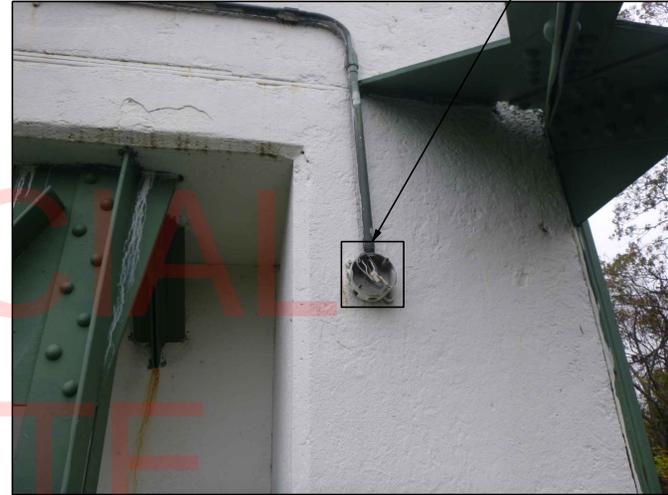
MISSING CONDUIT BOX COVER ON THE COUNTERWEIGHT

FURNISH AND INSTALL A NEW CONDUIT BOX COVER AND CONDUIT FITTING

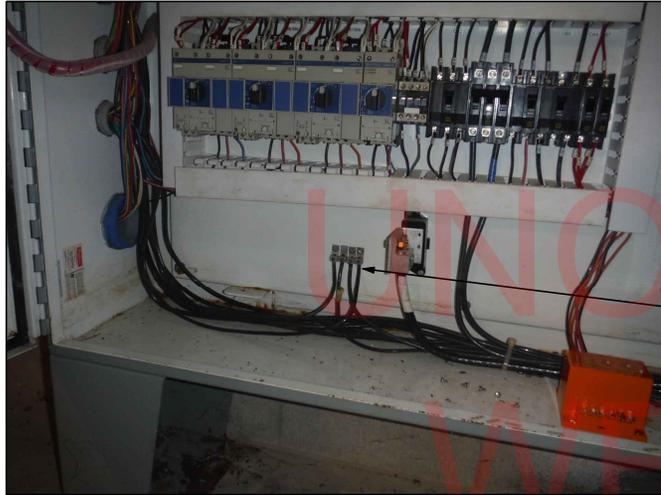
TYPICAL GROUND CONDUCTORS INSIDE THE MOTOR CONTROL PANEL WITHOUT AN IDENTIFIABLE MARKING

FURNISH AND MARK ALL EXISTING UNMARKED GROUND CONDUCTORS WITH GREEN TAPE

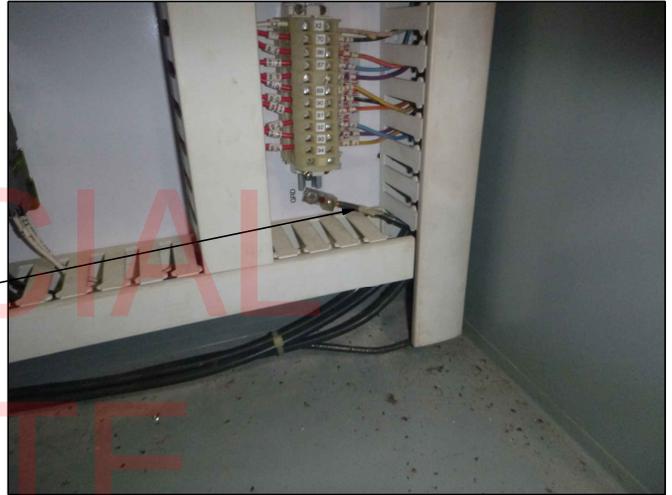
TYPICAL GROUND CONDUCTOR INSIDE THE CONTACTOR PANEL WITHOUT AN IDENTIFIABLE MARKING

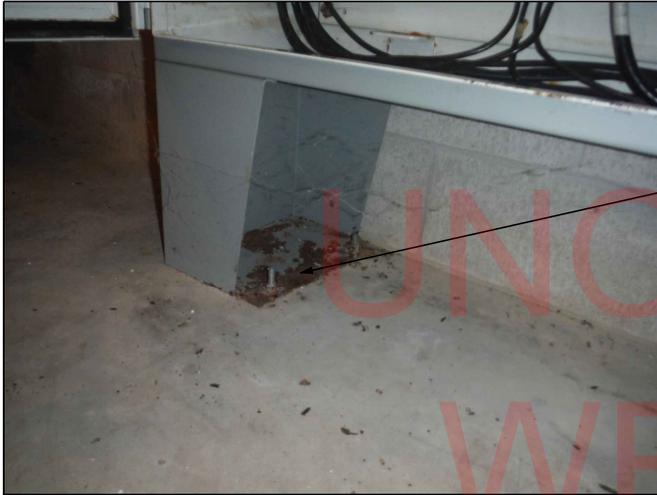
TYPICAL CORROSION AT THE BASE OF THE  
MOTOR CONTROL PANEL

REMOVE CORROSION  
WITH WIRE BRUSH  
AND APPLY PAINT.  
REPLACE CORRODED  
HARDWARE.

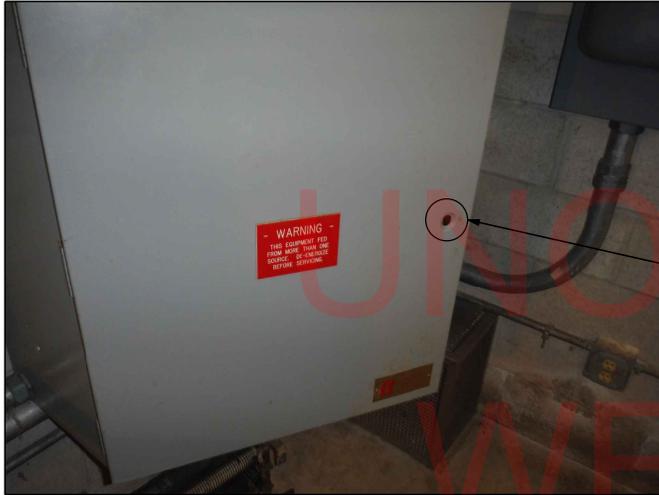
**CONTACTOR PANEL WITH A DAMAGED/MISSING DOOR LATCH (EXTERIOR VIEW)**

FURNISH AND  
INSTALL A NEW  
SLOTTED FLUSH  
DOOR LATCH

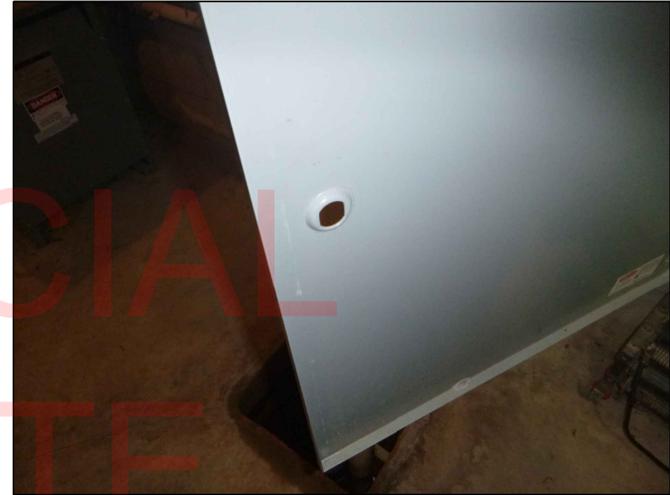
**CONTACTOR PANEL WITH A DAMAGED/MISSING DOOR LATCH (INTERIOR VIEW)**

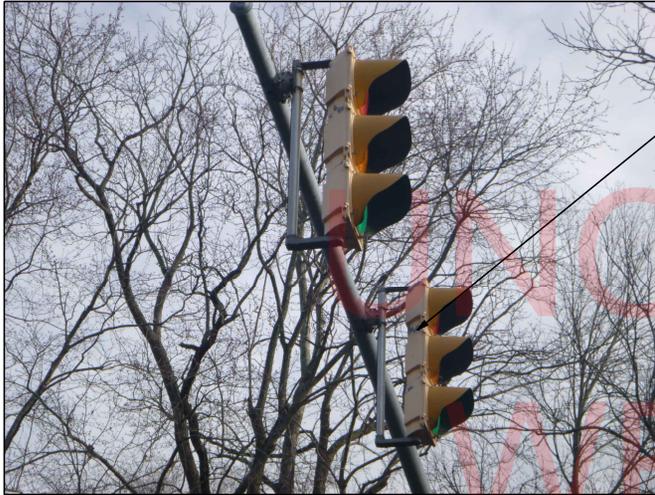
TYPICAL PEELING PAINT ON THE NORTH TRAFFIC SIGNAL HEADS (FRONT VIEW)

CLEAN AND APPLY PAINT

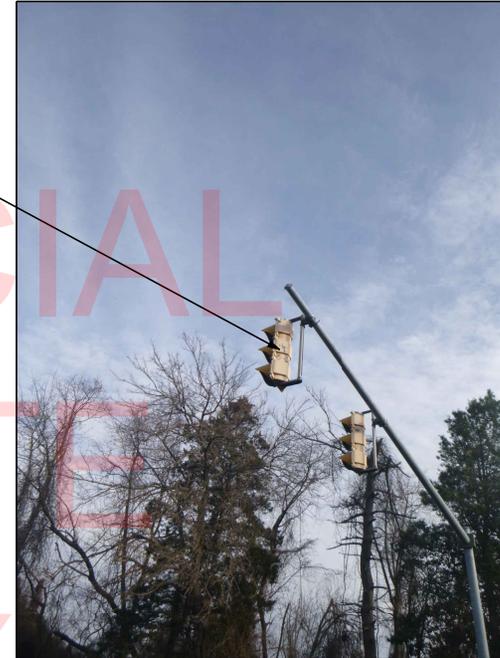
PEELING PAINT ON THE NORTH TRAFFIC SIGNAL HEADS (BACK VIEW)

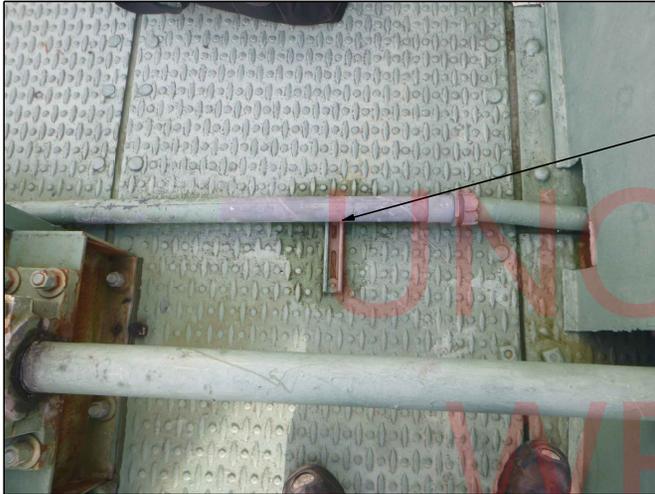
**MISSING CONDUIT CLAMP ON THE MACHINERY  
PLATFORM**

INSTALL S.S  
CONDUIT CLAMP TO  
EXISTING STRUT

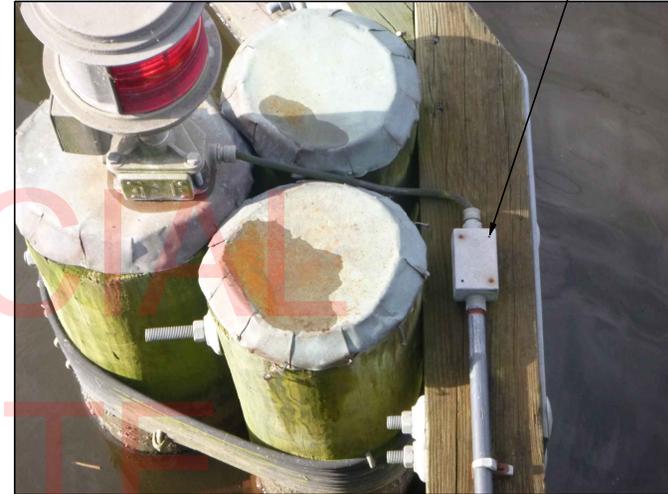
**SOUTHWEST PIER LIGHT JUNCTION BOX WITH  
MISSING HARDWARE**

FURNISH AND  
INSTALL MISSING  
HARDWARE. REPLACE  
CORRODED HARDWARE

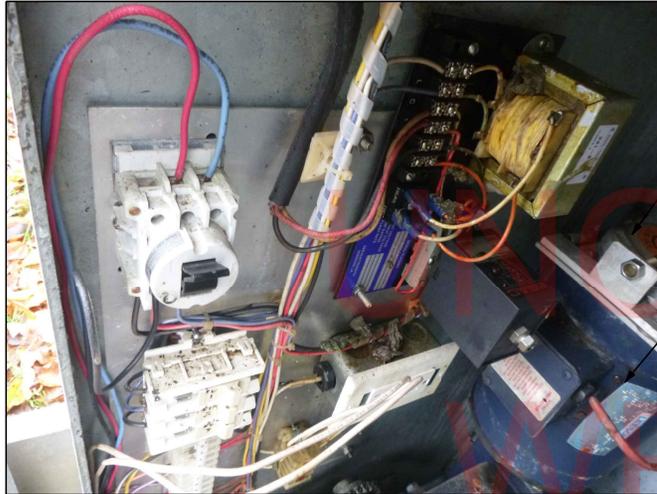
**TYPICAL WARNING GATE MOTOR INSIDE GATE HOUSING EXHIBITING CORROSION**

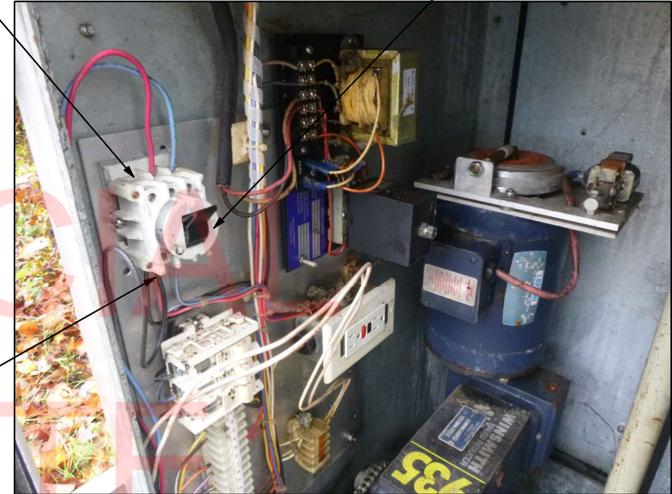
**BROKEN MOTOR DISCONNECT SWITCH INSIDE THE SOUTH GATE**

DAMAGE A PHASE OF DISCONNECT SWITCH

REPLACE THE MOTOR DISCONNECT SWITCH AND RECONNECT LINE SIDE AND MOTOR FEEDER CONDUCTORS

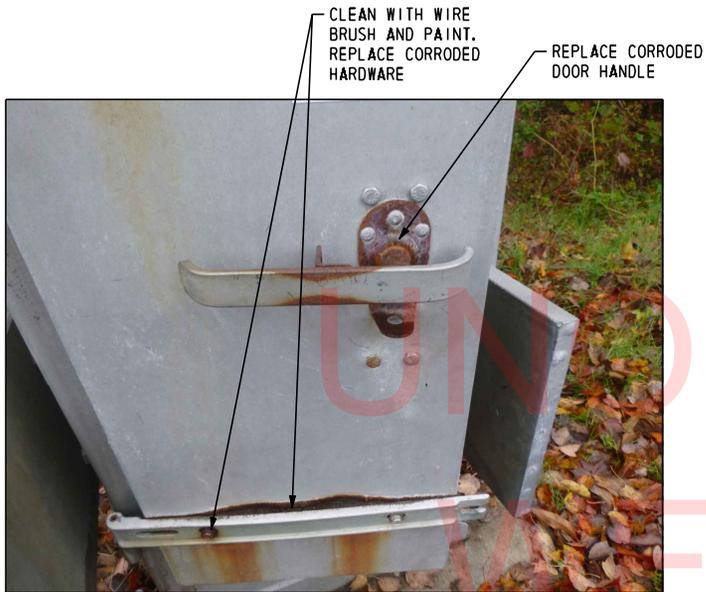
SOUTH WARNING GATE WITH CORROSION BEHIND  
THE DOOR HINGES AND THE REAR DOOR HANDLE

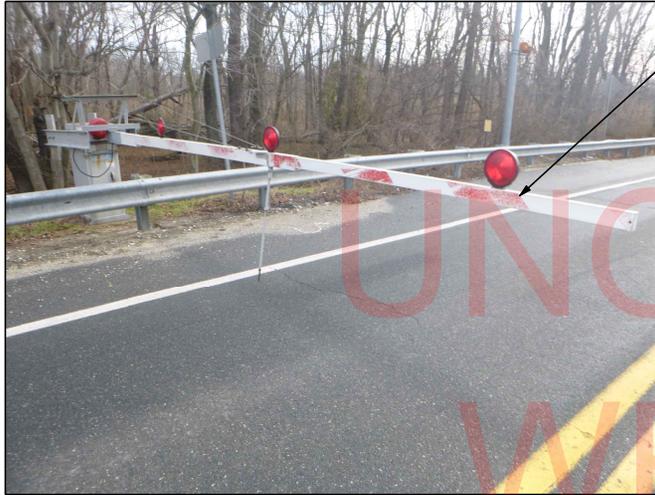
**TYPICAL WARNING GATE ARM WITH DISCOLORED STRIPES**

REMOVE EXISTING DISCOLORED STRIPING. FURNISH AND COVER GATE ARMS FRONT AND REAR WITH ALTERNATING RED AND WHITE REFLECTIVE SHEETING

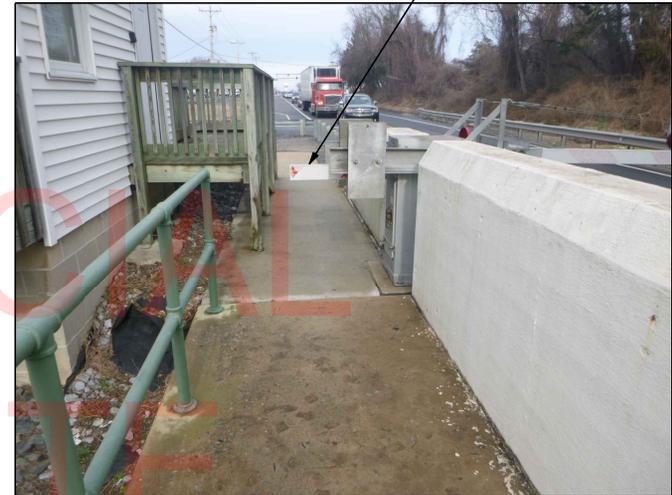
**PEDESTRIAN GATE ARM FOR THE NORTH GATE UNABLE TO RESTRICT WALKWAY PASSAGE**

FURNISH AND INSTALL A NEW PEDESTRIAN GATE ARM

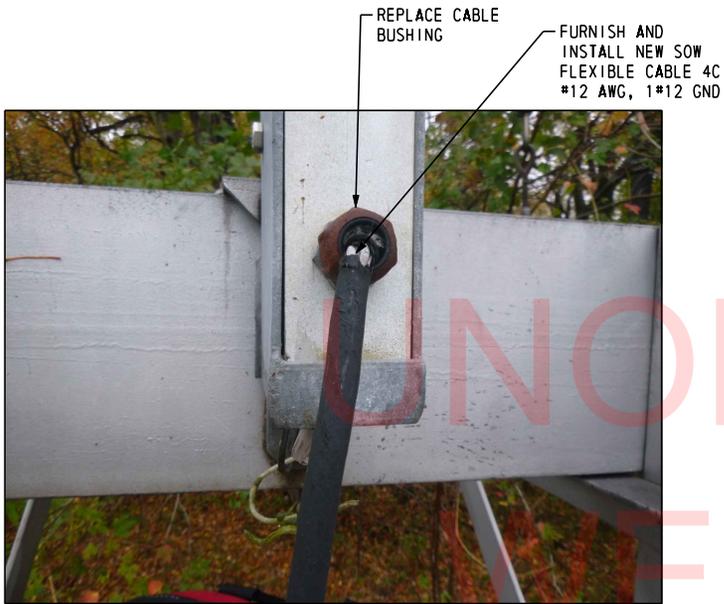
**DAMAGED FLEXIBLE CABLE AT THE SOUTH  
WARNING GATE**

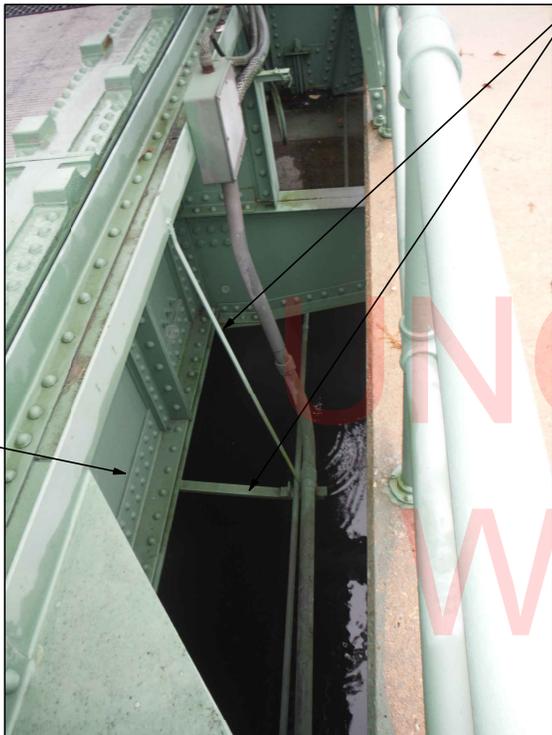
**EXISTING NORTH SPAN CONDUIT BRACKET NEAR THE SIDEWALK**

REPLACE EXISTING CONDUIT SUPPORT THAT IS WELDED TO THE TRACK GIRDER WITH NEW BOLTED SUPPORT (SEE NOTE 2)

1. REFER TO THE SPECIAL PROVISIONS FOR REQUIREMENTS.
2. THE CONDUIT SUPPORTS THAT ARE WELDED TO THE GIRDER SHALL BE REMOVED VIA MECHANICAL METHODS. THE SURFACE OF THE STRUCTURAL MEMBERS TO REMAIN SHALL BE CAREFULLY GROUND SMOOTH TO PREVENT GOUGING OR OTHER DAMAGE. THE CONTRACTOR SHALL PERFORM DYE PENETRANT TESTING AND ULTRASONIC TESTING TO CHECK FOR CRACKS IN A 12" DIAMETER AREA AROUND ALL WELDS THAT ARE REMOVED. SUBMIT TEST REPORT TO THE ENGINEER FOR REVIEW. ANY AREA WHERE THE PAINT IS DISTURBED BY THE WORK SHALL BE PAINTED TO MATCH THE EXISTING.
3. COORDINATE THE WORK WITH REPAIR E12.
4. THE NEW SUPPORT SHALL BE INSTALLED ADJACENT TO THE EXISTING SUPPORT USING THE EXISTING RIVET HOLES.
5. NEW STEEL SHALL BE ASTM A709 GRADE 50. PAINT SUPPORT TO MATCH EXISTING STRUCTURAL STEEL AFTER INSTALLATION.
6. ADJUST CONDUIT, WIRE AND BOX TO ACCOMMODATE NEW SUPPORT.

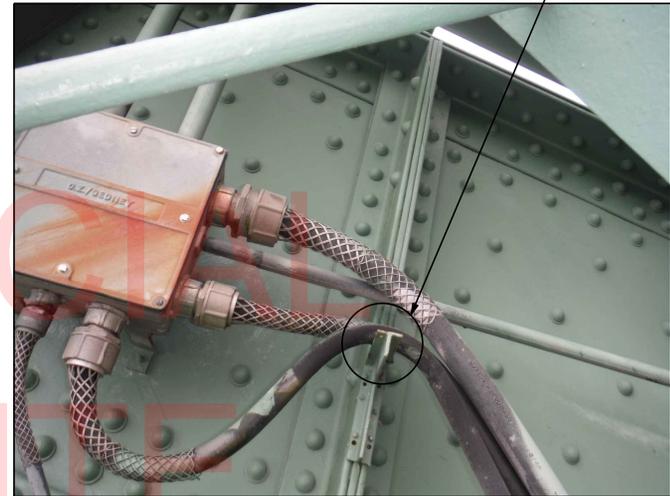
UNFASTENED DROOP CABLES TO SUPPORT

FURNISH AND  
INSTALL S.S  
U-BOLT AND  
FASTEN DROOP  
CABLES

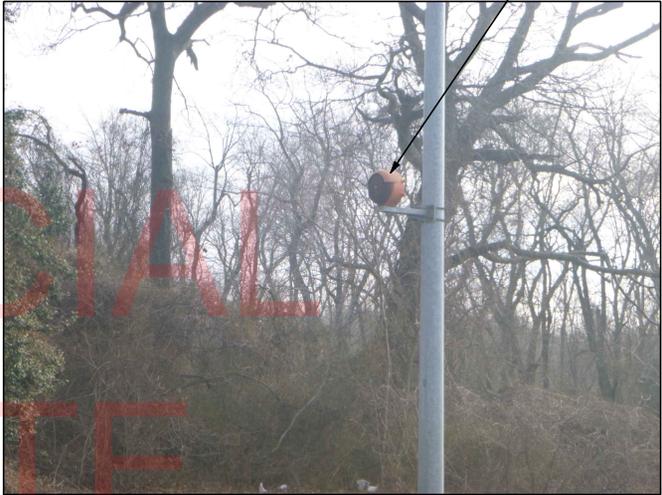
NONFUNCTIONAL GONG AT THE NORTH TRAFFIC SIGNAL POLE

TEST AND PERFORM REPAIRS TO GONG. CLEAN AND PAINT THE GONG

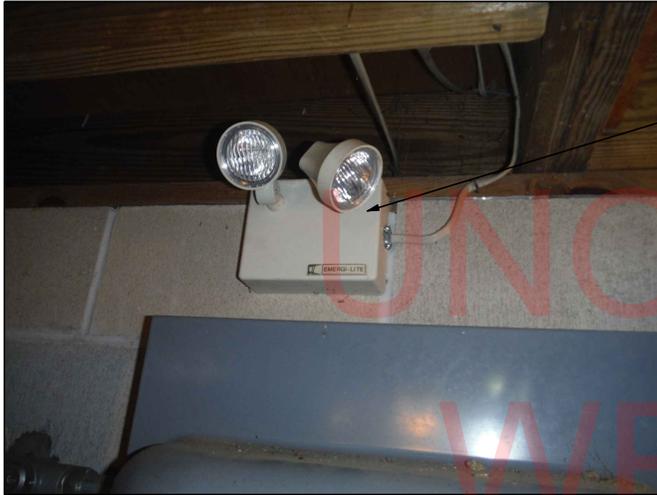
NON-OPERATIONAL EMERGENCY LIGHT IN THE LOWER LEVEL OF THE OPERATOR'S HOUSE

REPLACE THE EMERGENCY LIGHTS

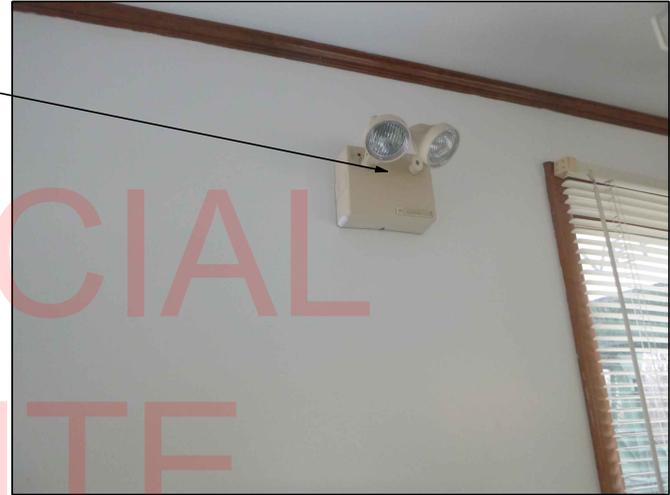
NON-OPERATIONAL EMERGENCY LIGHT IN THE MAIN LEVEL OF THE OPERATOR'S HOUSE

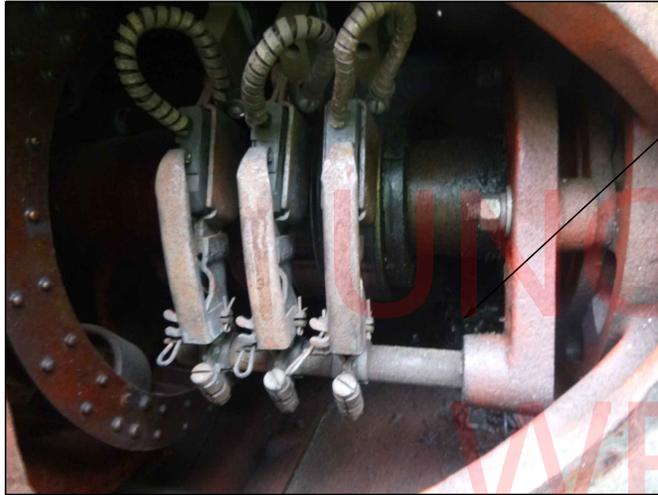
OVER-LUBRICATION INSIDE THE SPAN MOTOR

CLEAN AND REMOVE  
EXCESSIVE  
LUBRICATION

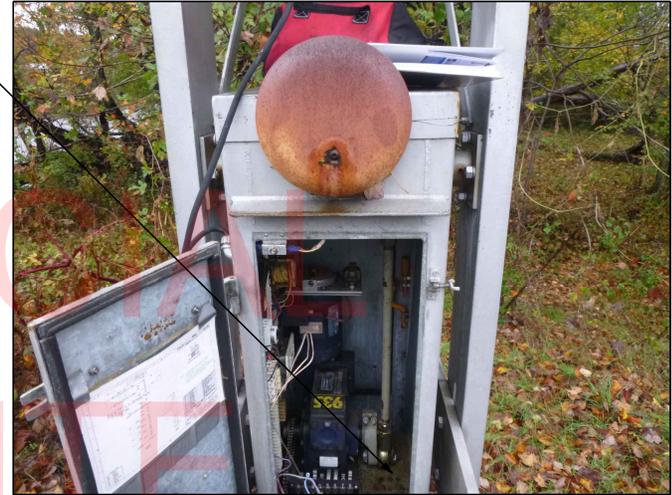
TYPICAL OVER-LUBRICATION ON COMPONENTS  
INSIDE THE WARNING GATE

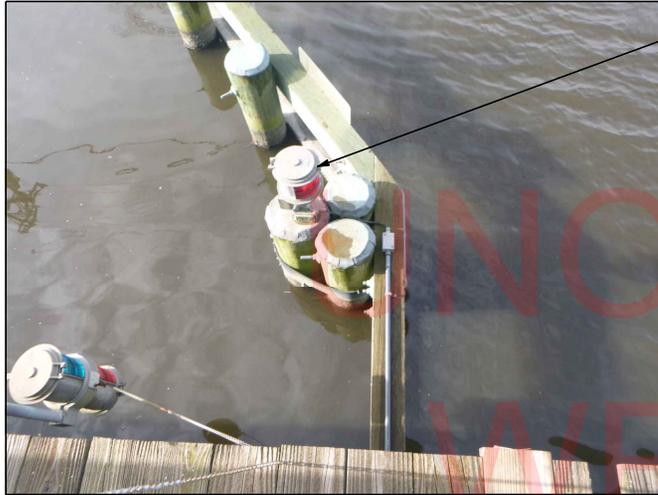
**TYPICAL FENDER PIER LIGHTS NOT ALIGNED  
WITH THE CHANNEL**

ADJUST AND ROTATE  
EXISTING PIER  
LIGHTS TO MEET  
USCG REQUIREMENTS  
33 CFR 118.65

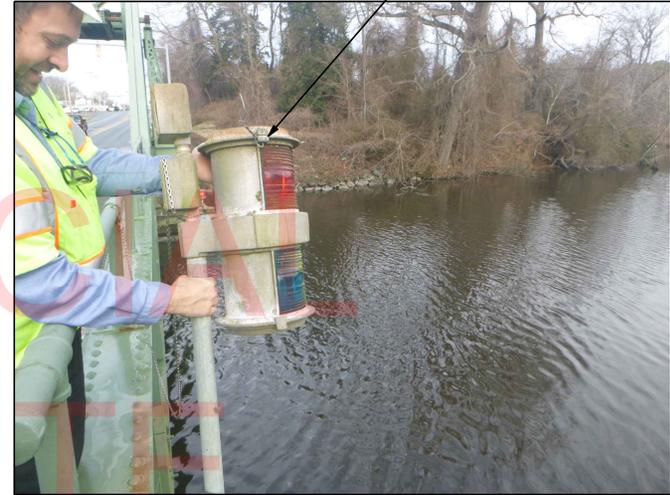
**EAST SPAN NAVIGATION LIGHT SYSTEM WITH  
WATER INTRUSION**

REPLACE GASKET AS  
NECESSARY AND  
TIGHTEN FIRMLY

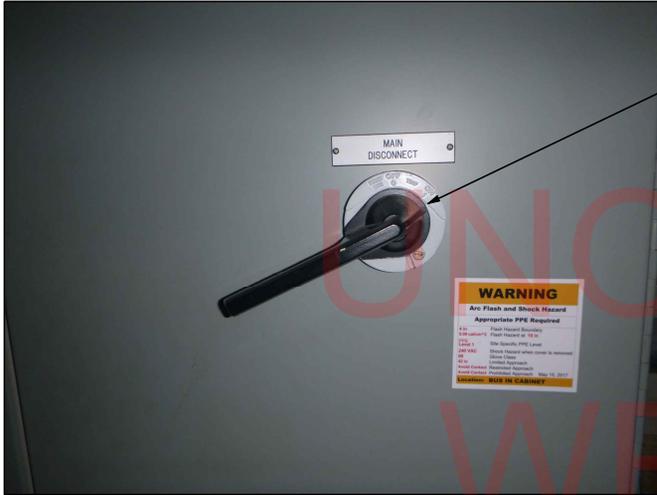
DAMAGED MOTOR CONTROL PANEL CIRCUIT BREAKER REMOTE OPERATOR

REPLACE THE HANDLE AND OPERATING MECHANISM FOR THE MAIN CIRCUIT BREAKER

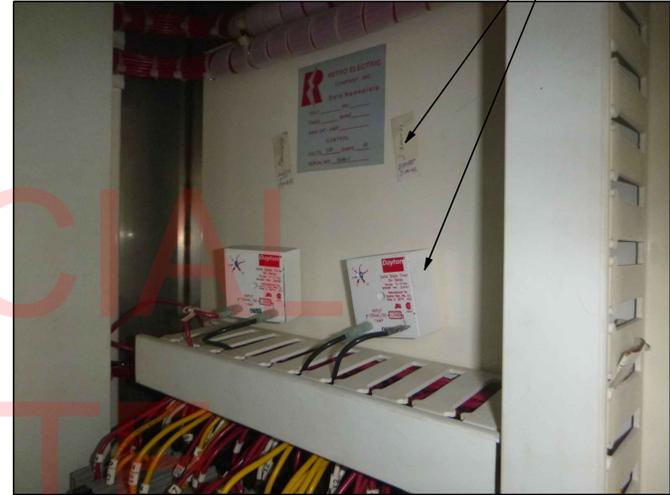
TYPICAL UNSECURED/UNSTABILIZED MOTOR OFF AND BRAKE TIMER RELAYS IN THE CONTROL DESK

SECURE TIMER RELAYS AND PROVIDE PRINTED LABELS

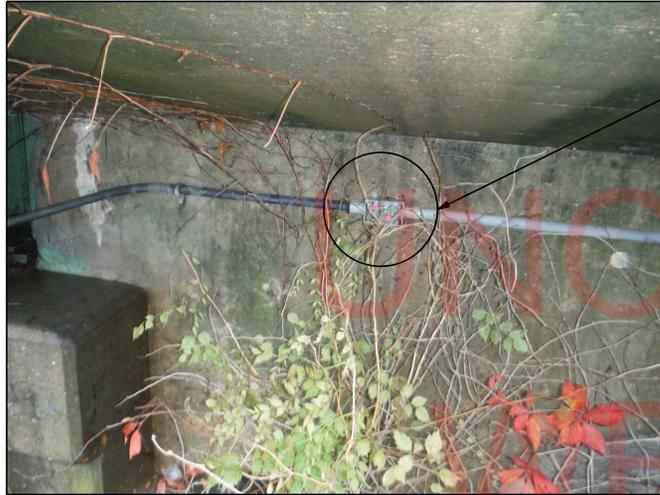
**ELECTRICAL BOX MISSING A COVER**

REPLACE THE COVER ON  
THE ELECTRIC BOX UNDER  
THE SOUTHWEST  
CANTILEVERED CONCRETE  
SIDEWALK
