Contract No.: T201707005

Title: Statewide Movable Bridge Preventative Maintenance
Location: Bridges 1-687, 1-688, 1-693, 2-021A, 3-151, 3-153, 3-154, 3-164
County: Statewide

Bridge 3-151

T201707005	FRONT STREET
615625 - INITIAL REPAIRS AT BRIDGE 3-151	
REPAIRS S1 & S2

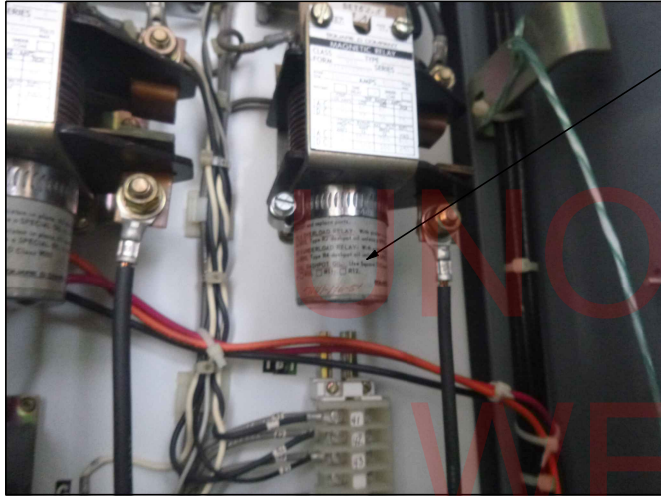
TYPICAL MOTOR OVERLOAD INSIDE THE MOTOR
CONTROL PANEL SHOWING SIGNS OF OIL LEAKS

REPLACE THE MOTOR
OVERLOADS

1. CLEAN OIL RESIDUE THAT HAS LEAKED ONTO COMPONENTS INSIDE THE MOTOR CONTROL PANEL.
2. REFER TO THE SPECIAL PROVISIONS FOR REQUIREMENTS.

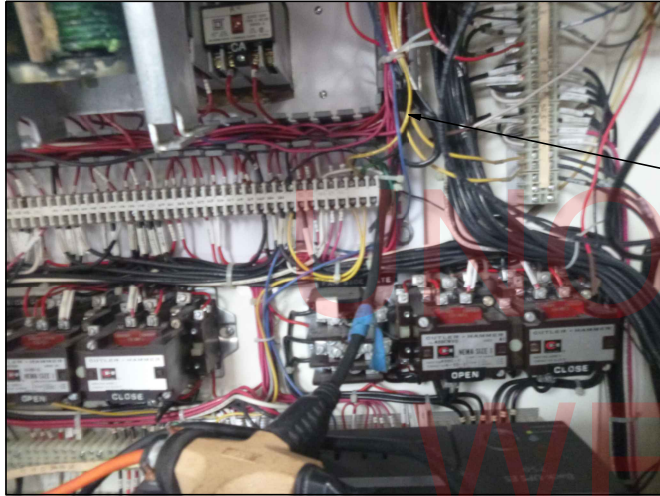
GROUND CONDUCTOR INSIDE THE CONTROL DESK
WITHOUT IDENTIFIABLE MARKINGS

MARK THE EXISTING
GROUND CONDUCTOR
WITH GREEN TAPE

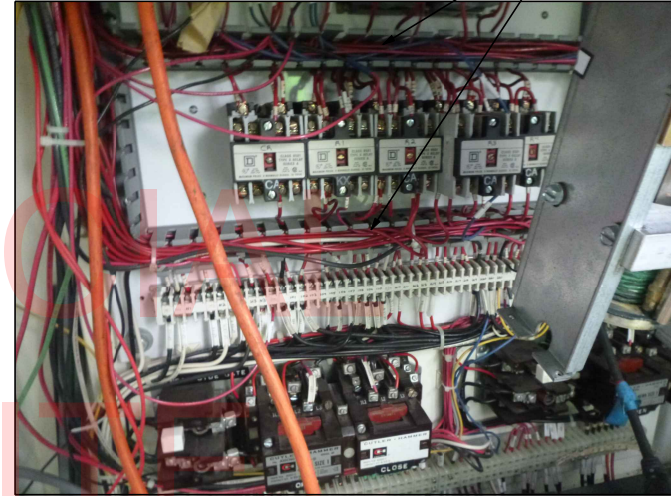
TYPICAL WIRE DUCTS INSIDE THE CONTROL
DESK WITHOUT COVERS

FURNISH AND
INSTALL WIRING
DUCTS COVERS

1. ALL WIRING IN THE WIRE DUCTS SHALL BE NEATLY INSERTED IN THE SLOTS BEFORE PLACING THE COVERS.
2. REFER TO THE SPECIAL PROVISIONS FOR REQUIREMENTS.

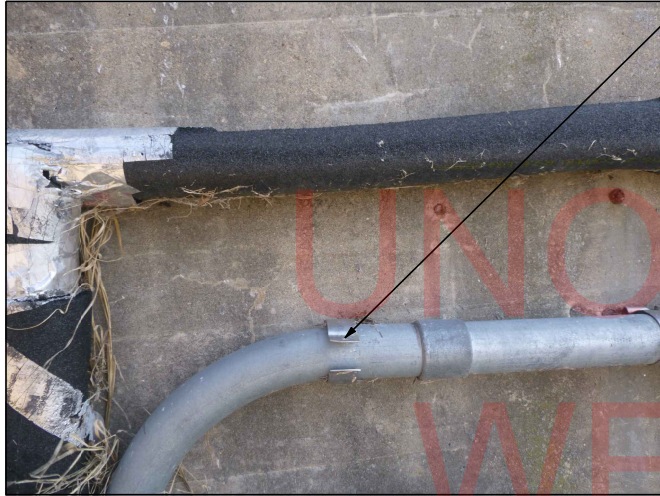
CONDUIT CLAMP AT THE NORTHWEST APPROACH
WITH A MISSING FASTENER

FURNISH AND
INSTALL NEW S. S
CONDUIT CLAMP
FASTENER

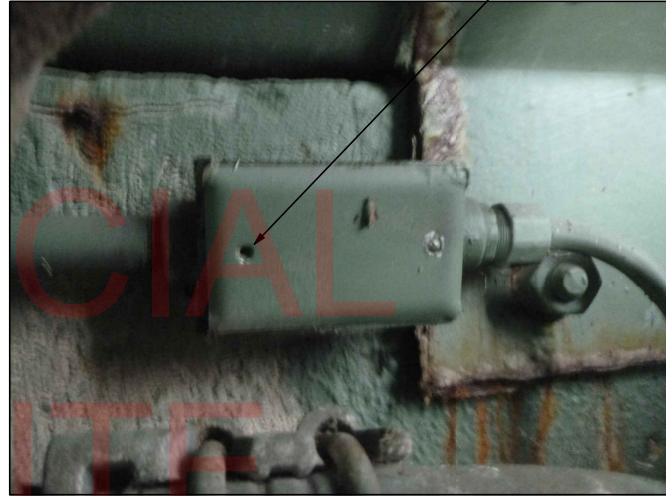
WEST DROOP CABLE JUNCTION BOX WTH MISSING
A FASTENER ON THE MACHINERY PLATFORM

FURNISH AND
INSTALL A NEW S. S
FASTENER FOR THE
JUNCTION BOX

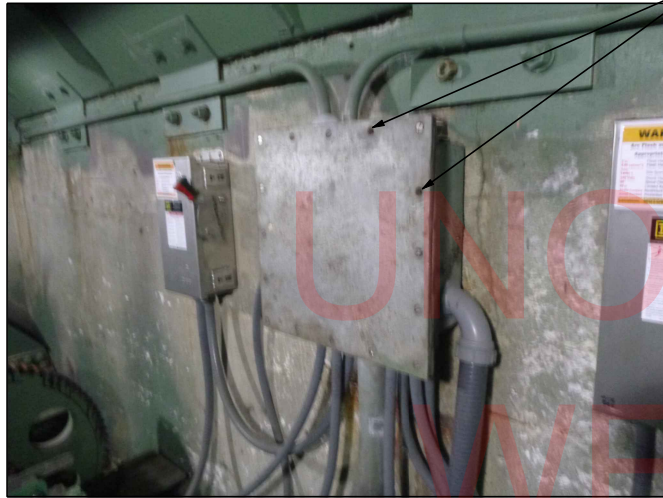
CORRODED FASTENERS AT THE JUNCTION BOX ON
THE MACHINERY PLATFORM

FURNISH AND
INSTALL NEW S. S
FASTENER

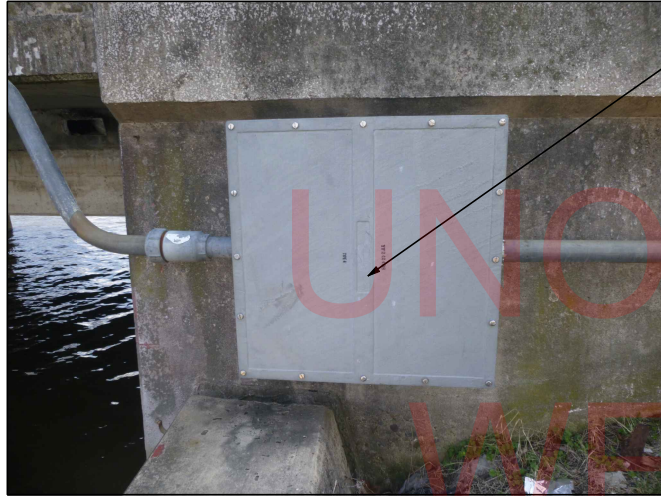
**SOUTHWEST APPROACH JUNCTION BOX WITH
DISCONNECTED WIRING INSIDE**

FURNISH AND
INSTALL TERMINAL
BLOCK AND
TERMINATE LOOSE
CONDUCTORS

1. ADD NEW TERMINAL BLOCK INSIDE THE EXISTING ENCLOSURE NEW BACKPANEL.
2. REFER TO THE SPECIAL PROVISIONS FOR REQUIREMENTS.

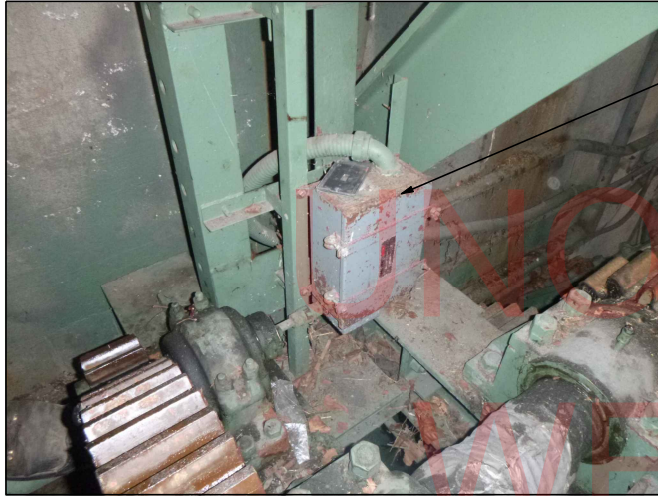
CORROSION ON THE ROTARY CAM LIMIT SWITCH
HOUSING

REMOVE CORROSION
AND DEBRIS WITH
WIRE BRUSH AND
APPLY PAINT ON
THE ROTARY CAM
HOUSING

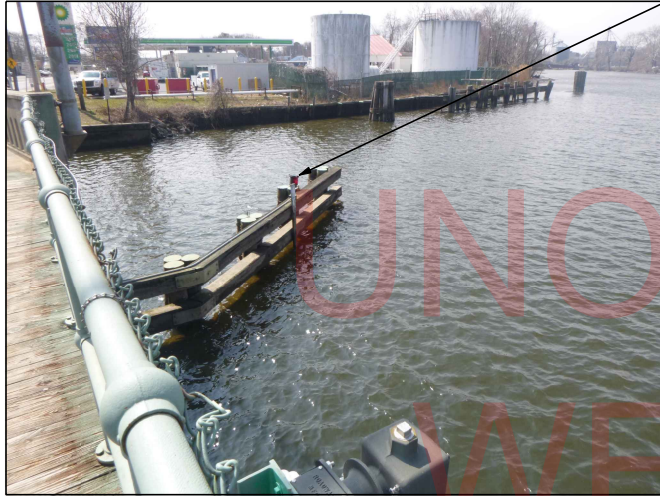
TYPICAL FENDER PIER LIGHTS NOT ALIGNED WITH THE CHANNEL

ADJUST AND ROTATE EXISTING PIER LIGHTS TO MEET USCG REQUIREMENTS 33 CFR 118.65

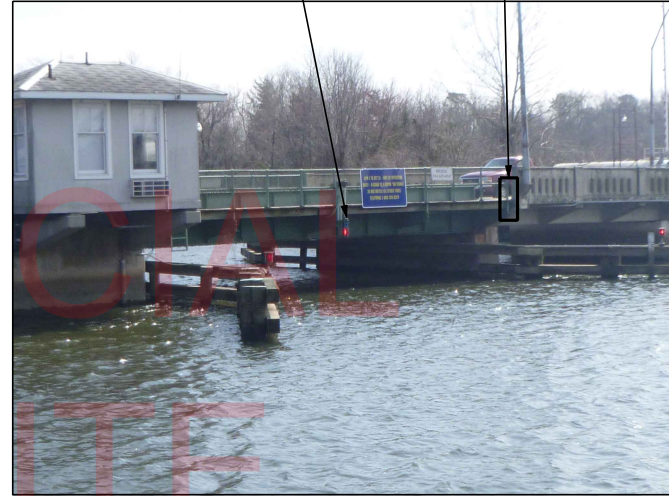
TYPICAL SPAN MOUNTED NAVIGATION LIGHT LOCATED AT THE CENTER OF THE SPAN

RELOCATE THE NAVIGATION LIGHT TO THE TIP OF THE SPAN.

NEW LOCATION FOR SPAN NAVIGATION LIGHTS. FURNISH AND INSTALL SUPOPRTS FOR NAVIGATION LIGHTS AS REQUIRED (TYP.)

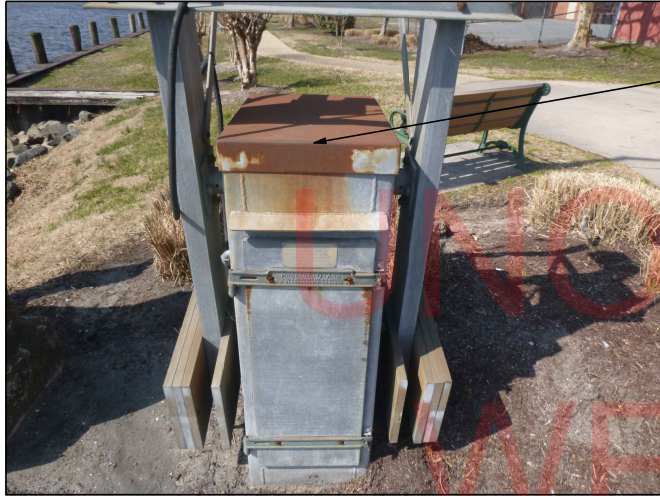
NORTH WARNING GATE HOUSING WITH CORROSION

REMOVE CORROSION ON THE GATE HOUSING AND APPLY PAINT

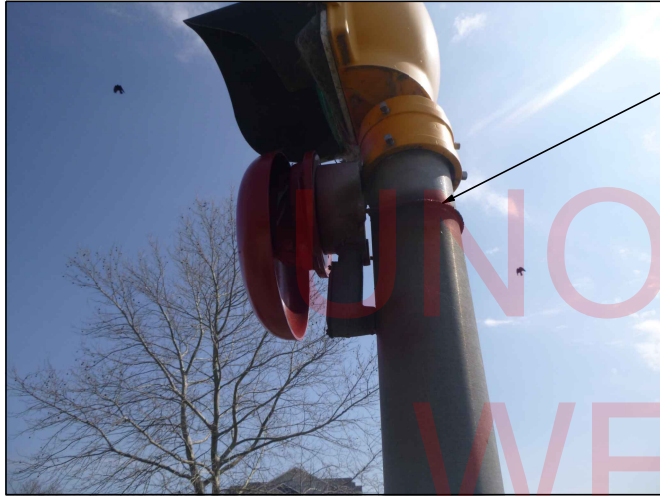
CORRODED CLAMP FOR THE WARNING BELL ON
THE NORTH TRAFFIC SIGNAL POLE

FURNISH AND
INSTALL A NEW
MOUNTING CLAMP

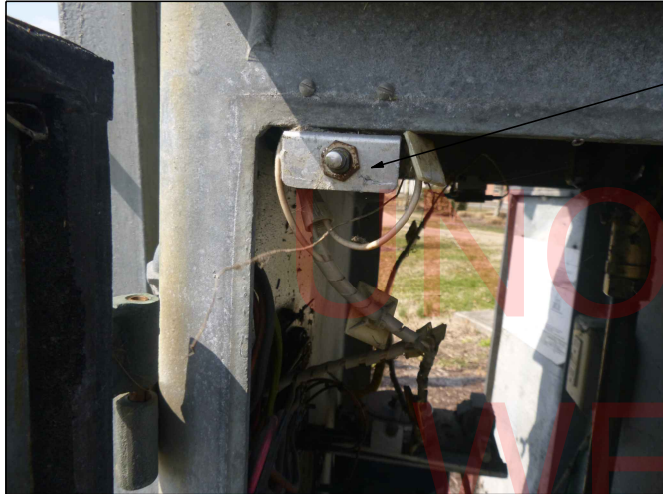
DISCONNECTED/BYPASSED SAFETY DOOR SWITCH
AT THE NORTH WARNING GATE

FURNISH AND
INSTALL A NEW
DOOR SAFETY
SWITCH AND
CONNECT ALL
WIRING
CONNECTIONS

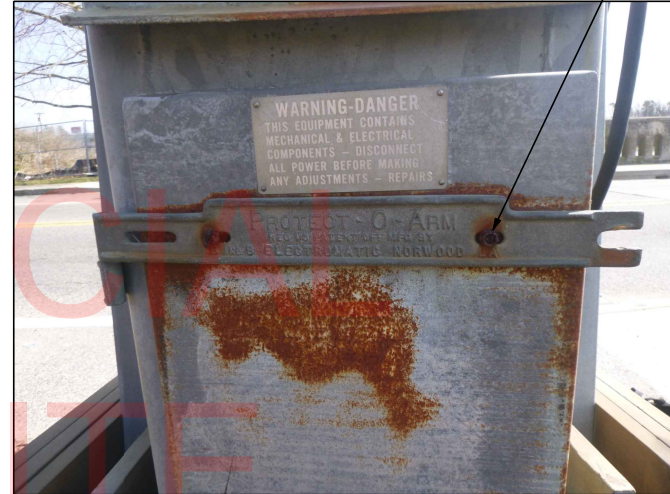
TYPICAL CORRODED HARDWARE ON THE NORTH
WARNING GATE DOOR STRAP

REPLACE CORRODED
HARDWARE

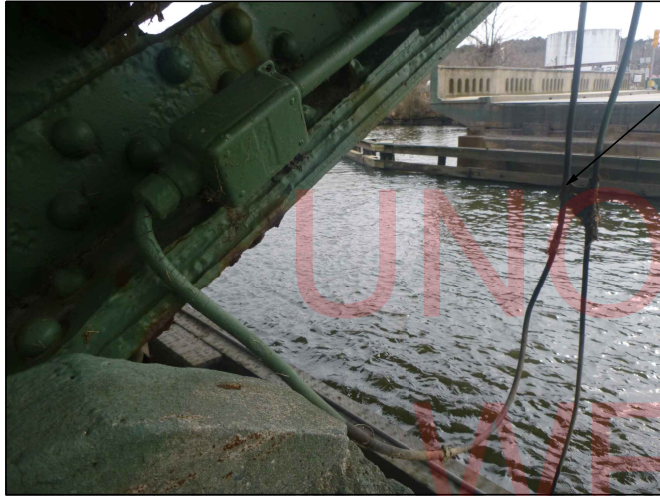
TYPICAL UNSUPPORTED DROOP CABLES

ADJUST CABLE LENGTH. FURNISH AND INSTALL BRACKET HANGERS TO SUPPORT DROOP CABLES

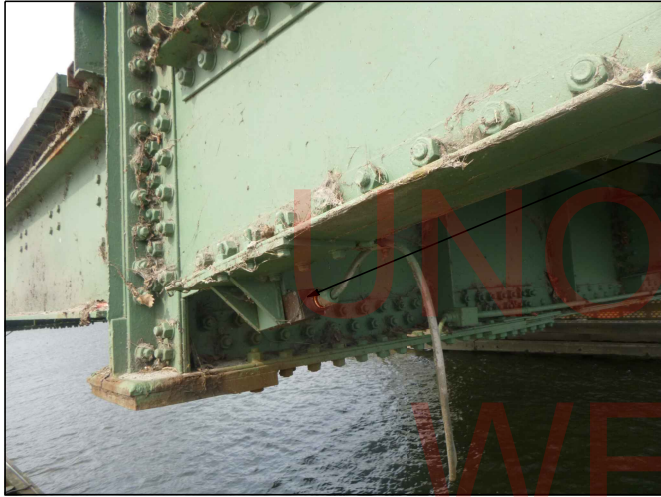
TYPICAL FULLY CLOSED LIMIT SWITCH
NONFUNCTIONAL LEVER ARM

FURNISH AND
INSTALL NEW FULLY
CLOSED LIMIT
SWITCH AND LEVER
ARM

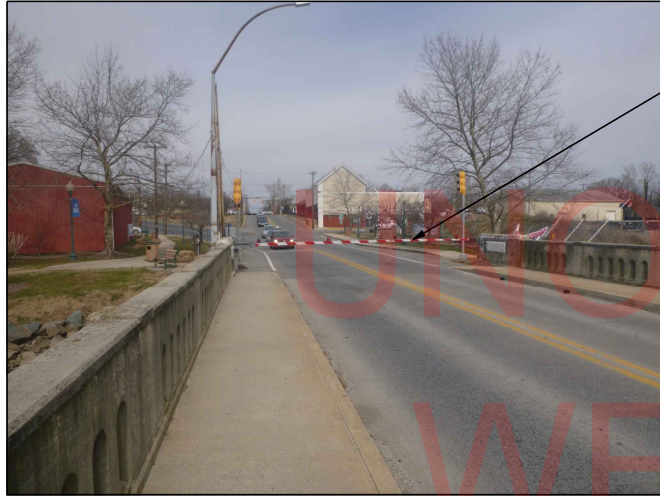
NORTH WARNING GATE ARM WARNING LIGHTS NOT
IN COMPLIANCE WITH THE MUTCD

ADJUST GATE ARM
WARNING LIGHT
CIRCUITS AND
FLASHER TO
ALTERNATE
FLASHING LIGHTS
AND ONE STEADY
LIGHT AT THE TIP
OF THE GATE ARM

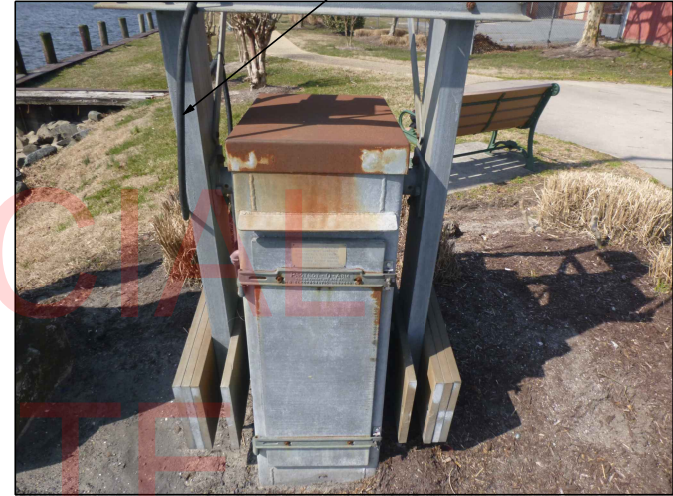
DAMAGED SOW CABLE FOR THE NORTH WARNING
GATE FLASHER

FURNISH AND INSTALL NEW
FLEXIBLE CABLE 4C #12
AWC, 1#12 GND. TERMINATE
ALL WIRING TO EXISTING
FLASHER

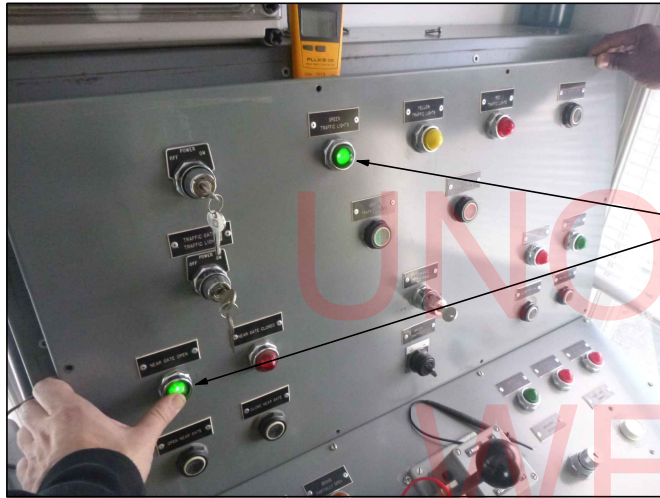
NEAR GATE OPEN AND GREEN TRAFFIC LIGHTS
PUSH TO TEST CIRCUIT IN THE SAME
CONNECTIONS

REVISE AND CORRECT THE PUSH TO TEST CIRCUIT SUCH THAT THE NEAR OPEN GATE AND GREEN TRAFFIC LIGHTS PUSH TO TEST CONNECTIONS ARE CONNECTED INDEPENDENTLY

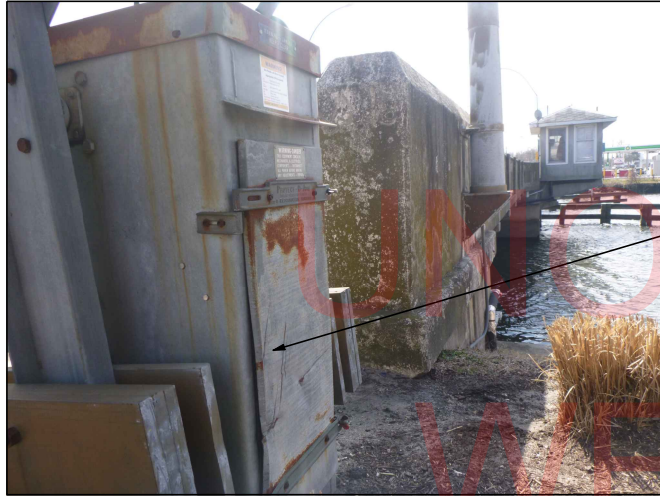
DAMAGED REAR DOOR AT THE NORTH WARNING GATE

FURNISH AND
INSTALL A NEW
REAR GALVANIZED
GATE DOOR.
FURNISH AND
INSTALL NEW
HARDWARE

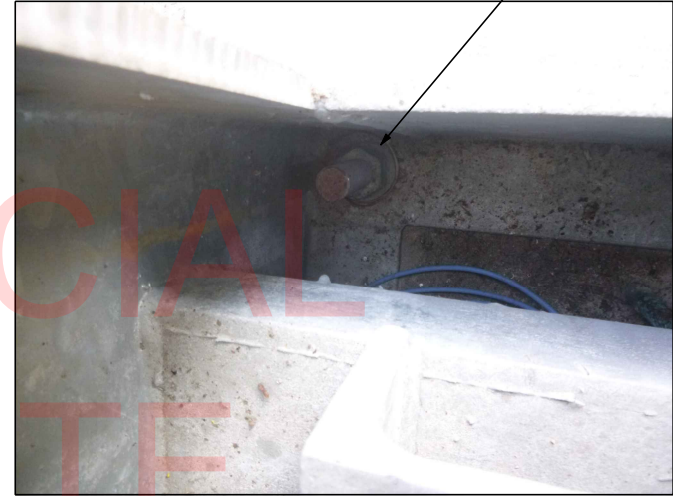
LOOSE ANCHOR AT THE BASE OF THE SOUTH WARNING GATE

TIGHTEN LOOSE
ANCHOR BOLT
