Contract No.: T201707005

Title: Statewide Movable Bridge Preventative Maintenance
Location: Bridges 1-687, 1-688, 1-693, 2-021A, 3-151, 3-153, 3-154, 3-164
County: Statewide

T201707005	WALNUT STREET
615600 - INITIAL REPAIRS AT BRIDGE 1-687	
REPAIR S1

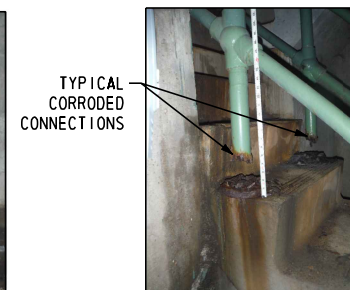
**TYPICAL FAILED
CONNECTION**

TYPICAL
CORRODED
CONNECTIONS

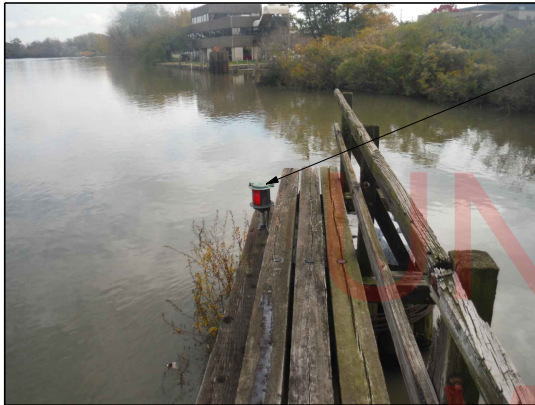
**FENDER NAVIGATION LIGHTS NOT
ALIGNED WITH THE CHANNEL**

ADJUST AND ROTATE
EXISTING PIER
LIGHTS TO MEET
USCG REQUIREMENTS
33 CFR 118.65

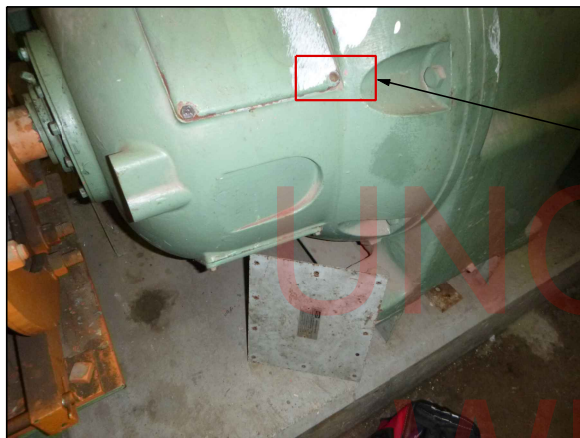
TYPICAL SPAN MOTOR WITH MISSING
HARDWARE ON ACCESS COVER

FURNISH AND INSTALL MISSING
HARDWARE FOR SPAN MOTOR
ACCESS COVER (4 MOTORS)

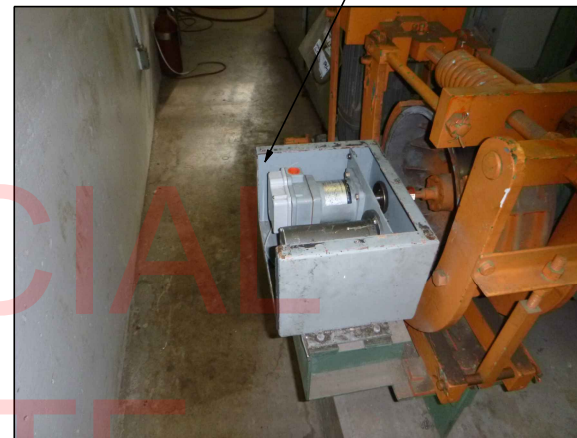
TYPICAL TACHOMETER AND OVERSPEED
ENCLOSURE WITH UNSECURED COVER (2 TOTAL)

INSTALL EXISTING COVER
AND FURNISH WITH NEW
HARDWARE FOR TACHOMETER
AND OVERSPEED ENCLOSURE

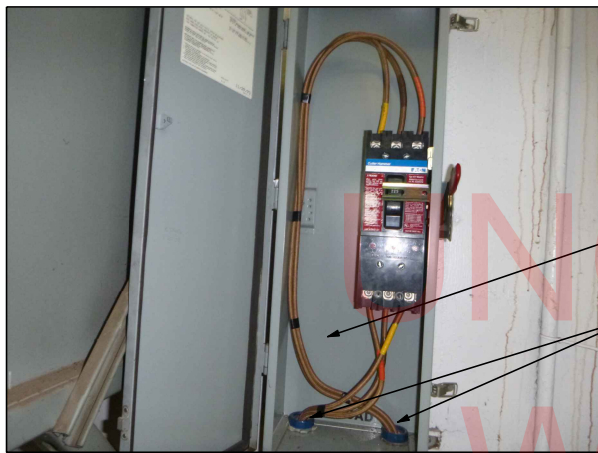
TYPICAL SPAN MOTOR DISCONNECT SWITCH WITHOUT A GROUND CONDUCTOR

FURNISH AND INSTALL GROUND
LUG IN EACH ENCLOSURE AND
BOND NEW GROUND CONDUCTOR

FURNISH AND INSTALL GROUND
CONDUCTOR IN EXISTING CONDUIT

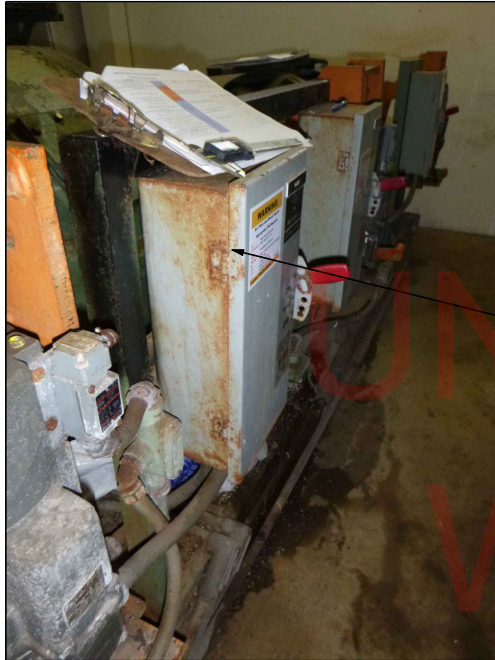
TYPICAL MOTOR DISCONNECT SWITCHES,
CONDUIT AND FITTINGS WITH CORROSION

CLEAN ALL SIDES OF CONDUIT AND
ENCLOSURES, SCRAPE WITH WIRE
BRUSH AND PAINT AS SPECIFIED

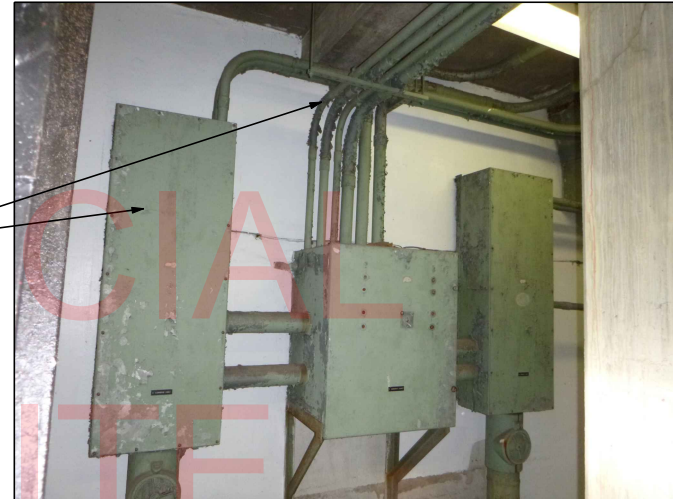
TYPICAL TERMINATION ENCLOSURES,
CONDUIT AND PULL BOXES EXHIBITING PEELING PAINT

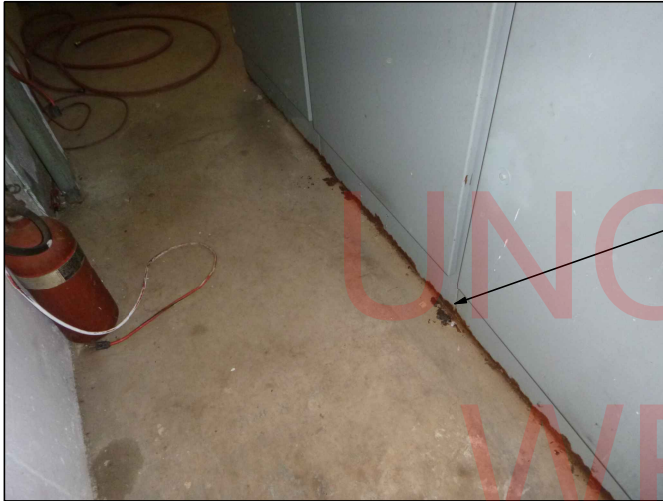
**TYPICAL CONTROL ENCLOSURE
WITH CORROSION AT THE BASE**

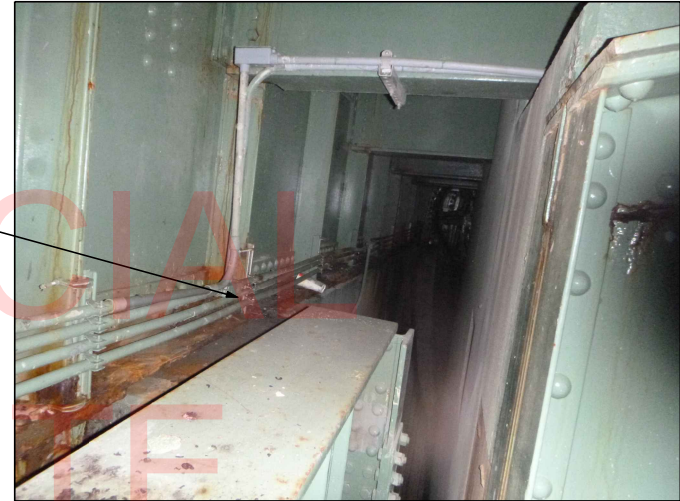
**TYPICAL CONDUIT IN BASCULE PIER
WITH PEELING PAINT AND CORROSION**

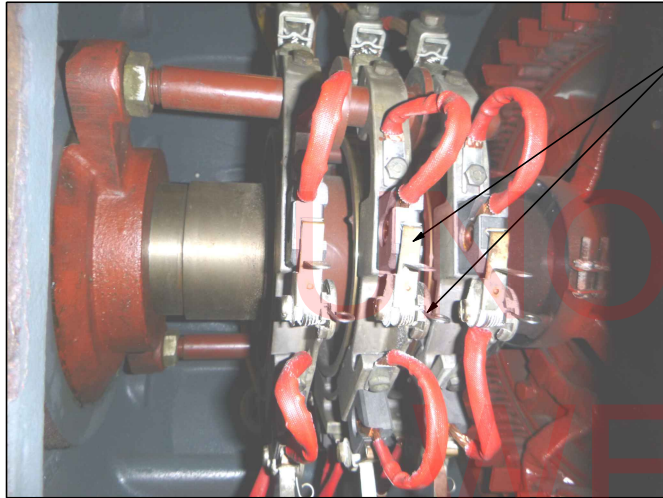
BRUSHES WITH POOR
CONTACT

TYPICAL SPAN MOTOR BRUSHES, SPRINGS,
HOLDERS AND SLIP RINGS WITH POOR ALIGNMENT

ADJUST BRUSH HOLDERS
AND SPRINGS TO ACHIEVE 90%
CONTACT (MINIMUM). REPLACE
COMPONENTS AS NEEDED

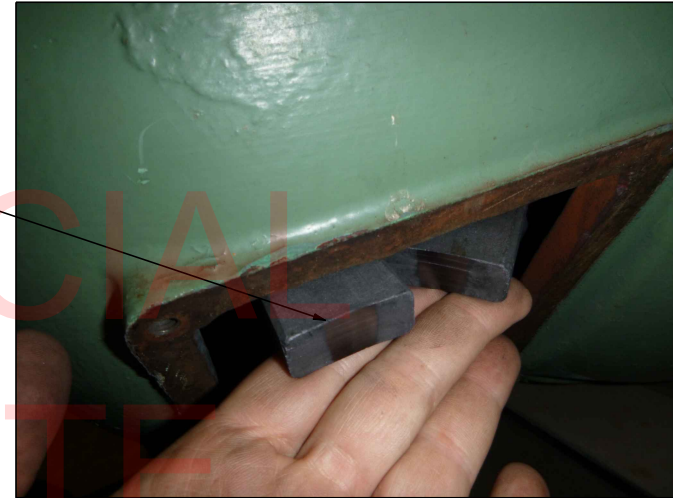
TYPICAL MOTOR BRUSHES WITH
POOR CONTACT WITH SLIP RINGS

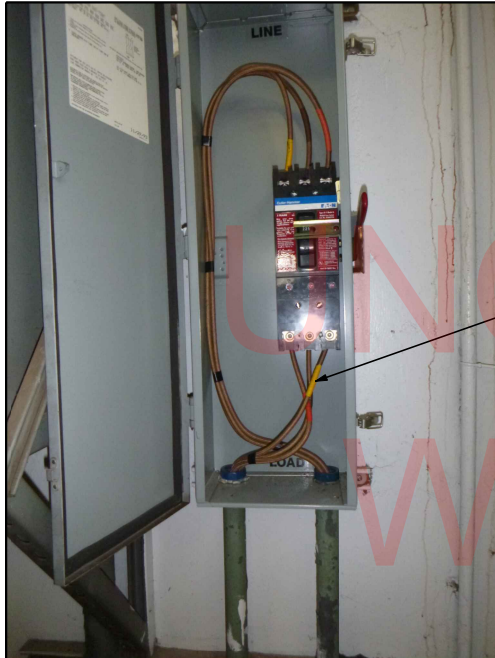
**IMPROPER COLOR CODING INSIDE
THE MOTOR DISCONNECT SWITCH**

SWITCH CONNECTIONS AT PHASE A
AND C ON THE LOAD SIDE AND
CHANGE PHASE CONNECTIONS WITHIN
THE MOTOR JUNCTION BOX FOR
CORRECT MOTOR ROTATION.

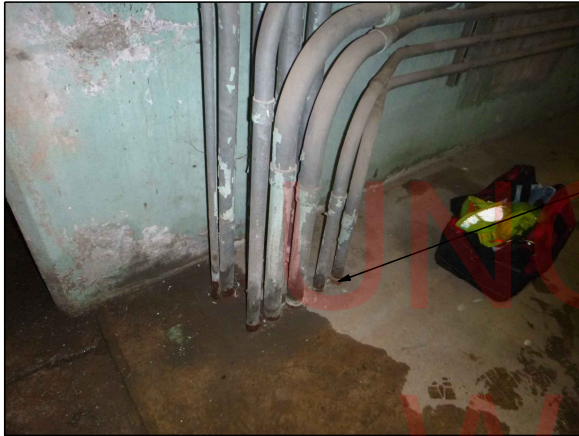
PEELING PAINT AND CORROSION
ON CONDUIT INSTALLED THROUGH THE NORTH
MACHINERY ROOM FLOOR NEAR SPAN MOTOR
DISCONNECT SWITCHES

CLEAN ALL SIDES OF CONDUIT
SCRAPE WITH WIRE BRUSH
AND PAINT

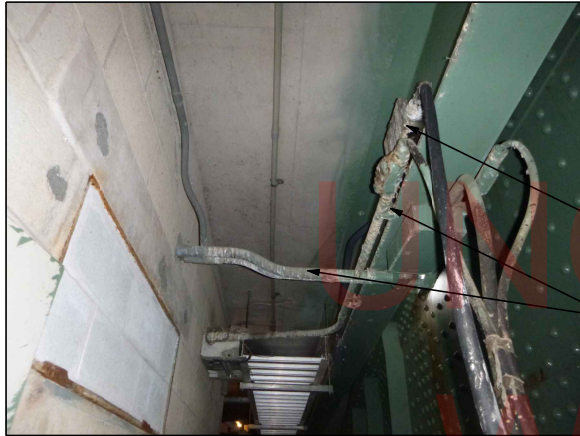
BIRD WASTE AND PEELING PAINT
ON CONDUIT NEAR DROOP CABLE JUNCTION BOX
IN THE BASCULE PIER

CLEAN ALL SIDES OF CONDUIT AND ENCLOSURES, SCRAPE WITH WIRE BRUSH AND PAINT

FURNISH AND INSTALL HEAVY DUTY S.S PIGEON SPIKES IN AREAS OF SUSPECTED PIGEON NESTING
