Bridge No: 1001 279  
 Date of Inspection: 04/23/2024  
 Load Rating Date: 03/25/2020

6) Feature Intersected: BRANDYWINE CREEK

7) Facility Carried: RISING SUN LANE

43 A & B) Main Span Mtrl/Design: 3 Steel 10 Truss-Thru

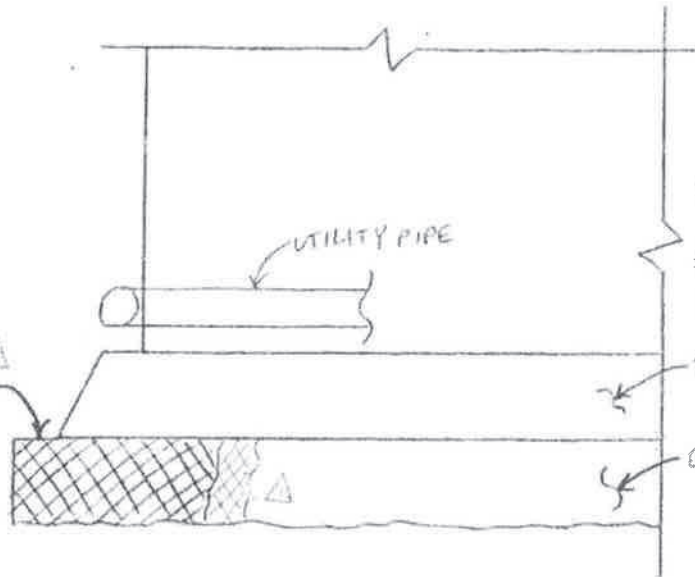
6' L x 3' H x 1.5' D

VOID UNDERMINING  
TOP APRON

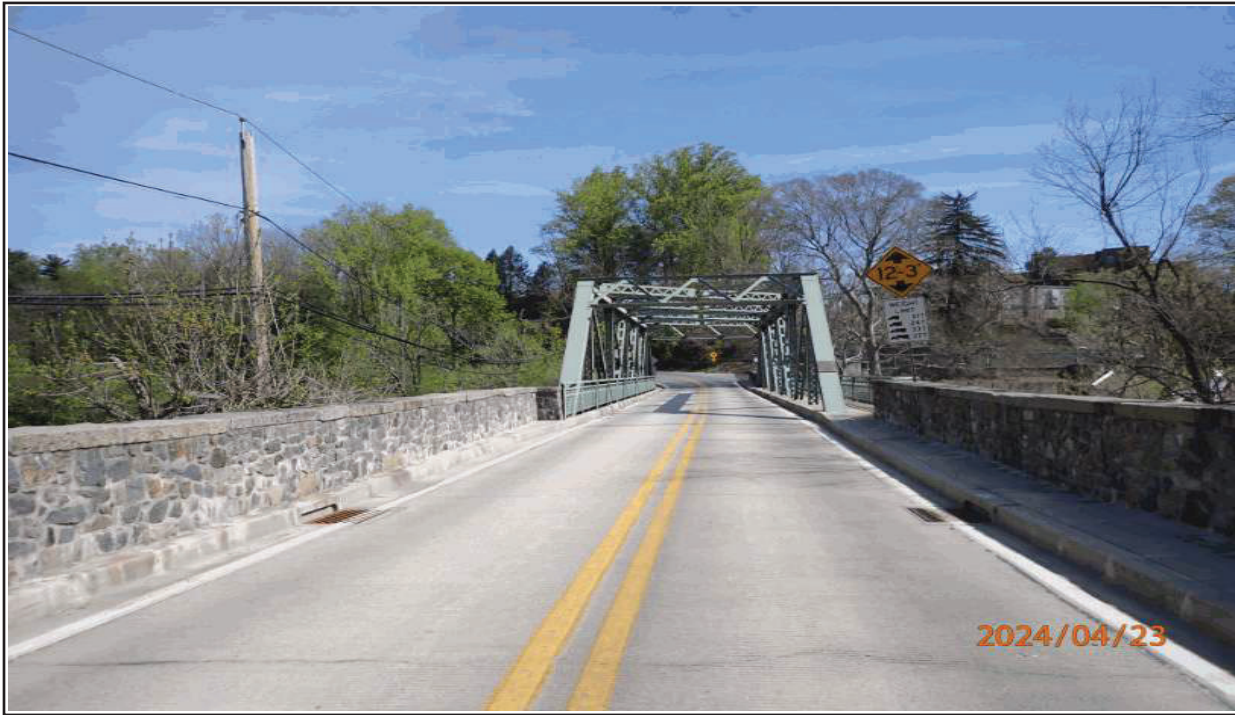
1 SOUTH APPROACH LOOKING NORTH

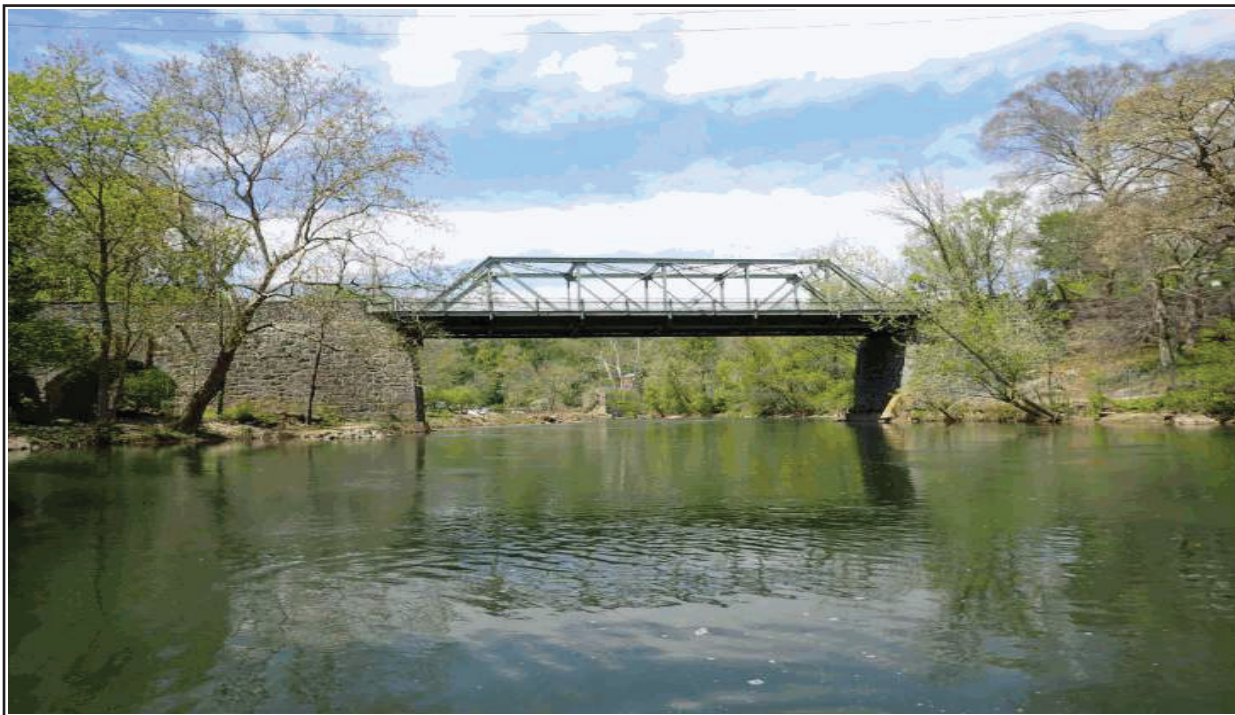
2 EAST ELEVATION LOOKING WEST

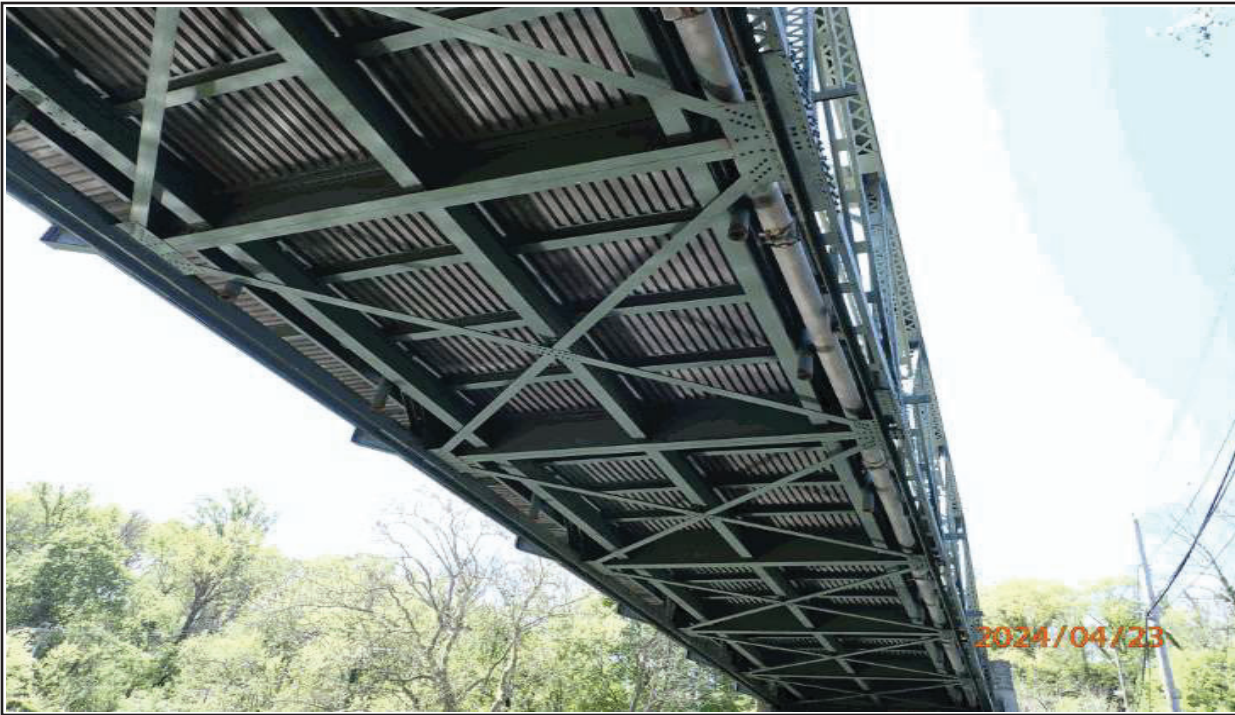
3 TYPICAL VIEW OF UNDERSIDE, LOOKING SOUTH

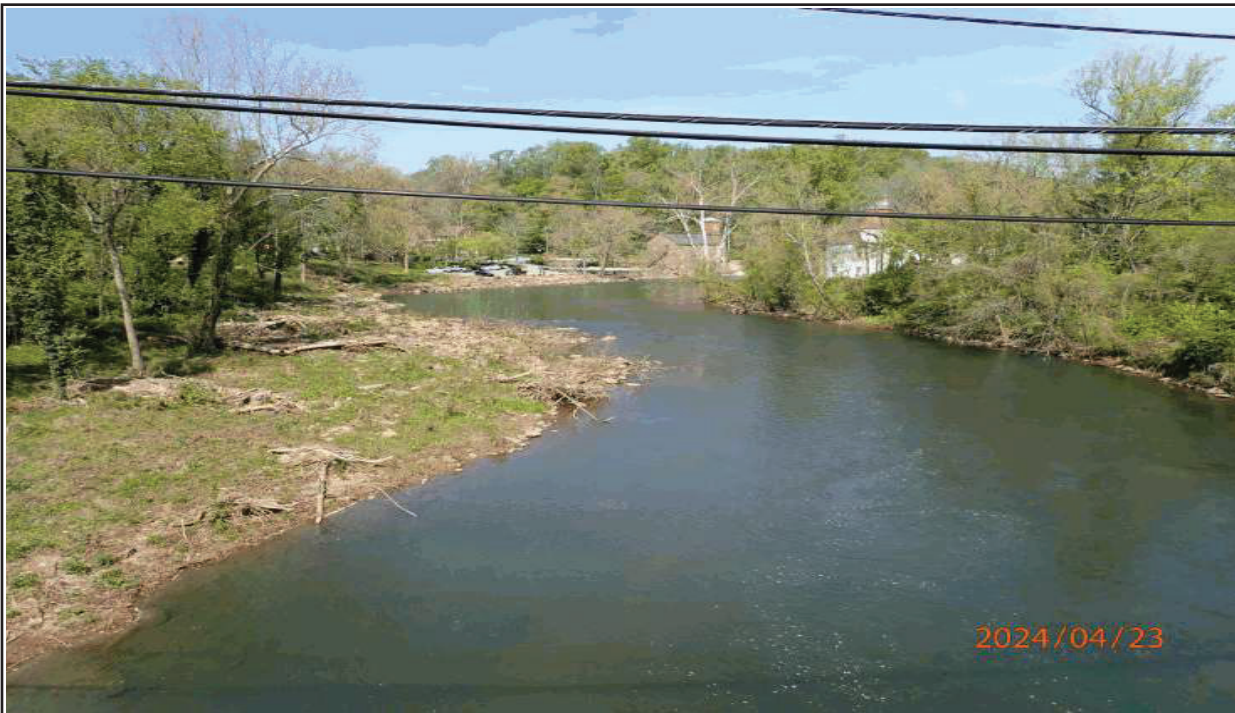
4 BRANDYWINE CREEK, LOOKING UPSTREAM (WEST)

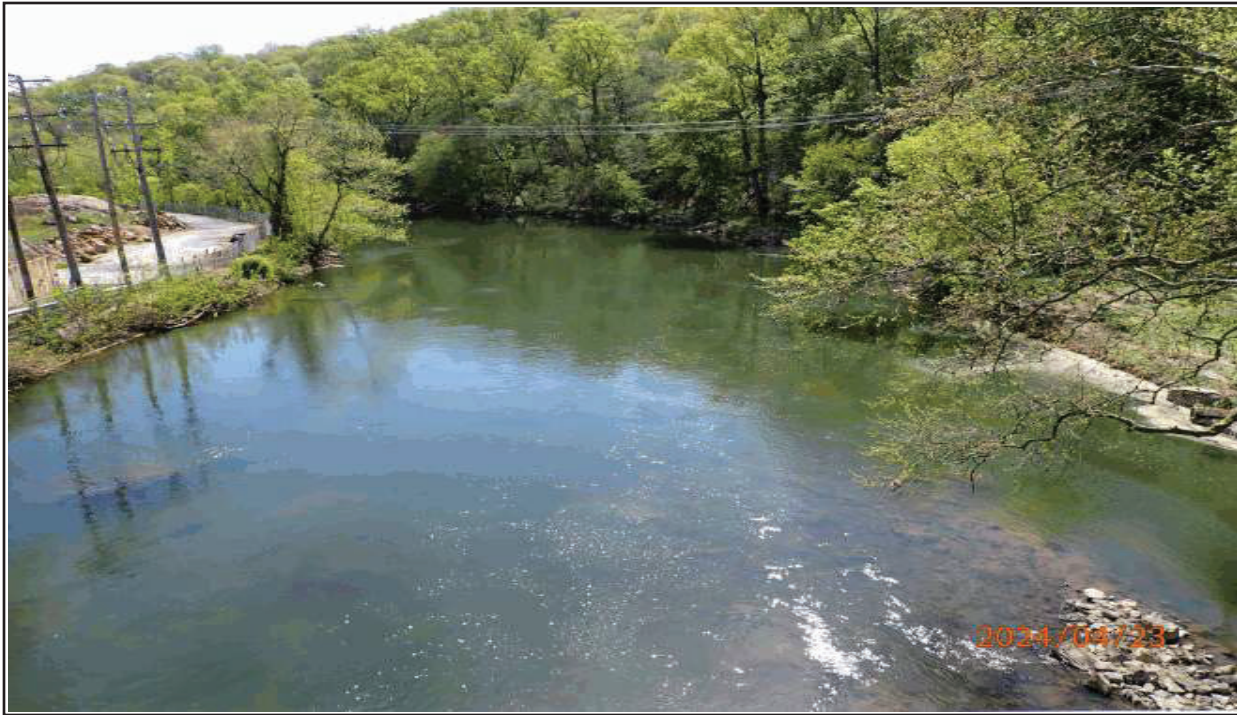
5 BRANDYWINE CREEK, LOOKING DOWNSTREAM (EAST)

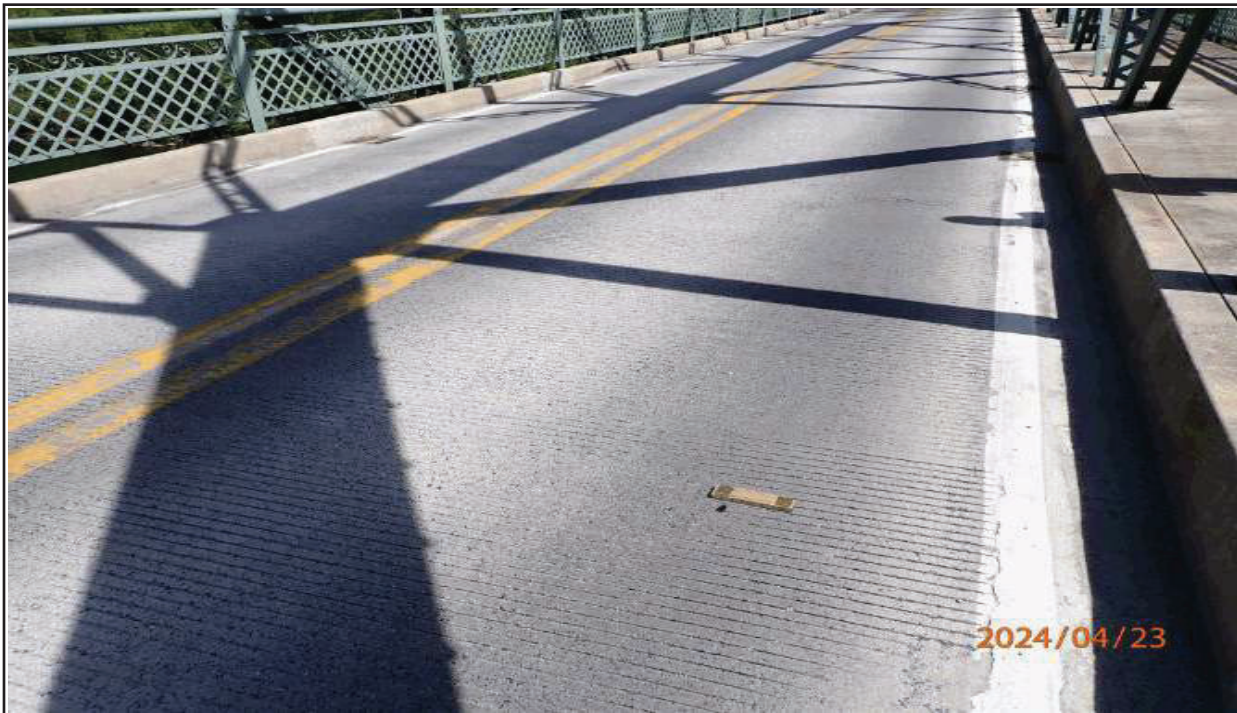
6 GENERAL VIEW OF DECK, LOOKING NORTH

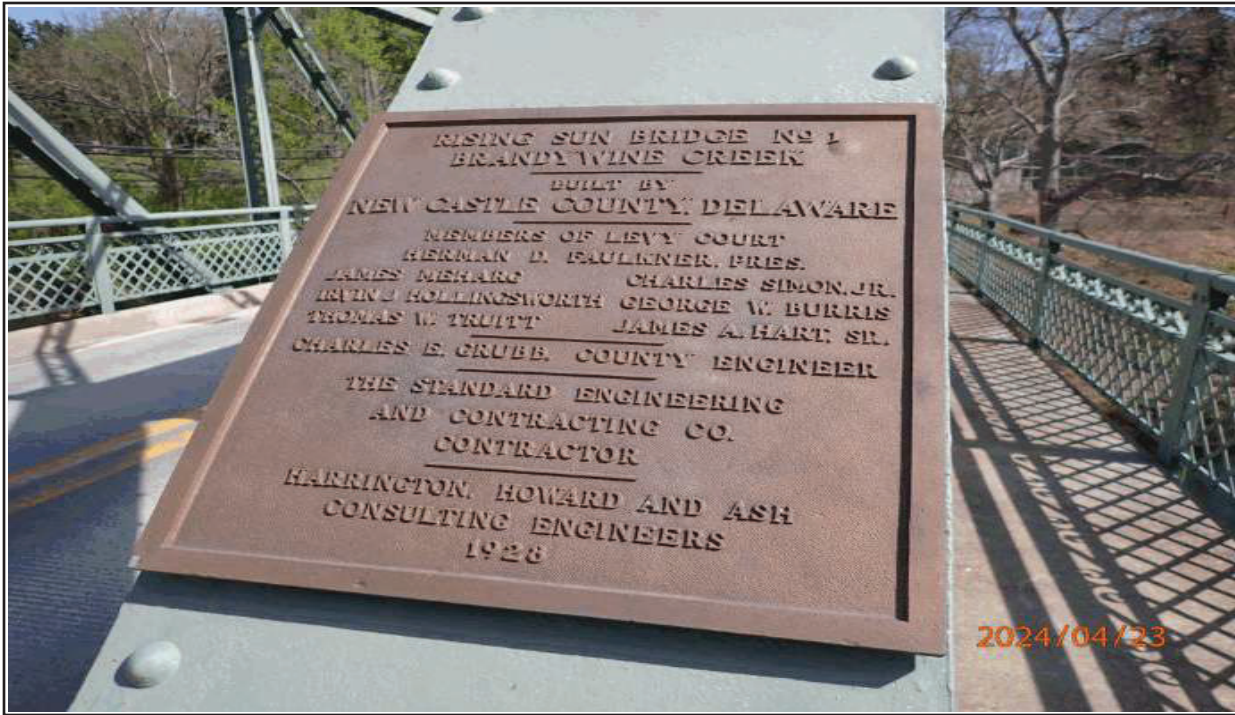
7 BRIDGE PLAQUE AT SOUTHEAST CORNER (NORTHWEST CORNER SIMILAR), LOOKING NORTH

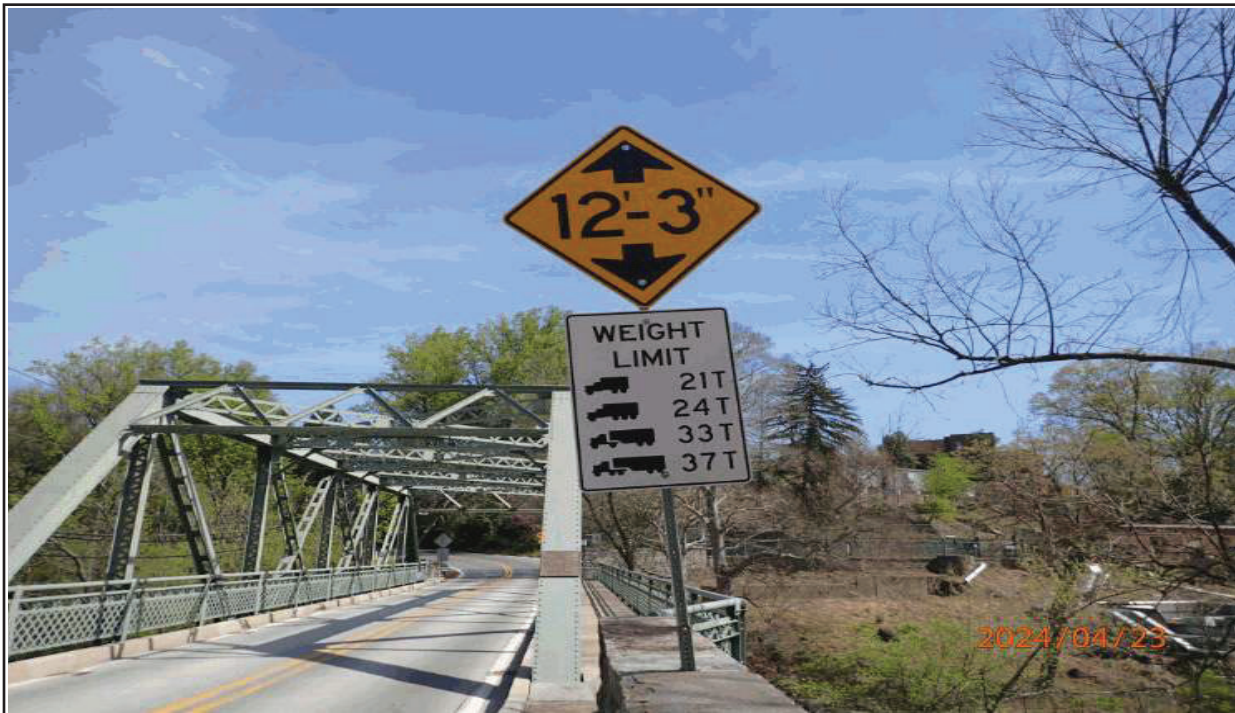
8 VERTICAL CLEARANCE AND LOAD POSTING SIGNS AT SE CORNER (NW SIMILAR)

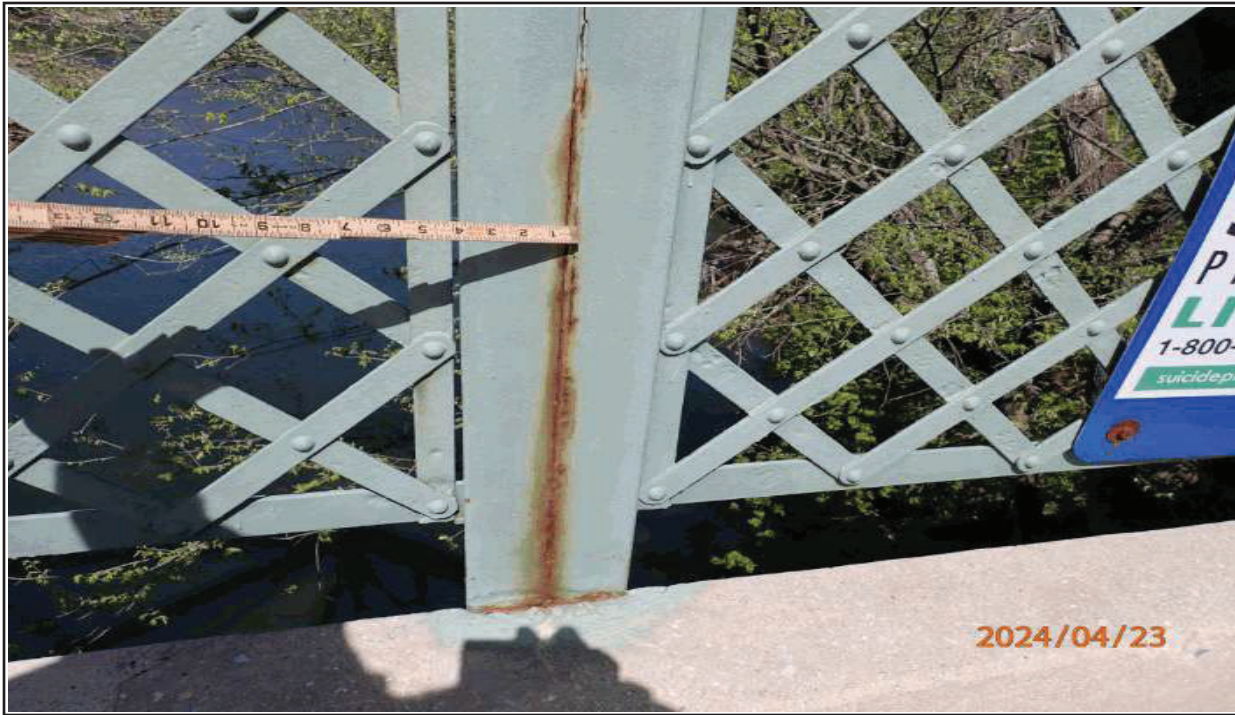
| Elm/Env | Description | Unit | Total Qty | Qty. St. 1 | Qty. St. 2 | Qty. St. 3 | Qty. St. 4 | Notes |
|---|---|---|---|---|---|---|---|---|
| 330/2 | Metal Bridge Railing | ft | 264.00 | 203.00 | 55.00 | 6.00 | 0.00 | NOTE: THE METAL RAILING MEMBERS ON THE TRUSS TYPICALLY EXHIBIT RANDOM AREAS OF ARRESTED METAL LOSS UP TO 1/16-INCH DEEP AND A FEW LOCALIZED AREAS UP TO 1/8-INCH DEEP.<br><br>CORROSION (1000):<br>CS3: (6 LF) APPROXIMATELY 25% OF THE METAL RAILING POSTS EXHIBIT PACK RUST UP TO 3/8-INCH THICK AT THE FASCIA STRINGER CONNECTION (PHOTO 9). (NC-24)<br><br>CS2: (55 LF) RANDOM AREAS EXHIBIT EXPOSED STEEL WITH ACTIVE CORROSION (PHOTO 10) (30 LF). WEST RAIL, 40-FEET SOUTH OF NORTH ABUTMENT EXHIBITS IMPACT SCRAPES ON THREE (3) POSTS AND TWO (2) PANELS WITH EXPOSED CORRODED BARE METAL AND MINOR DISTORTION (25 LF) (PHOTO 10). (NC-24)<br><br>DAMAGE (7000):<br>CS2: (25 LF) ELEMENT HAS IMPACT DAMAGE CAPTURED UNDER CORROSION DEFECT ABOVE. (NC-24) |

9 WEST RAILING, NORTH END - TYPICAL PACK RUST BETWEEN POST ANGLES

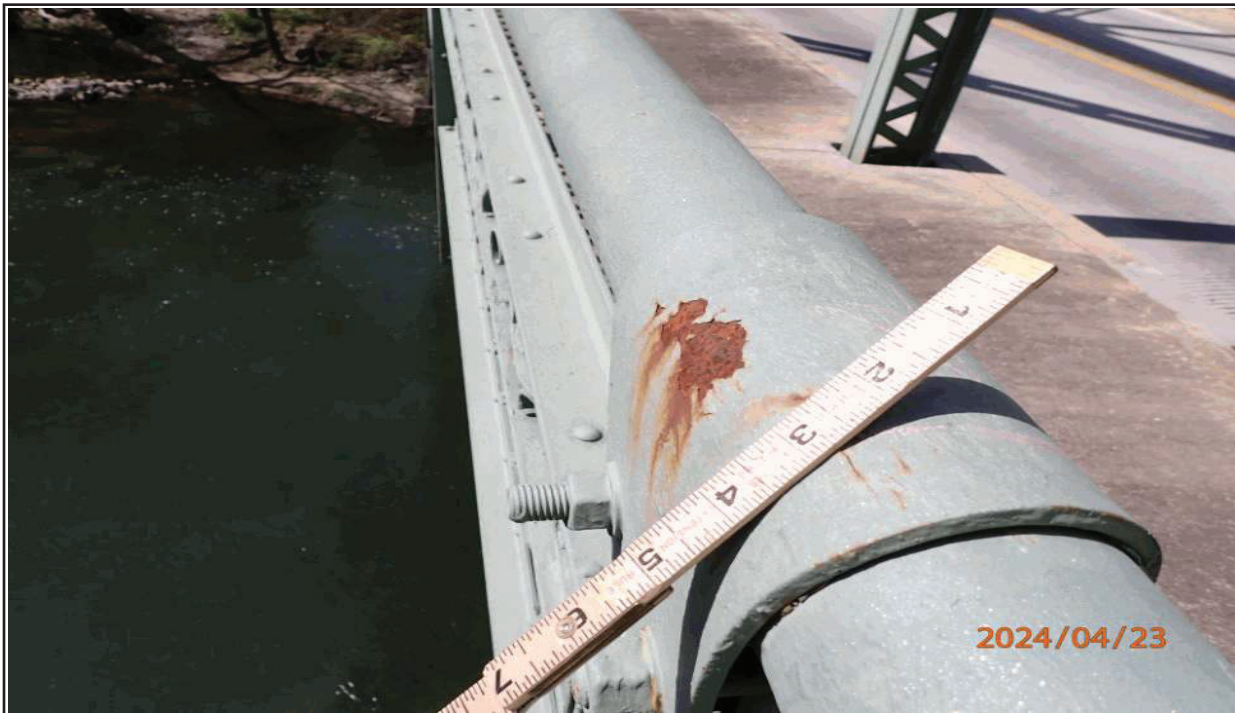
10 EAST RAILING, 2ND POST FROM NORTH END - TYPICAL ACTIVE CORROSION

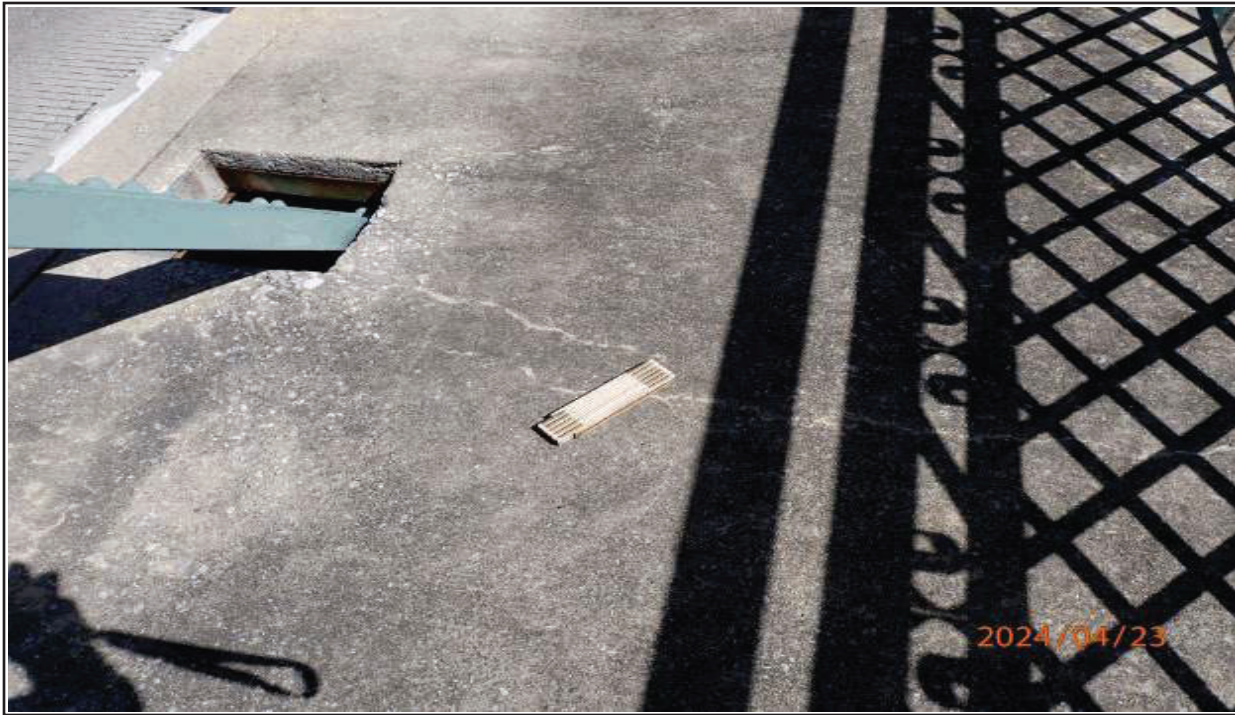
| Elm/Env | Description | Unit | Total Qty | Qty. St. 1 | Qty. St. 2 | Qty. St. 3 | Qty. St. 4 | Notes |
|---|---|---|---|---|---|---|---|---|
| 856/2 | R/C Sidewalk | (LF) | 197.00 | 156.00 | 41.00 | 0.00 | 0.00 | NOTE THAT THERE IS MINOR SCALING TYPICALLY ADJACENT TO THE TRUSS MEMBERS.<br>EFFLORESCENCE/RUST STAINING (1120):<br>CS2: (41 LF) THE SOUTHEAST APPROACH SIDEWALK EXHIBITS FULL-WIDTH HAIRLINE CRACKS WITH EFFLORESCENCE SPACED ON AVERAGE 5-FEET APART (40 LF). THE EAST SIDEWALK NEAR MIDSPAN EXHIBITS A FULL-WIDTH HAIRLINE CRACK WITH EFFLORESCENCE (1 LF) (PHOTO 11).<br><br>CRACKING (1130):<br>CS1: (13 LF) THE SIDEWALK EXHIBITS SEVERAL SEALED TRANSVERSE CRACKS WITH A FEW RE-OPENING AT RANDOM LOCATIONS THROUGHOUT. THE NORTHEAST CORNER AT THE METAL RAIL POST CONNECTION EXHIBITS A 14IN L x 1/16IN W DIAGONAL CRACK. (NC-24) |

11 EAST SIDEWALK, NEAR MIDSPAN - FULL-WIDTH HAIRLINE CRACK WITH EFFLORESCENCE

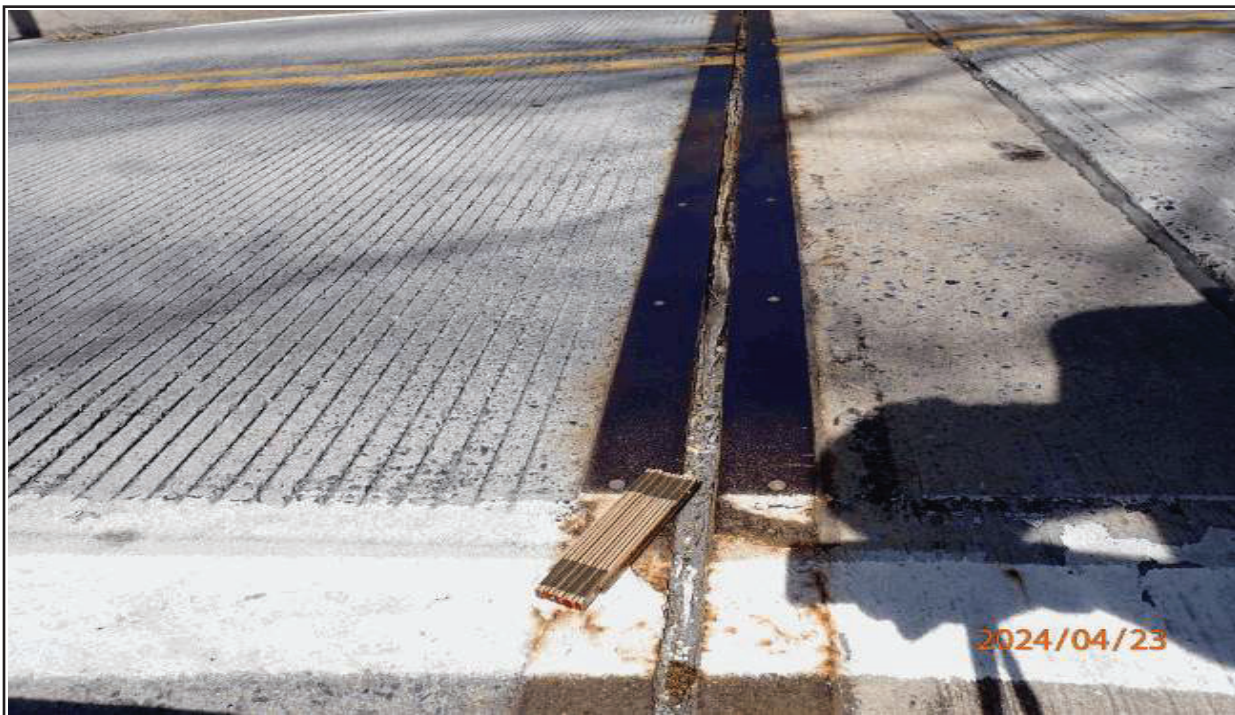
| Elm/Env | Description | Unit | Total Qty | Qty. St. 1 | Qty. St. 2 | Qty. St. 3 | Qty. St. 4 | Notes |
|---|---|---|---|---|---|---|---|---|
| 302/2 | Compressn Joint Seal | ft | 54.00 | 0.00 | 22.00 | 0.00 | 32.00 | EVIDENCE OF LEAKAGE WAS OBSERVED ON ABUTMENT SEATS (NC-24).<br><br>SEAL ADHESION (2320):<br>CS4: (32 LF) THE NORTH ABUTMENT JOINT IS FULLY DEBONDED WITH EVIDENCE OF LEAKAGE AND DEBRIS ACCUMULATION BELOW (27 LF) (PHOTO 12). THE SOUTH ABUTMENT JOINT AT WEST RAIL IS FULLY DEBONDED IN SOUTHBOUND LANE AND PULLED OUT OF ARMORING AND THERE IS A 3/8" DROP DOWN ACROSS SB LANE (5 LF).<br><br>CS2: (22 LF) THE SOUTH ABUTMENT JOINT IS DEBONDED LESS THAN 50% OF THE JOINT LENGTH, PRIMARILY ACROSS FROM SB LANE. THE JOINT IS ALSO PARTIALLY FILLED WITH DEBRIS THROUGHOUT. JOINT ARMORING EXHIBITS LIGHT TO MODERATE CORROSION IN WHEEL PATH AND SHOULDERS AT THE SOUTH ABUTMENT AND MODERATE TO HEAVY CORROSION AT THE NORTH ABUTMENT. |

12 NORTH COMPRESSION JOINT SEAL - FULLY DEBONDED & FILLED WITH DEBRIS

- B005-S2K - SPOT PAINT SUPERSTRUCTURE (1 EA)
- B009-S1H - REPAIR NORTH ABUTMENT COMPRESSION JOINT (32 LF)
- B042-B7A - REPAIR SPALLS AT THE TOP OF THE NORTH AND SOUTH CONCRETE ABUTMENTS (1 CY). REPAIR AREA OF MISSING STONES AT THE SOUTH MASONRY ABUTMENT (1 CY).
- B054-S6D - REPAIR SCURED AREA BELOW NORTH ABUTMENT (2 CY).
- B055-V1A - CUT BACK VEGETATION BLOCKING THE SOUTH APPROACH VERTICAL CLEARANCE AND LOAD POSTING SIGNAGE (1 CY).

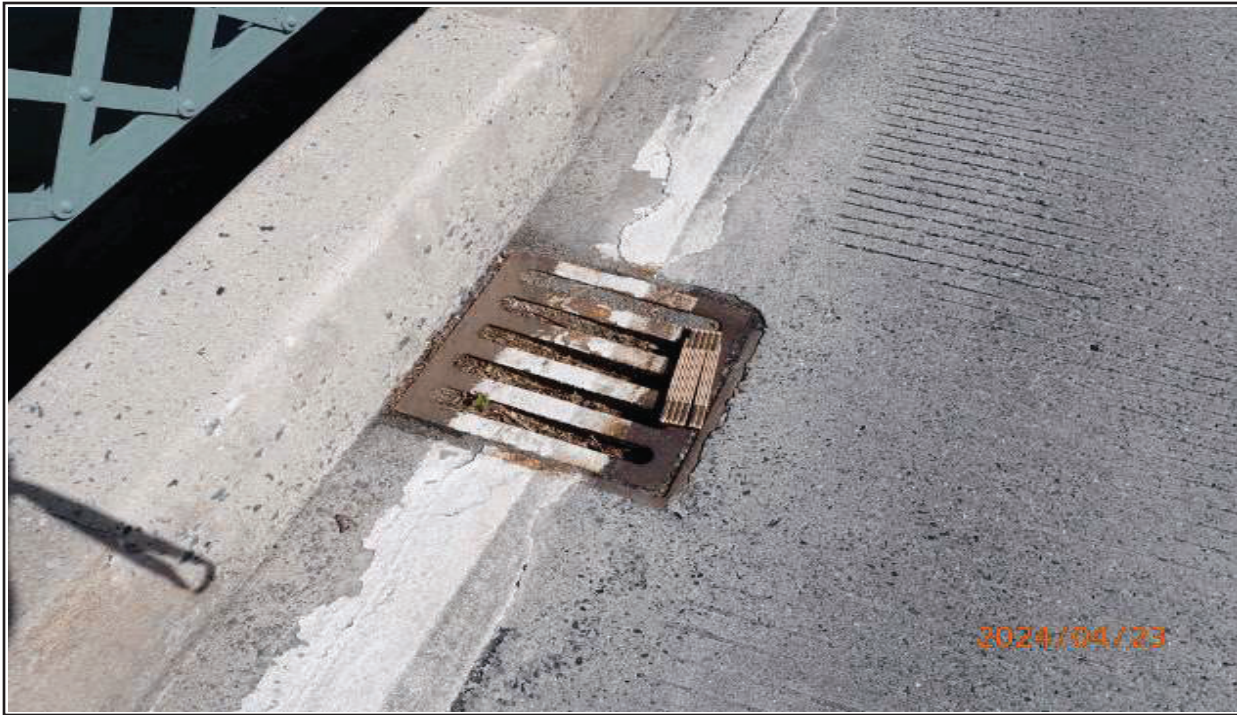
| Elm/Env | Description | Unit | Total Qty | Qty. St. 1 | Qty. St. 2 | Qty. St. 3 | Qty. St. 4 | Notes |
|---|---|---|---|---|---|---|---|---|
| 865/2 | Drainage | (EA) | 14.00 | 0.00 | 7.00 | 7.00 | 0.00 | NOTE: THERE ARE TWO (2) DRAINS IN THE NORTH APPROACH SLAB AND FOUR (4) ON THE SOUTH APPROACH SLAB THAT ARE CLEAR. THE QUANTITY SHOWN REPRESENTS THE DRAINS ON THE TRUSS ONLY.<br><br>CORROSION (1000):<br>CS3: (1 EA) THE EAST DRAIN OUTLET BETWEEN FLOORBEAM 1 AND FLOORBEAM 2 EXHIBITS CORROSION WITH UP TO 1/16IN SECTION LOSS (PHOTO 14).<br><br>DRAINAGE EFFECTIVENESS (9000):<br>CS3: (6 EA) THE WEST SIDE (SB) EXHIBITS SIX (6) DRAINS THAT ARE COMPLETELY CLOGGED WITH DEBRIS IN BOTH THE PAN AND DOWNSPOUT (PHOTO 13).<br><br>CS2: (7 EA) THE REMAINDER OF THE DRAINAGE PANS AND GRATES ARE PARTIALLY FILLED WITH DEBRIS, HOWEVER THE DOWNSPOUTS ARE CLEAR. |

13 SOUTHWESTMOST DRAIN - TYPICAL CLOGGED SOUTH DRAIN

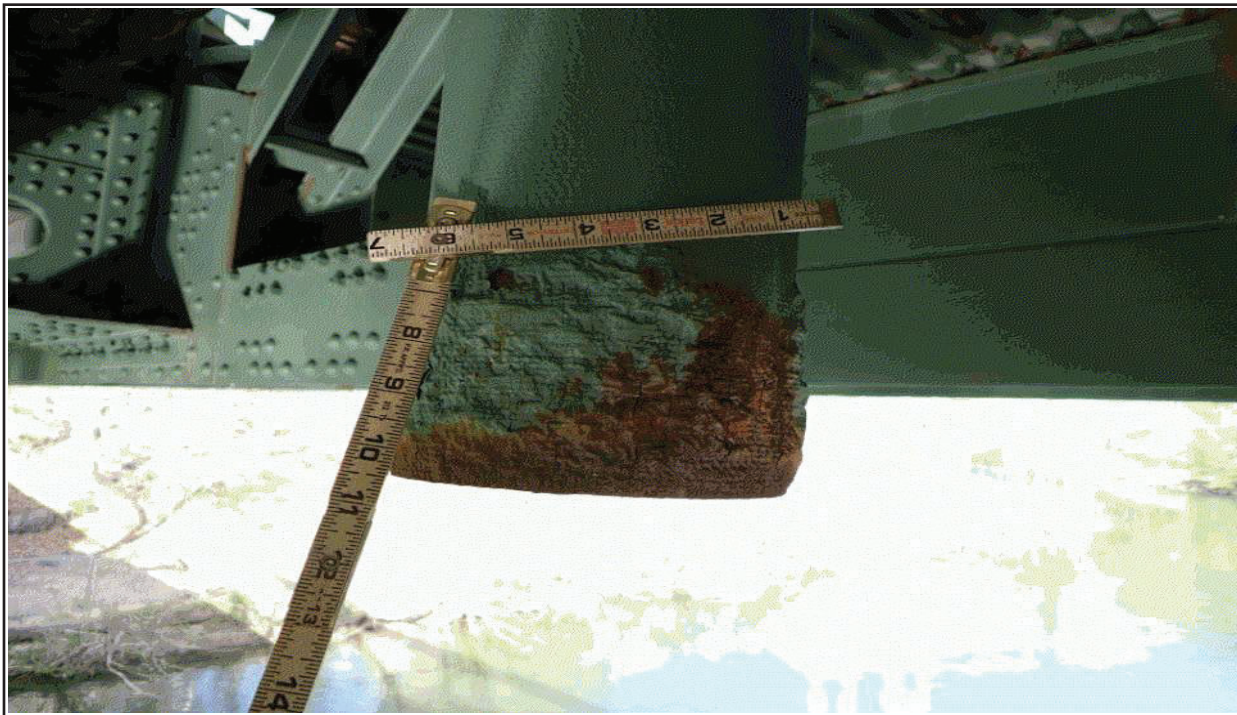
14 EAST DRAIN OUTLET, BETWEEN FLOORBEAM 1 & 2 - CORROSION WITH SECTION LOSS

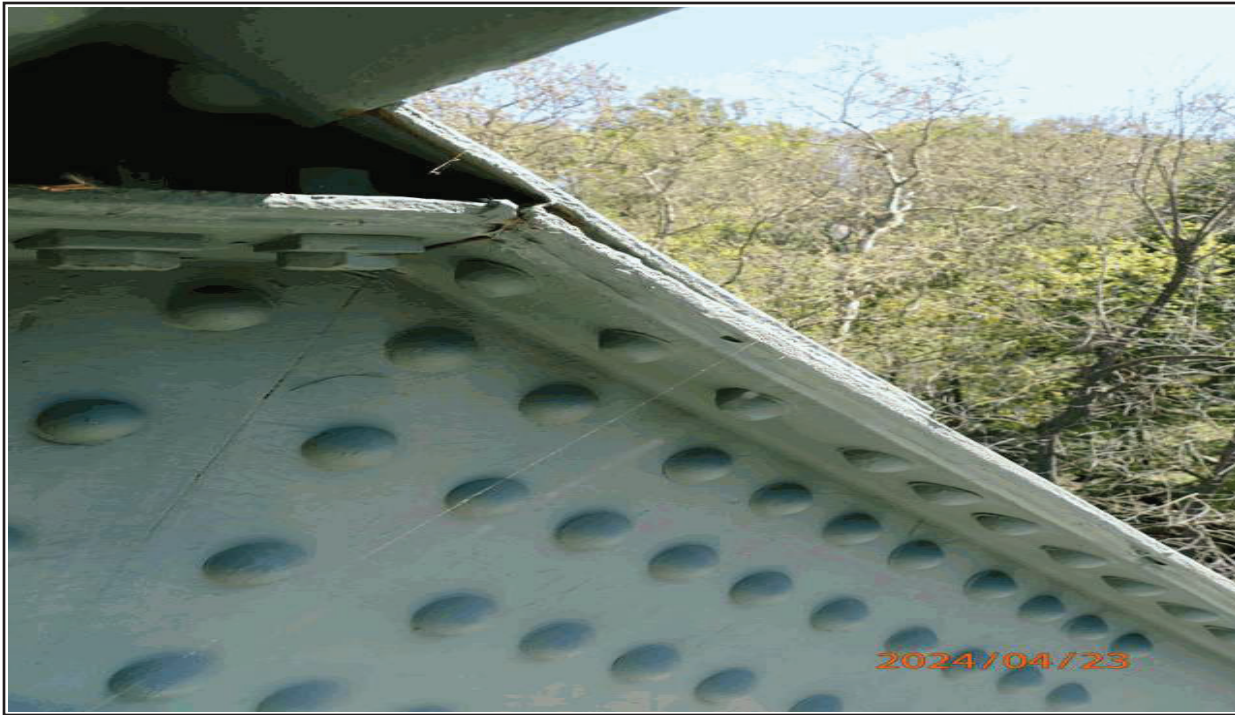
| Elm/Env | Description | Unit | Total Qty | Qty. St. 1 | Qty. St. 2 | Qty. St. 3 | Qty. St. 4 | Notes |
|---|---|---|---|---|---|---|---|---|
| 120/4 | Steel Truss | ft | 247.00 | 123.00 | 62.00 | 62.00 | 0.00 | CORROSION (1000):<br>CS3: (62 LF) SEE ATTACHED TABLE FOR DEFECTS AND QUANTITIES (PHOTOS 15-22).<br><br>CS2: (62 LF) SEE ATTACHED TABLE FOR DEFECTS AND QUANTITIES.<br><br>DAMAGE (7000):<br>CS3: (1 LF) ELEMENT HAS IMPACT DAMAGE CAPTURED UNDER CORROSION DEFECT ABOVE. |

| MEMBER/<br>CONNECTION | LOCATION | DEFECT | REMARKS |
|---|---|---|---|
| | | 1-1/2"H x 6"L x up to 3/16"D section loss on underside of upper connection plate to U1E at west edge with adjacent 1/4" thick pack rust (Photo 15). | Painted over (CS3) (NC-24) |

15 SOUTH PORTAL, CONNECTION PLATE TO U1E, WEST EDGE - PAINTED OVER SECTION LOSS & PACK RUST

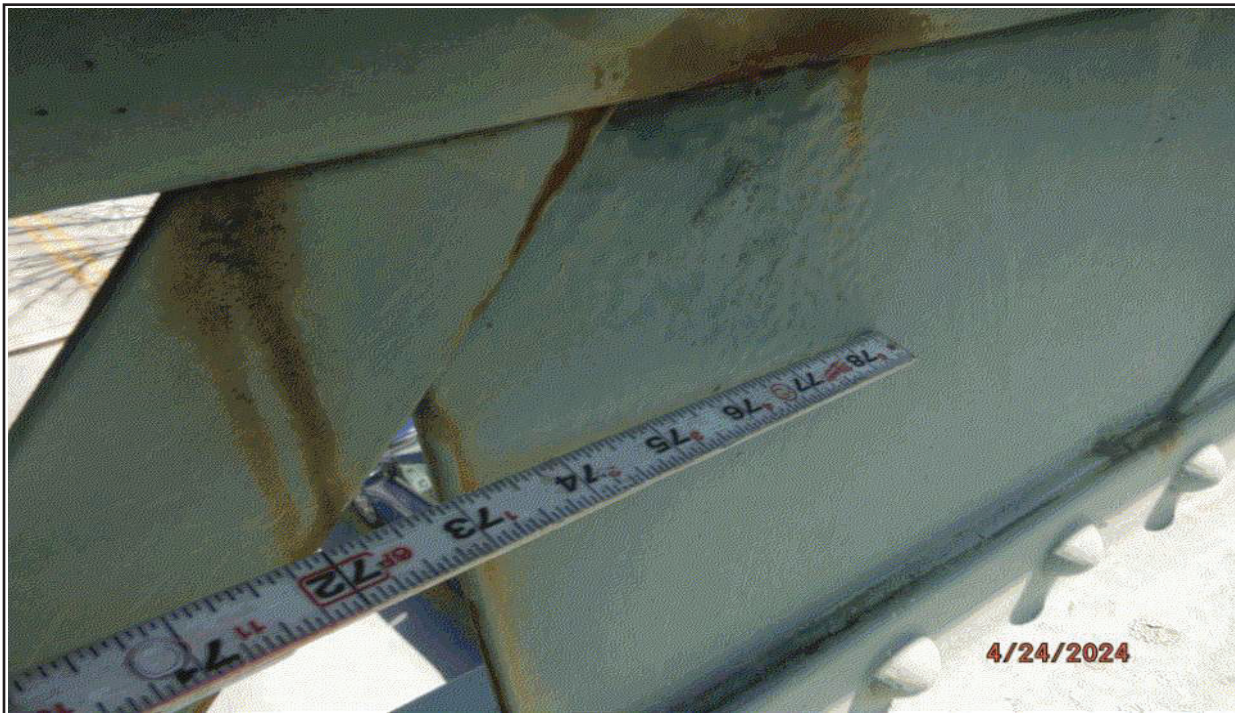
16 BATTEN PLATES ADJACENT TO U4W & U4E, NORTH FACE - AREAS OF PITTING

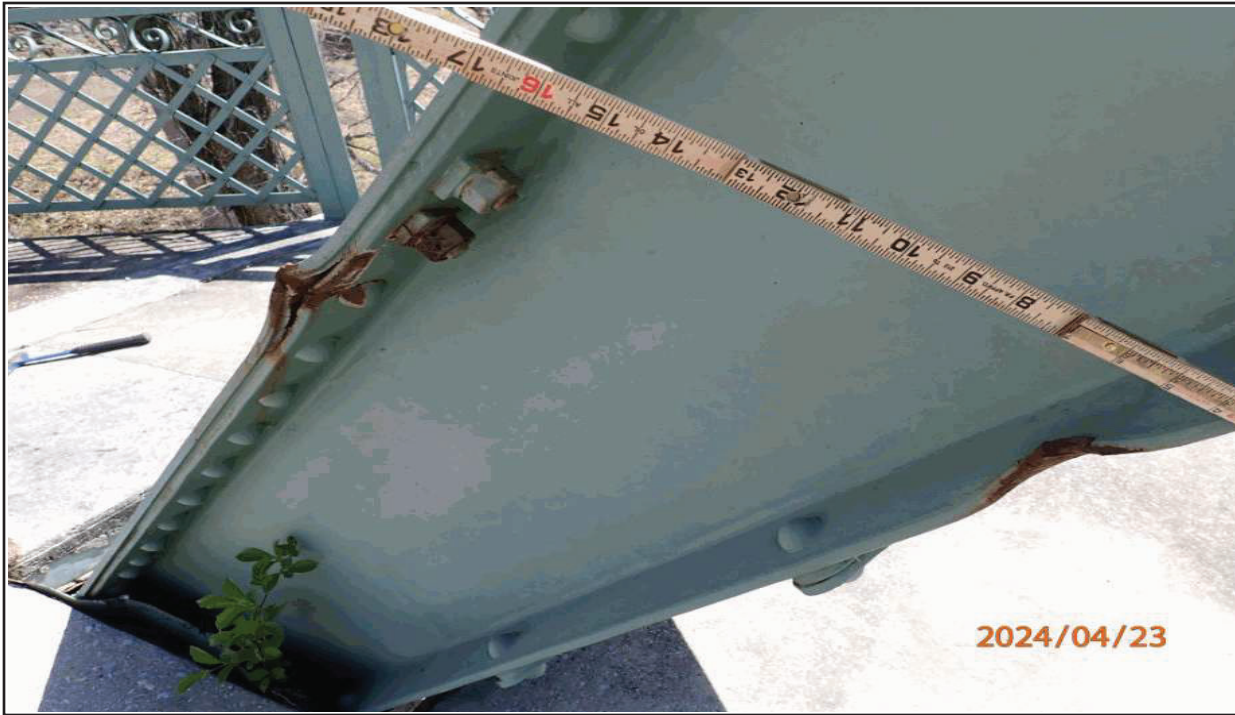
17 EAST CHORD, U5-L6, NORTHEAST CORNER - IMPACT DAMAGE WITH CORROSION

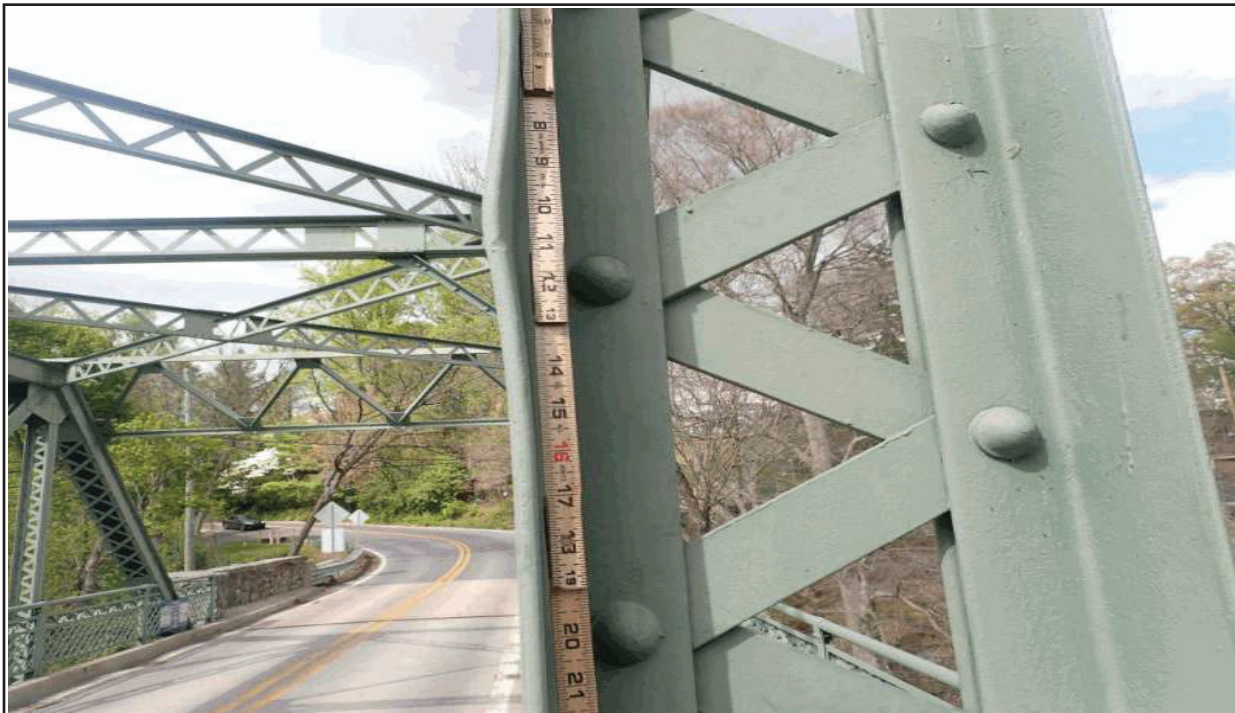
18 EAST CHORD, L3-U3, SW ANGLE, MID-HEIGHT - DEFORMATION IN FLANGE

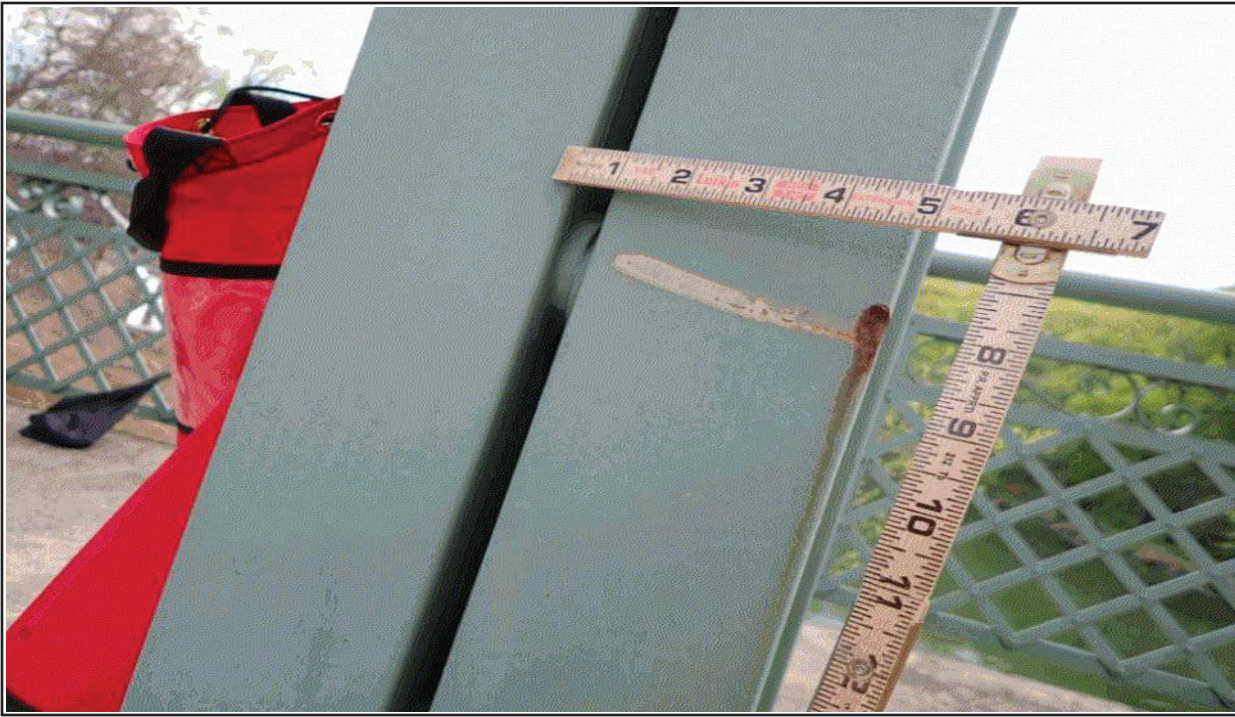
19 EAST CHORD, L4-U4, SW ANGLE, 2'-6" ABOVE SIDEWALK - PAINT SCRAPE AND GOUGE WITH CORROSION

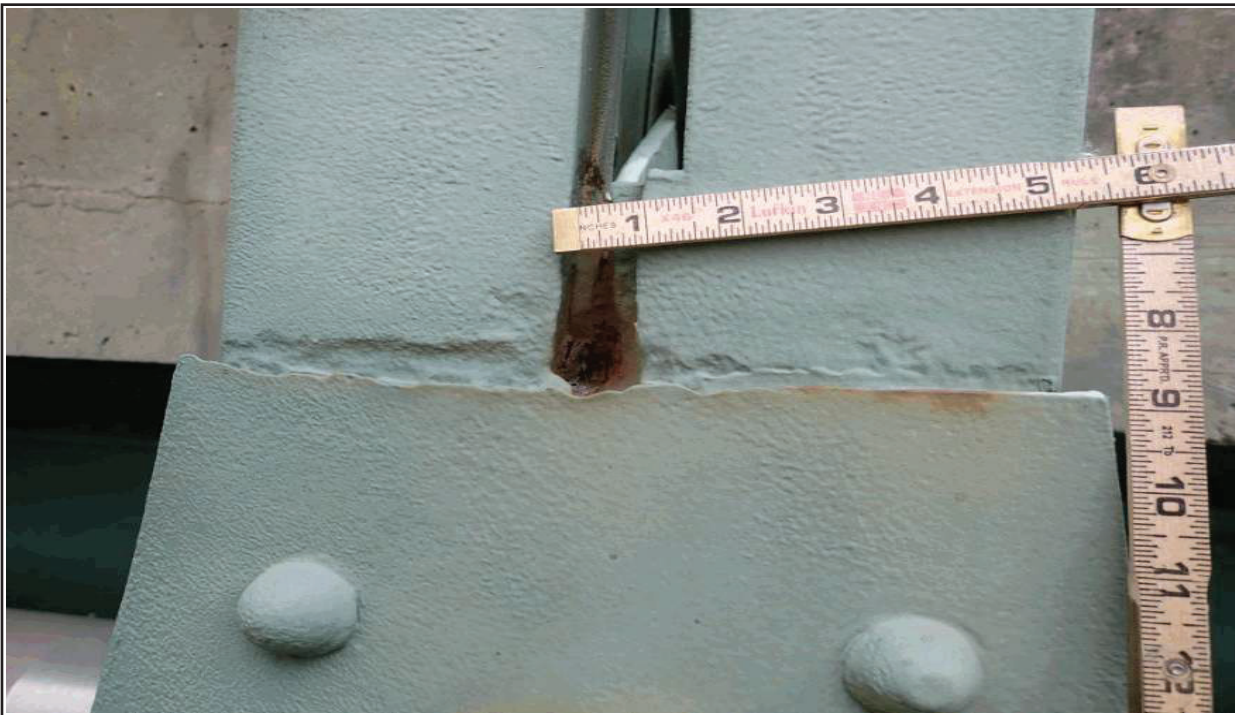
20 WEST TRUSS, L5-U5, EXTERIOR FACE OF OUTBOARD ANGLE @ L5 CONNECTION - PAINTED OVER SECTION LOSS

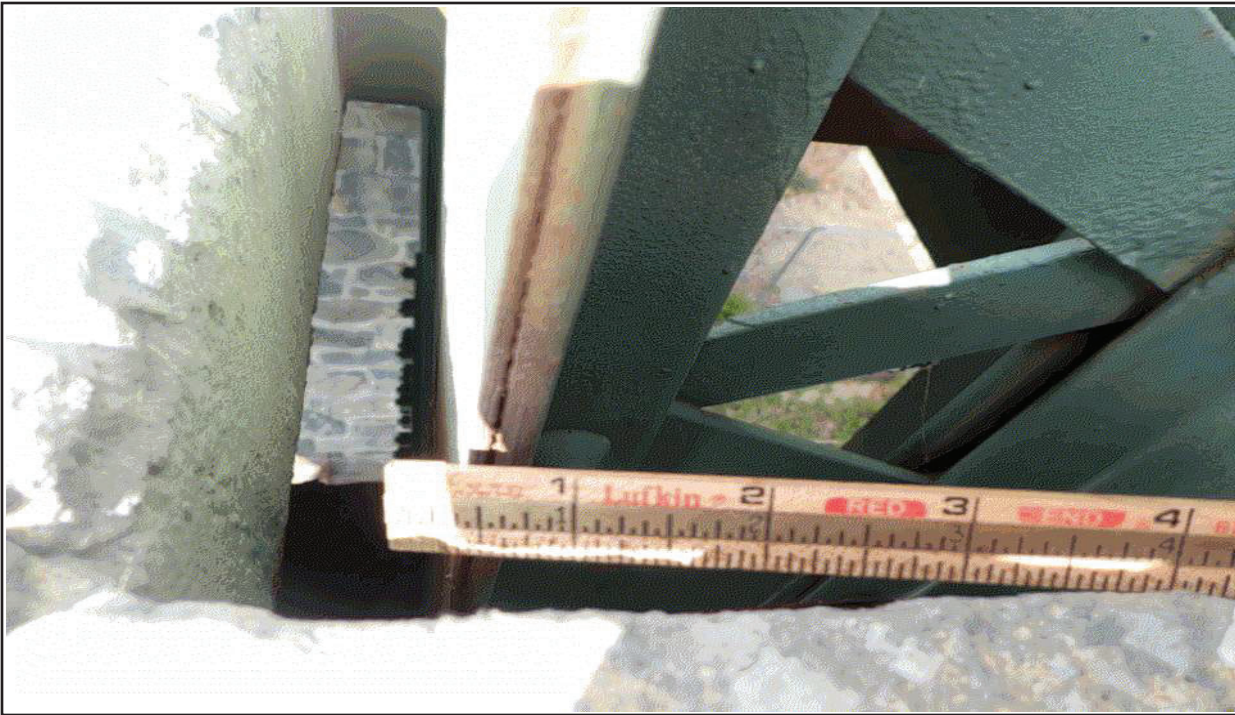
21 EAST TRUSS, L5-U5, SOUTHWEST ANGLE EDGE - PACK RUST CAUSING SEPARATION

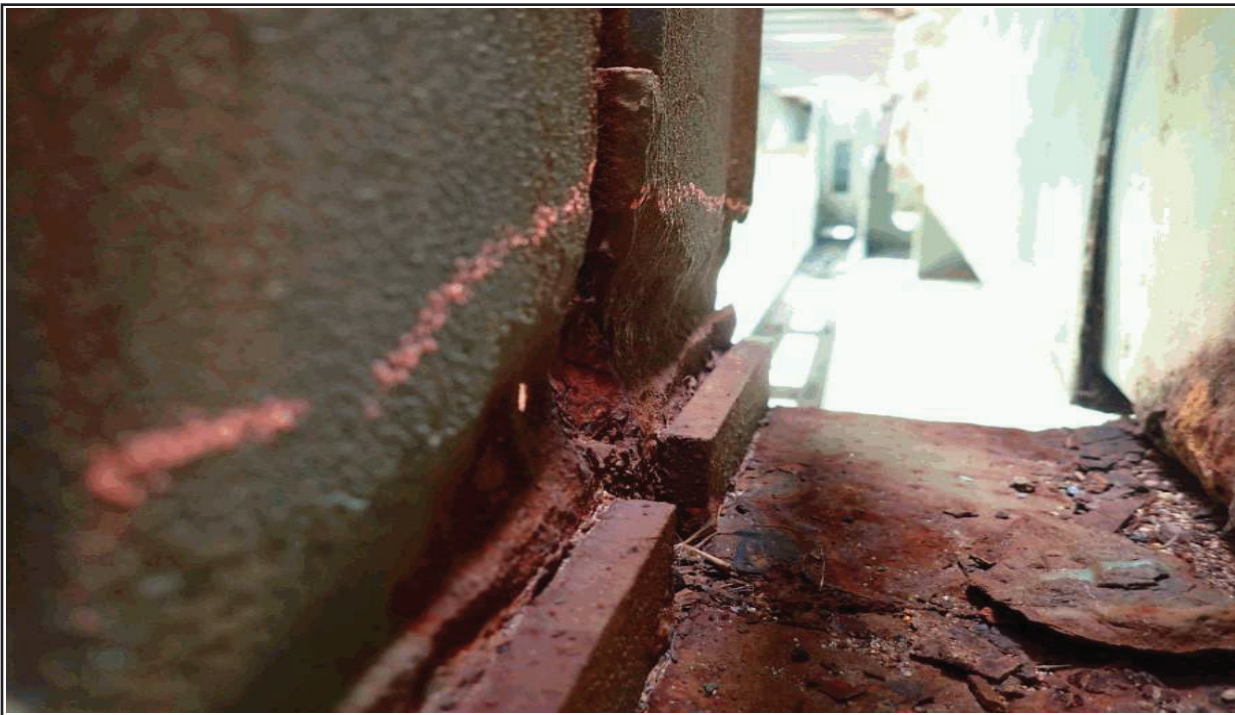
22 EAST TRUSS, L5-U5 INBOARD ANGLE LEGS ABOVE L5, WEST FACE - SECTION LOSS WITH ACTIVE CORROSION

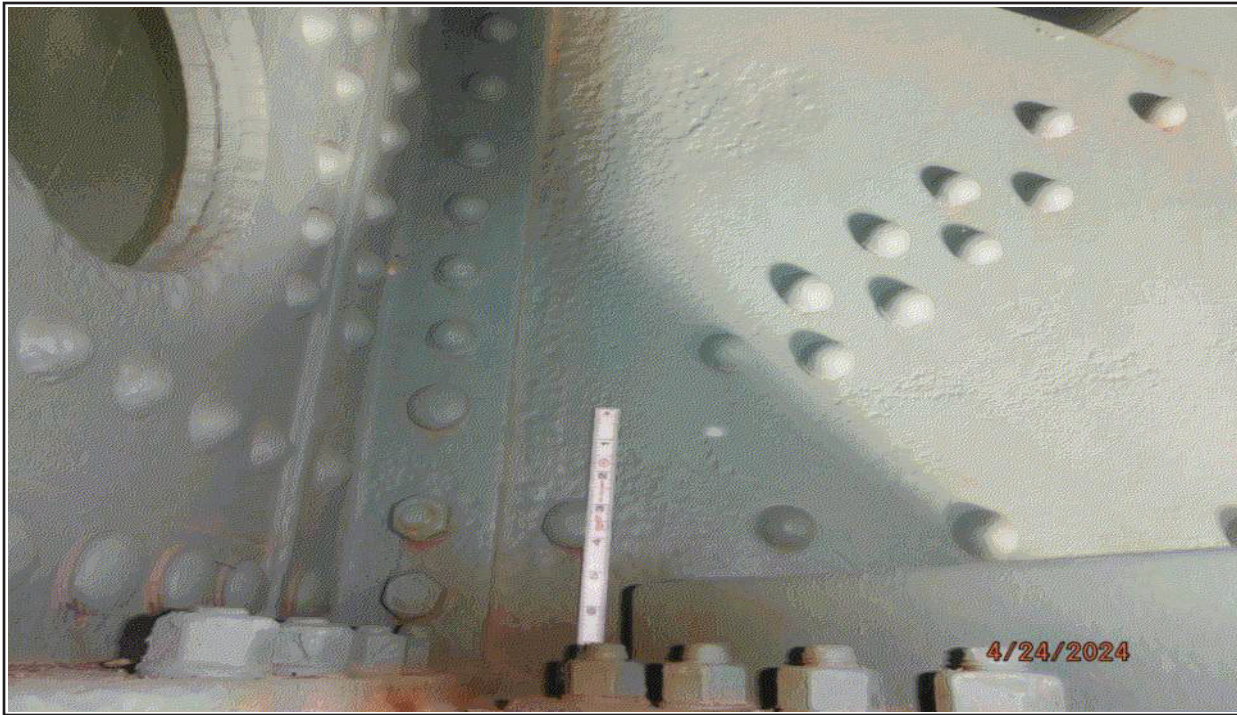
| Elm/Env | Description | Unit | Total Qty | Qty. St. 1 | Qty. St. 2 | Qty. St. 3 | Qty. St. 4 | Notes |
|---|---|---|---|---|---|---|---|---|
| 162/4 | Stl Gus Plate | each | 24.00 | 2.00 | 1.00 | 21.00 | 0.00 | CORROSION (1000):<br>CS3: (21 EA) SEE ATTACHED TABLE FOR DEFECTS AND QUANTITIES. (PHOTOS 23-25)<br><br>CS2: (1 EA) SEE ATTACHED TABLE FOR DEFECTS AND QUANTITIES. |

23 EAST TRUSS, L3 INBOARD GUSSET PLATE - MODERATE PITTING
