Bridge No: 1001 279  
 Date of Inspection: 04/23/2024  
 Load Rating Date: 03/25/2020

6) Feature Intersected: BRANDYWINE CREEK

7) Facility Carried: RISING SUN LANE

43 A & B) Main Span Mtrl/Design: 3 Steel 10 Truss-Thru

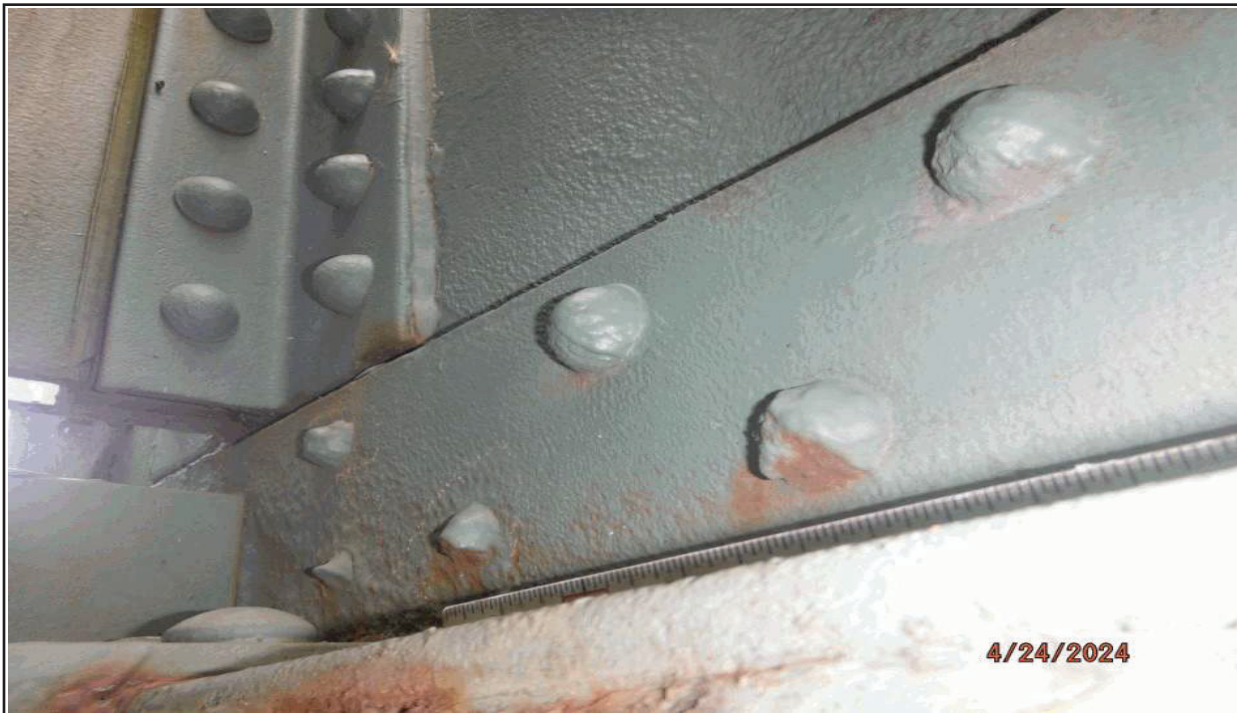
| Elm/Env | Description | Unit | Total Qty | Qty. St. 1 | Qty. St. 2 | Qty. St. 3 | Qty. St. 4 | Notes |
|---|---|---|---|---|---|---|---|---|
| 162/4 | Stl Gus Plate | each | 24.00 | 2.00 | 1.00 | 21.00 | 0.00 | CORROSION (1000):<br>CS3: (21 EA) SEE ATTACHED TABLE FOR DEFECTS AND QUANTITIES. (PHOTOS 23-25)<br><br>CS2: (1 EA) SEE ATTACHED TABLE FOR DEFECTS AND QUANTITIES. |

24 WEST TRUSS, L4 OUTBOARD GUSSET, INTERIOR CONNECTION - RIVET HEADS WITH SECTION LOSS

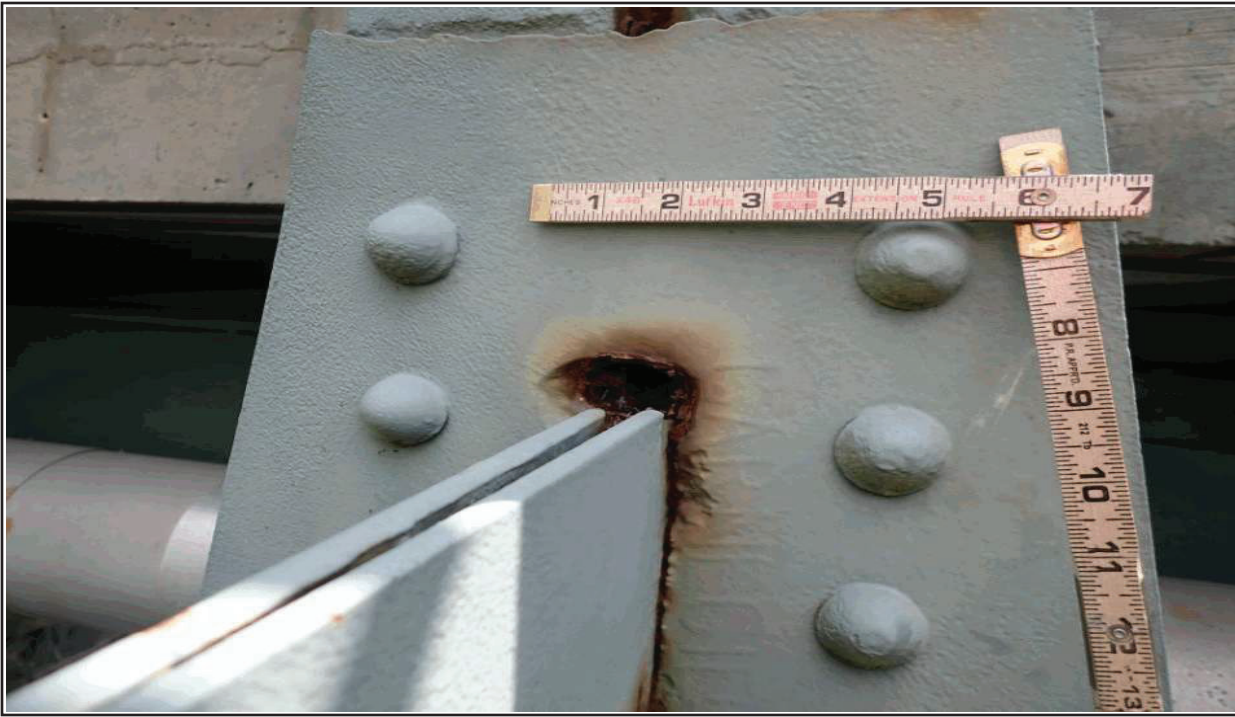
25 WEST TRUSS, L5 OUTBOARD GUSSET PLATE AND STRAPPING PLATE CONNECTION - SECTION LOSS

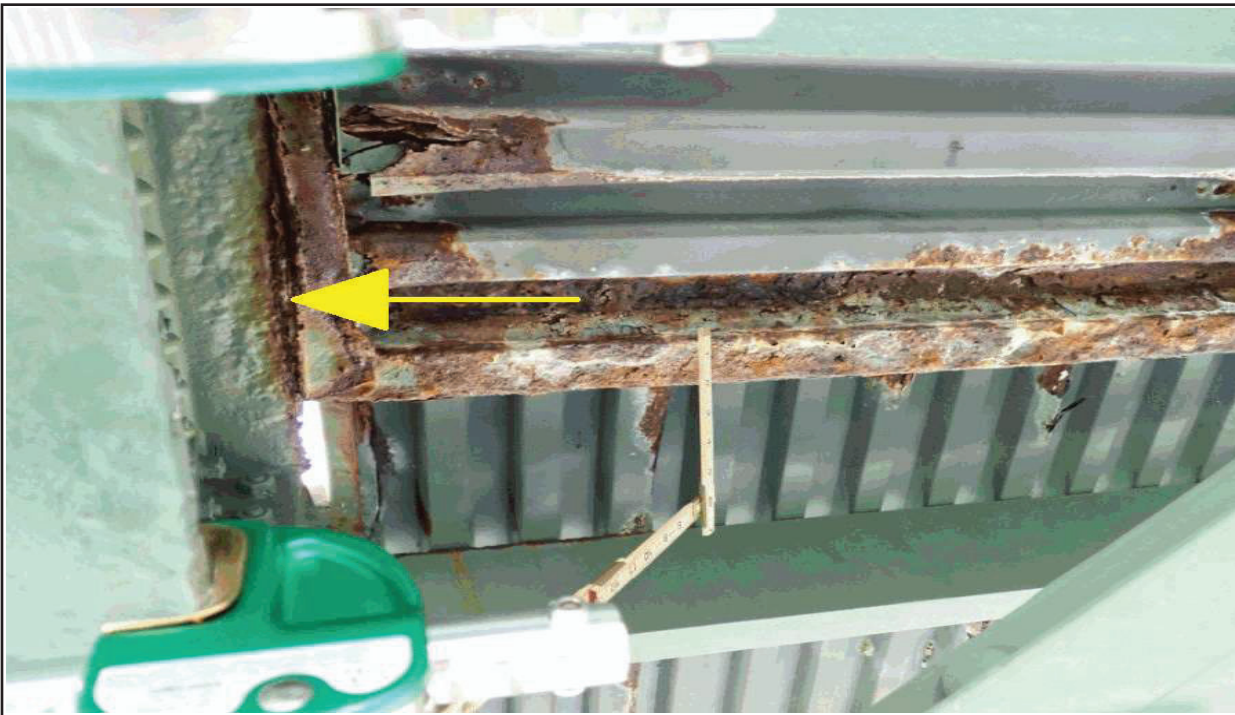
| Elm/Env | Description | Unit | Total Qty | Qty. St. 1 | Qty. St. 2 | Qty. St. 3 | Qty. St. 4 | Notes |
|---|---|---|---|---|---|---|---|---|
| 152/3 | Steel Floor Beam | ft | 196.00 | 101.00 | 8.00 | 87.00 | 0.00 | CORROSION (1000):<br>CS3: (87 LF) SEE ATTACHED TABLE FOR DEFECTS AND QUANTITIES (PHOTOS 26-28).<br><br>CS2: (8 LF) SEE ATTACHED TABLE FOR DEFECTS AND QUANTITIES. |

26 FLOORBEAM 1, EAST SIDE, UNDERSIDE OF TOP FLANGE - SECTION LOSS

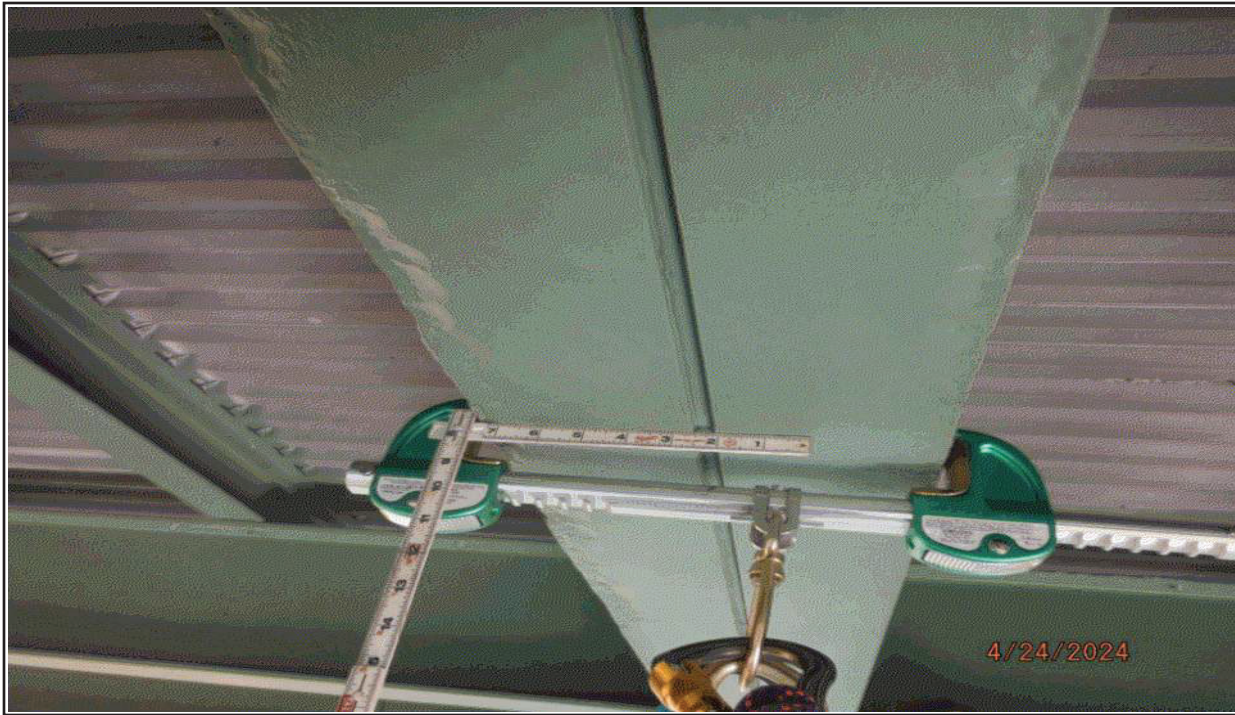
27 FLOORBEAM 3, WEST END, NORTH AND SOUTH BOTTOM FLANGE ANGLES - SECTION LOSS

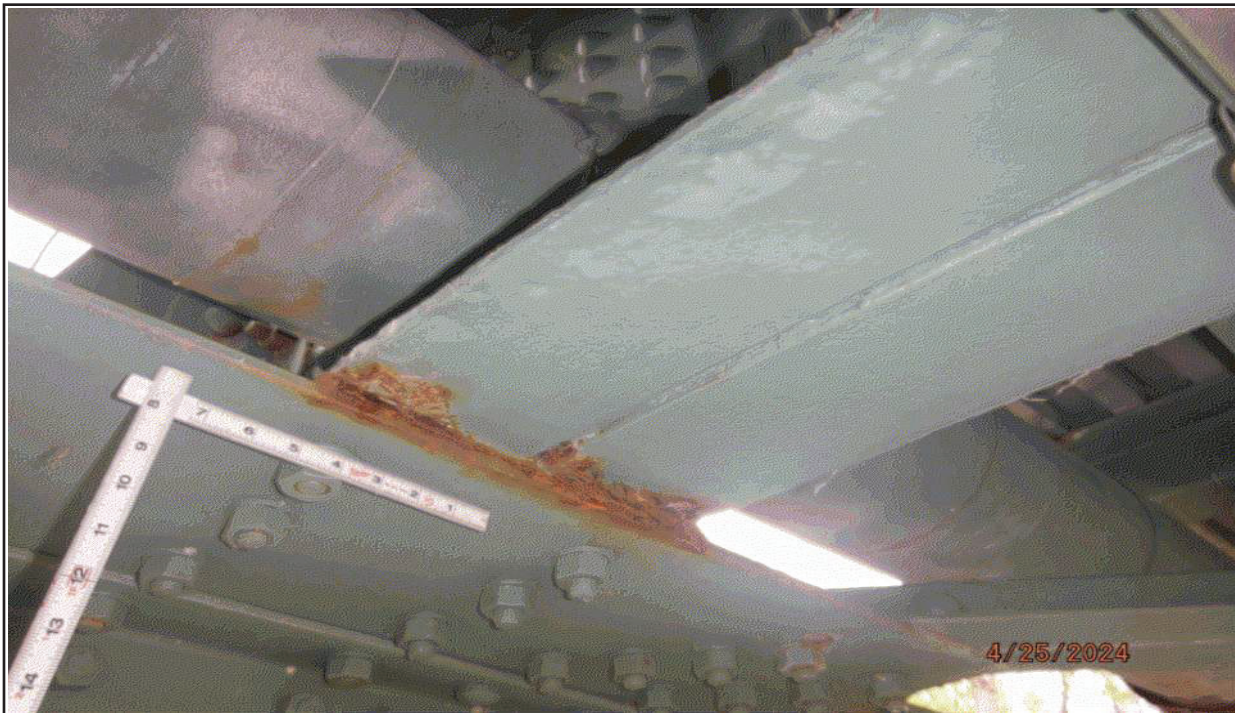
28 FLOORBEAM 5, WEST END, CONNECTION TO LATERAL GUSSET PLATE - SECTION LOSS WITH ACTIVE CORROSION

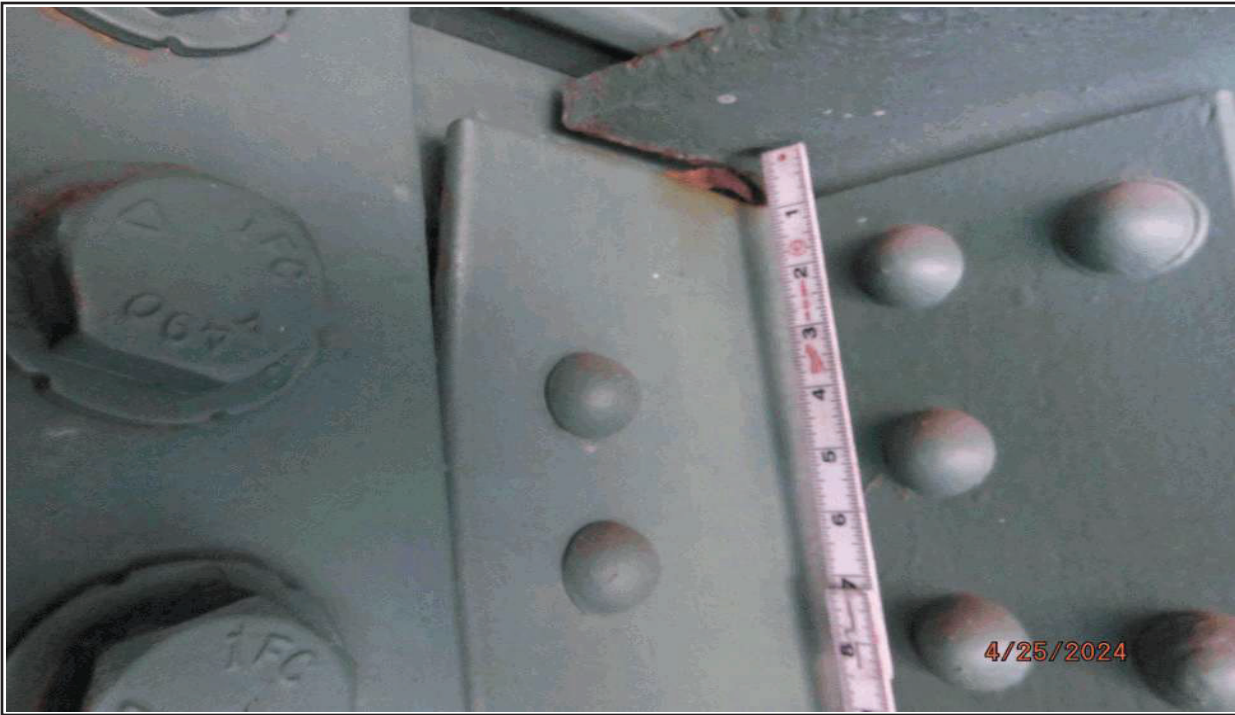
| Elm/Env | Description | Unit | Total Qty | Qty. St. 1 | Qty. St. 2 | Qty. St. 3 | Qty. St. 4 | Notes |
|---|---|---|---|---|---|---|---|---|
| 113/2 | Steel Stringer | ft | 941.00 | 870.00 | 0.00 | 71.00 | 0.00 | NOTE: THE TRANSVERSE DECK SUPPORTS ARE INCLUDED IN THE STRINGER QUANTITY.<br><br>CORROSION (1000):<br>CS3: (71 LF) SEE ATTACHED TABLE FOR DEFECTS AND QUANTITIES (PHOTOS 29-31). |

29 PANEL 1, STRINGER 1, WEST CONNECTION ANGLE TO FLOORBEAM 0 - ANGLE NOT FLUSH

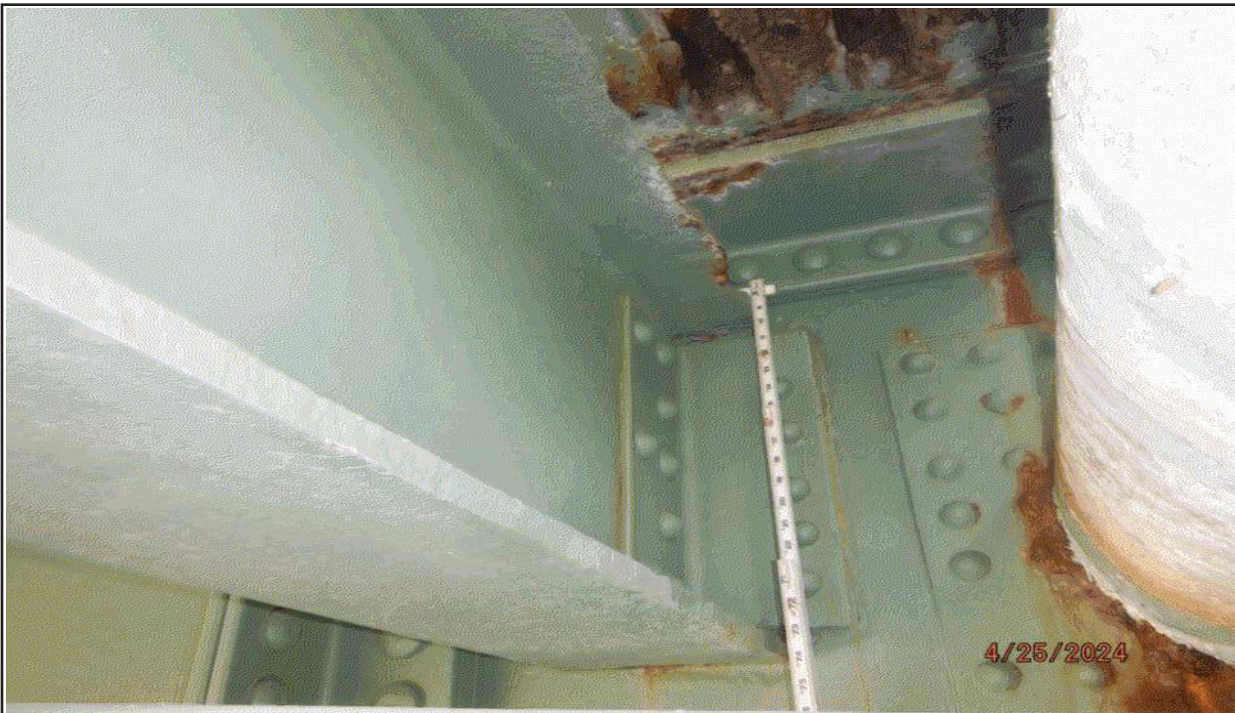
30 PANEL 1, STRINGER 1, EAST TOP FLANGE NEAR FLOORBEAM 1 CONNECTION - KNIFE EDGING AND PAINTED OVER PITTING

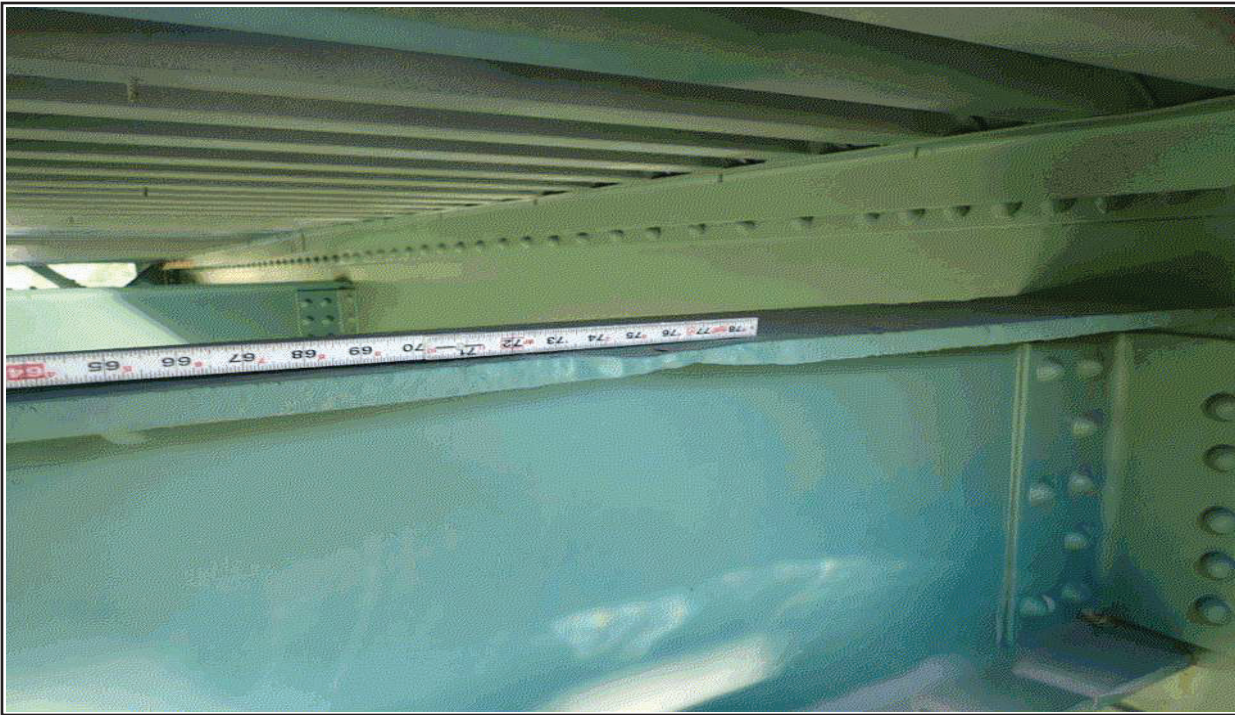
31 PANEL 3, STRINGER 1, WEST TOP FLANGE NEAR FLOORBEAM 2 - SECTION LOSS

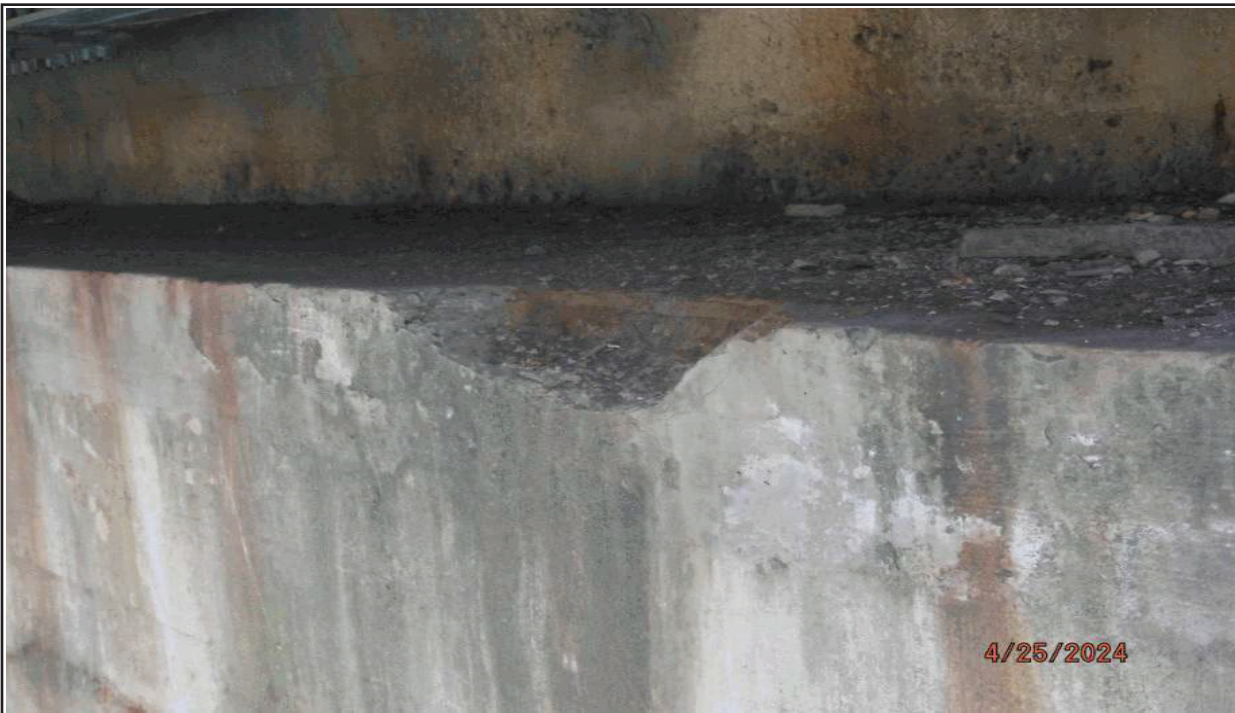
| Elm/Env | Description | Unit | Total Qty | Qty. St. 1 | Qty. St. 2 | Qty. St. 3 | Qty. St. 4 | Notes |
|---|---|---|---|---|---|---|---|---|
| 215/2 | Re Conc Abutment | ft | 56.00 | 29.00 | 0.00 | 27.00 | 0.00 | NOTE: THIS ELEMENT INCLUDES THE REINFORCED CONCRETE ABUTMENT BEARING SEATS.<br><br>SPALL/DELAM (1080):<br>CS3: (19 LF) THE SOUTH ABUTMENT BEARING SEAT EXHIBITS AN 18IN L X 4IN W X 1 1/2IN D SPALL BELOW STRINGER 1 ON THE NORTH FACE (2 LF) (PHOTO 32). THE NORTH ABUTMENT BEAM SEAT UNDERNEATH STRINGER 1, PANEL 6 AND STRINGER 2, PANEL 6 EXHIBITS A 12FT L x 10IN H x 3IN D SPALL WITH AN EXPOSED METAL PLATE (12 LF). THE NORTH ABUTMENT AT THE EAST END OF THE SEAT EXHIBITS A 43IN L x 9IN H x 3IN D CORNER SPALL WITH AN EXPOSED METAL PLATE AND A 12IN H x 10IN L x 2IN D SPALL JUST BELOW (4 LF). THE NORTH ABUTMENT JUST INBOARD OF THE WEST TRUSS EXHIBITS A 3IN L x 1FT H x 3/4IN D SPALL WITH EXPOSED CORRODED STEEL REINFORCEMENT (1 LF).<br><br>EFFLORESCENCE/RUST STAINING (1120):<br>CS3: (8 LF) THE SOUTH ABUTMENT BREASTWALL BETWEEN STRINGERS 2 AND 3 EXHIBITS A HAIRLINE CRACK WITH RUST STAINS (1 LF) AND THE BACKWALL BEHIND THE WEST CHORD EXHIBITS A HAIRLINE CRACK WITH RUST STAINS (1 LF). THE NORTH ABUTMENT BACKWALL EXHIBITS FIVE (5) VERTICAL / DIAGONAL CRACKS WITH RUST STAINING AND EFFLORESCENCE (6 LF). |

32 SOUTH CONCRETE ABUTMENT, BELOW STRINGER 1 - EDGE SPALL

- B005-S2K - SPOT PAINT SUPERSTRUCTURE (1 EA)
- B009-S1H - REPAIR NORTH ABUTMENT COMPRESSION JOINT (32 LF)
- B042-B7A - REPAIR SPALLS AT THE TOP OF THE NORTH AND SOUTH CONCRETE ABUTMENTS (1 CY). REPAIR AREA OF MISSING STONES AT THE SOUTH MASONRY ABUTMENT (1 CY).
- B054-S6D - REPAIR SCURED AREA BELOW NORTH ABUTMENT (2 CY).
- B055-V1A - CUT BACK VEGETATION BLOCKING THE SOUTH APPROACH VERTICAL CLEARANCE AND LOAD POSTING SIGNAGE (1 CY).

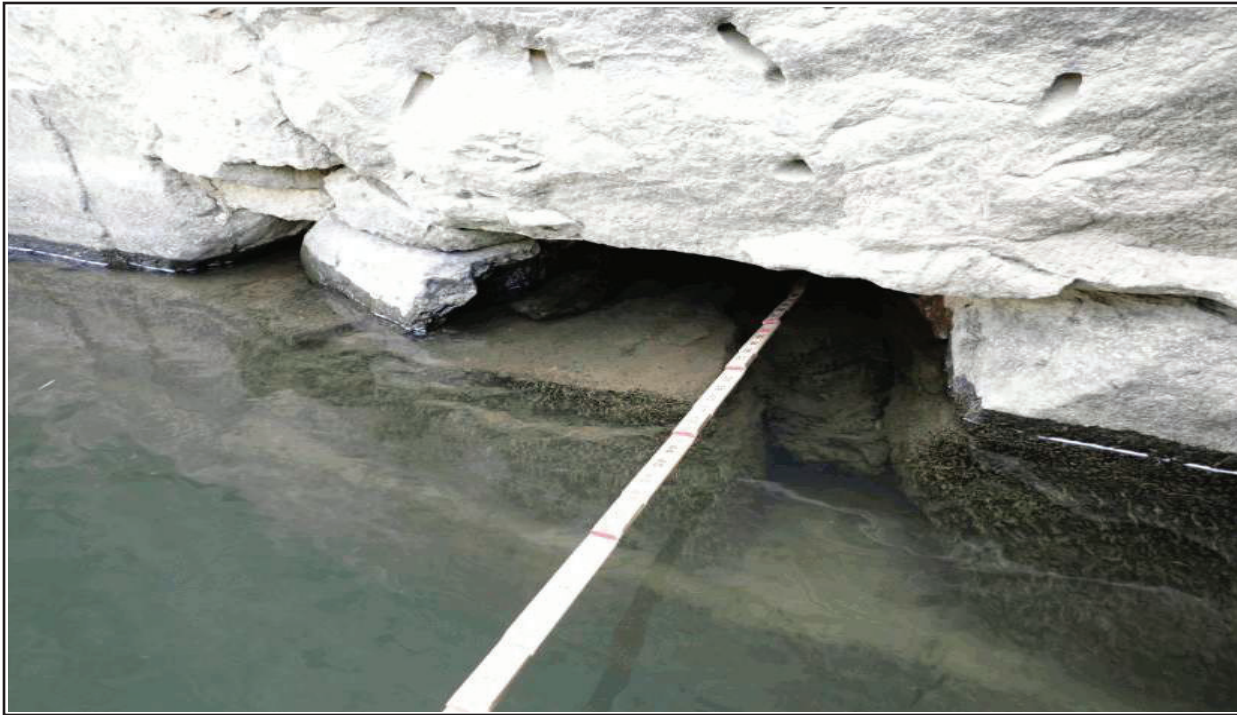
| Elm/Env | Description | Unit | Total Qty | Qty. St. 1 | Qty. St. 2 | Qty. St. 3 | Qty. St. 4 | Notes |
|---|---|---|---|---|---|---|---|---|
| 217/2 | Masonry Abutment | ft | 65.00 | 24.00 | 17.00 | 24.00 | 0.00 | <p>NOTE: THE SCOUR DEFECT QUANTITY IS INCLUDED WITH THE MASONRY DISPLACEMENT QUANTITY, AS THERE IS NO UNDERMINING OF THE ABUTMENT STEM AND THE CONDITION STATE IS GOVERNED BY THE MISSING STONES. DEFECT NOTES ARE PROVIDED FOR INFORMATION. UTILITY PIPE STRAPS AT THE NORTH ABUTMENT EXHIBIT UP TO 20% SECTION LOSS TO THE OLD STRAPS AND UP TO 75% SECTION LOSS ON THE NEW STRAPS.</p> <p>MASONRY DISPLACEMENT (1640):<br/>CS3: (24 LF)<br/>SOUTH ABUTMENT:<br/>- NEAR THE WEST END ALONG THE WATERLINE THE ABUTMENT STEM EXHIBITS A 2FT L x 1FT H x UP TO 3FT D AREA OF MISSING STONES (2 LF) (PHOTO 33).<br/>- APRON EXHIBITS A 10FT L x 1FT-8IN W x 1FT-6IN D AREA OF MISSING STONES ON THE NORTH FACE AT THE WEST BOTTOM CORNER THAT EXTENDS 2FT-6IN L x 1FT-8IN W x 1FT-6IN D ONTO THE WEST FACE (10 LF).<br/>- PREVIOUSLY NOTED MISSING STONES AT THE TOP OF THE ABUTMENT ON THE NORTH AND WEST FACES HAVE BEEN PATCHED, BUT THE PATCH HAS FAILED WITH A 61IN x 10IN H x 7IN D SPALL WITH VEGETATION GROWING IN MISSING STONES (6 LF).</p> <p>NORTH ABUTMENT:<br/>- NORTHEAST THRUST BLOCK AT ABUTMENT BASE EXHIBITS A FL x 15IN H x 18IN D VOID IN THE REPOINTED SECTION (NOT PART OF ORIGINAL STRUCTURE) (5 LF) (PHOTO 34). (NC-24)<br/>- APRON AT THE WEST END EXHIBITS A 7FT L x 1.5FT H VOID WITH UNDERMINING OF THE APRON BY UP TO 2-FEET; HOWEVER, THE ABUTMENT IS NOT UNDERMINED (1 LF) (SEE SCOUR DEFECT FOR ADDITIONAL NOTES).</p> <p>MORTAR BREAKDOWN (1610):<br/>CS2: (11 LF) THERE ARE RANDOM HAIRLINE VERTICAL AND HORIZONTAL CRACKS IN STONES AND IN MORTAR JOINTS WITH AND WITHOUT EFFLORESCENCE, MOSTLY ALONG THE BOTTOM OF THE STEM OF BOTH ABUTMENTS (APPROXIMATELY 25% OF THE LENGTH). SOUTH ABUTMENT, 5-FEET ABOVE THE APRON EXHIBITS A 4IN H x 2IN W VOID IN THE GROUT WITH UP TO 13-INCHES OF PENETRATION.<br/>(NC-24)</p> <p>SPLIT / SPALL (1630):<br/>CS2: (6 LF) THERE ARE RANDOM HAIRLINE VERTICAL AND HORIZONTAL CRACKS IN STONES, MOSTLY ALONG THE BOTTOM OF THE STEM, WITH NO SHIFTING OF THE STONES.<br/>(NC-24)</p> <p>SCOUR (6000):<br/>CS2: (QUANTITY COVERED IN MASONRY DISPLACEMENT) THE NORTH ABUTMENT BOTTOM APRON AT THE WEST END EXHIBITS A 7FT L x 1.5FT H VOID THAT IS UNDERMINING THE APRON BY 2-FEET. THE VOID WRAPS AROUND THE WEST FACE BY 3FT L x 1FT-6IN H. THE APRON IS 2.5FT WIDE, THEREFORE ONLY THE APRON IS UNDERMINED.<br/>(NC-24)</p> |

33 SOUTH MASONRY ABUTMENT, NEAR WEST END - AREA OF MISSING STONES

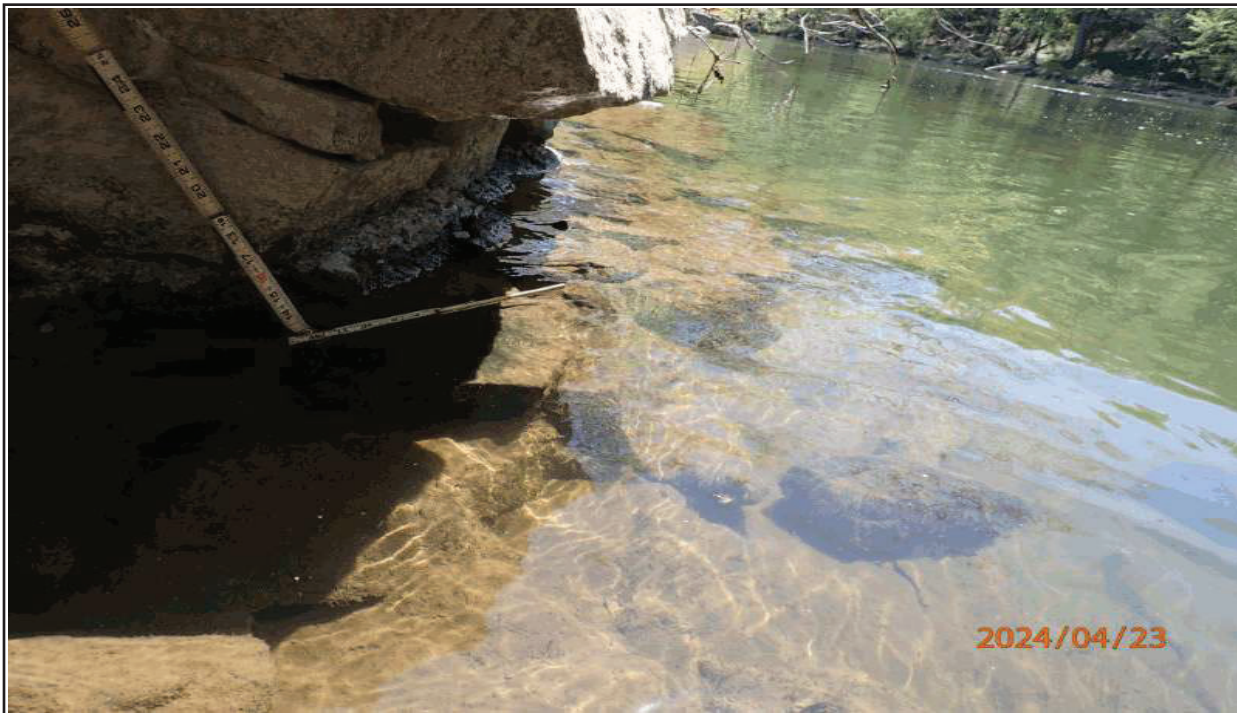
34 NORTH MASONRY ABUTMENT, EAST THRUST BLOCK, VOID IN REPOINTED SECTION

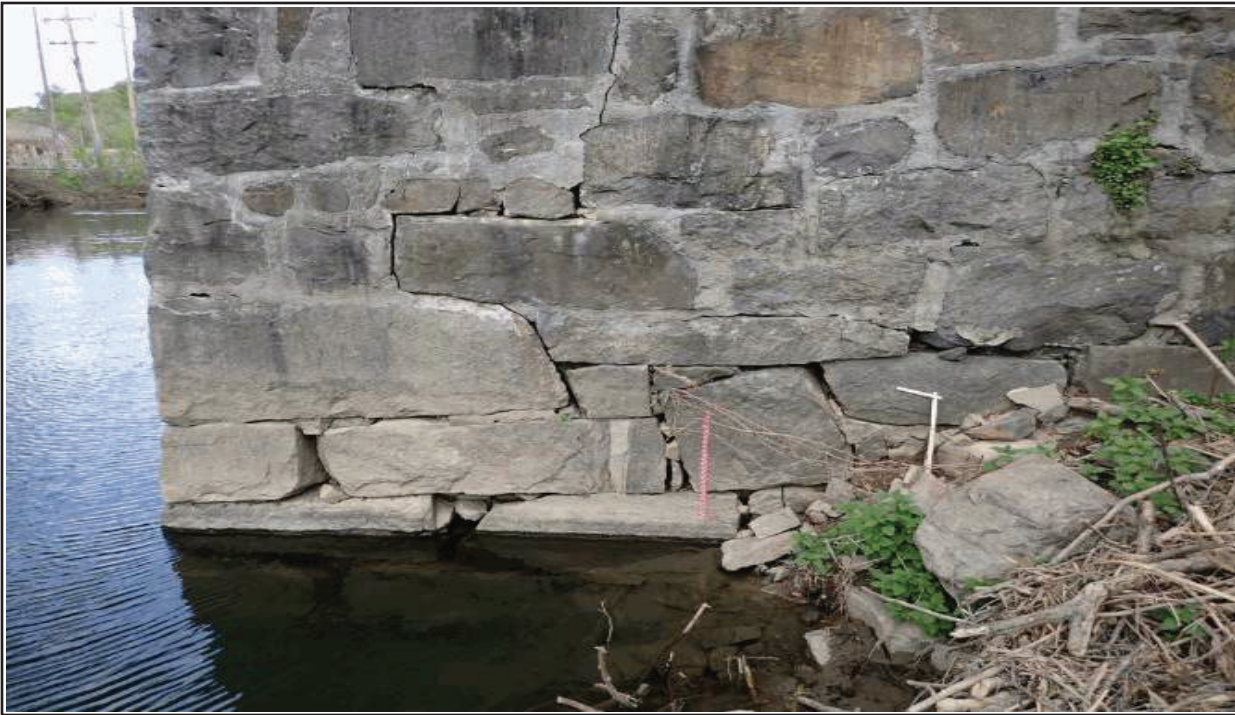
| Elm/Env | Description | Unit | Total Qty | Qty. St. 1 | Qty. St. 2 | Qty. St. 3 | Qty. St. 4 | Notes |
|---|---|---|---|---|---|---|---|---|
| 892/2 | Other Wingwall | (LF) | 197.00 | 139.00 | 50.00 | 8.00 | 0.00 | <p>MORTAR BREAKDOWN (1610):<br/>CS3: (8 LF) THE SOUTHWEST WINGWALL NEAR THE SOUTH ABUTMENT EXHIBITS AN 8FT L x 5FT H AREA OF MISSING MORTAR BETWEEN STONES WITH ASSOCIATED DISPLACEMENT OF STONES NEAR THE BOTTOM OF THE WINGWALL UP TO 1/2IN (PHOTO 35).</p> <p>CS2: (15 LF) THE SOUTHEAST AND SOUTHWEST WINGWALLS EXHIBIT A FEW RANDOM CRACKS THROUGH MORTAR JOINTS.</p> <p>EFFLORESCENCE / RUST STAINING (1120):<br/>CS2: (30 LF) THE BASE OF THE NORTHWEST WINGWALL EXHIBITS A FL x 15FT H AREA OF CRACKS WITH MODERATE TO HEAVY EFFLORESCENCE.</p> <p>SPLIT / SPALL (1620):<br/>CS2: (5 LF) SOUTHEAST AND SOUTHWEST WINGWALLS EXHIBIT A FEW ISOLATED CRACKS UP TO 1/16-INCH WIDE THROUGH STONES WITH NO SHIFTING OF THE STONES OBSERVED. (NC-24)</p> |

35 SOUTHWEST MASONRY WINGWALL - AREA OF MISSING MORTAR AND DISPLACED STONES

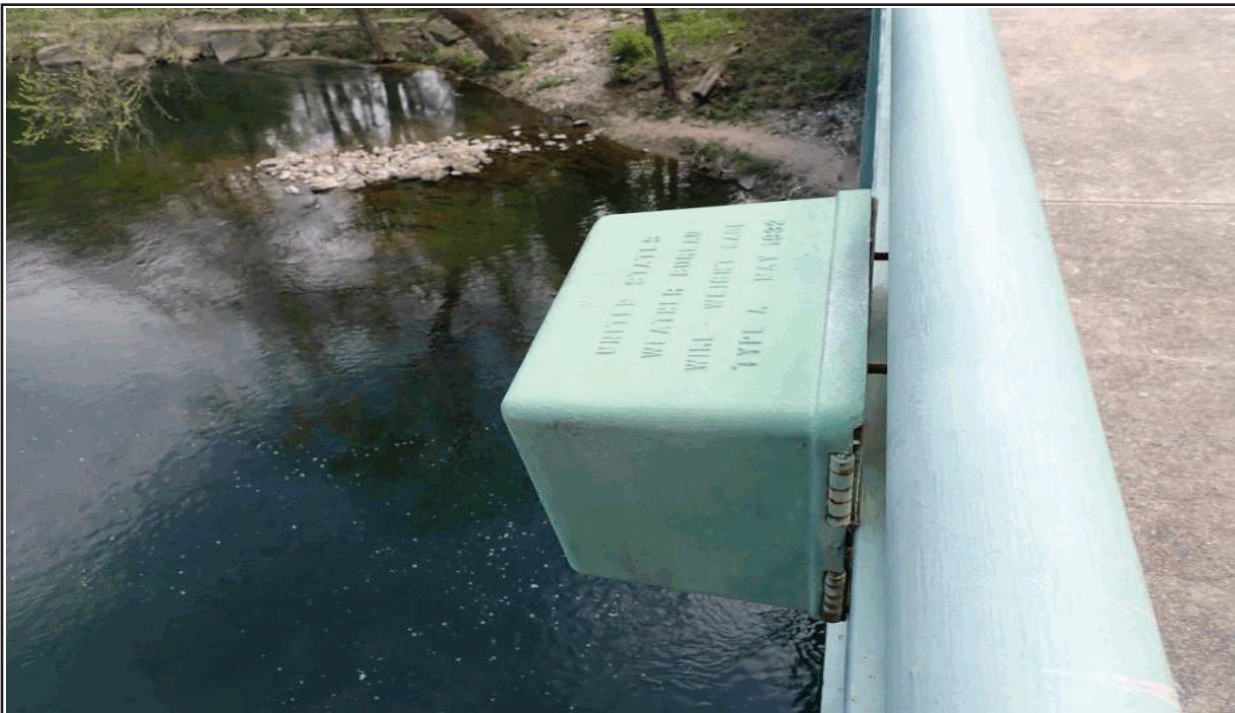
- THE NE AND SE TRUSS MEMBERS ARE ADJACENT TO TRAFFIC AND AN OM3 (OR SIMILAR) SIGN SHOULD BE INSTALLED.
- THERE IS A STREAM GAUGE ATTACHED TO THE OUTSIDE FACE OF THE EAST RAIL AT MIDSPAN WITH NO DEFICIENCIES NOTED (PHOTO 36).

36 EAST RAIL, MIDSPAN - STREAM GAUGE ATTACHMENT

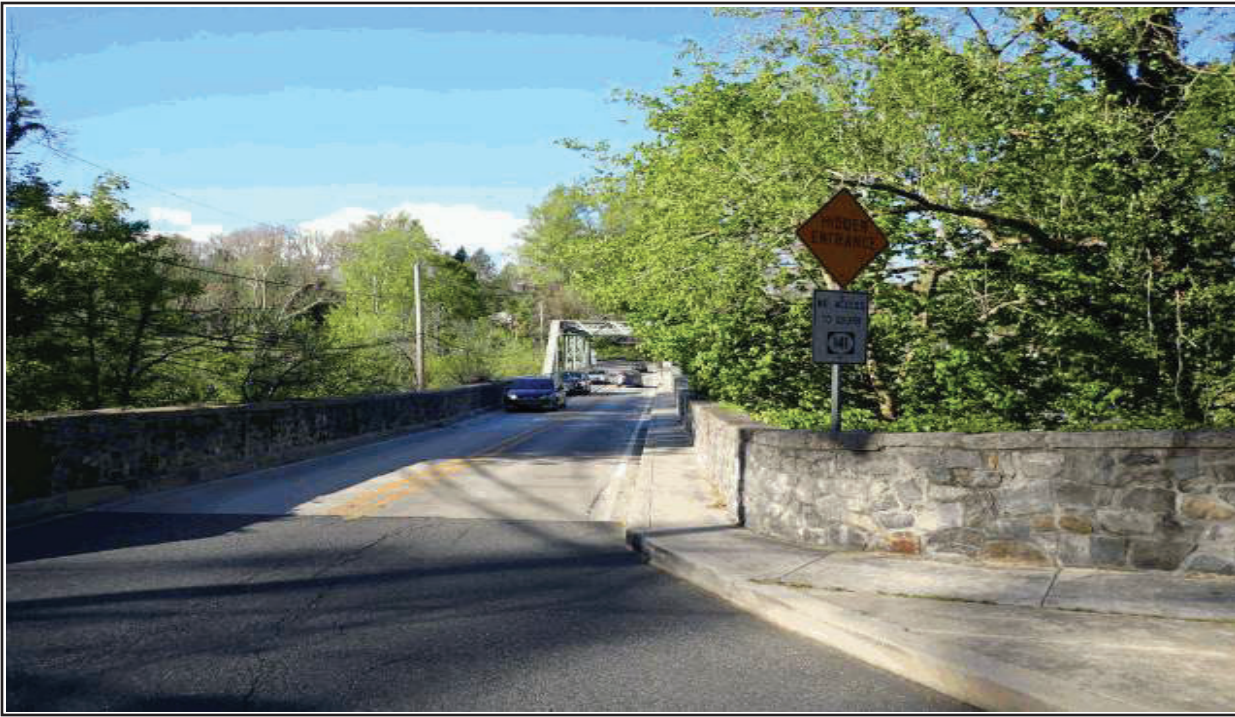
37 SOUTH APPROACH - VERTICAL CLEARANCE & LOAD POSTING NOT VISIBLE DUE TO VEGETATION

- REPLACE/REPAIR THE DETERIORATED SIP FORMS THROUGHOUT THE STRUCTURE (LS) (NC-24).
- INSTALL LOAD POSTING SIGN AT SOUTH ADVANCED APPROACH AND VERTICAL CLEARANCE SIGNS AT BOTH ADVANCED APPROACHES (3 EA) (NC-24). COMPLETED JULY 2024.
