Bridge ID: 1229A011

6) Feature Intersected: MUDDY RUN

7) Facility Carried: CAPITAL TRAIL/SR2

90) Inspection Date: 4/25/2024

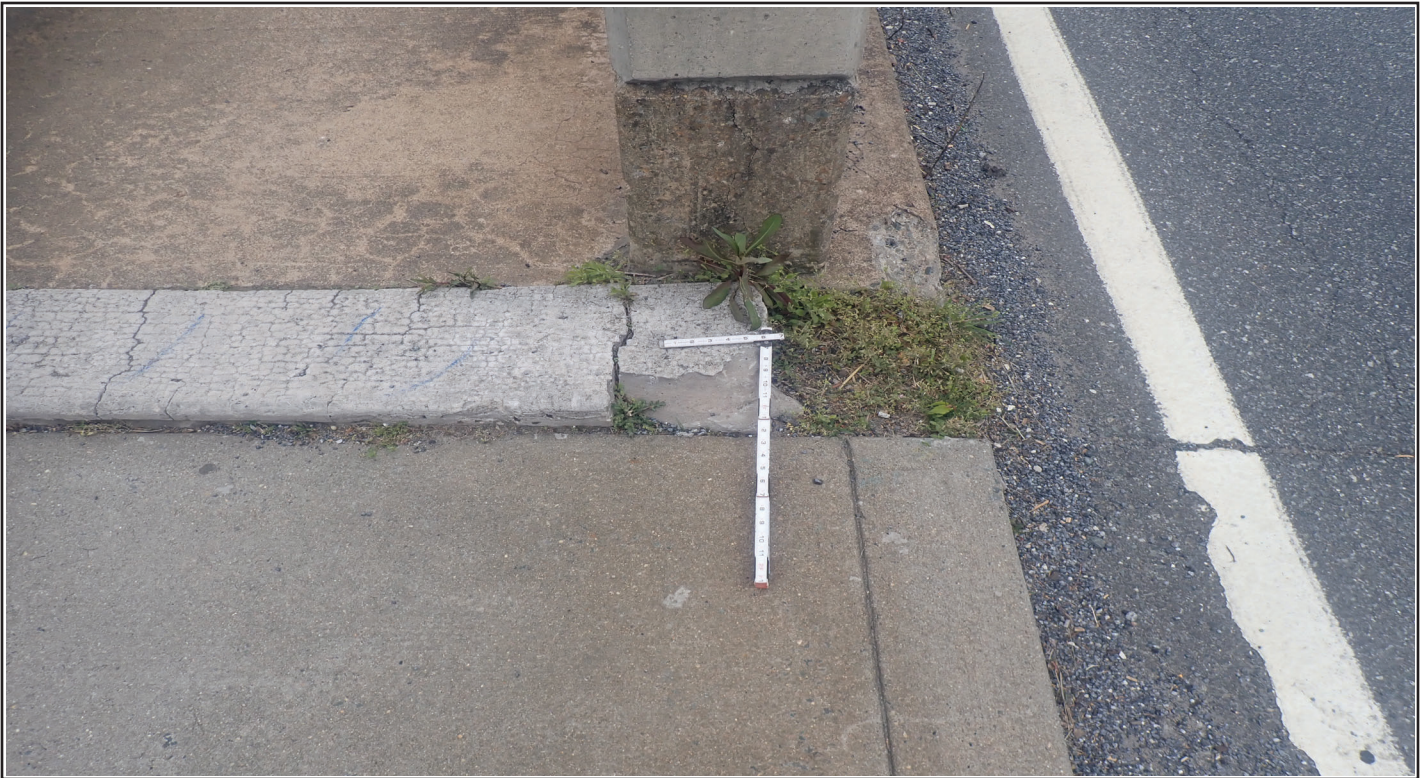
| Elm/Env | Description | Unit | Total Qty | Qty. St. 1 | Qty. St. 2 | Qty. St. 3 | Qty. St. 4 | Notes |
|---|---|---|---|---|---|---|---|---|
| 856/2 | R/C Sidewalk | (LF) | 112.00 | 100.00 | 7.00 | 5.00 | 0.00 | SOUTH SIDEWALK:<br>SPALL / DELAM:<br>CS-3=1 LF: DEEP SPALL TO REPAIR AT EAST END. THE REPAIR / SPALL IS HIGHER THAN THE APPROACH SIDEWALK. (PHOTO 7)<br><br>NORTH SIDEWALK:<br>SPALL / DELAM:<br>CS-3=4 LF: DEEP SPALLS AT THE EAST END.<br>CS-2=7 LF: DELAM ADJACENT TO SPALLS AT THE EAST END. |

7 SOUTH SIDEWALK DEEP SPALLS AT EAST END

-B060-A1C: PLACE WEDGES AT BOTH ENDS OF THE SOUTH SIDEWALK...WO#1341312

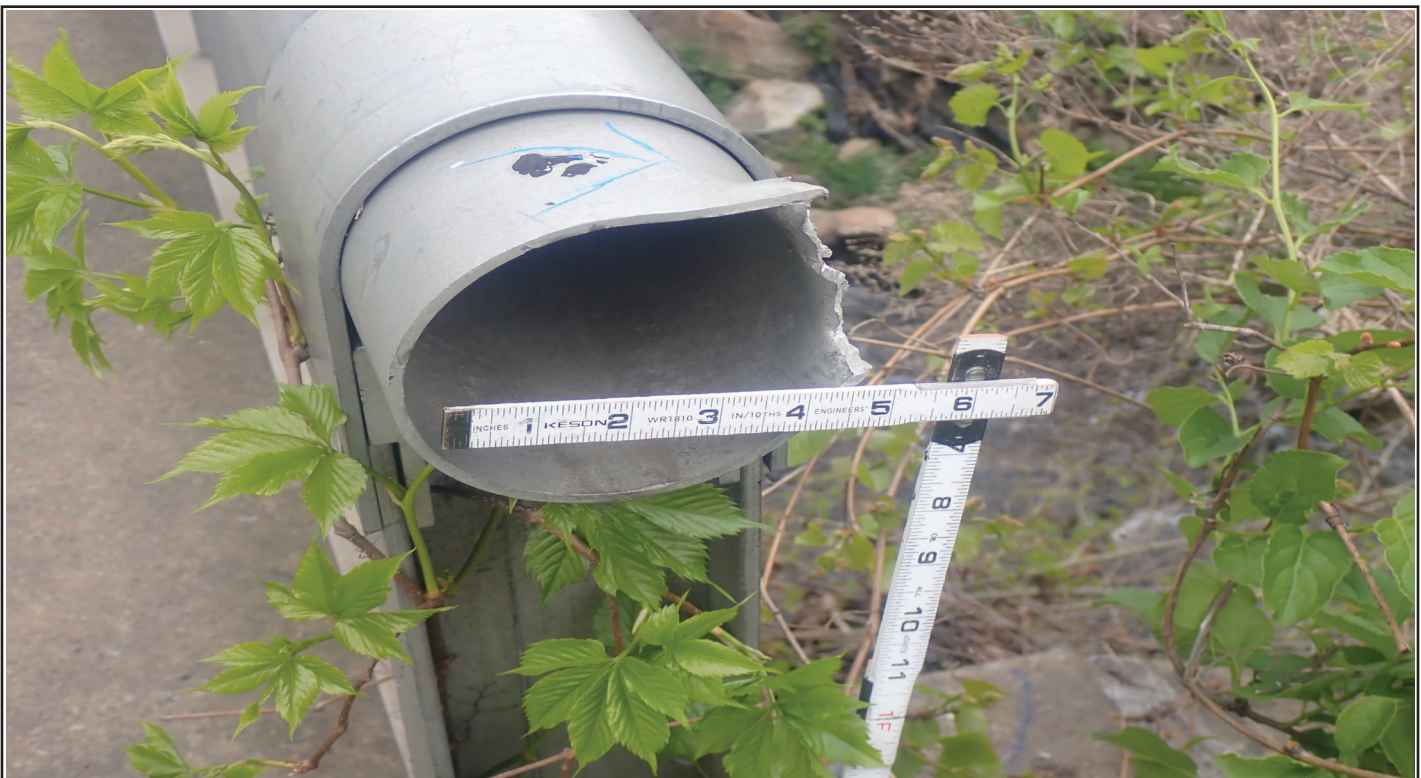
| Elm/Env | Description | Unit | Total Qty | Qty. St. 1 | Qty. St. 2 | Qty. St. 3 | Qty. St. 4 | Notes |
|---|---|---|---|---|---|---|---|---|
| 330/2 | Metal Bridge Railing | ft | 168.00 | 164.00 | 0.00 | 4.00 | 0.00 | SOUTH RAIL:<br>CONNECTION:<br>CS-3=3 LF: MISSING CONNECTION BOLTS TO VERTICAL POSTS 2,3,6 BASE PLATES FROM THE SOUTH. (PHOTO 9)<br><br>DISTORTION:<br>CS-3=1 LF: DISTORTION TO TOP HORIZONTAL MEMBER AT WEST END. (PHOTO 8)<br><br>NORTH RAIL:<br>CS-1= NDN |

8 SOUTH METAL RAIL TEAR / DAMAGE WEST END

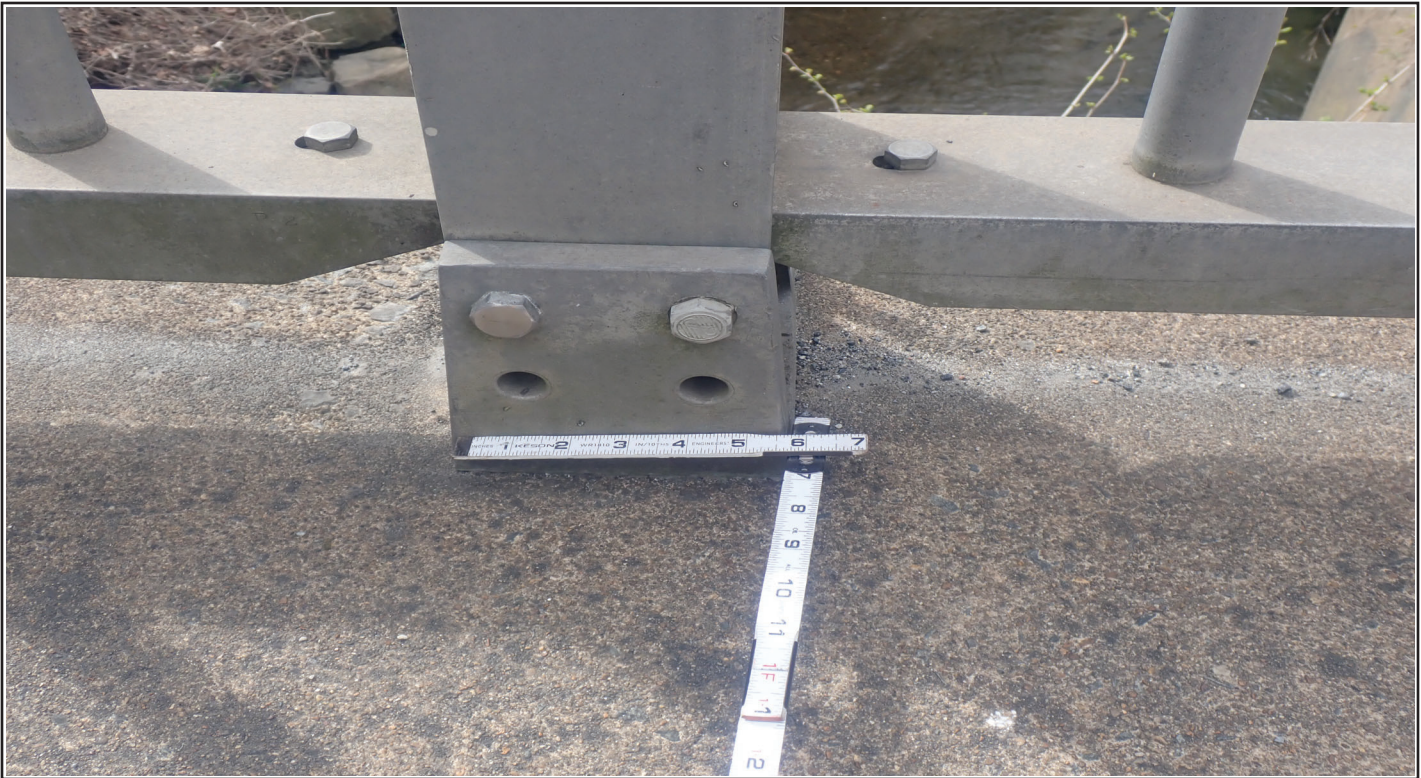
9 SOUTH METAL MISSING CONNECTION AT POST 2 FROM WEST

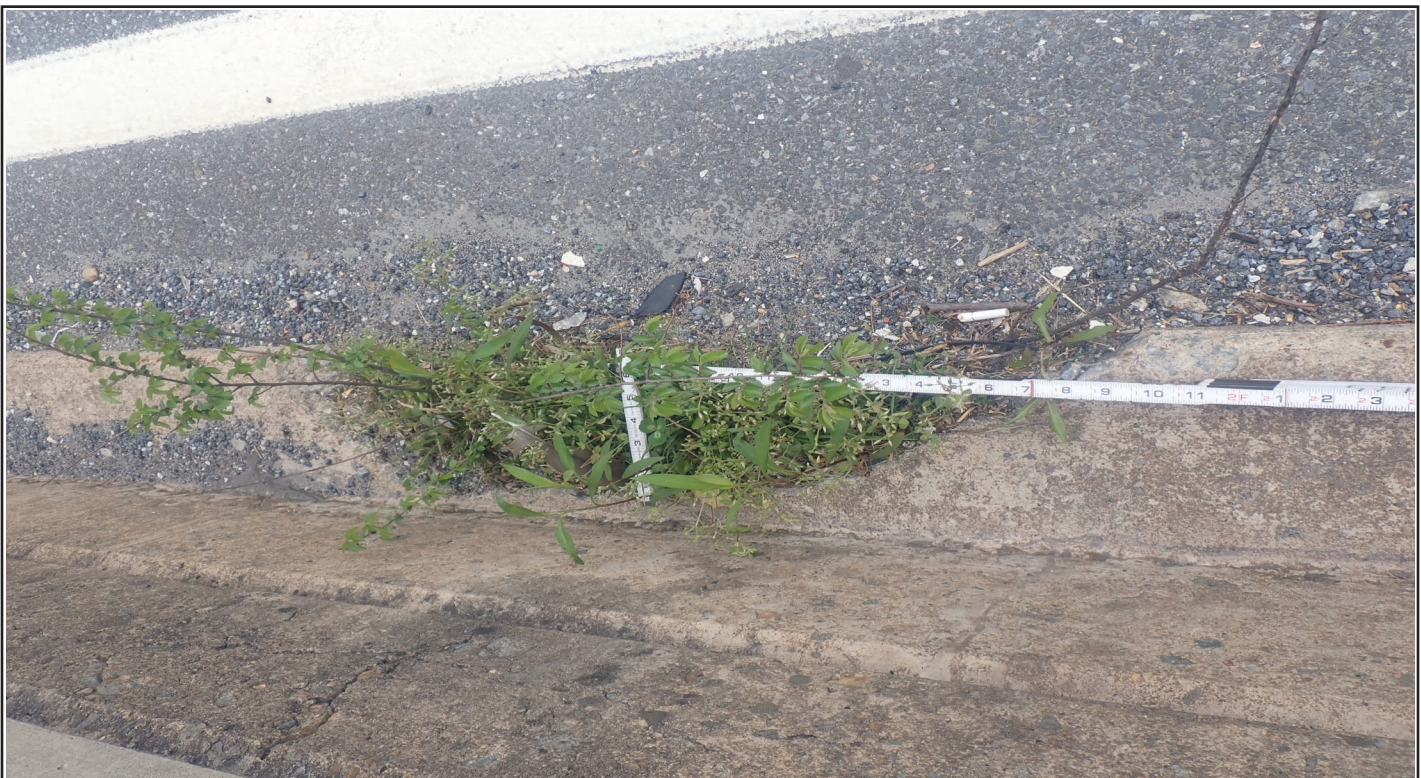
| Elm/Env | Description | Unit | Total Qty | Qty. St. 1 | Qty. St. 2 | Qty. St. 3 | Qty. St. 4 | Notes |
|---|---|---|---|---|---|---|---|---|
| 331/2 | Re Conc Bridge Railing | ft | 112.00 | 107.00 | 2.00 | 3.00 | 0.00 | SOUTH RAIL:<br>SPALL /DELAM:<br>CS-3=2 LF: DEEP SPALL TO BASE OF RAIL, NORTH FACE NEAR MIDSPAN (2 LF) (PHOTO 10) AND NORTH FACE AT EAST END (1 LF).<br>CS-2=2 LF: DELAM SOUTH FACE APPROX 8 FT. FROM THE EAST END.<br><br>NORTH RAIL:<br>EXP BAR:<br>CS-3=1 LF: EXP BAR w/LOSS OF SECTION SOUTH FACE AT THE WEST END. (PHOTO 12) |

10 SOUTH RAIL DEEP SPALL NORTH FACE MID SPAN

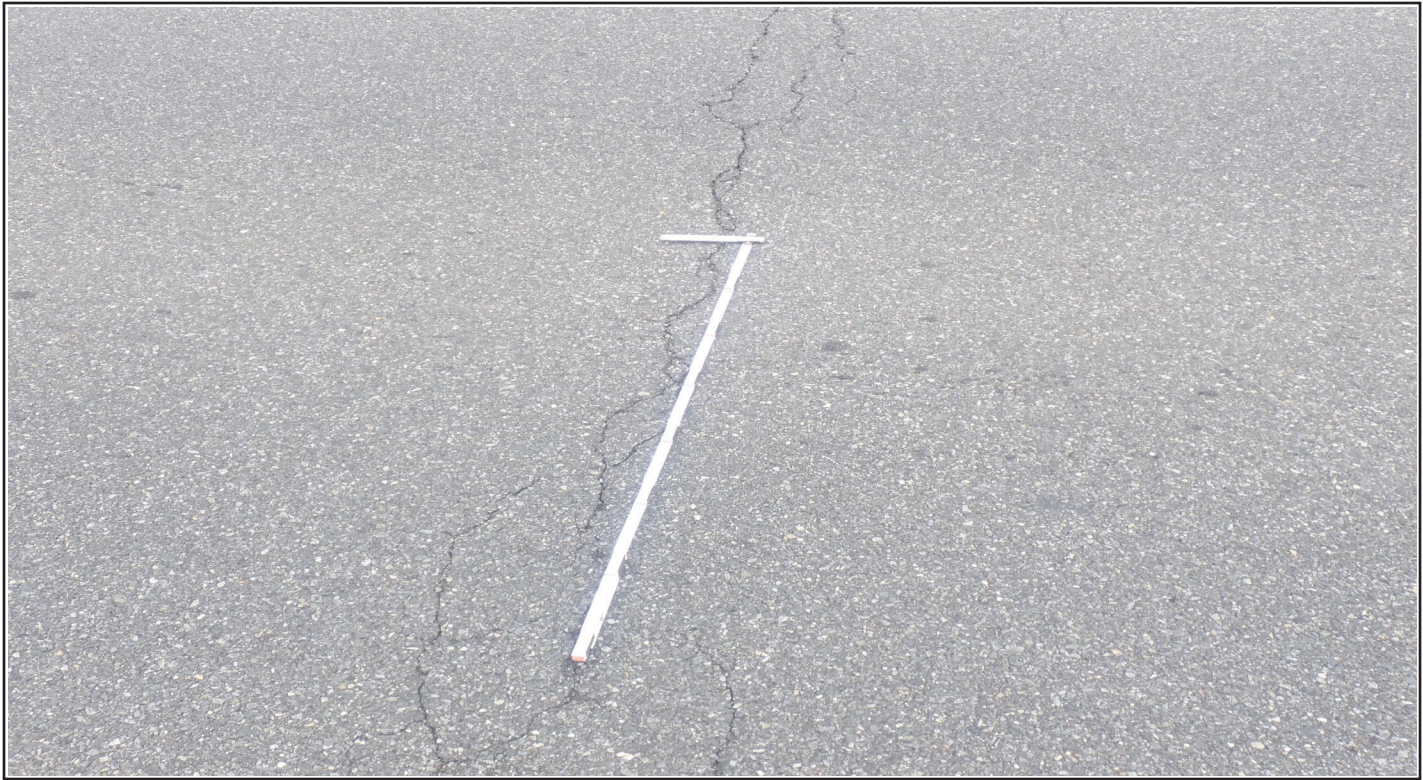
| Elm/Env | Description | Unit | Total Qty | Qty. St. 1 | Qty. St. 2 | Qty. St. 3 | Qty. St. 4 | Notes |
|---|---|---|---|---|---|---|---|---|
| 811/2 | Asphaltic Conc. Wearing Surface | sq.ft | 1,975.00 | 1,775.00 | 0.00 | 200.00 | 0.00 | CRACKING:<br>CS-3=200 SF: AREAS OF DENSE WIDE MAPPING CRACKING ALONG w/LONGITUDINAL AND TRANSVERSE CRACKING. (PHOTO 11) |

11 AC OVERLAY WIDE CRACKS IN WESTBOUND LANE

-B022-S1D: SEAL CRACKS IN THE AC OVERLAY...WO#1341310

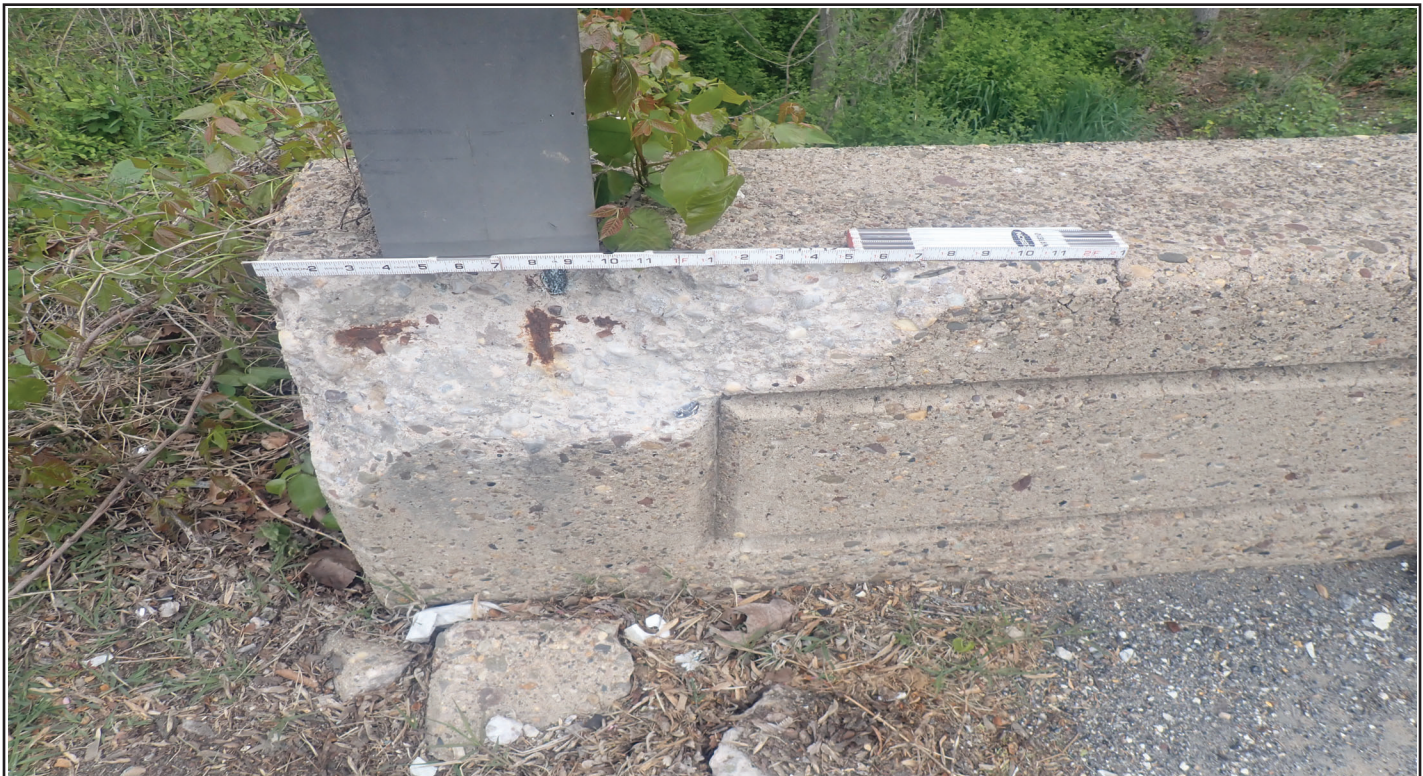
12 NORTH RAIL EXP BARS w/LOSS OF SECTION AT WEST END

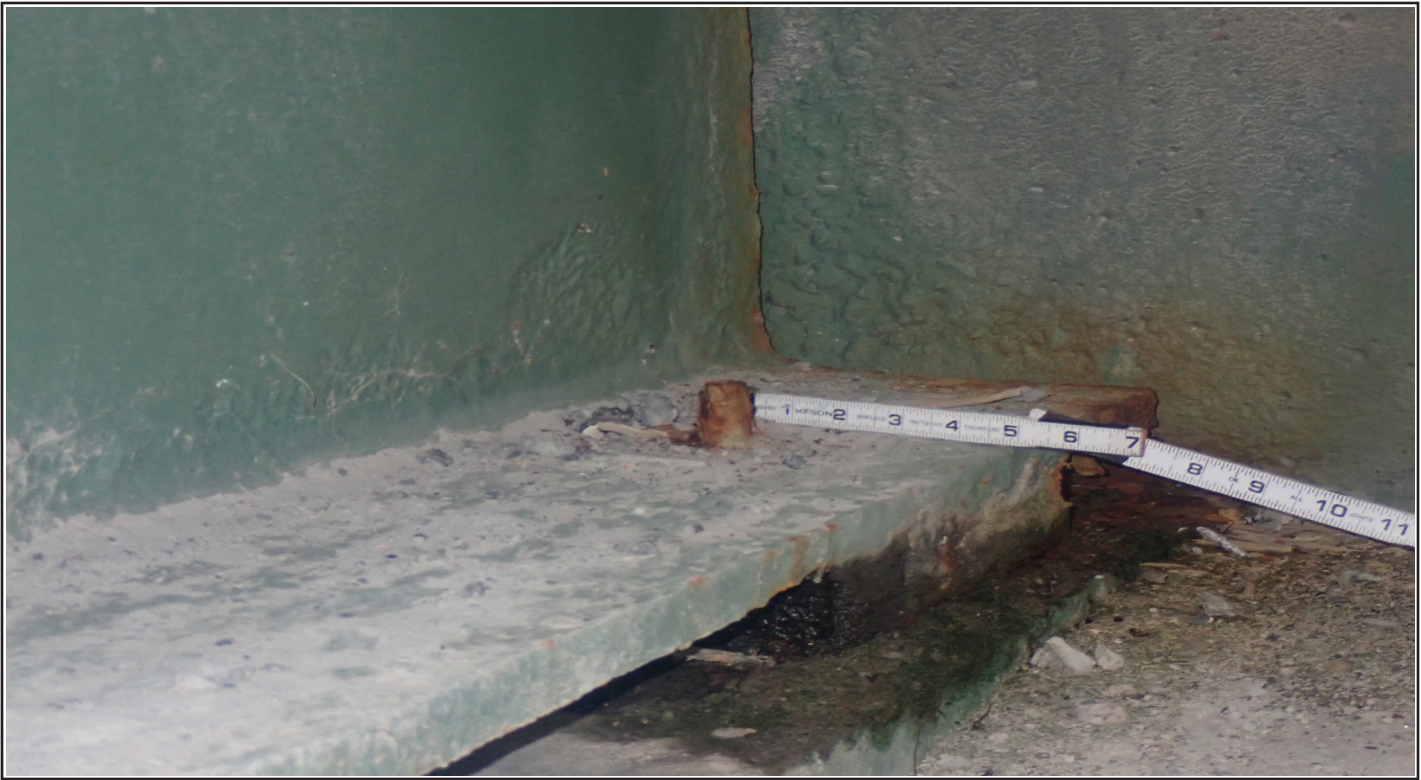
| Elm/Env | Description | Unit | Total Qty | Qty. St. 1 | Qty. St. 2 | Qty. St. 3 | Qty. St. 4 | Notes |
|---|---|---|---|---|---|---|---|---|
| 313/2 | Fixed Bearing | each | 7.00 | 3.00 | 2.00 | 2.00 | 0.00 | WEST ABUTMENT BEARINGS:<br><br>CONNECTION:<br>CS-3=2 EA: BEARINGS 1 AND 5 HAVE MISSING CONNECTION BOLTS. (PHOTO 13)<br>CS-2=2 EA: BEARINGS 2 AND 3 HAVE LOOSE CONNECTION BOLTS.<br>(NC-24) |

13 FIXED BEARING 1 OVER WEST ABUTMENT MISSING CONNECTION

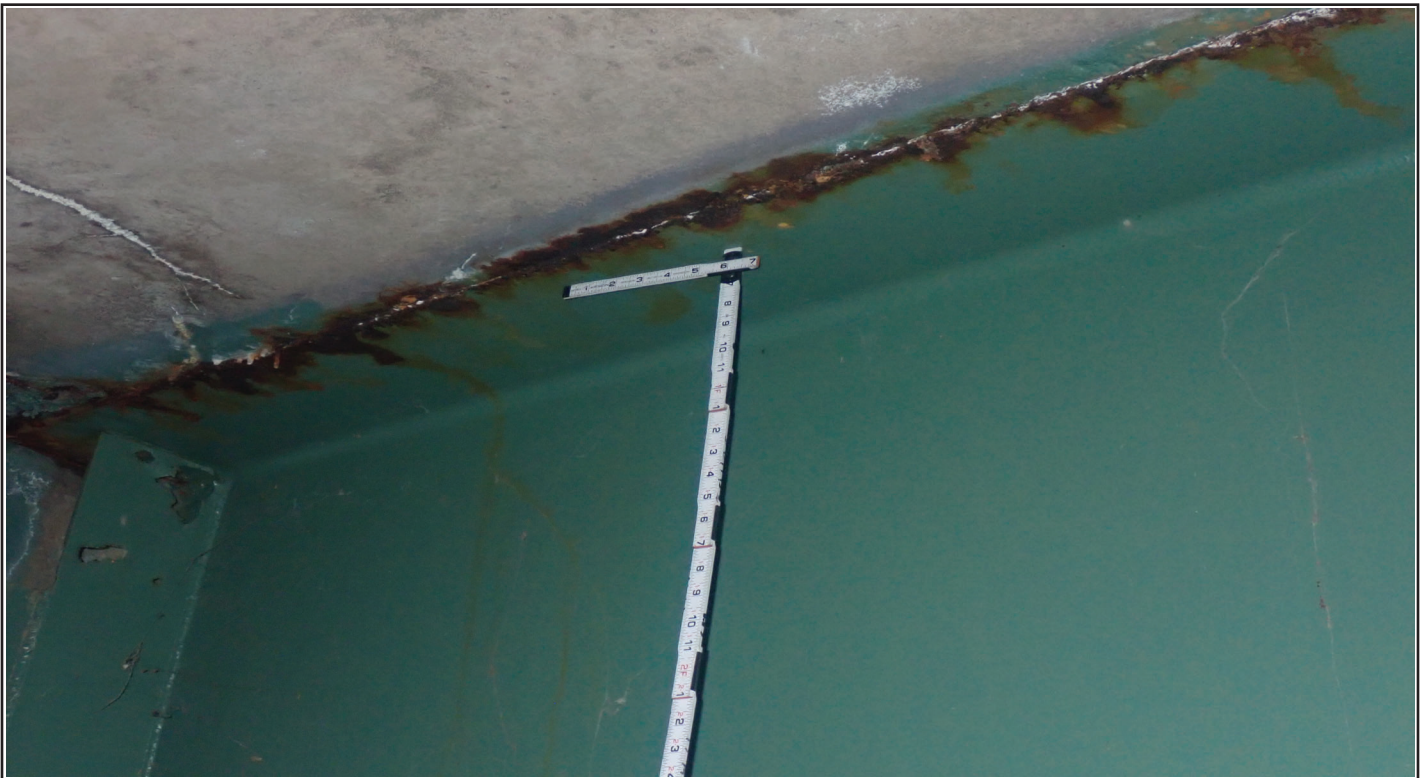
14 GIRDER 1 TOP FLANGE CORROSION w/LOSS OF SECTION OVER WEST ABUTMENT

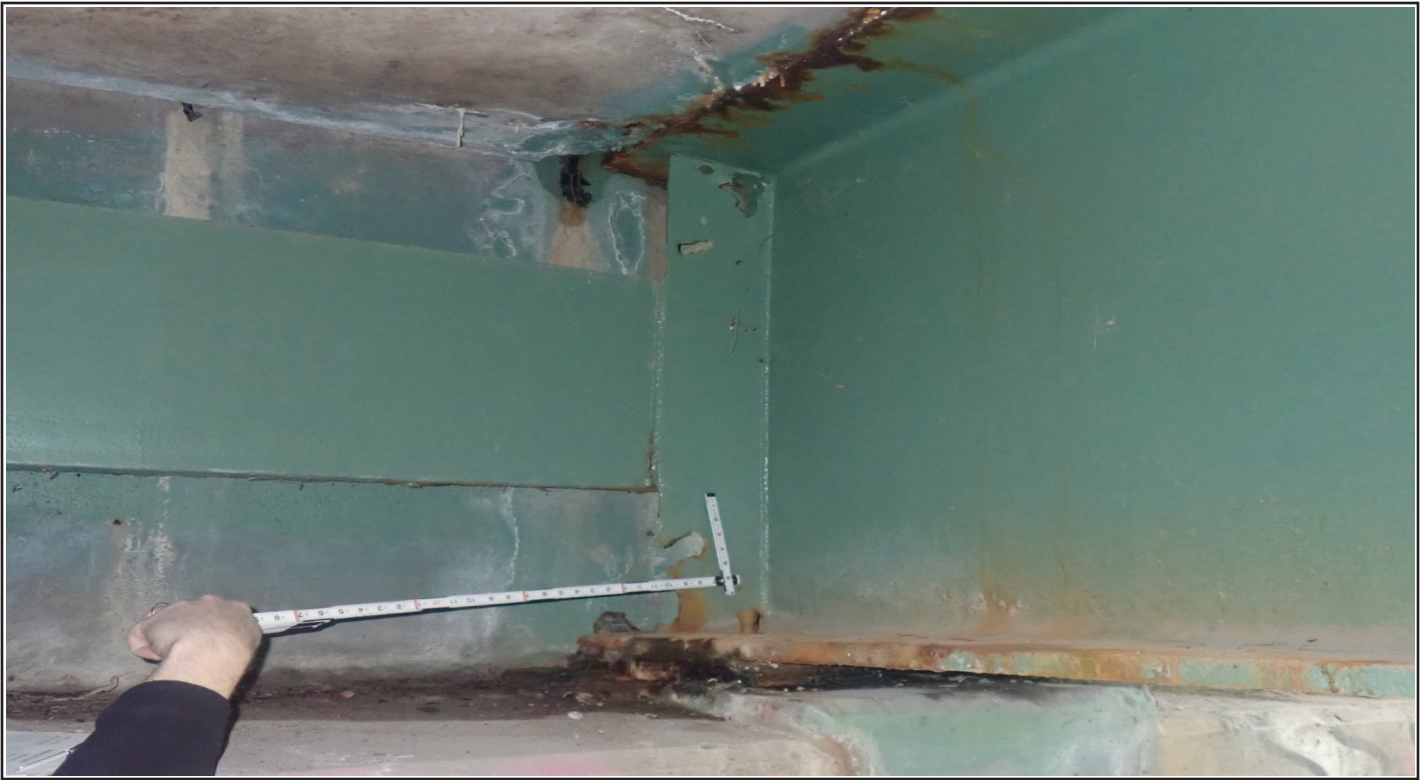
| Elm/Env | Description | Unit | Total Qty | Qty. St. 1 | Qty. St. 2 | Qty. St. 3 | Qty. St. 4 | Notes |
|---|---|---|---|---|---|---|---|---|
| 107/2 | Steel Opn Girder/Beam | ft | 364.00 | 173.00 | 50.00 | 141.00 | 0.00 | CORROSION:<br>CS-3=141 LF: CORROSION w/LOSS OF SECTION MAINLY TO THE TOP FLANGE OF GIRDER#1 (20 LF), GIRDER#2 (20 LF), GIRDER#3 (40 LF), GIRDER#4 (50 LF), GIRDER#5 (10 LF), AND GIRDER#7 (1 LF). (PHOTO 14)<br>CS-2=50 LF: LIGHT CORROSION AND OF FRECKLE RUST HAS FORMED AT RANDOM.<br><br>NOTE:<br>-THERE ARE AREAS OF PAINTED OVER SECTION LOSS MAINLY AT THE ENDS. (PHOTO 15) |

15 GIRDER 1 EXISTING PERFORATIONS IN STIFFNER OVER WEST BEARING

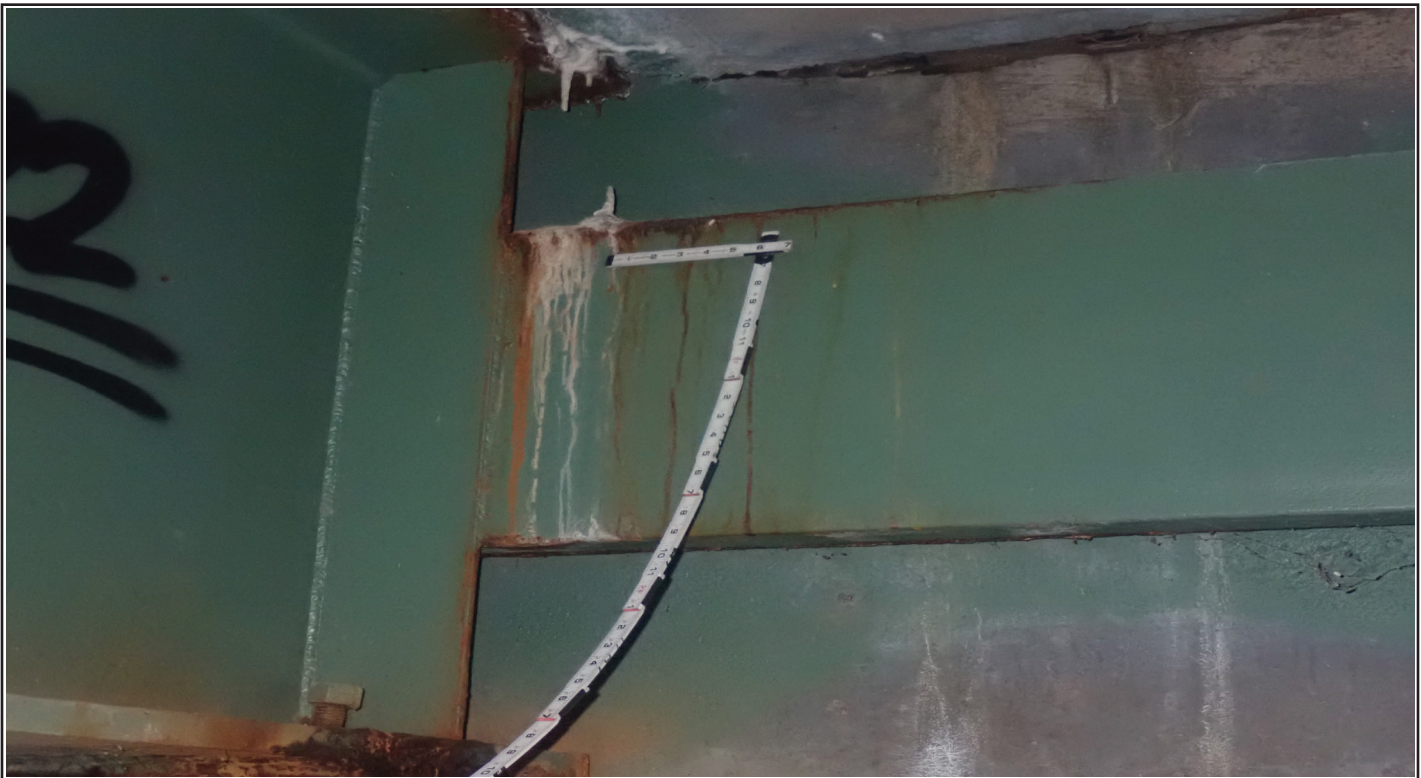
| Elm/Env | Description | Unit | Total Qty | Qty. St. 1 | Qty. St. 2 | Qty. St. 3 | Qty. St. 4 | Notes |
|---|---|---|---|---|---|---|---|---|
| 881/2 | Steel Diap | (EA) | 21.00 | 12.00 | 4.00 | 5.00 | 0.00 | CORROSION:<br>CS-3=4 EA: CORROSION w/LOSS OF SECTION TO DIAPHRAGMS 1,2 OVER WEST ABUTMENT, BAY 5 DIAPHRAGM OVER WEST ABUTMENT AND BAY 6 MID SPAN DIAPHRAGM. (PHOTO 16)<br>CS-2=4 EA: LIGHT CORROSION OR FRECKLE RUST HAS FORMED TO DIAPHRAGMS IN BAYS#1,2,4 AT RANDOM.<br><br>CRACK:<br>CS-3=1 EA: DIAPHRAGM IN BAY#1 OVER EAST ABUTMENT HAS CRACKED / SEPARATED WELD AT GIRDER#1. (2022 PHOTO 24) |

16 DIAPHRAGM BAY 2 CORROSIONN w/LOSS OF SECTION OVER WEST ABUTMENT

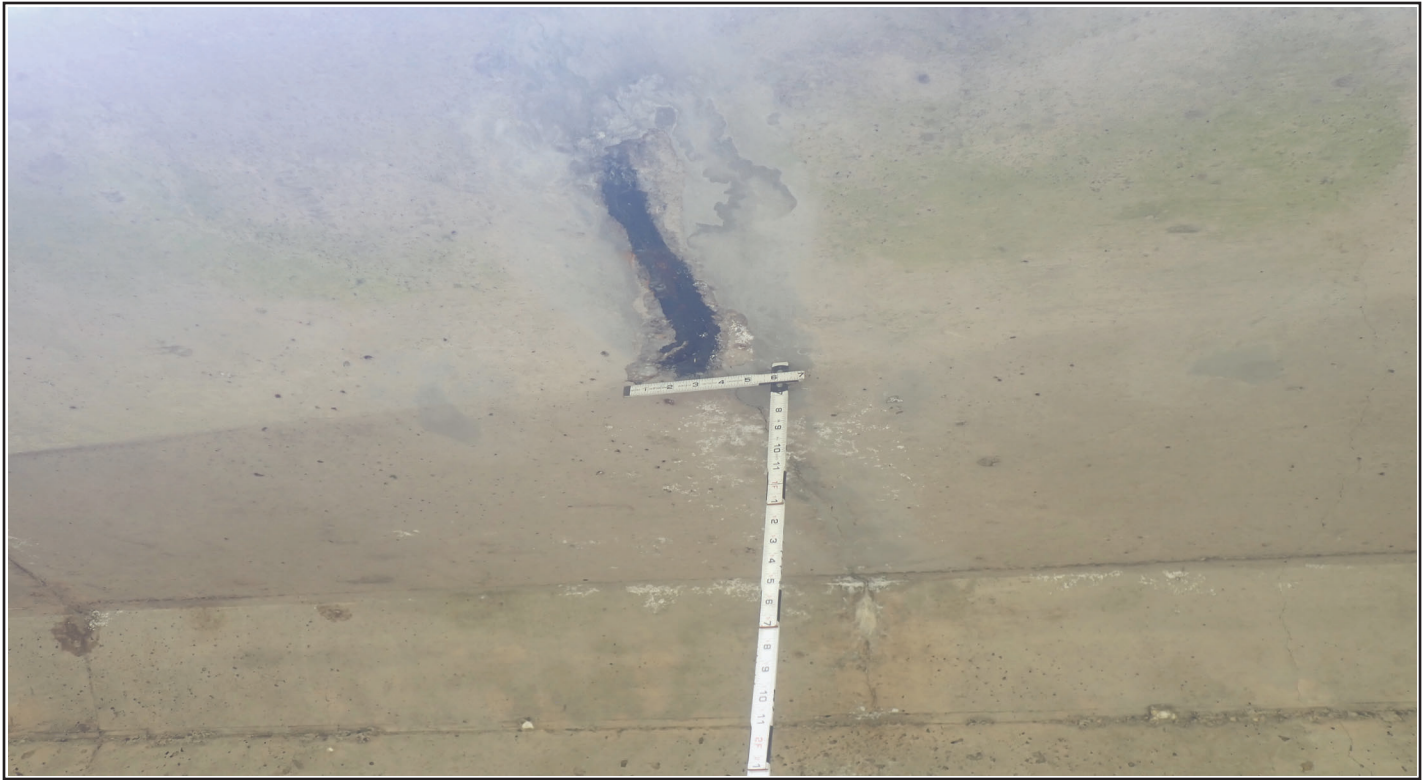
17 SOFFIT NORTH OVERHANG EXP BAR w/LOSS OF SECTON NEAR MID SPAN

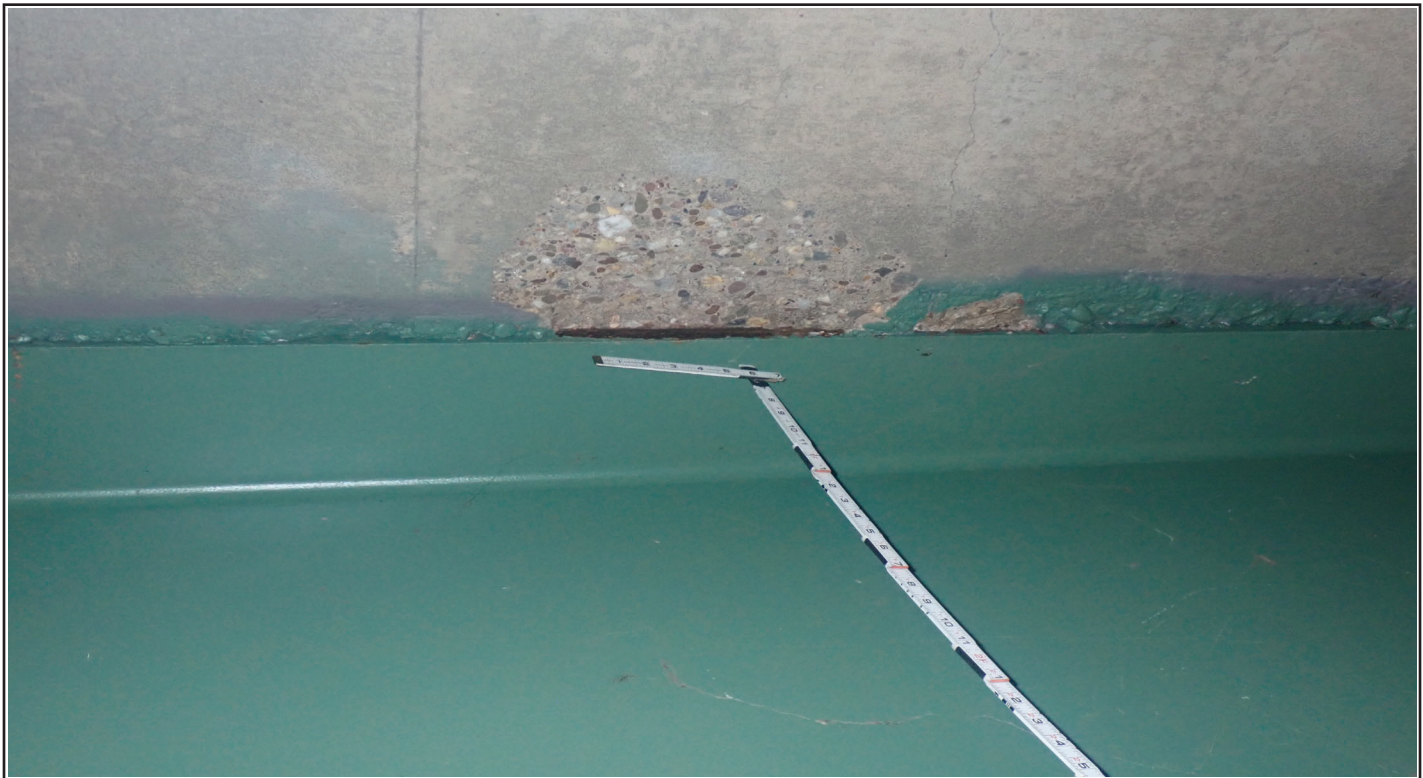
18 SOFFIT BAY 1 DEEP SPALL NEAR MID SPAN

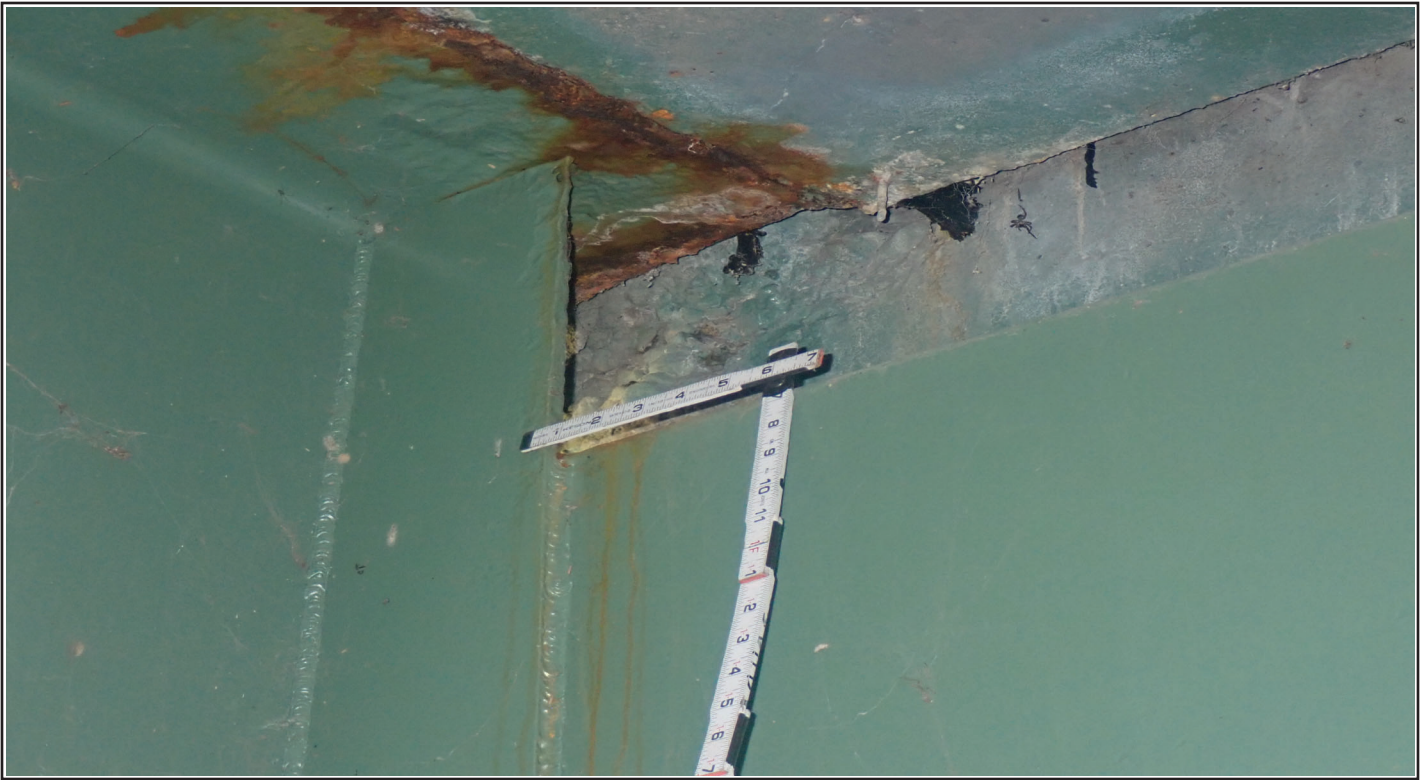
19 WEST ABUTMENT BACKWALL DEEP SPALL BEHIND GIRDER 1

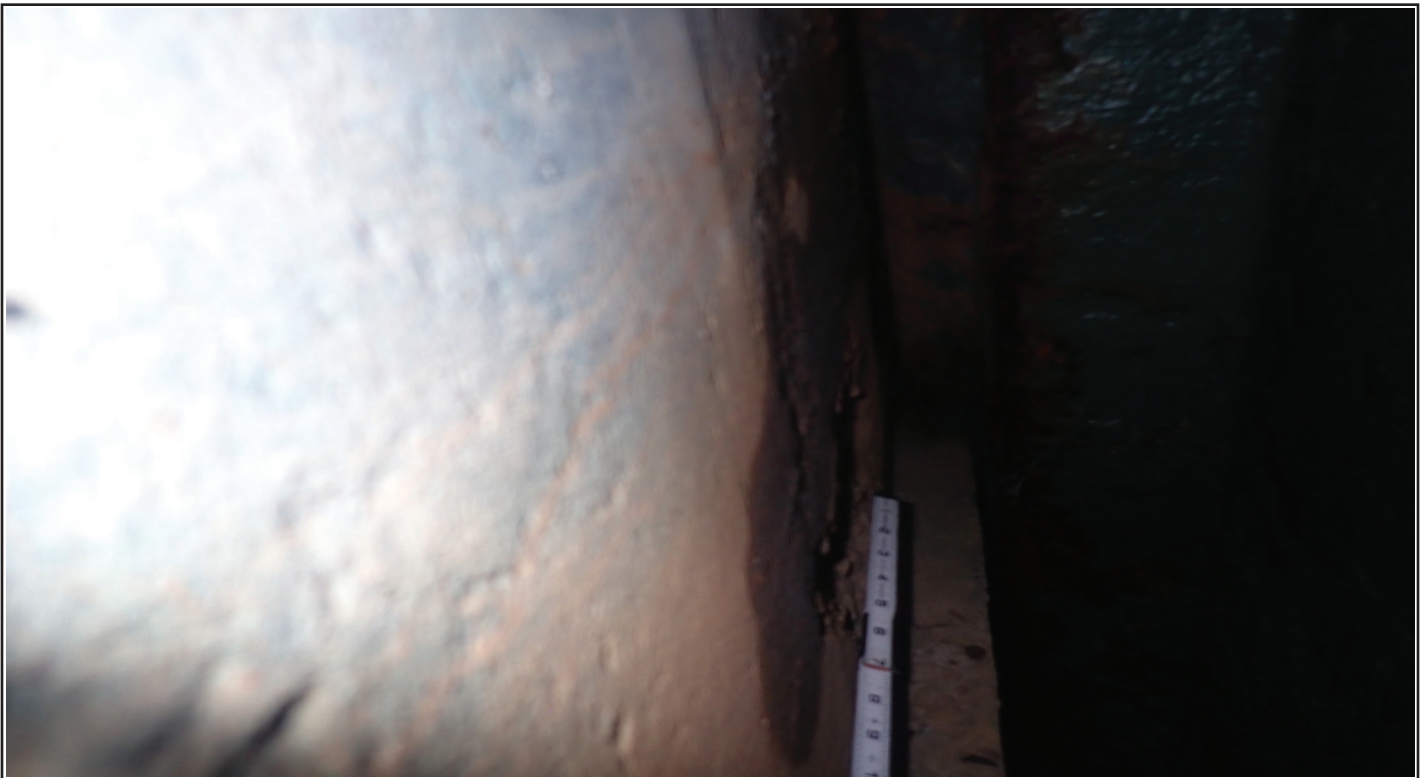
20 ARCH DEEP SPALL SOUTH FACE ADJACENT TO GIRDER

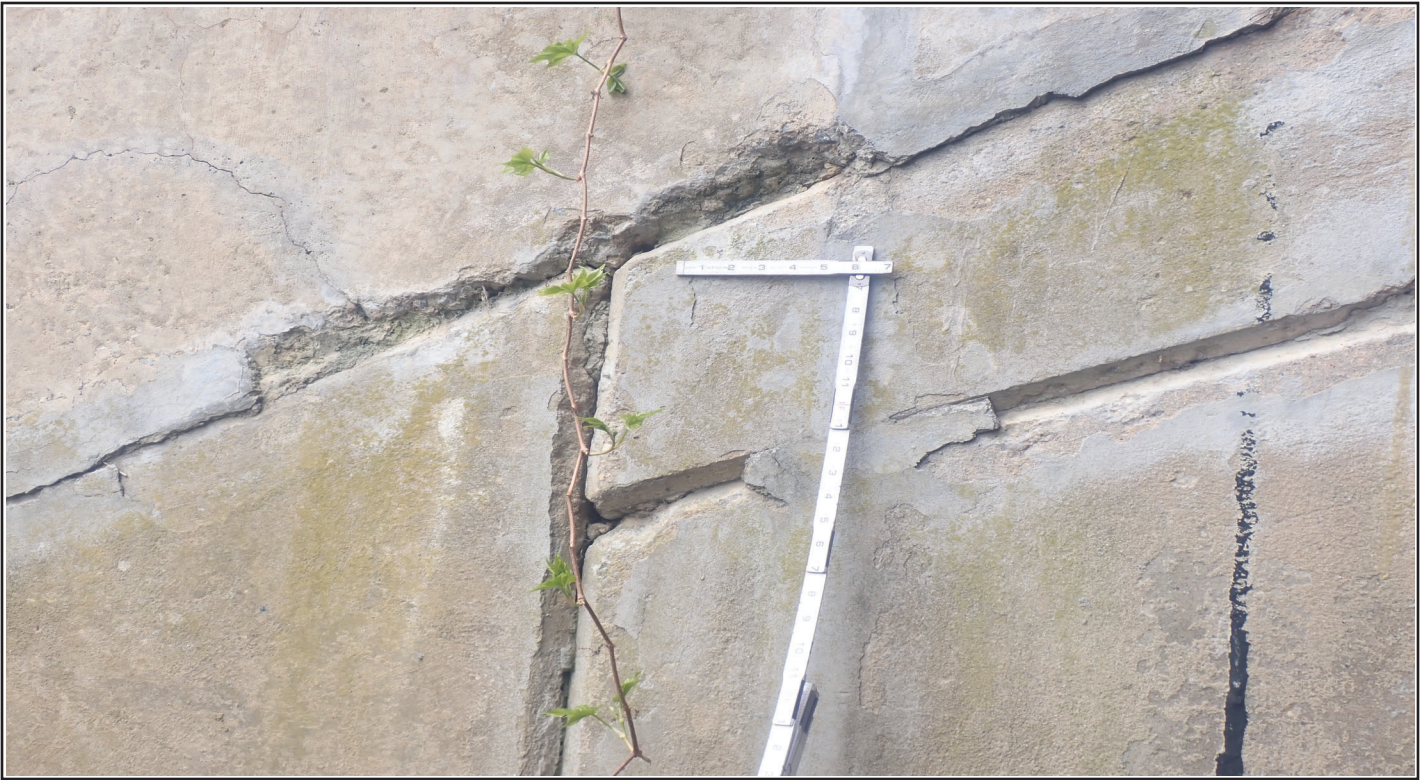
| Elm/Env | Description | Unit | Total Qty | Qty. St. 1 | Qty. St. 2 | Qty. St. 3 | Qty. St. 4 | Notes |
|---|---|---|---|---|---|---|---|---|
| 890/2 | RC Wingwalls | (LF) | 106.00 | 99.00 | 1.00 | 6.00 | 0.00 | SOUTHWEST WINGWALL:<br>SPALLS / DELAM<br>CS-3=6 LF: DEEP SPALLS EAST FACE NEAR THE ABUTMENT. (PHOTO 21)<br>CS-2=1 LF: DELAM ADJACENT TO THE ABUTMENT. |

21 SOUTHWEST WINGWALL DEEP SPALL MID SPAN
