Bridge No: 1279E003  
 Date of Inspection: 05/03/2022  
 Load Rating Date: 09/12/2018

6) Feature Intersected: CHRISTINA RIVER

7) Facility Carried: CHRISTIANA BYPASS

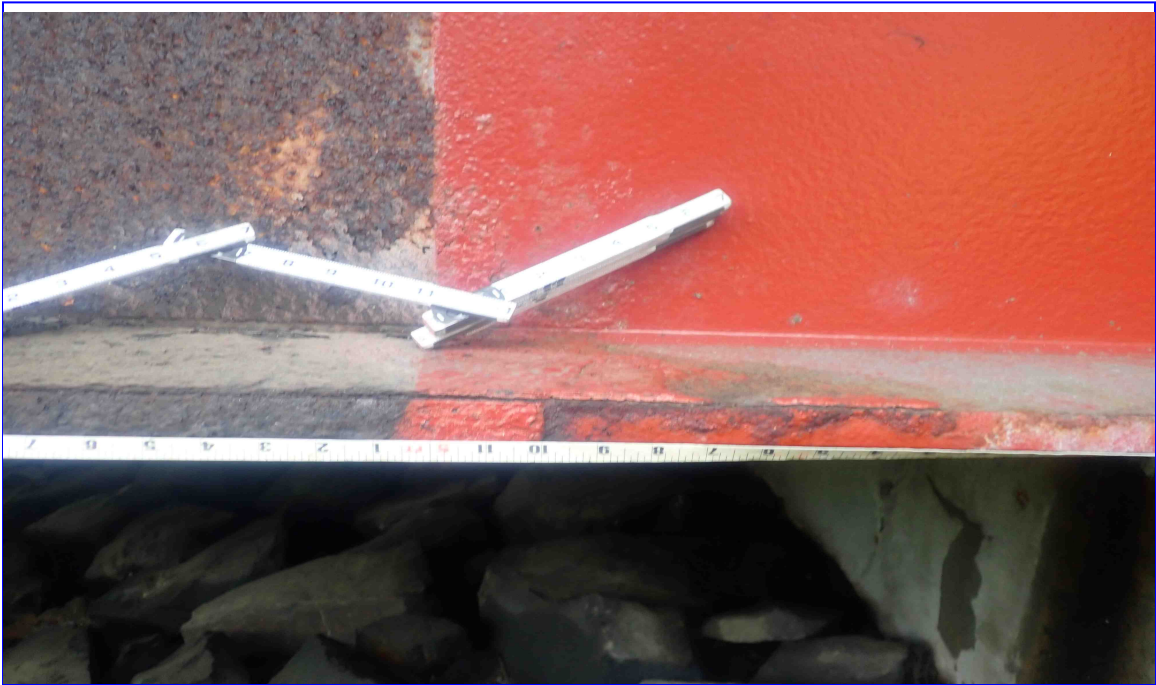
| Elm/Env | Description | Unit | Total Qty | Qty. St. 1 | Qty. St. 2 | Qty. St. 3 | Qty. St. 4 | Notes |
|---|---|---|---|---|---|---|---|---|
| 107/2 | Steel Opn Girder/Beam | ft | 420.00 | 139.00 | 256.00 | 25.00 | 0.00 | 1000 CS3-003 LF: NORTH EXTERIOR PAINTED STEEL GIRDER HAS LAMINAR CORROSION NEAR WEST END (PHOTO 7).<br>1000 CS3-002 LF: NORTH EXTERIOR PAINTED STEEL GIRDER HAS PAINTED OVER CORROSION NEAR W END (PHOTO 7).<br>1000 CS3-020 LF: NORTH EXTERIOR WEATHERING STEEL GIRDER HAS LAMINAR CORROSION NEAR W END (PHOTO 7).<br>1000 CS2-128 LF: RANDOM ~3/8 INCH DIAMETER FLAKES OF CORROSION PRIMARILY ON N & S FACIA GIRDERS.<br>1000 CS2-128 LF: RANDOM GRANULAR CORROSION PRIMARILY ON THE INTERIOR GIRDERS. |
| 515/2 | Steel Protective Coating | sq.ft | 360.00 | 310.00 | 0.00 | 0.00 | 50.00 | CS4-050 SF: NORTH EXTERIOR PAINTED STEEL GIRDER HAS PAINTED OVER CORROSION NEAR WEST END (PHOTO 7). |
| 815/2 | Weathering Steel Protection | sq.ft | 3,840.00 | 1,080.00 | 0.00 | 2,560.00 | 200.00 | CS4-0200 SF: NORTH EXTERIOR WEATHERING STEEL GIRDER HAS LAMINAR CORROSION NEAR W END (PHOTO 7).<br>CS3-1280 SF: RANDOM ~3/8 INCH DIAMETER FLAKES OF CORROSION PRIMARILY ON N & S FACIA GIRDERS.<br>CS3-1280 SF: RANDOM GRANULAR CORROSION PRIMARILY ON THE INTERIOR GIRDERS.<br>(~NO CHANGE 2022) |

7. SPAN 1 N PAINT & WEATHR STEEL FACIA GIRDER 1 LAM CORROS AT W END LOOK S

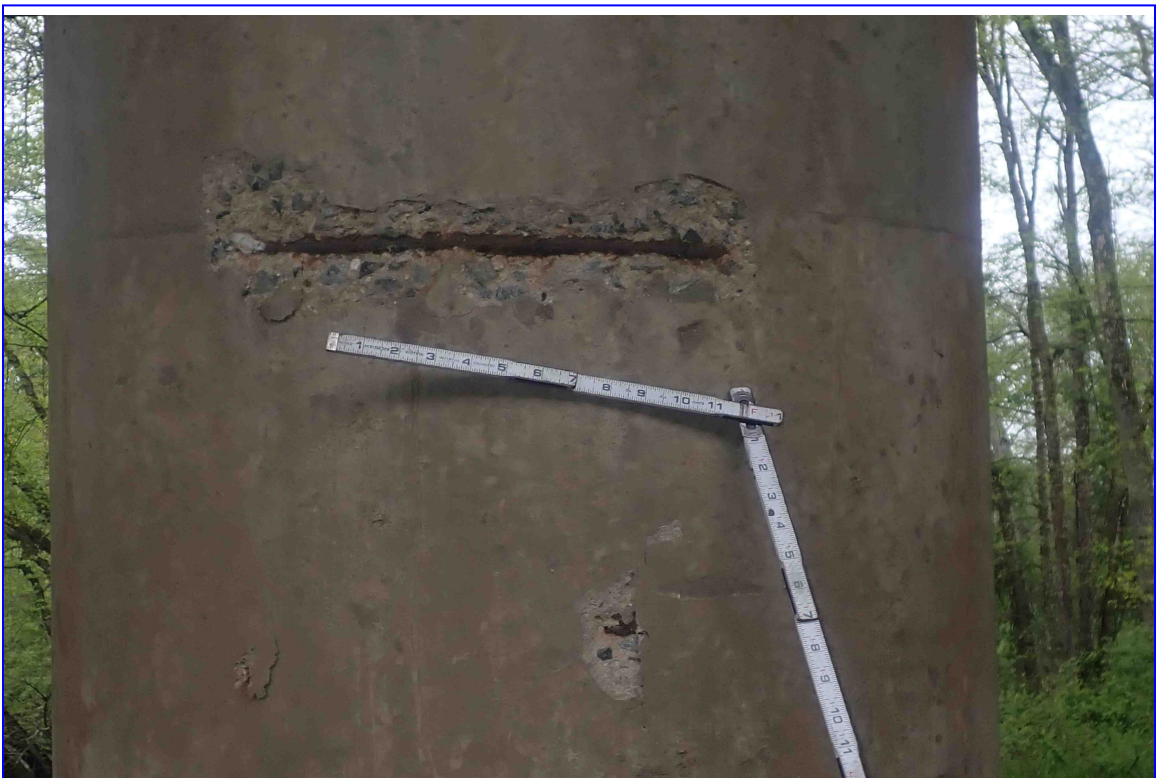
| Elm/Env | Description | Unit | Total Qty | Qty. St. 1 | Qty. St. 2 | Qty. St. 3 | Qty. St. 4 | Notes |
|---|---|---|---|---|---|---|---|---|
| 210/2 | Re Conc Pier Wall | ft | 20.00 | 19.00 | 0.00 | 1.00 | 0.00 | 1090 CS3-1 LF: SPAN 1 WEST PIERWALL EXPOSED PITTED BARS AND SPALL AT NORTH END (PHOTO 8).<br>(NO CHANGE 2022) |

8. SPAN 1 WEST PIERWALL EXPOSED PITTED BARS AND SPALL AT NORTH END LOOK S

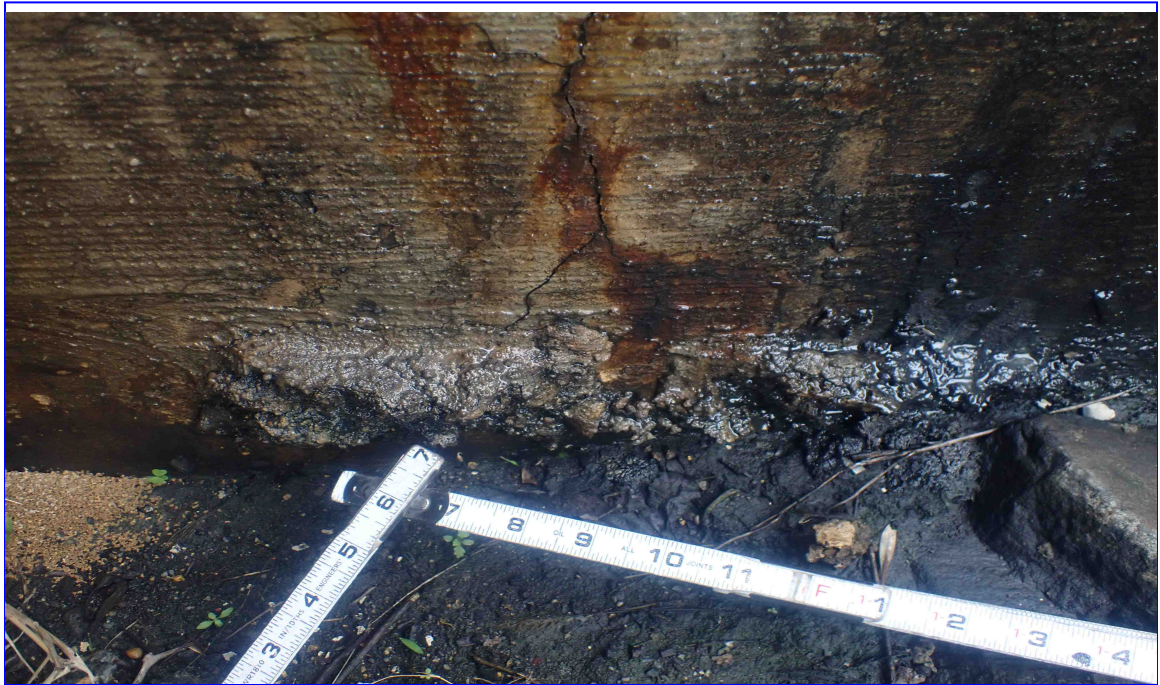
| Elm/Env | Description | Unit | Total Qty | Qty. St. 1 | Qty. St. 2 | Qty. St. 3 | Qty. St. 4 | Notes |
|---|---|---|---|---|---|---|---|---|
| 215/2 | Re Conc Abutment | ft | 52.00 | 50.00 | 0.00 | 2.00 | 0.00 | 1120 CS3-2 LF: W ABUT BREASTWALL ~36 & 43 FT FROM SOUTH END, HAS RUST STAINS & CRACKS (PHOTO 9). |

9. SPAN 1 W ABUTMENT STEM RUST STAINED CRACK ~43 FT FROM SOUTH END LOOK W

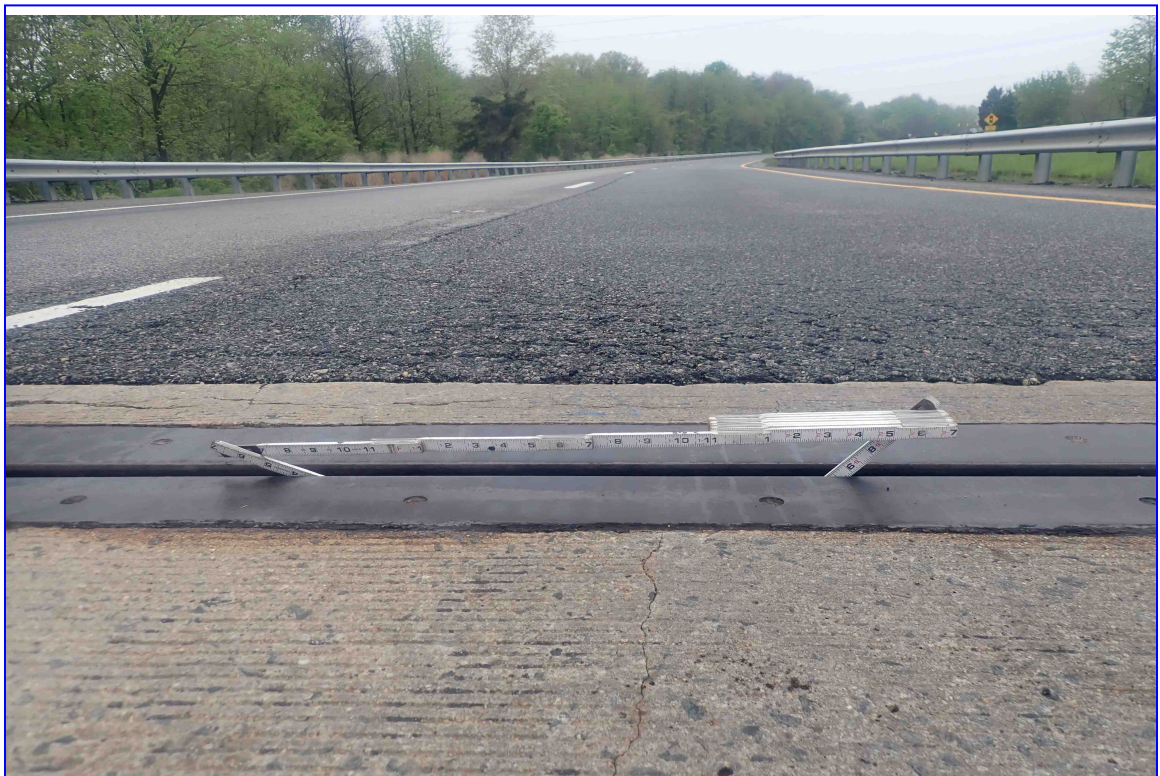
| Elm/Env | Description | Unit | Total Qty | Qty. St. 1 | Qty. St. 2 | Qty. St. 3 | Qty. St. 4 | Notes |
|---|---|---|---|---|---|---|---|---|
| 300/4 | Strip Seal Exp Joint | ft | 43.00 | 23.00 | 5.00 | 13.00 | 2.00 | 2330 CS4-2 LF: STRIP SEAL JOINT GLAD IS PERFORATED & WATER IS LEAKING ~28-29 FT FROM SOUTH END (PHOTO 10 & 11).<br>2360 CS3-1 LF: STRIP SEAL JOINT HEADER RUST STAINED CRACKS NEAR SOUTH END (PHOTO 12).<br>2360 CS3-3 LF: STRIP SEAL JOINT HEADER LG SPALLS ON NORTH AND S SHOULDERS (PHOTO 13).<br>2360 CS3-6 LF: STRIP SEAL JOINT HEADER ~3/4 INCH WIDE CRACK NEAR CENTER RD (PHOTO 14).<br>2370 CS3-3 LF: STRIP SEAL JOINT ARMOR CORROSION AND PITTING ON RANDOM EDGES (2020 PHOTO 11).<br>2360 CS2-5 LF: HEADER DELAMINATED AT RANDOM LOCATIONS. |

10. SPAN 1 STRIP SEAL JOINT GLAND PERFORATION ~28 FT FROM SOUTH END LOOK UP

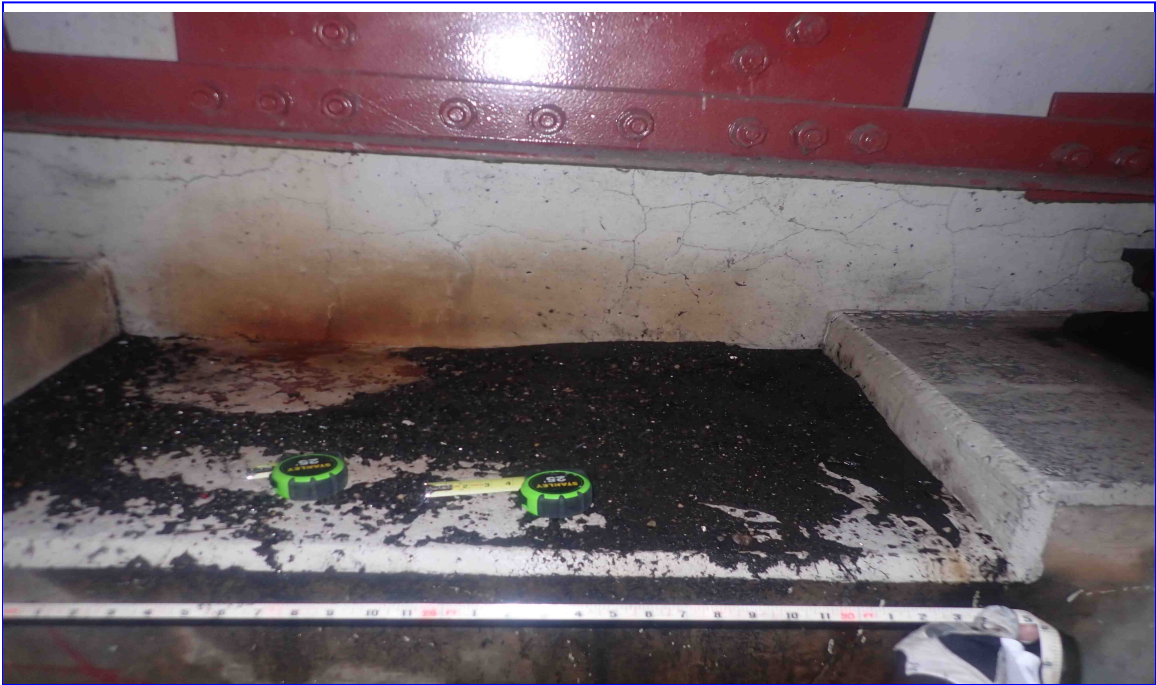
11. SPAN 1 STRIP SEAL JOINT IS LEAKING WATER & DEBRIS ON TOP OF W ABUT LOOK N

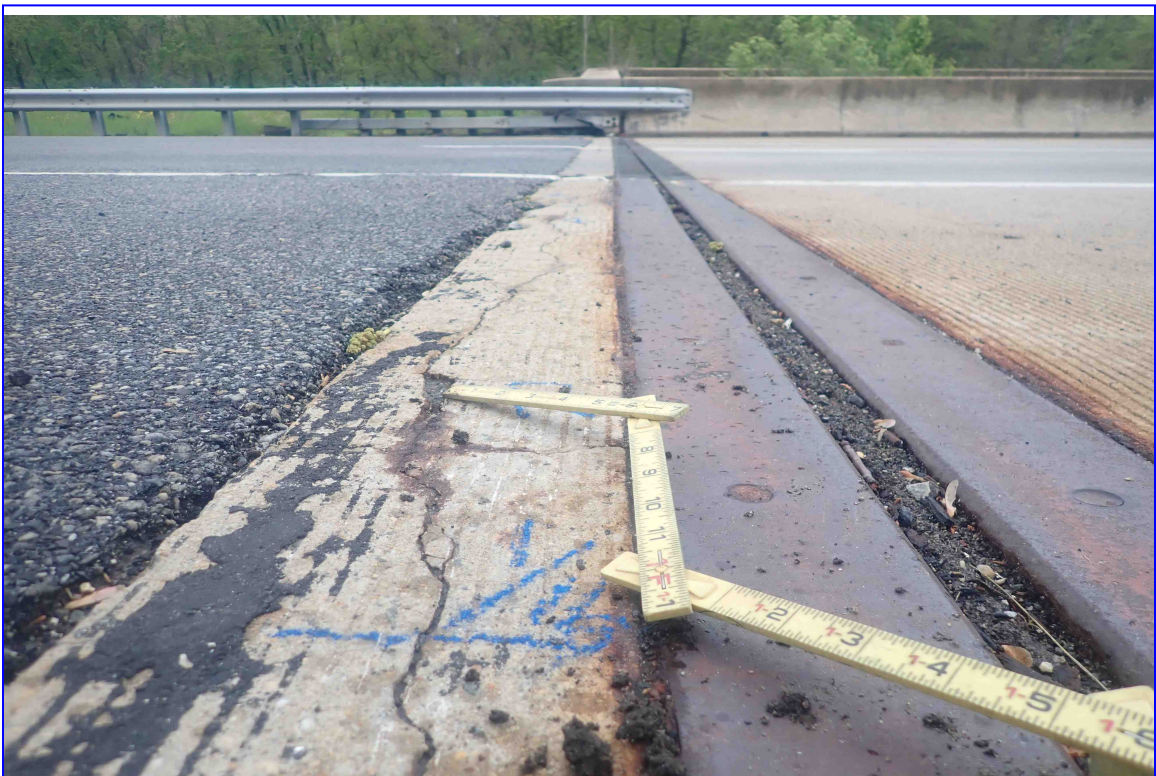
12. SPAN 1 STRIP SEAL HEADER RUST STAINED CRACK SOUTH SHOULDER LOOKING N

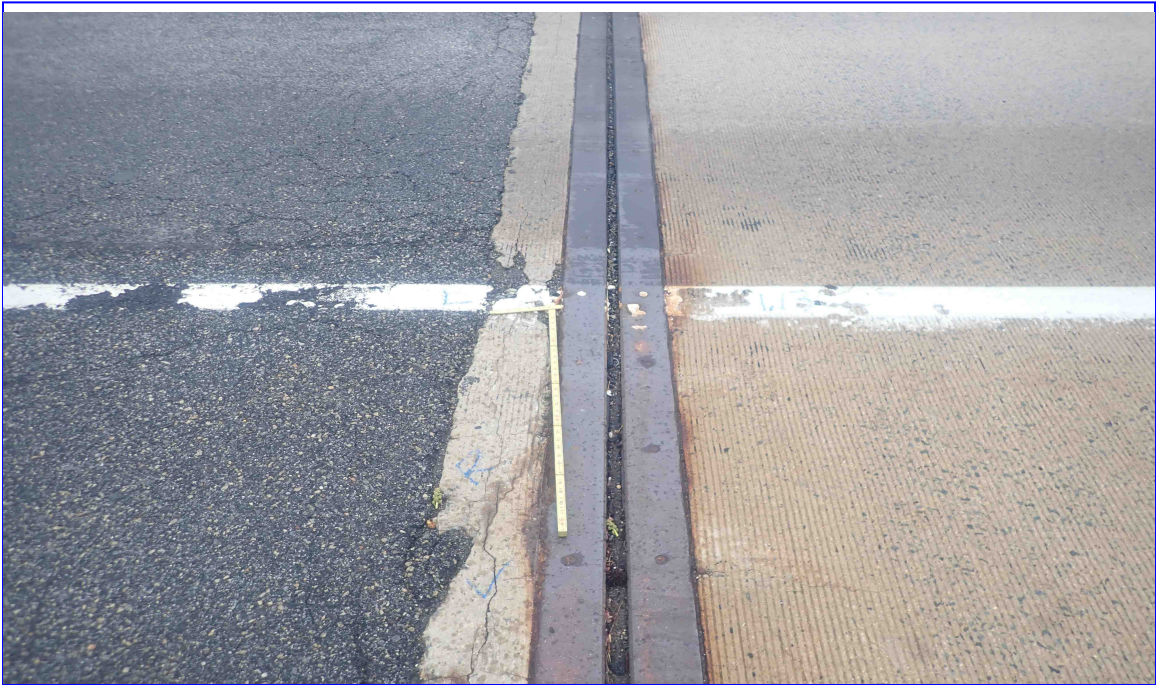
13. SPAN 1 STRIP SEAL HEADER SPALLS AT SOUTH SHOULDER & WHITE LINE LOOK N

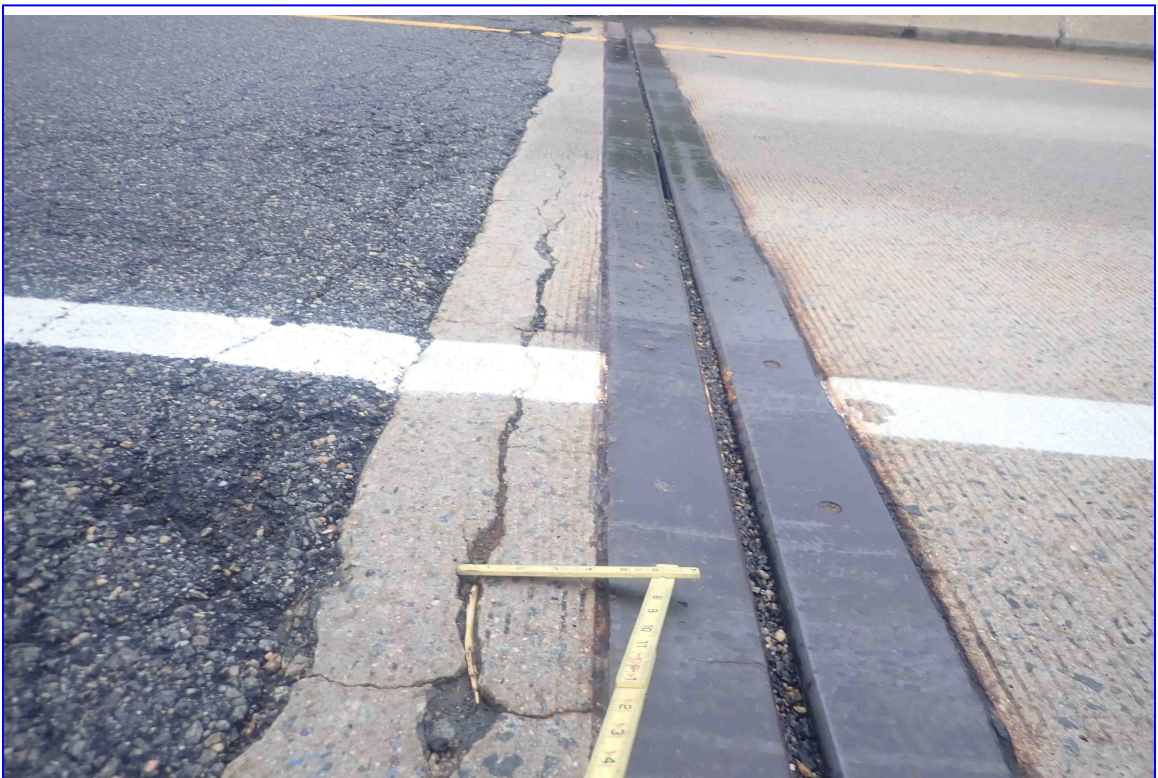
14. SPAN 1 STRIP SEAL W ABUT JOINT HEADER ~3/4 INCH WIDE CRACK AT CL RD LOOK N

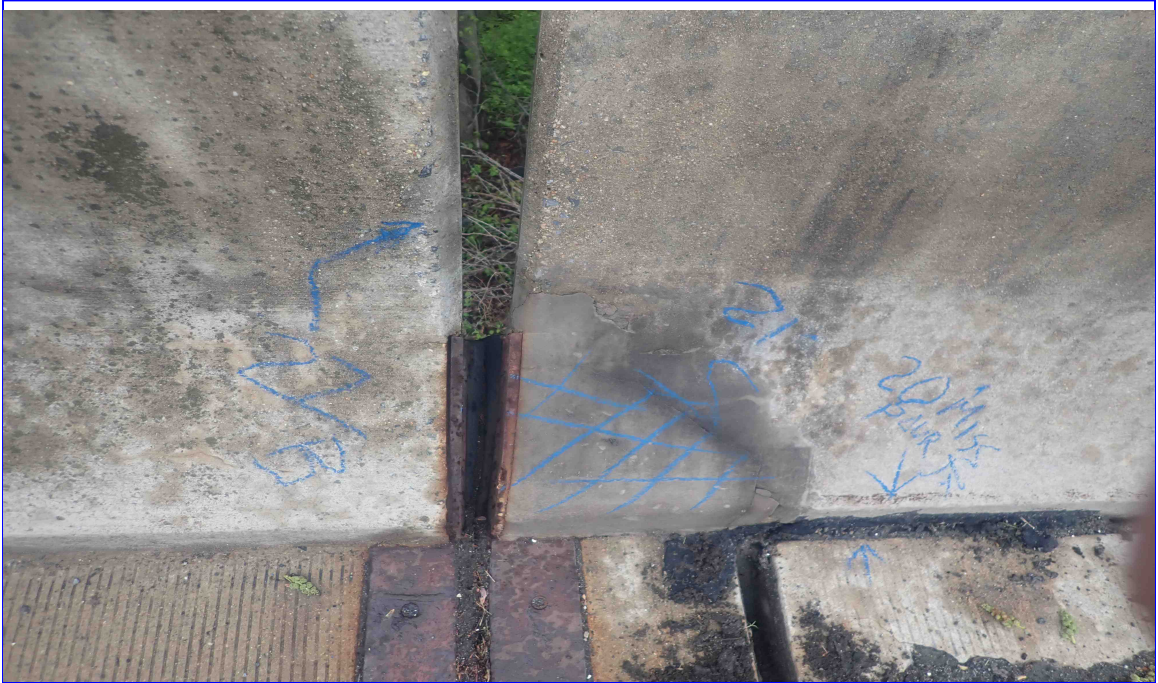
| Elm/Env | Description | Unit | Total Qty | Qty. St. 1 | Qty. St. 2 | Qty. St. 3 | Qty. St. 4 | Notes |
|---|---|---|---|---|---|---|---|---|
| 331/4 | Re Conc Bridge Railing | ft | 174.00 | 147.00 | 15.00 | 12.00 | 0.00 | 1080 CS3-07 LF: S RC RAIL ~ 12, 25, 36, 42, 68, 81 & 88 FT FROM W END HAS LG/DEEP SPALLS AT THE BOTTOM (PHOTO 15).<br>1080 CS3-05 LF: N RC RAIL ~1, & FT FROM WEST END HAS SMALL/SALLOW SPALLS AT BOTTOM AT W ABUT.<br>1120 CS2-12 LF: N & S RAILS HAVE EFFLORESCENCE AT JOINTS & RANDOM CRACKS ON S FACE OF SW WING & NW MEDIAN.<br>1090 CS2-02 LF: N RC RAIL ~62 & 64 FT FROM W END HAS EXPOSED BARS DUE TO LACK OF COVER ON S FACE NEAR TOP.<br>1090 CS2-01 LF: S RC RAIL ~22 FT FROM W END AT JOINT BETWEEN JOINT EXPOSED BAR DUE TO LACK OF COVER. |

15. SPAN 1 S RC RAIL DELAM CURB PATCH ~22 FT FROM WEST END NORTH FACE LOOK S

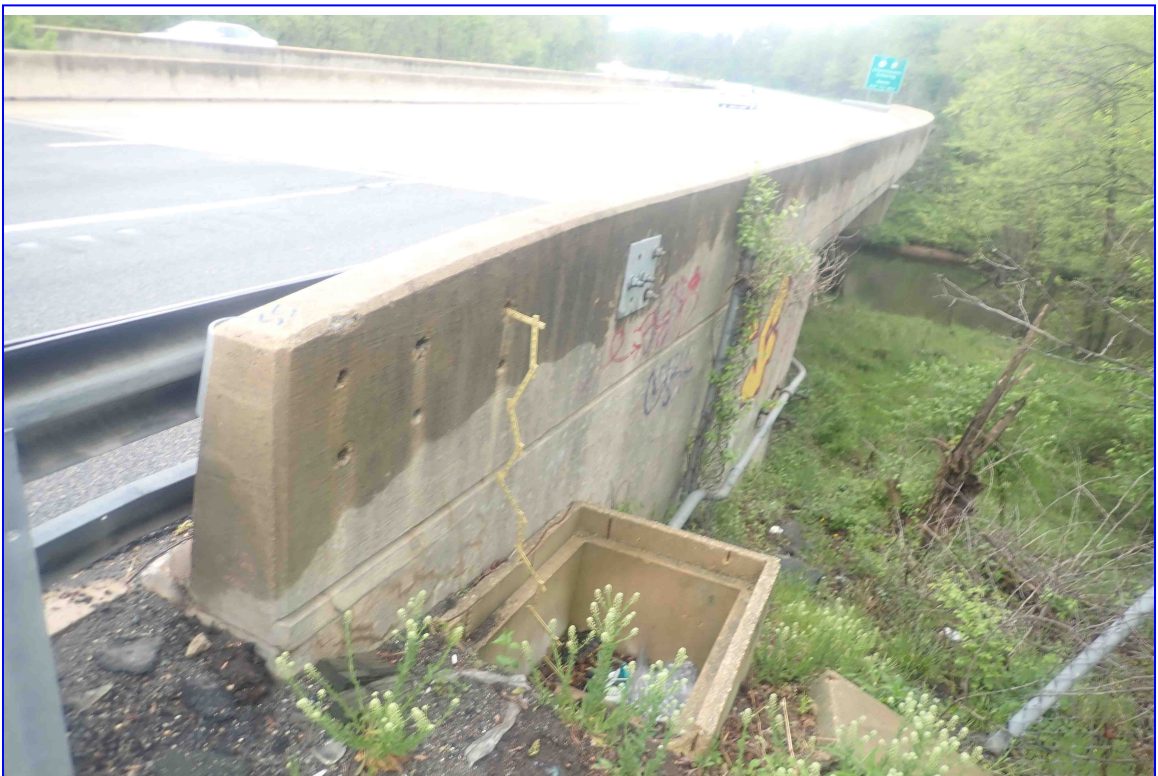
16. SPAN 1 S RC RAIL DEEP GUARDRAIL ATTACHMENT HOLES & OPEN UTILITY COVER LOOK E

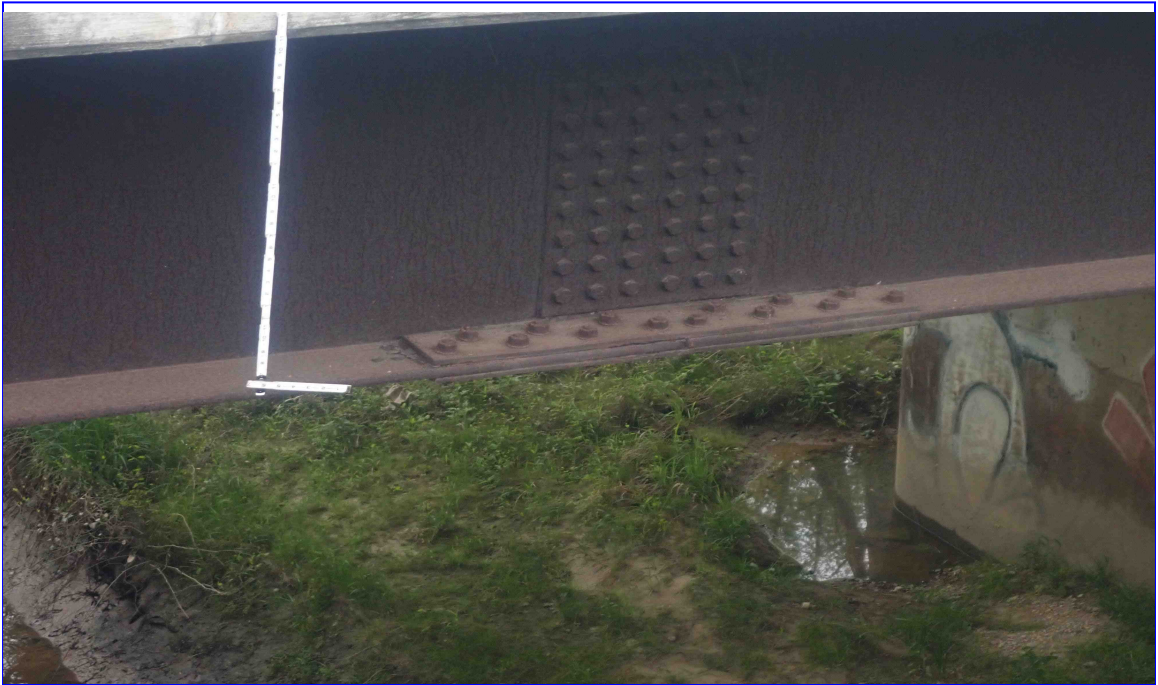
| Elm/Env | Description | Unit | Total Qty | Qty. St. 1 | Qty. St. 2 | Qty. St. 3 | Qty. St. 4 | Notes |
|---|---|---|---|---|---|---|---|---|
| 107/2 | Steel Opn Girder/Beam | ft | 522.00 | 180.00 | 338.00 | 4.00 | 0.00 | 1000 CS3-004 LF: NORTH EXTERIOR WEATHERING STEEL GIRDER HAS LAMINAR PACK RUST AT SPLICE PLATES (PHOTO 17).<br>1000 CS2-167 LF: RANDOM ~3/8 INCH DIAMETER FLAKES OF CORROSION PRIMARILY ON N & S FACIA GIRDERS.<br>1000 CS2-171 LF: RANDOM GRANULAR CORROSION PRIMARILY ON THE INTERIOR GIRDERS.<br>(NO CHANGE 2022) |

17. SPAN 2 N GIRDER SPLICE, CORROSION FLAKES & PACK RUST BETWEEN PLATES LOOK S

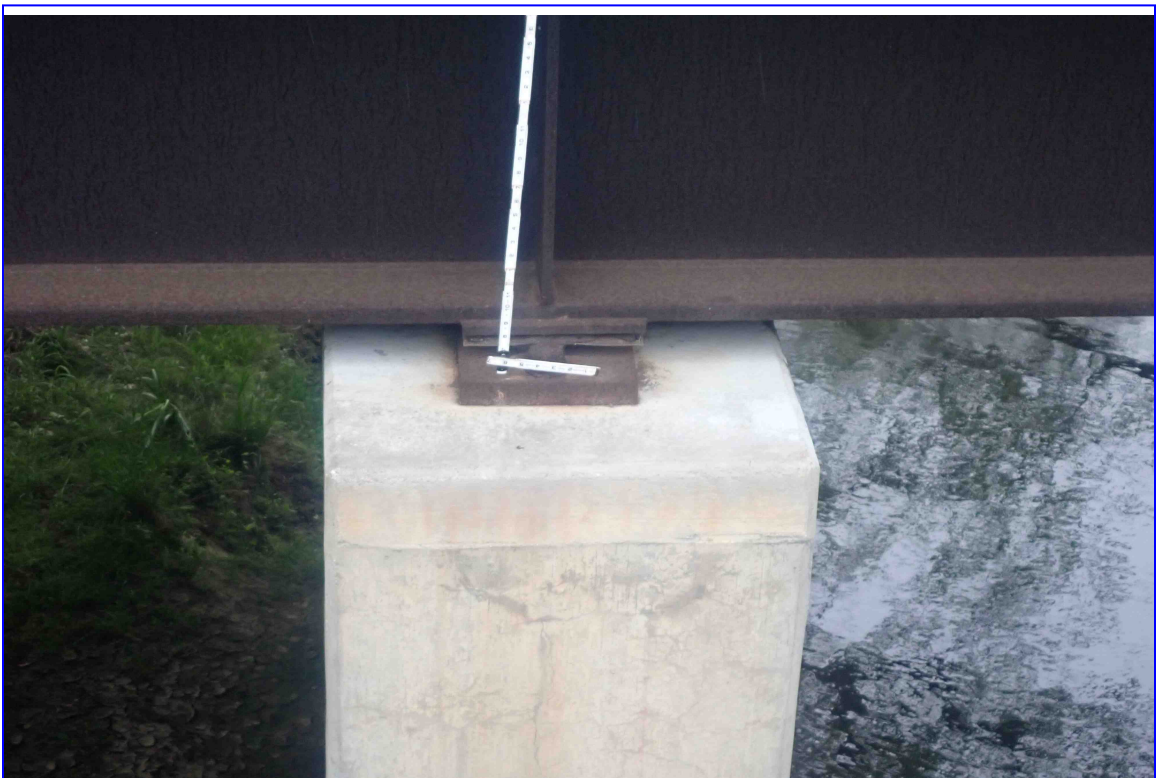
| Elm/Env | Description | Unit | Total Qty | Qty. St. 1 | Qty. St. 2 | Qty. St. 3 | Qty. St. 4 | Notes |
|---|---|---|---|---|---|---|---|---|
| 815/2 | Weathering Steel Protection | sq.ft | 5,610.00 | 1,934.00 | 0.00 | 3,633.00 | 43.00 | CS4-0043 SF: NORTH EXTERIOR WEATHERING STEEL GIRDER HAS LAMINAR PACK RUST AT SPLICE PLATE (PH 18).<br>CS3-3633 SF: RANDOM ~3/8 INCH DIAMETER FLAKES OF CORROSION PRIMARILY ON N & S FACIA GIRDERS AND RANDOM GRANULAR CORROSION PRIMARILY ON THE INTERIOR GIRDERS.<br>(~NO CHANGE 2022) |
| 311/2 | Moveable Bearing | each | 6.00 | 4.00 | 0.00 | 2.00 | 0.00 | 1000 CS3-2 EA: LARGE FLAKES OF CORROS ON SOLE PLATE OF FACIA GIRDERS & LATERAL DISPLACE (PH18 & 2020 PH18).<br>NOTE: GIRDER 2 BEARING IS ATTACHED TO THE GIRDER & FIXED Laterally WITH WELDED KEEPER PLATES.<br>(NO CHANGE 2022) |
| 815/2 | Weathering Steel Protection | sq.ft | 36.00 | 24.00 | 0.00 | 0.00 | 12.00 | CS4-12 SF: LRGE FLAKES OF CORROSION ON SOLE PLATE OF FACIA GIRDERS & LATERAL DISPLACEM (PH 18 & 2020 PH18).<br>(~NO CHANGE 2022) |

18. SPAN 2 PIER 2, N FACIA BEARING MISALIGN, TEPHLON PL SEPARATION & CORROS LOOK S

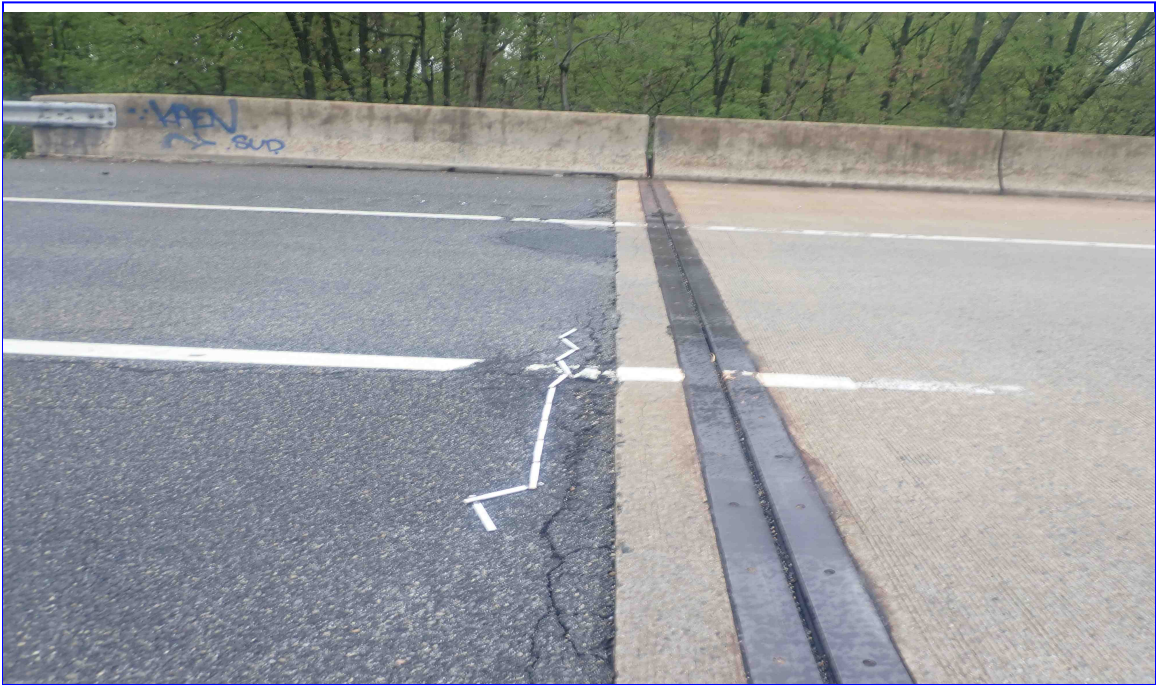
| Elm/Env | Description | Unit | Total Qty | Qty. St. 1 | Qty. St. 2 | Qty. St. 3 | Qty. St. 4 | Notes |
|---|---|---|---|---|---|---|---|---|
| 811/4 | Asphaltic Conc. Wearing Surface | sq.ft | 1,025.00 | 1,010.00 | 10.00 | 5.00 | 0.00 | 3210 CS3-05 SF: EAST APPROACH SLAB ASPHALT OVERLAY HAS DEEP SPALLS OVER E ABUTMENT AT RANDOM (PH 19).<br>3220 CS2-10 SF: EAST APPROACH SLAB ASPHALT OVERLAY HAS CRACKS NEAR EAST ABUTMENT IN TRAFFIC LANES (PH 19). |

19. SPAN 3 E APPR SLAB LG ASPHALT WEARING SURFACE SPALLS & ~1/2 INCH CRACK LOOK S

INSPECTION BY: DSOBOTA(TL,I,P,S), SKOMAR(R)  
ADDITIONAL MAXIMO MAINTENANCE:  
1205263 B007-S1H: CLEAN & RESEAL MISSING POURED JOINTS AT S ABUT / SE & SW WINGWALL  
RAIL TO APPROACH SLABS.  
1205264 B022-S1D: REMOVE CRACKED/DELAM ASPHALT. THEN REPAIR ASPHALT APPROACH SLAB  
SPALLS & SEAL HOT MIX ASPHALT CRACKS.

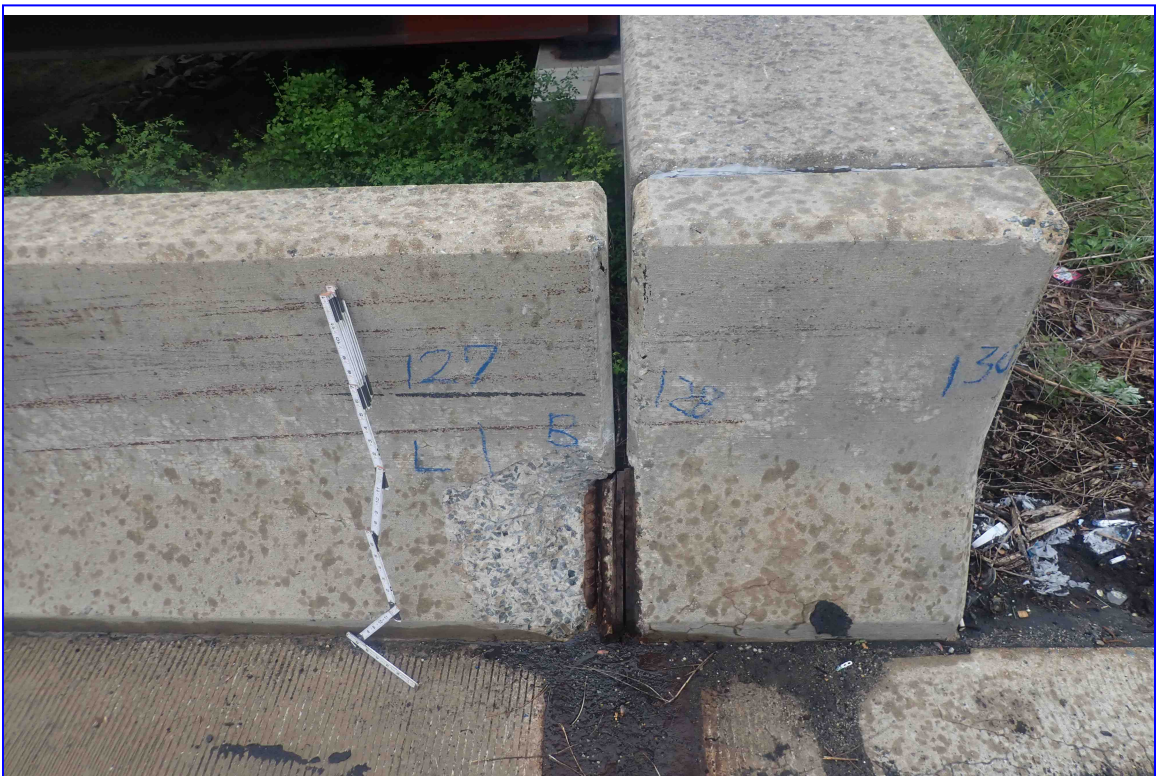
| Elm/Env | Description | Unit | Total Qty | Qty. St. 1 | Qty. St. 2 | Qty. St. 3 | Qty. St. 4 | Notes |
|---|---|---|---|---|---|---|---|---|
| 331/4 | Re Conc Bridge Railing | ft | 174.00 | 158.00 | 12.00 | 4.00 | 0.00 | 1080 CS3-01 LF: N RC RAIL ~127 FT FROM W END LG/DEEP SPALLS AT BOTTOM OF S FACE (PHOTO 20).<br>1080 CS3-03 LF: S RC RAIL ~201, 260 & 265 FT FROM W END HAS LG/DEEP SPALLS AT BOTTOM OF N FACE.<br>1080 CS2-01 LF: S RC RAIL ~231 FT FROM W END HAS SMALL SPALL/DELAM AT BOTTOM OF N FACE.<br>1090 CS2-01 LF: N RC RAIL ~128 FT FROM W END HAS EXPOSED UNPITTED BAR ON S FACE (PHOTO 20).<br>1120 CS2-10 LF: N & S RAILS HAVE EFFLORESCENCE AT JOINTS AND ON OUTSIDE FACE ABOVE SE WINGWALL. |

20. SPAN 3 N RC RAIL ~127-128 FT FROM W END PITTED BAR & LG SPALL S FACE LOOK N
