Bridge ID: 1279W003

6) Feature Intersected: CHRISTINA RIVER

7) Facility Carried: CHRISTIANA BYPASS

90) Inspection Date: 5/3/2022

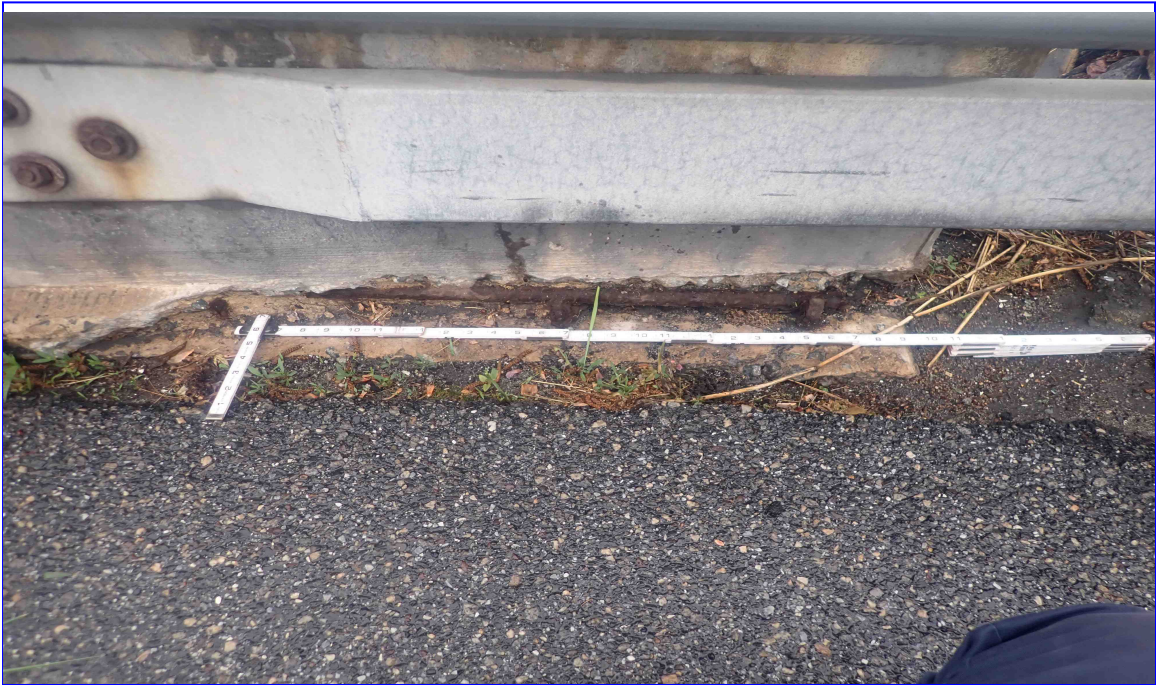
| Elm/Env | Description | Unit | Total Qty | Qty. St. 1 | Qty. St. 2 | Qty. St. 3 | Qty. St. 4 | Notes |
|---|---|---|---|---|---|---|---|---|
| 331/4 | Re Conc Bridge Railing | ft | 151.00 | 141.00 | 2.00 | 8.00 | 0.00 | CS-3=3 LF: LARGE, DEEP SPALL EXPOSING BAR WITH LOSS OF SECTION ON THE EAST END OF THE NORTH RAIL (PHOTO 7)<br>CS-3=5 LF: DEEP SPALL AT BOTTOM OF NORTH (3 LF) AND SOUTH (2 LF) RAIL INTERIOR FACES. (PHOTO 8)<br>CS-2=2 LF: CRACKS WITH EFFLO ON THE SOUTH FACE OF THE NORTH RAIL NEAR MID SPAN .<br>CS-1= LF: SUPERFICIAL VERTICAL CACKS AT RANDOM LOCATIONS.<br>(NC-22)<br>NOTE: FORMWORK POPOUTS ON THE INTERIOR FACE OF THE NORTH RAIL |

7. SPAN 3, NORTH CONCRETE RAIL EXPOSED PITTED BAR EAST END ON S FACE LOOK N

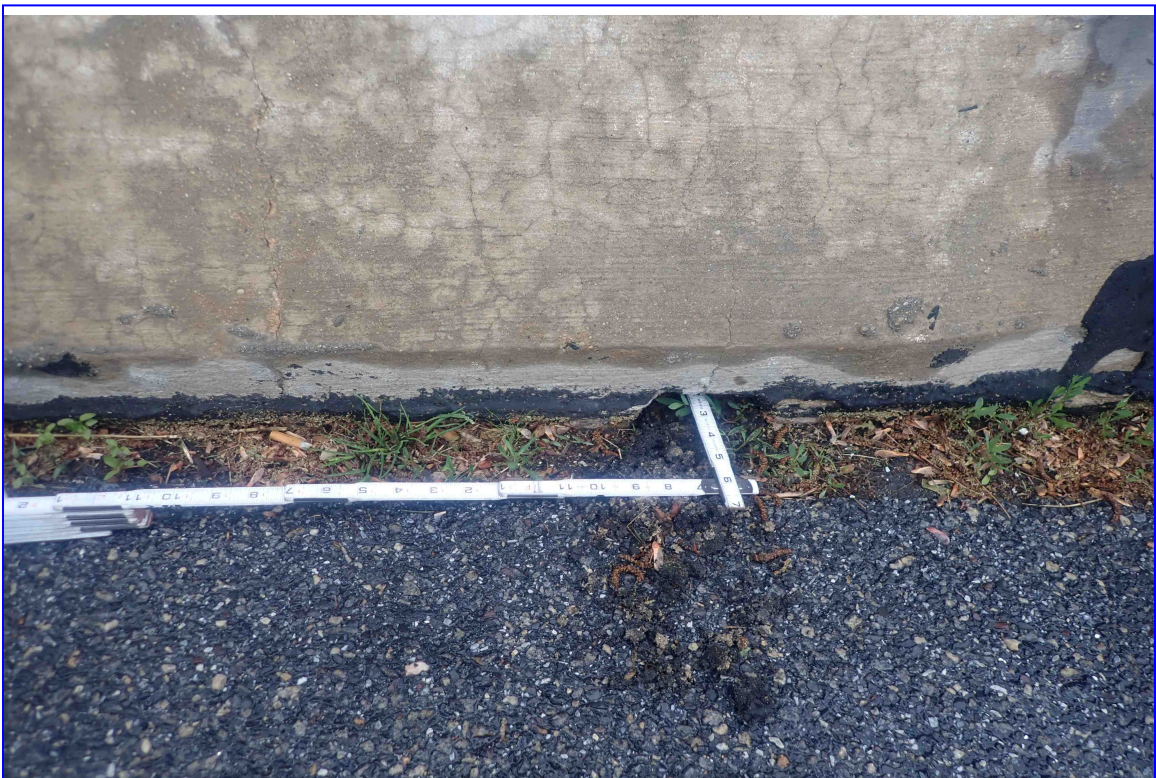
8. SPAN 3 NORTH CONCRETE RAIL, DEEP SPALL IN SOUTH CURB FACE LOOKING N

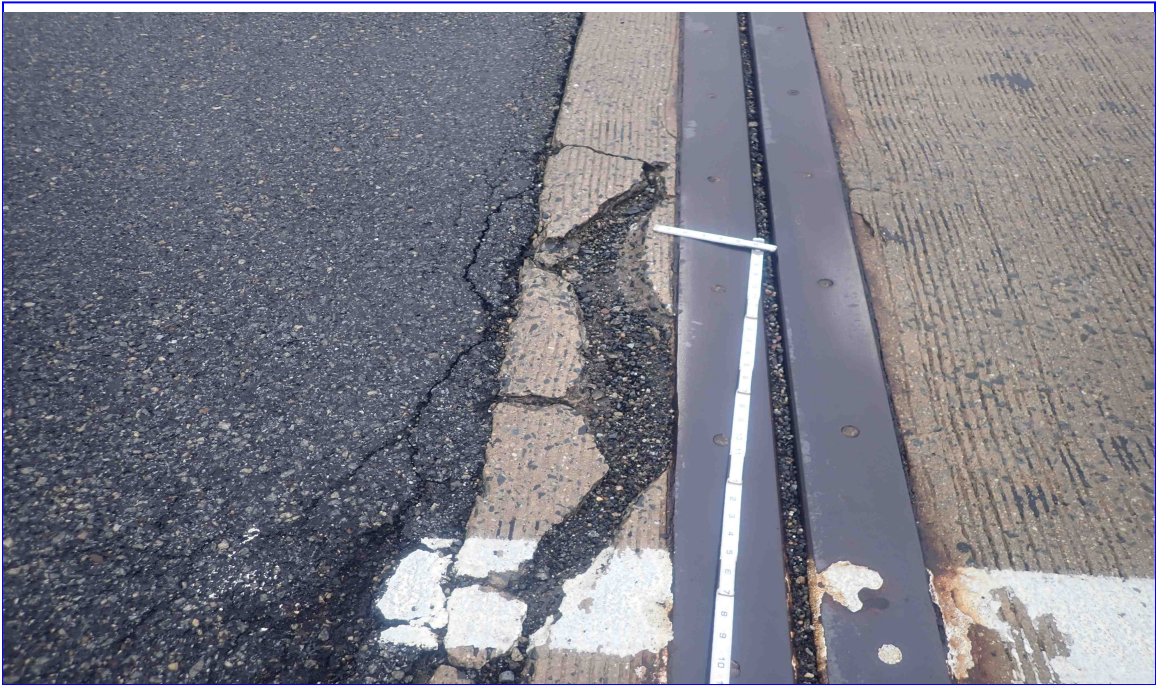
| Elm/Env | Description | Unit | Total Qty | Qty. St. 1 | Qty. St. 2 | Qty. St. 3 | Qty. St. 4 | Notes |
|---|---|---|---|---|---|---|---|---|
| 300/4 | Strip Seal Exp Joint | ft | 45.00 | 0.00 | 43.00 | 2.00 | 0.00 | CS-3=2 LF: DEEP SPALL IN THE JOINT HEADER AT THE CENTER OF THE LEFT LANE. (PHOTO 9)<br>CS-2=6 LF: SHALLOW SPALLS ALONG EDGE OF HEADER IN BOTH TRAVEL LANES AND IN THE NORTH SHOULDER.<br>CS-2=37 LF: MINOR CRACKS w/ AREAS OF DELAM ALONG HEADER. |

9. SPAN 3 STRIP SEAL JOINT HEADER LARGE SPALL IN THE LEFT LANE LOOK DOWN & S

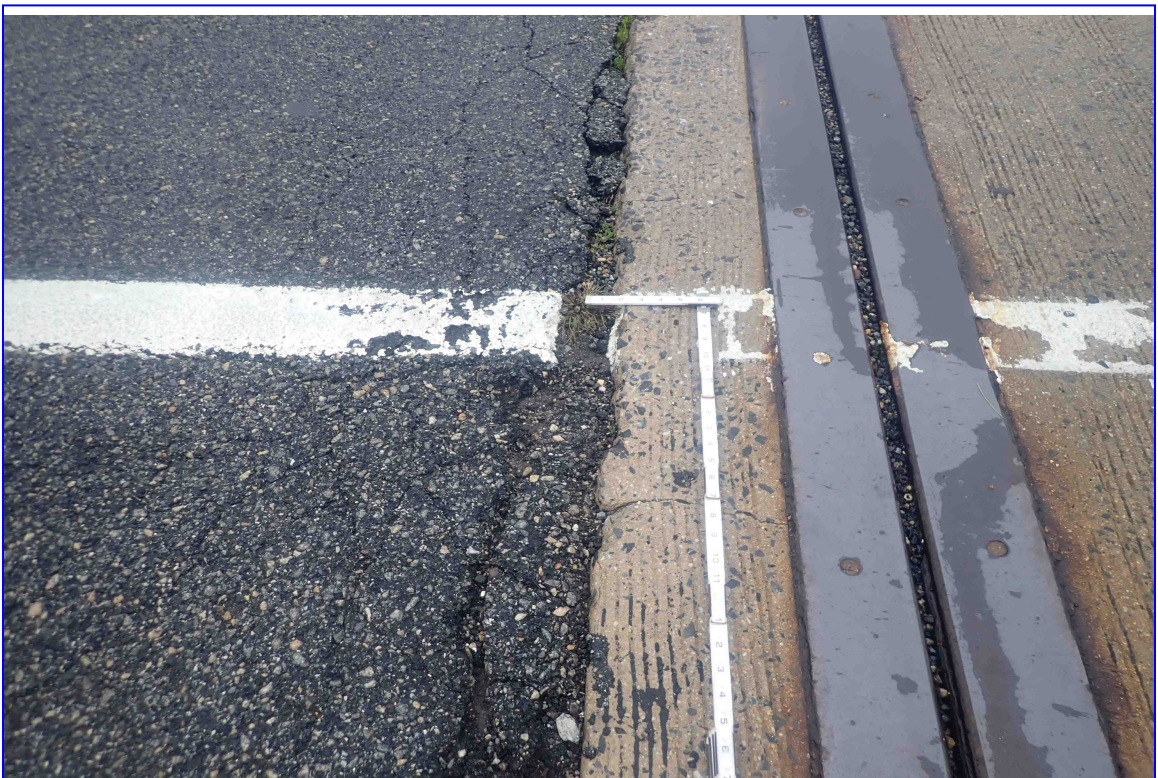
| Elm/Env | Description | Unit | Total Qty | Qty. St. 1 | Qty. St. 2 | Qty. St. 3 | Qty. St. 4 | Notes |
|---|---|---|---|---|---|---|---|---|
| 811/1 | Asphaltic Conc. Wearing Surface | sq.ft | 1,088.00 | 1,063.00 | 0.00 | 25.00 | 0.00 | CS-3=25 SF: LARGE, DEEP EDGE SPALLS IN THE AC OVERLAY IN BOTH TRAVEL LANES AT THE JOINT HEADER INTERFACE. (PHOTO 10)<br>CS-1= SF: NDN. |

10. SPAN 3 E APPR SLAB LARGE DEEP SPALLS IN ASPHALT OVERLAY AT HEADER LOOK S

B022-S1D: REPAIR SPALLS IN AC OVERLAY AT BOTH WEST AND EAST APPROACH SLABS ALONG  
THE JOINT HEADER. (WO# 1205855)

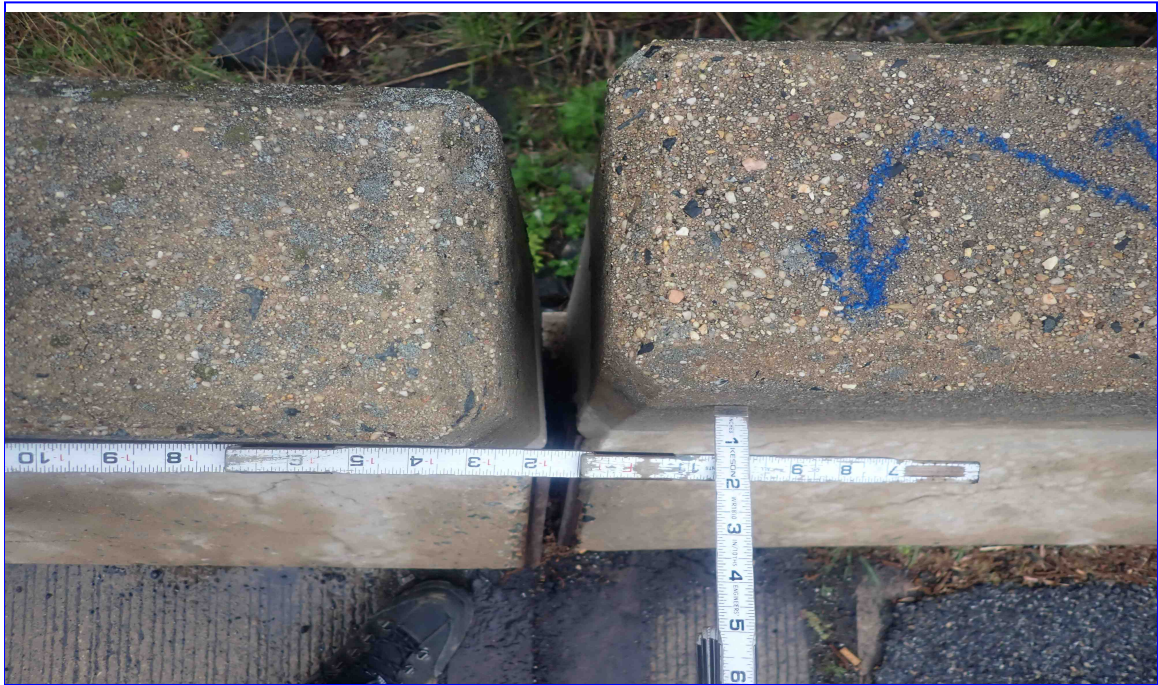
| Elm/Env | Description | Unit | Total Qty | Qty. St. 1 | Qty. St. 2 | Qty. St. 3 | Qty. St. 4 | Notes |
|---|---|---|---|---|---|---|---|---|
| 890/2 | RC Wingwalls | (LF) | 15.00 | 14.00 | 1.00 | 0.00 | 0.00 | CS-2=1 LF: TOP OF NORTHEAST WINGWALL RC RAIL<br>TILTING NORTH 1 1/4 INCHES. (PHOTO 11)<br>CS-1= LF: SUPERFICIAL MAP CRACKING TYP. |

11. SPAN 3 NE WING/ RC RAIL SETTLED-TOP ROTATING N ~1-1/4" AT E ABUT LOOK N

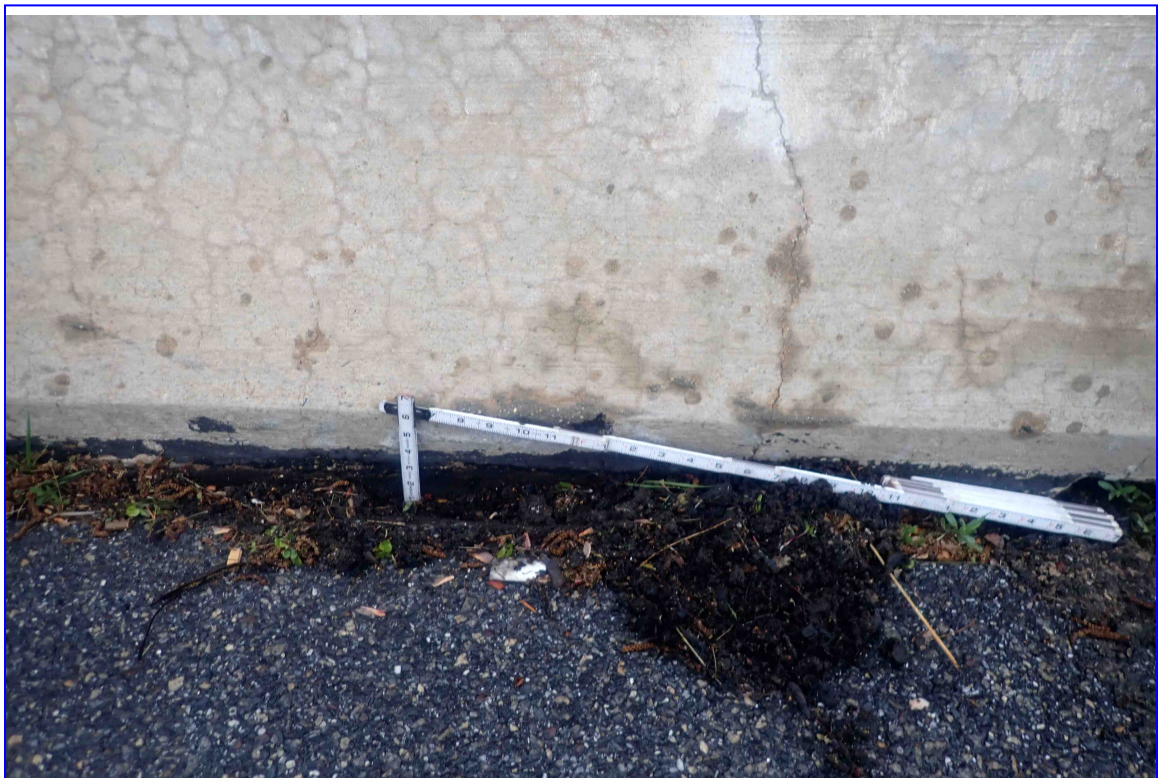
| Elm/Env | Description | Unit | Total Qty | Qty. St. 1 | Qty. St. 2 | Qty. St. 3 | Qty. St. 4 | Notes |
|---|---|---|---|---|---|---|---|---|
| 301/1 | Pourable Joint Seal | ft | 15.00 | 0.00 | 0.00 | 0.00 | 15.00 | CS-4=15 LF: THE POUR JOINT IS MISSING/ FULLY DEBONDED FOR THE ENTIRE LENGTH. (PHOTO 12) (NC-22)<br>NOTE: POURED JOINT ONLY EXISTS ALONG LENGTH OF PARAPET OVER N/W WINGWALL. |

12. SPAN 3 POURED JOINT MISSING AT NORTHEAST WINGWALL PARAPET LOOKING N

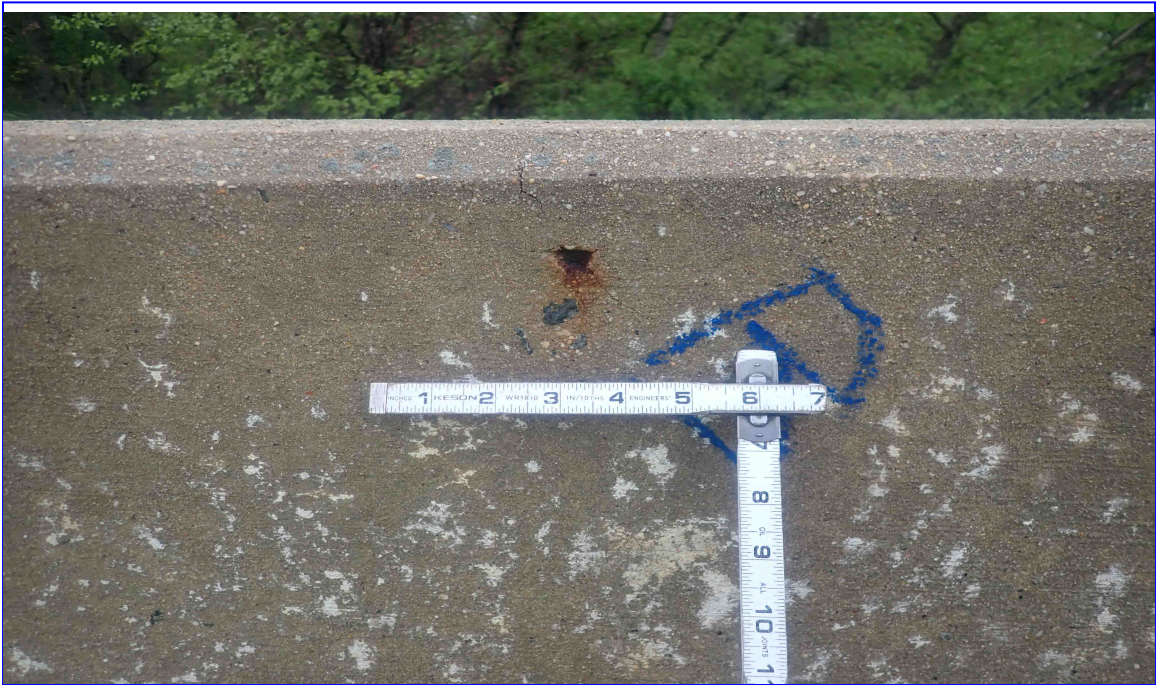
| Elm/Env | Description | Unit | Total Qty | Qty. St. 1 | Qty. St. 2 | Qty. St. 3 | Qty. St. 4 | Notes |
|---|---|---|---|---|---|---|---|---|
| 331/4 | Re Conc Bridge Railing | ft | 170.00 | 169.00 | 0.00 | 1.00 | 0.00 | CS-3= 1 LF: SMALL SPALL WITH EXPOSED REBAR IN SOUTH FACE OF NORTH RAIL NEAR WEST END (PHOTO 13)<br>CS-1= 1 LF: SUPERFICIAL VERTICAL CRACKS w/ SIGNS OF A.S.R. TYPICAL.<br>(NC-22) |

13. SPAN 2 NORTH CONCRETE RAIL SPALL & EXPOSED BAR ON SOUTH FACE LOOK N

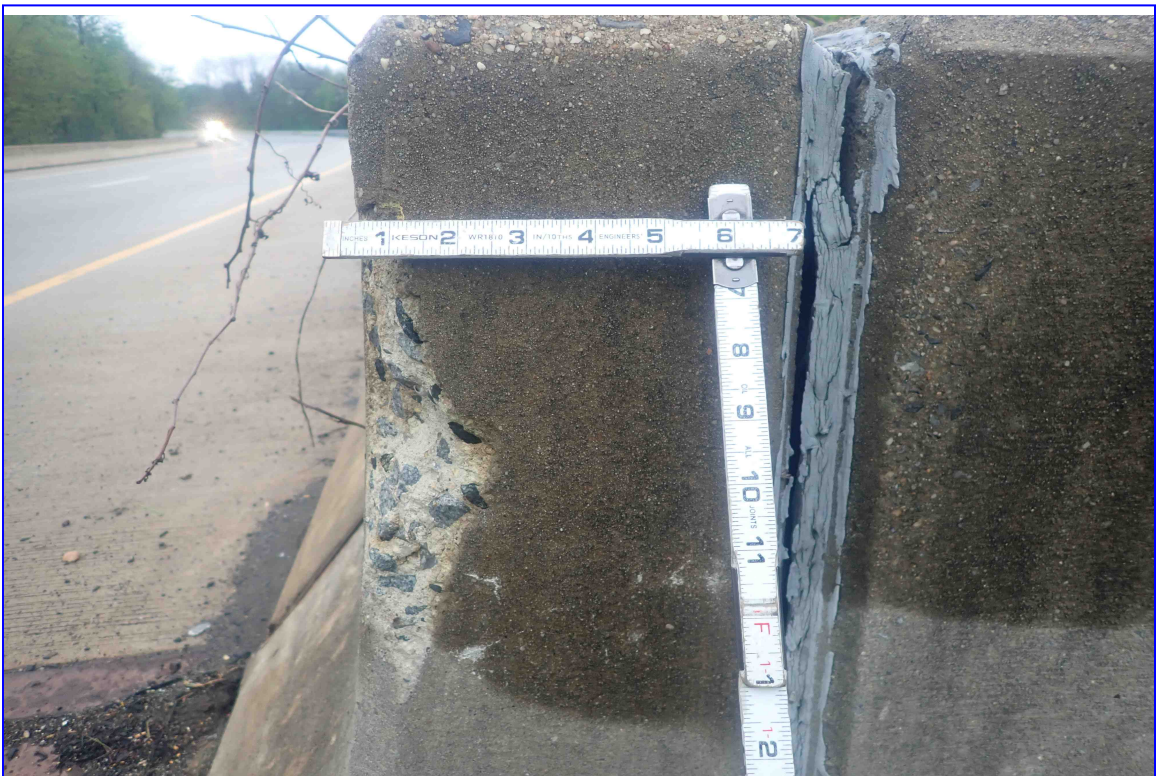
| Elm/Env | Description | Unit | Total Qty | Qty. St. 1 | Qty. St. 2 | Qty. St. 3 | Qty. St. 4 | Notes |
|---|---|---|---|---|---|---|---|---|
| 331/4 | Re Conc Bridge Railing | ft | 151.00 | 149.00 | 1.00 | 1.00 | 0.00 | CS-3=1 LF: DEEP SPALL AT THE NORTH WEST CORNER OF THE SOUTH RAIL. (PHOTO 14)<br>CS-2=1 LF: SHALLOW SPALL DUE TO LACK OF COVER WITH EXPOSED REBAR AT SOUTH FACE OF NORTH RAIL.<br>CS-1=149 LF: AT THE SOUTH FACE OF THE NORTH RAIL THERE ARE 2 FORMWORK HOLES AT RANDOM LOCATIONS. ADDITIONALLY, SUPERFICIAL VERTICAL CRACKS w/ SIGNS OF A.S.R. TYPICAL.<br>(NC-22) |

14. SPAN 1 SOUTH CONCRETE RAIL LARGE DEEP SPALL ON NORTHWEST CORNER LOOK E

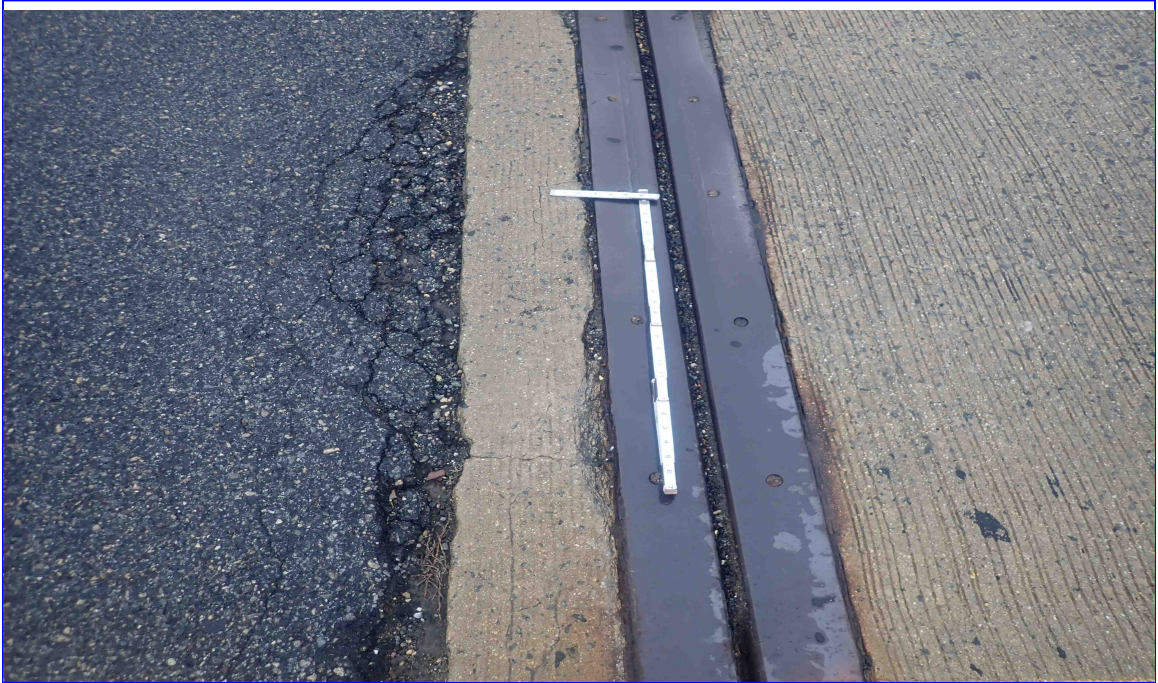
| Elm/Env | Description | Unit | Total Qty | Qty. St. 1 | Qty. St. 2 | Qty. St. 3 | Qty. St. 4 | Notes |
|---|---|---|---|---|---|---|---|---|
| 811/1 | Asphaltic Conc. Wearing Surface | sq.ft | 1,088.00 | 1,071.00 | 17.00 | 0.00 | 0.00 | CS-2=17 SF: SHALLOW EDGE SPALLS AND LONGITUDINAL CRACKS AT THE HEADER INTERFACE. (PHOTO 15)<br>CS-1= SF: NDN |

15. SPAN 1 STRIP SEAL JT HEADER LARGE SPALL RIGHT LN & APPR SLAB ASPH SPALL LOOK N

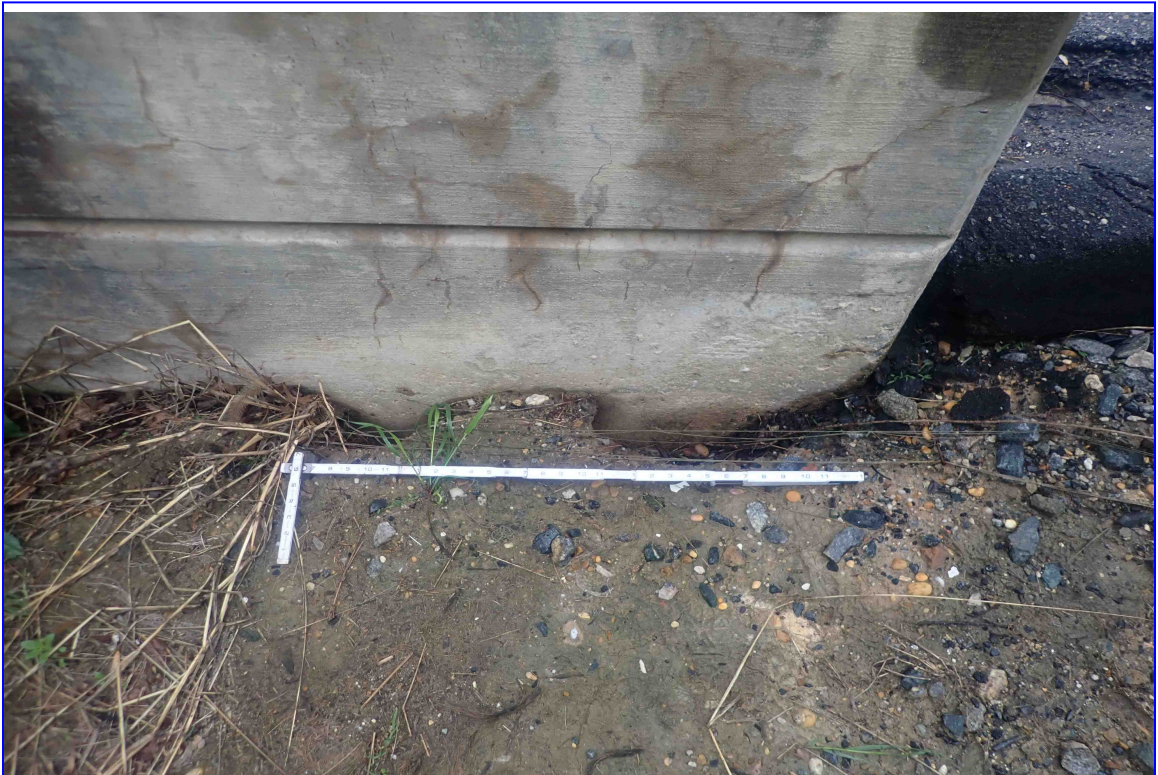
16. SPAN 1 EROSION HOLES AT NW NORTHWEST WINGWALL LOOKING SOUTH

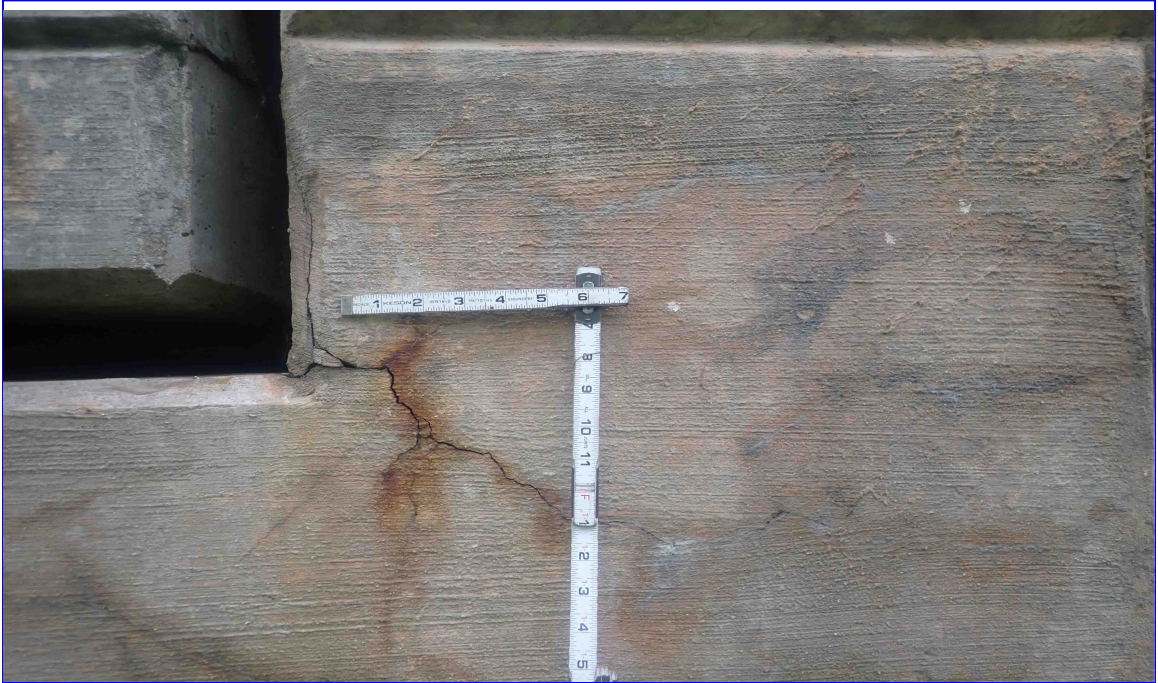
| Elm/Env | Description | Unit | Total Qty | Qty. St. 1 | Qty. St. 2 | Qty. St. 3 | Qty. St. 4 | Notes |
|---|---|---|---|---|---|---|---|---|
| 825/1 | R/C Abutment Backwall | ft | 41.00 | 40.00 | 0.00 | 1.00 | 0.00 | CS-3=1 LF: CRACK W/ RUST STAIN AT NORTH END. (PHOTO 17) |

17. SPAN 1 W ABUT BACKWALL CRACK & RUST STAIN AT NORTH END ON N FACE LOOK S

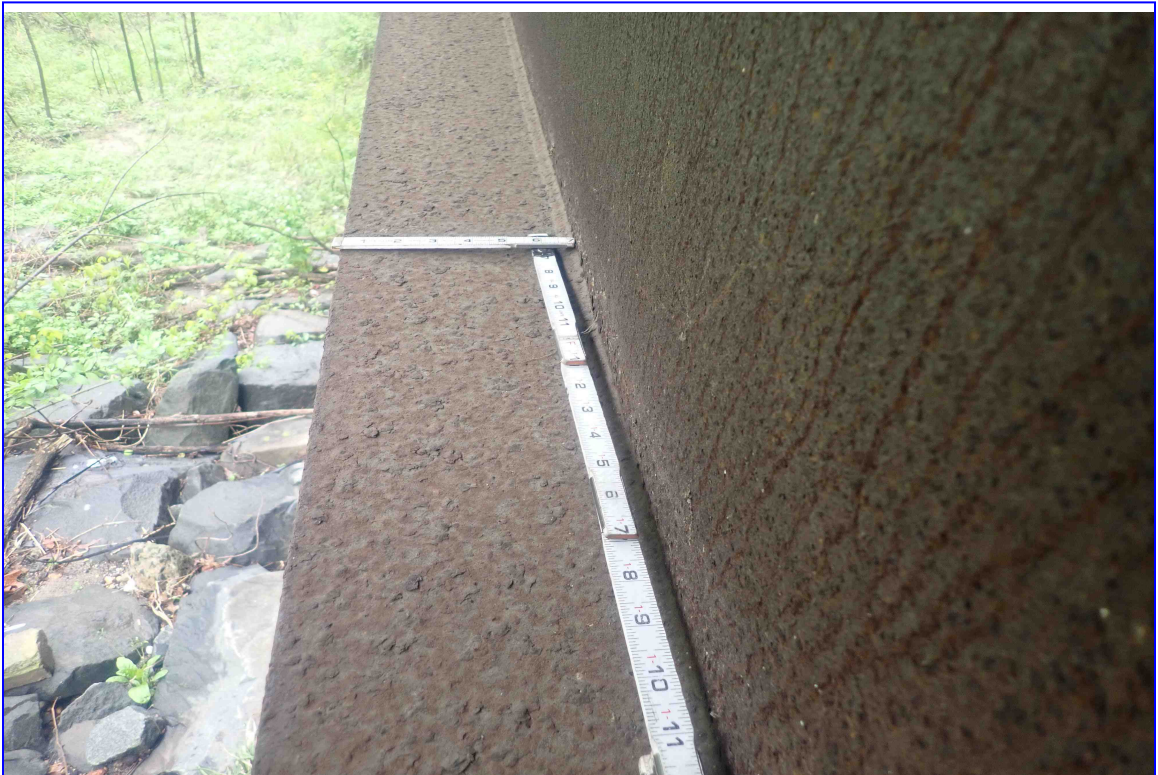
-BIE DETERMINED NBI SUPERSTRUCTURE RATING IS 6 SINCE WEATHERING STEEL CORROSION  
FLAKES ARE LESS THAN 1/2". MJM 6/16/22

| Elm/Env | Description | Unit | Total Qty | Qty. St. 1 | Qty. St. 2 | Qty. St. 3 | Qty. St. 4 | Notes |
|---|---|---|---|---|---|---|---|---|
| 107/2 | Steel Opn Girder/Beam | ft | 408.00 | 36.00 | 248.00 | 124.00 | 0.00 | CS-3=124 LF: ACTIVE CORROSION WITH SECTION LOSS ON EXTERIOR GIRDERS. UP TO 1/4-INCH FLAKES HAVE FORMED ALONG TOP OF EXTERIOR BOTTOM FLANGE ON FASCIA GIRDERS. (PHOTO 18)<br>CS-2=248 LF: ACTIVE CORROSION WITH SMALL FLAKES AT RANDOM LOCATIONS ON INTERIOR BEAMS.<br>CS-1=36 LF: NDN<br>(VISUAL INSPECTION ONLY. ASSUME NC-22) |

18. SPAN 1 N FACIA GRDR 1 HAS ~1/4 INCH CORROSION FLAKES ON TOP OF BOT FL LOOK E

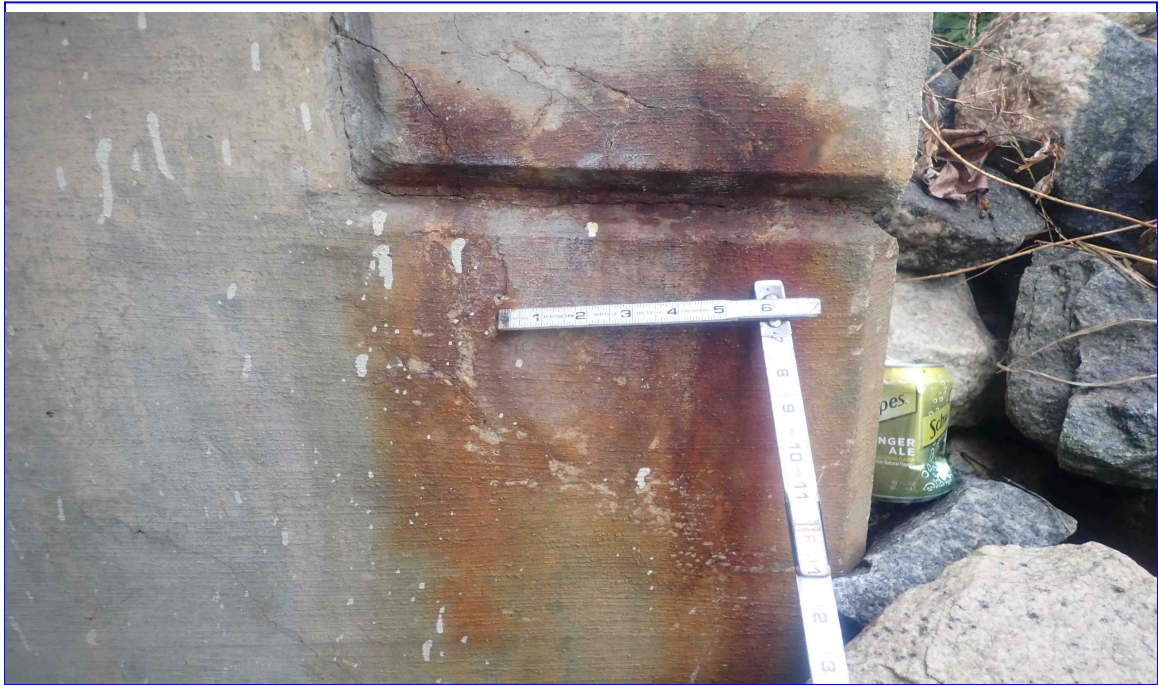
| Elm/Env | Description | Unit | Total Qty | Qty. St. 1 | Qty. St. 2 | Qty. St. 3 | Qty. St. 4 | Notes |
|---|---|---|---|---|---|---|---|---|
| 215/2 | Re Conc Abutment | ft | 52.00 | 49.00 | 2.00 | 1.00 | 0.00 | CS-3=1 LF: CRACK WITH RUST STAIN (PHOTO 19) AT NORTH END OF THE ABUTMENT.<br>CS-2=2 LF: 1/16" WIDE HORIZONTAL CRACKS IN THE MEDIAN AT THE NORTH END ADJACENT TO THE BACKWALL.<br>CS-1= LF: HAIRLINE VERTICAL CRACKS AT RANDOM LOCATIONS ON ABUTMENT. |

19. SPAN 1 WEST ABUTMENT BREASTWALL RUST STAIN & CRACK ON EAST FACE LOOK W

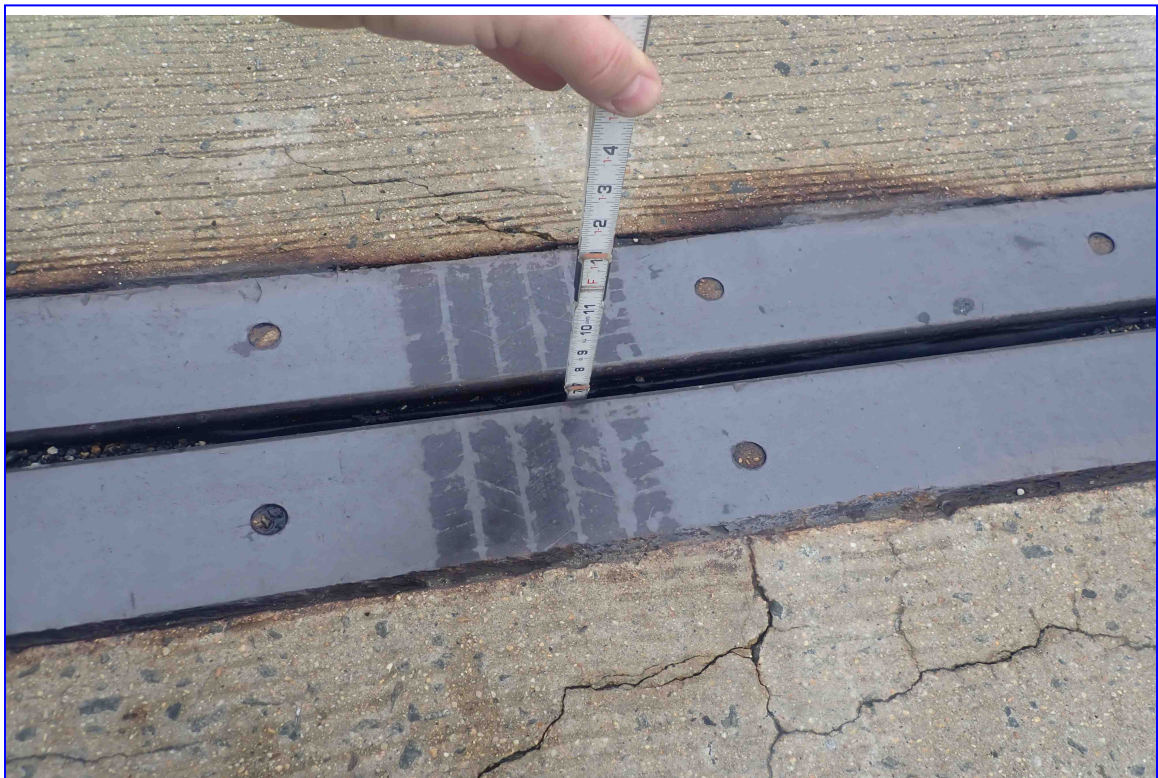
| Elm/Env | Description | Unit | Total Qty | Qty. St. 1 | Qty. St. 2 | Qty. St. 3 | Qty. St. 4 | Notes |
|---|---|---|---|---|---|---|---|---|
| 300/4 | Strip Seal Exp Joint | ft | 45.00 | 16.00 | 26.00 | 1.00 | 2.00 | CS-4=2 LF: THE GLAND PUNCTURED COMPLETELY THROUGH IN THE LEFT TRAVEL LANE NEAR THE WHITE LINE. (PHOTO 20)<br>CS-3=1 LF: DEEP SPALL IN THE HEADER AT THE RIGHT TRAVEL LANE. (PHOTO 15)<br>CS-2=5 LF: SHALLOW SPALLS ON THE LEFT TRAVEL LANE WITH MINOR CRACKING WITHIN THE SAME LINEAR FOOT.<br>CS-2=21 LF: DEBRIS BUILT UP WITHIN THE JOINT BUT FUNCTIONS AS INTENDED.<br>CS-1= LF: MINOR CRACKS ALONG THE HEADER. |

20. SPAN 1 STRIP SEAL GLAND IS TORN IN LEFT LANE NEAR WHITE LINE LOOK DOWN

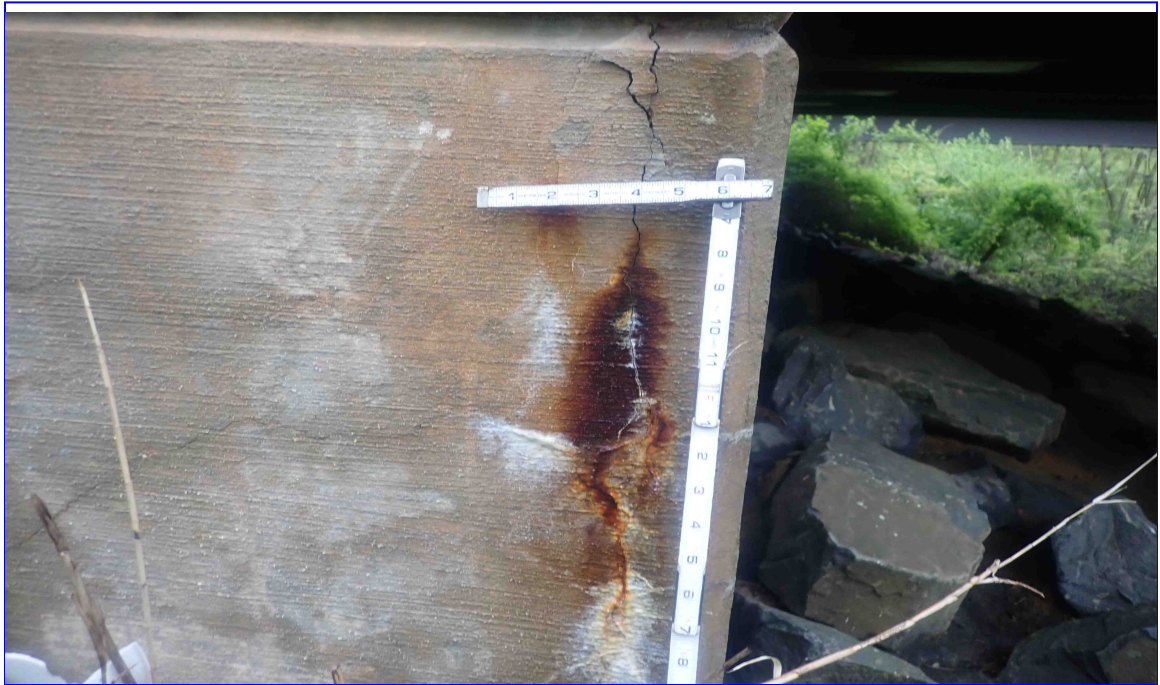
| Elm/Env | Description | Unit | Total Qty | Qty. St. 1 | Qty. St. 2 | Qty. St. 3 | Qty. St. 4 | Notes |
|---|---|---|---|---|---|---|---|---|
| 215/2 | Re Conc Abutment | ft | 52.00 | 51.00 | 0.00 | 1.00 | 0.00 | CS-3=1 LF: SUPERFICIAL CRACK WITH RUST STAINING AT NORTH END, NORTH FACE (PHOTO 21)<br>CS-1= LF: HAIRLINE VERTICAL CRACKS AT RANDOM LOCATIONS. |

21. SPAN 3 EAST ABUTMENT BREASTWALL CRACK & RUST STAIN AT NORTH END LOOK S

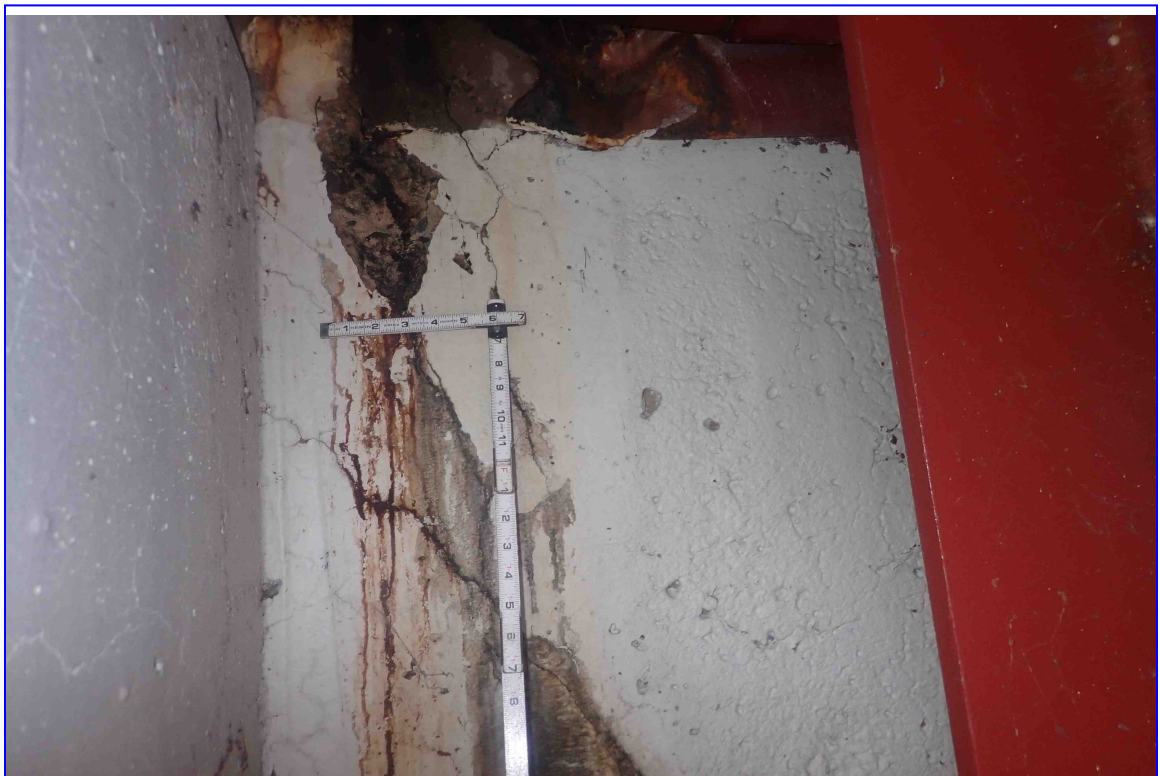
| Elm/Env | Description | Unit | Total Qty | Qty. St. 1 | Qty. St. 2 | Qty. St. 3 | Qty. St. 4 | Notes |
|---|---|---|---|---|---|---|---|---|
| 825/1 | R/C Abutment Backwall | ft | 41.00 | 40.00 | 0.00 | 1.00 | 0.00 | CS-3=1 LF: SHALLOW SPALL WITH RUST STAINING<br>SUPERFICIAL CRACK AT THE NORTH END (PHOTO<br>22)<br>CS-1= LF: MAP CRACKING TYP. IN ABUTMENT<br>BACKWALL. |

22. SPAN 3 E ABUTMENT BACKWALL RUST STAIN, SHALLOW SPALL & CRACK AT N END LOOK E

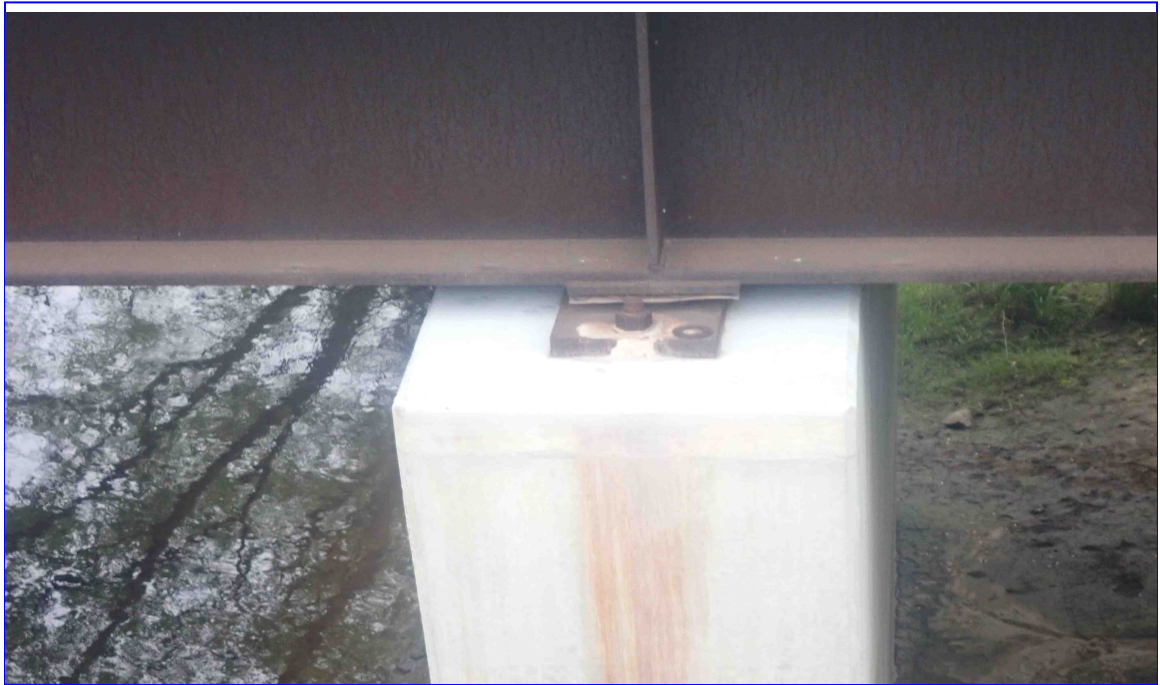
| Elm/Env | Description | Unit | Total Qty | Qty. St. 1 | Qty. St. 2 | Qty. St. 3 | Qty. St. 4 | Notes |
|---|---|---|---|---|---|---|---|---|
| 311/2 | Moveable Bearing | each | 6.00 | 0.00 | 3.00 | 3.00 | 0.00 | PIER 2<br>CS-3=3 EA: MODERATE CORROSION ON BEARINGS(1,4,6) BETWEEN SOLE PLATE & SLIDING PLATE, NOT HINDERING MOVEMENT OF BEARING. (2020 PHOTO 19)<br>CS-2=3 EA: FRECKLED RUST ON INTERIOR BEARINGS.<br>(VISUAL INSPECTION ONLY. ASSUME NC-22)<br>NOTE: SEPARATION OF THE TEFLON PLATE AND LARGE CORROSION FLAKES AT BEARING 1. (PHOTO 23) |

23. SPAN 3 E PIER 2 MOVE BEAR 1 SEPARATION TEPHLON PL & LG CORROS FLAKES LOOK E
