Bridge No: 1640 011

Date of Inspection: 05/28/2024

6) Feature Intersected: CENTERVILLE RD.

7) Facility Carried: KIRKWOOD HWY/SR2

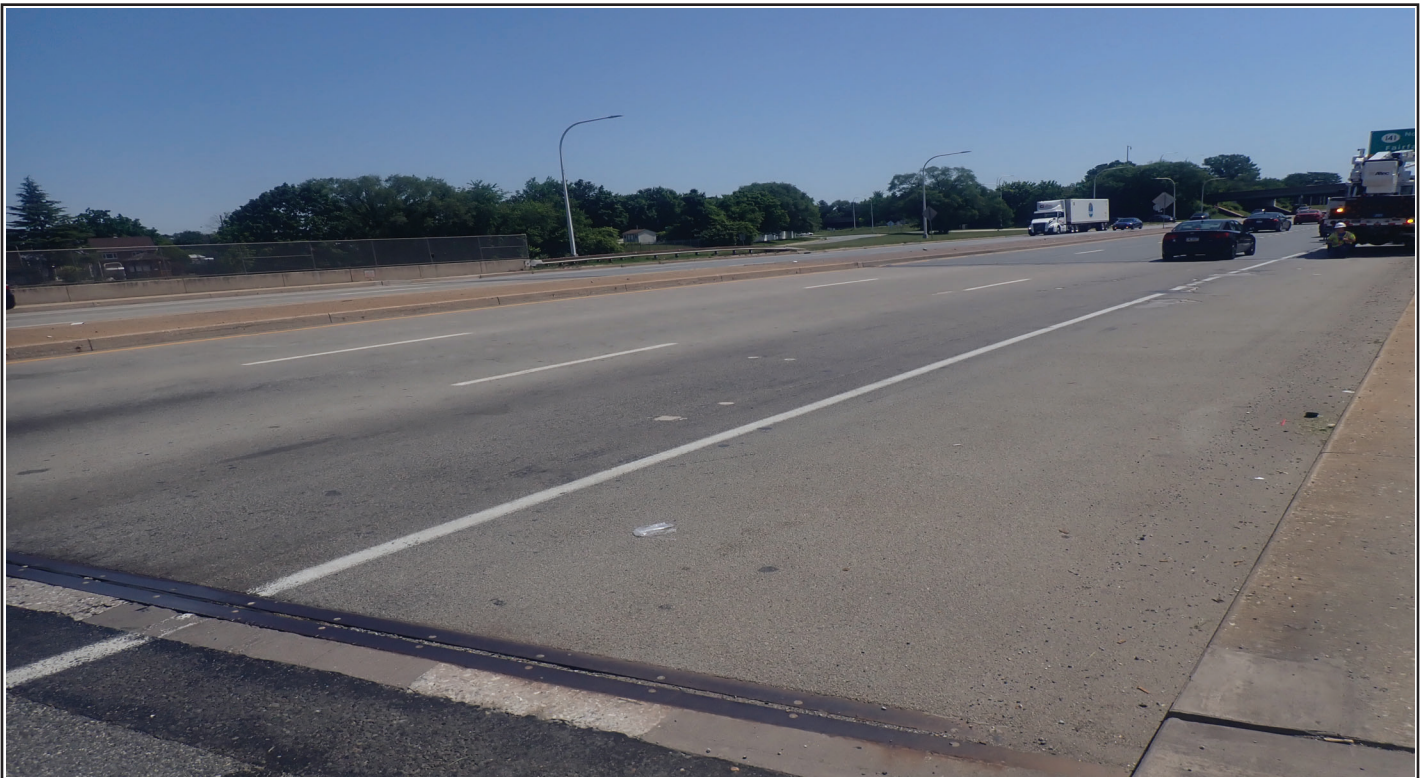
6 WEARING SURFACE LOOKING EAST IN THE EASTBOUND LANES

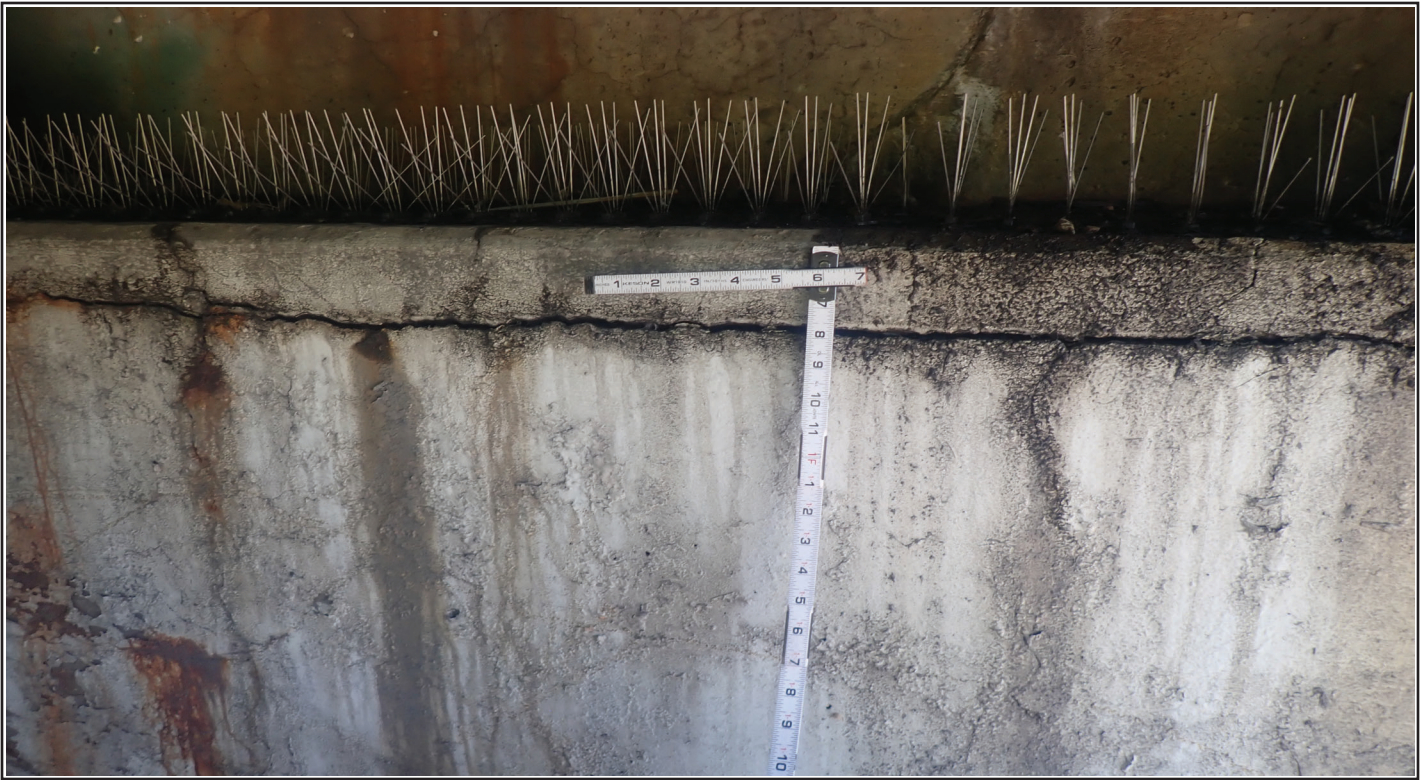
| Elm/Env | Description | Unit | Total Qty | Qty. St. 1 | Qty. St. 2 | Qty. St. 3 | Qty. St. 4 | Notes |
|---|---|---|---|---|---|---|---|---|
| 215/2 | Re Conc Abutment | ft | 246.00 | 139.00 | 91.00 | 16.00 | 0.00 | <p>EAST ABUTMENT:</p> <p>CRACKING:</p> <p>CS-3=8 LF: 1/2-INCH WIDE HORIZONTAL CRACK NEAR THE TOP OF THE BREASTWALL UNDER BAY 14. (PHOTO 7)</p> <p>CS-2=6 LF: 1/4-INCH WIDE HORIZONTAL CRACK NEAR THE TOP OF THE BREASTWALL UNDER BAY 10 AND GIRDERS 14,15.</p> <p>CS-1= SUPERFICIAL CRACKS SOME w/EFFLO AND RUST.</p> <p>SPALL / DELAM:</p> <p>CS-3=1 LF: DEEP SPALL UNDER BAY 14. (PHOTO 11)</p> <p>CS-2=1 LF: SHALLOW SPALL AT THE NORTH END.</p> <p>CS-2=25 LF: AREAS OF DELAM UNDER BAYS 1, 5 AND GIRDER 13.</p> <p>WEST ABUTMENT:</p> <p>CRACKING:</p> <p>CS-3=4 LF: 1/2-INCH WIDE HORIZONTAL CRACK NEAR THE TOP OF THE BREASTWALL UNDER BAY 14.</p> <p>CS-2=11 LF: 1/4-INCH WIDE HORIZONTAL CRACK AND DELAM NEAR THE TOP OF THE BREASTWALL UNDER BAYS10-13.</p> <p>CS-1= SUPERFICIAL CRACKS SOME w/EFFLO AND RUST.</p> <p>EXP BAR:</p> <p>CS-3=3 LF: EXP BAR w/LOSS OF SECTON UNDER BAY 10. (PHOTO 14)</p> <p>SPALL / DELAM::</p> <p>CS-2=48 LF: AREAS OF DELAM UNDER</p> |

7 EAST ABUTMENT WIDE HORIZONTAL CRACK UNDER BAY 14

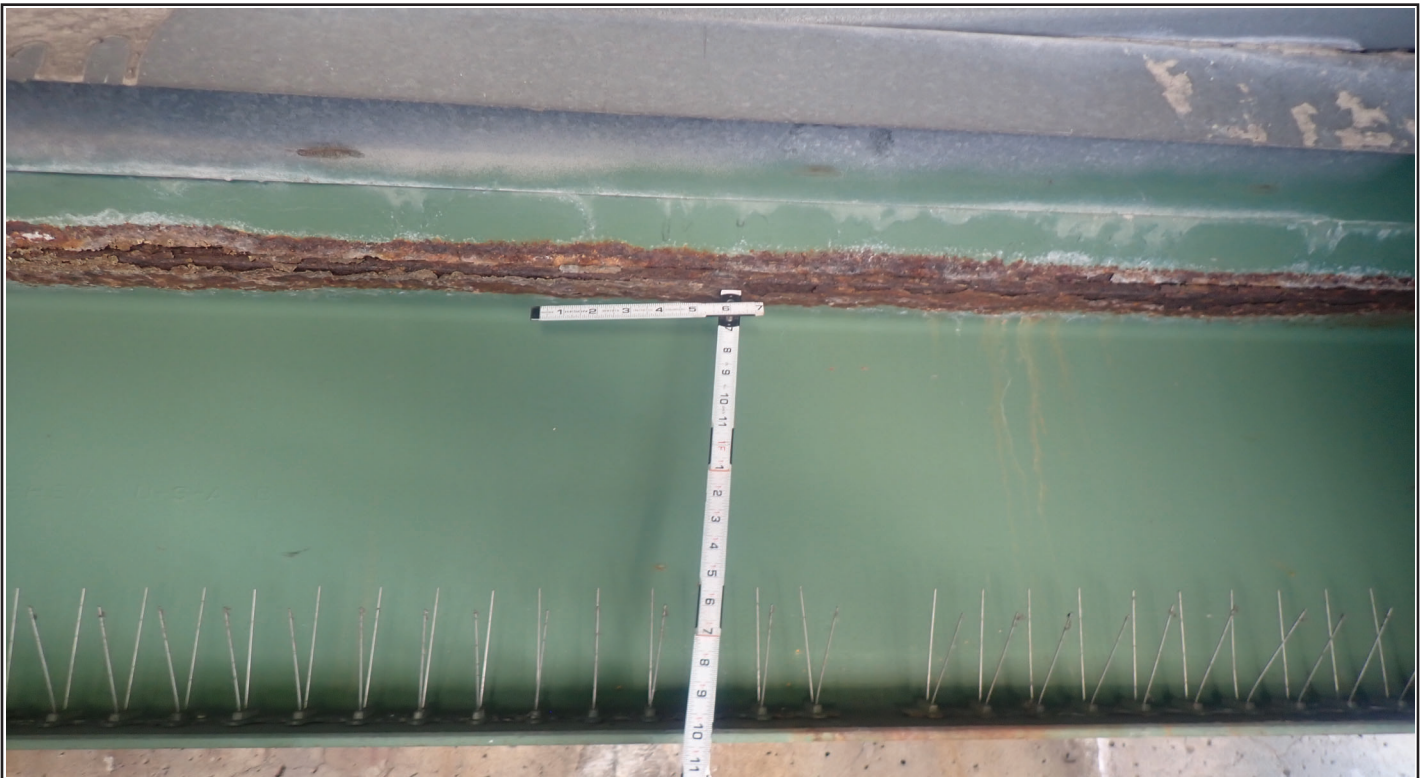
| Elm/Env | Description | Unit | Total Qty | Qty. St. 1 | Qty. St. 2 | Qty. St. 3 | Qty. St. 4 | Notes |
|---|---|---|---|---|---|---|---|---|
| 881/2 | Steel Diap | (EA) | 78.00 | 0.00 | 63.00 | 15.00 | 0.00 | CORROSION:<br>CS-3=15 LEA: CORROSION w/LOSS OF SECTION<br>DIAPHRAGMS 1,4,6,8,13,14 OVER THE EAST<br>ABUTMENT (PHOTO 8) AND DIAPHRAGMS<br>1,2,3,4,6,8,13,14,15 OVER THE WEST ABUTMENT.<br>CS-2=63 EA: ALL DIAPHRAGMS HAVE LIGHT<br>CORROSION AND OR FRECKLE RUST. |

8 EAST ABUTMENT BAY 14 DIAPHRAGM CORROSION W/LOSS OF SECTION

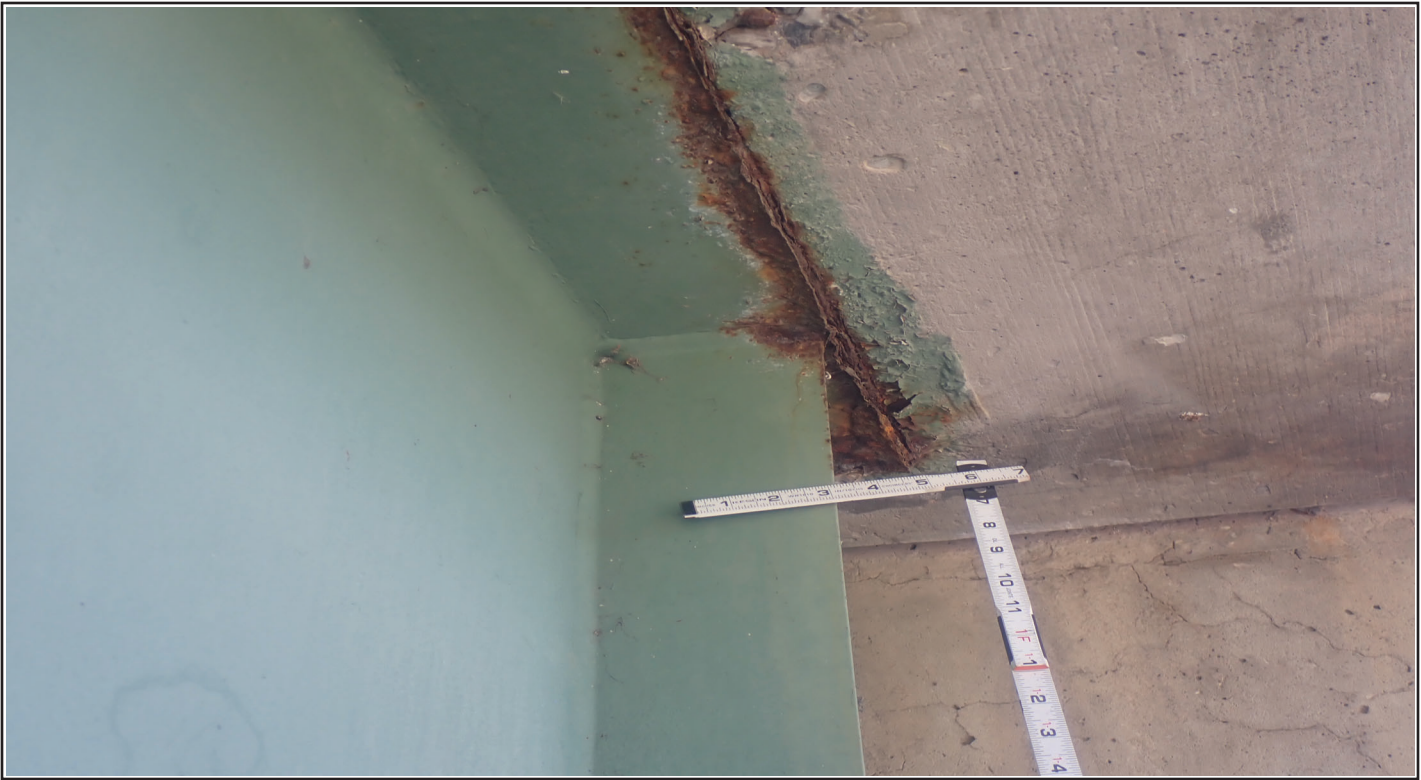
| Elm/Env | Description | Unit | Total Qty | Qty. St. 1 | Qty. St. 2 | Qty. St. 3 | Qty. St. 4 | Notes |
|---|---|---|---|---|---|---|---|---|
| 107/2 | Steel Opn Girder/Beam | ft | 1,348.00 | 0.00 | 1,330.00 | 18.00 | 0.00 | <p>CORROSION:</p> <p>CS-3=18 LF: CORROSION WITH LOSS OF SECTION TO BOTH ENDS OF GIRDER 1 AND GIRDER 15. (PHOTO 9)</p> <p>CORROSION w/LOSS OF SECTION TO GIRDER 5 AND GIRDER 9 OVER THE EAST ABUTMENT.</p> <p>CORROSION w/LOSS OF SECTION TO GIRDERS 2,3,4,5 OVER THE WEST ABUTMENT.</p> <p>CS-2=1330 LF: LIGHT CORROSION AND FRECKLE RUST BLISTERS TYPICAL.</p> |

9 GIRDER 15 CORROSION w/LOSS OF SECTION TO TOP FLANGE OVER EAST ABUTMENT

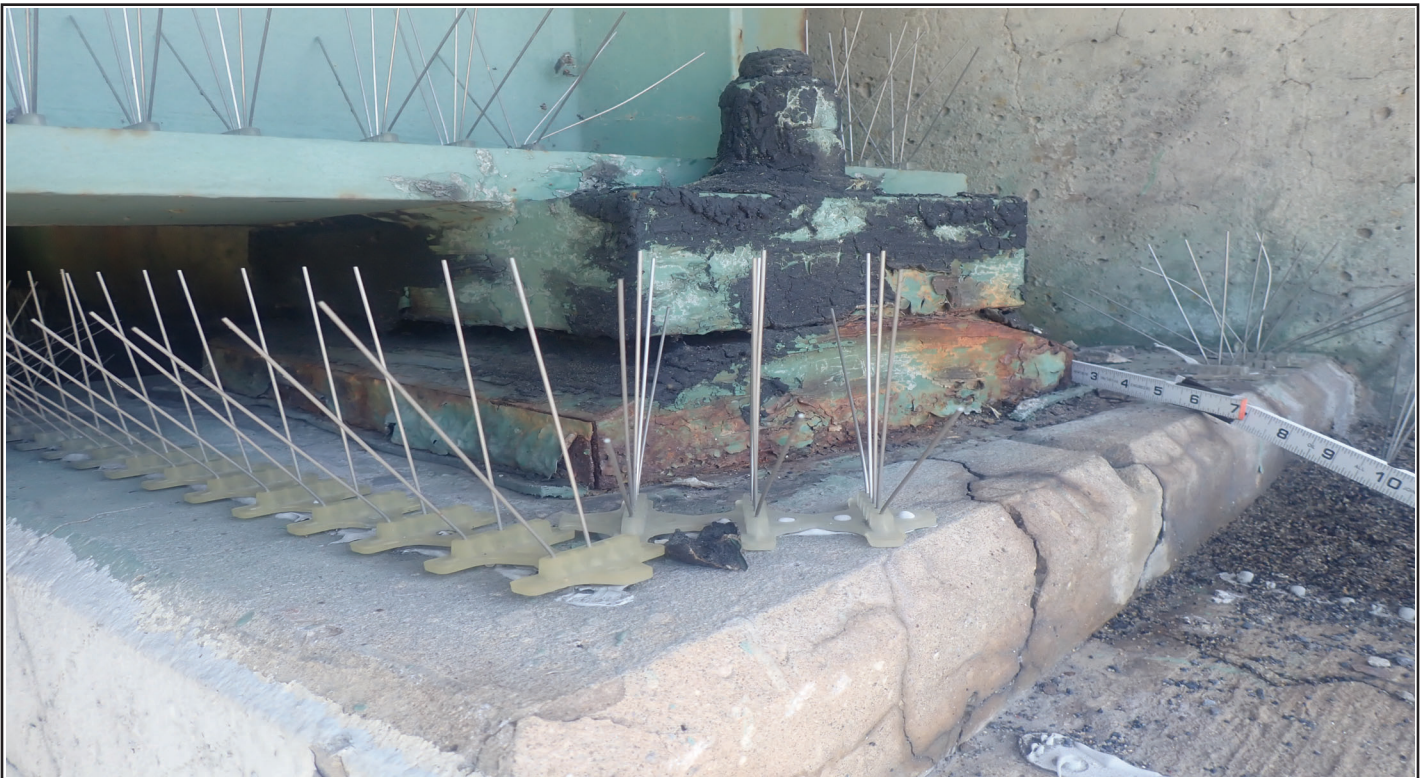
| Elm/Env | Description | Unit | Total Qty | Qty. St. 1 | Qty. St. 2 | Qty. St. 3 | Qty. St. 4 | Notes |
|---|---|---|---|---|---|---|---|---|
| 313/2 | Fixed Bearing | each | 15.00 | 13.00 | 1.00 | 1.00 | 0.00 | EAST ABUTMENT BEARINGS:<br>CORROSION:<br>CS-3=1 EA: CORROSION w/LOSS OF SECTION TO<br>THE MASONRY PLATE OF BEARING 15 (PHOTO 10)<br><br>CONNECTION:<br>CS-2=1 EA: BENT ANCHOR BOLT AT BEARING 8 BUT<br>FUNCTIONING AS INTENDED. |

10 EAST ABUTMENT FIXED BEARING 15 CORROSION w/LOSS OF SECTION

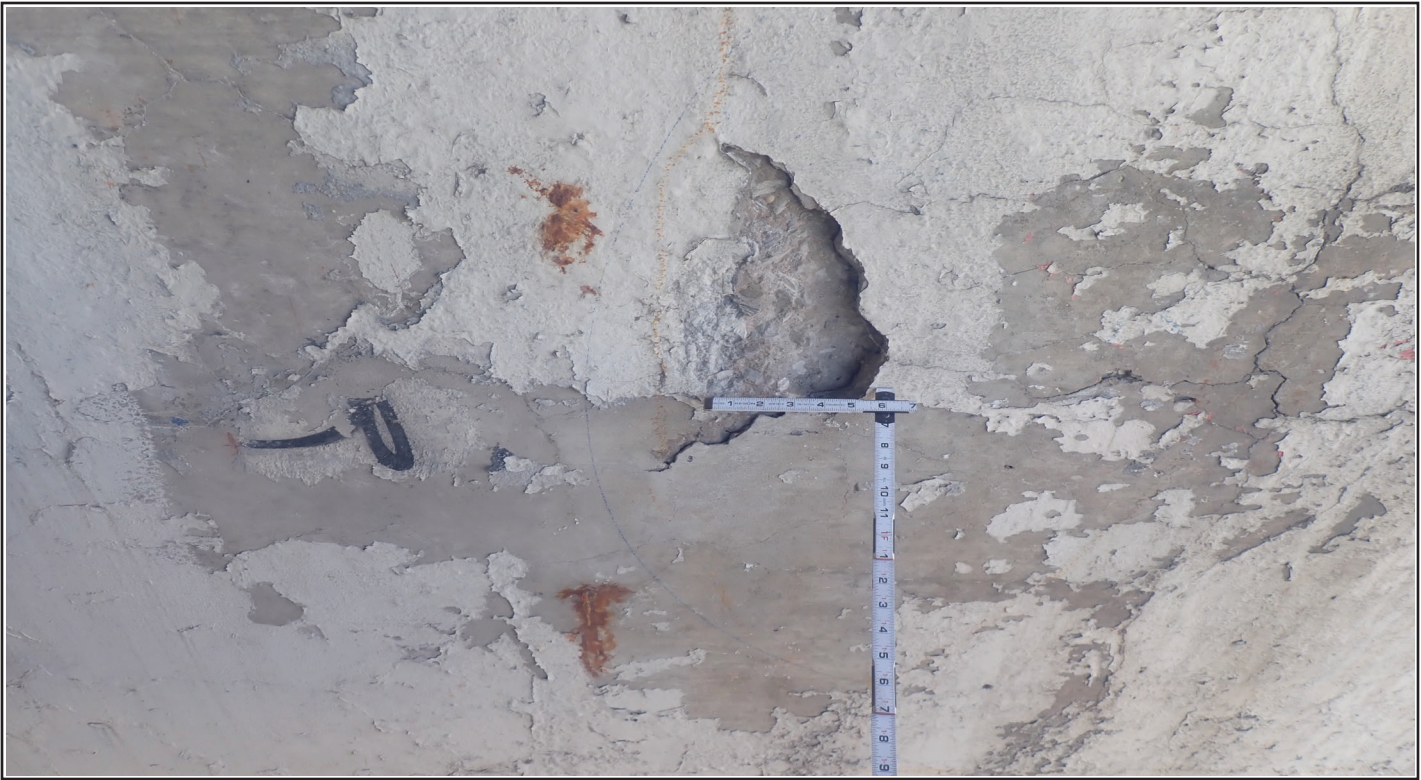
11 EAST ABUTMENT BREASTWALL DEEP SPALL UNDER GIRDER 14

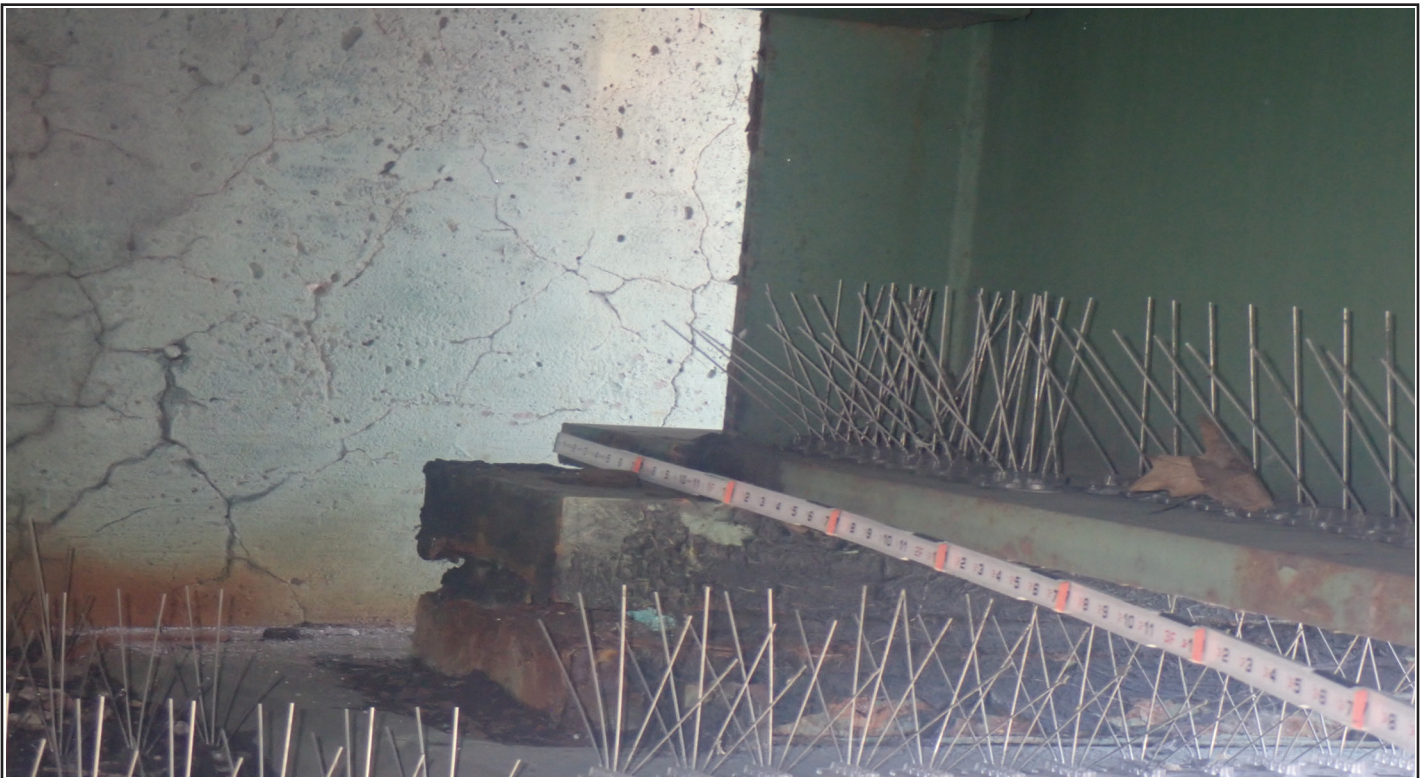
| Elm/Env | Description | Unit | Total Qty | Qty. St. 1 | Qty. St. 2 | Qty. St. 3 | Qty. St. 4 | Notes |
|---|---|---|---|---|---|---|---|---|
| 311/2 | Moveable Bearing | each | 15.00 | 6.00 | 7.00 | 2.00 | 0.00 | WEST ABUTMENT BEARINGS:<br>CONNECTION:<br>CS-3=1 EA: MISSING ANCHOR BOLT ON BEARING 1<br>ALONG w/CORROSION TO THE MASONRY PLATE.<br>(PHOTO 12)<br>CS-2=1 EA: BENT ANCHOR BOLT AT BEARING 8 BUT<br>FUNCTIONING AS INTENDED.<br><br>CORROSION:<br>CS-3=1 EA: ACTIVE CORROSION WITH LOS TO BOTH<br>PLATES ON BEARING 15 (PHOTO 15)<br><br>ALIGNMENT:<br>CS-2=6 EA: 1/2-INCH OF LATERAL MOVEMENT<br>TOWARDS THE NORTH ON BEARINGS #2-7<br><br>(NC-24) |

12 WEST ABUTMENT MOVEABLE BEARING 1 MISSING CONNECTION

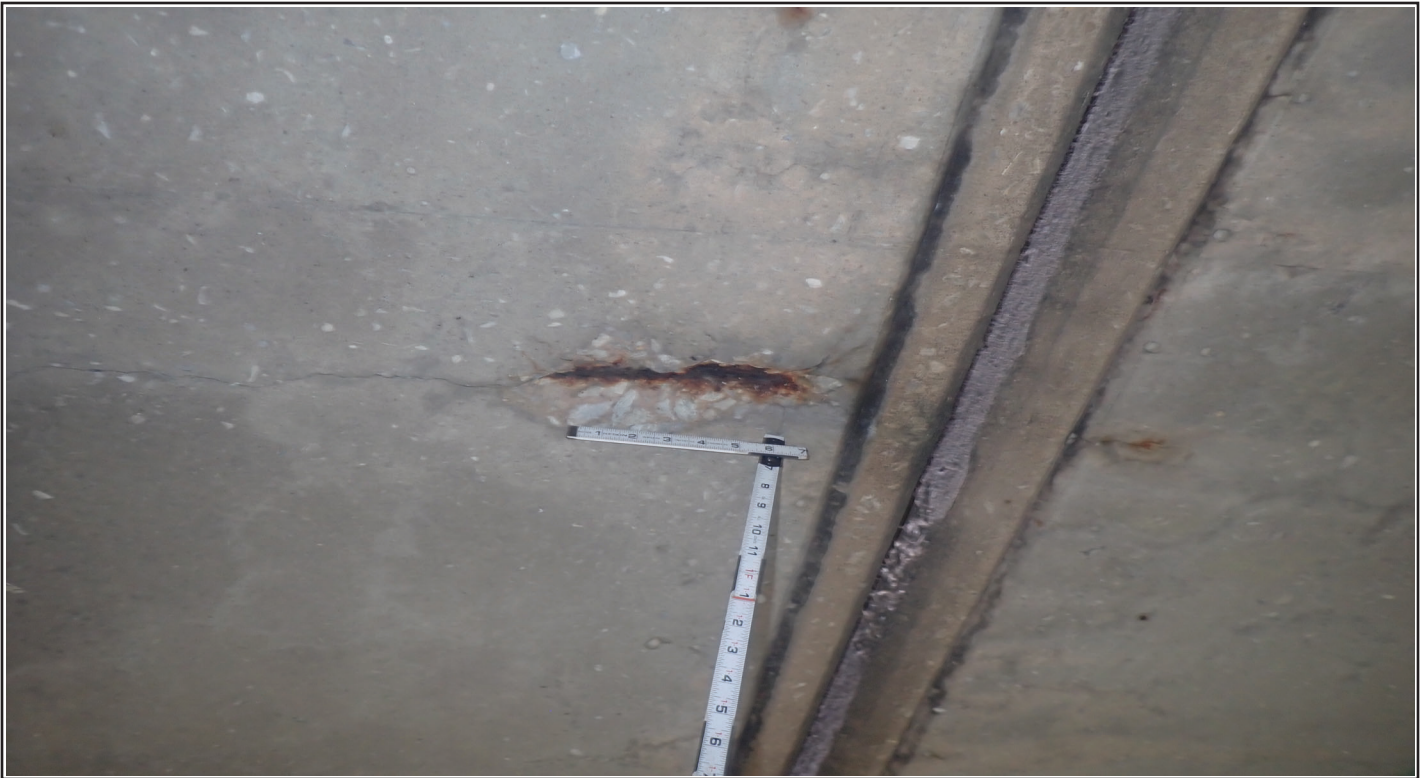
13 SOFFIT EXP BAR w/LOSS OF SECTION IN BAY 7 OVER WEST SIDEWALK

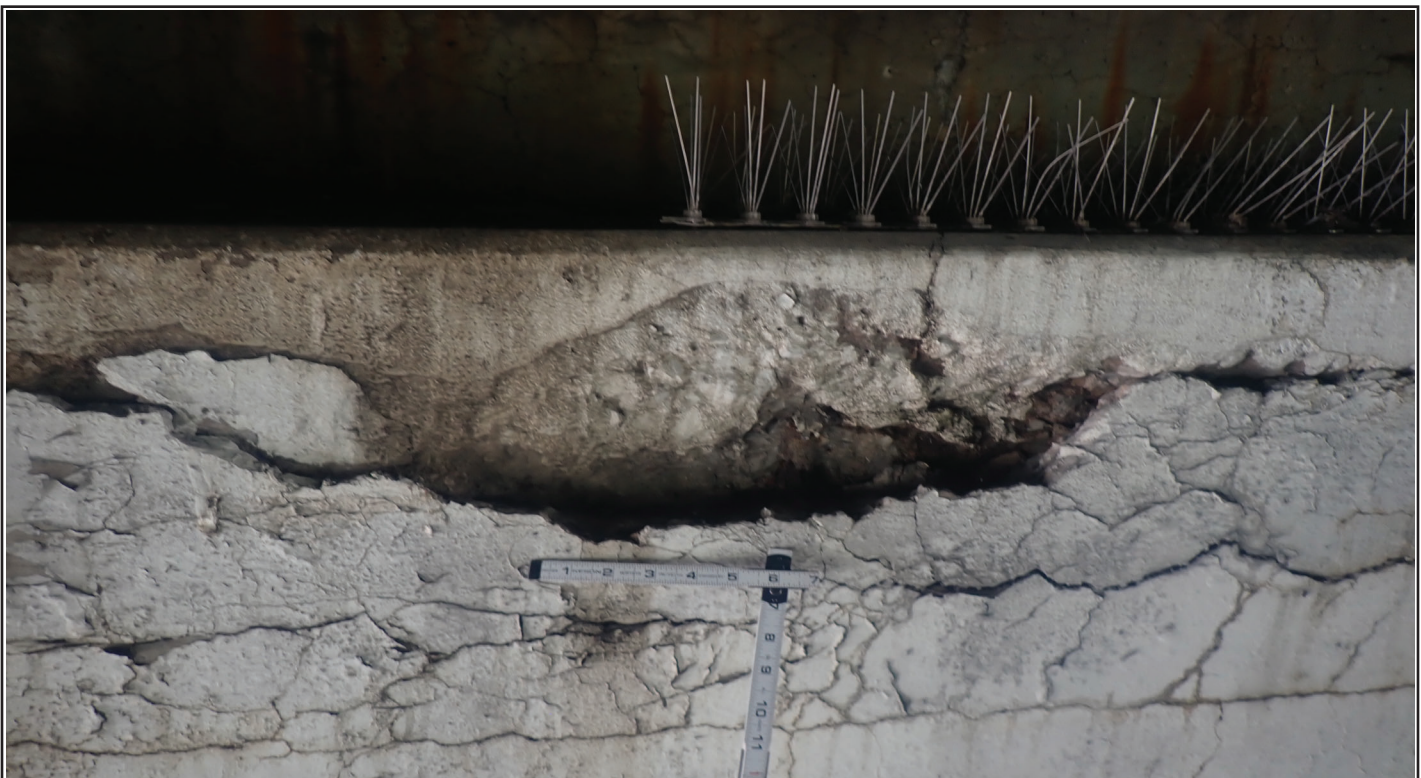
14 WEST ABUTMENT EXP BAR w/LOSS OF SECTION UNDER BAY 10

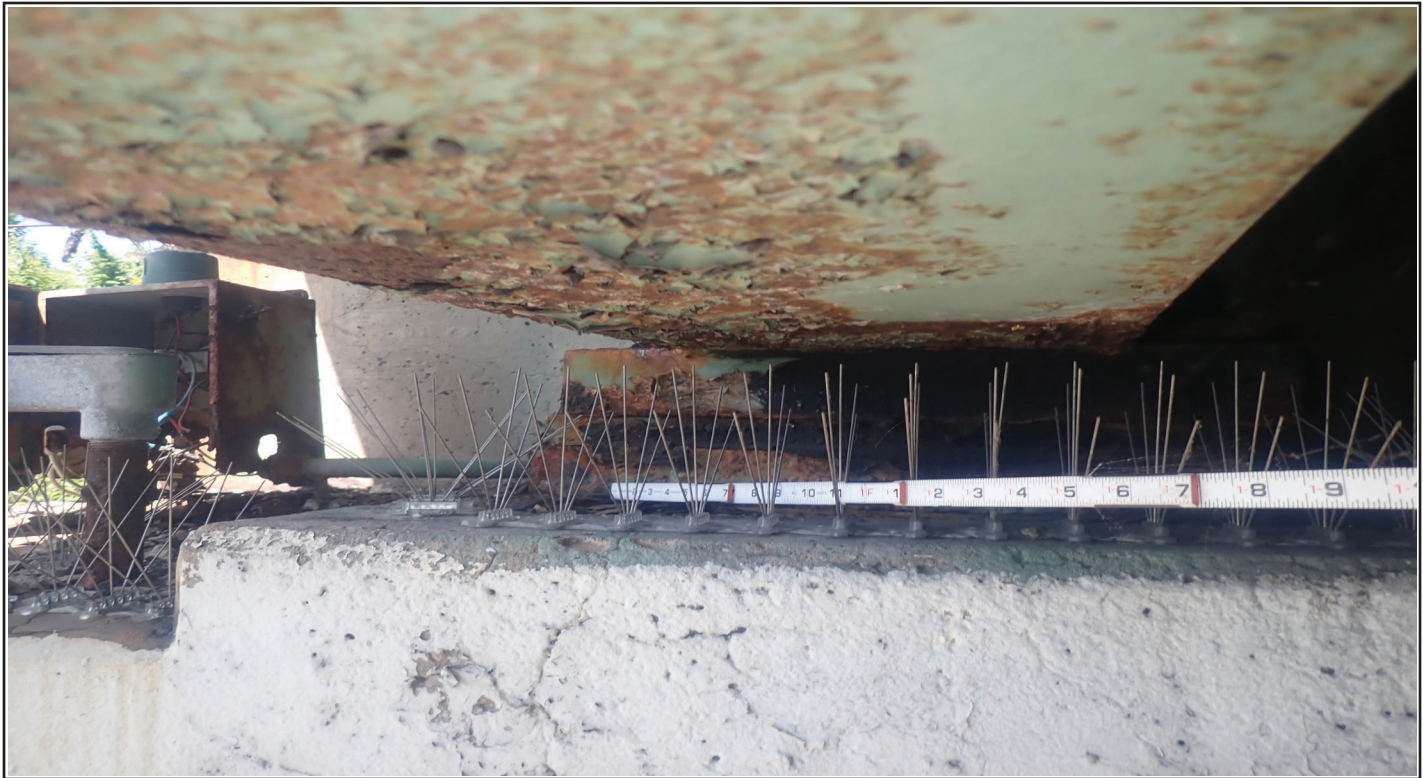
15 WEST ABUTMENT MOVEABLE BEARING 15 CORROSION w/LOSS OF SECTION

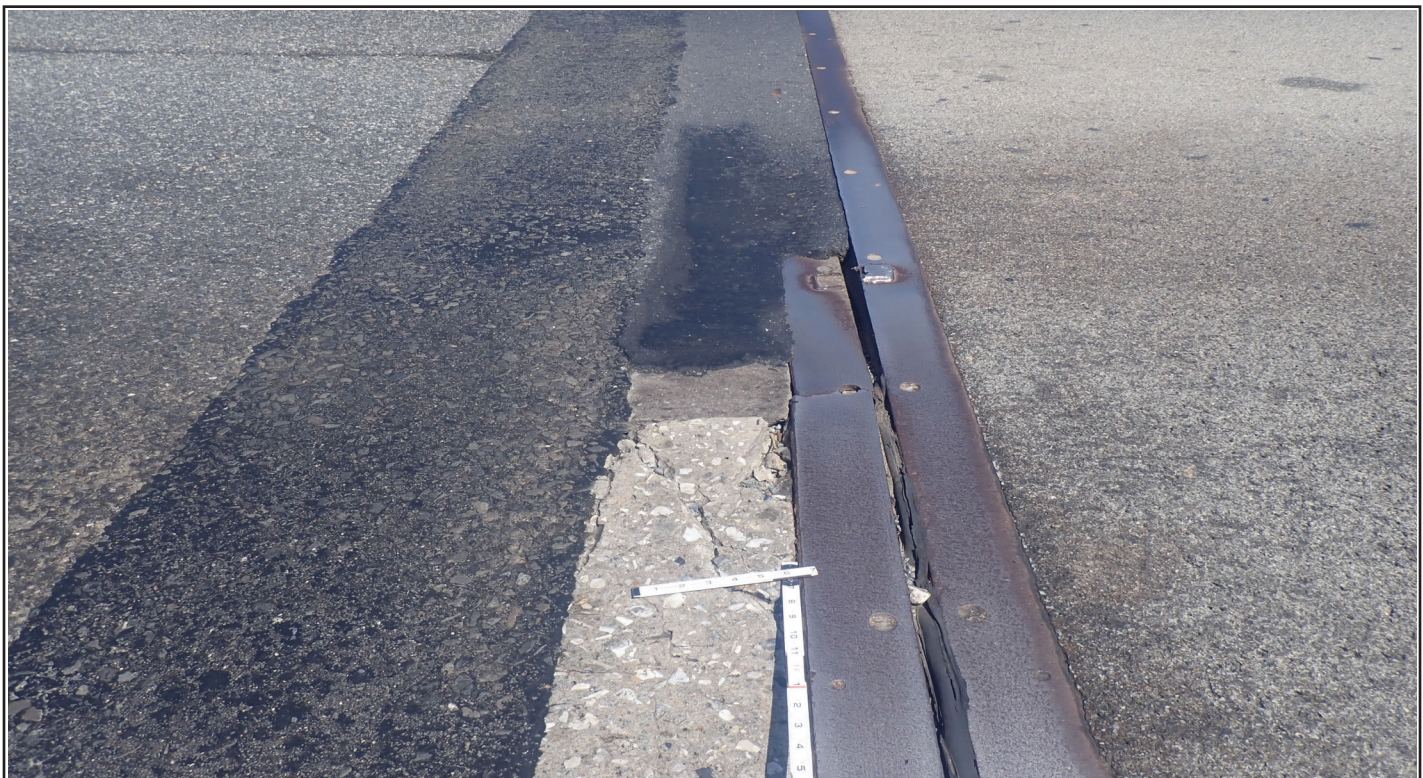
| Elm/Env | Description | Unit | Total Qty | Qty. St. 1 | Qty. St. 2 | Qty. St. 3 | Qty. St. 4 | Notes |
|---|---|---|---|---|---|---|---|---|
| 825/2 | R/C Abutment Backwall | ft | 246.00 | 229.00 | 0.00 | 17.00 | 0.00 | WEST BACKWALL:<br>SPALL / DELAM:<br>CS-3=17 LF: THE TOP SIDE IN THE EASTBOUND LANE HAS AREAS OF DEEP SPALLS AND ASPHALT PATCHES. (PHOTO 16)<br><br>CRACKING:<br>CS-1= SUPERFICIAL CRACKS SOME w/EFFLO.<br><br>EAST BACKWALL:<br>CRACKING:<br>CS-1= SUPERFICIAL CRACKS SOME w/EFFLO AND RUST. |

16 WEST ABUTMENT BACKWALL TOP SIDE DEEP SPALLS AND ASPHALT PATCHES IN EASTBOUND LANE

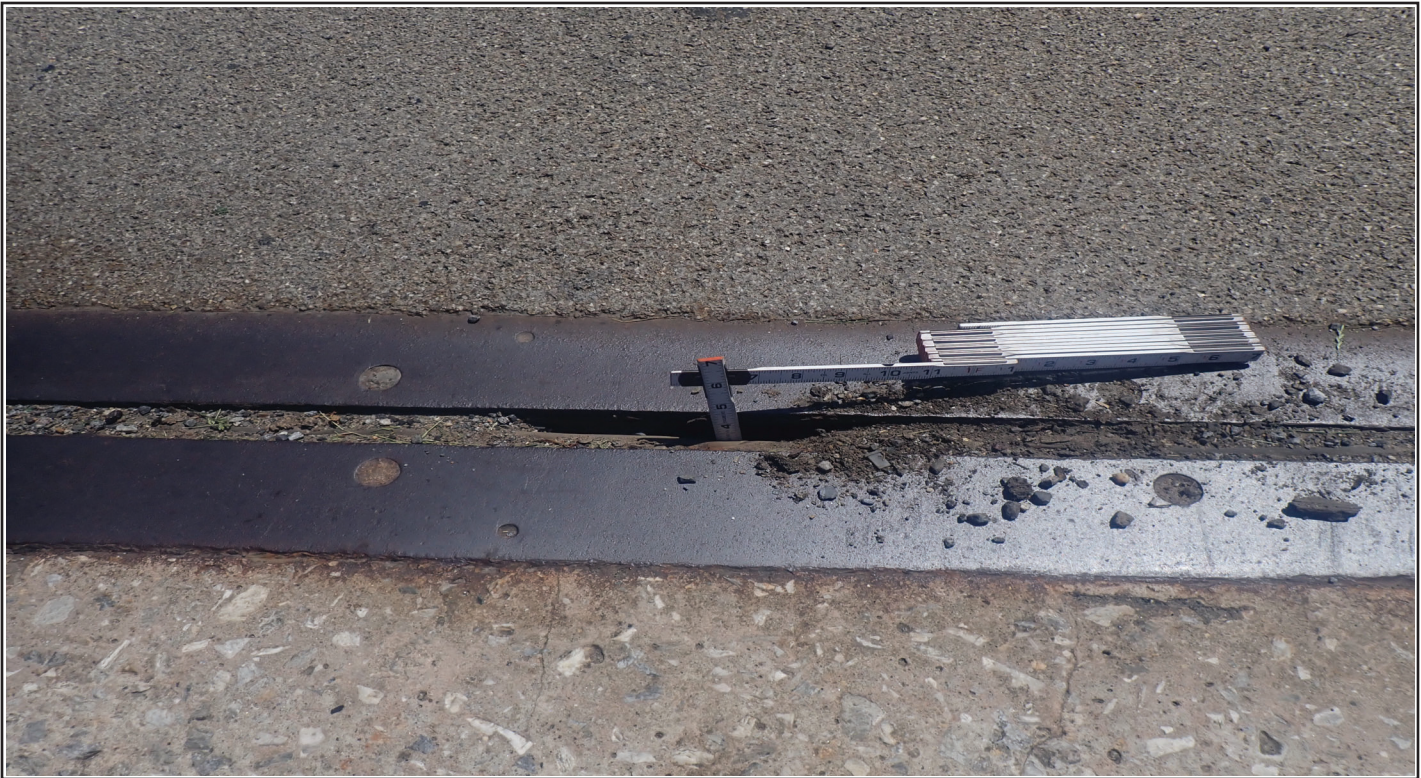
| Elm/Env | Description | Unit | Total Qty | Qty. St. 1 | Qty. St. 2 | Qty. St. 3 | Qty. St. 4 | Notes |
|---|---|---|---|---|---|---|---|---|
| 302/2 | Compressn Joint Seal | ft | 242.00 | 151.00 | 0.00 | 0.00 | 91.00 | <p>WEST JOINT:</p> <p>SEAL ADHESION:</p> <p>CS-4=19 LF: FULLY DEBONDED IN THE EASTBOUND (13 LF) AND WESTBOUND (6 LF) LANES AT RANDOM. (PHOTO 17)</p> <p>SEAL DAMAGE:</p> <p>CS-4=35 LF: MISSING JOINT MATERIAL IN THE EASTBOUND (15 LF) AND WESTBOUND (20 LF) TRAVEL LANES. (PHOTO 18)</p> <p>EAST JOINT:</p> <p>SEAL ADHESION:</p> <p>CS-4=37 LF: FULLY DEBONDED IN THE EASTBOUND (20 LF) AND WESTBOUND (17 LF) LANES AT RANDOM.</p> |

17 WEST COMPRESSION JOINT FULLY DEBONDED IN THE EASTBOUND LANES

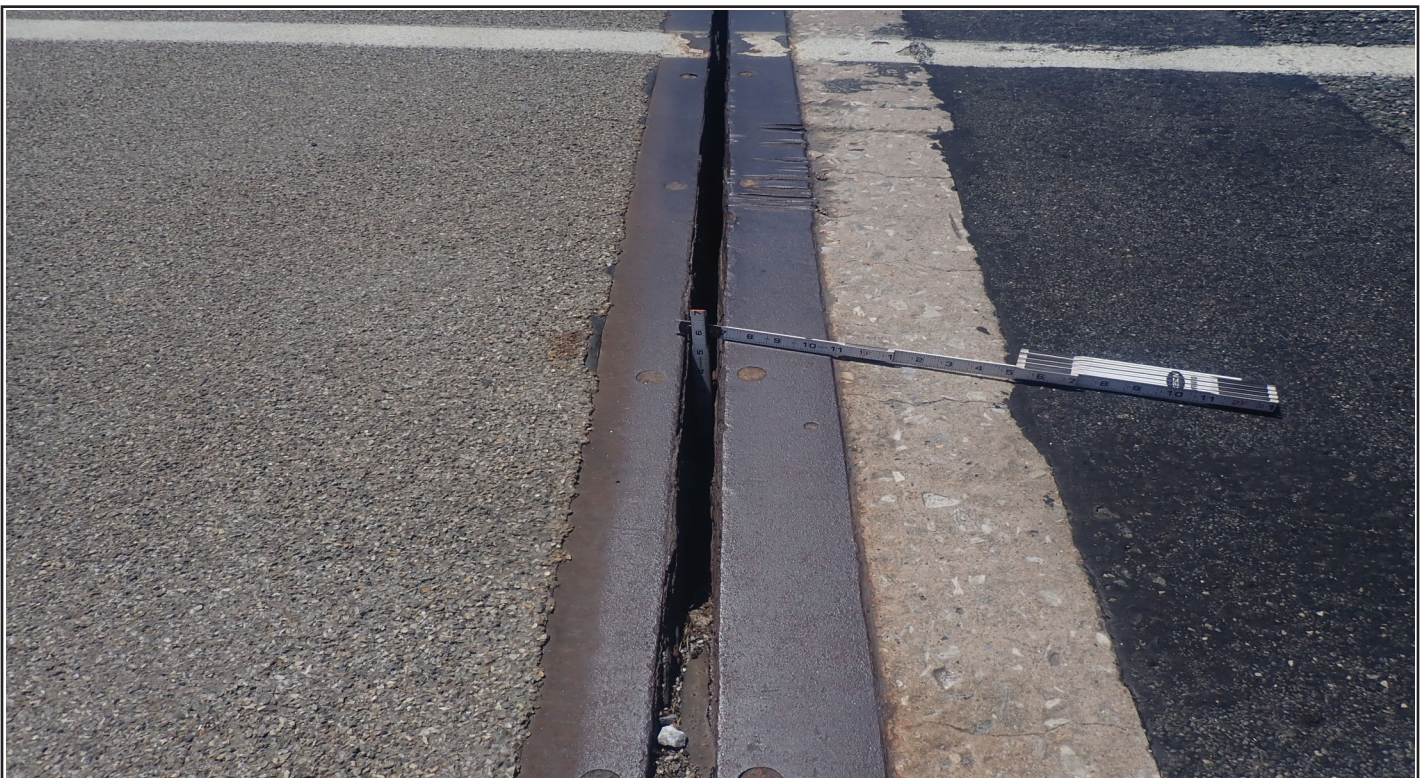
18 WEST COMPRESSION JOINT MISSING IN THE WESTBOUND LANE

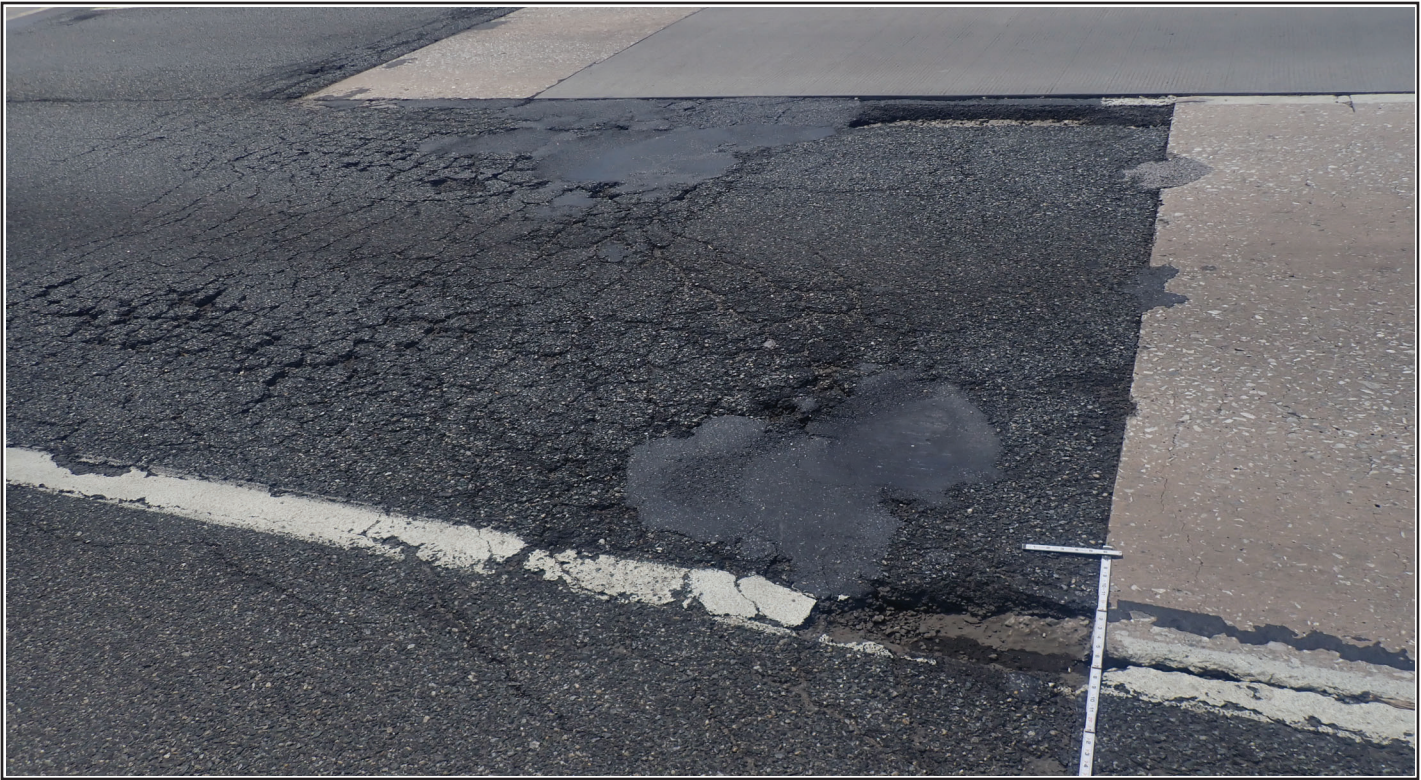
| Elm/Env | Description | Unit | Total Qty | Qty. St. 1 | Qty. St. 2 | Qty. St. 3 | Qty. St. 4 | Notes |
|---|---|---|---|---|---|---|---|---|
| 811/2 | Asphaltic Conc. Wearing<br>Surface | sq.ft | 2,239.00 | 2,007.00 | 202.00 | 30.00 | 0.00 | NORTHWEST SLAB:<br>SPALL / DELAM / PATCH:<br>CS-3=30 SF: DEEP SPALLS AND DELAMINATED<br>CRACKED ASPHALT IN THE WESTBOUND LANES.<br>(PHOTO 19)<br><br>CRACKING:<br>CS-2=50 SF: MINOR CRACKS AT RANDOM.<br><br>SOUTHWEST SLAB:<br>SPALL / DELAM / PATCH:<br>CS-2=2 SF: SHALLOW SPALLS IN THE WESTBOUND<br>LANE ADJACENT TO WHITE LINE.<br><br>CRACKING:<br>CS-2=50 SF: MINOR CRACKS AT RANDOM.<br><br>NORTHEAST SLAB:<br>CRACKING:<br>CS-2=50 SF: MINOR CRACKS AT RANDOM.<br><br>NORTHWEST SLAB:<br>CRACKING:<br>CS-2=50 SF: MINOR CRACKS AT RANDOM. |

19 NORTHWEST ASPHALT APPROACH SLAB DEEP SPALLS w/DETERIORATING ASPHALT

-B022-S1D: REPAIR SPALLS IN THE NORTHWEST ASPHALT APPROACH SLAB...WO#1346157

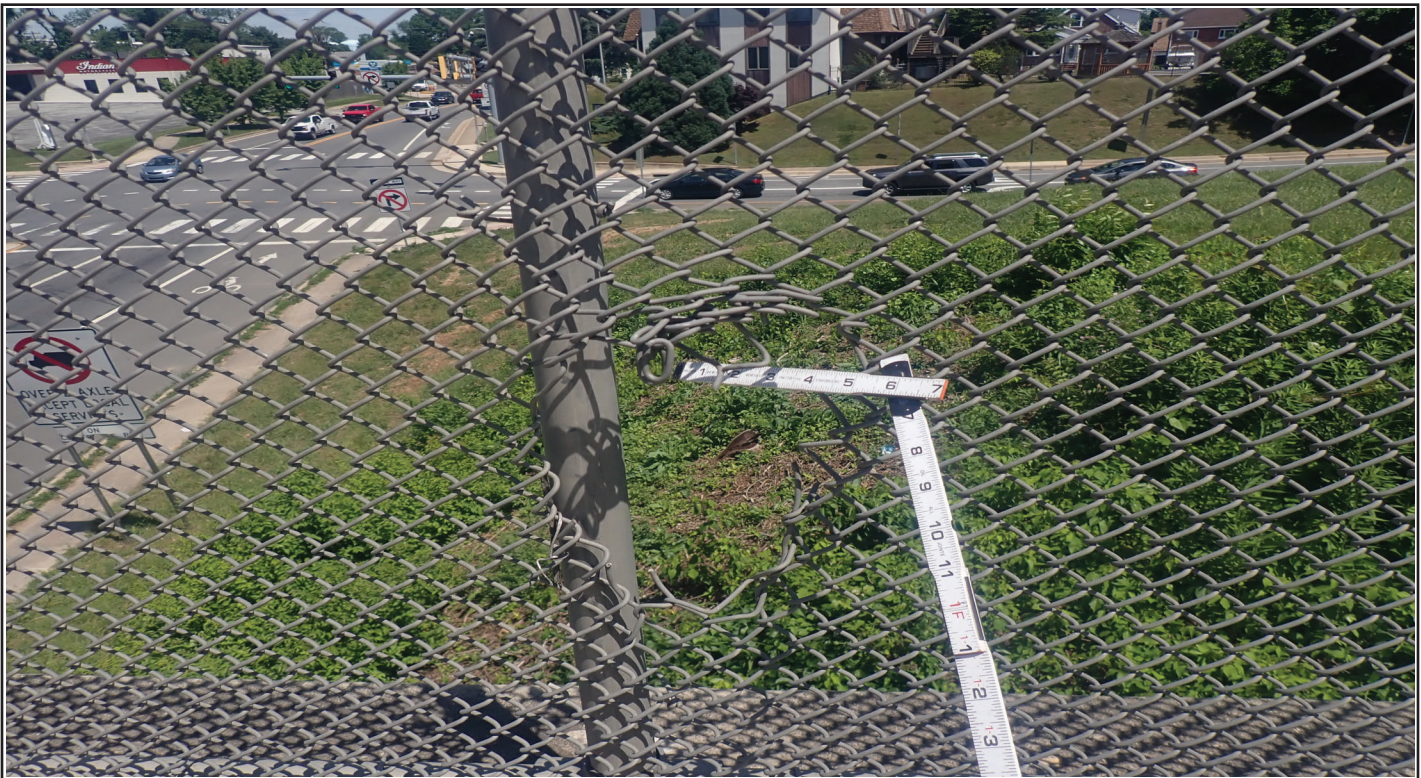
| Elm/Env | Description | Unit | Total Qty | Qty. St. 1 | Qty. St. 2 | Qty. St. 3 | Qty. St. 4 | Notes |
|---|---|---|---|---|---|---|---|---|
| 330/2 | Metal Bridge Railing | ft | 308.00 | 306.00 | 0.00 | 2.00 | 0.00 | NORTH FENCE:<br>DISTORTION:<br>CS-3=1 LF: HOLE IN THE FENCE MATERIAL OVER THE EAST WINGWALL. (PHOTO 20)<br><br>SOUTH FENCE:<br>CONNECTION:<br>CS-3=1 LF: MISSING BASEPLATE FASTENERS AT THE EAST END. (PHOTO 22)<br><br>(NC-24) |

20 NORTH METAL RAIL FENCE HOLE OVER THE EAST ABUTMENT

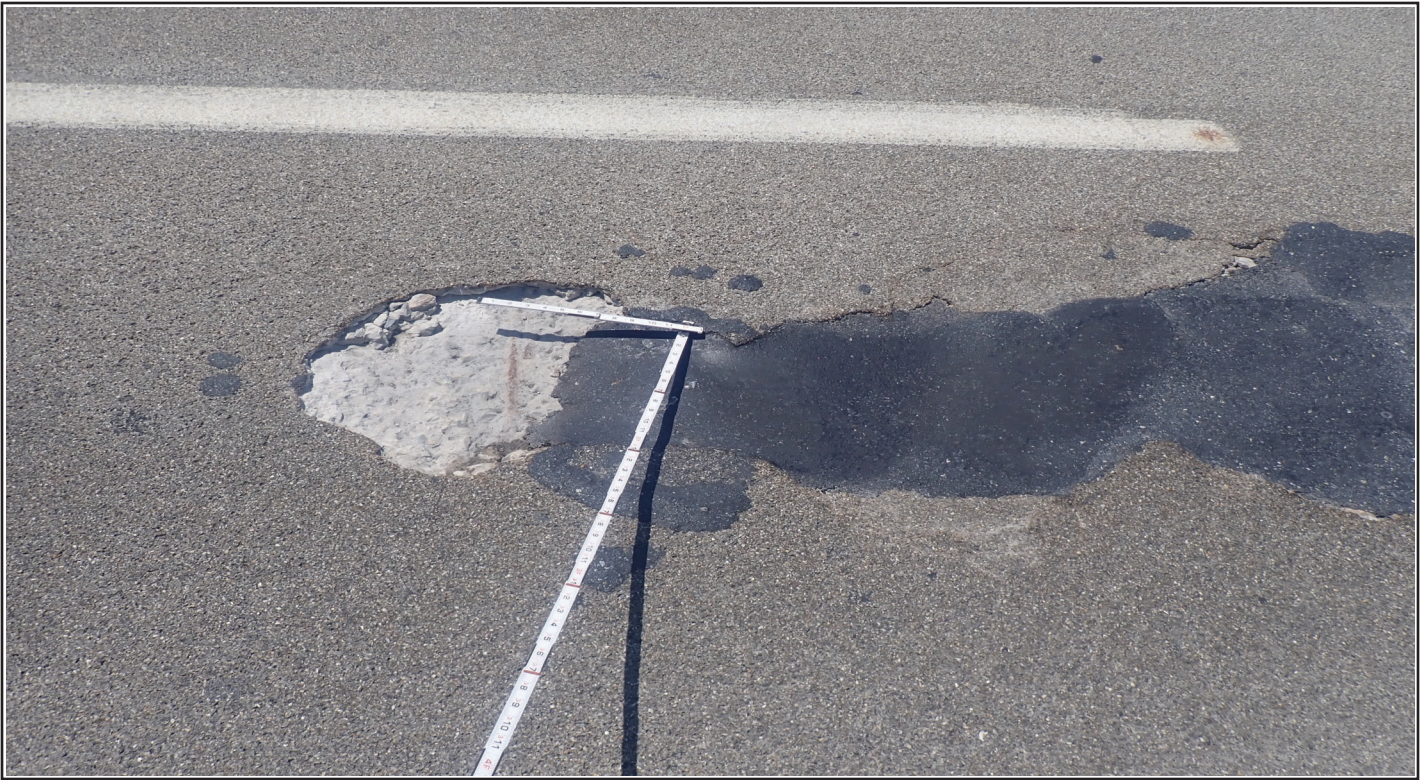
| Elm/Env | Description | Unit | Total Qty | Qty. St. 1 | Qty. St. 2 | Qty. St. 3 | Qty. St. 4 | Notes |
|---|---|---|---|---|---|---|---|---|
| 12/2 | Re Concrete Deck | sq.ft | 10,890.00 | 10,428.00 | 424.00 | 38.00 | 0.00 | <p>DECK:</p> <p>EXP BAR:</p> <p>CS-3=2 SF: EXPOSED BAR w/LOSS OF SECTION IN WESTBOUND TRAVEL LANE. (PHOTO 21)</p> <p>SPALL / DELAM:</p> <p>CS-3=35 SF: DEEP SPALLS AND ASPHALT PATCHES IN BOTH EASTBOUND (15 SF) AND WESTBOUND (20 SF) LANES. (PHOTO 21)</p> <p>CS-2=424 SF: AS PER THE DECK EVALUATION THERE IS DELAM AT RANDOM. SEE ATTACHED SHEET.</p> <p>SOFFIT:</p> <p>EXP BAR:</p> <p>CS-3=1 SF: EXPOSED BAR w/LOSS OF SECTION IN BAY 7 OVER THE WEST SIDEWALK. (PHOTO 13)</p> <p>EFFLO / RUST:</p> <p>CS-1=3 SF: SUPERFICIAL CRACKS WITH RUST STAINING IN BAY 7 OVER THE WEST SHOULDER (2020 PHOTO 14)</p> <p>NOTE:</p> <p>- THE DECK IS COVERED w/HIGH FRICTION EPOXY OVERLAY. AS PER BIE ELEMENT #810 THIN OVERLAY IS NOT TO BE USED.</p> |

21 DECK EXP BAR w/ASPHALT PATCH IN WESTBOUND LANE

-B025-P1A: REPAIR SPALLS IN THE CONCRETE DECK IN BOTH LANES...WO#1346159

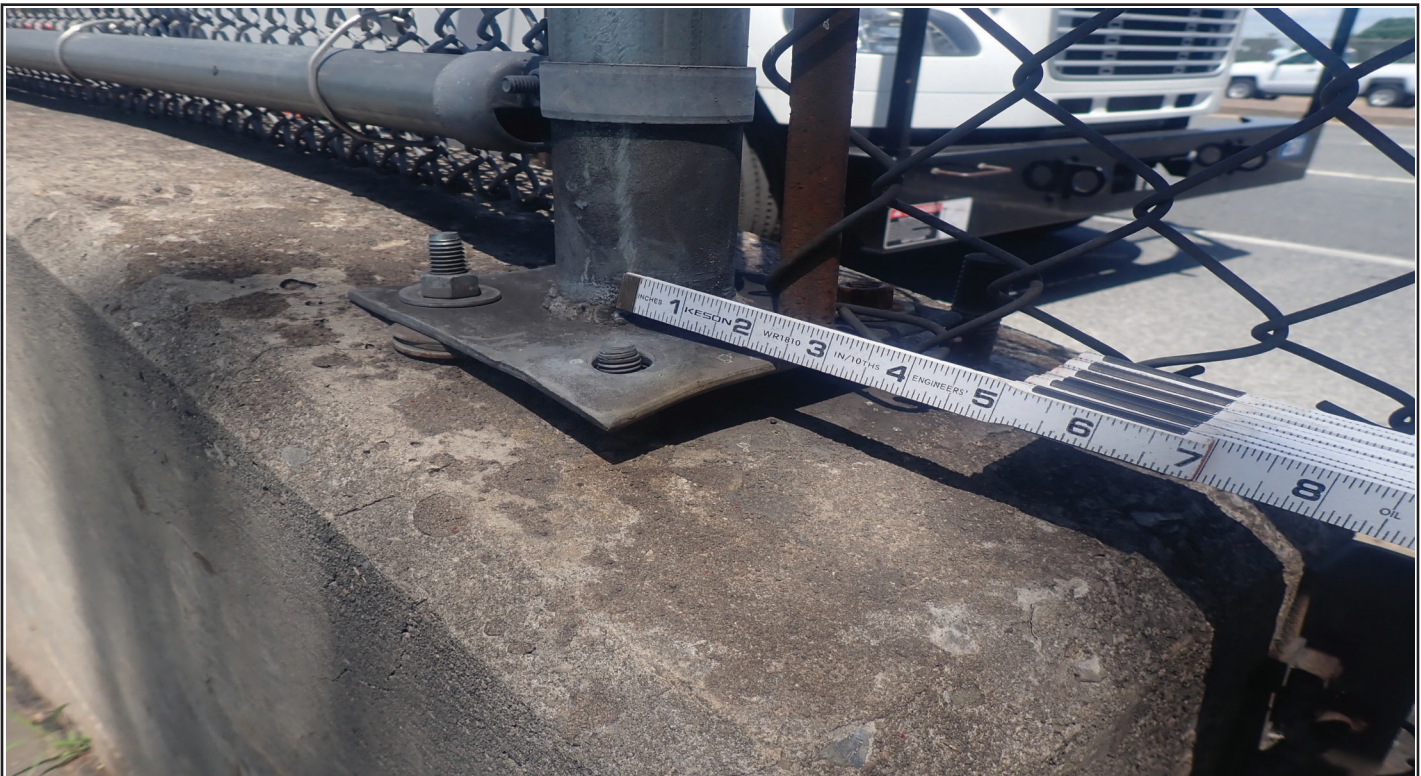
22 SOUTH METAL RAIL FENCE MISSING PARAPET CONNECTION AT THE EAST END
