Bridge No: 1701 397

Date of Inspection: 08/15/2024

6) Feature Intersected: I 95, DELAWARE TURNPIKE

7) Facility Carried: OTTS CHAPEL RD

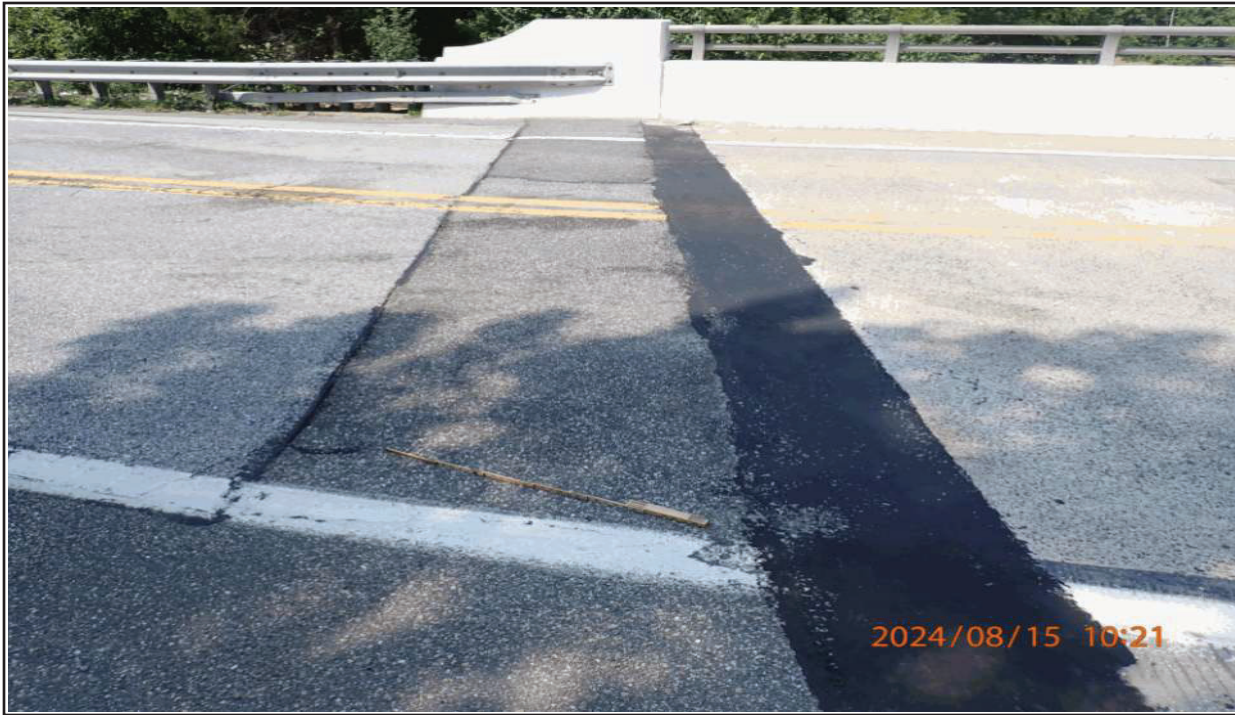
- RECOMMEND THE BIE UPDATE ITEM 10 INCREASE FROM 15.9 TO 16.0. - UPDATED
- RECOMMEND THE BIE UPDATE ITEM 47 DECREASE FROM 57.7 TO 57.1 - UPDATED
- RECOMMEND THE BIE UPDATE ITEM 55 INCREASE FROM 11.36 TO 11.51 - UPDATED
- THE PREVIOUSLY REPORTED HEAVILY CRACKED AND SPALLS AT THE SOUTH APPROACH ROADWAY, ADJACENT TO THE DECK HAS BEEN REPAIRED SINCE LAST INSPECTED (PHOTO 9).

9 SPAN 1 WEARING SURFACE, SOUTH ABUTMENT, SOUTHBOUND LANE - REPAIRED (NOTICE SOUTHEAST APPROACH ROADWAY AT DECK REPAIRED)

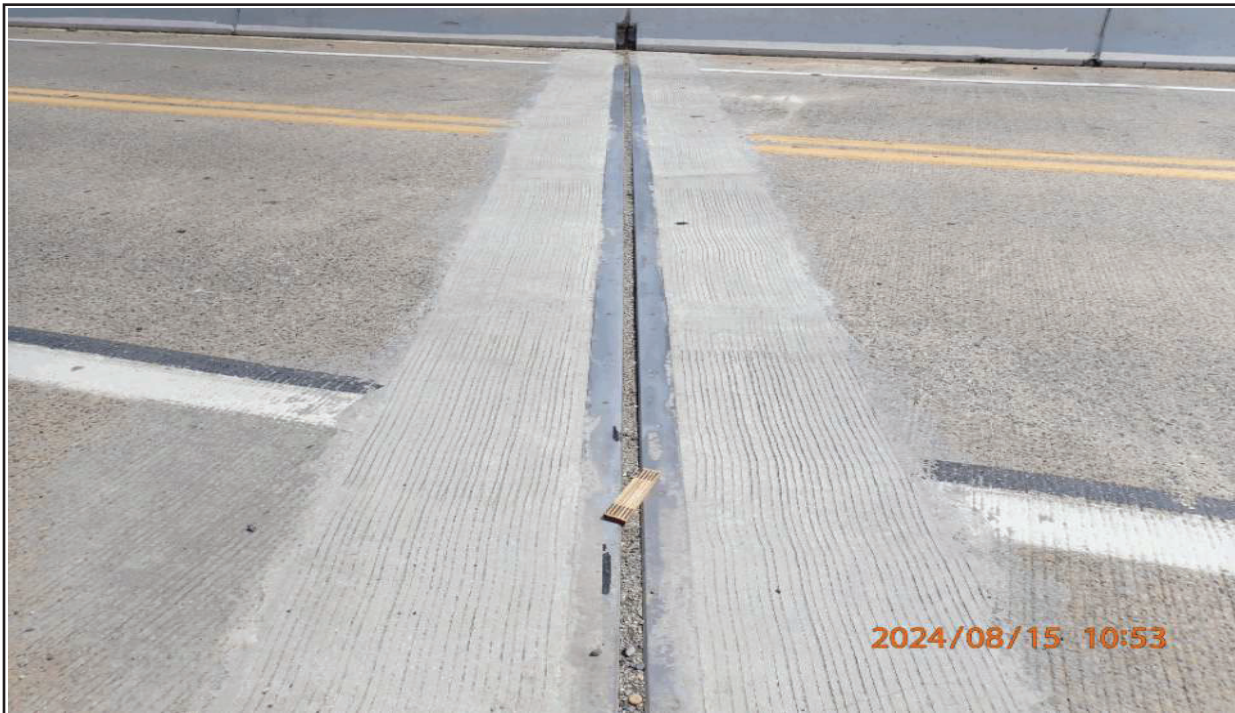
| Elm/Env | Description | Unit | Total Qty | Qty. St. 1 | Qty. St. 2 | Qty. St. 3 | Qty. St. 4 | Notes |
|---|---|---|---|---|---|---|---|---|
| 300/2 | Strip Seal Exp Joint | ft | 36.00 | 0.00 | 0.00 | 36.00 | 0.00 | NOTE: STRIP SEAL JOINT WAS REPLACED IN 2023<br><br>DEBRIS IMPACTION (2350):<br>CS3: (36 SF) THE STRIP SEAL JOINT EXHIBITS HARD PACKED DEBRIS FOR THE FULL LENGTH THAT COULD AFFECT MOVEMENT (PHOTO 10). |

10 SPAN 3 STRIP SEAL JOINT - FULL OF DEBRIS

- REPAIR THE SPALLS IN THE SOFFIT (PHOTO 20).
- REPLACE THE MISSING/SHEARED OR CRACKED HANDRAIL ANCHOR BOLT NUTS (PHOTO (PHOTO 13)).
- RE-GREASE PIER 3 AND PIER 4 BEARINGS WHERE NEEDED (PHOTO 31).
- REPAIR THE DAMAGED GUARDRAIL AT THE SOUTHEAST APPROACH (PHOTO 45).
- CLEAN THE DEBRIS FROM THE STRIP SEAL JOINTS (PHOTO 10). (WO# 1379835)

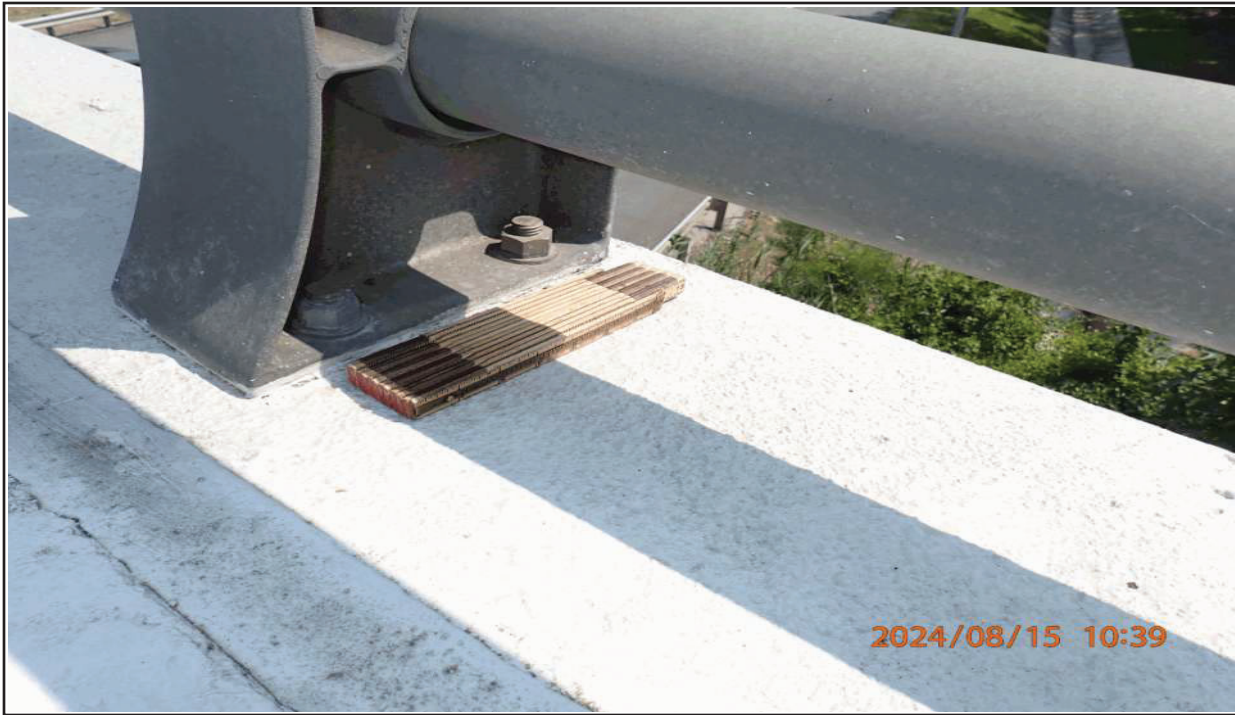
| Elm/Env | Description | Unit | Total Qty | Qty. St. 1 | Qty. St. 2 | Qty. St. 3 | Qty. St. 4 | Notes |
|---|---|---|---|---|---|---|---|---|
| 330/2 | Metal Bridge Railing | ft | 74.00 | 74.00 | 0.00 | 0.00 | 0.00 | NOTE: ALL MISSING / CRACKED OR SHEARED BOLTS HAVE BEEN REPAIRED SINCE LAST INSPECTED (PHOTO 11).<br><br>CS1: (74 LF) NDN. |

11 SPAN 1, EAST METAL RAIL AT POST 5 - NEW ANCHOR BOLT NUTS

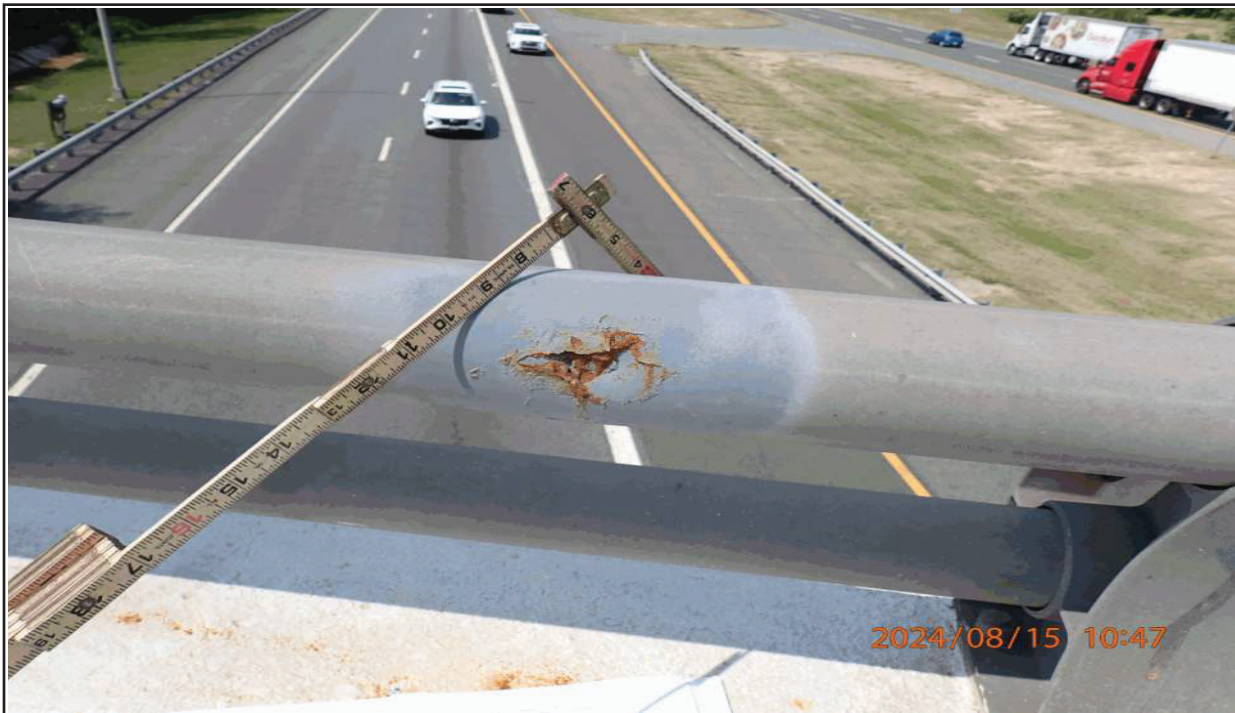
| Elm/Env | Description | Unit | Total Qty | Qty. St. 1 | Qty. St. 2 | Qty. St. 3 | Qty. St. 4 | Notes |
|---|---|---|---|---|---|---|---|---|
| 330/2 | Metal Bridge Railing | ft | 154.00 | 151.00 | 3.00 | 0.00 | 0.00 | NOTE: NUMEROUS MISSING/CRACKED OR SHEARED NUTS HAVE BEEN REPLACED IN 2023. THE PUNCTURE HOLE NOTED IN THE PREVIOUS REPORT HAS BEEN REPAIRED IN 2023 (PHOTO 12).<br><br>CONNECTION (1020):<br>CS2: (1 LF) THE WEST RAILING EXHIBITS ONE (1) CRACKED ANCHOR BOLT NUT AT POST BASE 10 FROM THE SOUTH.<br><br>DISTORTION (1900):<br>CS2: (2 LF) WEST RAIL, POSTS 7 AND 8, EXHIBITS MINOR IMPACT DAMAGE WITH A DENTED BOTTOM RAIL (2 LF).<br><br>DAMAGE (7000):<br>CS2: (2 LF) WEST RAIL, POSTS 7 AND 8 EXHIBIT IMPACT MINOR DAMAGE, SEE CS2 DISTORTION DEFECT ABOVE. |

12 SPAN 2 WEST METAL RAIL, TOP HORIZONTAL RAIL - HOLE REPAIRED

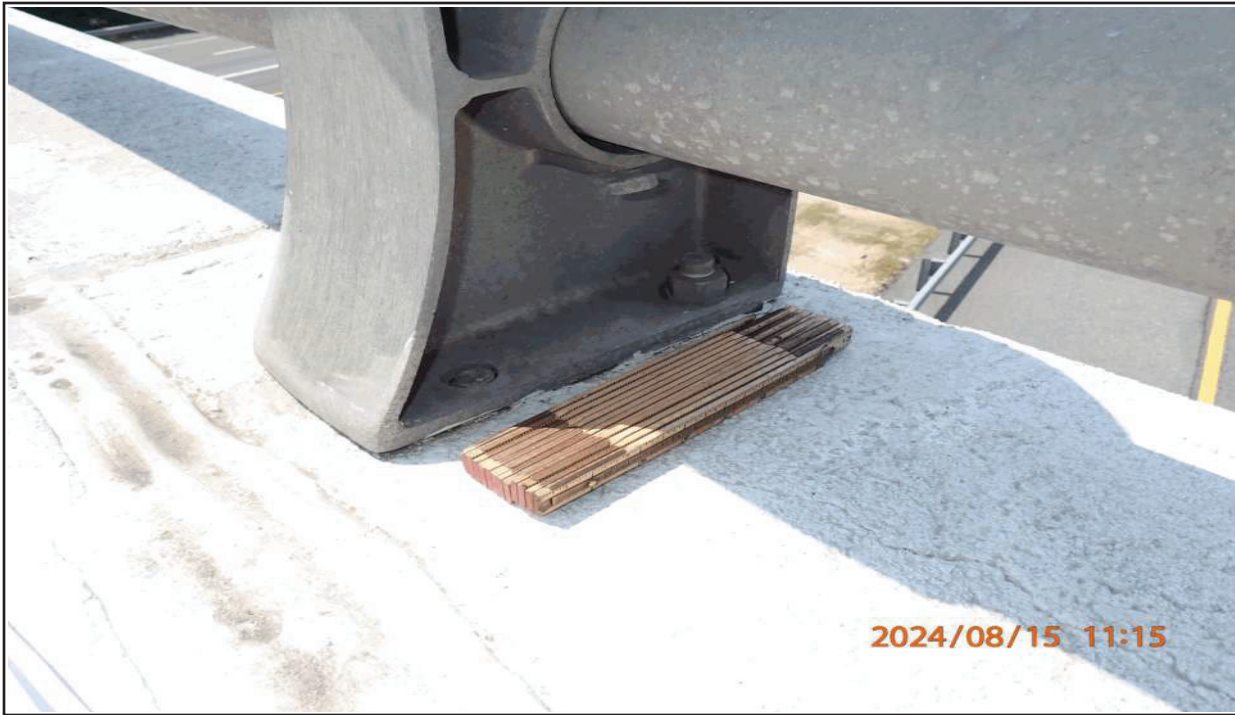
13 SPAN 4, WEST METAL RAIL AT POST 4 - SHEARED ANCHOR BOLT AND MISSING NUT

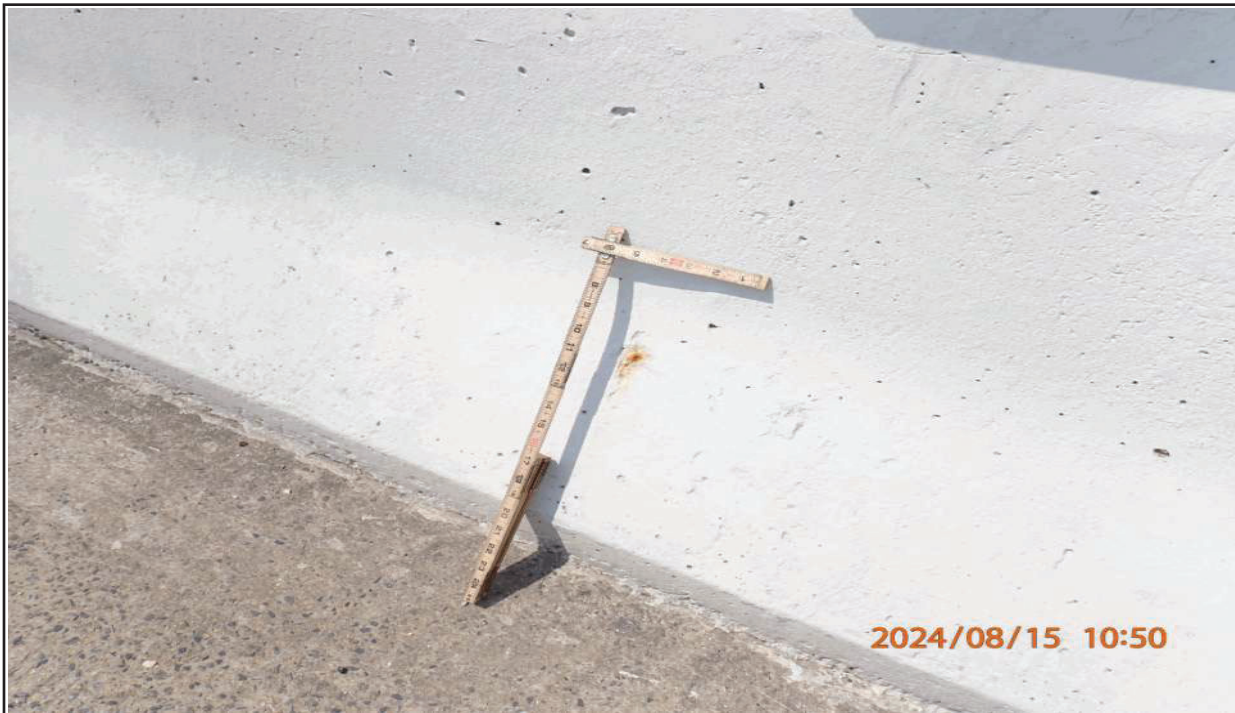
| Elm/Env | Description | Unit | Total Qty | Qty. St. 1 | Qty. St. 2 | Qty. St. 3 | Qty. St. 4 | Notes |
|---|---|---|---|---|---|---|---|---|
| 331/2 | Re Conc Bridge Railing | ft | 154.00 | 141.00 | 10.00 | 3.00 | 0.00 | NOTE: BOTH CONCRETE RAILS WERE PAINTED IN 2023<br><br>EXPOSED REBAR (1090):<br>CS3: (3 LF) WEST CONCRETE RAIL BETWEEN POSTS 7 AND 8 EXHIBIT THREE (3) EXPOSED CORRODED STEEL REINFORCEMENT BARS WITH NEGLIGIBLE SECTION LOSS (PHOTO 14).<br><br>CRACKING (1130):<br>CS2: (10 LF) WEST CONCRETE RAIL, TOP FACE BETWEEN POSTS 7 AND 9, EXHIBIT A 10FT L x UP TO 1/4IN W SEALED CRACK WITH AN ADJACENT 5IN L x 4IN W x 1IN D PAINTED OVER SPALL. |

14 SPAN 2, WEST CONCRETE RAIL BETWEEN POSTS 7 AND 8 - EXPOSED CORRODED STEEL REINFORCEMENT WITH SECTION LOSS

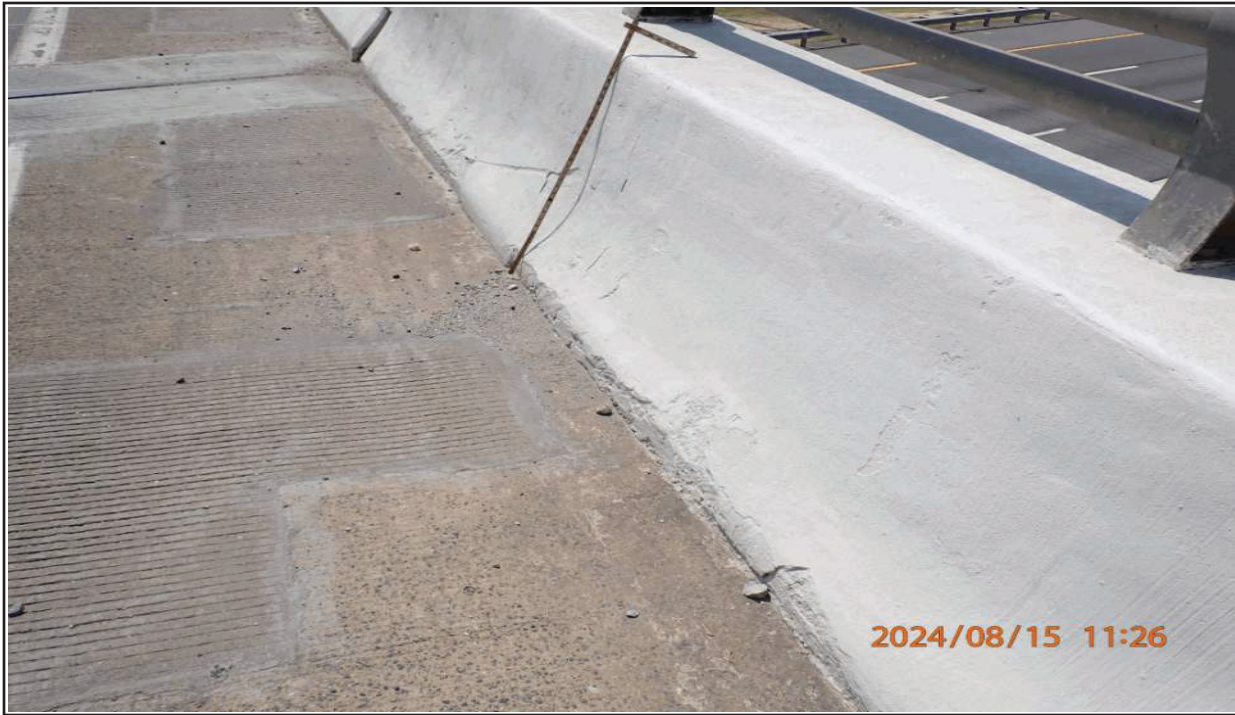
15 SPAN 5, WEST CONCRETE RAIL ALONG THE BASE - PAINTED OVER SPALLS

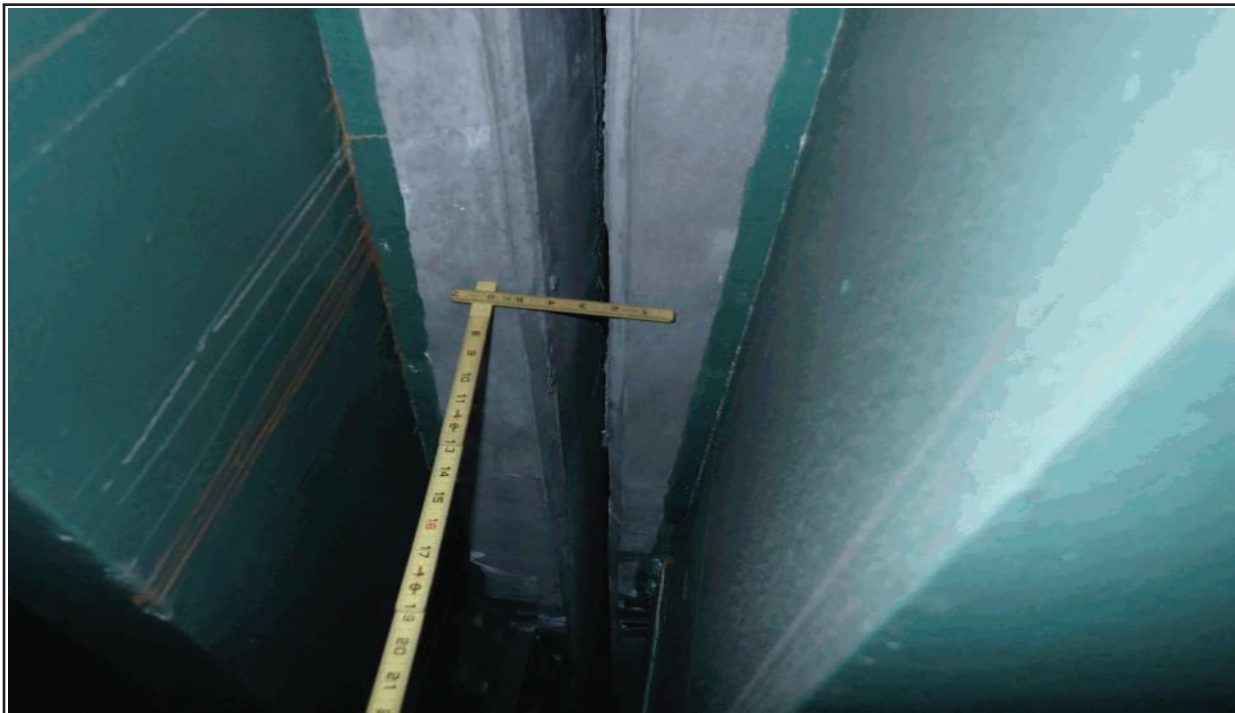
| Elm/Env | Description | Unit | Total Qty | Qty. St. 1 | Qty. St. 2 | Qty. St. 3 | Qty. St. 4 | Notes |
|---|---|---|---|---|---|---|---|---|
| 12/2 | Re Concrete Deck | sq.ft | 10,700.00 | 10,628.00 | 25.00 | 47.00 | 0.00 | <p>NOTE: THERE HAS BEEN NUMEROUS SOFFIT REPAIRS THROUGHOUT ALL SPANS, INCLUDING HAUNCHES OVER PIERS AND ABUTMENTS (PHOTOS 16 AND 17)</p> <p>DECK NOTES:<br/>SEE 510 WEARING SURFACE.</p> <p>SOFFIT NOTES:<br/>EXPOSED REBAR:<br/>CS3: (2 SF) SPAN 2, BAY 4, 8-FEET SOUTH OF PIER 2; 1FT-3IN L x 3IN W x 1IN D WITH EXPOSED CORRODED REINFORCEMENT WITH NEGLIGIBLE SECTION LOSS (PHOTO 21), (2 SF).</p> <p>DELAMINATION/SPALL (1080):<br/>CS3: (37 SF) WEST OVERHANG, 5-FEET NORTH OF THE SOUTH ABUTMENT; 5IN L x 5IN W x 1IN D (1 SF). EAST OVERHANG, 8-FEET NORTH OF THE SOUTH ABUTMENT EXHIBITS A 10IN L x 6IN W x 1 1/2IN D PAINTED OVER SPALL (1 SF). SPAN 1 SOFFIT HAUNCH, ALONG THE EAST TOP FLANGE OF GIRDER 1, BETWEEN DIAPHRAGM 3 AND PIER 1 EXHIBITS A 10FT L x 2IN W x 2IN D SPALL (10 SF). SPAN 1, BAY 1, BETWEEN INTERIOR DIAPHRAGM 2 AND 3 EXHIBITS A 2FT L x 1.5FT W UNSOUND CONCRETE PATCH (2 SF). SPAN 2, BAY 1 AT PIER 1 EXHIBITS A 3FT W x 13IN L x 1 3/4IN D SPALL WITH EXPOSED AND LIGHTLY CORRODED STEEL REINFORCEMENT (3 SF), (PHOTO 20). SPAN 2, BAY 1, OVER THE LEFT SHOULDER EXHIBITS A 6IN L x 6IN W x 2 1/2IN D SPALL WITH EXPOSED CORRODED STEEL REINFORCEMENT (1 SF), (PHOTO 18). SPAN 2, BAY 1, OVER THE CENTER LANE EXHIBITS A 1FT DIAMETER x 3IN D SPALL WITH EXPOSED CORRODED STEEL REINFORCEMENT (1 SF), (PHOTO 19). SPAN 2, BAY 1, OVER THE RIGHT LANE, 25-FEET NORTH OF PIER 1 EXHIBITS A 2FT-3IN L x 2FT-3IN W DELAMINATED CONCRETE PATCH, (5 SF). SPAN 5, EAST SOFFIT HAUNCH ADJACENT TO GIRDER 3 AT PIER 4, EXHIBITS A 3FT L x 2IN W x 2IN D SPALL (3 SF). SPAN 5, EAST SOFFIT HAUNCH ADJACENT TO GIRDER 5 BETWEEN INTERIOR DIAPHRAGM 3 AND PIER 4 EXHIBITS A 10FT L x 2IN W x 2IN D SPALL (10 SF).</p> <p>CS2: (8 SF) SPAN 1, BAY 4, AT THE SOUTH ABUTMENT EXHIBITS A 2FT L x 2FT W DELAMINATION (4 SF). SPAN 1, BAY 4, AT MID-SPAN EXHIBITS A 1-FOOT DIAMETER (1 SF). SPAN 4, EAST OVERHANG, AT PIER 3 EXHIBITS A 1FT-3IN L x 2FT W DELAMINATION/ IMMINENT SPALL (3 SF).</p> <p>EFFLORESCENCE/RUST STAINING (1120):<br/>CS3: (8 SF) SPAN 3, BAY 1, AT THE FIRST INTERIOR DIAPHRAGM EXHIBITS A 4FT L x 2FT W AREA OF HAIRLINE MAP CRACKING WITH CORROSION (8 SF), (PHOTO 22).</p> <p>CS2: (17 SF) SPAN 1, BAY 1, AT MID-SPAN EXHIBITS A 1-FOOT LONG HAIRLINE TRANSVERSE CRACK WITH EFFLORESCENCE (1 SF). SPAN 1, BAY 1, AT 2/3 SPAN EXHIBITS A 4-FOOT LONG HAIRLINE TRANSVERSE CRACK WITH EFFLORESCENCE (1 SF). SPAN 3, BAY 4, AT NORTH END EXHIBITS A 1-FOOT LONG HAIRLINE TRANSVERSE CRACK WITH EFFLORESCENCE (1 SF). SPAN 4, BAY 1, 5-FEET FROM PIER 4 EXHIBITS A 2-FOOT LONG HAIRLINE CRACK WITH EFFLORESCENCE (2 SF). SPAN 4, BAY 1, 18-FEET SOUTH OF PIER 4 EXHIBITS A 2-FOOT LONG HAIRLINE TRANSVERSE CRACK WITH AN ADJACENT 10IN L x 6IN W DELAMINATION (1 SF).</p> |

16 SPAN 3, PIER 3, BAY 2 - TYPICAL SOFFIT HAUNCH OVER PIER REPAIR

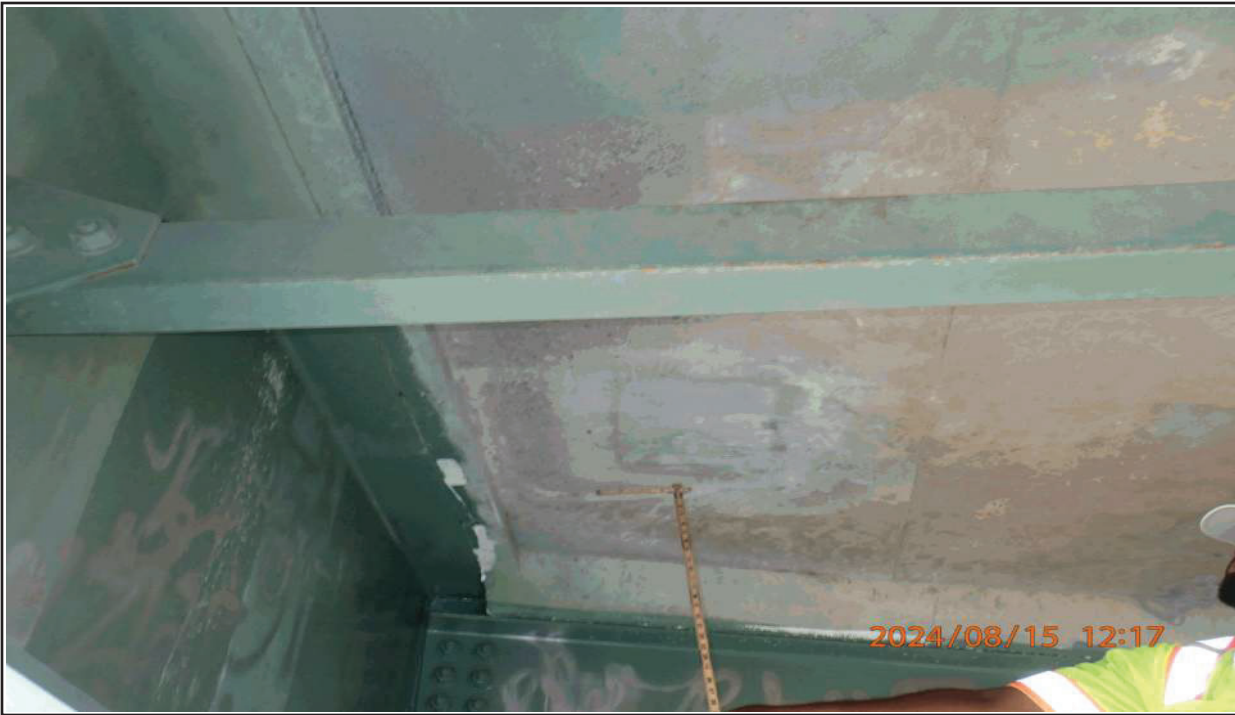
17 SOFFIT, SPAN 5 ADJACENT TO GIRDER 1 - REPAIRED

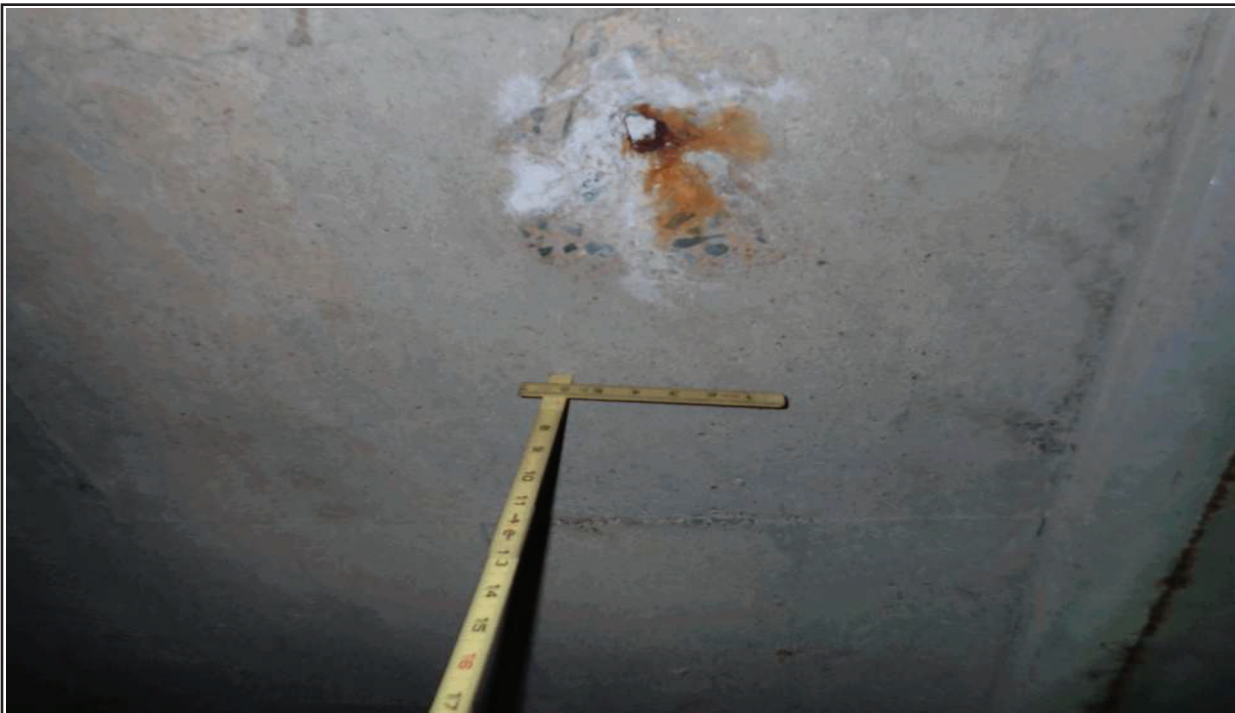
18 SOFFIT, SPAN 2, BAY 1 OVER THE LEFT LANE - SPALL WITH EXPOSED CORRODED STEEL REINFORCEMENT

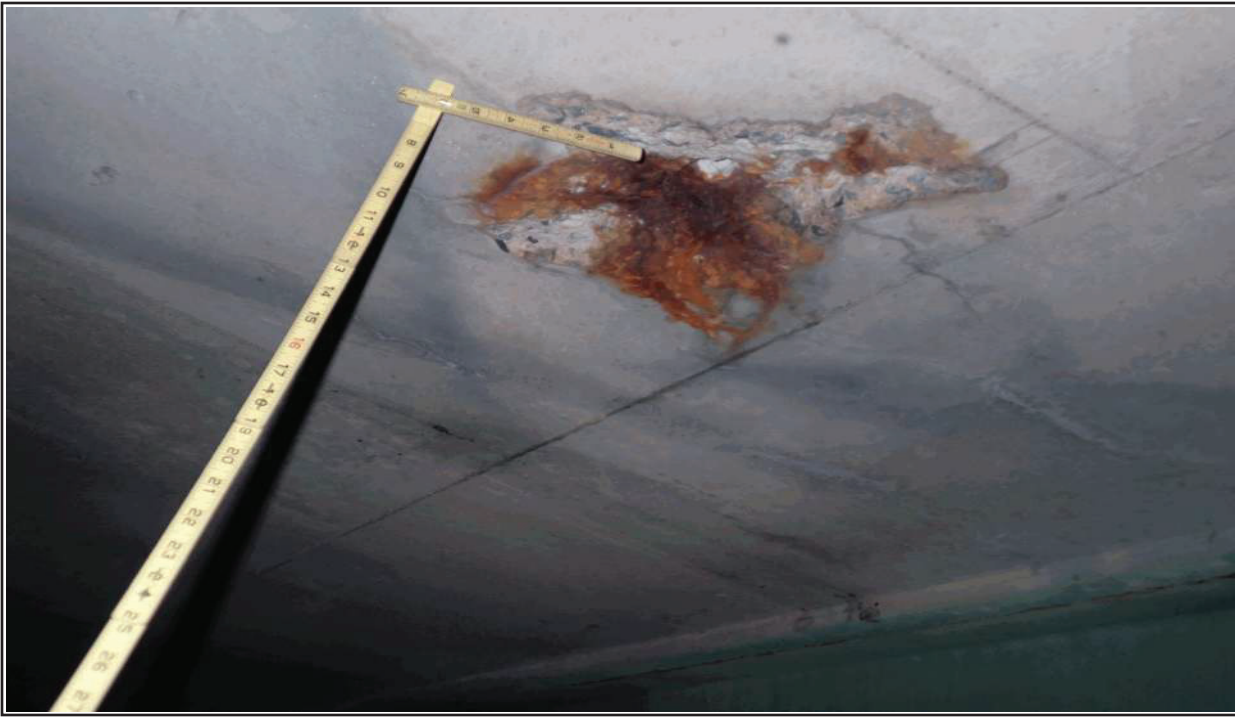
19 SOFFIT, SPAN 2, BAY 1 AT PIER 1 - SPALL WITH EXPOSED CORRODED STEEL REINFORCEMENT

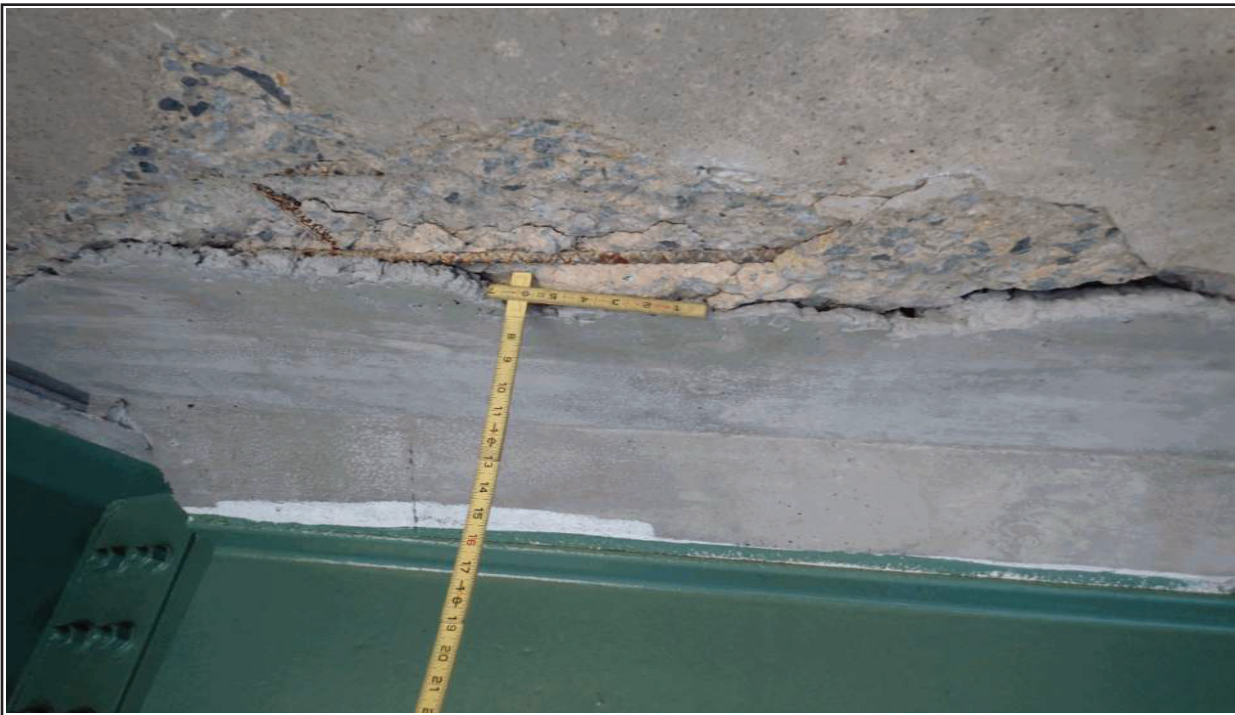
20 SOFFIT, SPAN 2, BAY 1 AT PIER 1 - SPALL WITH EXPOSED CORRODED STEEL REINFORCEMENT

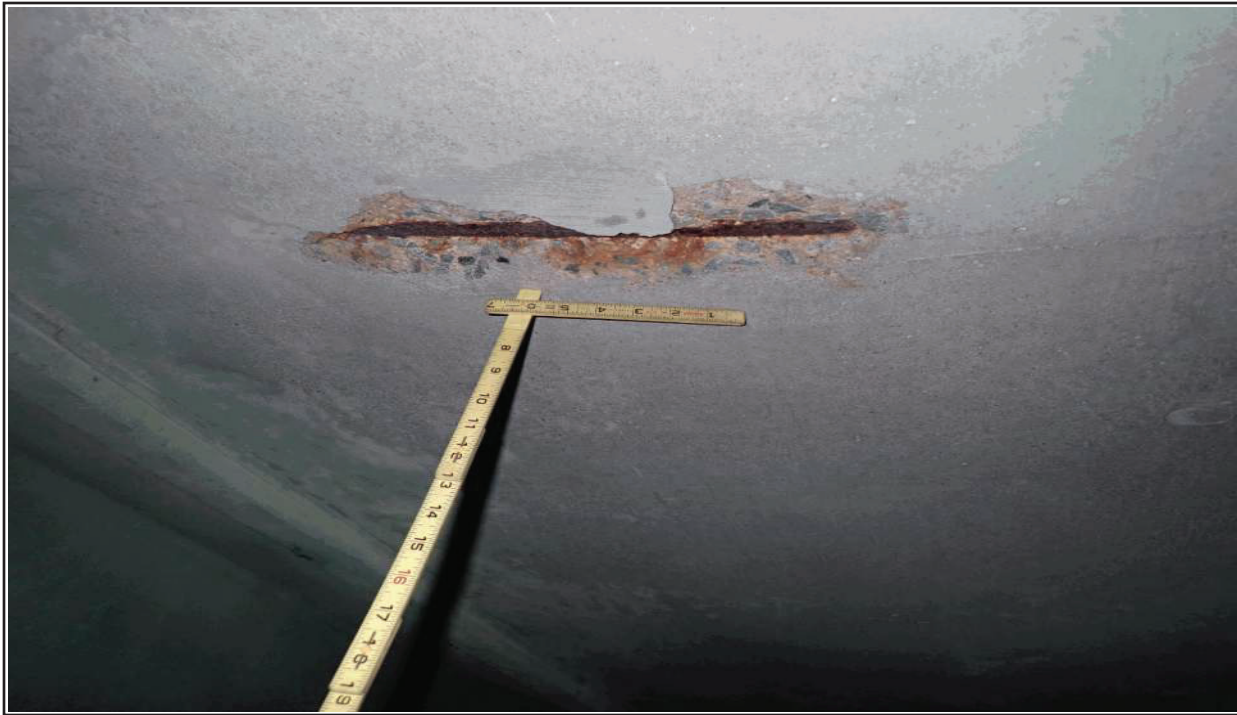
21 SOFFIT, SPAN 2, BAY 4 SOUTH OF PIER 2 - SPALL WITH EXPOSED CORRODED STEEL REINFORCEMENT WITH SECTION LOSS

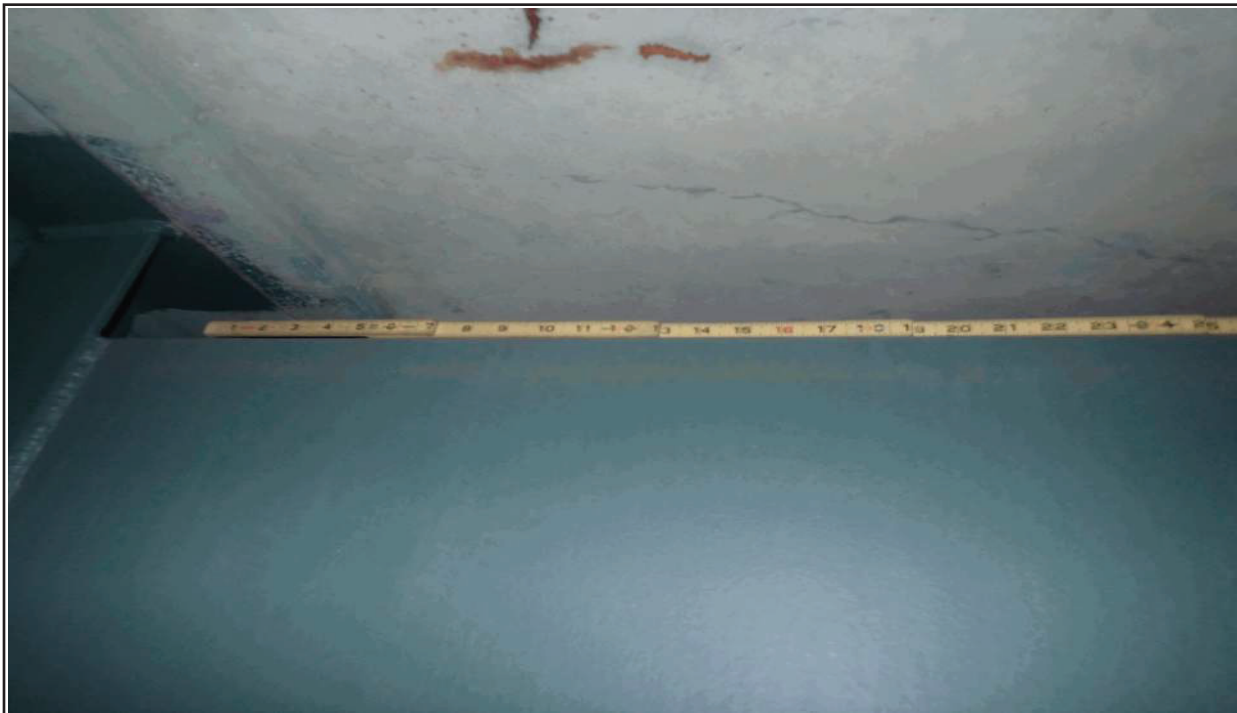
22 SOFFIT, SPAN 3, BAY 1 AT INTERIOR DIAPHRAGM 1 - CRACKS WITH CORROSION STAINS

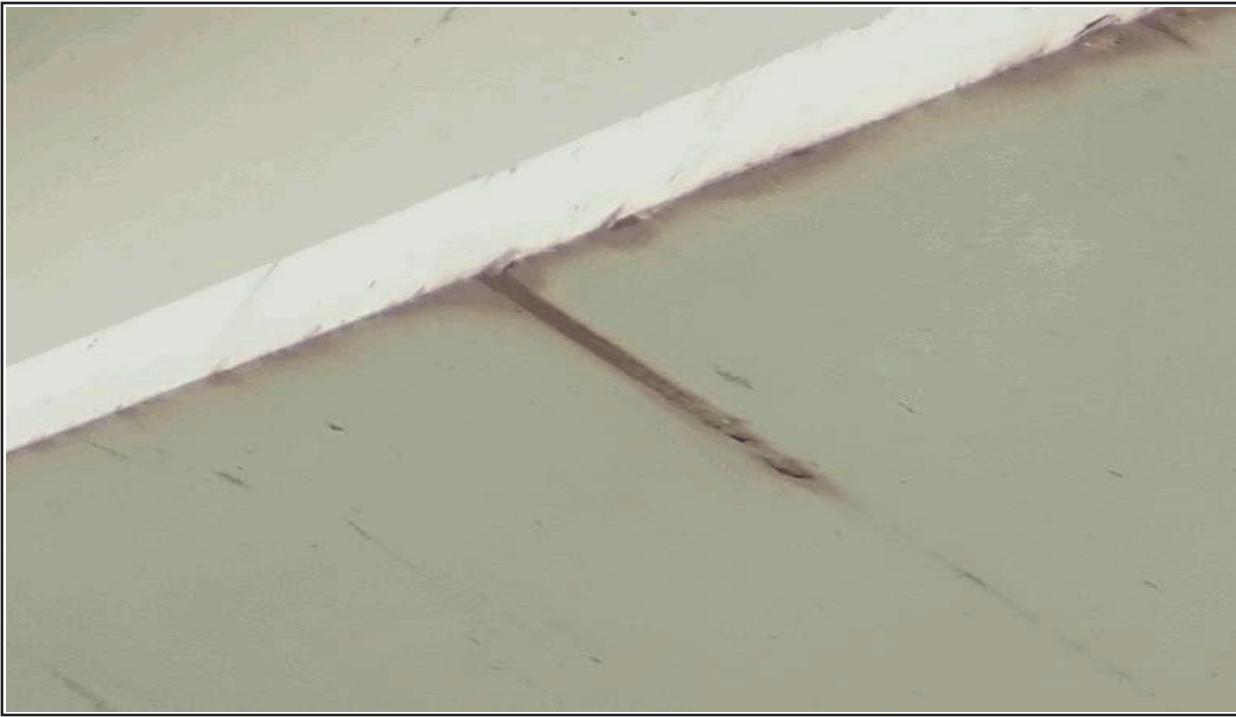
23 SPAN 4, GIRDER 5 OVER RIGHT LANE - TRAFFIC IMPACT GOUGE AND SCRAPE

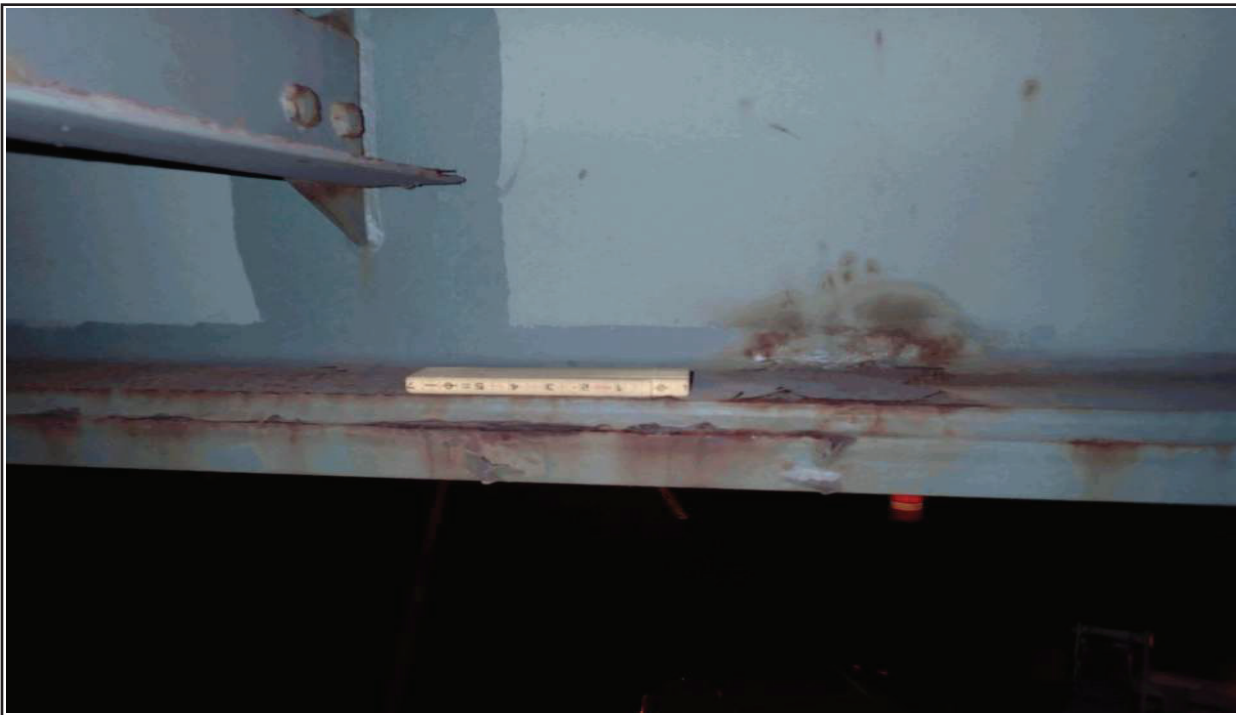
24 SPAN 4, GIRDER 4, BETWEEN DIAPHRAGMS 1 AND 2 - CORROSION WITH SECTION LOSS TO EAST BOTTOM FLANGE AND BOTTOM OF WEB

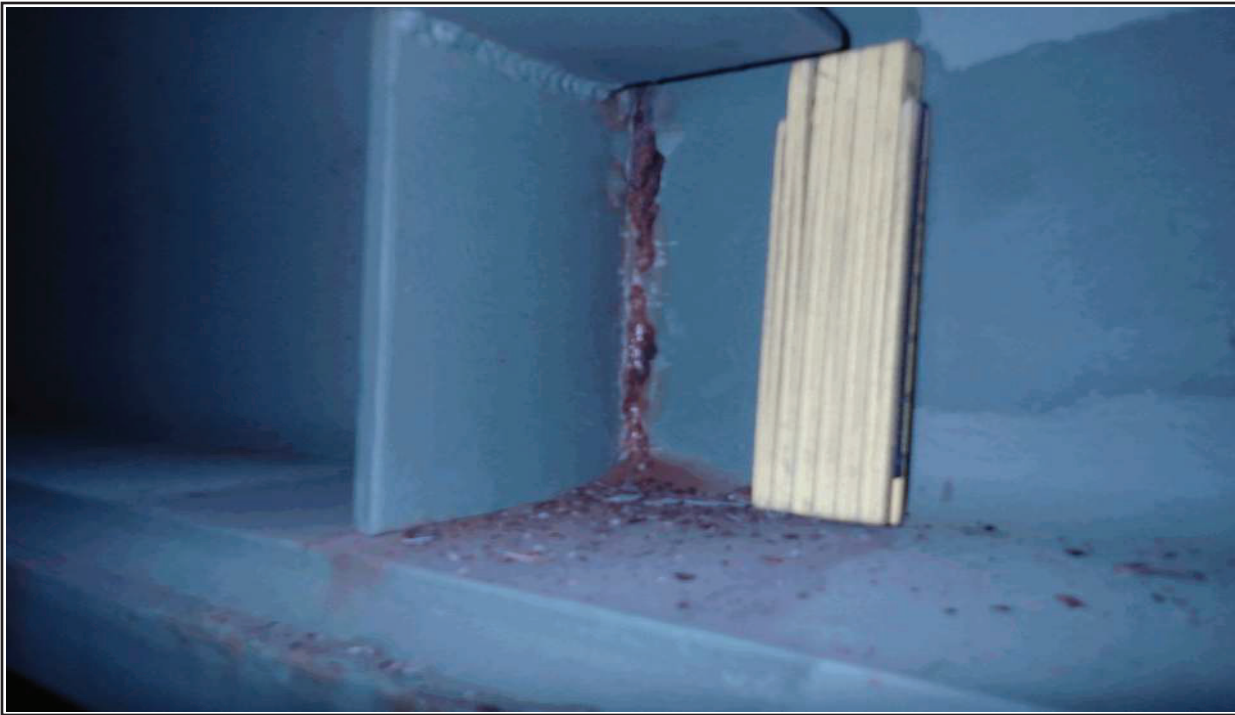
25 SPAN 4, BAY 4 AT GIRDER 4 WEB STIFFENER TO DIAPHRAGM 2 - CORROSION ALONG WELD  
(NO CRACK FOUND)

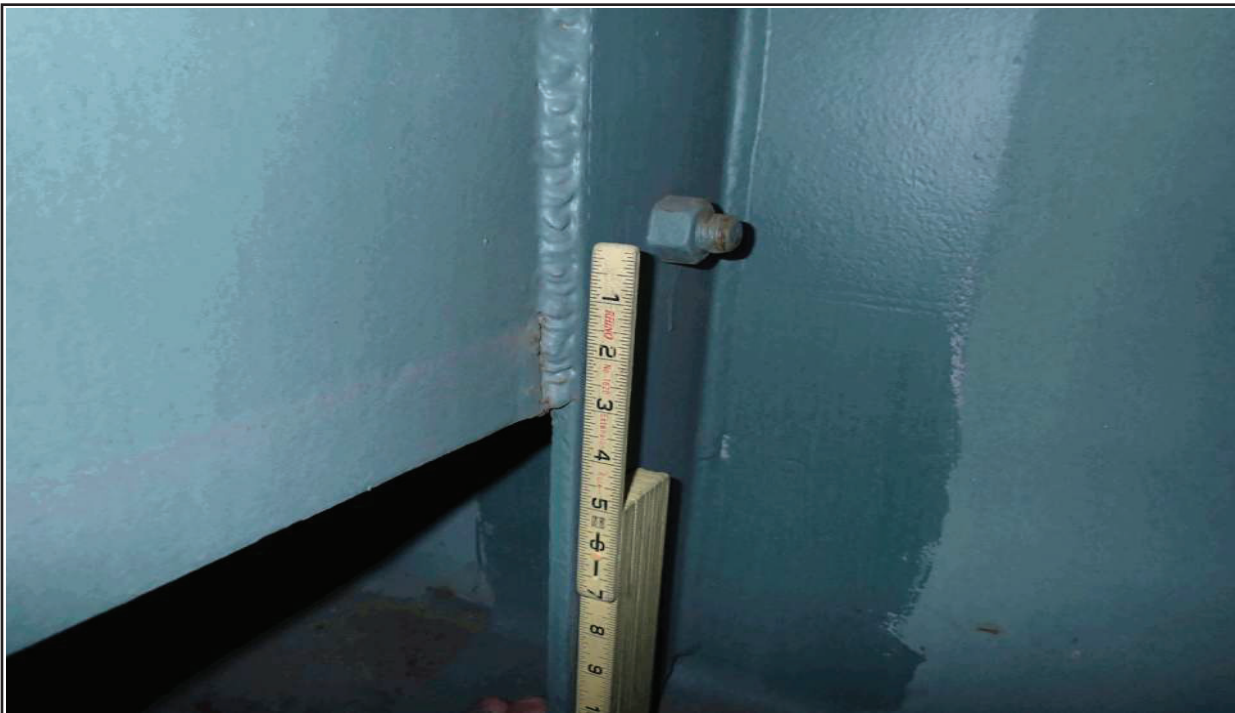
26 SPAN 4, BAY 4, GIRDER 5 AT INTERIOR DIAPHRAGM 1 - EAST VERTICAL WELD CRACK AT  
BOTTOM

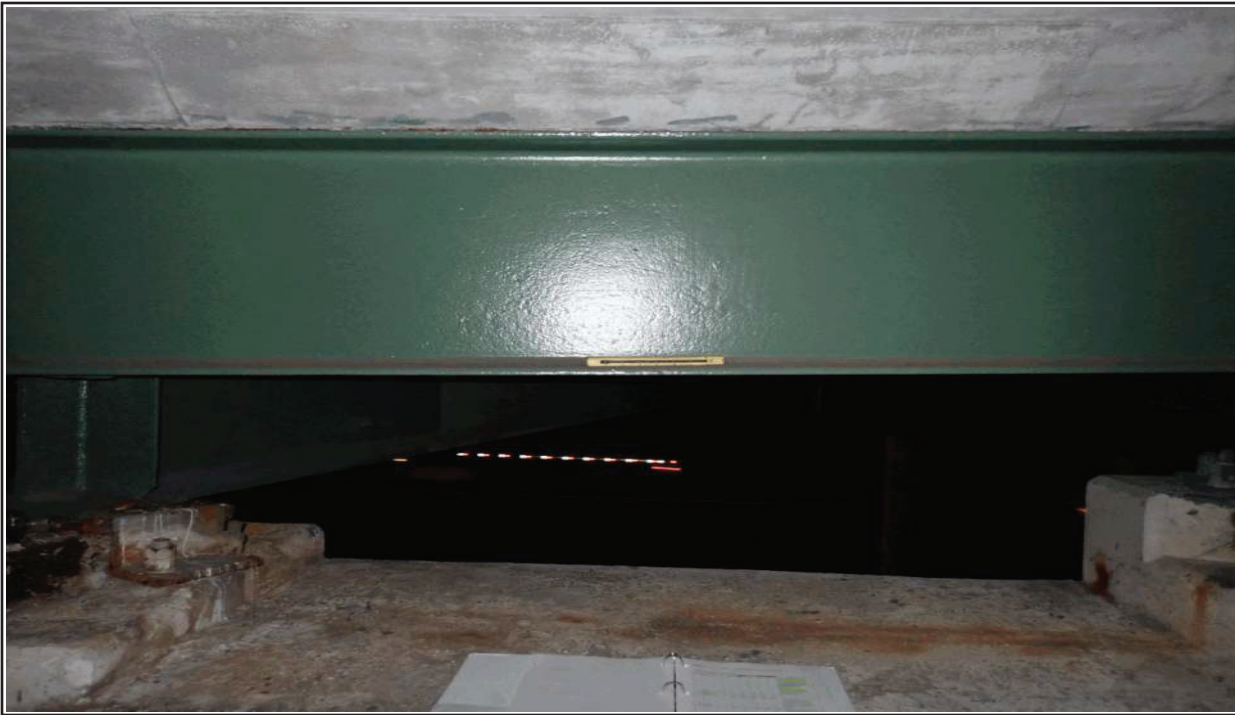
| Elm/Env | Description | Unit | Total Qty | Qty. St. 1 | Qty. St. 2 | Qty. St. 3 | Qty. St. 4 | Notes |
|---|---|---|---|---|---|---|---|---|
| 881/2 | Steel Diap | (EA) | 23.00 | 8.00 | 15.00 | 0.00 | 0.00 | NOTE: THE DIAPHRAGMS WERE PAINTED OVER AT BOTH PIERS IN 2023 (PHOTO 27).<br><br>CORROSION<br>CS2: (15 EA) INTERIOR DIAPHRAGMS EXHIBIT RANDOM AREAS OF MINOR FRECKLED CORROSION.<br><br>(NC-24) |

27 SPAN 3, PIER 3, BAY 4 END DIAPHRAGM - TYPICAL PAINT

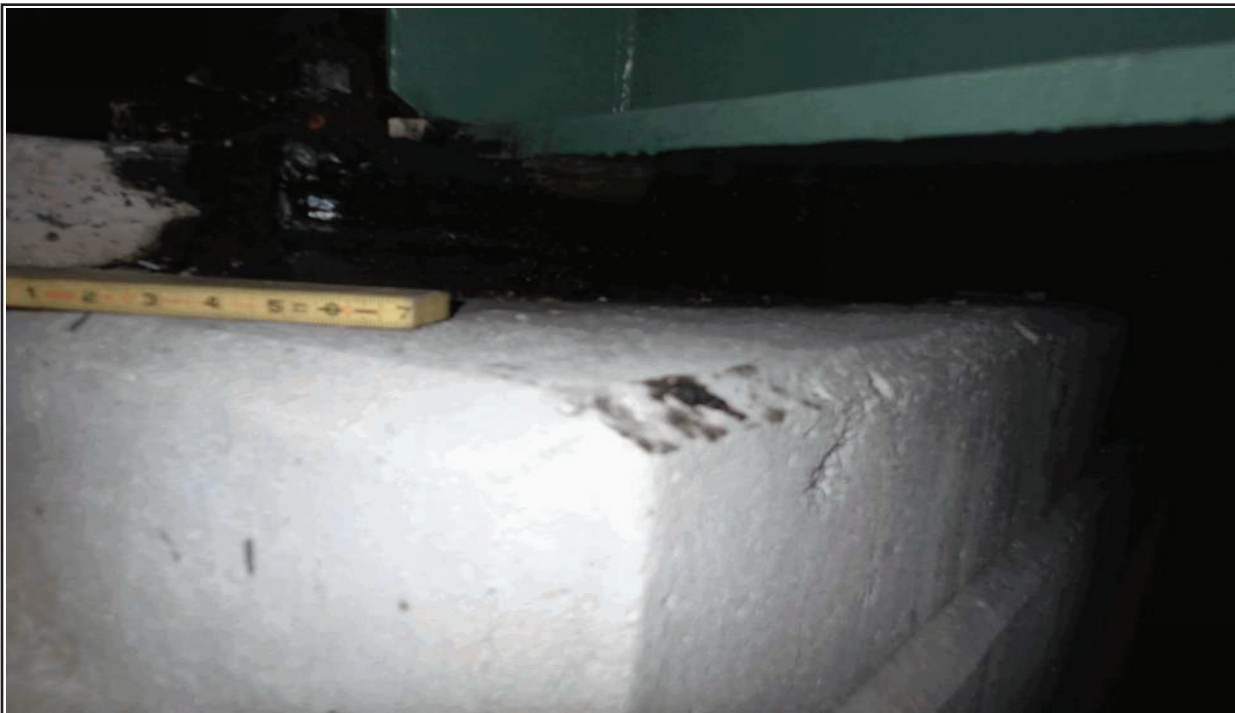
28 SPAN 2, PIER 2, BEARING 4 - COVERED IN GREASE (TYPICAL OF ALL)

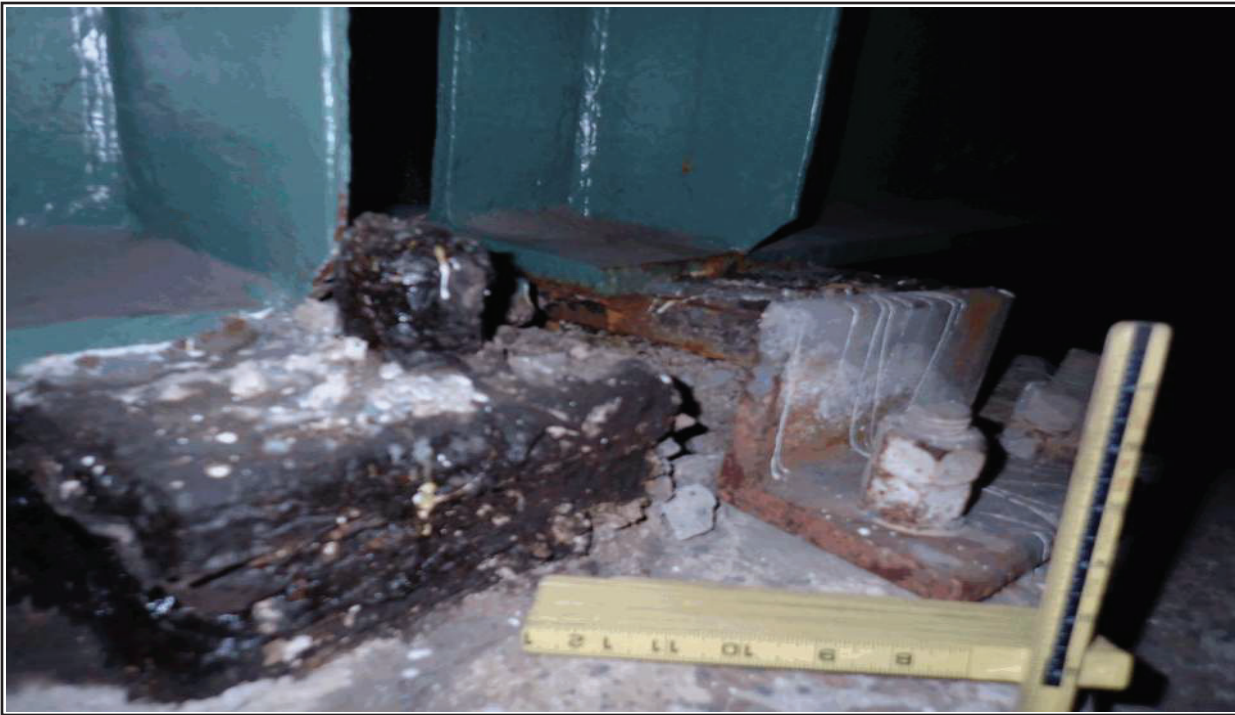
29 PIER 3, SPAN 3, BEARING 5 - VIEW OF KEEPER PLATE AND MISSING ANCHOR BOLT

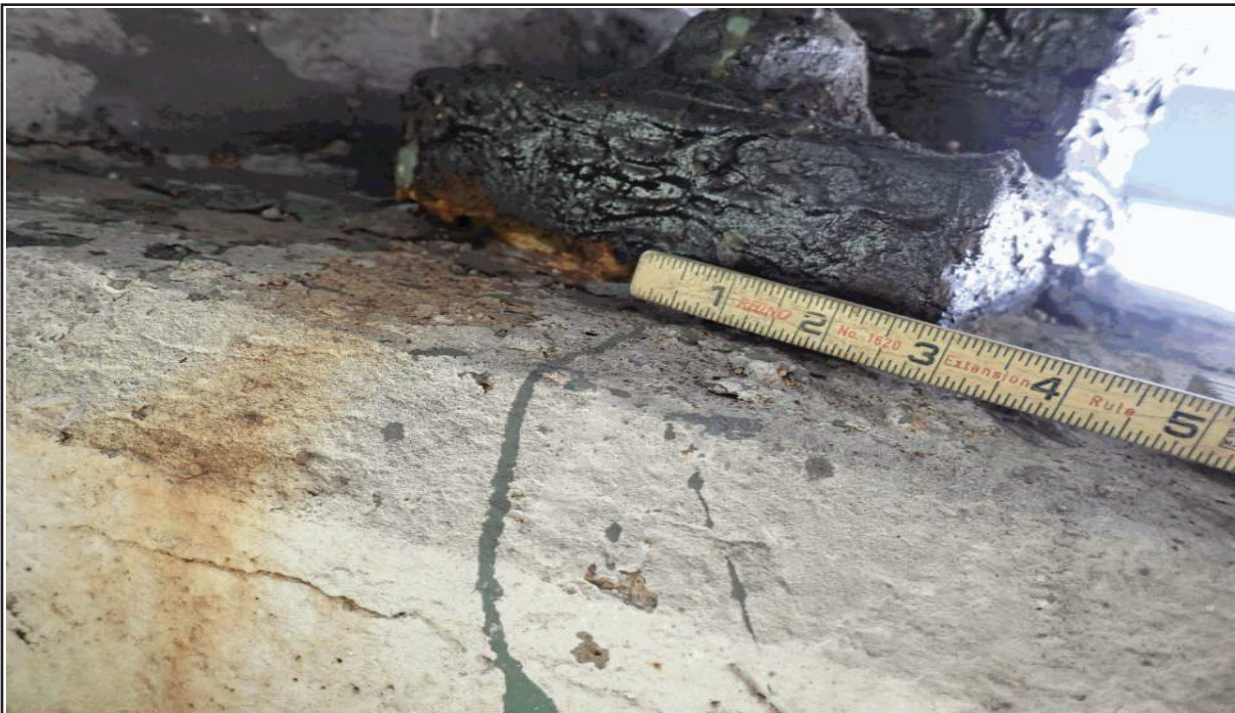
30 PIER 4, SPAN 4, BEARING 4 - LAMINAR CORROSION WITH SECTION LOSS ALONG THE MASONRY PLATE

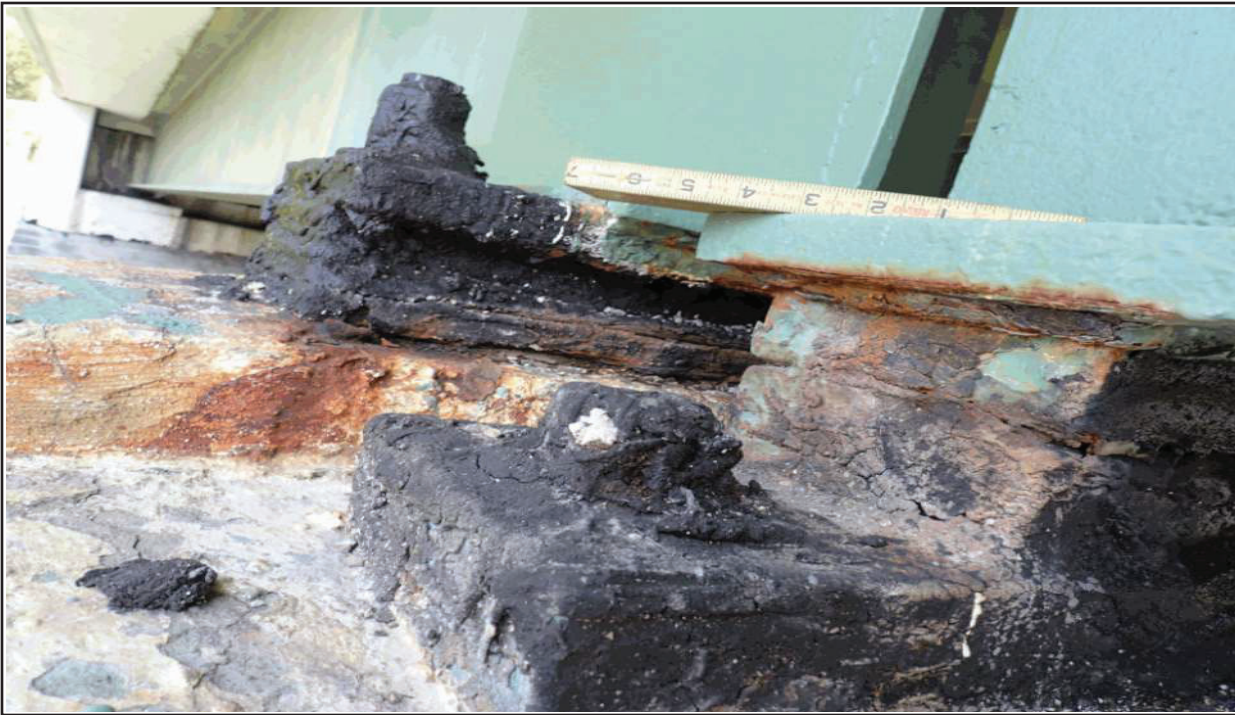
31 PIER 4, SPAN 5, BEARING 1 - LAMINAR CORROSION WITH SECTION LOSS ALONG MASONRY PLATE
