Bridge No: 1701 397

Date of Inspection: 08/15/2024

6) Feature Intersected: I 95, DELAWARE TURNPIKE

7) Facility Carried: OTTS CHAPEL RD

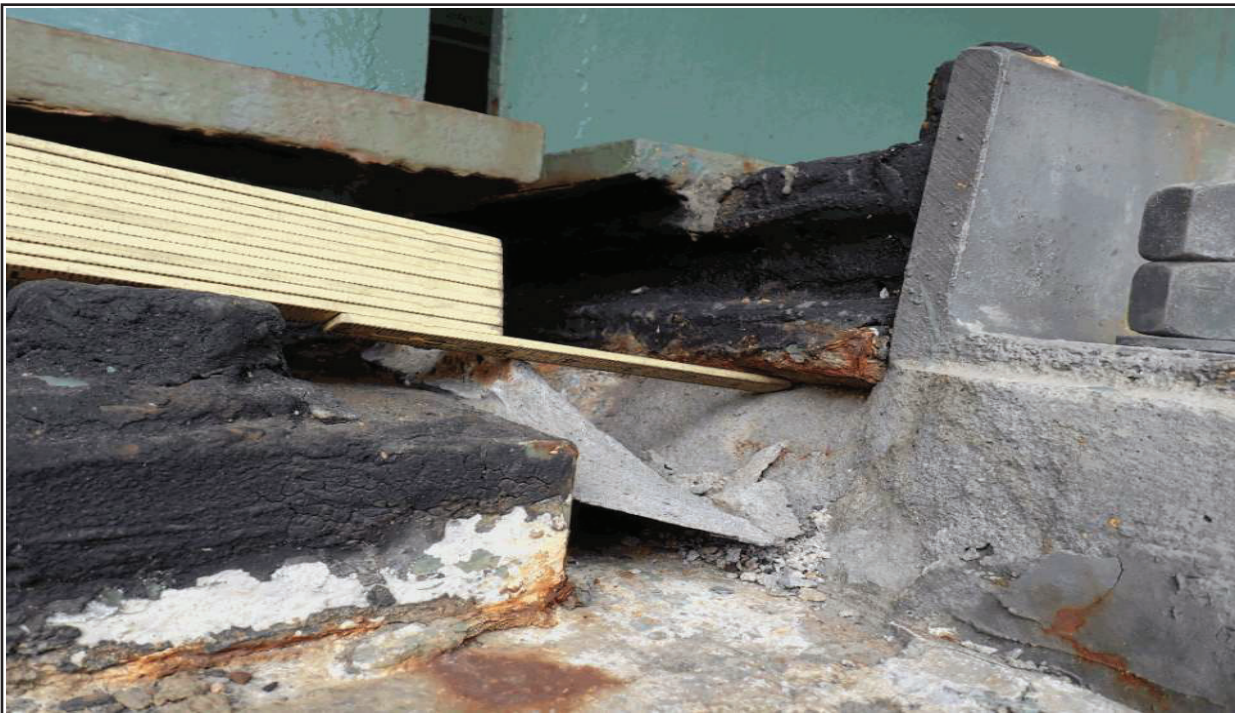
32 PIER 4, SPAN 5, BEARING PEDESTAL 5 SOUTH SIDE - FAILED REPAIR WITH BEARING LOSS

PIER 4, SPAN 5, PEDESTAL 5 IS SPALLED WITH BEARING LOSS AND SHOULD BE REPAIRED (PHOTO 32).

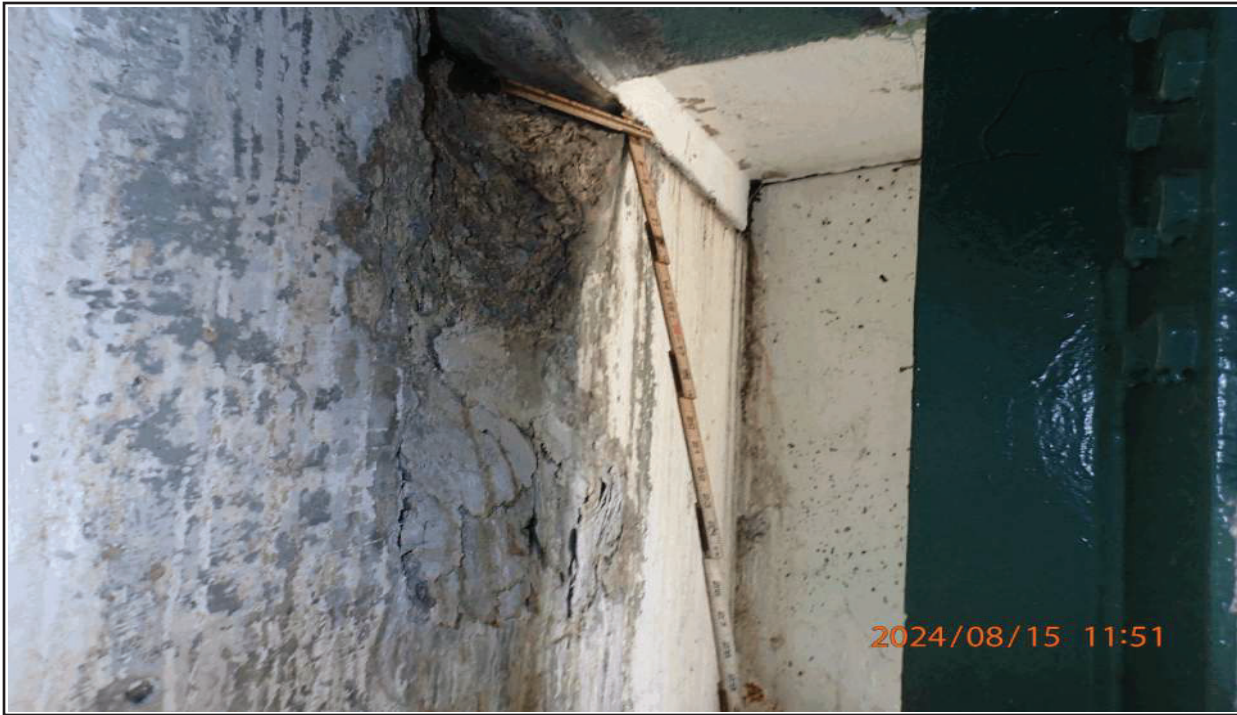
| Elm/Env | Description | Unit | Total Qty | Qty. St. 1 | Qty. St. 2 | Qty. St. 3 | Qty. St. 4 | Notes |
|---|---|---|---|---|---|---|---|---|
| 825/2 | R/C Abutment Backwall | ft | 40.00 | 38.00 | 0.00 | 2.00 | 0.00 | DELAMINATION/SPALL (1080):<br>CS3: (2 LF) BACKWALL, BEHIND GIRDER 1, EXHIBITS A 10IN W x 5IN H x UP TO 2IN D SPALL (PHOTO 33), (1 LF). BACKWALL BEHIND GIRDER 5 EXHIBITS A 10IN W x 5IN H x 1/4-IN D SPALL AT THE TOP (1 LF).<br><br>CRACKING (1130):<br>CS1: (38 LF) THE BACKWALL EXHIBITS RANDOM AREAS OF HAIRLINE CRACKS THROUGHOUT.<br><br>(NC-24) |

33 SOUTH ABUTMENT BACKWALL BEHIND GIRDER 1 - SPALL

B041-S3B: REPAIR THE SPALLS IN THE NORTH AND SOUTH ABUTMENT BACKWALLS (< 1 CY) (PHOTO 33).

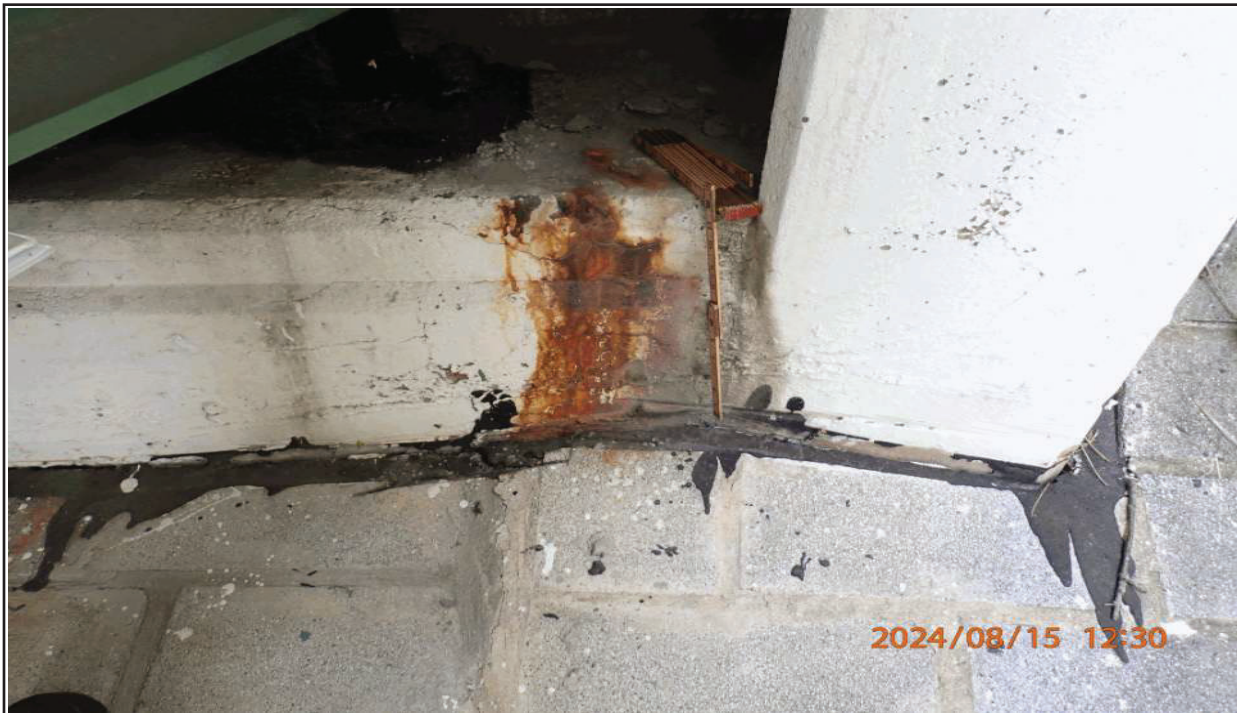
34 NORTH ABUTMENT, EAST END AT BEARING 5 - CRACKS WITH CORROSION STAINS

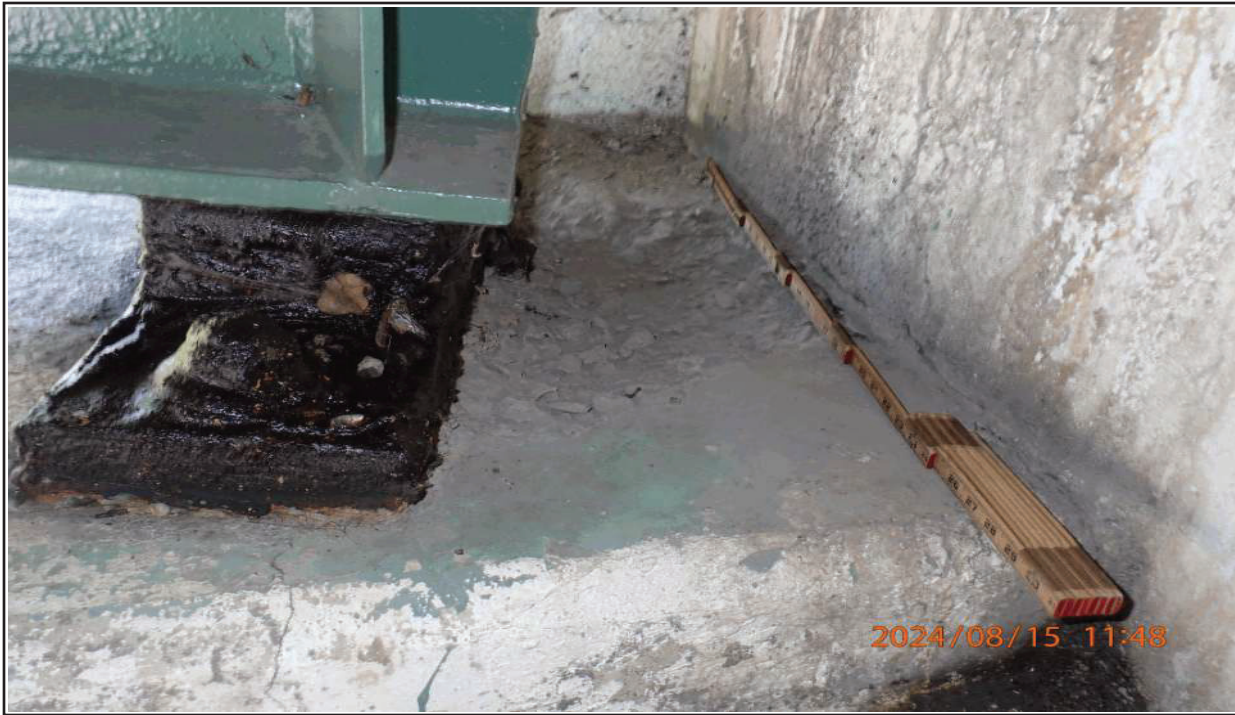
| Elm/Env | Description | Unit | Total Qty | Qty. St. 1 | Qty. St. 2 | Qty. St. 3 | Qty. St. 4 | Notes |
|---|---|---|---|---|---|---|---|---|
| 215/2 | Re Conc Abutment | ft | 40.00 | 39.00 | 0.00 | 1.00 | 0.00 | DELAMINATION/SPALL (1080):<br>CS3: (1 LF) PEDESTAL 5, BEHIND GIRDER 5, EXHIBITS A 1FT DIAMETER x UP TO 1 1/2IN D PAINTED OVER SPALL (PHOTO 35).<br><br>CRACKING (1130):<br>CS1: (39 LF) THE ABUTMENT STEM EXHIBITS RANDOM AREAS OF HAIRLINE CRACKS THROUGHOUT.<br><br>(NC-24) |

35 SOUTH ABUTMENT, BEARING PEDESTAL 5 - PAINTED OVER SPALL BEHIND BEARING

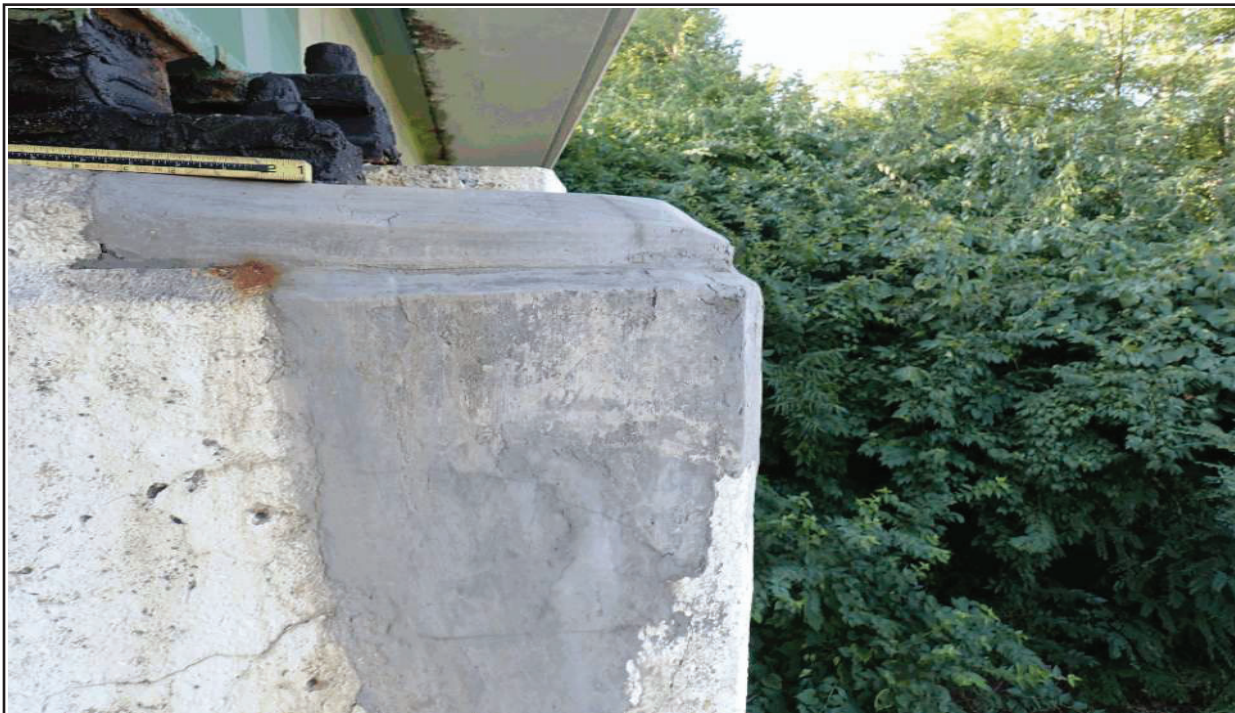
| Elm/Env | Description | Unit | Total Qty | Qty. St. 1 | Qty. St. 2 | Qty. St. 3 | Qty. St. 4 | Notes |
|---|---|---|---|---|---|---|---|---|
| 234/2 | Re Conc Pier Cap | ft | 37.00 | 27.00 | 7.00 | 3.00 | 0.00 | NOTE: THE NORTH FACE OF PIER CAP AT GIRDER 1 AND BEARING 1 PEDESTAL HAVE BEEN REPAIRED SINCE LAST INSPECTED (PHOTO 36).<br><br>EFFLORESCENCE/RUST STAINING (1120):<br>CS3: (3 LF) NORTH FACE, AT THE WEST END, EXHIBITS FOUR (4) UP TO 1FT L x HAIRLINE HORIZONTAL CRACKS WITH CORROSION STAINING (2 LF), (PHOTO 37). EAST UNDERSIDE END OF THE PIER CAP BELOW GIRDER 5 EXHIBITS A 1-FOOT LONG HAIRLINE CRACK WITH CORROSION (1 LF).<br><br>DELAMINATION/SPALL (1080):<br>CS2: (6 LF) NORTH FACE AT BAY 1 ALONG THE TOP EXHIBITS A 2FT-6IN L HORIZONTAL CRACK WITH A 2FT-6IN L x 6IN H DELAMINATION (3 LF). NORTH FACE, BAY 4, EXHIBITS A 1FT L x 1/16IN W HORIZONTAL CRACK WITH AN ASSOCIATED MINOR DELAMINATION AT THE TOP OF THE CAP, AND A 4IN H x 2FT-4IN L DELAMINATION WITH 1/16IN W CRACKING THROUGHOUT AT THE BOTTOM OF THE CAP (3 LF).<br><br>CRACKING (1130):<br>CS2: (1 LF) PEDESTAL 3, NORTHWEST CORNER EXHIBITS A 1/8-INCH WIDE VERTICAL CRACK FROM THE BASE UP TO THE ANCHOR BOLT, AND THE WEST HALF OF THE NORTH FACE IS DELAMINATED 1FT W x 8IN H (PHOTO 38), (1 LF).<br><br>CS1: (24 LF) THE PIER CAP EXHIBITS RANDOM UP TO 1/16IN W VERTICAL, HORIZONTAL, AND MAP CRACKS THROUGHOUT. |

36 PIER 1, PEDESTAL 1 NORTH FACE AND WEST END OF CAP - REPAIRED

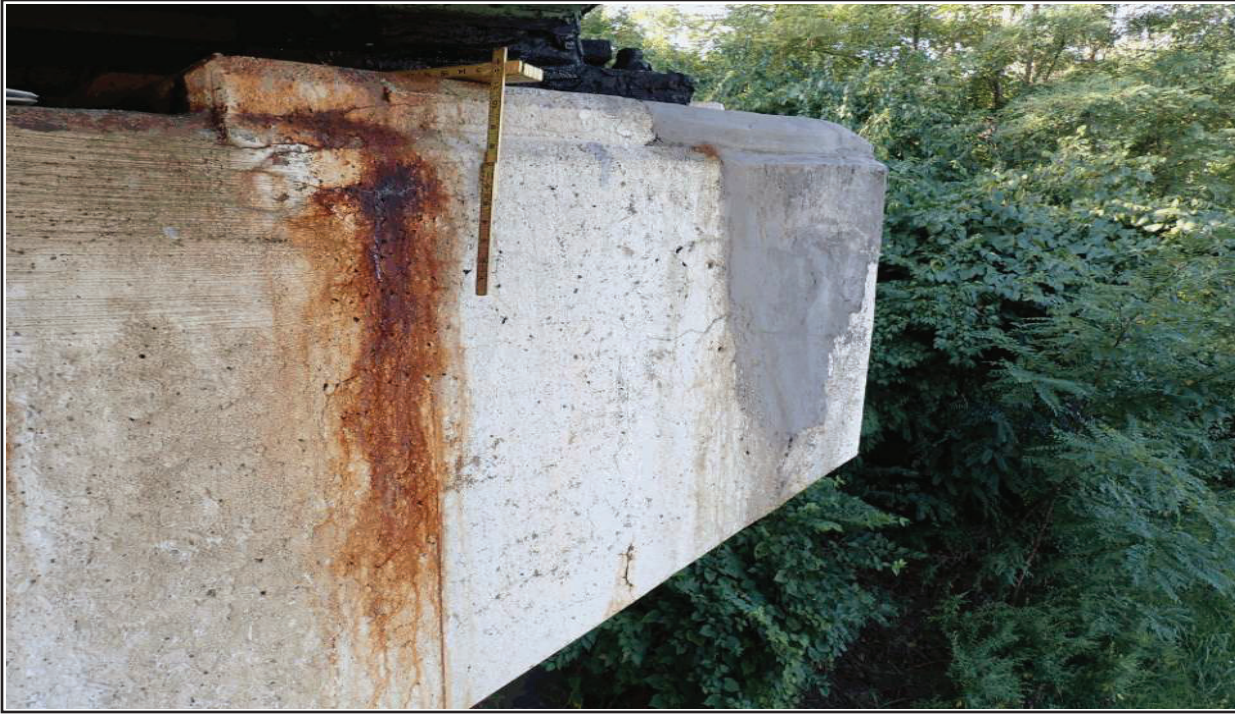
37 PIER 1, NORTH FACE, WEST END BELOW BEARING 1 - CRACKS WITH CORROSION STAINS

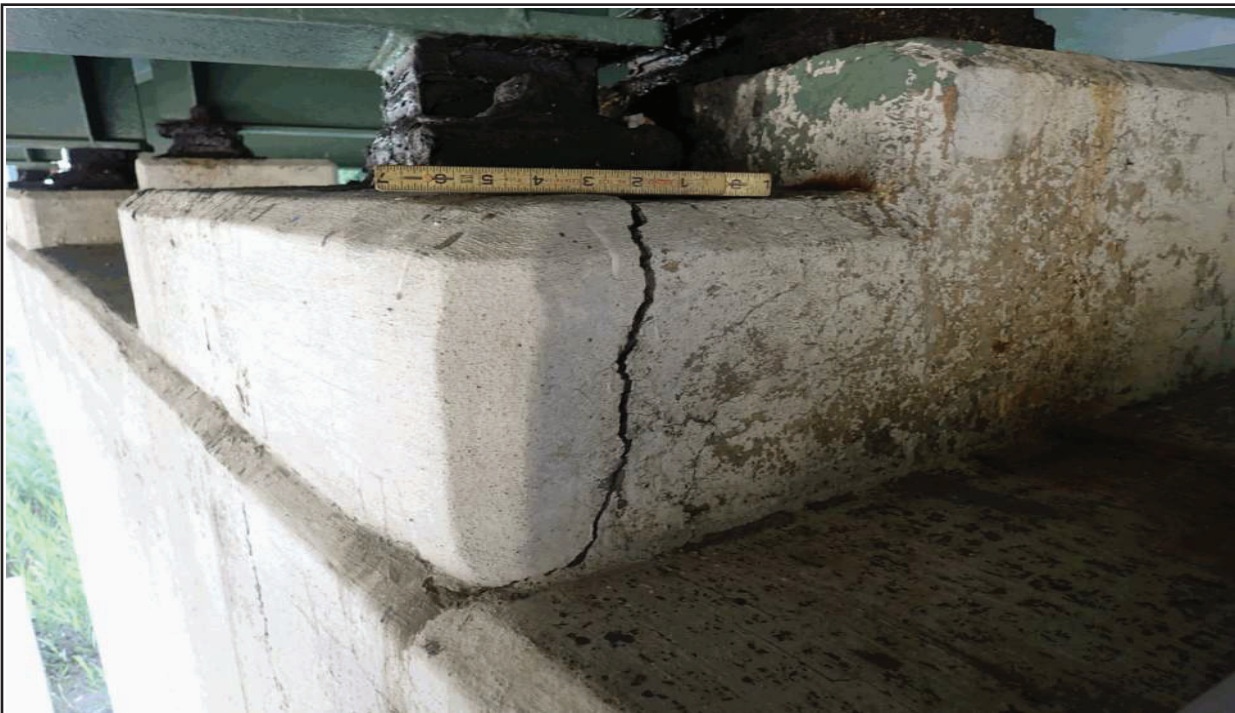
38 PIER 1, SPAN 2, PEDESTAL 3, NORTHWEST CORNER CRACK AND NORTH FACE DELAMINATION

B003-S2J: PIER 1, SPAN 2, PEDESTAL 3 IS CRACKED AND DELAMINATED AND SHOULD BE REPAIRED (PHOTO 38).

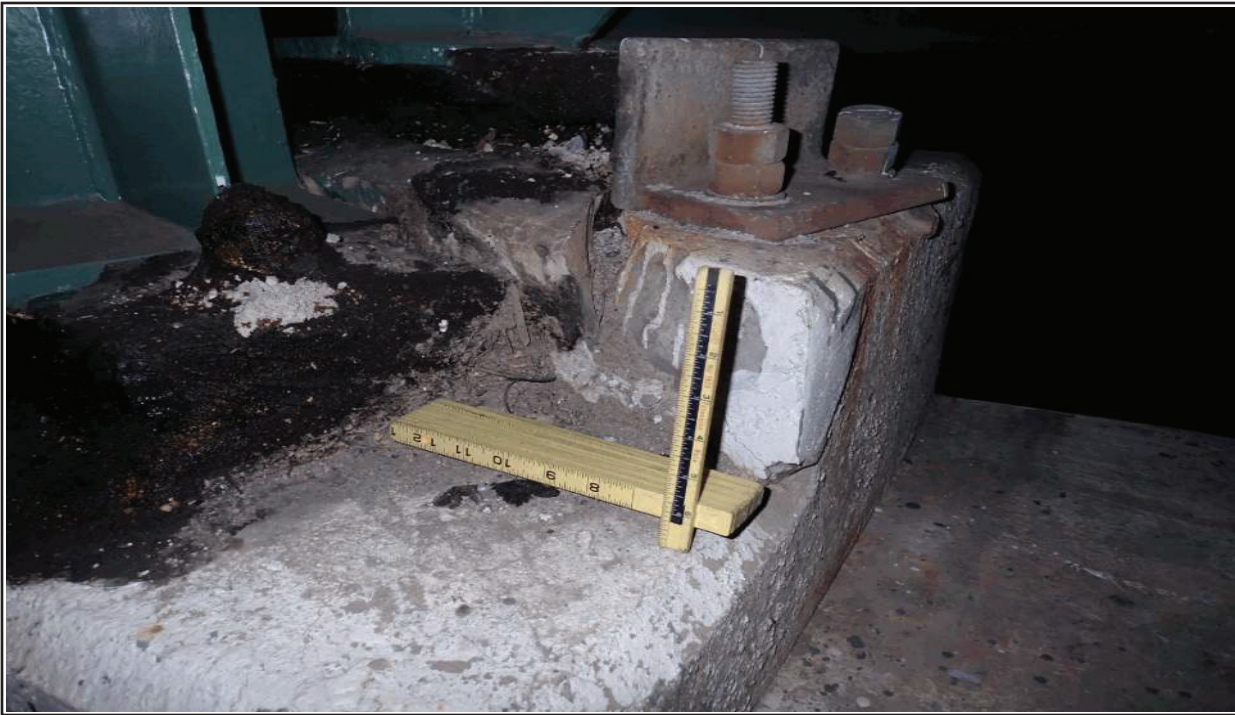
39 PIER 3, SPAN 3, PEDESTAL 3, NORTH FACE - SPALL / FRACTURE

PIER 3, SPAN 3, PEDESTAL 3 IS FRACTURED/SPALLED AND SHOULD BE RECONSTRUCTED (PHOTO 39).

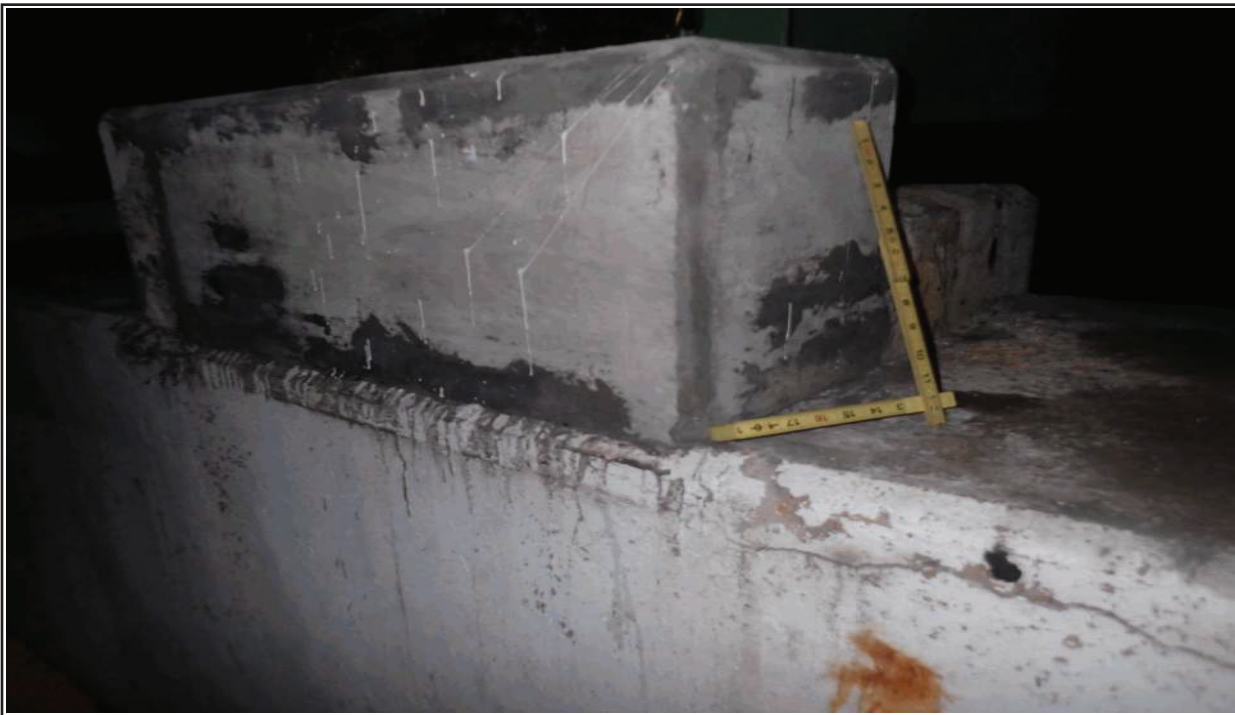
| Elm/Env | Description | Unit | Total Qty | Qty. St. 1 | Qty. St. 2 | Qty. St. 3 | Qty. St. 4 | Notes |
|---|---|---|---|---|---|---|---|---|
| 234/2 | Re Conc Pier Cap | ft | 37.00 | 27.00 | 0.00 | 10.00 | 0.00 | NOTE: PEDESTAL 3, SOUTH FACE HAS BEEN REPAIRED SINCE LAST INSPECTED (PHOTO 40)<br><br>EFFLORESCENCE/RUST STAINING (1120):<br>CS3: (8 LF) NORTH FACE, WEST OVERHANG, EXHIBITS A 1-FOOT LONG HAIRLINE VERTICAL CRACK WITH CORROSION STAINING (1 LF) AND A 1-FOOT LONG DIAGONAL HAIRLINE CRACK WITH CORROSION (1 LF). SOUTH FACE, WEST OVERHANG, EXHIBITS A 1-FOOT LONG HAIRLINE VERTICAL CRACK WITH CORROSION STAINING (1 LF). SOUTH FACE, BAY 2 EXHIBITS A HAIRLINE VERTICAL CRACK WITH CORROSION STAINING (1 LF). SOUTH FACE, BAY 4, EXHIBITS A 2FT L x 1/16IN W HORIZONTAL CRACK WITH CORROSION STAINING (2 LF). UNDERSIDE, EAST OVERHANG, EXHIBITS A 1-FOOT LONG HAIRLINE LONGITUDINAL CRACK WITH CORROSION STAINING (1 LF), AND THE EAST FACE 2-FOOT HIGH HAIRLINE VERTICAL CRACK WITH CORROSION STAINING (1 LF).<br><br>DELAMINATION/SPALL (1080):<br>CS3: (2 LF) PEDESTAL 3, SPAN 3 BEARING, NORTH FACE, EXHIBITS A 1FT-6IN W x FULL-HEIGHT x 3IN D SPALL/FRACTURE. THE FRACTURED CONCRETE IS STILL IN PLACE WITH NO MEASURABLE BEARING LOSS (PHOTO 39), (IF FRACTURED CONCRETE WERE TO COME OUT, BEARING LOSS WOULD OCCUR).<br><br>CRACKING (1130):<br>CS1: (10 LF) THE PIER CAP EXHIBITS UP TO 1/16-INCH W VERTICAL AND HORIZONTAL CRACKS RANDOMLY THROUGHOUT (APPROX. 25% OF TOTAL LENGTH). |

40 PIER 3, SPAN 3, PEDESTAL 3, SOUTH FACE - REPAIRED

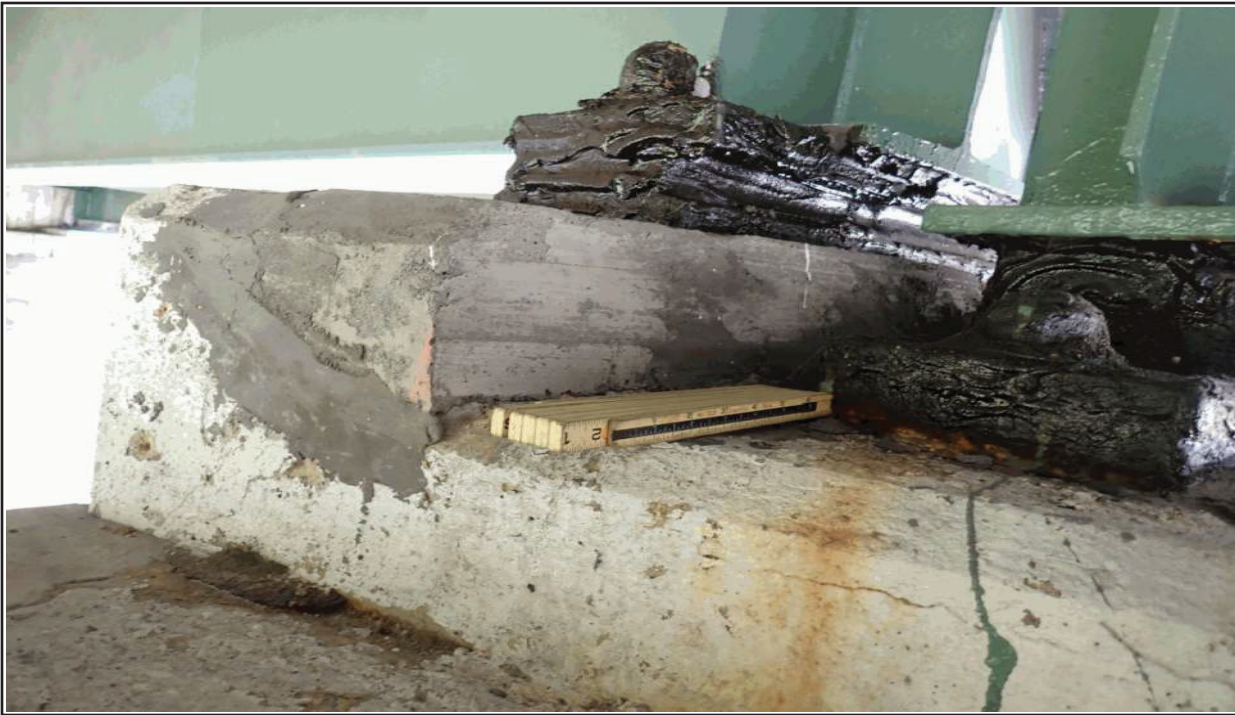
41 PIER 4, SPAN 5, PEDESTAL 4, SOUTH FACE - REPAIRED

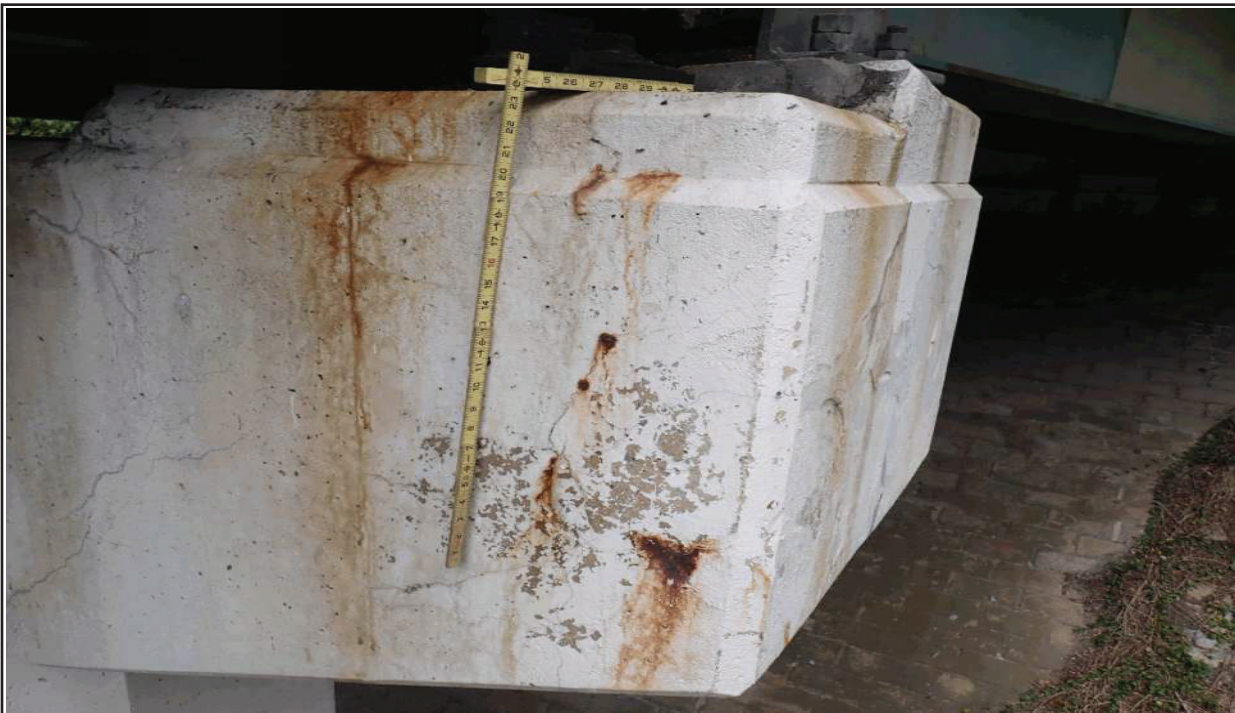
42 SPAN 4, PIER 4, SOUTH FACE BELOW BEARING 5 - CRACKS WITH CORROSION STAINS

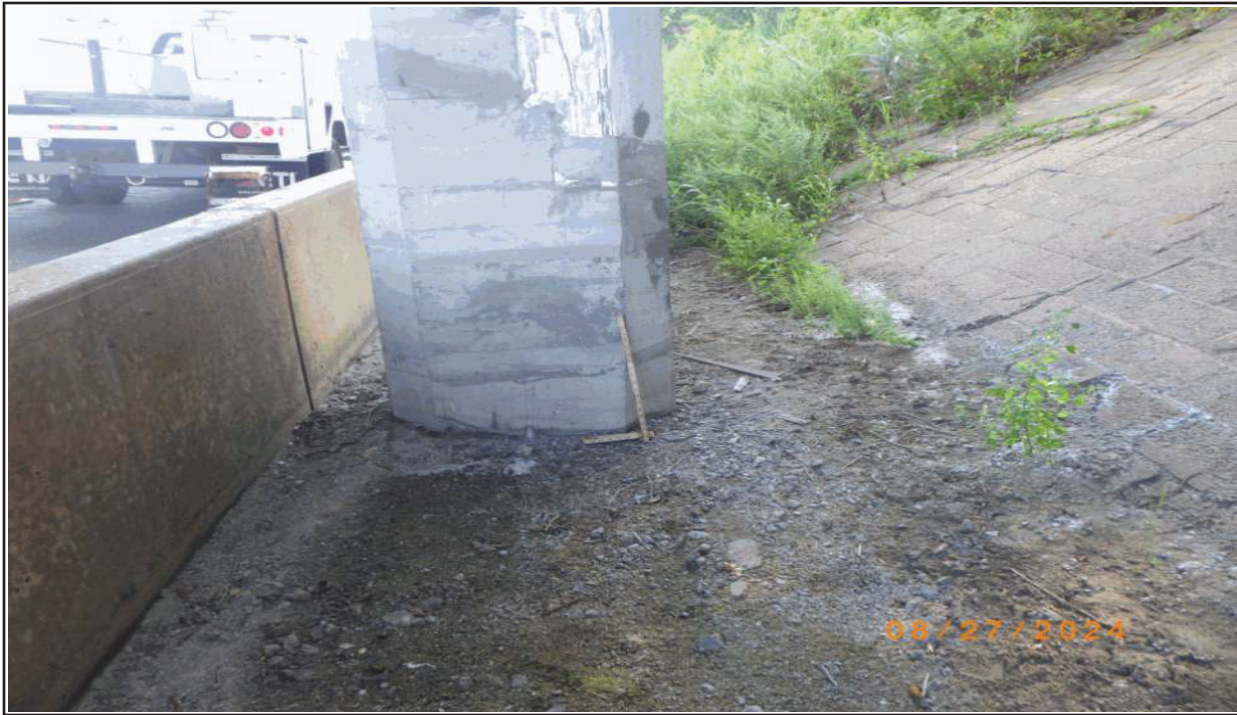
| Elm/Env | Description | Unit | Total Qty | Qty. St. 1 | Qty. St. 2 | Qty. St. 3 | Qty. St. 4 | Notes |
|---|---|---|---|---|---|---|---|---|
| 205/2 | Re Conc Column | each | 3.00 | 2.00 | 1.00 | 0.00 | 0.00 | NOTE: PIER 1 COLUMNS HAVE HAD REPAIRS MADE SINCE THE LAST INSPECTION (PHOTO 43).<br><br>DELAMINATION/SPALL (1080):<br>CS2: (1 EA) PIER 1, NORTH FACE EXHIBITS A 2FT H x 6IN W DELAMINATION. THE WEST FACE EXHIBITS A 6FT H x 2FT W DELAMINATION. THE NORTH FACE AT THE BASE EXHIBITS A 3IN DIAMETER x 1IN D SPALL. THE NORTHWEST AND SOUTHWEST CHAMFER PORTIONS EXHIBIT DELAMINATIONS UP TO 3FT H x 6IN W. |

43 SPAN 1, PIER 1, COLUMN 2, WEST FACE - REPAIRED

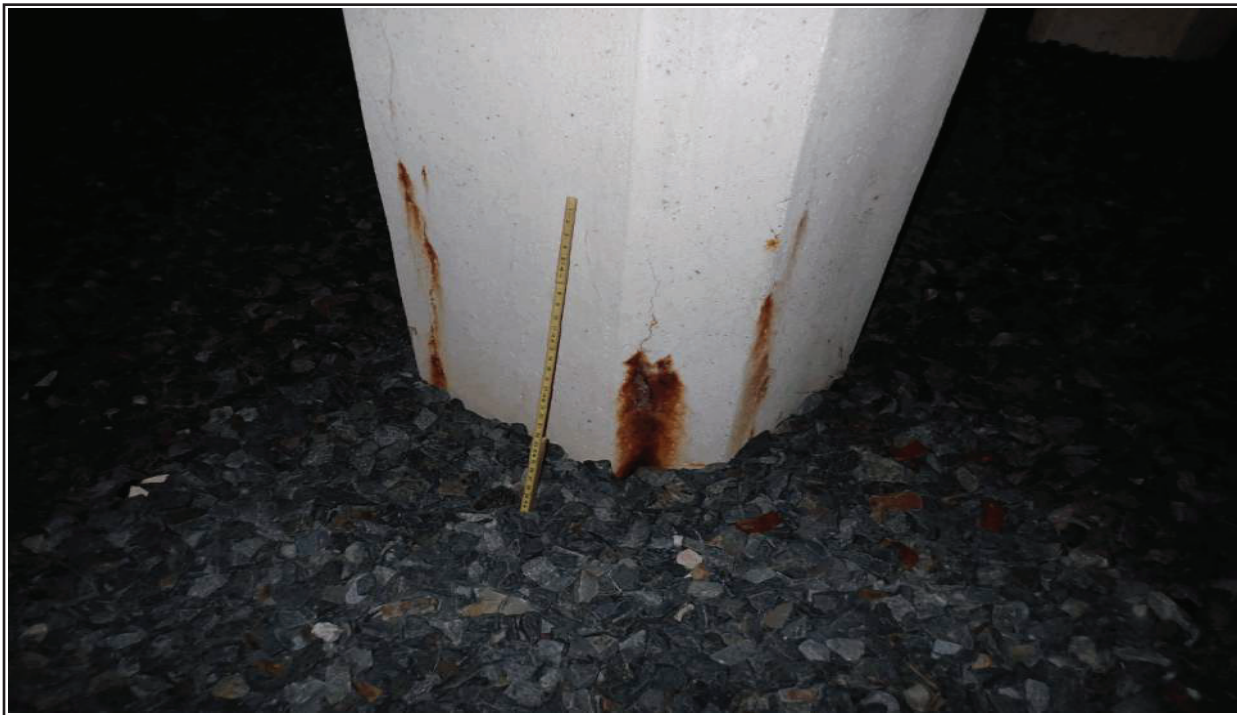
44 SPAN 3, PIER 3, COLUMN 3, NORTH AND EAST FACE - CRACKS WITH CORROSION

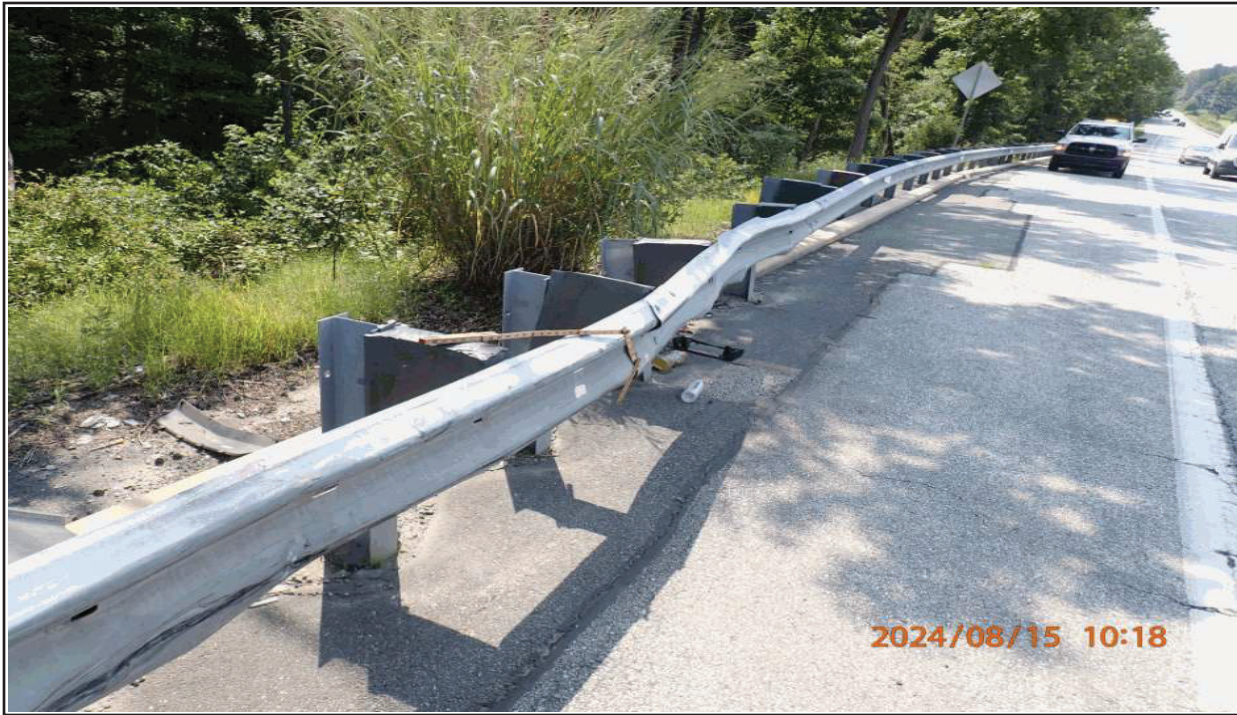
- THE SOUTHEAST APPROACH GUARDRAIL EXHIBITS MODERATE COLLISION DAMAGE BETWEEN POSTS 8 TO 12 (PHOTO 45).
- ITEM 59 SUPERSTRUCTURE HAS BEEN DOWNGRADED FROM A 6 TO A 5 IN ACCORDANCE WITH APPENDIX G OF THE BEIM.
- ITEM 60 SUBSTRUCTURE HAS BEEN DOWNGRADED FROM A 6 TO A 5 IN ACCORDANCE WITH APPENDIX G OF THE BEIM.

45 SOUTHEAST APPROACH GUARDRAIL - TRAFFIC IMPACT DAMAGE

- REPAIR THE SPALLS IN THE SOFFIT (PHOTO 20).
- REPLACE THE MISSING/SHEARED OR CRACKED HANDRAIL ANCHOR BOLT NUTS (PHOTO (PHOTO 13)).
- RE-GREASE PIER 3 AND PIER 4 BEARINGS WHERE NEEDED (PHOTO 31).
- REPAIR THE DAMAGED GUARDRAIL AT THE SOUTHEAST APPROACH (PHOTO 45).
- CLEAN THE DEBRIS FROM THE STRIP SEAL JOINTS (PHOTO 10). (WO# 1379835)
