Bridge No: 1740 060  
Date of Inspection: 04/23/2024  
Load Rating Date: 04/14/2010

Bridge ID 1740 060  
5) Inventory Route  
A) On/Under: Route On Structure  
D) Route No: 00495  
6) Feature Intersected I 295 SB  
7) Facility Carried: RAMP 6107  
9) Location: CHRISTIANA INTERCHANGE  
16) Latitude: 39° 42' 24"  
98) Border Bridge Code Not Applicable (P)

Inspection Date: 04/23/2024 Type: 1 Regular NBI  
Inspector: PENNONI PENNONI BrM User:  
Scope:  
NBI: ☒ Other: ☐ Element: ☒  
Underwater: ☐ Fracture Critical ☐

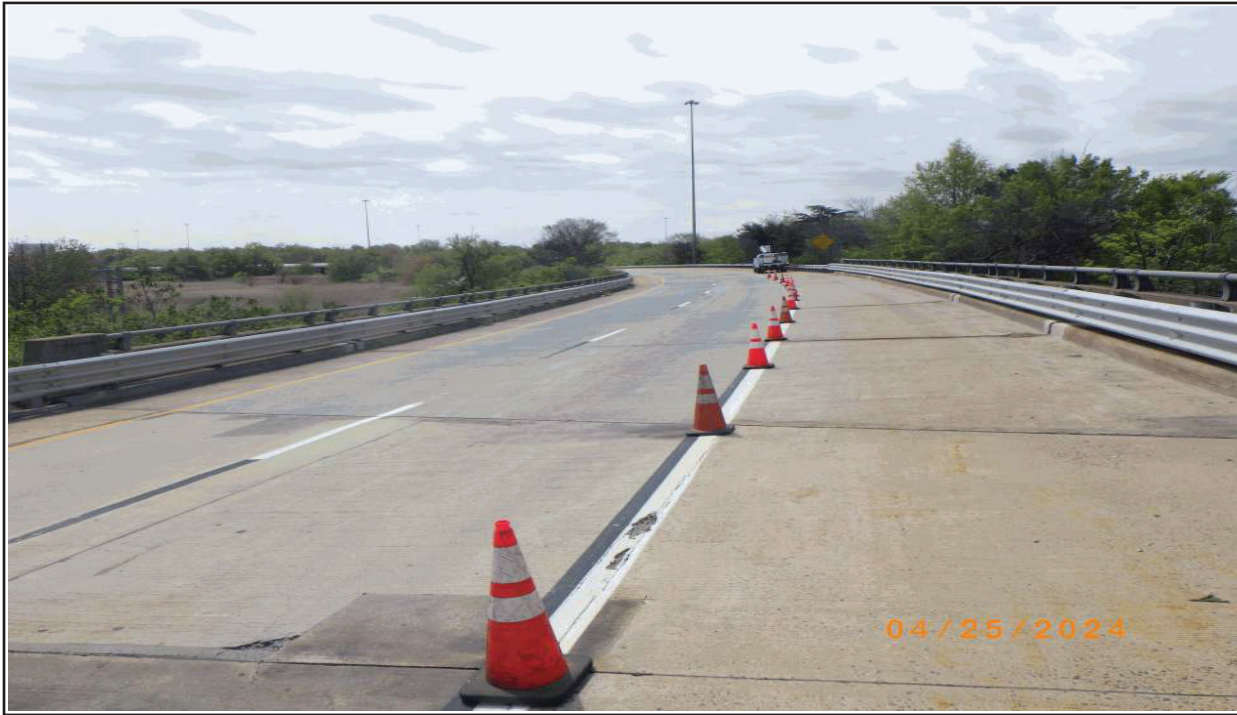
1 NORTH APPROACH, LOOKING SOUTH

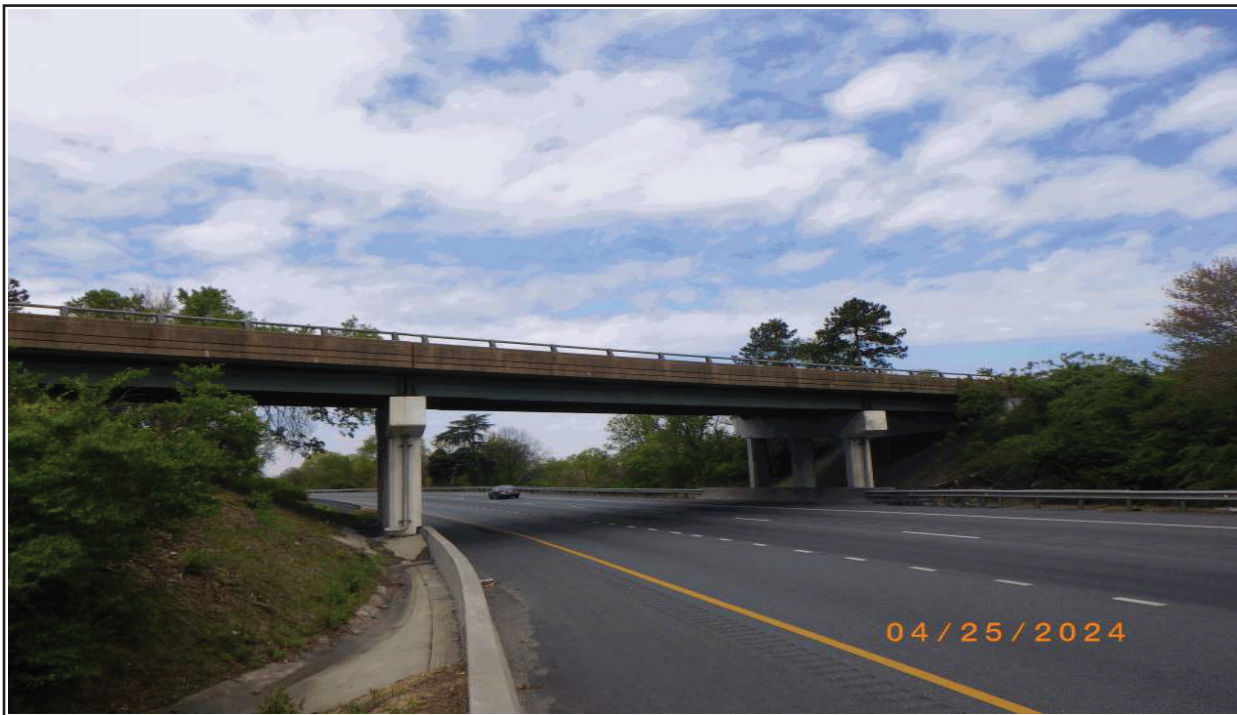
2 EAST ELEVATION, LOOKING WEST

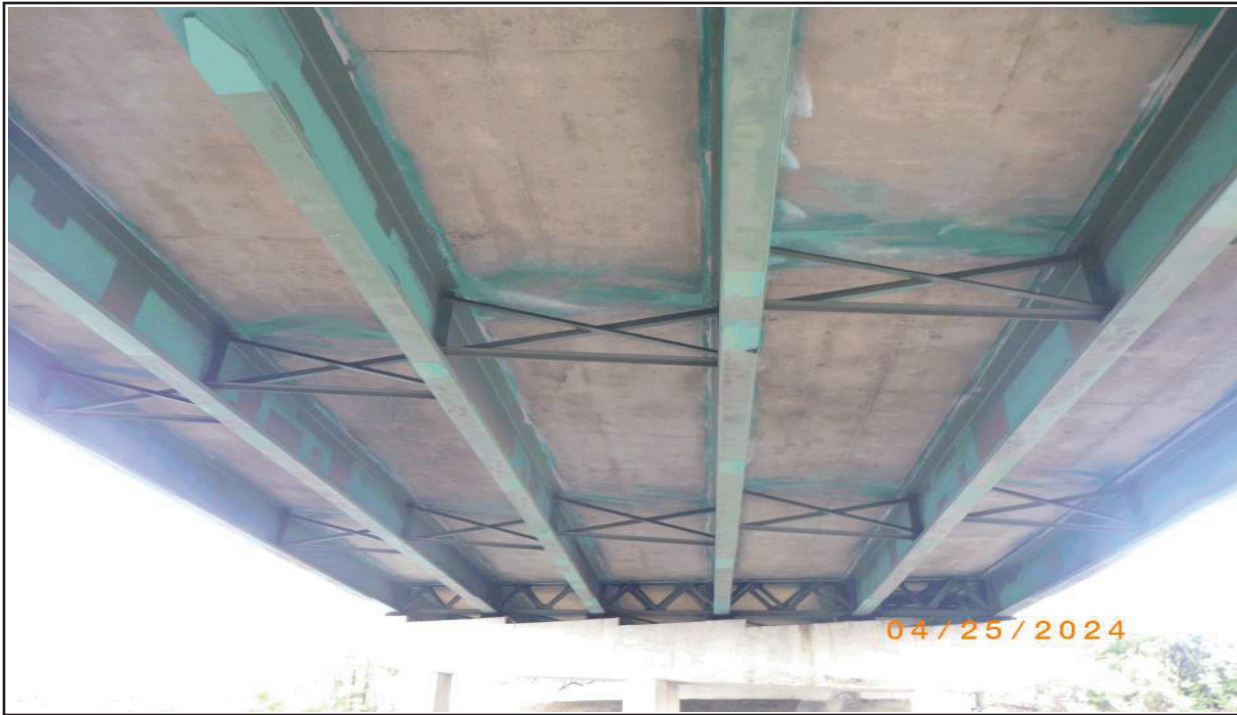
3 GENERAL VIEW OF SUPERSTRUCTURE (SPAN 2 SHOWN), LOOKING NORTH

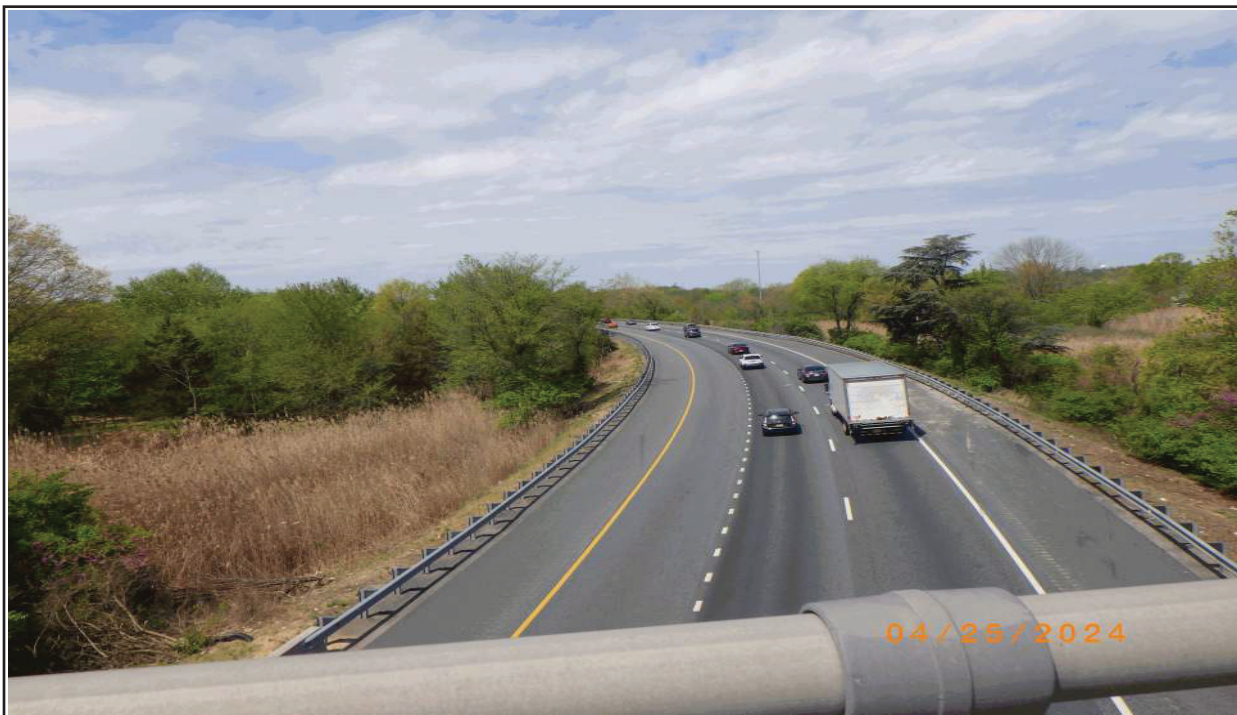
4 UNDER RECORD (SPAN 2 OVER I-95SB), LOOKING WEST

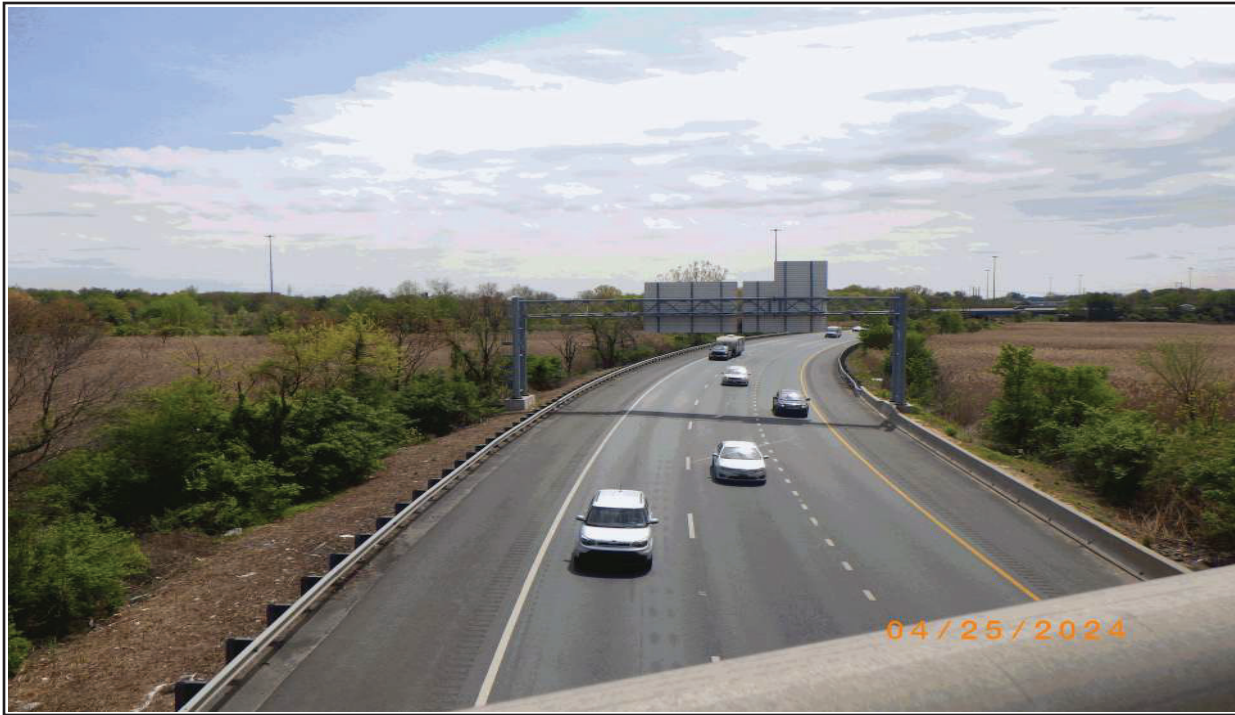
5 UNDER RECORD (SPAN 2 OVER I-95SB), LOOKING EAST

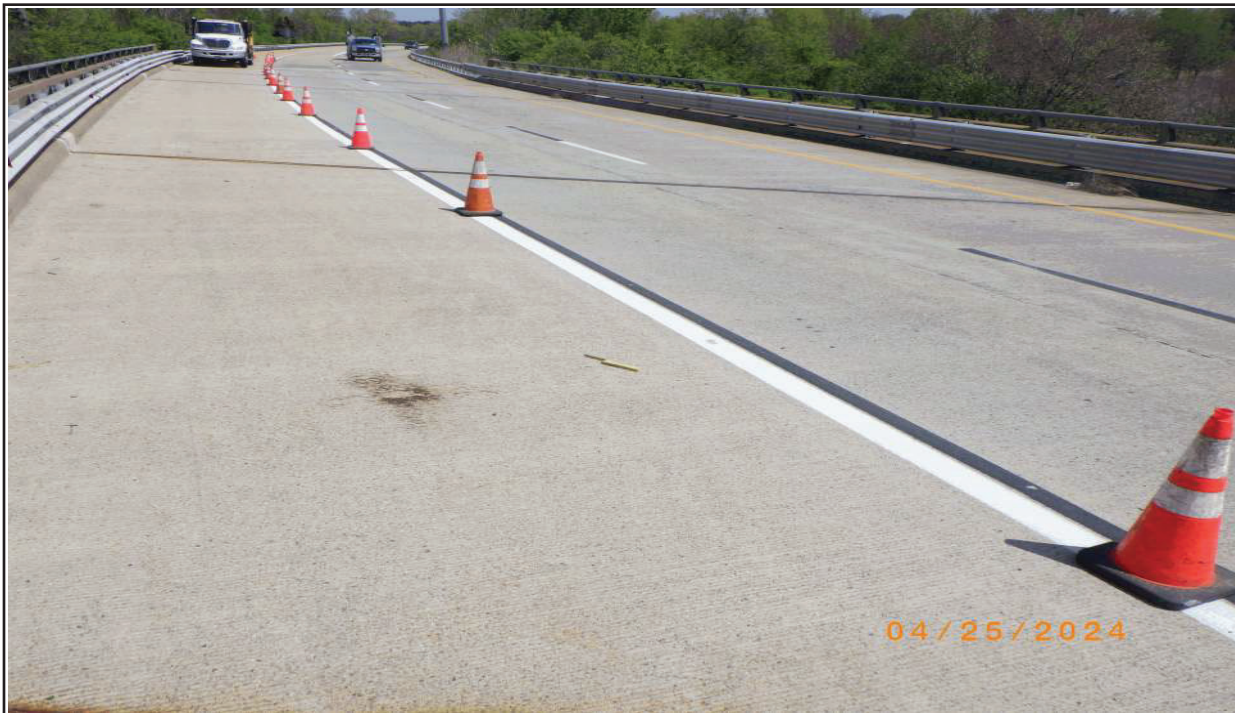
6 GENERAL TOP OF DECK (SPAN 1 SHOWN), LOOKING NORTH

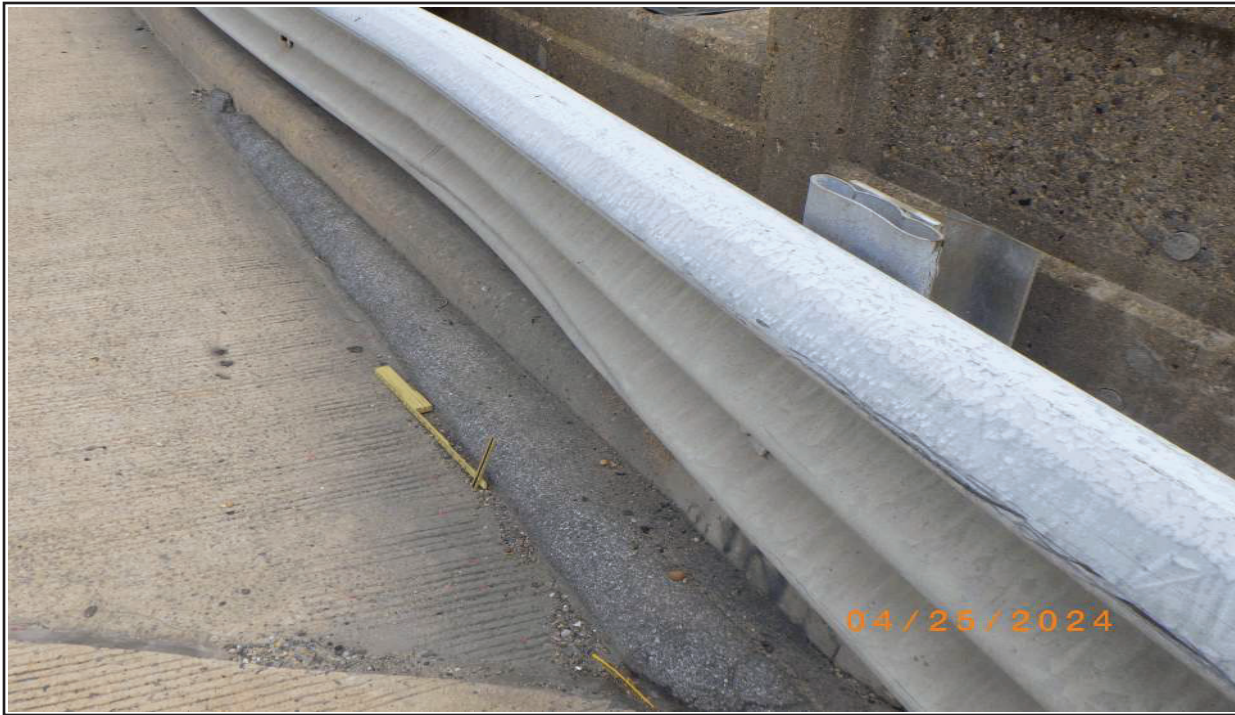
7 SPAN 1, EAST THRIE BEAM AT SOUTH ABUTMENT - IMPACT DAMAGE

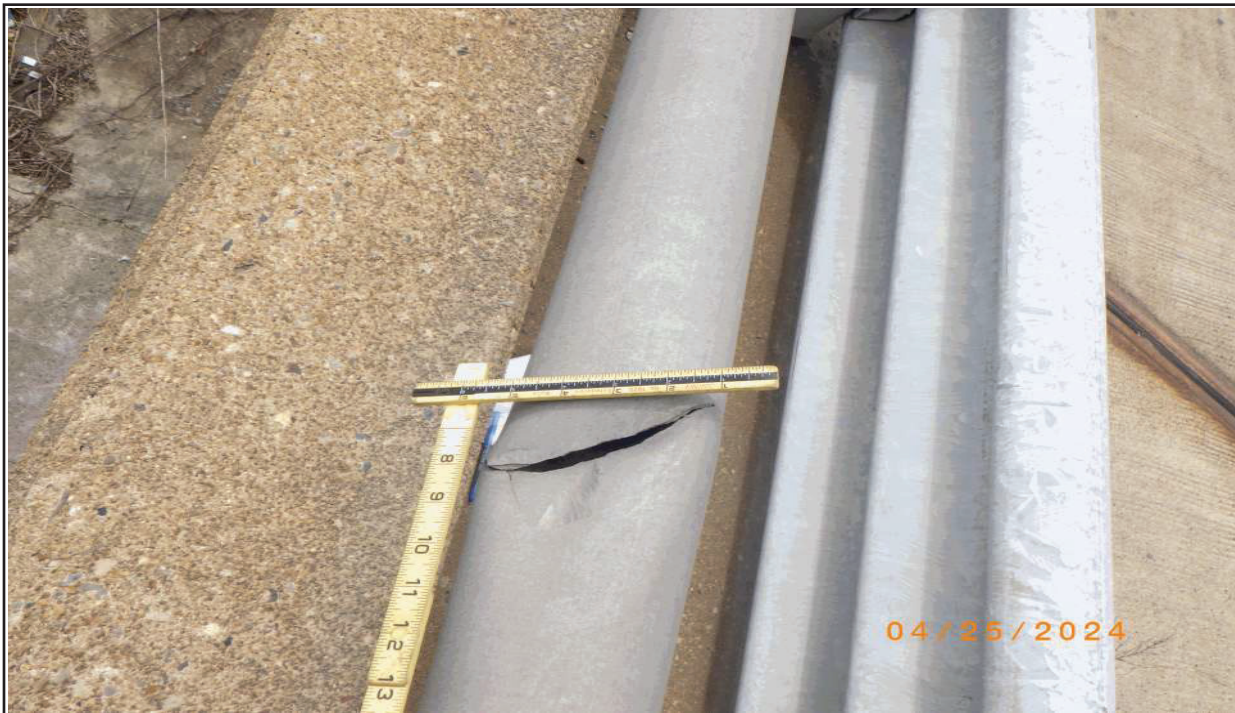
| Elm/Env | Description | Unit | Total Qty | Qty. St. 1 | Qty. St. 2 | Qty. St. 3 | Qty. St. 4 | Notes |
|---|---|---|---|---|---|---|---|---|
| 330/2 | Metal Bridge Railing | ft | 248.00 | 237.00 | 0.00 | 11.00 | 0.00 | ALUMINUM RAIL (120 LF):<br>CRACKING (1010):<br>CS3: (1 LF) THE EAST RAIL HAS A DENT/CRACK IN THE TOP HORIZONTAL MEMBER BETWEEN POSTS 5 AND 6 FROM THE SOUTH (PHOTO 8).<br><br>GALVANIZED STEEL RAIL (128 LF):<br>DISTORTION (1900):<br>CS3: (10 LF) THE EAST THRIE-BEAM HAS COLLISION DAMAGE AT THE SOUTH ABUTMENT WITH CRUSHED ATTENUATOR TUBES AND LATERAL DEFLECTION (PHOTO 7).<br><br>DAMAGE (7000):<br>CS3: (11 LF) THE EAST GUARDRAIL EXHIBITS IMPACT DAMAGE/CRACK AS NOTED ABOVE.<br><br>(NC-24) |

8 SPAN 1, EAST ALUMINUM RAIL BETWEEN POSTS 5 AND 6 - DISTORTION WITH CRACK

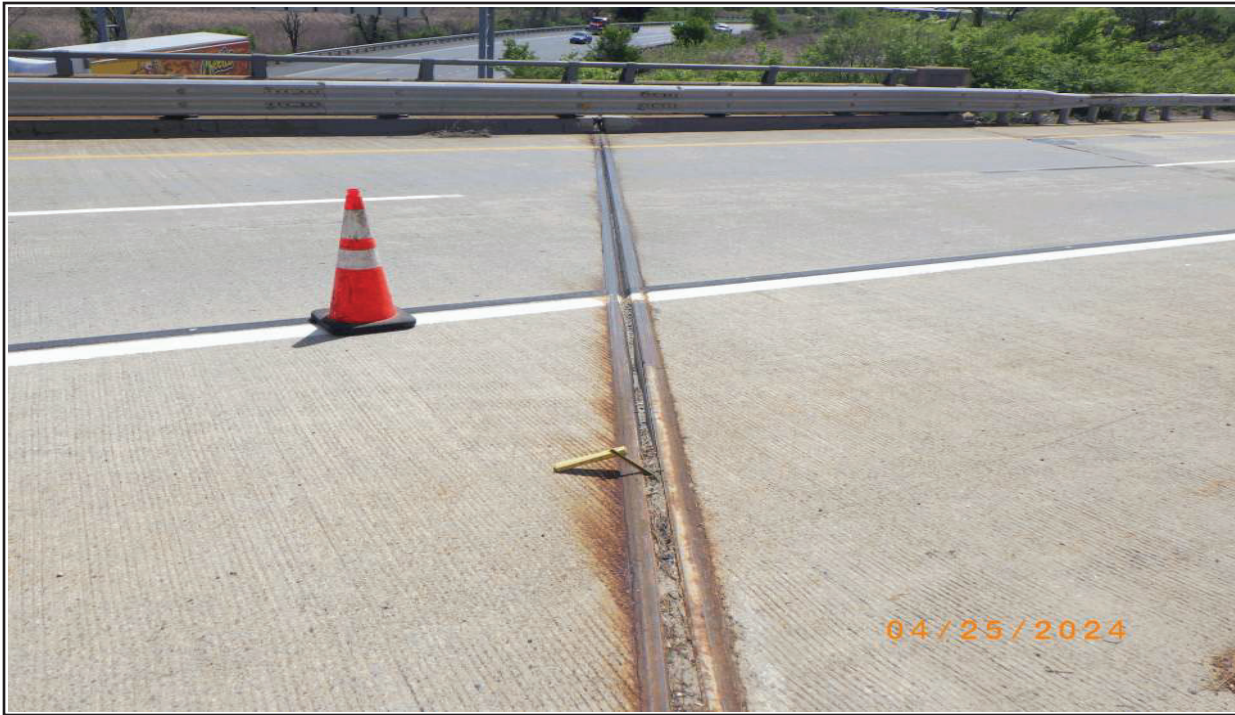
9 SPAN 1, SOUTH ABUTMENT STRIP SEAL - JOINT ARMORING HAS CORROSION WITH SECTION LOSS

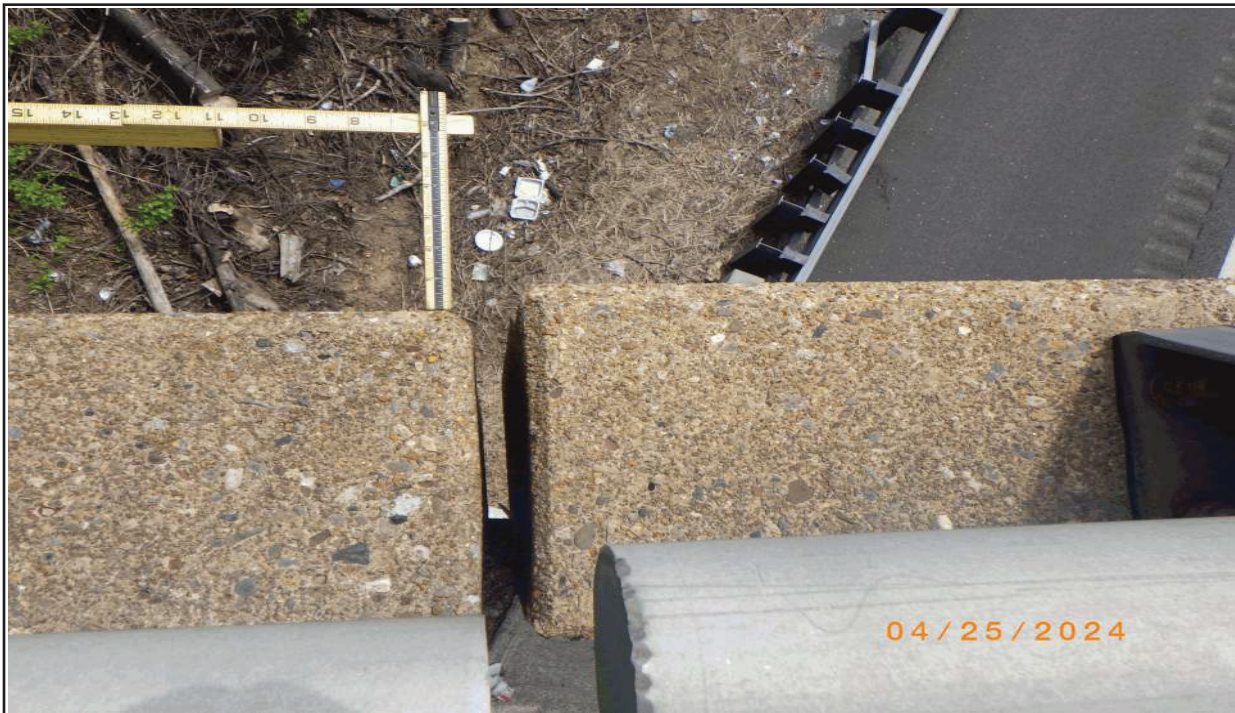
INSPECTION NOTES:  
- SPAN 2 IS HORIZONTALLY MISALIGNED UP TO 1-INCH TOWARDS THE EAST AT THE NORTH ABUTMENT JOINT (PHOTO 10).  
- DECK NBI RATING WAS CHANGED FROM A 6 TO A 7 BASED ON THE GUIDANCE FOR NBI CONDITION RATING ASSIGNMENTS.

10 SPAN 2, SPAN IS HORIZONTALLY MISALIGNED TOWARDS THE EAST AT THE NORTH ABUTMENT

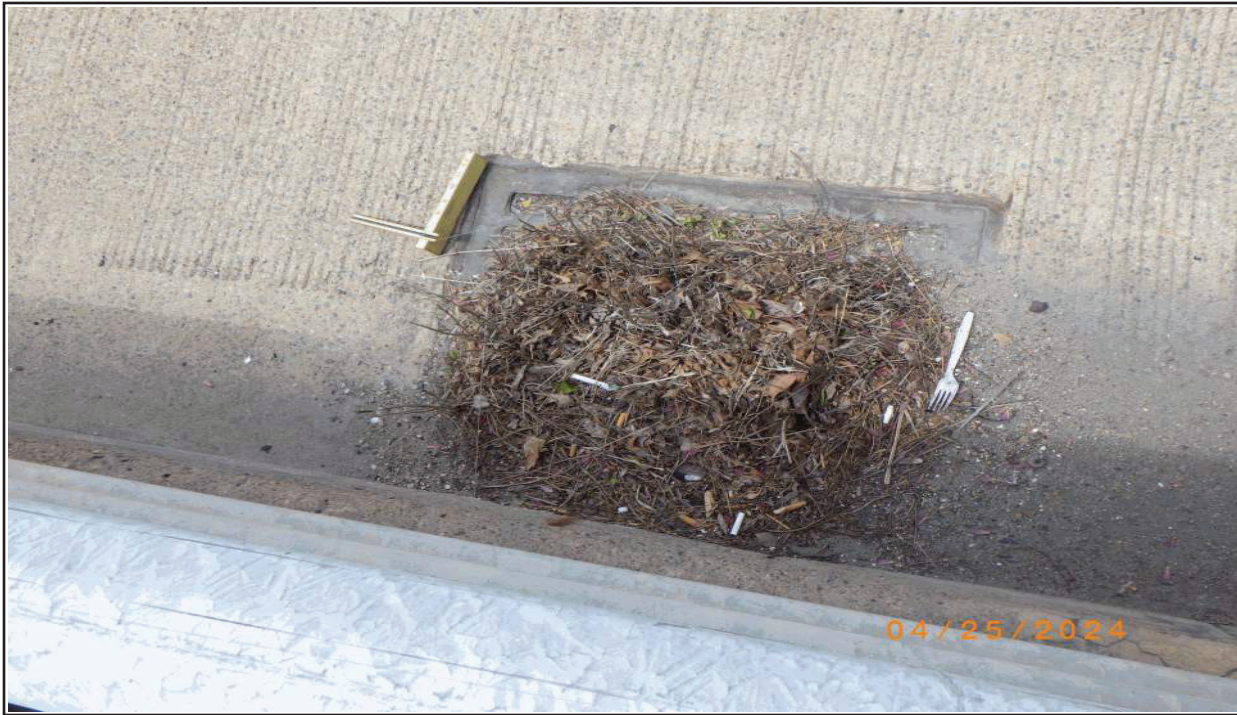
11 SPAN 3, EAST DRAIN - FULLY CLOGGED

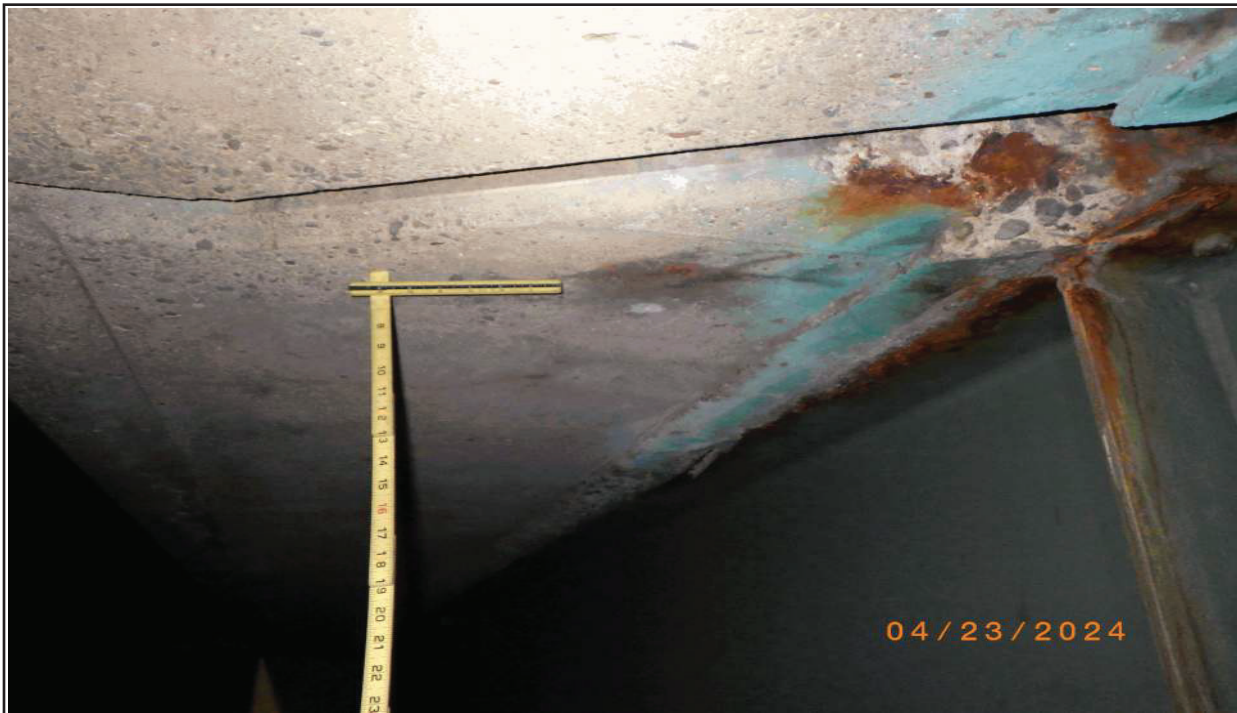
12 SPAN 1, SOFFIT IN BAY 2 AT SOUTH ABUTMENT - SPALL EXPOSING TOP FLANGE OF GIRDER

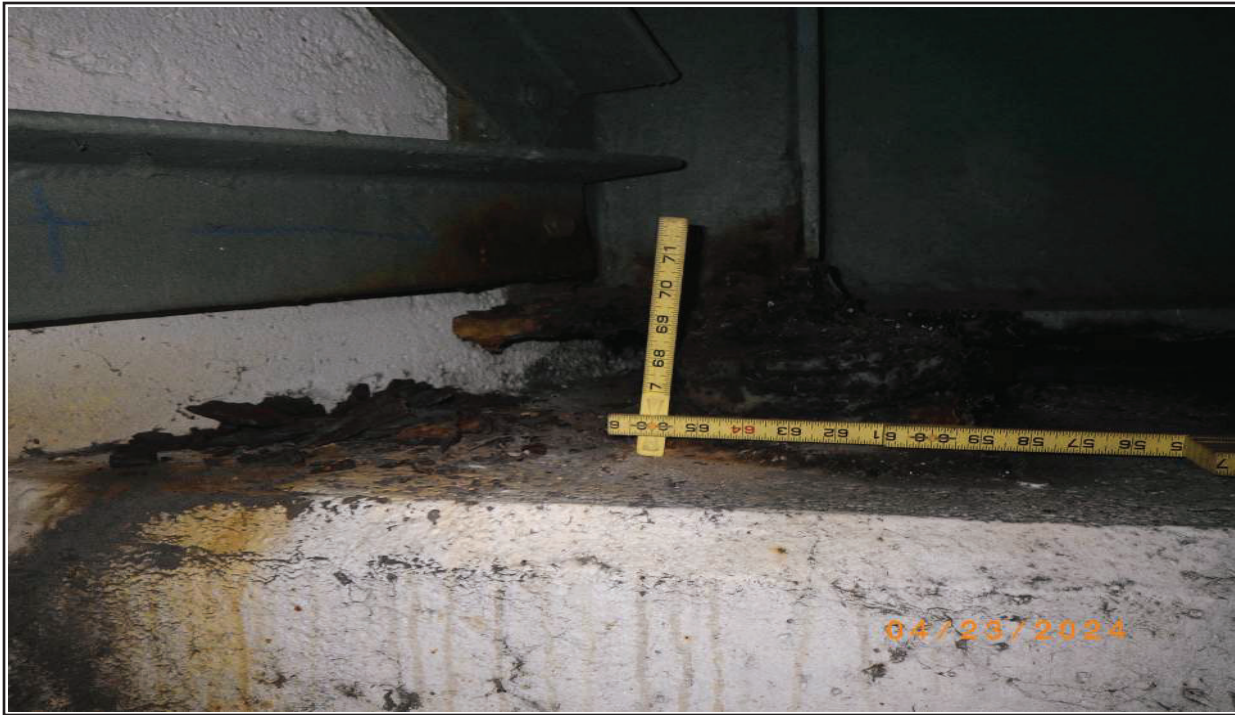
13 SPAN 1, BAY 3 END DIAPHRAGM AT SOUTH ABUTMENT - CORROSION AND PACK RUST CAUSING DISTORTION TO ANGLE

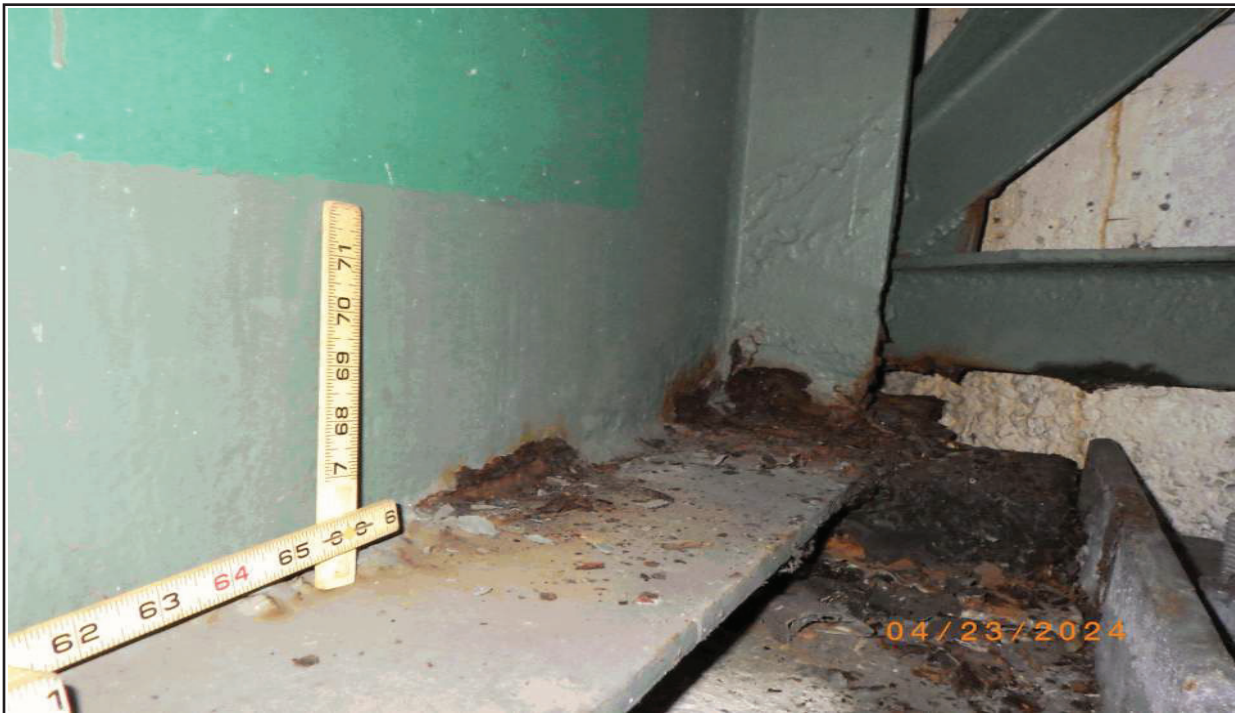
14 SPAN 1, GIRDER 5 WEST BOTTOM FLANGE AT SOUTH ABUTMENT - CORROSION WITH LOSS OF SECTION

PENNONI RECOMMENDED MAXIMO MAINTENANCE:  
- B005-S2K: SPOT PAINT THE SUPERSTRUCTURE AT AREAS OF CORROSION (1 LS), (PHOTOS 14 AND 15).  
- B020-S2J: REPAIR/PATCH SPALL AT NORTH ABUTMENT BEARING 5 SEAT AND CRACK WITH CORROSION AT SOUTH ABUTMENT BEARING 5 SEAT (2 CY), (PHOTOS 19 AND 21).  
- B042-P7A: REPAIR/PATCH SPALLS AND DELAMINATIONS AT THE NORTH AND SOUTH ABUTMENT (4 CY), (PHOTOS 20, 22 AND 23).  
- B054-S6D: BACKFILL THE ERODED AREA BEHIND THE SOUTH APPROACH, EAST GUARDRAIL (10 CY), (PHOTO 26).

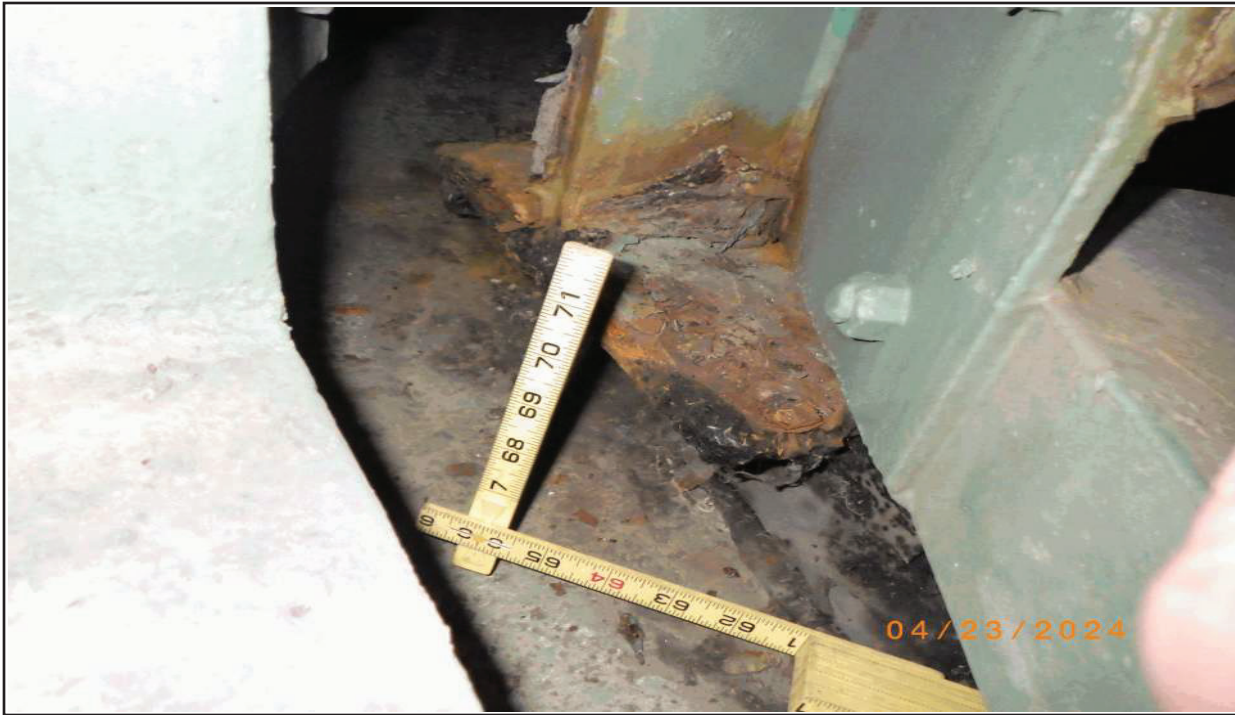
| Elm/Env | Description | Unit | Total Qty | Qty. St. 1 | Qty. St. 2 | Qty. St. 3 | Qty. St. 4 | Notes |
|---|---|---|---|---|---|---|---|---|
| 107/2 | Steel Opn Girder/Beam | ft | 433.00 | 328.00 | 100.00 | 5.00 | 0.00 | CORROSION (1000):<br>CS3: (5 LF) GIRDERS 5 AND 6 AT BOTH ENDS EXHIBIT CORROSION WITH UP TO 10% SECTION LOSS TO THE BOTTOM FLANGE (4 LF) (PHOTO 15), GIRDER 3 AT PIER 1, BOTTOM FLANGE, EAST END, EXHIBITS PITTING TO THE TOP FACE WITH 3/8-INCH DIAMETER SECTION LOSS (1 LF).<br><br>CS2: (100 LF) FRECKLE RUST HAS FORMED AT RANDOM IN THE BOTTOM FLANGE AND WEBS. |

15 SPAN 2, GIRDER 5, EAST BOTTOM FLANGE AT PIER 1 - CORROSION WITH LOSS OF SECTION

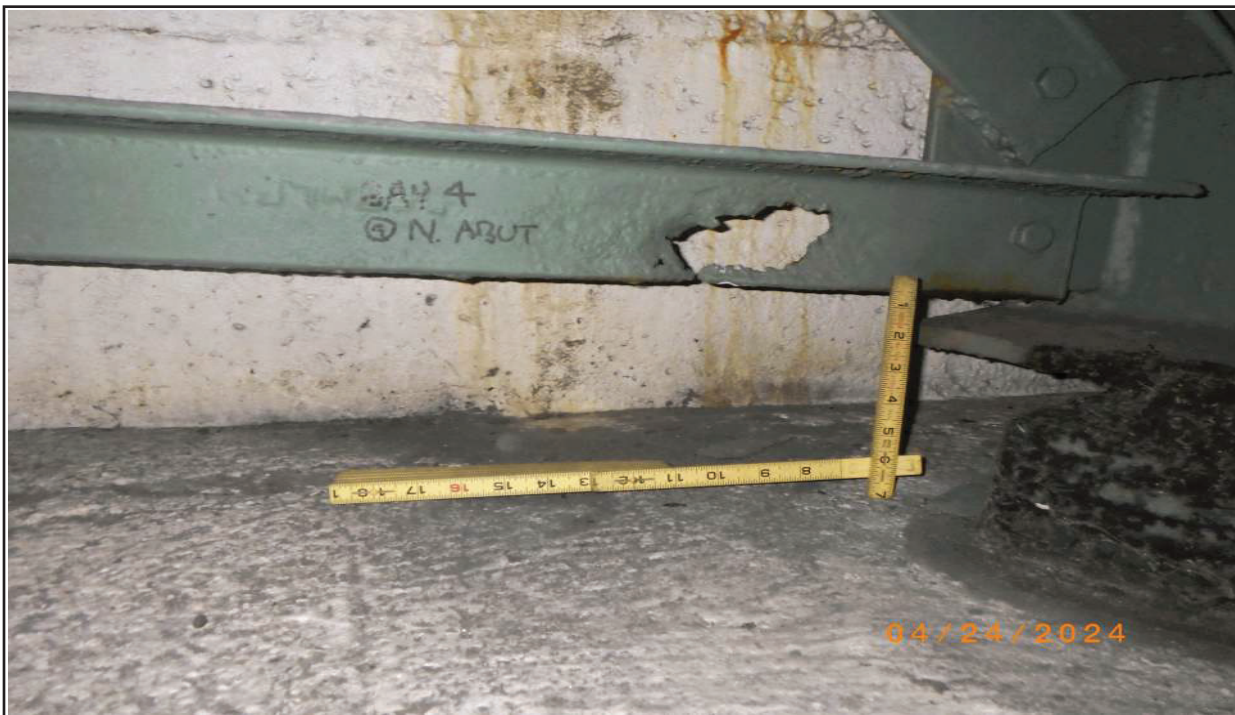
16 SPAN 3, BAY 4 DIAPHRAGM AT NORTH ABUTMENT - PAINTED OVER SECTION LOSS IN BOTTOM ANGLE

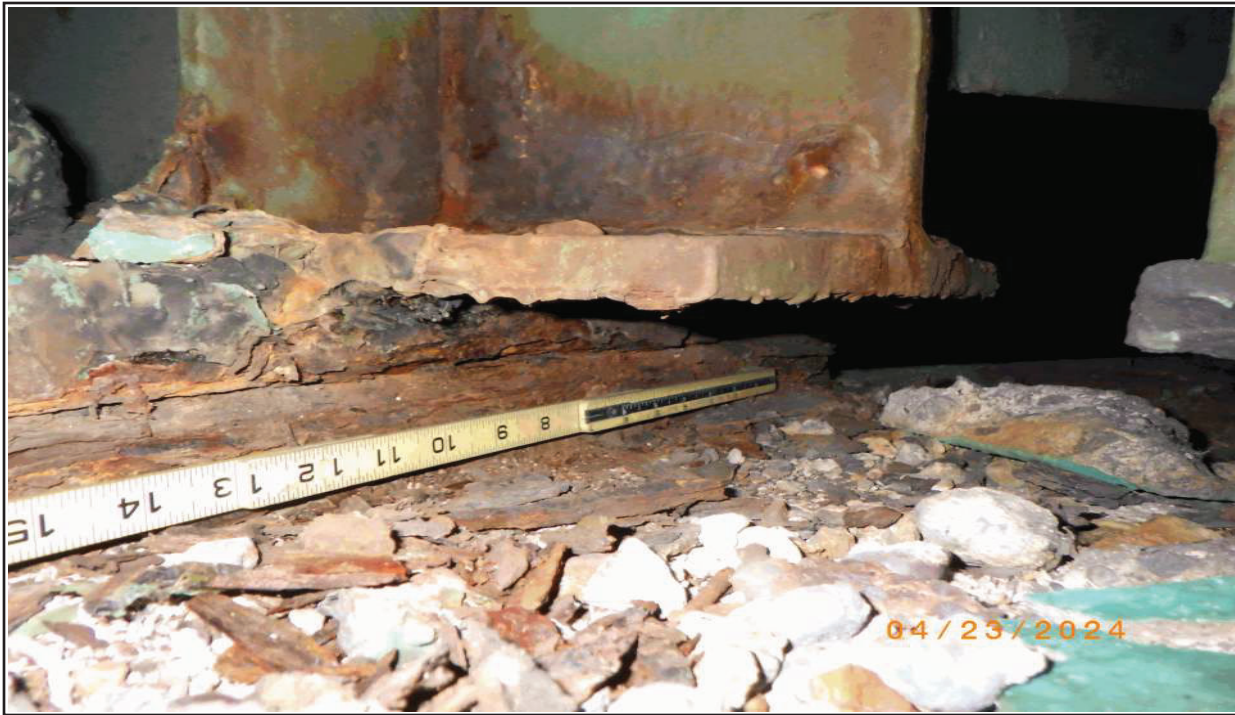
| Elm/Env | Description | Unit | Total Qty | Qty. St. 1 | Qty. St. 2 | Qty. St. 3 | Qty. St. 4 | Notes |
|---|---|---|---|---|---|---|---|---|
| 311/2 | Moveable Bearing | each | 6.00 | 5.00 | 0.00 | 1.00 | 0.00 | NOTE: MOVEABLE BEARINGS ARE LOCATED ON PIER 1. BEARINGS 1, 2, 3, 4, AND 5 ARE WELL GREASED.<br><br>CORROSION (1000):<br>CS3: (1 EA) CORROSION WITH LOSS OF SECTION IN THE BEARING 6 MASONRY PLATE (PHOTO 17).<br><br>(NC-24) |

17 SPAN 1, BEARING 6 AT PIER 1, NORTH FACE - CORROSION AND LOSS OF SECTION TO MASONRY PLATE

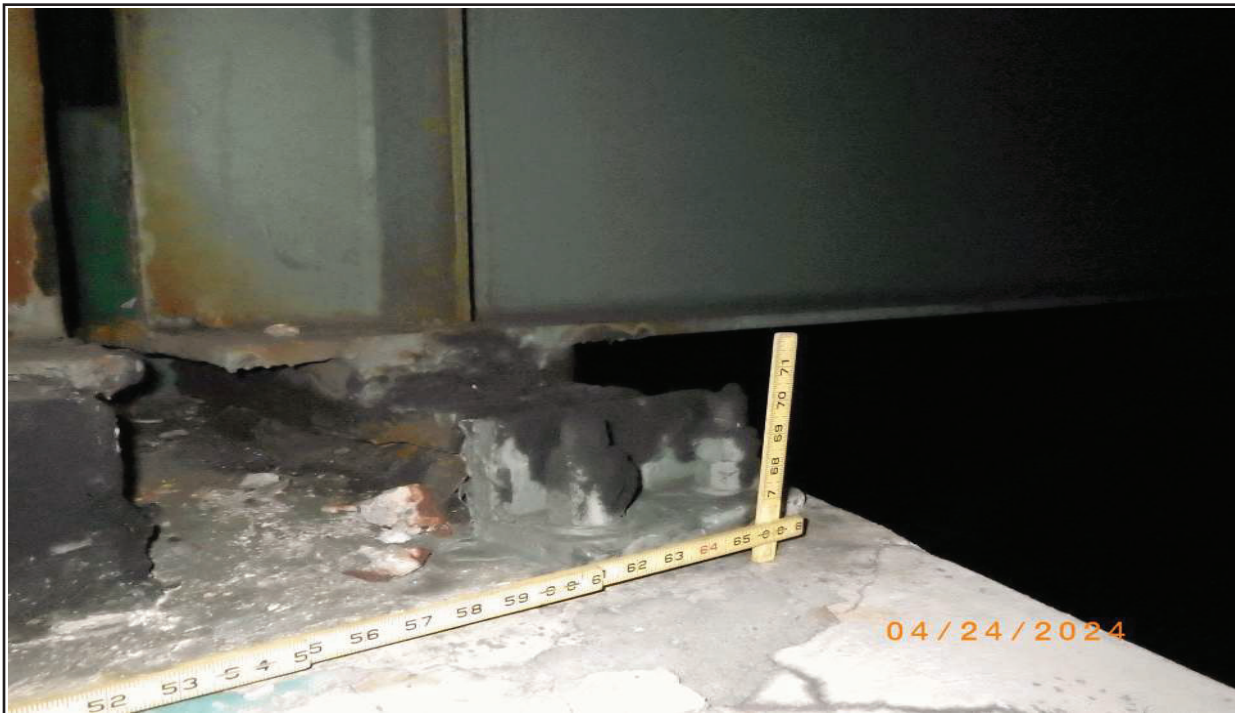
18 SPAN 3, BEARING 6 AT PIER 2 - TYPICAL GIRDER OVERHANGING BEARING

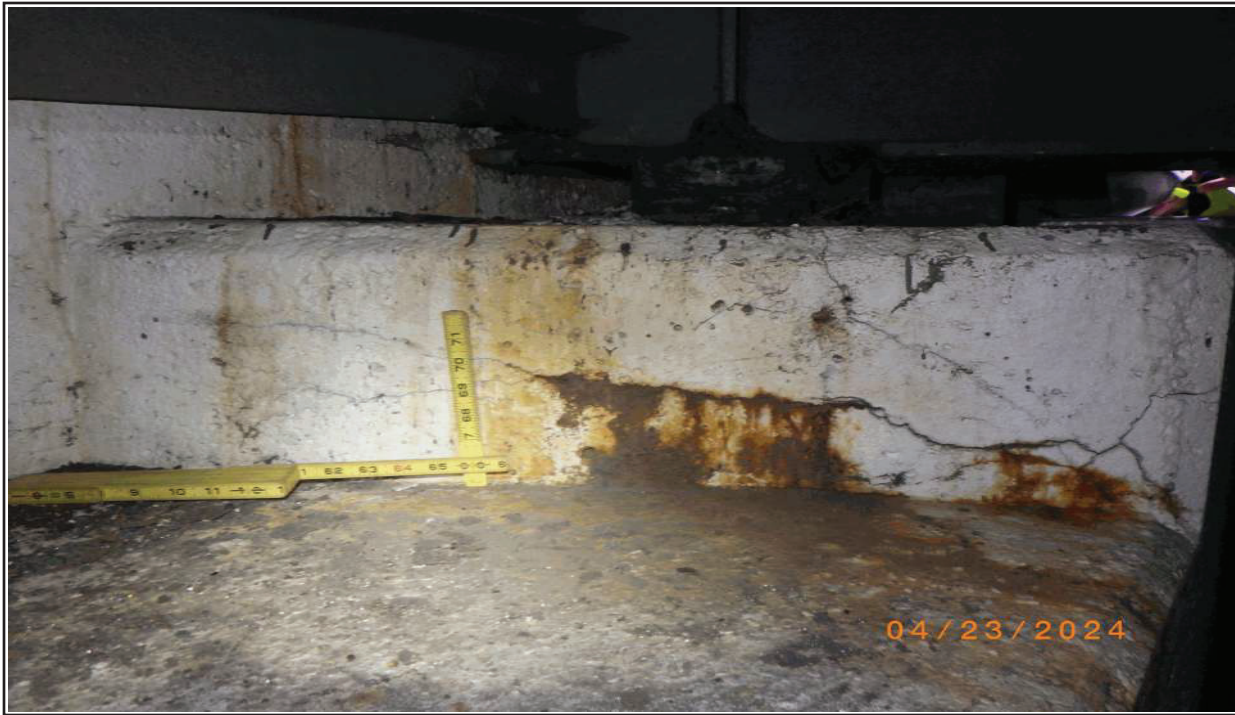
19 SPAN 1, SOUTH ABUTMENT, BEARING 5 SEAT, EAST FACE - HORIZONTAL CRACKS WITH CORROSION STAINING

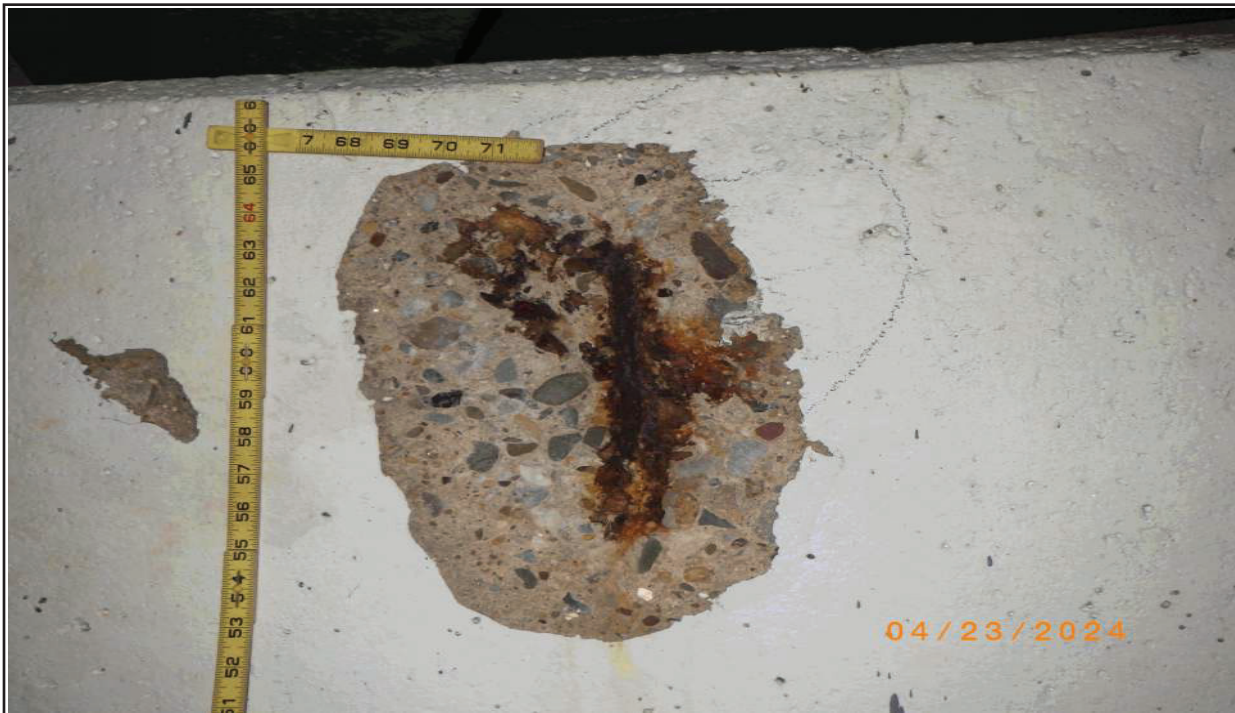
| Elm/Env | Description | Unit | Total Qty | Qty. St. 1 | Qty. St. 2 | Qty. St. 3 | Qty. St. 4 | Notes |
|---|---|---|---|---|---|---|---|---|
| 215/2 | Re Conc Abutment | ft | 54.00 | 43.00 | 8.00 | 3.00 | 0.00 | SPALL/DELAMINATION (1080):<br>CS3: (1 LF) 1FT L x 8IN W x 1/2IN D SPALL WITH EXPOSED REINFORCEMENT AND MINOR LOSS OF SECTION IN THE FRONT FACE UNDER GIRDER 6 (PHOTO 20).<br><br>CS2: (7 LF) AREAS OF DELAMINATION UP TO 14IN L x 18IN W SCATTERED THROUGHOUT.<br><br>EFFLORESCENCE/RUST STAINING (1120):<br>CS3: (2 LF) HAIRLINE CRACK WITH CORROSION STAINING ON THE EAST FACE OF BEARING SEAT 5 (1 LF) (PHOTO 19) AND IN THE FRONT FACE UNDER GIRDER 6 (1 LF).<br><br>EXPOSED REBAR (1090):<br>CS2: (1 LF) EXPOSED REINFORCEMENT DUE TO LACK OF COVER IN THE TOP FACE AT THE WEST END. |

20 SPAN 1, SOUTH ABUTMENT, BREASTWALL BELOW GIRDER 6 - SPALL WITH ECSR AND SECTION LOSS

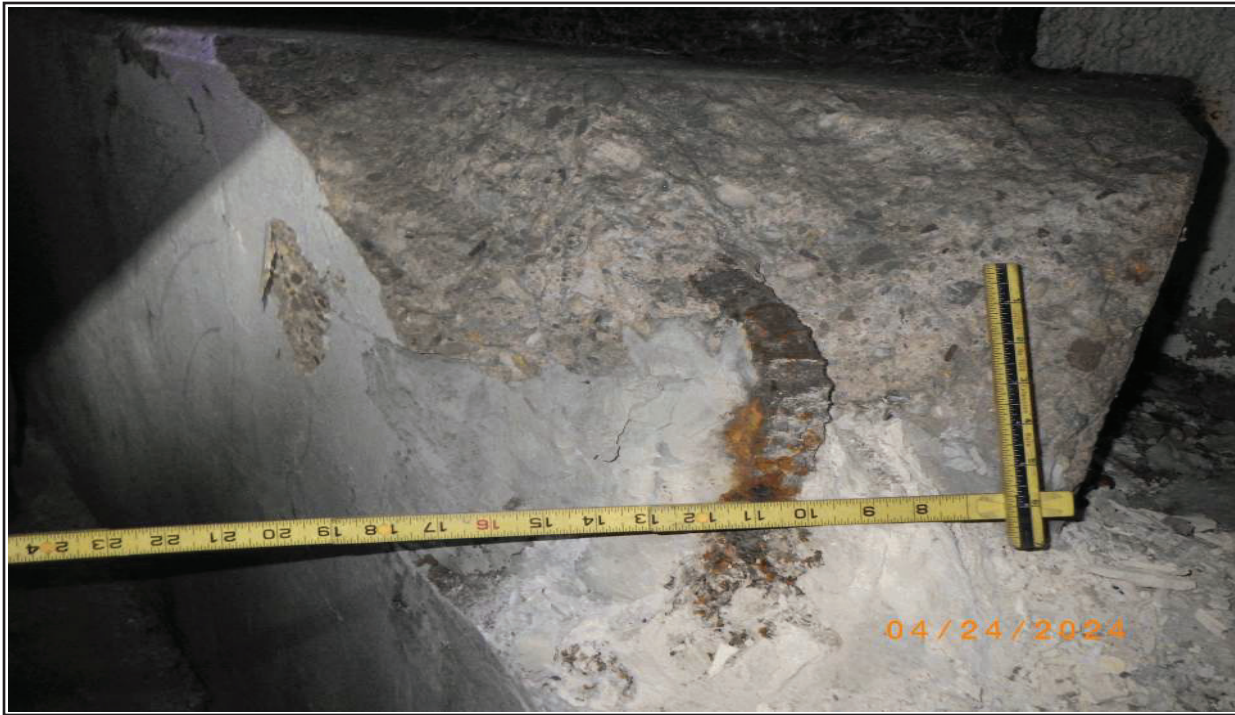
| Elm/Env | Description | Unit | Total Qty | Qty. St. 1 | Qty. St. 2 | Qty. St. 3 | Qty. St. 4 | Notes |
|---|---|---|---|---|---|---|---|---|
| 215/2 | Re Conc Abutment | ft | 52.00 | 36.00 | 9.00 | 7.00 | 0.00 | SPALL/DELAMINATION (1080):<br>CS3: (1 LF) 18IN W x 2FT H x 1/4IN D SPALL IN THE FRONT FACE UNDER GIRDER 5 WITH ASSOCIATED 2FT W x 18IN H DELAMINATION.<br><br>CS2: (9 LF) AREAS OF DELAMINATION AT RANDOM UNDER BAYS 1-3 UP TO 1FT W x 1FT H.<br><br>EXPOSED REBAR (1090):<br>CS3: (6 LF) BAY 5 EXHIBITS A DEGRADED PATCH WITH A 3FT L x 2FT H x 3 1/2IN D SPALL WITH EXPOSED CORRODED STEEL REINFORCEMENT AND 10% SECTION LOSS ON REINFORCEMENT (3 LF) (PHOTO 23), AND THE CORNER OF BRIDGE SEAT 4 IN BAY 5 EXHIBITS A 2.5FT L x 1FT H x 3IN D SPALL WITH EXPOSED CORRODED STEEL REINFORCEMENT AND 10% SECTION LOSS ON REINFORCEMENT (3 LF) (PHOTO 21). |

21 SPAN 3, NORTH ABUTMENT BEARING 5 SEAT BELOW BAY 5 - SPALL WITH ECSR AND SECTION LOSS

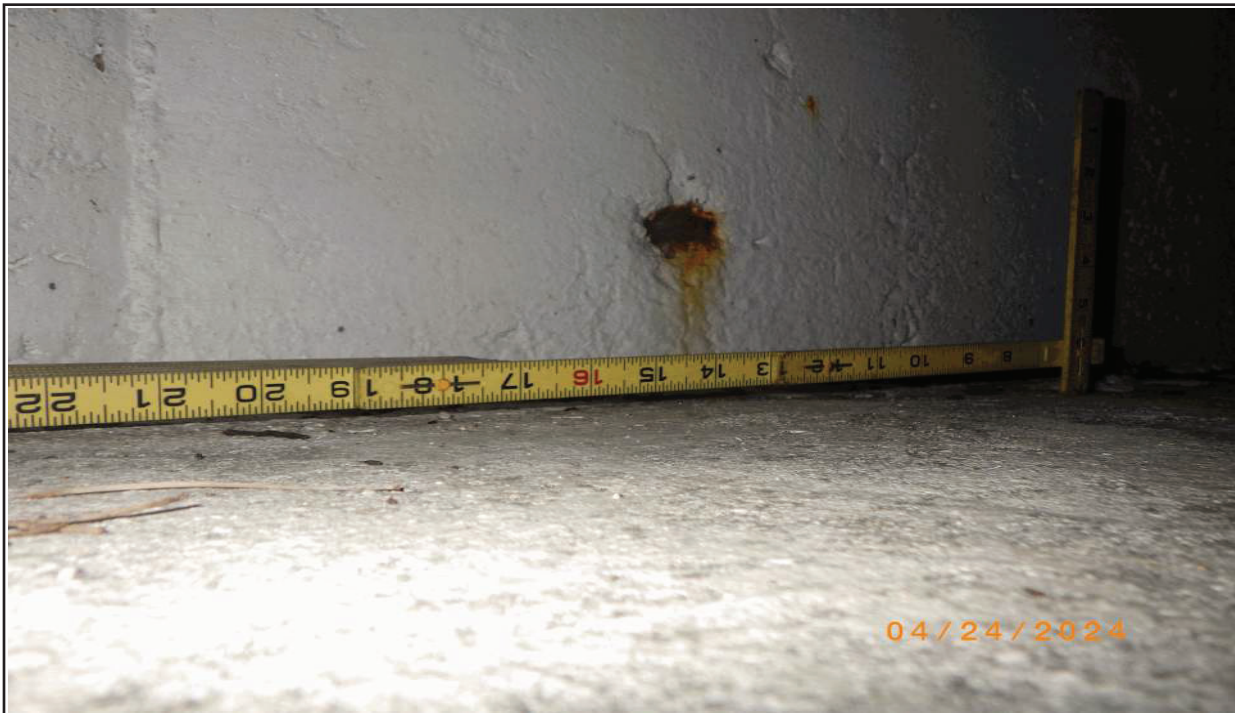
| Elm/Env | Description | Unit | Total Qty | Qty. St. 1 | Qty. St. 2 | Qty. St. 3 | Qty. St. 4 | Notes |
|---|---|---|---|---|---|---|---|---|
| 825/2 | R/C Abutment Backwall | ft | 52.00 | 51.00 | 0.00 | 1.00 | 0.00 | EXPOSED REBAR (1090):<br>CS3: (1 LF) 2IN W x 2IN L x 1IN D POP-OUT SPALL WITH EXPOSED REINFORCEMENT AND 10% SECTION LOSS ON REINFORCEMENT NEAR THE WEST END (PHOTO 22).<br><br>(NC-24) |

22 SPAN 3, NORTH ABUTMENT BACKWALL, WEST END - SPALL WITH ECSR AND SECTION LOSS

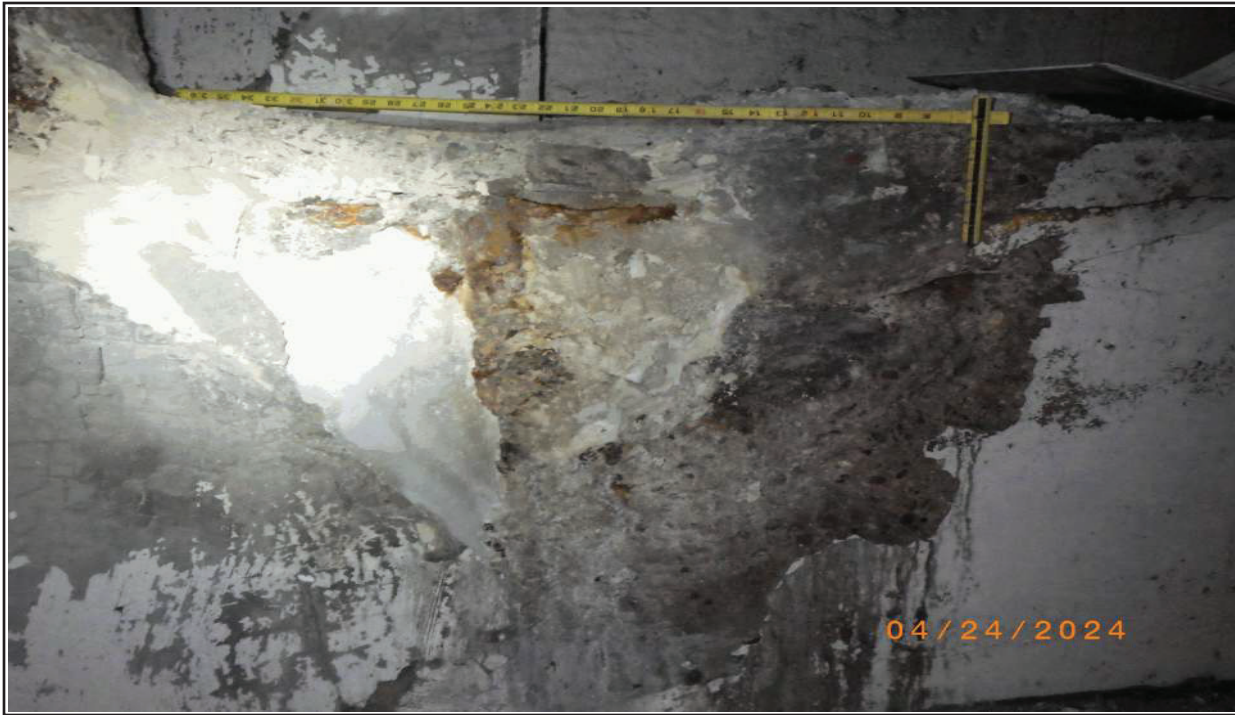
23 SPAN 3, NORTH ABUTMENT BREASTWALL BELOW BAY 5 - SPALL WITH ECSR
