Bridge No: 1740 060  
Date of Inspection: 04/23/2024  
Load Rating Date: 04/14/2010

Bridge ID 1740 060  
5) Inventory Route  
A) On/Under: Route On Structure  
D) Route No: 00495  
6) Feature Intersected I 295 SB  
7) Facility Carried: RAMP 6107  
9) Location: CHRISTIANA INTERCHANGE  
16) Latitude: 39° 42' 24"  
98) Border Bridge Code Not Applicable (P)

Inspection Date: 04/23/2024 Type: 1 Regular NBI  
Inspector: PENNONI PENNONI BrM User:  
Scope:  
NBI: ☒ Other: ☐ Element: ☒  
Underwater: ☐ Fracture Critical ☐

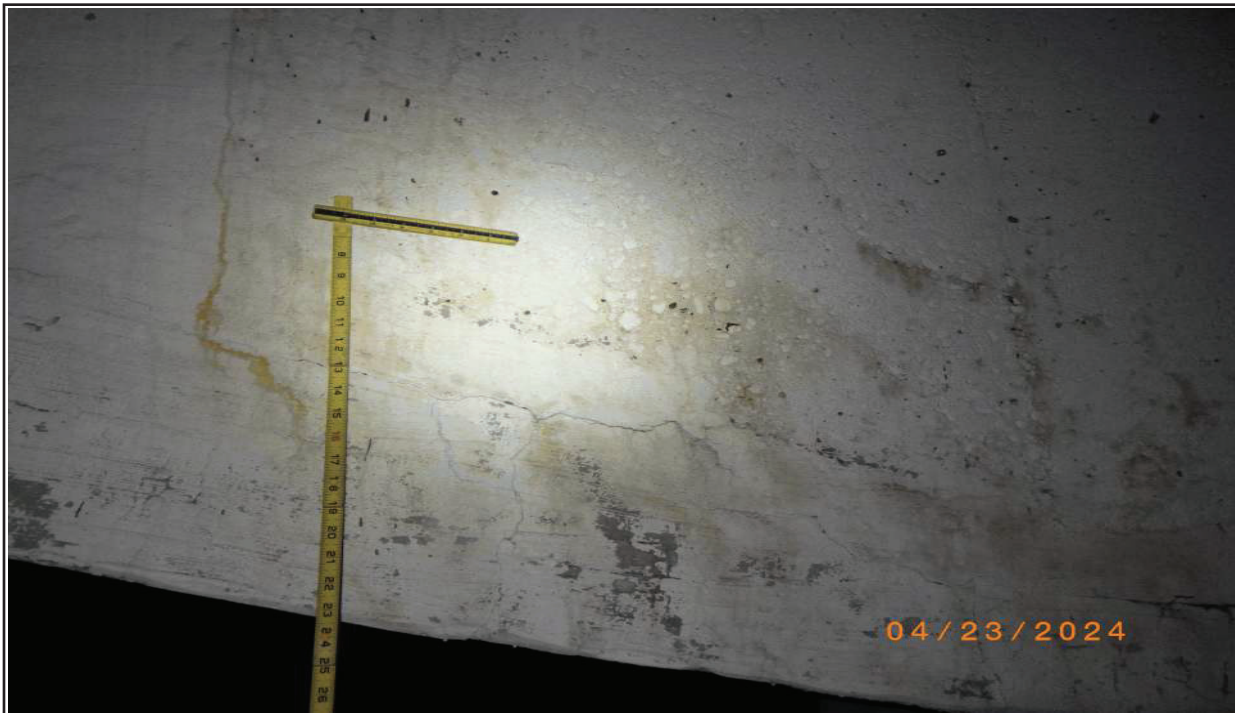
| Elm/Env | Description | Unit | Total Qty | Qty. St. 1 | Qty. St. 2 | Qty. St. 3 | Qty. St. 4 | Notes |
|---|---|---|---|---|---|---|---|---|
| 234/2 | Re Conc Pier Cap | ft | 50.00 | 31.00 | 17.00 | 2.00 | 0.00 | EFFLORESCENCE/RUST STAINING (1120):<br>CS3: (2 LF) HAIRLINE CRACK WITH CORROSION STAINING IN THE SOUTH FACE OVER COLUMN 3 (PHOTO 24) AND IN BEARING SEAT 5 ON THE EAST FACE.<br><br>SPALL/DELAMINATION (1080):<br>CS2: (17 LF) AREAS OF DELAMINATION UP TO 3IN H x 18IN W IN THE NORTH, SOUTH, AND BOTTOM FACES AT RANDOM.<br><br>(NC-24) |

24 SPAN 1, PIER 1, SOUTH FACE OF CAP ABOVE COLUMN 3 - CRACK WITH CORROSION STAINING

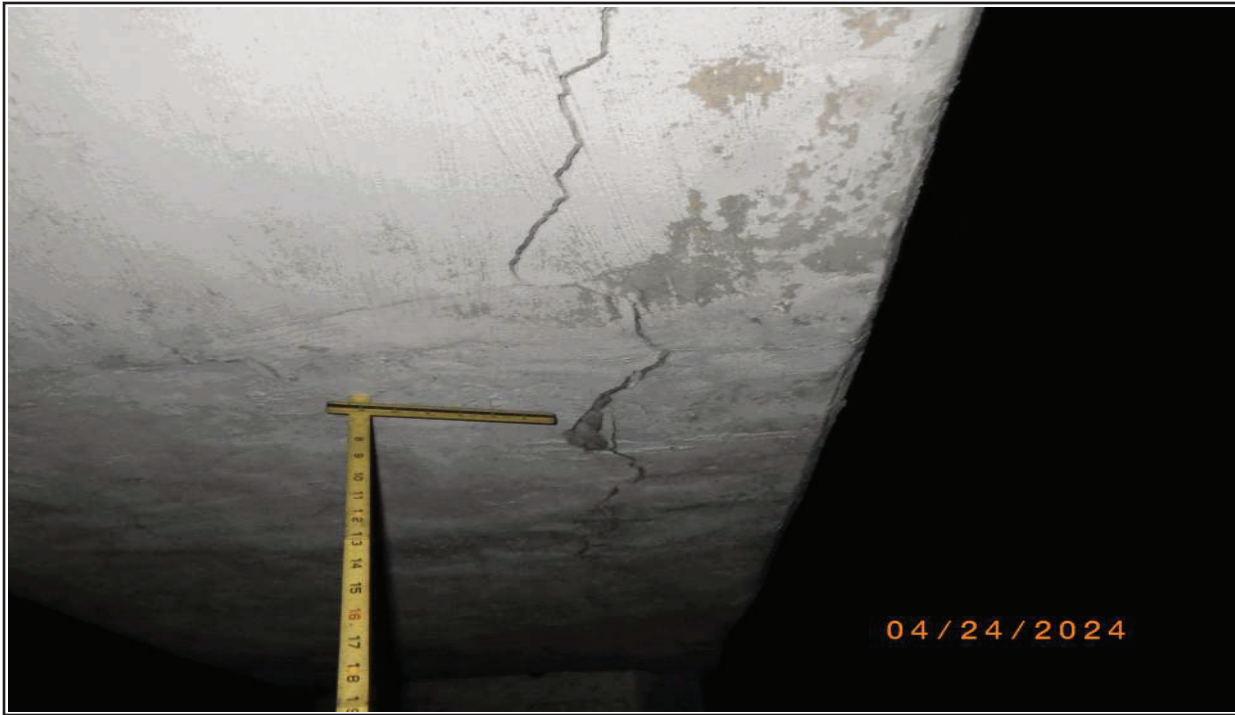
| Elm/Env | Description | Unit | Total Qty | Qty. St. 1 | Qty. St. 2 | Qty. St. 3 | Qty. St. 4 | Notes |
|---|---|---|---|---|---|---|---|---|
| 234/2 | Re Conc Pier Cap | ft | 50.00 | 26.00 | 15.00 | 9.00 | 0.00 | CRACKING (1130):<br>CS3: (7 LF) LONGITUDINAL CRACKING UP TO 1/4-INCH WIDE IN THE BOTTOM FACE BETWEEN COLUMNS 2 AND 3 (PHOTO 25).<br><br>EFFLORESCENCE/RUST STAINING (1120):<br>CS3: (2 LF) HAIRLINE CRACKS WITH CORROSION STAINING IN THE BOTTOM AND NORTH FACES NEAR THE EAST END.<br><br>SPALL/DELAMINATION (1080):<br>CS2: (15 LF) AREAS OF DELAMINATION UP TO 6FT W x 3FT L IN THE NORTH, SOUTH, AND BOTTOM FACES AT RANDOM.<br><br>(NC-24) |

25 SPAN 2, PIER 2, UNDERSIDE OF CAP BETWEEN COLUMNS 2 AND 3 - LONGITUDINAL CRACKS

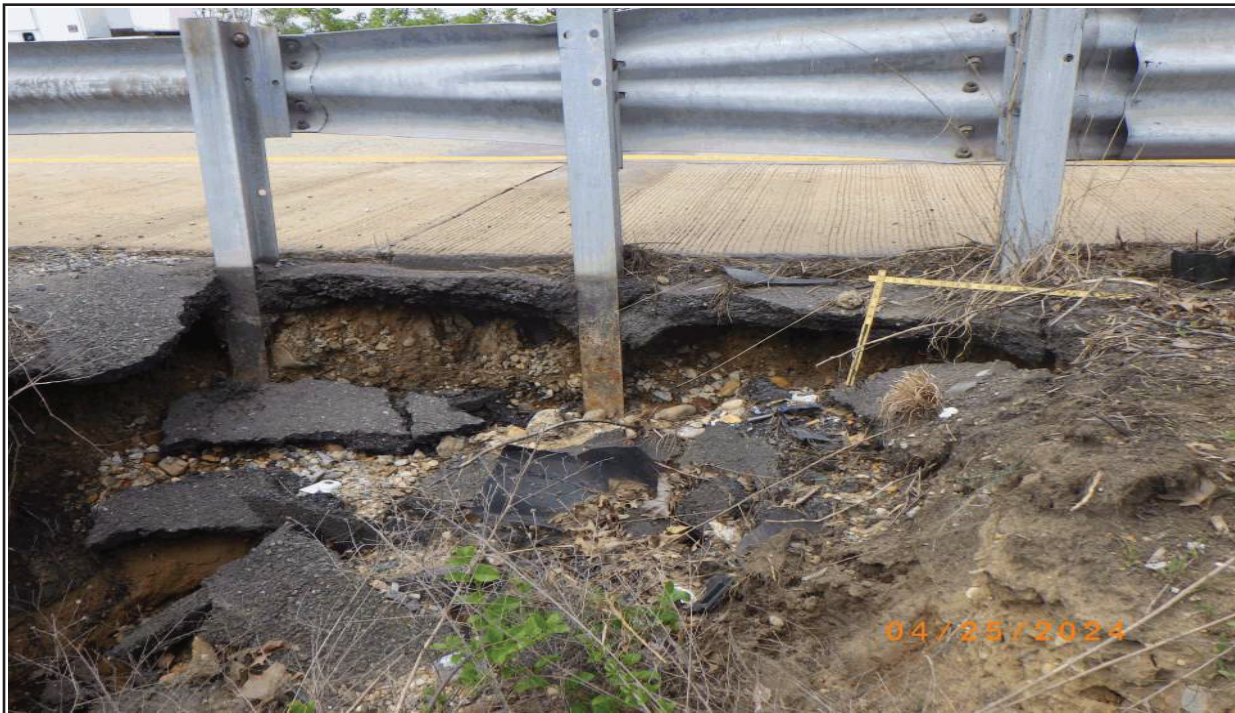
26 SOUTHEAST EMBANKMENT - EROSION BEHIND GUARDRAIL AT TRANSITION GUARDRAIL

PENNONI RECOMMENDED MAXIMO MAINTENANCE:  
- B005-S2K: SPOT PAINT THE SUPERSTRUCTURE AT AREAS OF CORROSION (1 LS), (PHOTOS 14 AND 15).  
- B020-S2J: REPAIR/PATCH SPALL AT NORTH ABUTMENT BEARING 5 SEAT AND CRACK WITH CORROSION AT SOUTH ABUTMENT BEARING 5 SEAT (2 CY), (PHOTOS 19 AND 21).  
- B042-P7A: REPAIR/PATCH SPALLS AND DELAMINATIONS AT THE NORTH AND SOUTH ABUTMENT (4 CY), (PHOTOS 20, 22 AND 23).  
- B054-S6D: BACKFILL THE ERODED AREA BEHIND THE SOUTH APPROACH, EAST GUARDRAIL (10 CY), (PHOTO 26).
