## PETROGRAPHIC EXAMINATION REPORT

<b>Client:</b>	Pennoni Associates, Inc.	<b>Client ID:</b>	PENN003
<b>Project:</b>	I-95 Viaduct Project	<b>Report #:</b>	SL0845-01
<b>Location:</b>	Delaware	<b>Dates Received:</b>	12/15/14, 01/07/15, 01/14/15
<b>Sample Type:</b>	Concrete cores	<b>Report Date:</b>	02/14/15
<b>Delivered by:</b>	Client (M. Padula)	<b>Petrographer:</b>	J. Walsh
		<b>Analyst:</b>	M. Pattie

- This report presents the results of petrographic examination and air-void analysis on six concrete core samples taken from viaduct structures along I-95 near Wilmington, DE.

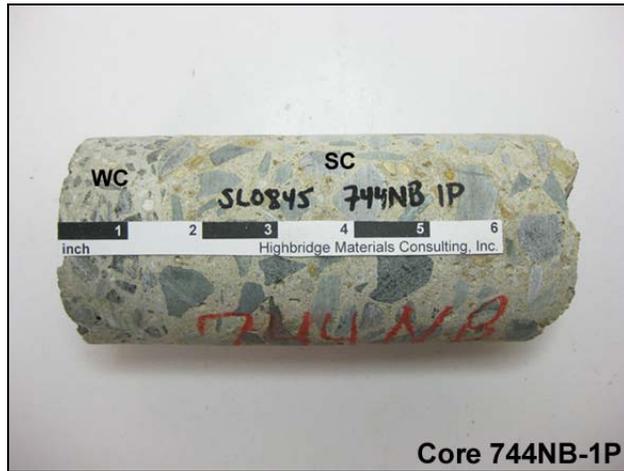
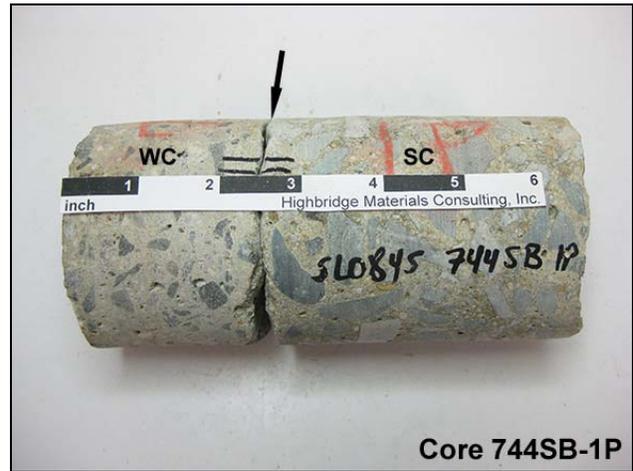
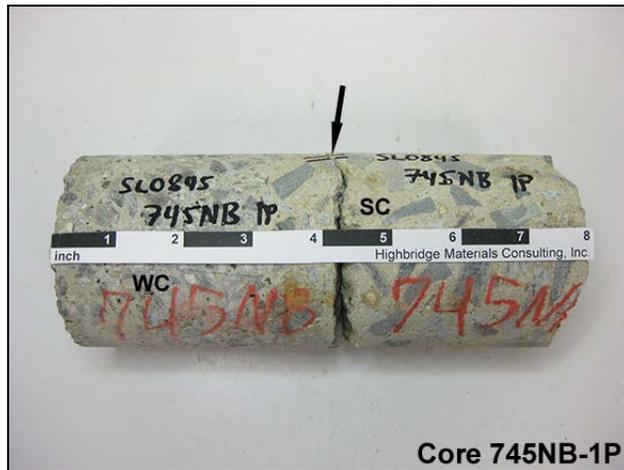
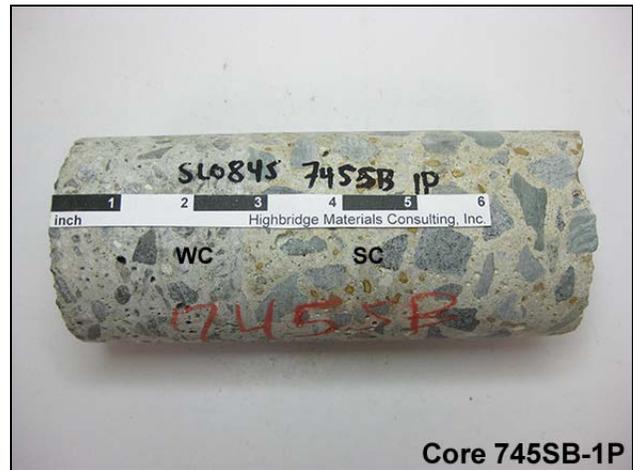
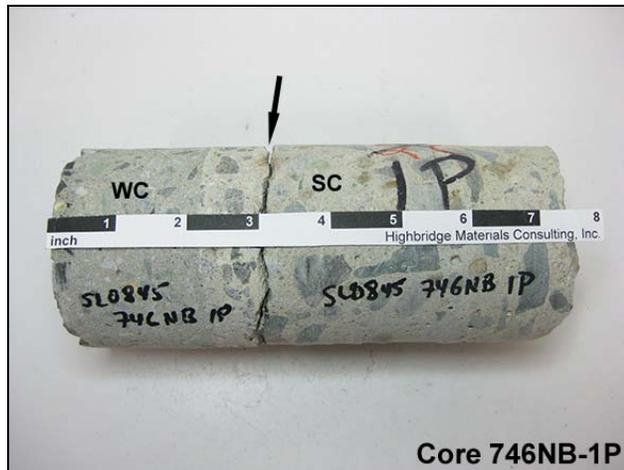
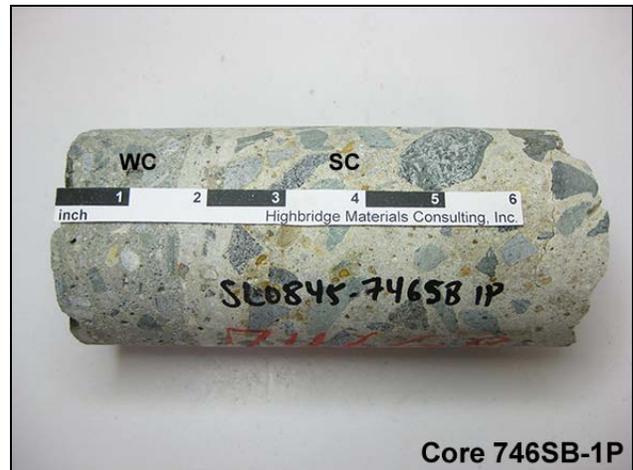
**Figure 1:** Photographs of the six concrete core samples used for petrographic examination and air-void analysis of the structural concrete layers. All are shown with their upper surfaces toward the left of each image. All contain wear course layers (WC) overlying normal weight structural concrete (SC). The arrows indicate core breaks present in three of the samples as delivered. These occur as cohesive failures within the substrate in Cores 744SB-1P and 745NB-1P and are interpreted to represent pre-existing axial cracks. The break in Core 746NB-1P is an adhesive failure between the wear course and substrate.

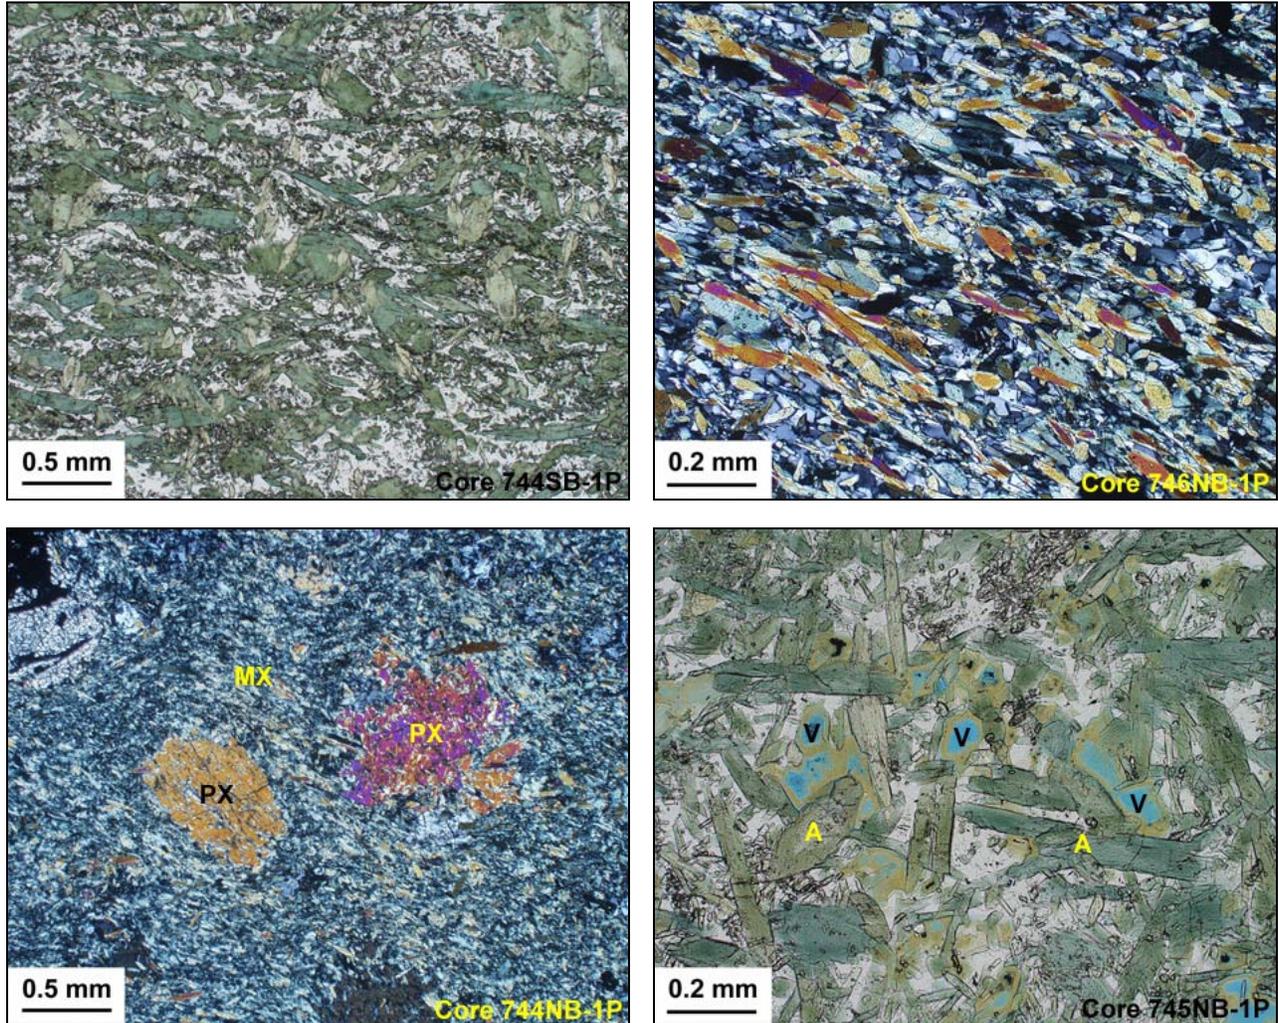
**Figure 3:** Amphibolite represents the major component in the coarse aggregate. Four of the core samples have similar amphibolite lithologies and examples of the range are shown in these photomicrographs. (Upper left PPL image) The green minerals are amphibole and these dominate the rock. The white areas are mostly feldspar. (Upper right XPL image) A similar grain is shown under crossed polars. The amphibole appears brightly colored in this image. Note the preferred orientation of the crystals. (Lower XPL image) Relict pyroxenes (PX) are embedded in a matrix of lower temperature phases (MX). The pyroxene suggests the amphibolites are the metamorphosed products of basic rocks such as gabbro. (Lower right PPL image) Microscopic vugs (V) are lined with a low-temperature phase and these are found between amphibole crystals (A). The open vugs suggest an original basaltic source for this particular lithology. Basalts and gabbros are related rock types.

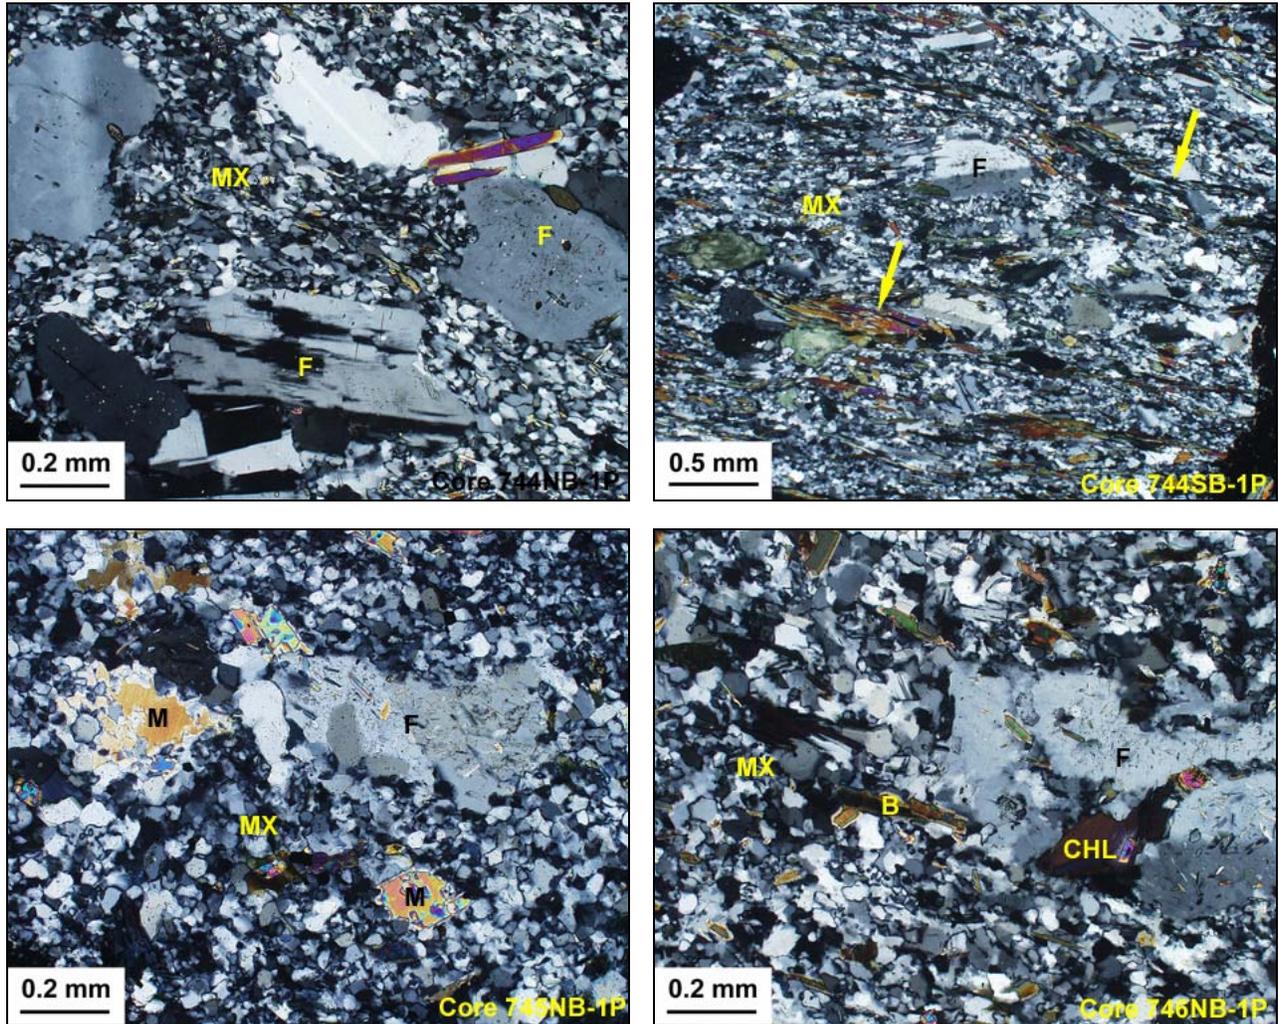
**Figure 5:** Schistose granofels are associated with the amphibolites in the four cores illustrated in Figure 3. Examples of the range of lithologies are shown in these XPL photomicrographs. In all cases, the stone is dominated by a matrix (MX) of fine-grained quartz subgrains. The matrix is essentially a strained quartzite. The deformation causes the stone to be alkali-silica reactive and much of the early stage reactions identified in this study are found in this lithology. Coarser porphyroclasts are entrained within the sheared matrix. Feldspar (F) is common. However, muscovite (M), biotite (B), and chlorite (CHL) are also identified. The arrows indicate thin laminae of amphibole. Though these rock types do not immediately appear similar to the amphiboles, increasing amounts of amphibole suggests that there may be a full gradation between these two lithologies. The gradation is better observed in Cores 745SB-1P and 746SB-1P.

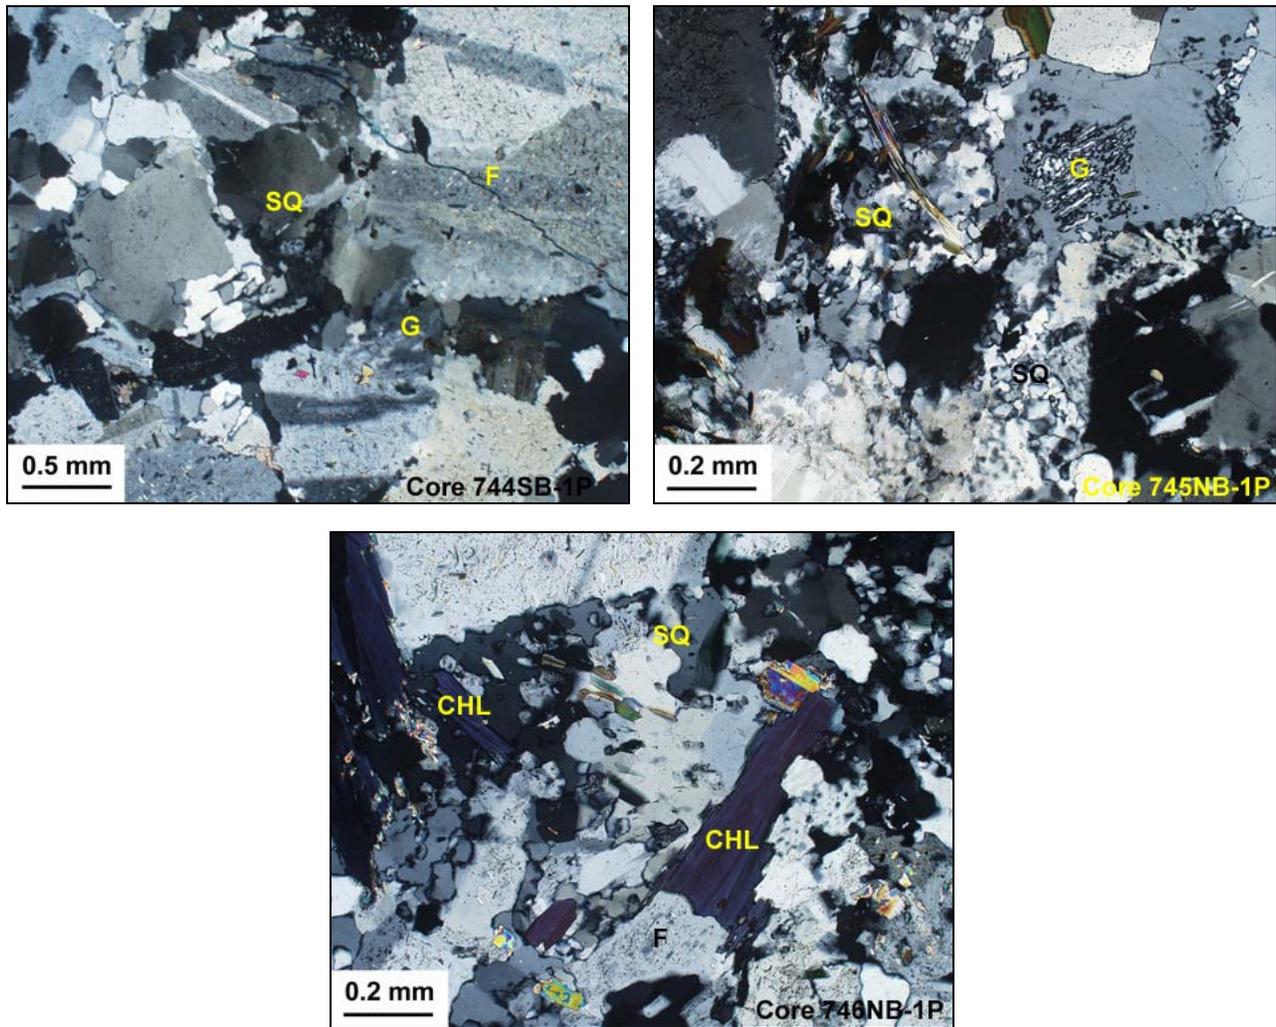
**Figure 6:** Granitoid lithologies are a minor portion of the coarse aggregate in Cores 744SB-1P, 745NB-1P, and 746NB-1P. Feldspar is dominant (F) and darker accessory minerals such as chlorite (CHL) are also observed in low concentration. More importantly, there is an abundance of fine interstitial matrix. This contains both graphic intergrowths (G) of quartz and feldspar as well as patches of strained quartz (SQ). The fine, deformed quartz is considered to be alkali-silica reactive and some of the early stage reactions observed in this study are found in these rocks.

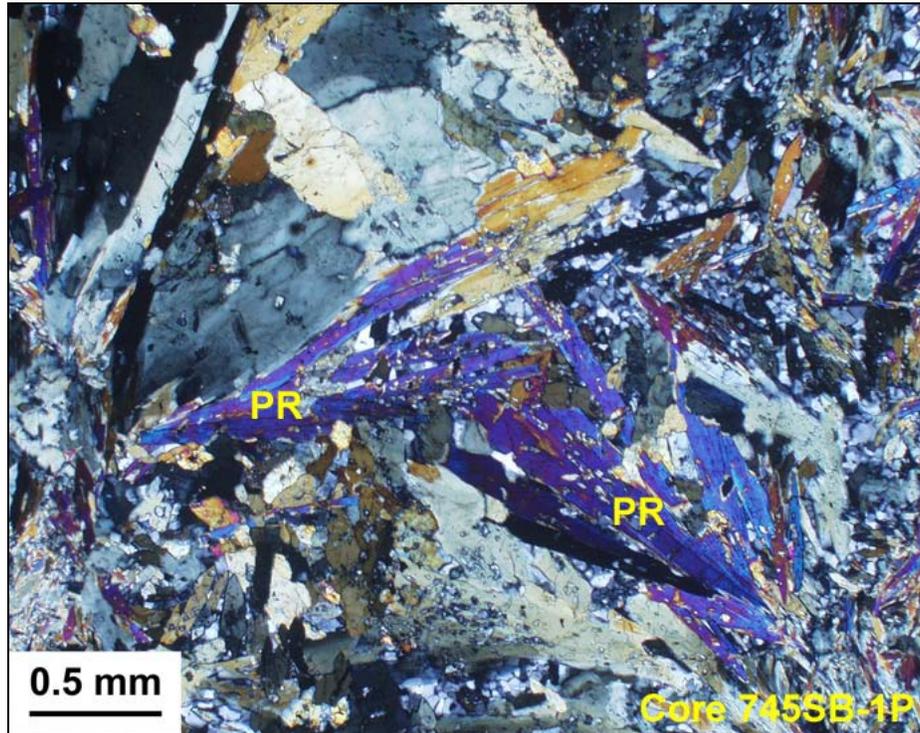
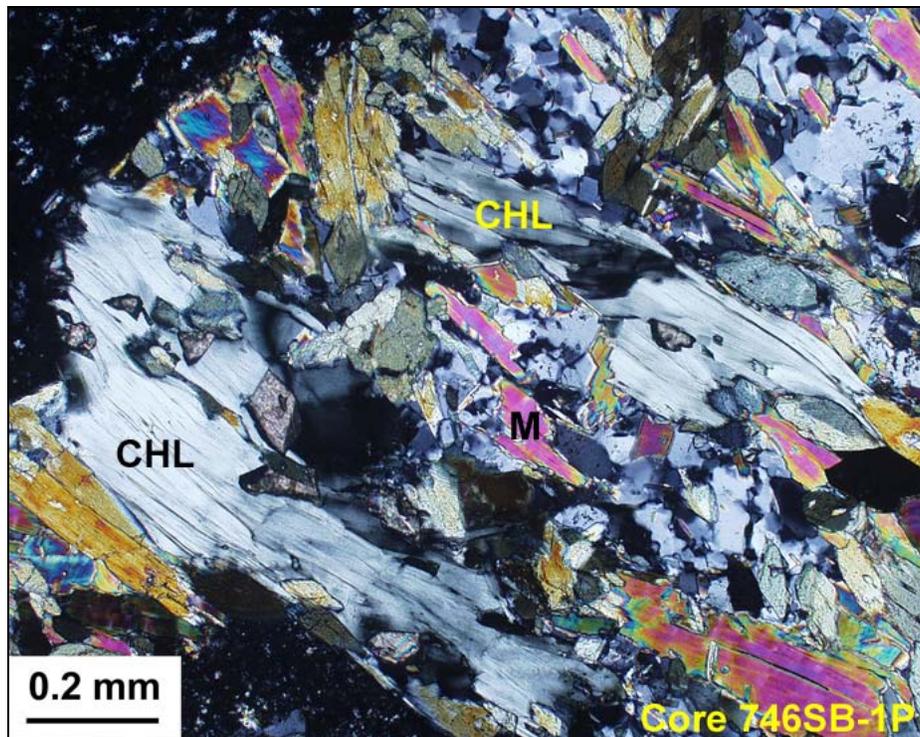
**Figure 7:** The amphibolites in Cores 745SB-1P and 746SB-1P are notably different than those of the other four cores. Two examples are shown in these XPL photomicrographs. In the upper image, prehnite crystals (PR) indicate a lower metamorphic grade. The grain in the lower image is rich in chlorite (CHL) as well as other micas (M).

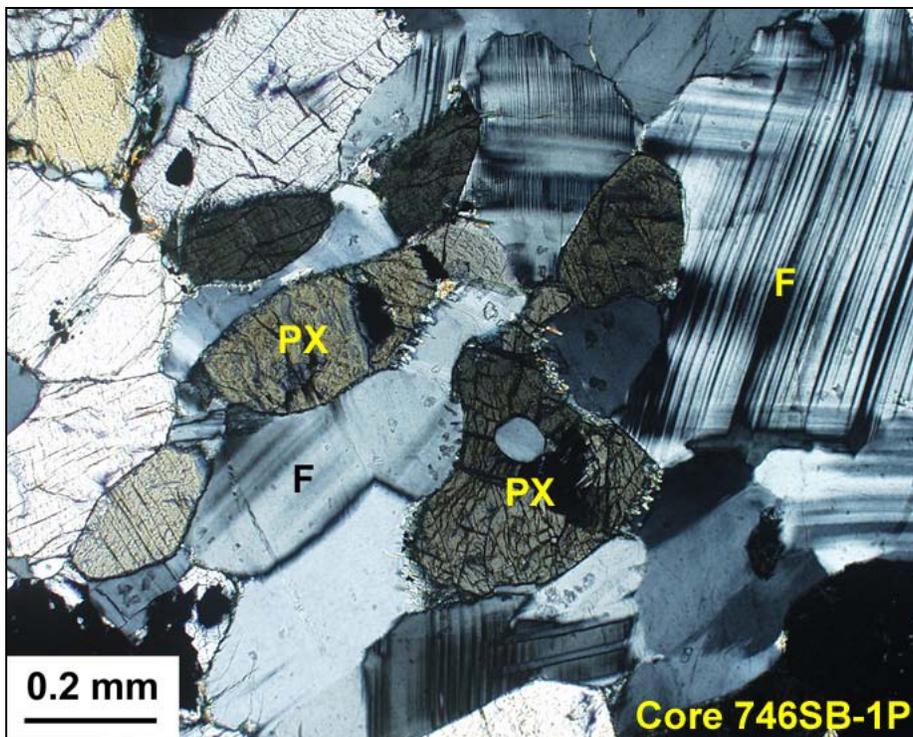
**Figure 9:** Diorites are a minor component of the coarse aggregate in Cores 745SB-1P and 746SB-1P as shown in these XPL images. The diorite has a granoblastic texture containing plagioclase feldspar (F) and orthopyroxene (PX). Quartz (Q) is only found in Core 745SB-1P.

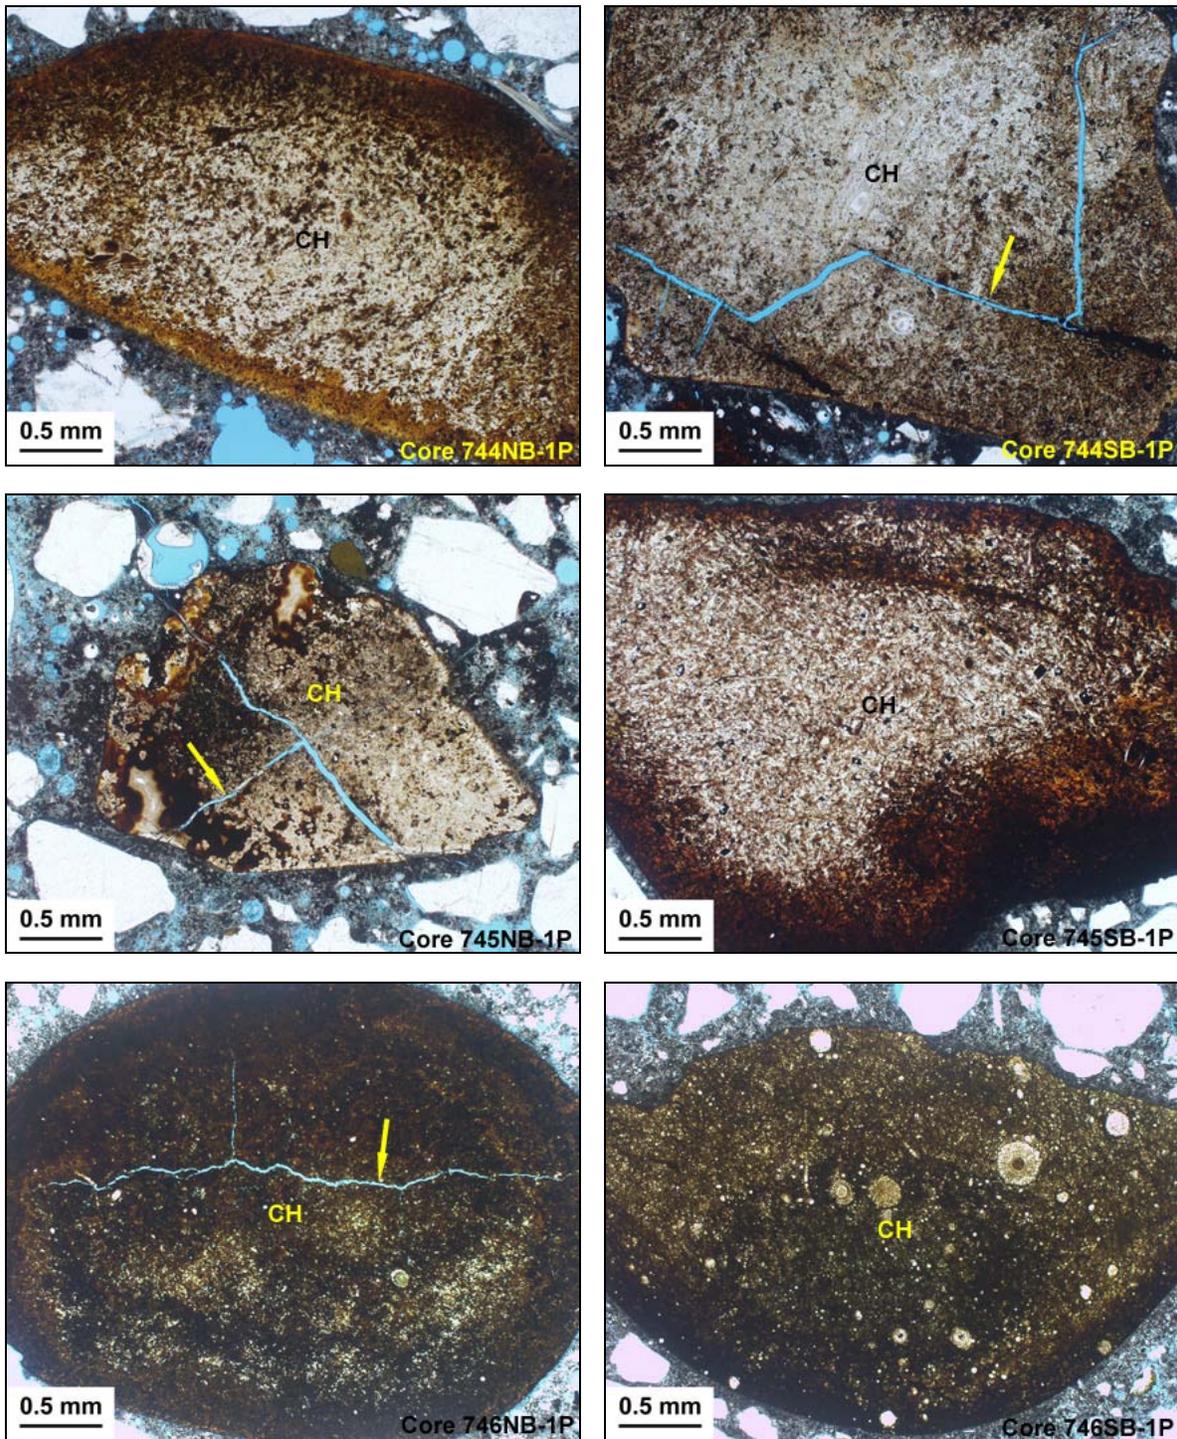
**Figure 10:** PPL photomicrographs. All cores contain ferruginous chert (CH) in the fine aggregate at about several percent by volume. Chert is considered to be one of the most highly alkali-reactive rock types. Traces of reaction are observed in this material in all cores. The internal microcracks shown by the arrows in these images represent one form of evidence for the reaction.

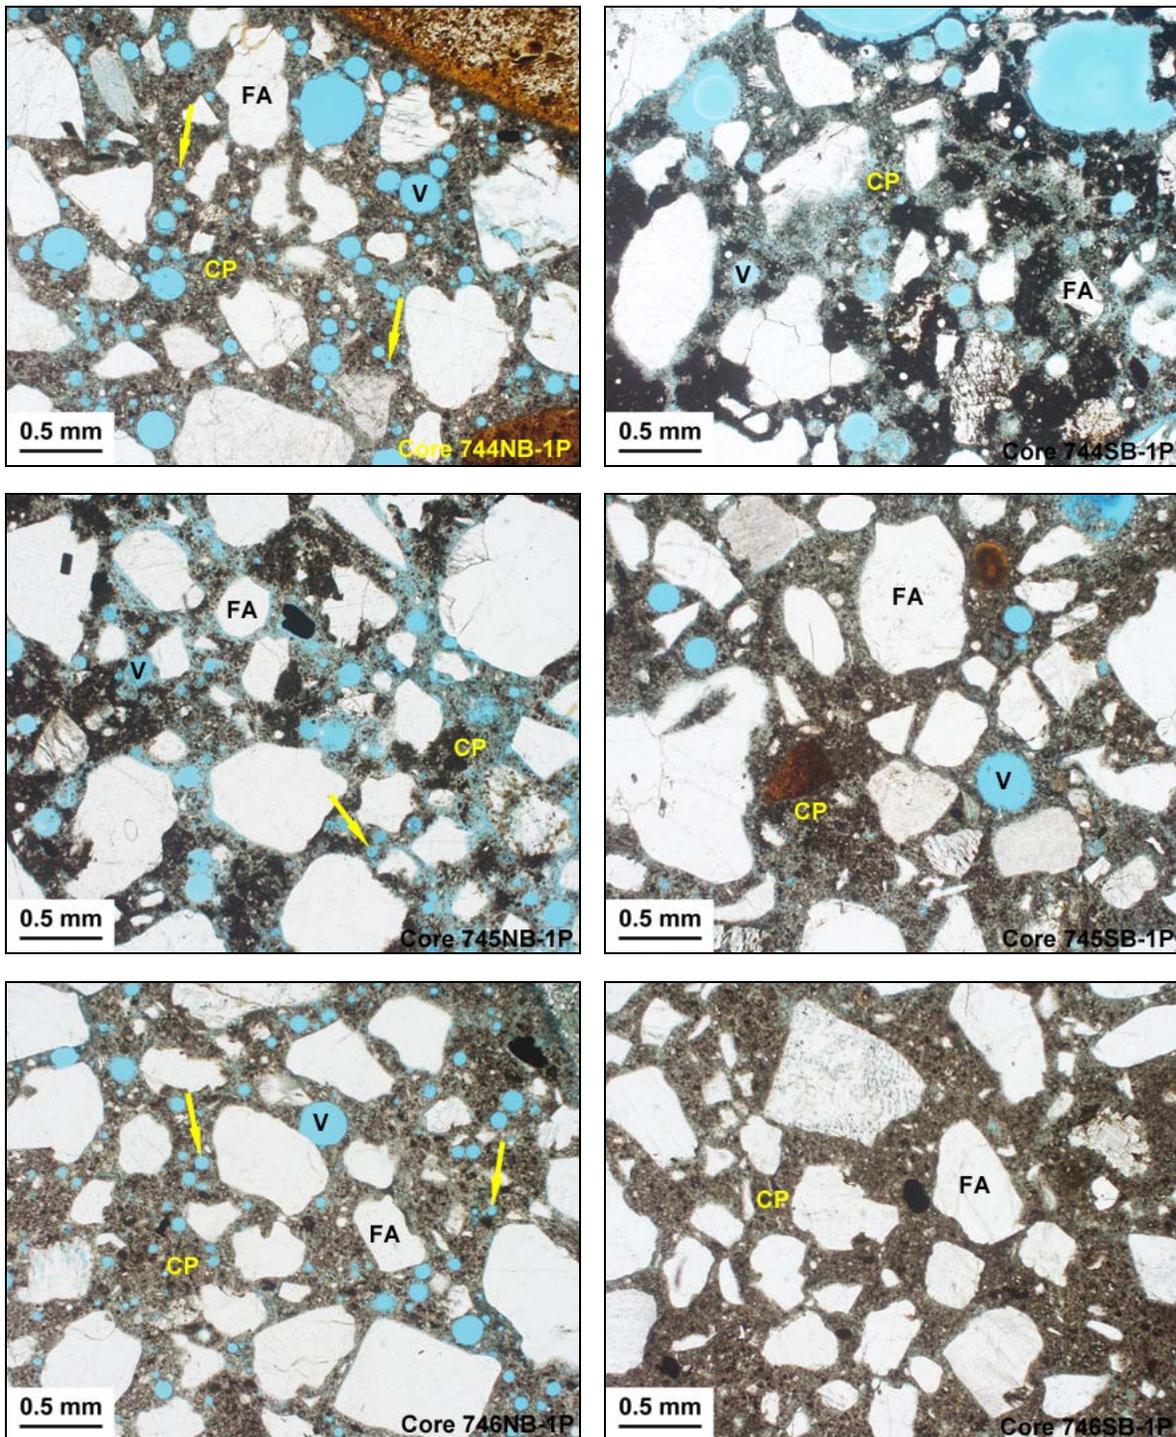
**Figure 11:** PPL photomicrographs illustrating the overall microstructure of the structural concrete. There is some variability in water contents and entrained-air development that result in some quality differences. In all of the examined samples, the cement paste (CP) is well-developed and relatively dense as indicated by the even brown coloration under plane light. Some mottling is identified in Cores 744SB-1P and 745NB-1P. This may represent a primary cement flocculation but could also have been a secondary effect of alkali-silica reaction. The samples are impregnated with a low-viscosity, blue-dyed epoxy in order to highlight cracks, pores, and voids. There is a moderate absorption of the epoxy consistent with moderate mix water contents. Note the lower absorption particularly in Cores 745SB-1P and 746SB-1P. The fine aggregate (FA) is well distributed throughout the matrix. The sand is somewhat coarse-grained but otherwise well graded. Fine, spherical voids (V) indicate intentional air-entrainment in all cores but 746SB-1P. The arrows illustrate very fine voids that are abundant in some of the northbound core samples.

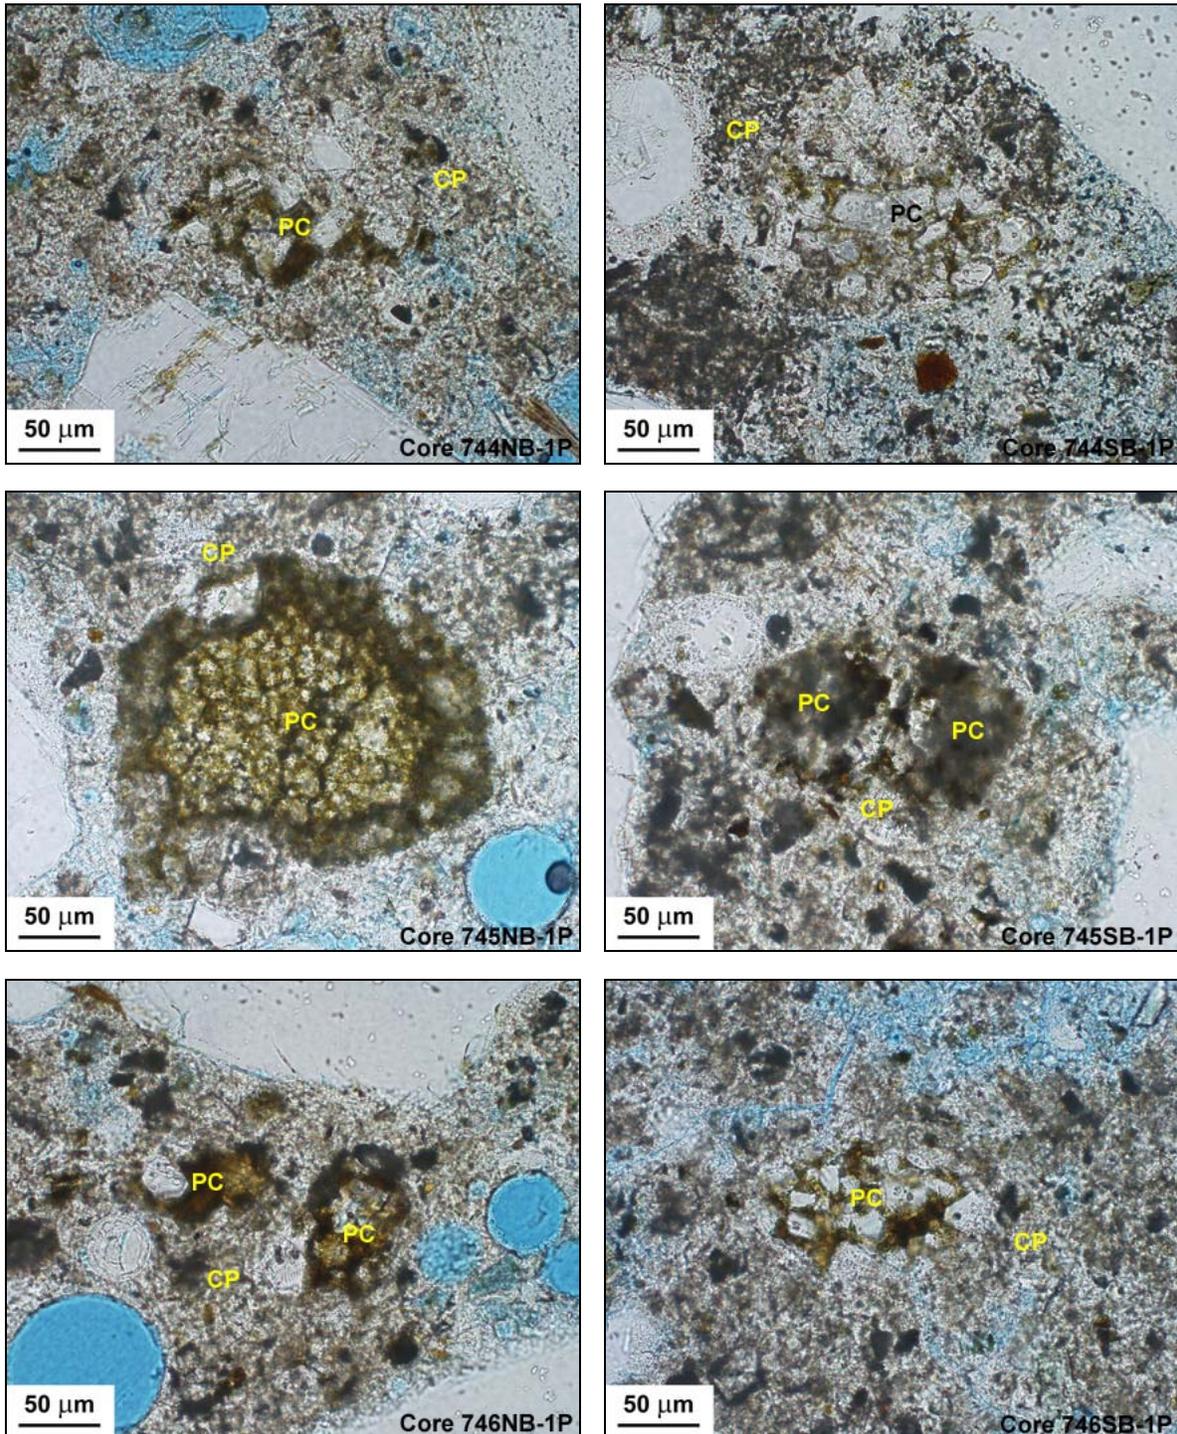
**Figure 12:** PPL photomicrographs illustrating the occurrence of residual portland cement (PC) in the examined concrete. The cement hydration is advanced and most calcium silicate is fully consumed. These appear as light-colored areas within the cement agglomerates. An exception is shown for Core 745NB-1P where belite remains unhydrated. For Core 745SB-1P, an area is shown where the empty pores are now filled with an amorphous cementitious hydrate. All of the cement residuals are fine to medium-grained agglomerates with brown-colored interstitial ferrite. The adjacent cement paste (CP) is well-formed in all samples.

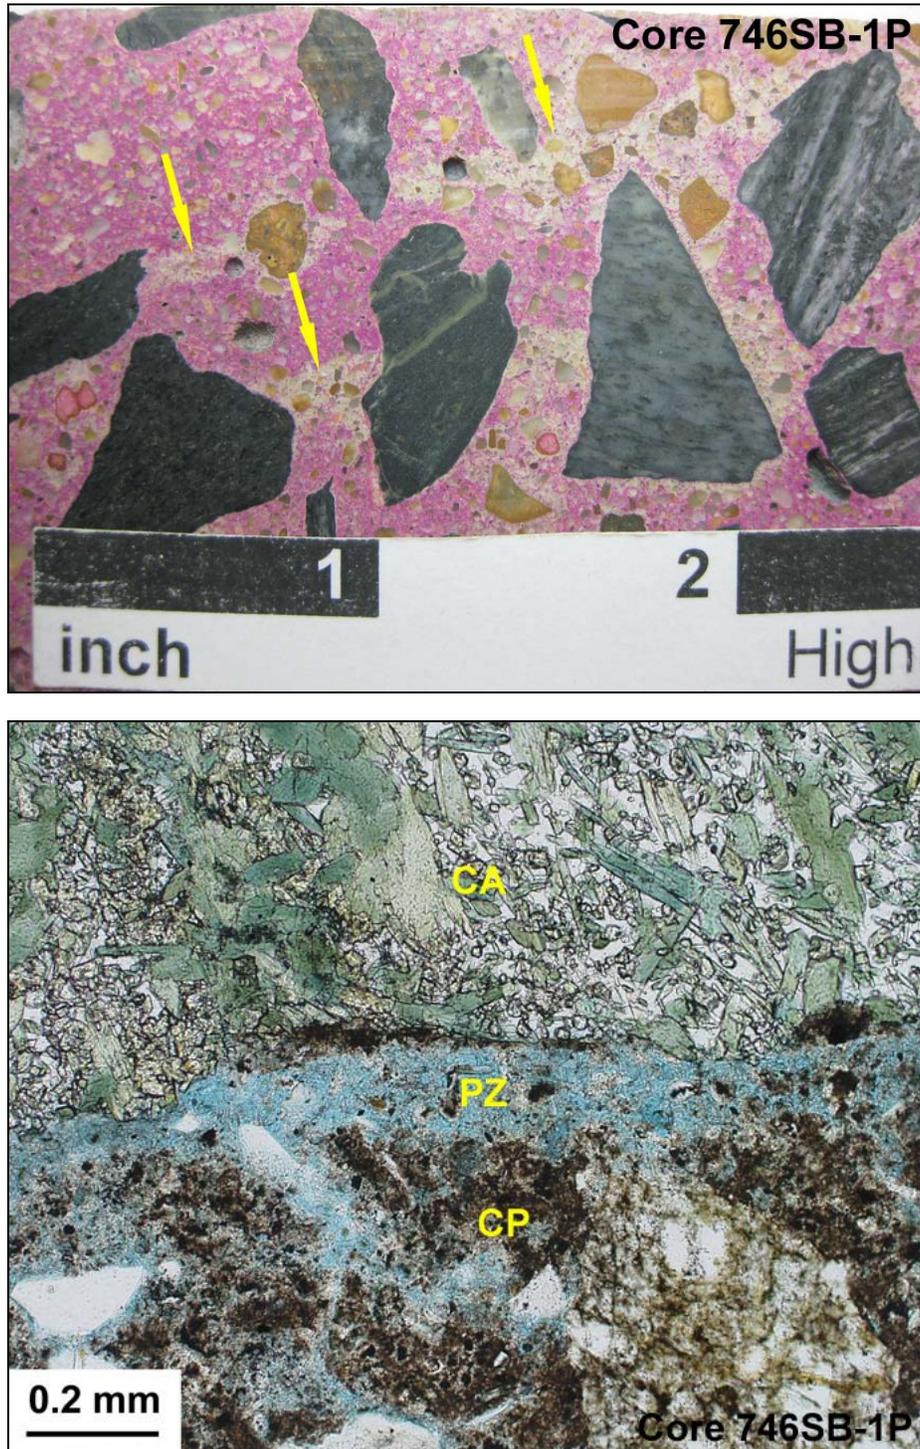
**Figure 14:** Evidence for bleed water migration and entrapment is found in Core 746SB-1P. The upper image is a close-up of the honed cross section treated with phenolphthalein indicator. The arrows indicate bleed water channels that show up as colorless bands. Note that the section is rotated on its side so that the channels appear horizontal rather than vertical. The lower PPL image illustrates a porous zone (PZ) between the cement paste (CP) and coarse aggregate (CA). This is caused by the local entrapment of mix water under the aggregate grain. The paste-aggregate bond is weakened as a result.

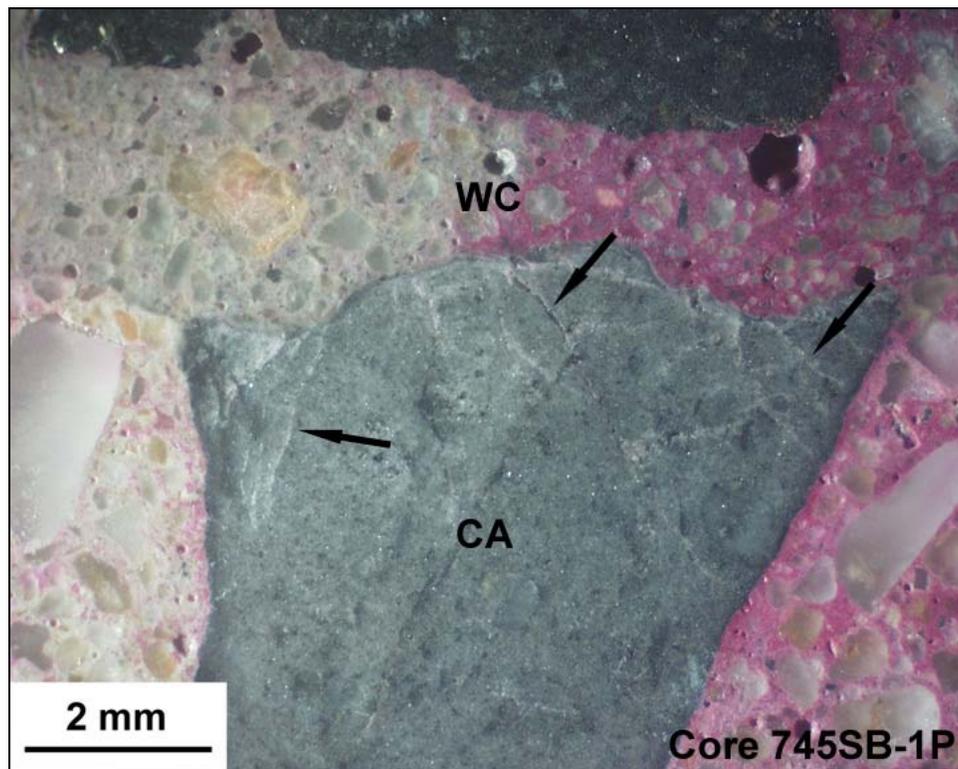
**Figure 15:** Reflected light photomicrograph of Core 745SB-1P. The wear course is shown directly over a truncated coarse aggregate grain in the structural layer (SC). The arrows indicate shatter cracks within the particle. The observations suggest a scarification process in advance of the wear course installation.

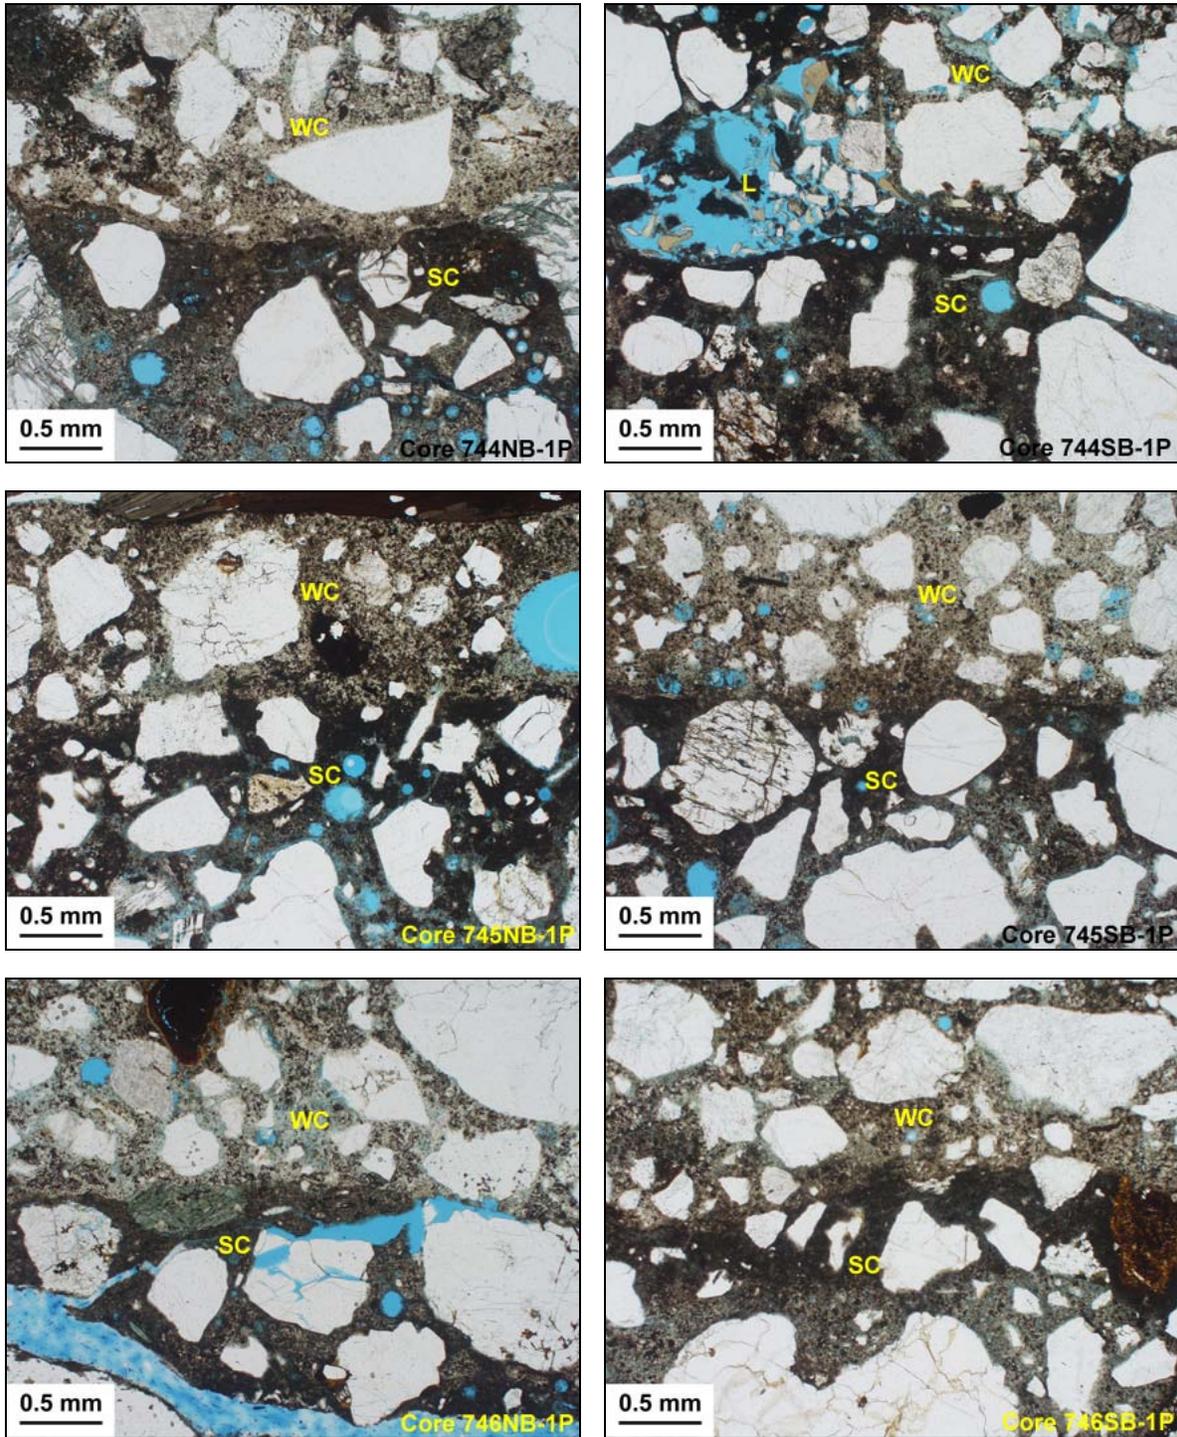
**Figure 16:** PPL photomicrographs illustrating the mostly tight contacts between wear course (WC) and structural concrete (SC). Some cracking is shown in blue for Core 746SB-1P. A patch of loose wear course material (L) is shown for Core 744SB-1P.

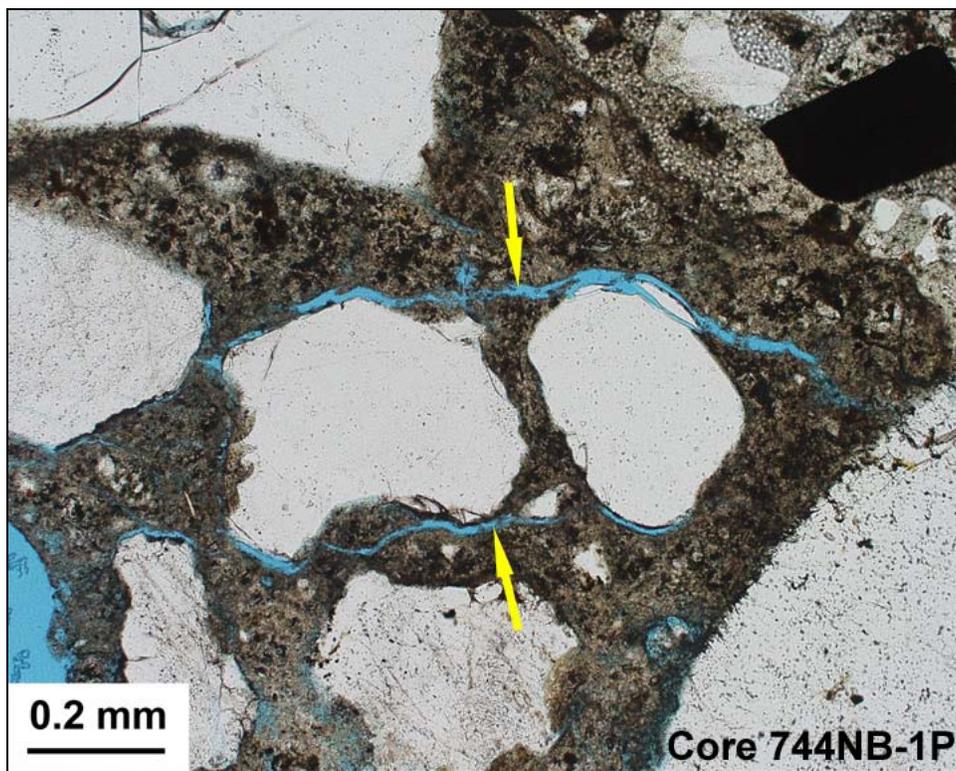
**Figure 17:** PPL photomicrograph of Core 744NB-1P. The arrows indicate minor surface-parallel microcracks just below the upper surface of the structural concrete. The cracking could be related to some freeze-thaw distress but the evidence is quite scant.

Aside from the potential for chloride infiltration, the issue most closely tied to water permeability is freeze-thaw resistance. Assuming the wear courses are equally permeable, it should be expected that the structural concrete is capable of at least partial saturation if regularly exposed to moisture. The northbound core samples have entrained air structures that would be considered by most industry professionals to be sufficient for adequate freeze-thaw protection. Even though two of the northbound cores have fine air contents less than 4% (Cores 745NB-1P and 746NB-1P), the calculated spacing factors and specific surfaces are within industry accepted ranges. Specifically this includes spacing factors less than 0.008 in. and specific surfaces greater than 600 in.<sup>-1</sup>. The southbound cores do not meet these criteria. In fact, no entrained air is present in Core 746SB-1P. Despite some deficiencies, there is no significant evidence for freeze-thaw related distress in the structural concrete of any sample. The only possible feature is a trace level of incipient scaling within the uppermost millimeter of structural concrete in Core 744NB-1P.

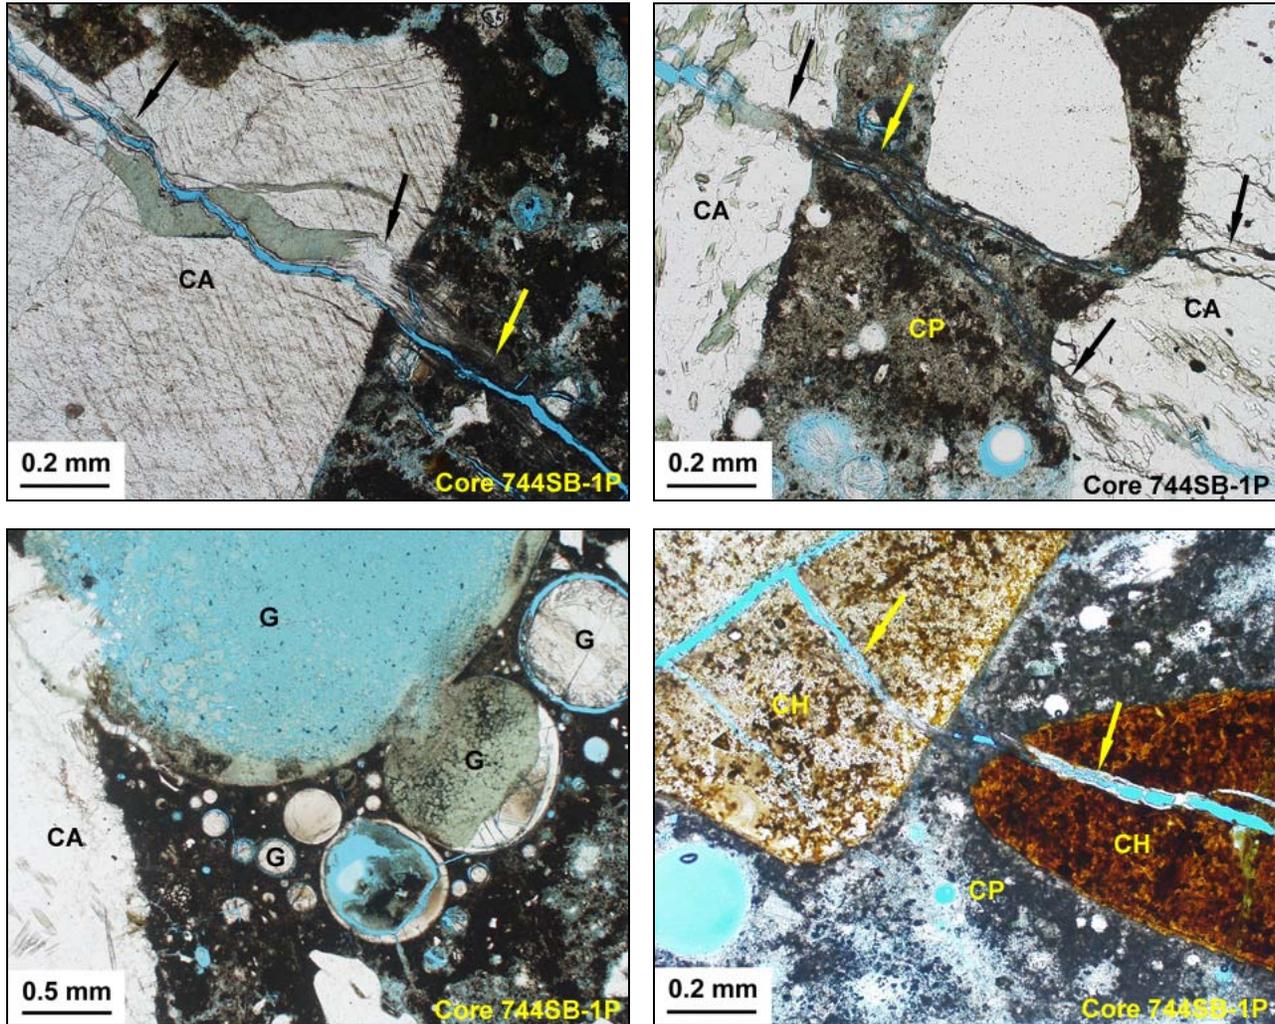
**Figure 18:** Core 744SB-1P exhibits the most well-developed alkali-silica reaction even if the reaction is only in its early stages. In the upper two PPL photomicrographs, the black arrows indicate reaction cracks within coarse aggregate grains (CA). The yellow arrows indicate where these have propagated into the adjacent cement paste (CP). ASR gel plugs are found at the periphery of the reactive stone. The reactive grain in the left image is a granitoid. The cracks span two granofels particles in the right image. Another granofels coarse aggregate grain (CA) is shown in the lower left PPL image. Alkali-silica reaction gels have deposited in adjacent air-voids (G). Chert (CH) in the fine aggregate is also reactive in this sample. In the lower right PPL image, the arrows indicate reaction cracks that are lined with ASR gel and link through the adjacent cement paste (CP).

While still somewhat minimal, Core 744SB-1P exhibits the most significant reaction. It is notable that this particular core contains the greatest concentration of the schistose granofels that are rich in strained quartz matrix. This is interpreted to be the primary reason for the slightly more advanced reaction. In cross section, reaction rims are found along most of the mottled aggregate particles (i.e. those that are not amphibole-rich). Internal cracks are found in many of the granofels and granitoids with opening thicknesses mostly less than 50  $\mu\text{m}$ . An exception is found near the upper surface with a width of approximately 125  $\mu\text{m}$ . In some cases, these link up to form semi-continuous microcracks with an axial orientation. The core break located just below the wear course in the sample as received is also identified as an extension of these cracks. The spacing of the more continuous cracks is relatively wide at the inch-scale. ASR gel plugs are found at the intersection between reacted aggregate and adjacent cement paste. Reaction gel is also identified in air-voids that are in proximity to reaction sites. Chert in the fine aggregate also exhibits internal microcracks along with some gel plugs. However, these do not appear widespread when evaluated in full depth cross section.
