## PETROGRAPHIC EXAMINATION REPORT

<b>Client:</b>	Pennoni Associates, Inc.	<b>Client ID:</b>	PENN003
<b>Project:</b>	I-95 Viaduct Project	<b>Report #:</b>	SL0845-01
<b>Location:</b>	Delaware	<b>Dates Received:</b>	12/15/14, 01/07/15, 01/14/15
<b>Sample Type:</b>	Concrete cores	<b>Report Date:</b>	02/14/15
<b>Delivered by:</b>	Client (M. Padula)	<b>Petrographer:</b>	J. Walsh
		<b>Analyst:</b>	M. Pattie

- This report presents the results of petrographic examination and air-void analysis on six concrete core samples taken from viaduct structures along I-95 near Wilmington, DE.

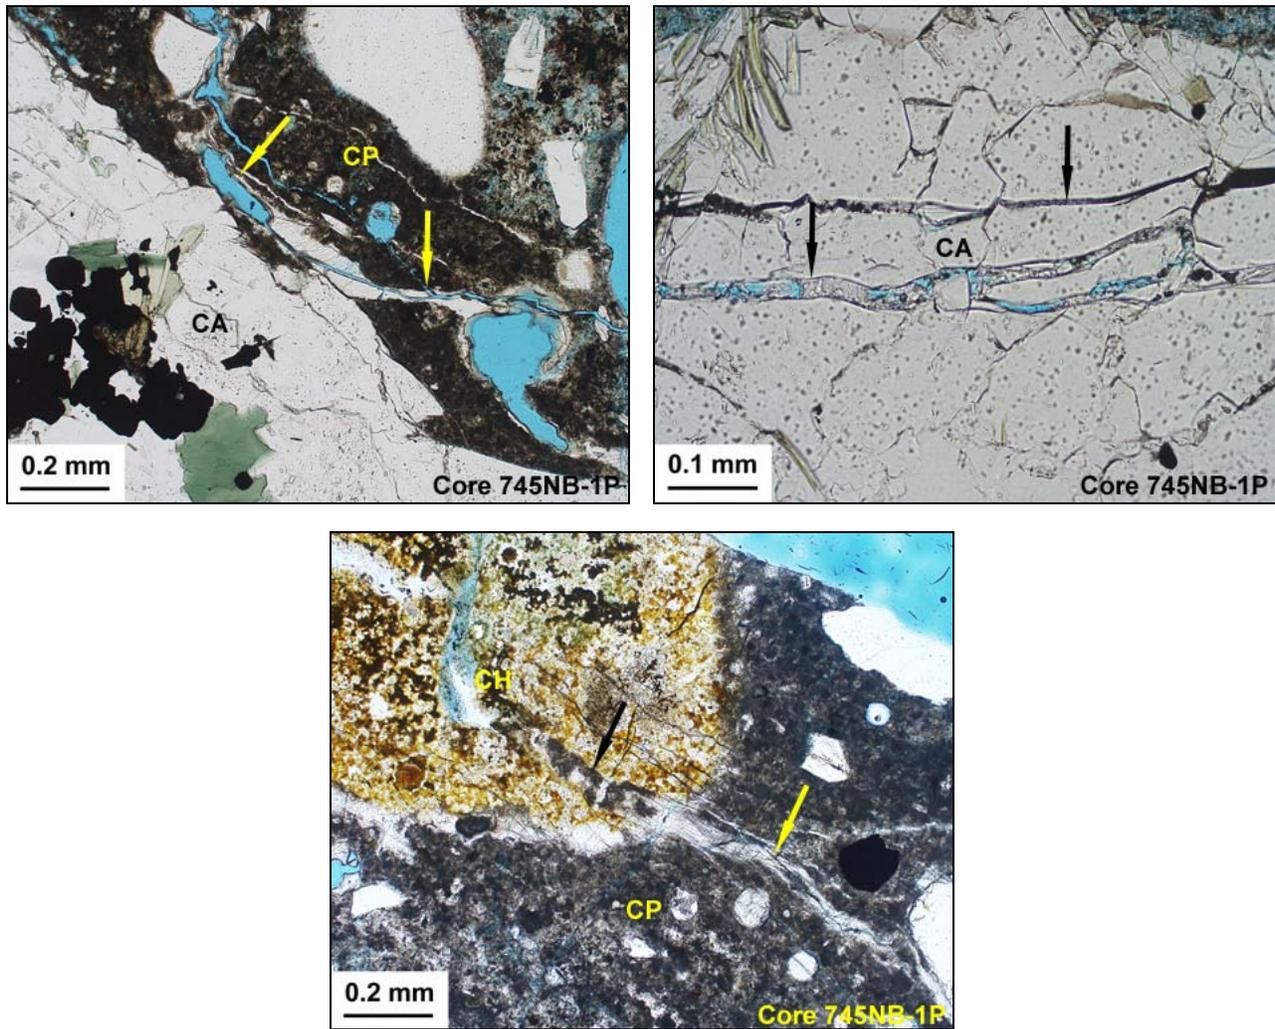
**Figure 19:** Early stage ASR reaction is also observed in Core 745NB-1P as shown by these PPL photomicrographs. (Upper left) The coarse aggregate shown (CA) is a granitoid. The arrows indicate cracks within the cement paste (CP) that are lined with well-developed ASR gels. (Upper right) The arrows indicate reaction cracks within another granitoid coarse aggregate particle (CA). (Lower image) The black arrow indicates a reaction crack within a chert particle (CH) in the fine aggregate. The yellow arrow indicates where this has propagated into the adjacent cement paste (CP). An ASR gel plug is found at the periphery of the reactive sand particle.

Cores 745NB-1P and 746NB-1P exhibit a similar reaction but only within a limited depth at the uppermost portions of the structural concrete. Occurrences of ASR are rare and isolated at depth. In 745NB-1P, the reactions are limited to the uppermost 2" of the structural concrete with semi-continuous axial cracks only within the upper 1". The core break approximately 1" below the top of the structural layer is a manifestation of the reaction cracking. The chert within the fine aggregate also exhibits some well-developed cracking and gel formation within the upper section. In cross section, there are also instances of reaction gel having exuded from around chert particles after the section had been sliced and honed. In Core 746NB-1P, the coarse aggregate reactions are limited to the uppermost 0.5" of the structural concrete. Reactions in chert are identified but less prevalent than in Core 745NB-1P.

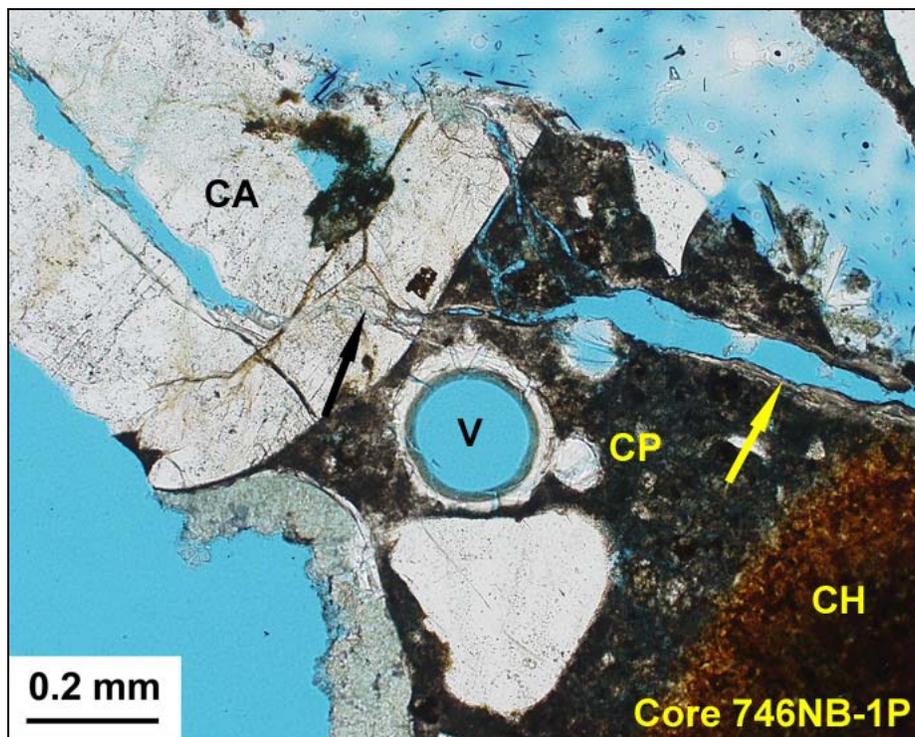
**Figure 20:** Core 746NB-1P exhibits an early stage ASR reaction almost equivalent to that observed in Core 745NB-1P. (Upper PPL image) The black arrows indicate reaction cracks within a granofels coarse aggregate grain (CA). The yellow arrows indicate where these have propagated into the adjacent cement paste (CP). ASR gel plugs are found at the periphery of the reactive stone. (Lower PPL image) A granitoid coarse aggregate (CA) and a chert sand particle (CH) are both involved in ASR reaction in this image. The arrows indicate cracks within the aggregate as well as the adjacent cement paste (CP). An adjacent air-void (V) is lined with reaction gel.

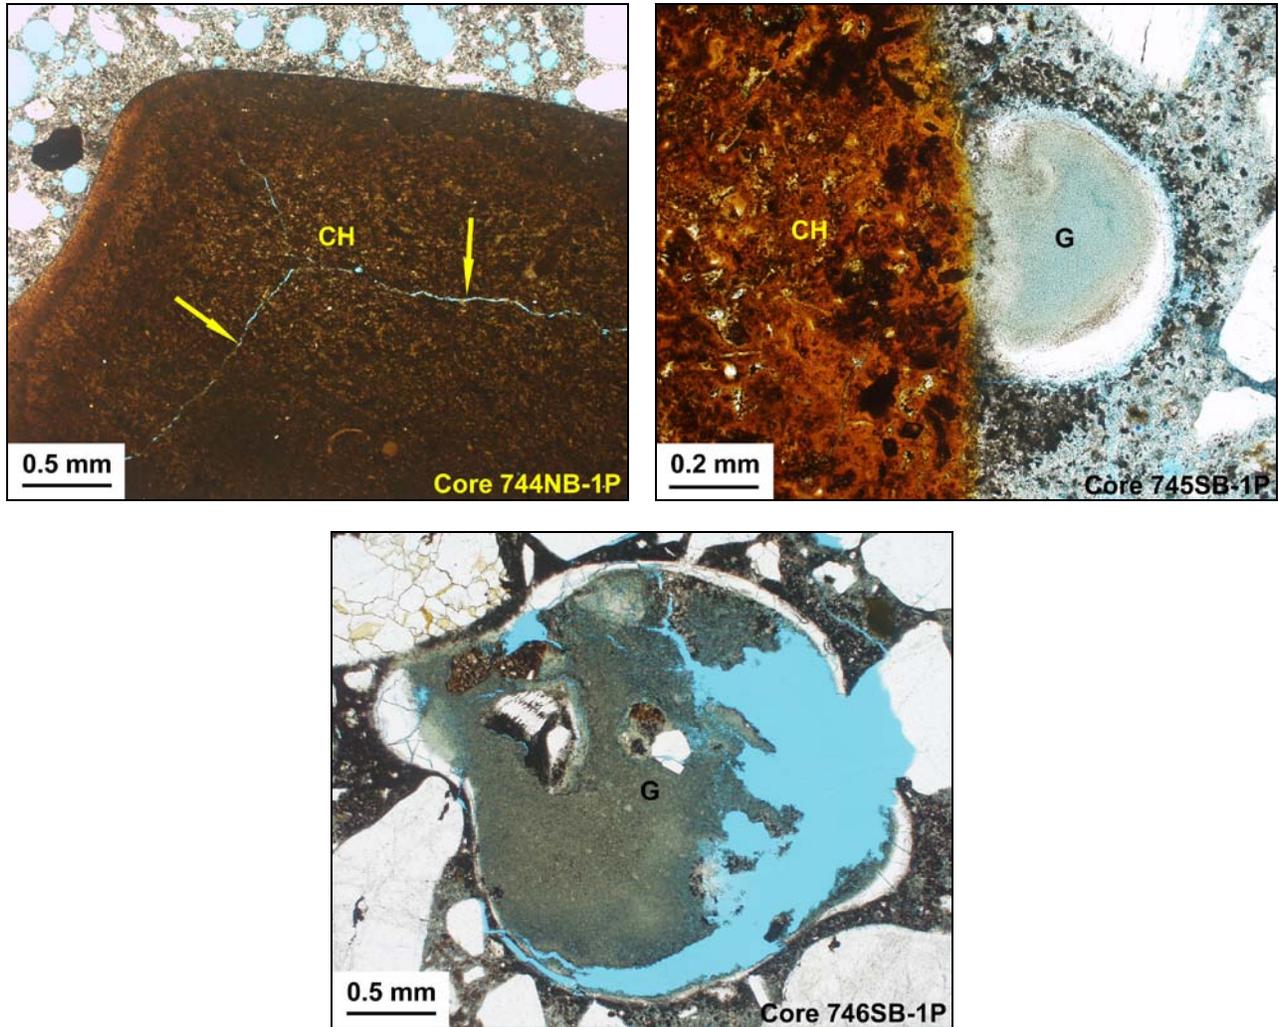
**Figure 21:** Only traces of ASR reaction are identified in the chert sand (CH) in the other core samples. (Upper left) The arrows indicate fine microcracks within a chert particle. (Upper right) A small deposit of reaction gel (G) has formed adjacent to a chert grain. (Lower image) A porous gel deposit (G) is shown in an air-void in the vicinity of a chert grain.

Only rare instances of trace ASR reaction are observed in Cores 744NB-1P, 745SB-1P, and 746SB-1P. These are exceptionally minor and include internal microcracks in chert fine aggregate and exudation of reaction gel around chert grains in freshly prepared cross section. No reaction is observed in the coarse aggregate of these samples. It is noted that the granitoids are absent from the coarse aggregate in all three of these cores. Additionally, the more granofels are less quartz-rich in Cores 745SB-1P and 746SB-1P.

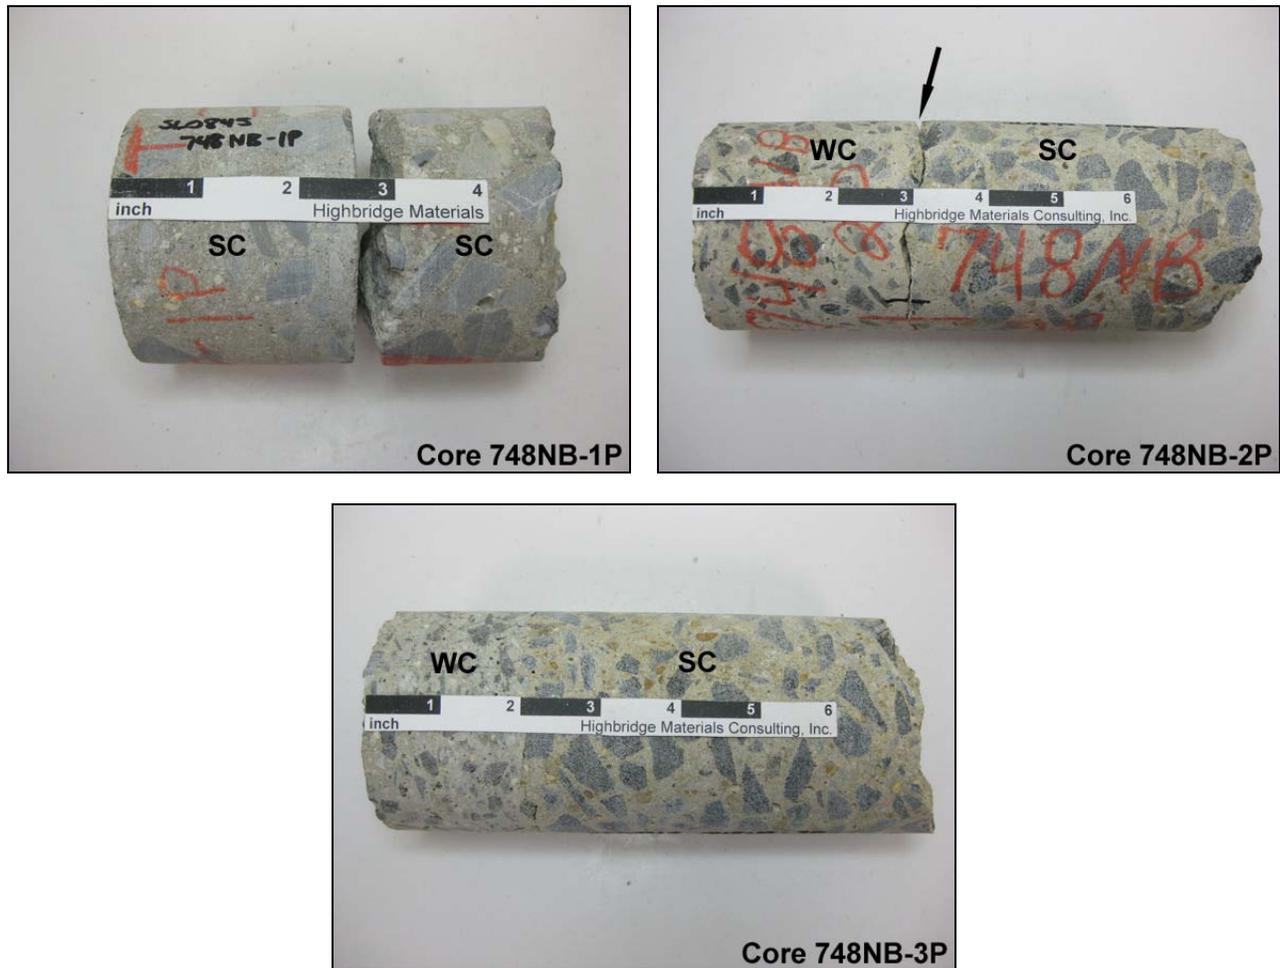
**Figure 1:** Photographs of the eleven concrete core samples used for petrographic examination and air-void analysis of the structural concrete layers. All are shown with their upper surfaces toward the left of each image. Core 748NB-1P was saw-cut and does not contain any original finished surfaces. Some of the cores contain wear course layers (WC) overlying normal weight structural concrete (SC). Wear courses are not present in the 758 Cores. The black arrow in the image for Core 748NB-2P illustrates a core break present in the sample as delivered. This is actually a cohesive failure in the substrate material. The blue arrow indicates a sharp, partial crack just below the wear course in Core 748SB-3P. Finally, steel wire reinforcement is included in Cores 758F-1P and 758G-1P. These are shown by the red arrows.

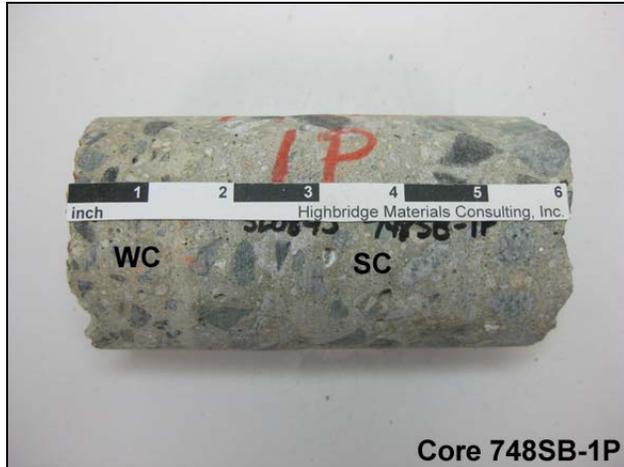
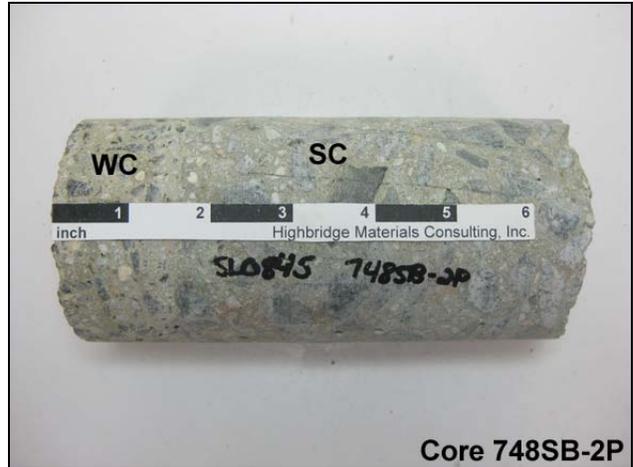
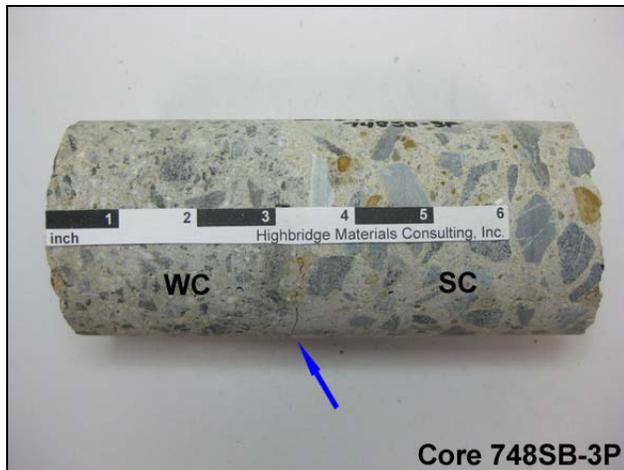
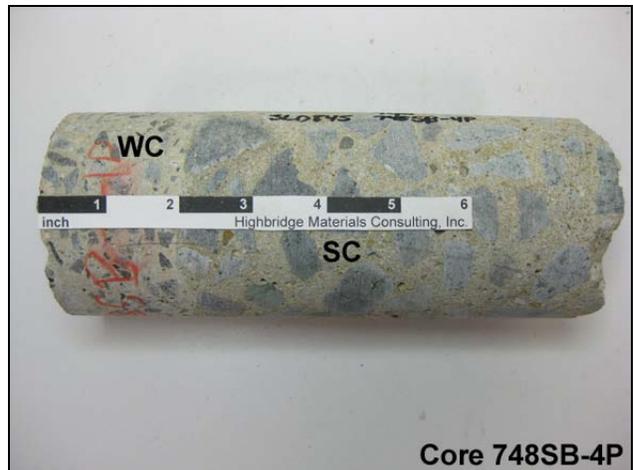
**Figure 1 (cont'd.):** Photographs of the eleven concrete core samples used for petrographic examination and air-void analysis of the structural concrete layers.

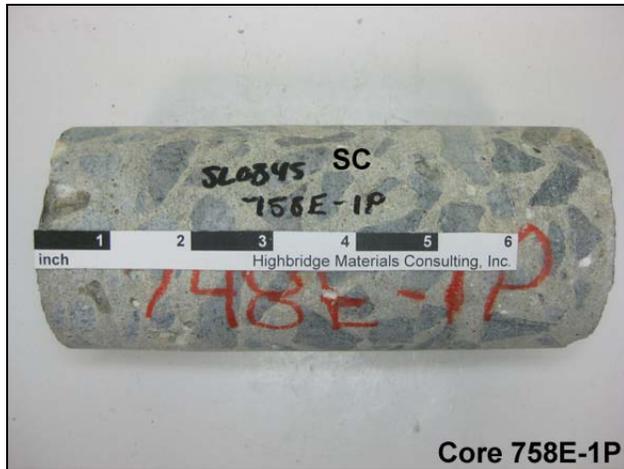
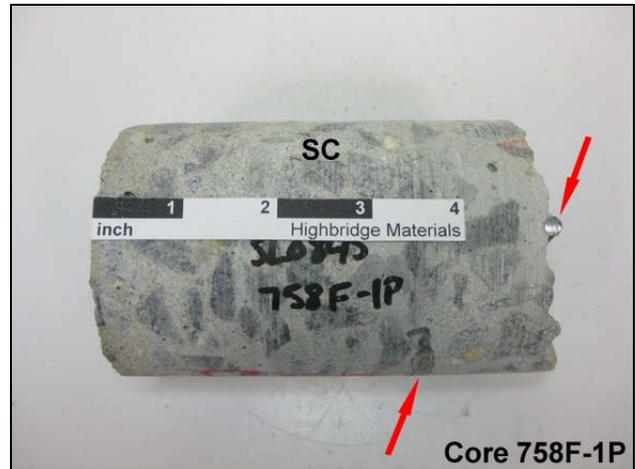
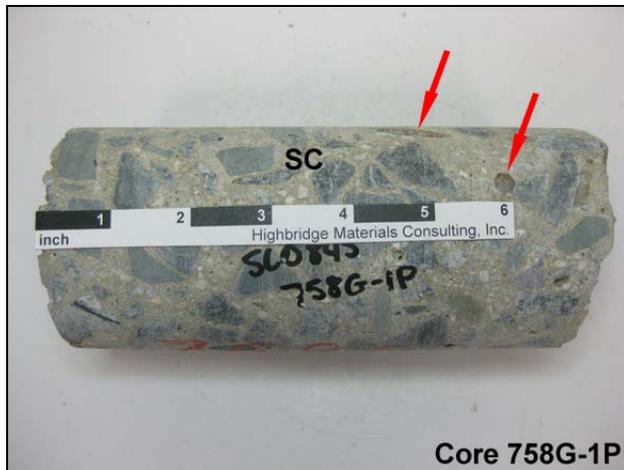
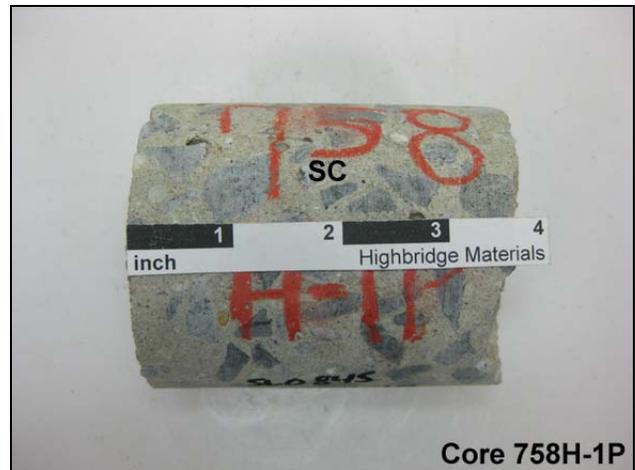
**Figure 1 (cont'd.):** Photographs of the eleven concrete core samples used for petrographic examination and air-void analysis of the structural concrete layers.

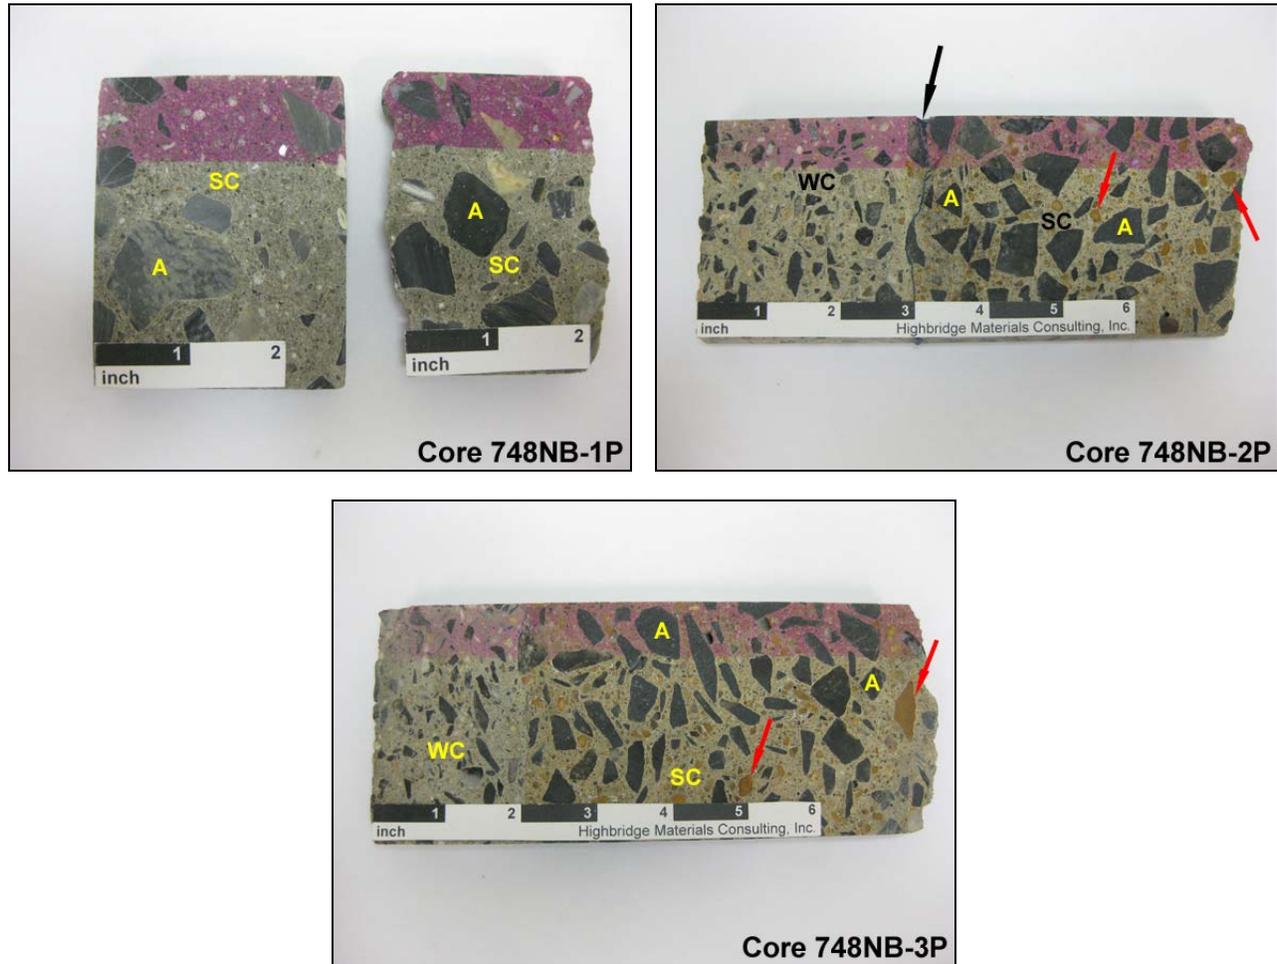
**Figure 2:** Photographs of honed concrete cross sections prepared for the full depth of each provided sample. The upper surfaces are shown to the left in each example. The black arrows indicate where core breaks were epoxied together prior to honing. Wear courses (WC) overlie structural concrete (SC). The size and gradation of the crushed stone aggregate (A) can be observed in the structural layers. Most cores have aggregate with a 3/4" nominal top size except for Core 748NB-1P where aggregate as coarse as 1" is observed. The aggregate is well distributed and no segregations are identified. Four of the cores contain a small but significant proportion of ferruginous chert in the fine aggregate. These orange-colored grains are highlighted by the red arrows. Finally, a portion of each core is treated with phenolphthalein indicator solution. The pink color indicates that the structural concrete is alkaline throughout all but a thin veneer along the upper surfaces. The high pH is indicative of the relative lack of carbonation within the structural layers. Steel embedded within the substrate concrete would not be at risk for depassivation at least within the upper portions represented here.

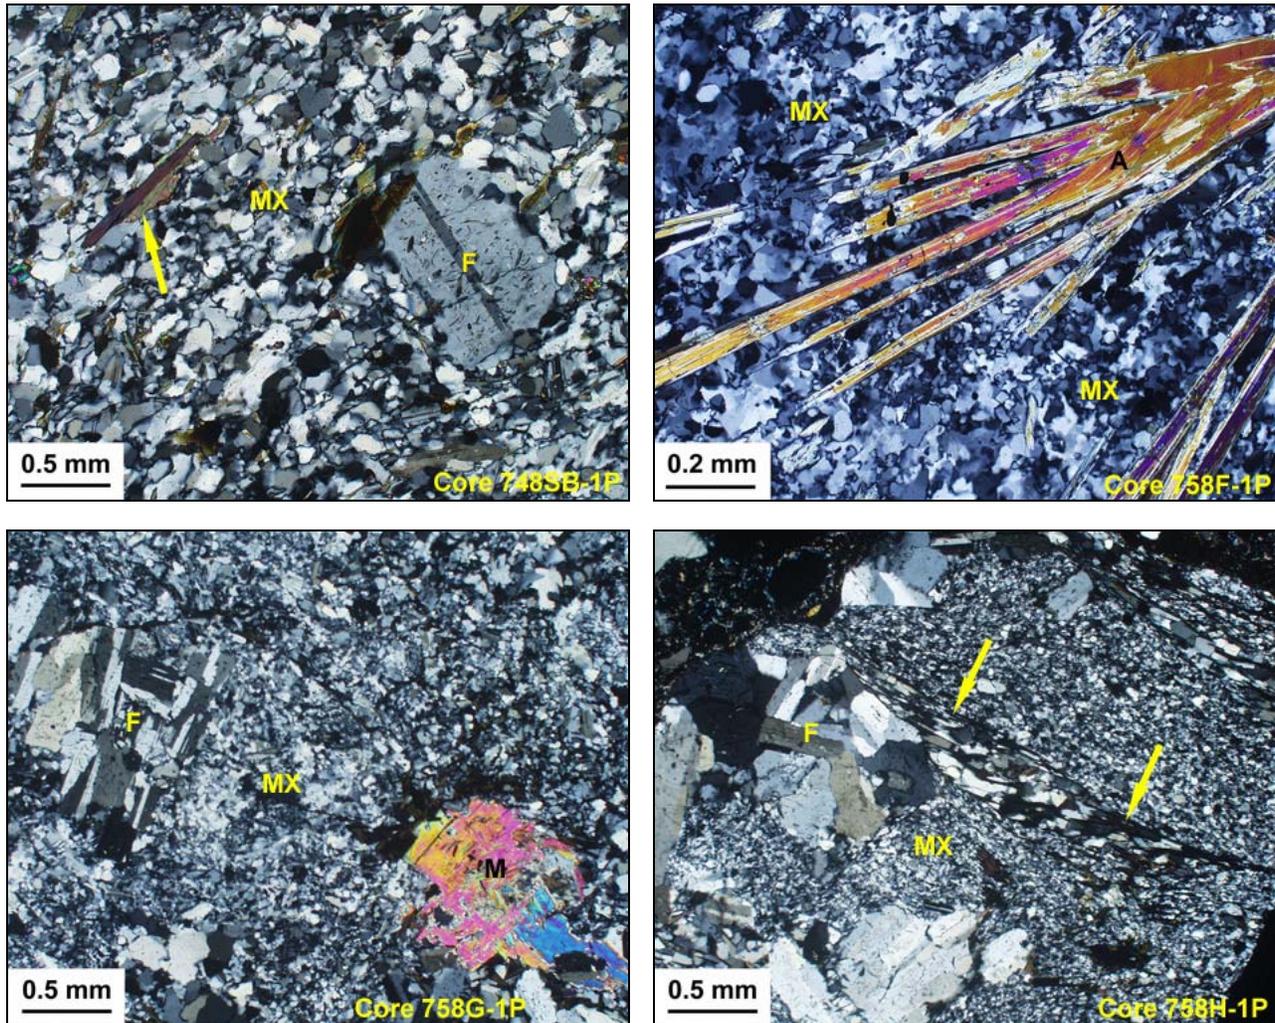
**Figure 7:** Examples of schistose granofels are shown in these XPL photomicrographs. This rock type present in some of the coarse aggregate exhibits the greatest degree of alkali-aggregate reactivity out of all the lithologies identified in the twenty-seven core samples. However, the granofels are only abundant in Cores 748SB-1P and 758G-1P of the eleven cores studied for this report. Minor to trace quantities are found in the other 758 cores. In all cases, the stone is dominated by a matrix (MX) of fine-grained quartz subgrains. The matrix is essentially a strained quartzite and the deformation causes the stone to be alkali-silica reactive. Coarser porphyroclasts are entrained within the sheared matrix including but not limited to feldspar (F), muscovite (M), and amphibole (A). A mild schistosity is caused by the preferred alignment of sparsely distributed micas such as the biotite shown by the arrow in the upper left image. The arrows in the lower right image indicate a sheared tail of chlorite and feldspar rotated off the main feldspar clast. This texture clearly indicates the shear deformation embodied by the granofels.

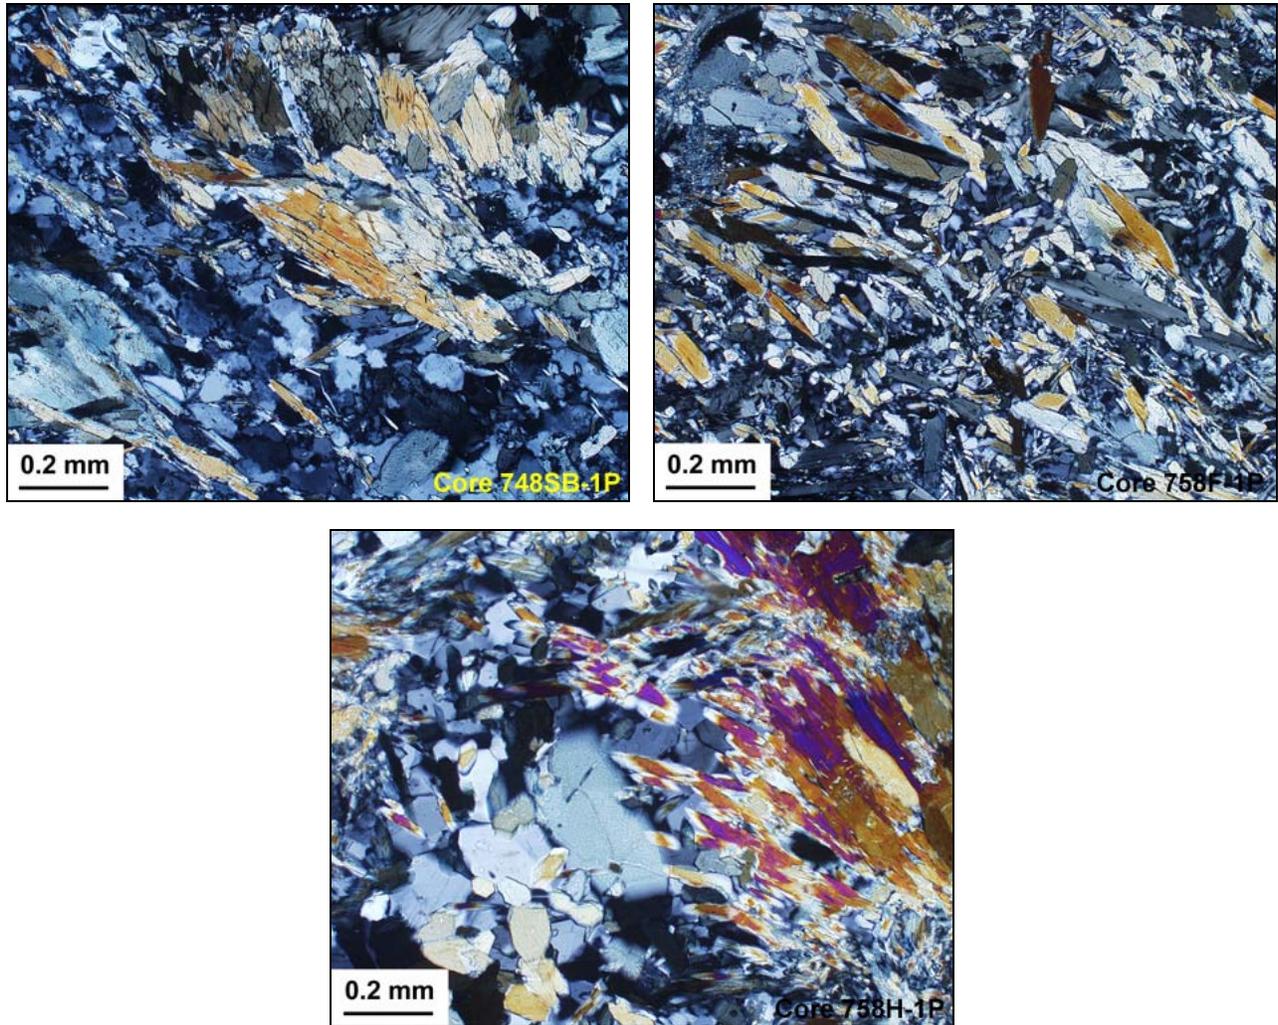
**Figure 8:** Amphibolites are only present in minor to trace quantity in the coarse aggregate of several of the core samples. Examples are shown in these XPL photomicrographs. The bright colored minerals are euhedral to subhedral amphiboles as well as some lower-grade alteration products. The white and gray phases are mostly composed of plagioclase feldspar though quartz is also present.

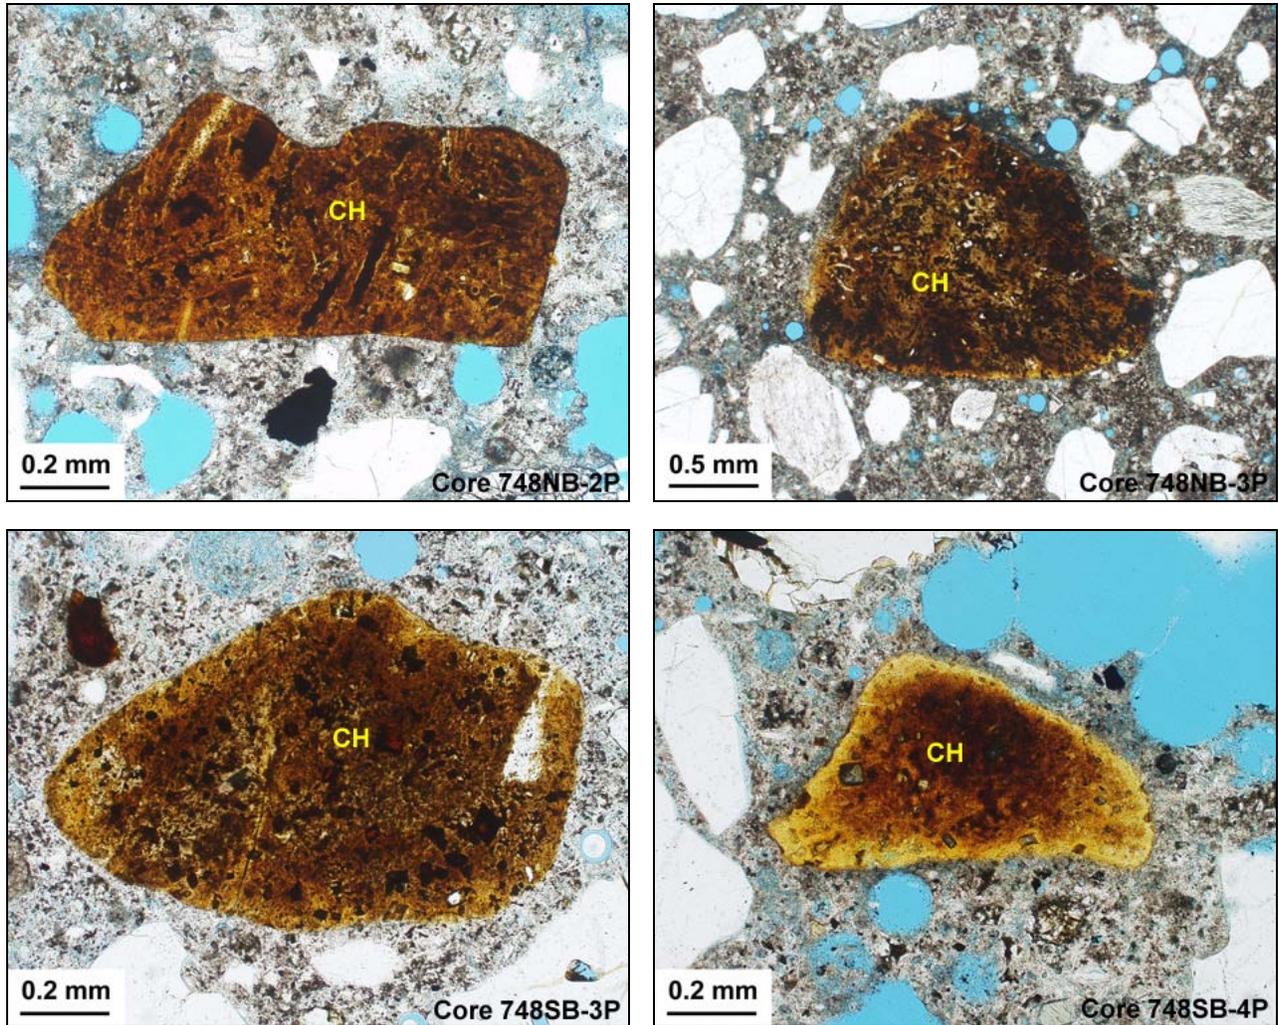
**Figure 10:** PPL photomicrographs. Four of the ten cores contain ferruginous chert (CH) in the fine aggregate at about several percent by volume. Chert is considered to be one of the most highly alkali-reactive rock types. Traces of reaction are observed in this material in all cores containing the phase.

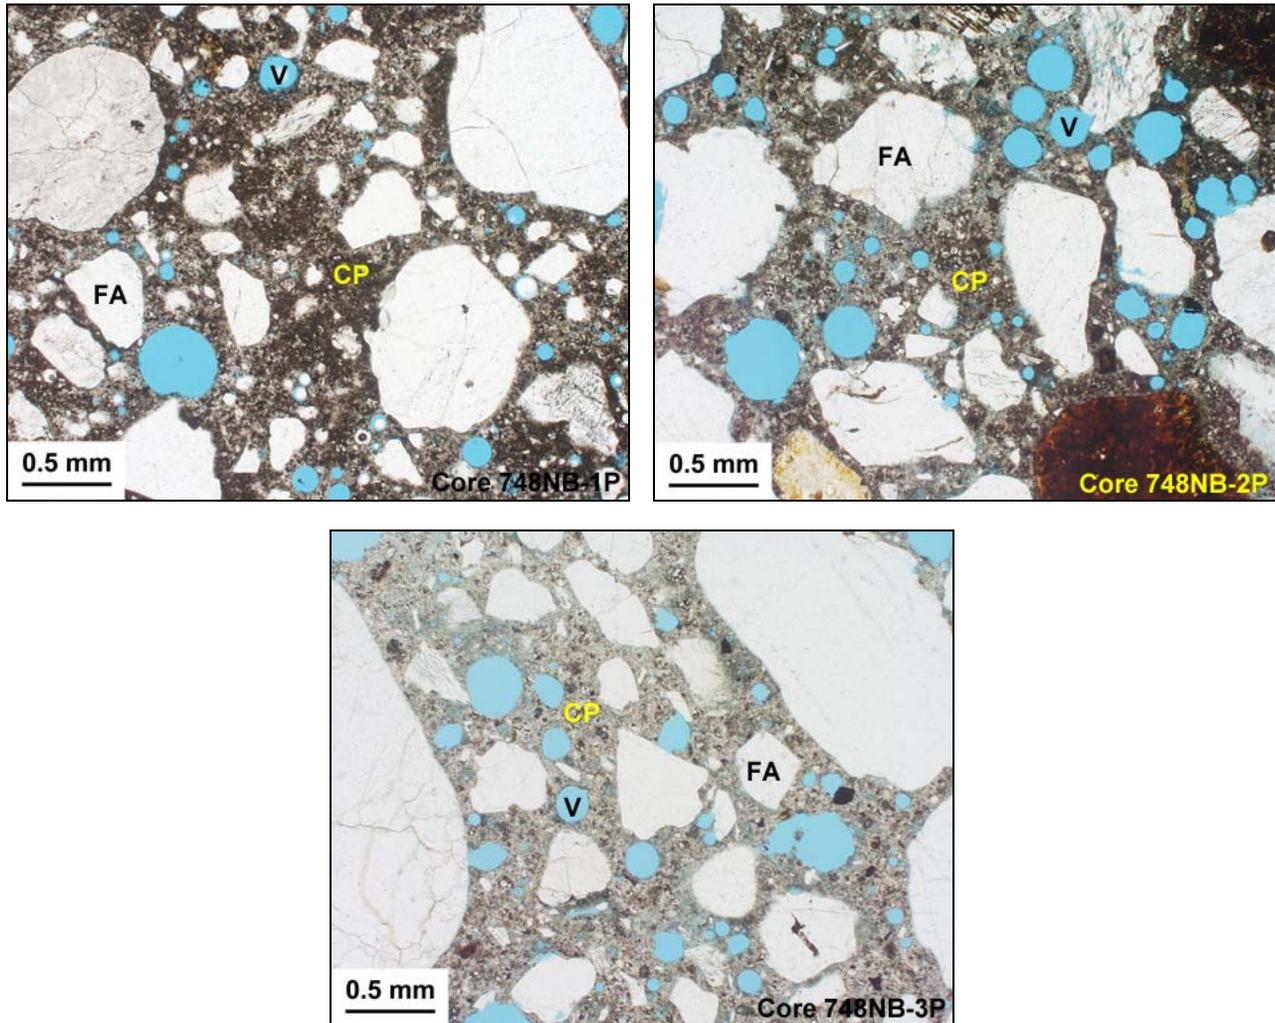
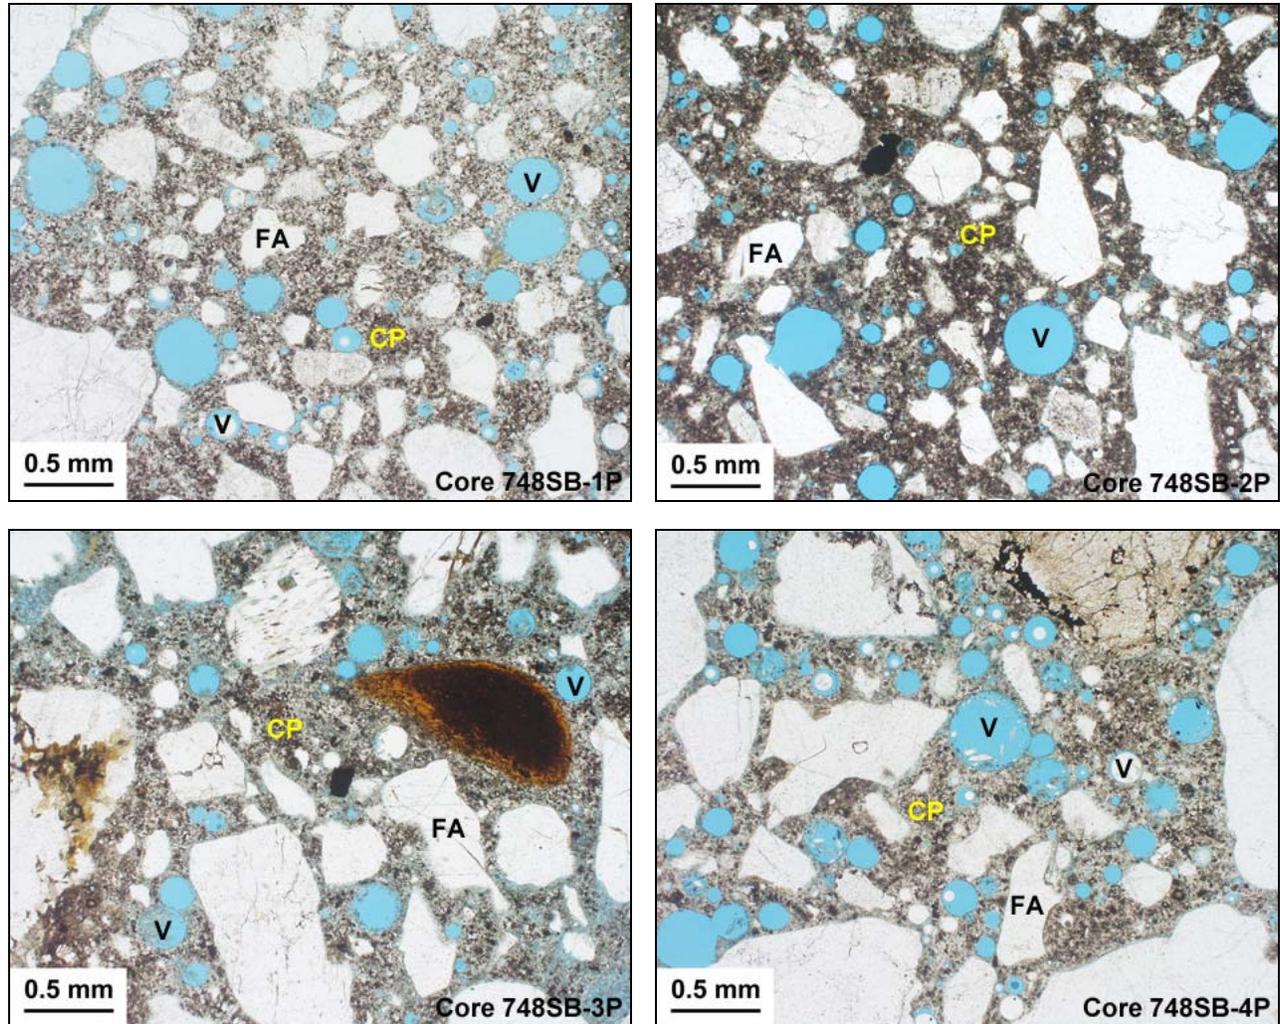
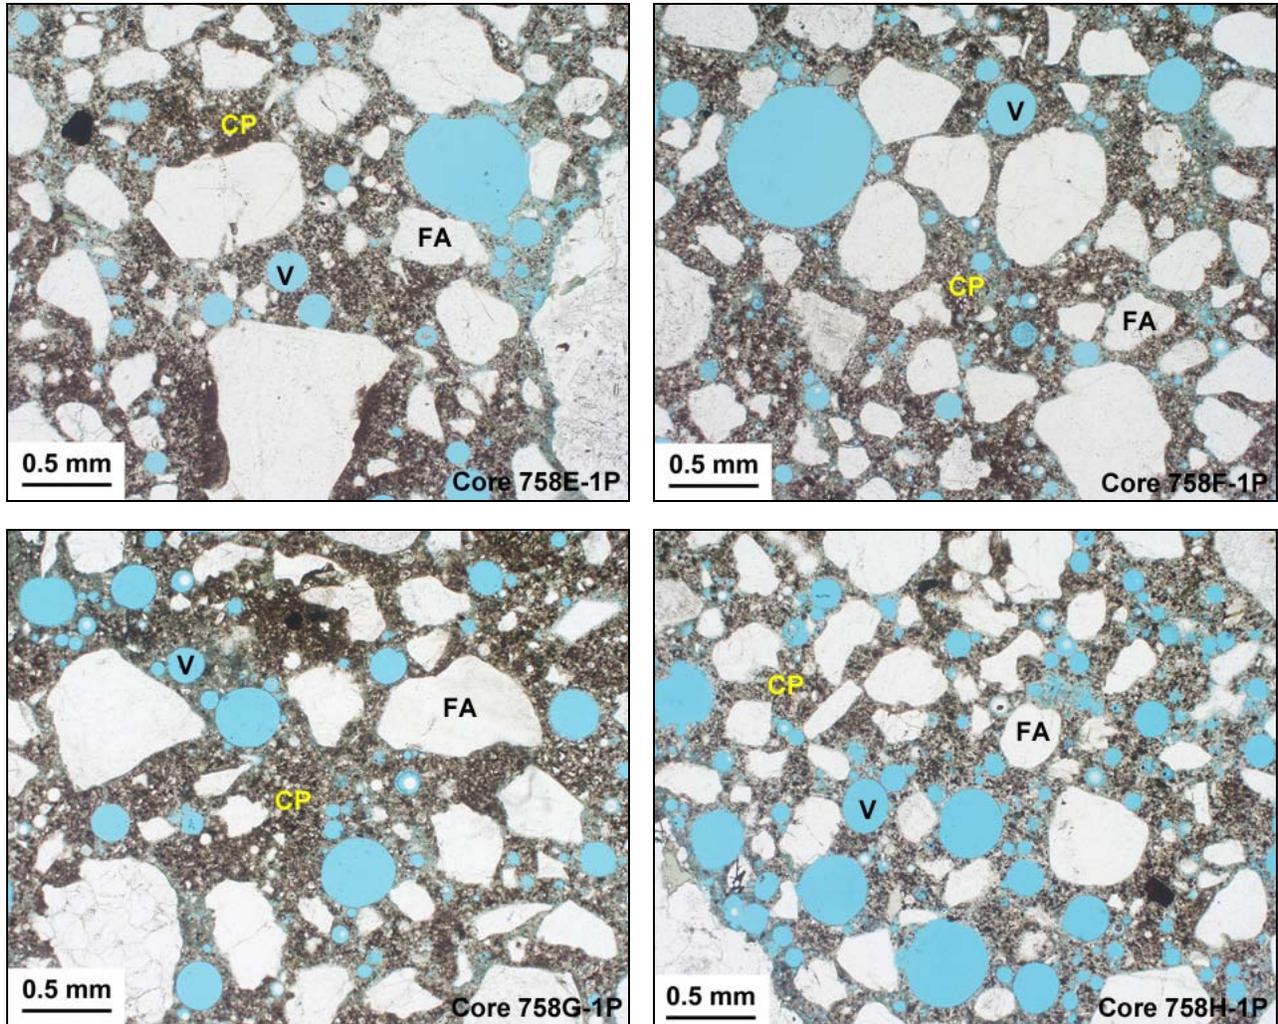
**Figure 11:** PPL photomicrographs illustrating the overall microstructure of the structural concrete. There is some variability in water contents and entrained-air development that result in some quality differences. In all of the examined samples, the cement paste (CP) is well-developed and relatively dense as indicated by the even brown coloration under plane light. Some microscopic clotting is detected in Core 748SB-3P and some mottling in Core 748NB-1P though this is not particularly obvious in the images. The features may represent a primary cement flocculation. The samples are impregnated with a low-viscosity, blue-dyed epoxy in order to highlight cracks, pores, and voids. There is a moderate absorption of the epoxy consistent with moderate mix water contents. Note the notably lower absorption in Core 748NB-1P. The fine aggregate (FA) is well distributed throughout the matrix though there are some subtle differences in the gradations between samples. Fine, spherical voids (V) indicate intentional air-entrainment in all cores. Air contents might be considered somewhat excessive in Cores 748SB-1P, 748SB-4P, and 758H-1P.

Figure 11 (cont'd.): PPL photomicrographs illustrating the overall microstructure of the structural concrete.

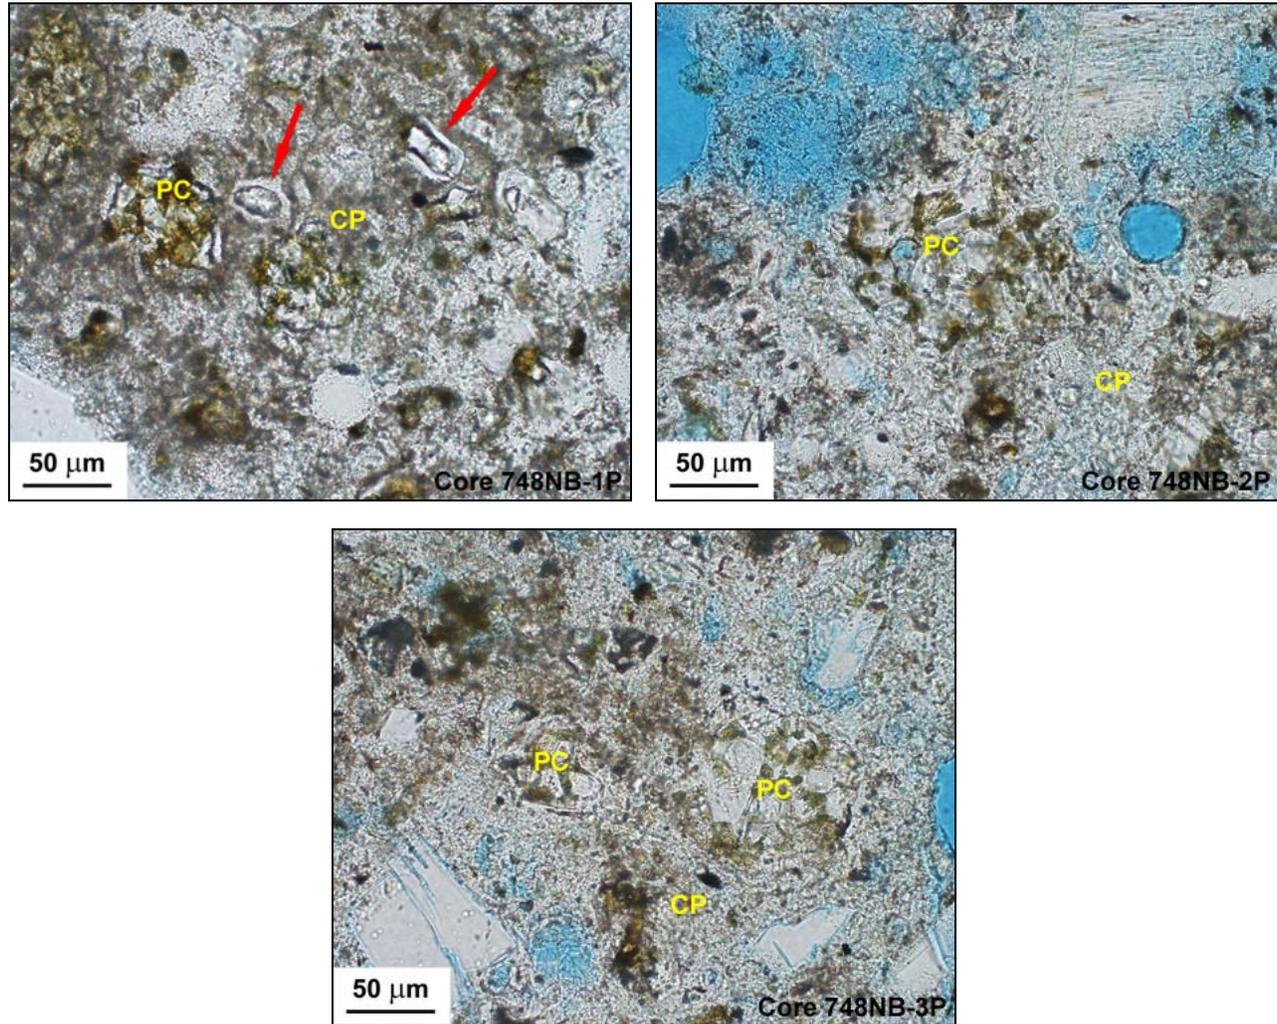
**Figure 12:** PPL photomicrographs illustrating the occurrence of residual portland cement (PC) in the examined concrete. The cement hydration is advanced and most calcium silicate is fully consumed. These appear as light-colored areas within the cement agglomerates. Exceptions are shown for Cores 748NB-1P, 748SB-1P, 748SB-4P where belite remains unhydrated. Unhydrated alite is also detected in Cores 748NB-1P and 758G-1P and these crystals are indicated by the red arrows. Traces are also detected in Core 758H-1P but not illustrated here. Moderately thick hydration rims surround these alite crystals where they are identified. For Core 758H-1P, an area is shown where the empty pores are now filled with an amorphous cementitious hydrate. All of the cement residuals are fine to medium-grained agglomerates with brown-colored interstitial ferrite. The adjacent cement paste (CP) is well-formed in all samples.

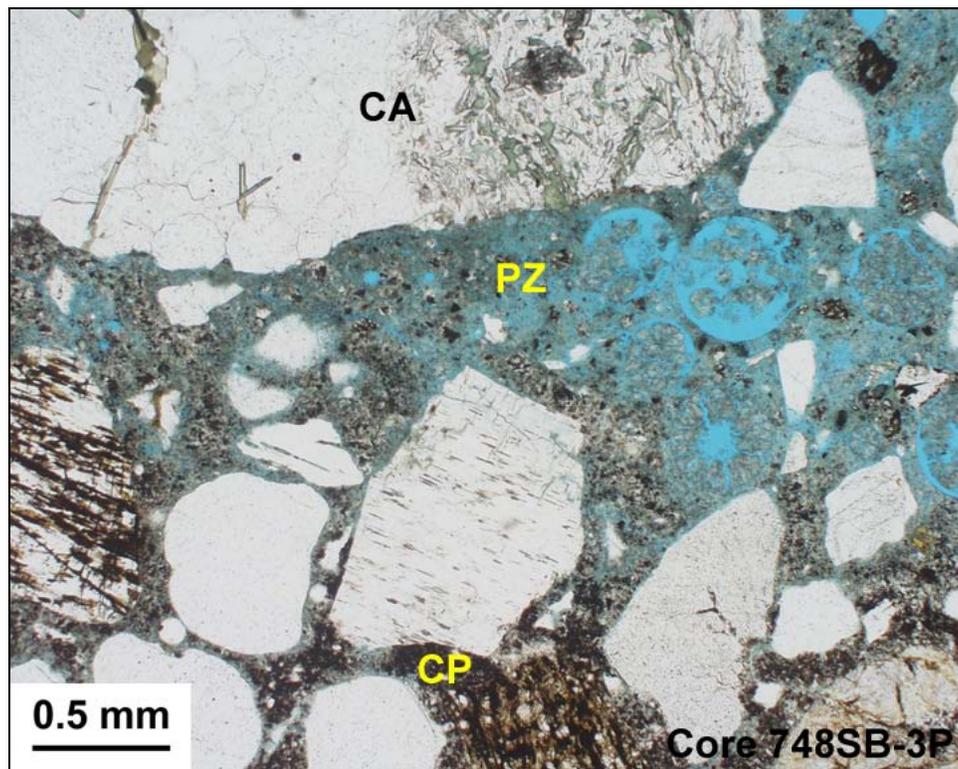
**Figure 14:** Evidence for bleed water migration and entrapment is found in Core 748SB-3P as shown in this PPL photomicrograph. A porous zone (PZ) is shown between the cement paste (CP) and coarse aggregate (CA). This is caused by the local entrapment of mix water under the aggregate grain. The paste-aggregate bond is weakened as a result.

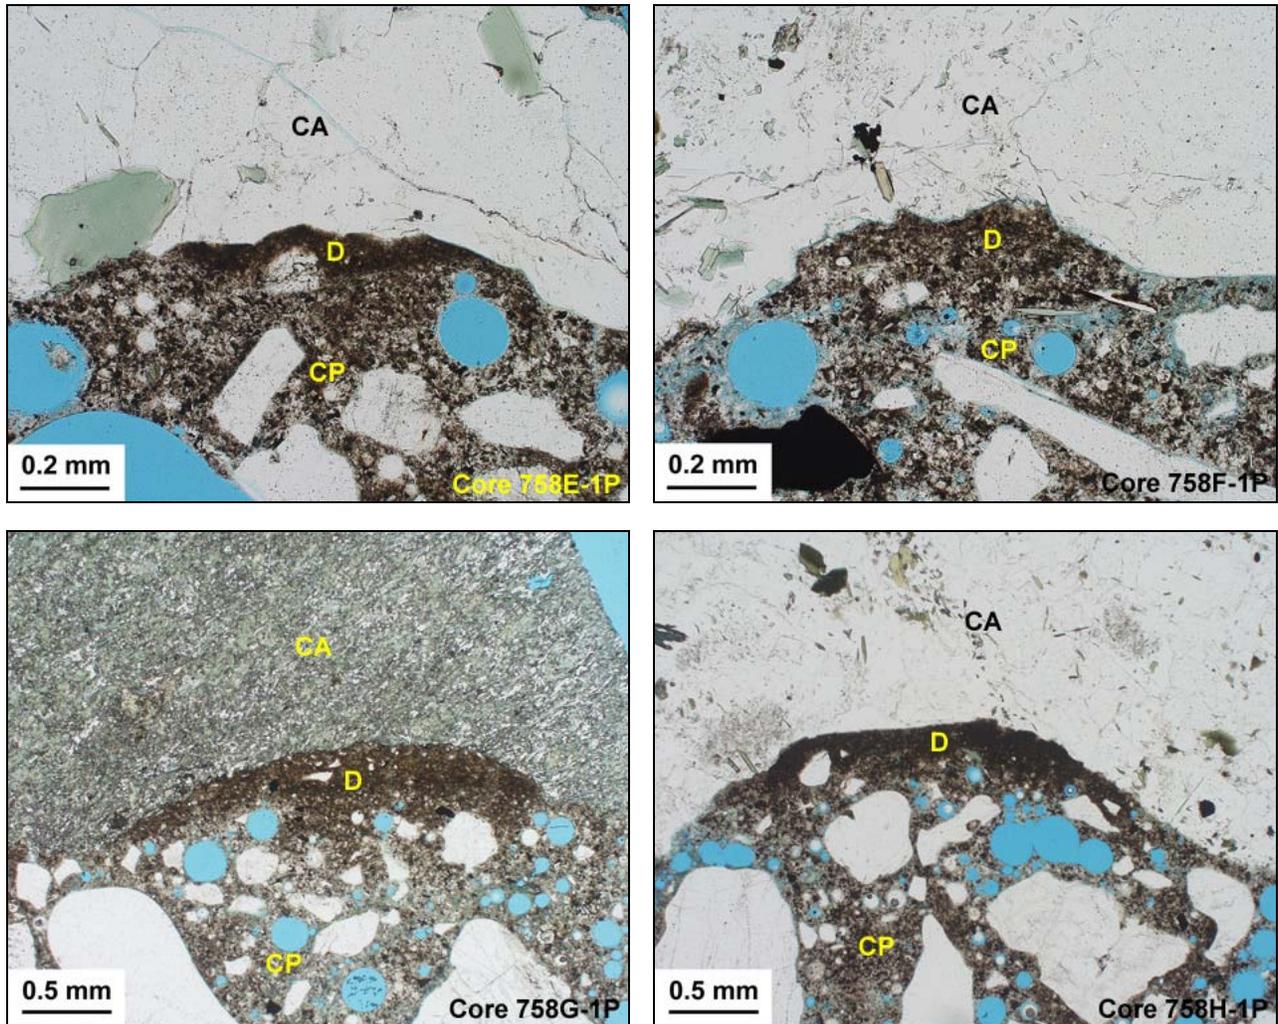
**Figure 15:** PPL photomicrographs. Thin discontinuous linings of dense cement paste (D) are also found between the “normal” cement paste (CP) and coarse aggregate (CA) in several of the core samples. These represent small bits of cement that did not fully incorporate with the mix water. However, they are more likely the result of microscopic embayments along aggregate surfaces and not indicative of inappropriate retempering.
