## PETROGRAPHIC EXAMINATION REPORT

<b>Client:</b>	Pennoni Associates, Inc.	<b>Client ID:</b>	PENN003
<b>Project:</b>	I-95 Viaduct Project	<b>Report #:</b>	SL0845-01
<b>Location:</b>	Delaware	<b>Dates Received:</b>	12/15/14, 01/07/15, 01/14/15
<b>Sample Type:</b>	Concrete cores	<b>Report Date:</b>	02/14/15
<b>Delivered by:</b>	Client (M. Padula)	<b>Petrographer:</b>	J. Walsh
		<b>Analyst:</b>	M. Pattie

- This report presents the results of petrographic examination and air-void analysis on six concrete core samples taken from viaduct structures along I-95 near Wilmington, DE.

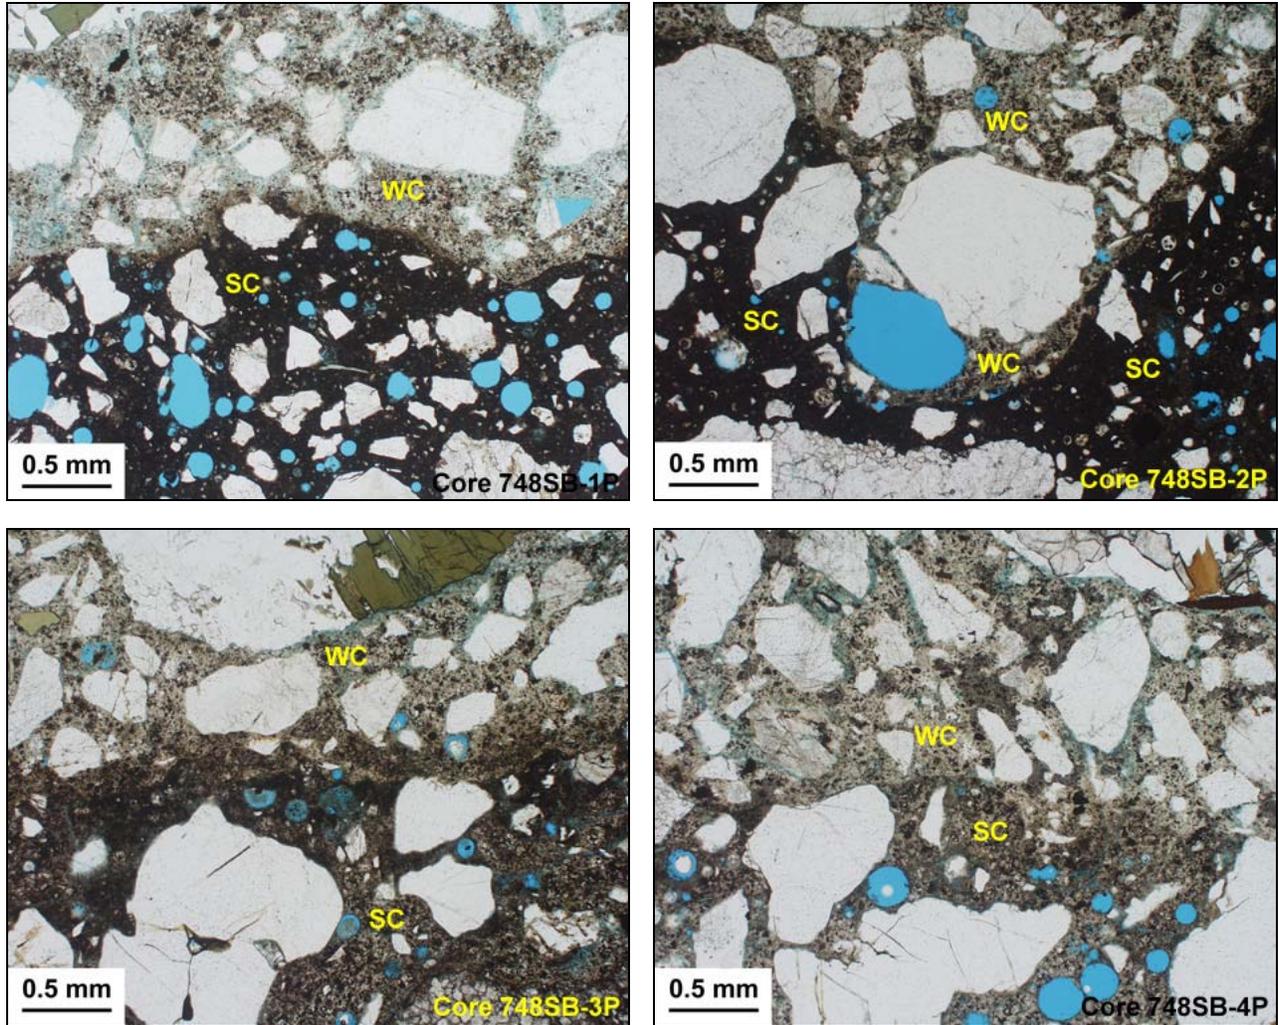
Figure 16 (cont'd.): PPL photomicrographs illustrating the tight contacts between wear course (WC) and structural concrete (SC) in six of the eleven core samples.

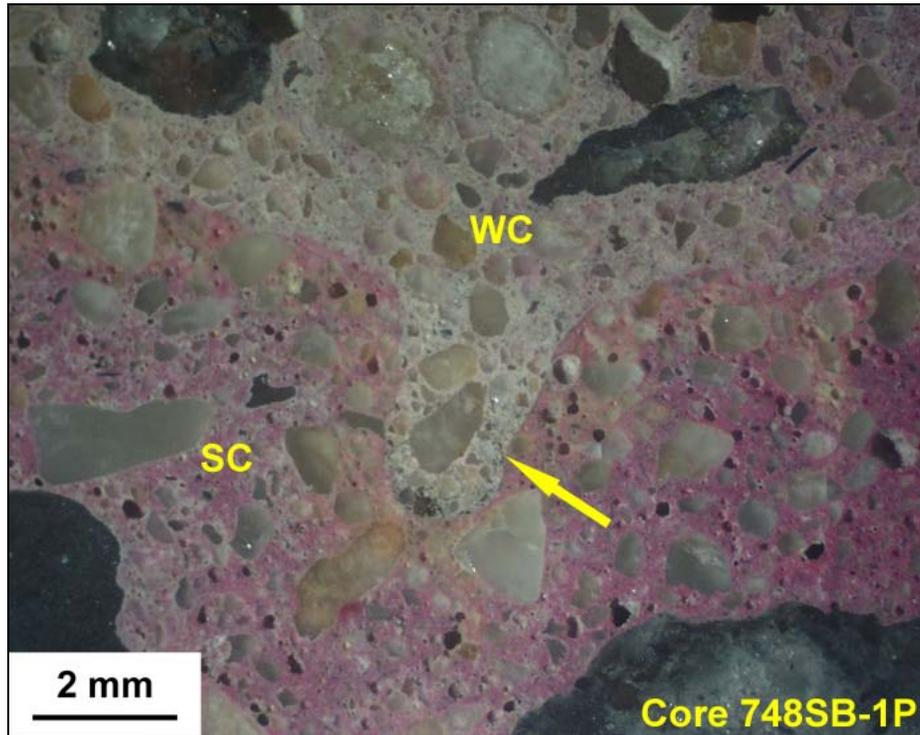
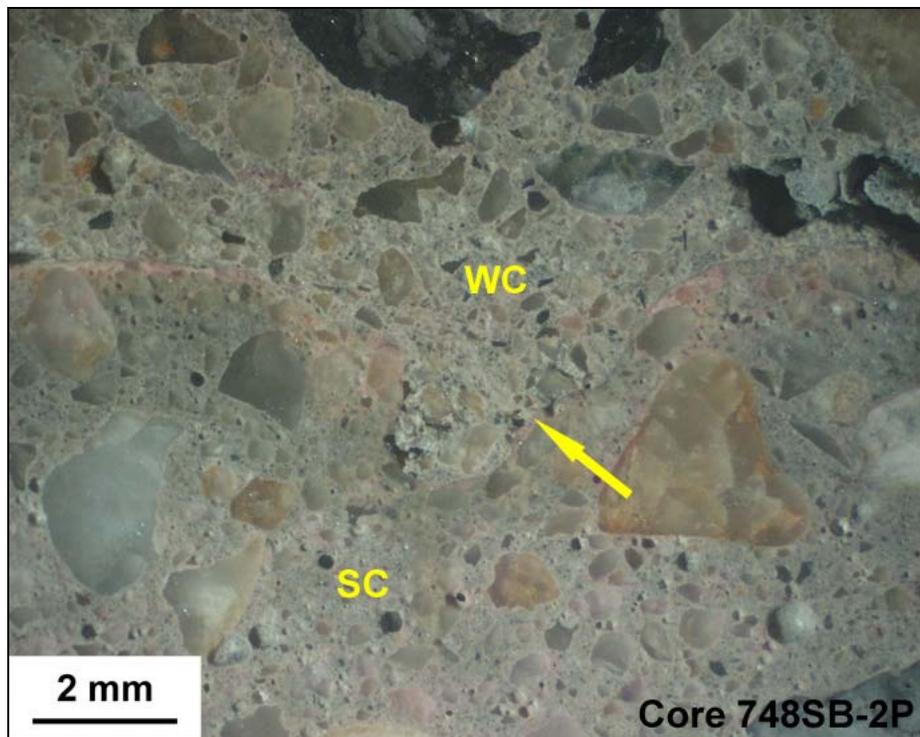
**Figure 17:** Reflected light photomicrographs. In two of the cores, thin “fingers” of wear course (WC) appear plastically embedded in the structural concrete (SC). These features are similar to those shown in plane polarized light for Core 748SB-2P in Figure 16.

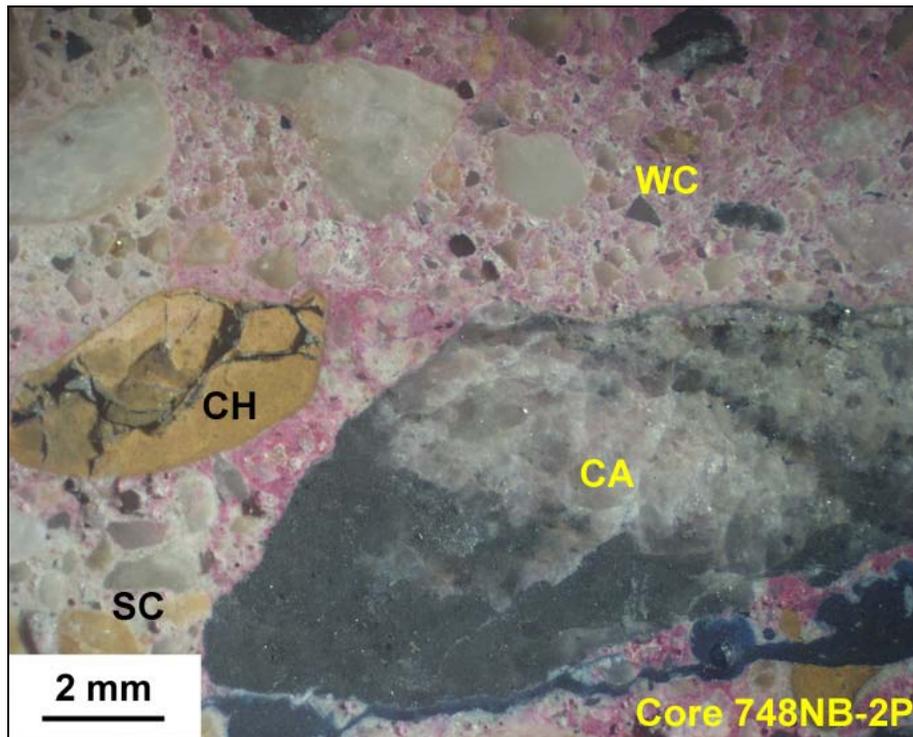
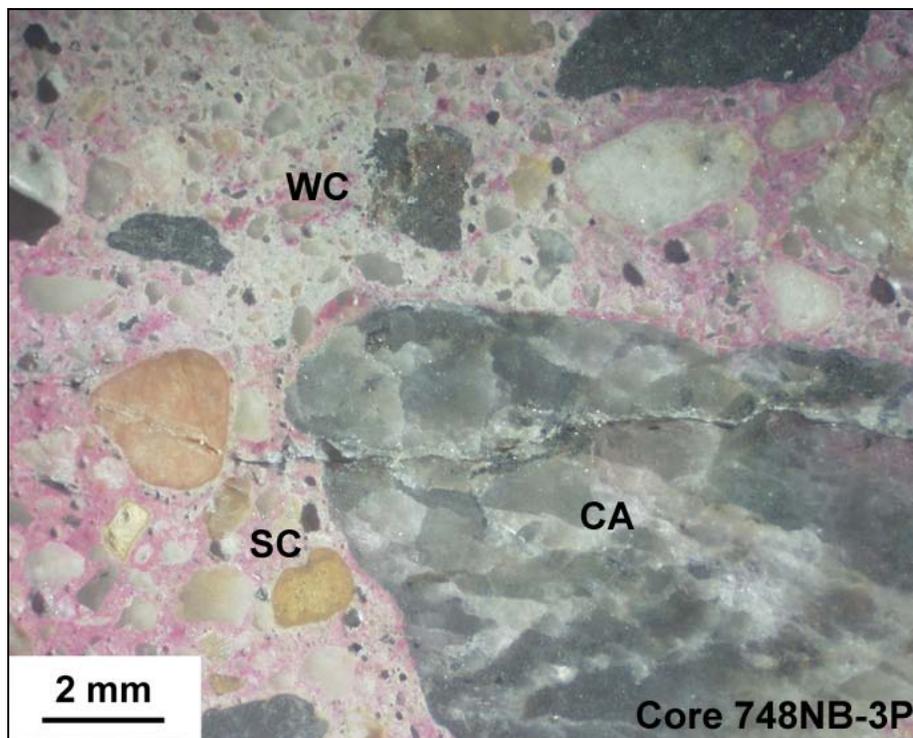
**Figure 18:** Reflected light photomicrographs of Cores 748NB-2P and 748NB-3P. In these two samples, coarse aggregate grains (CA) are truncated at the top of the structural concrete (SC). Wear course material (WC) is placed directly over the broken aggregate surface. This type of texture is suggestive of some type of scarification process. A chert grain (CH) appears broken as well in one of the samples. However in this case, the grain is actually below the surface and the cracking is due to alkali-silica reaction.

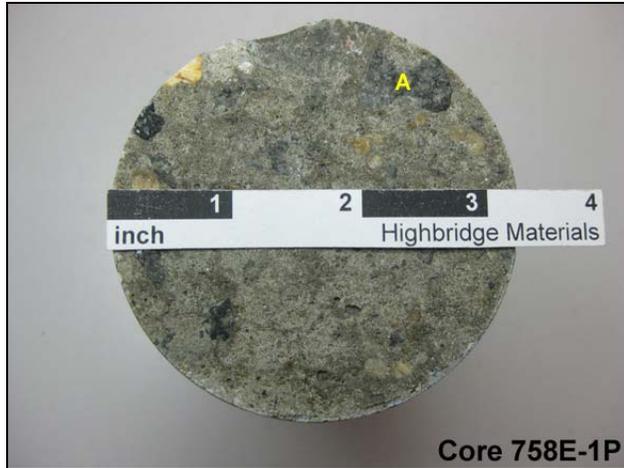
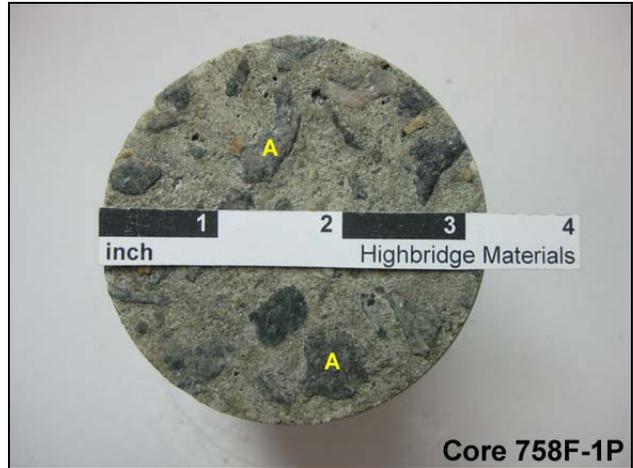
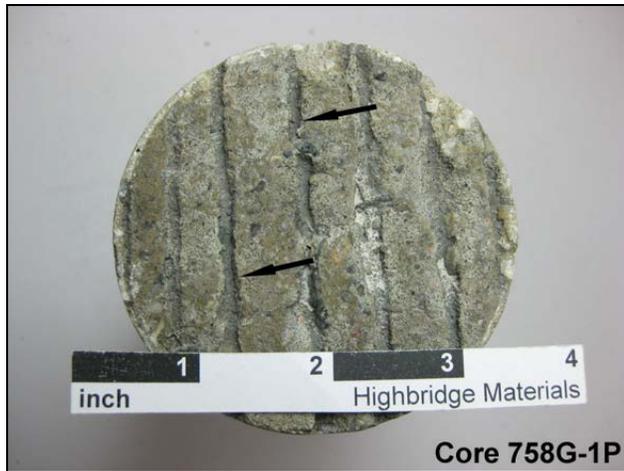
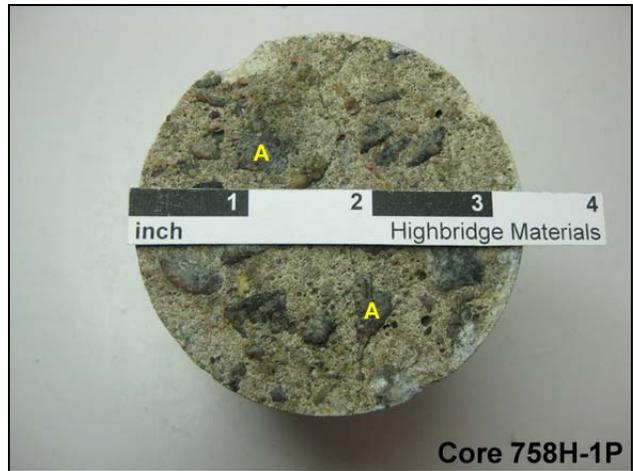
No wear courses are present in Cores 758E-1P, 758F-1P, 758G-1P, and 758H-1P. The upper surfaces of these cores are eroded with coarse aggregates exposure notable in Cores 758F-1P and 758H-1P (Fig. 19). Surface grooving is present only along the top of Core 758G-1P.

**Figure 19:** The 758 cores do not contain wear course material and the upper surfaces of the structural concrete are apparently exposed to the environment. Grooving is only applied to the surface of the concrete represented by Core 758G-1P. Weathering and erosion has resulted in the low to moderate relief exposure of coarse aggregate along the surface (CA). However, this is minimal in Core 758E-1P.

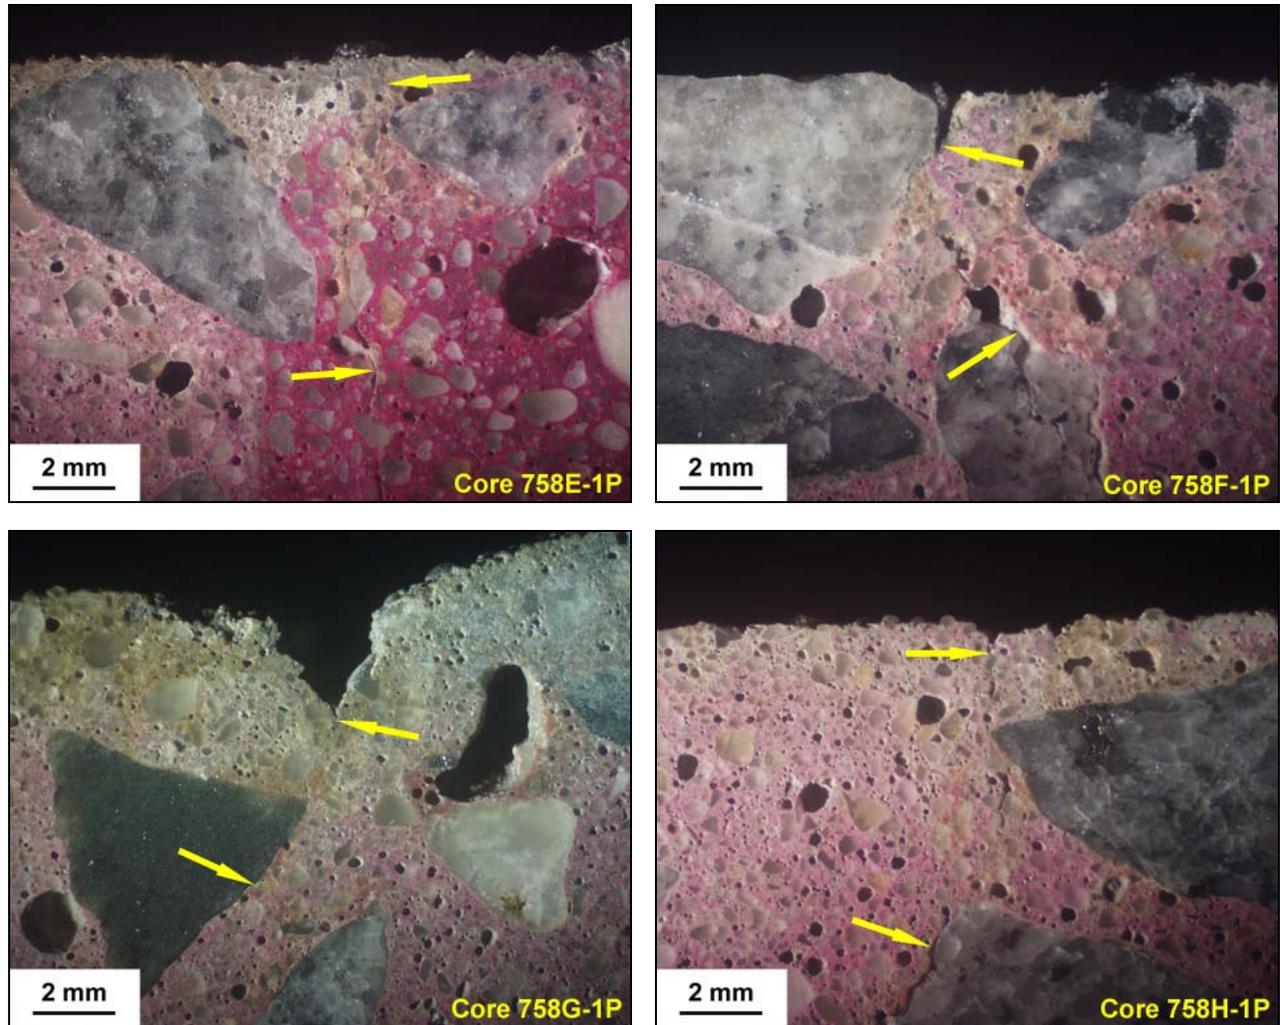
**Figure 20:** Reflected light photomicrographs of the 758 cores. Minor vertical crazing cracks (arrows) extend downward from the upper surfaces to relatively short depths. These hairline cracks are considered innocuous.

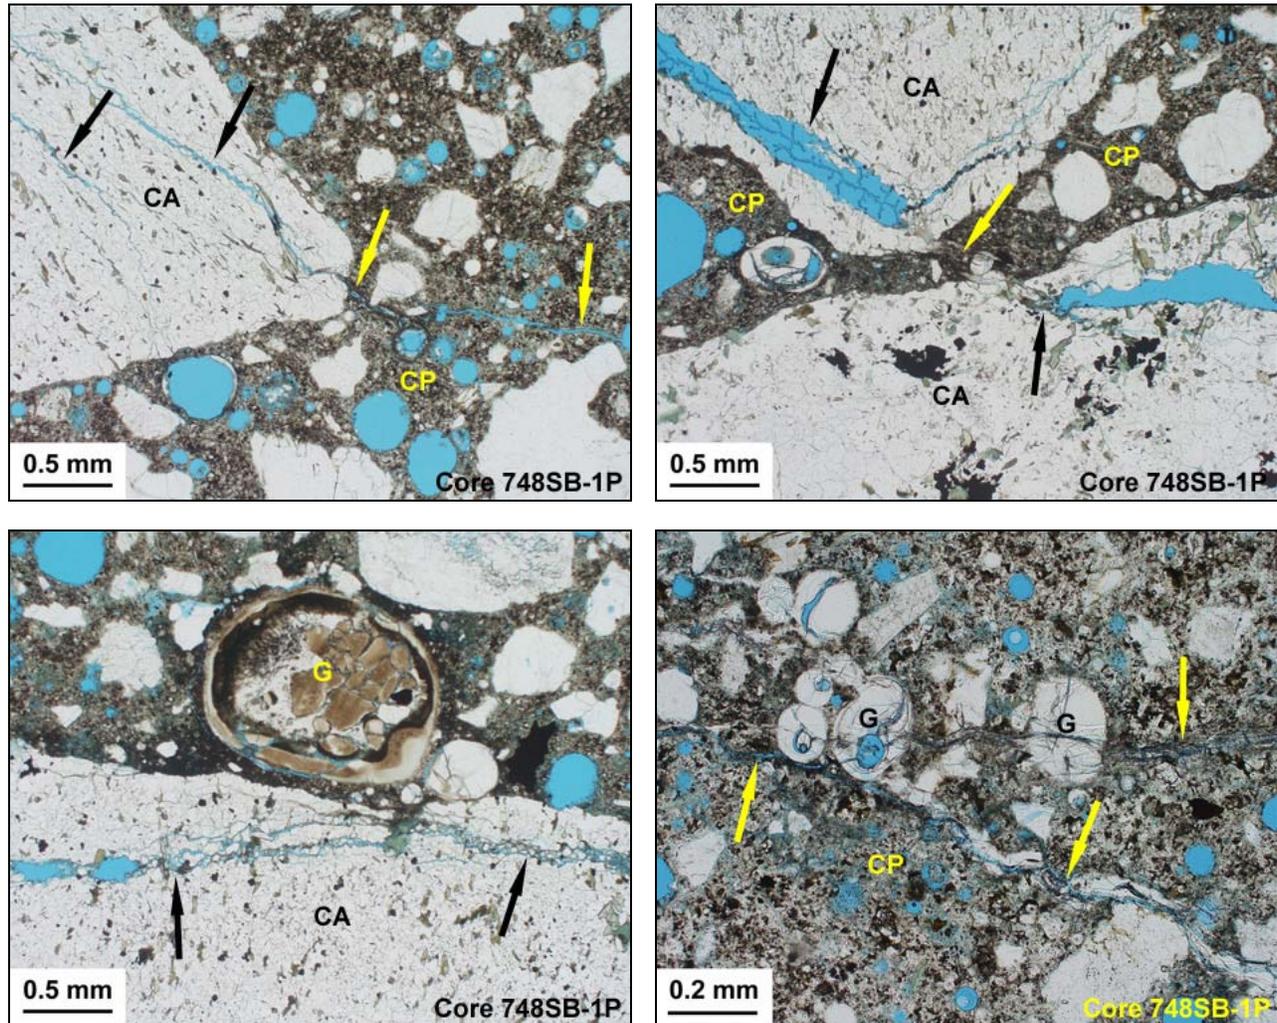
**Figure 21:** Cores 748SB-1P and 748SB-2P exhibit the most well-developed alkali-silica reaction even if the reaction is only in its early stages. Examples illustrating the microstructure of the reaction are shown for Core 748SB-1P in these PPL photomicrographs. In the upper two images, the black arrows indicate reaction cracks within coarse aggregate grains (CA). The yellow arrows indicate where these have propagated into the adjacent cement paste (CP). ASR gel plugs are found at the periphery of the reactive stone. The reactive grain in the left image is a granofels. The cracks span a granofels (upper) and a granitoid particle (lower) in the right image. Another granofels coarse aggregate grain (CA) is shown in the lower left PPL image. In this case, the reaction cracking parallels the aggregate surface (arrows). A deposit of ASR gel (G) is present adjacent to the stone. In the lower right image, the arrows indicate reaction cracks transecting the cement paste. These are lined with ASR gel and some of this gel (G) has also deposited in the air-voids transected by the cracks.

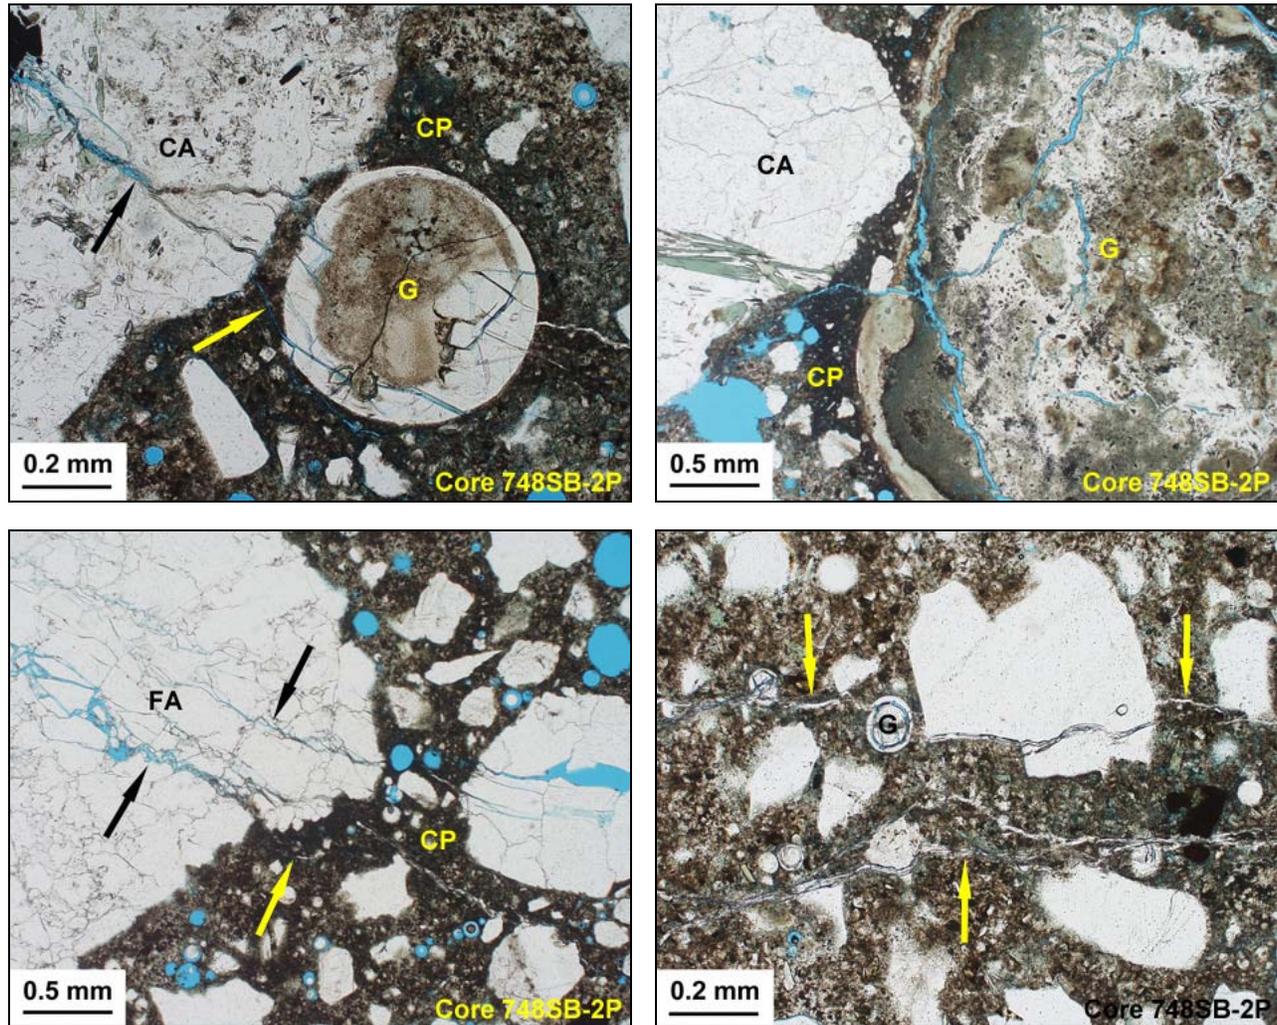
**Figure 22:** These PPL photomicrographs illustrate examples of the ASR microstructure in Core 748SB-2P. As described in the last figure, this core is one of the two exhibiting the most well-developed, even if early-stage alkali-silica reaction. In the upper two images, the black arrows (where present) indicate reaction cracks within coarse aggregate grains (CA). The yellow arrows indicate where these have propagated into the adjacent cement paste (CP). Most of the reaction has occurred within the granitoid lithologies for this sample. It is also more common in this sample for larger “blobs” of reaction gel (G) to be found at the site of reactive stone. (Lower left) In this image, the black arrows indicate reaction cracks within a strained quartzite fine aggregate grain (FA). The yellow arrow indicates where one of these has propagated into the adjacent cement paste (CP). (Lower right) The arrows indicate ASR reaction cracks transecting the paste some short distance from a reaction site. A small gel deposit (G) is found in an air-void transected by one of the reaction cracks.

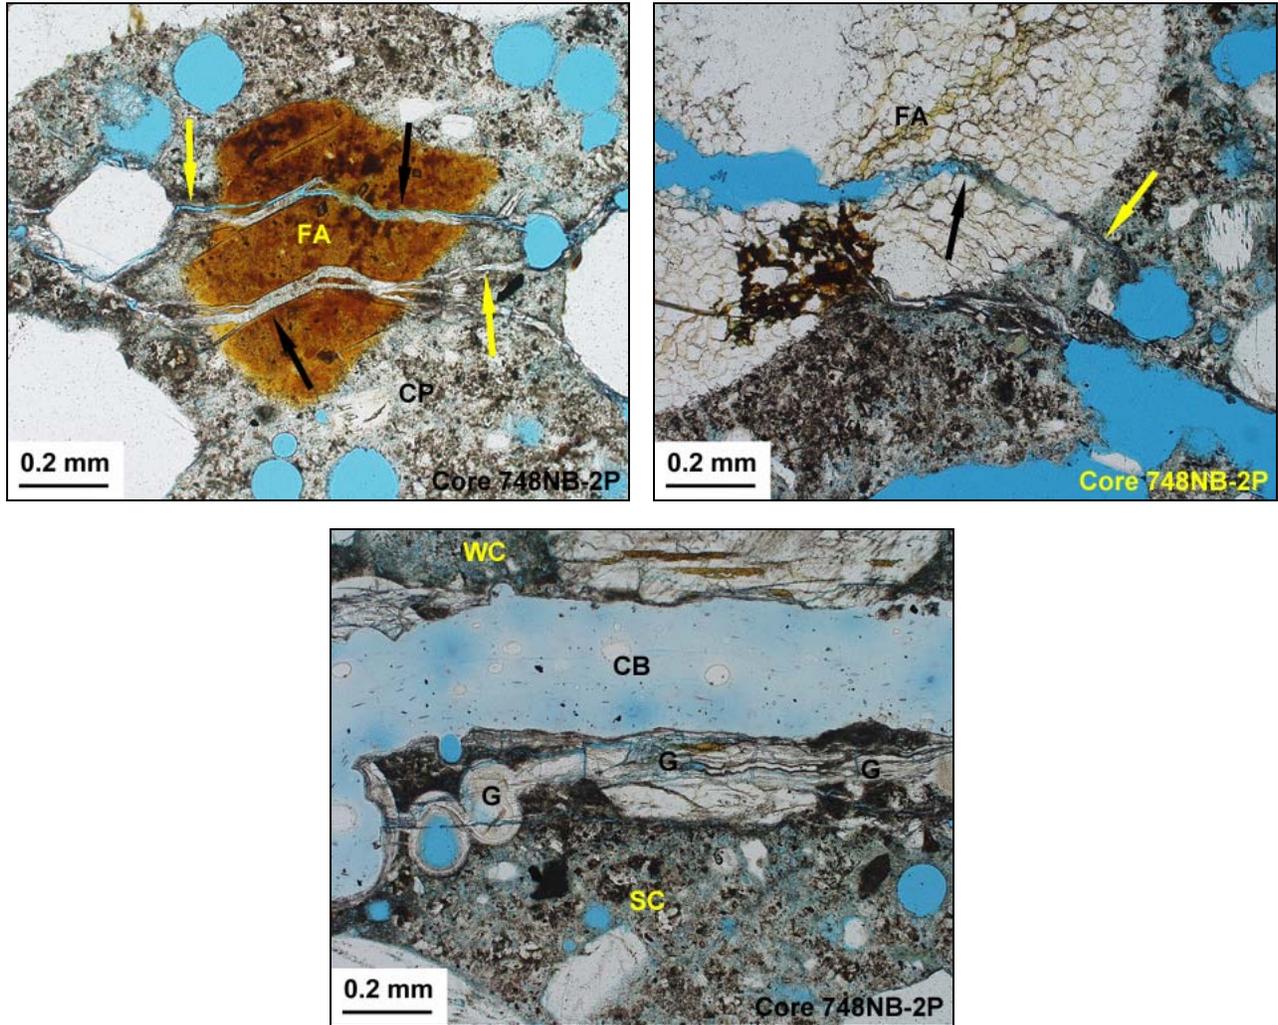
**Figure 23:** Early stage alkali-silica reactions are detected in Core 748NB-2P but these are limited to a narrow horizon at the top of the structural concrete. These PPL photomicrographs illustrate some of the microstructures identified. In the upper two images, the black arrows indicate reaction cracks within fine aggregate grains (FA). The yellow arrows indicate where these have propagated into the adjacent cement paste (CP). The reactive grain at left consists of chert and the particle at right is a strained quartzite. (Lower image) A higher magnification image illustrates a gel-lined microcrack (G) that is found just below the core break (CB) between the wear course (WC) and the structural concrete (SC).

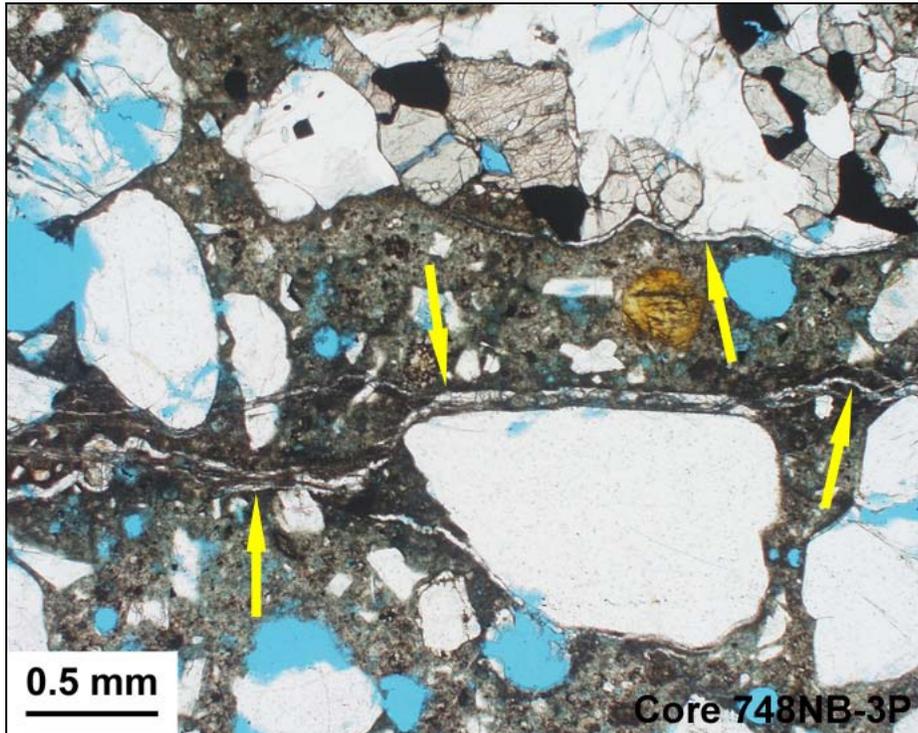
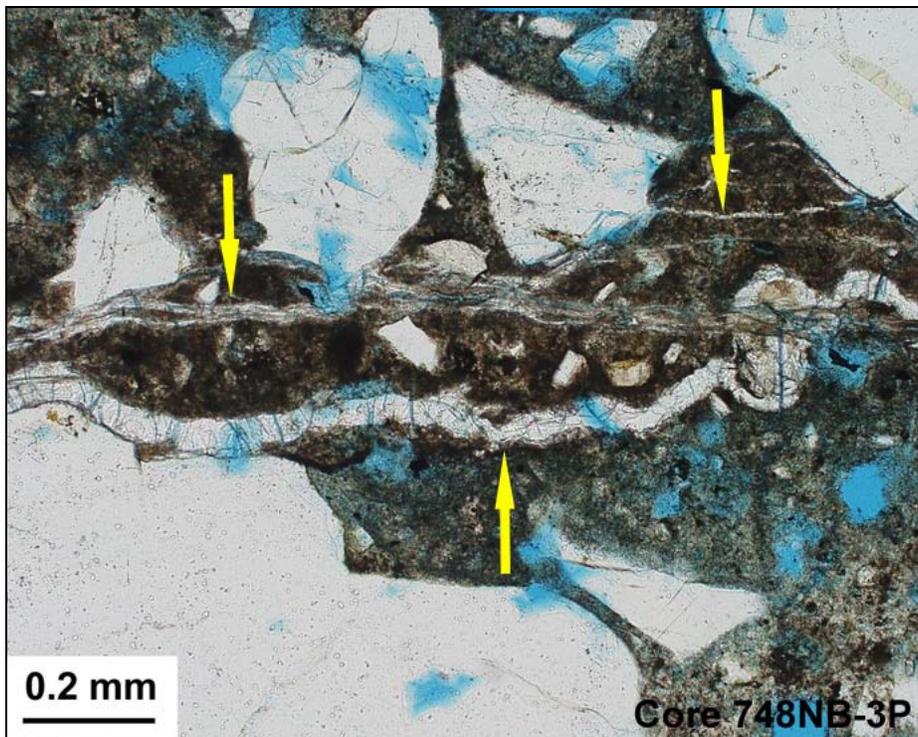
**Figure 24:** Early stage alkali-silica reactions are detected in Core 748NB-3P but these are only found within millimeters of the upper structural concrete surface. In these two PPL images, the arrows indicate microcracks lined with ASR gel that are found within this thin horizon. No positive association is identified with any particular aggregate type.

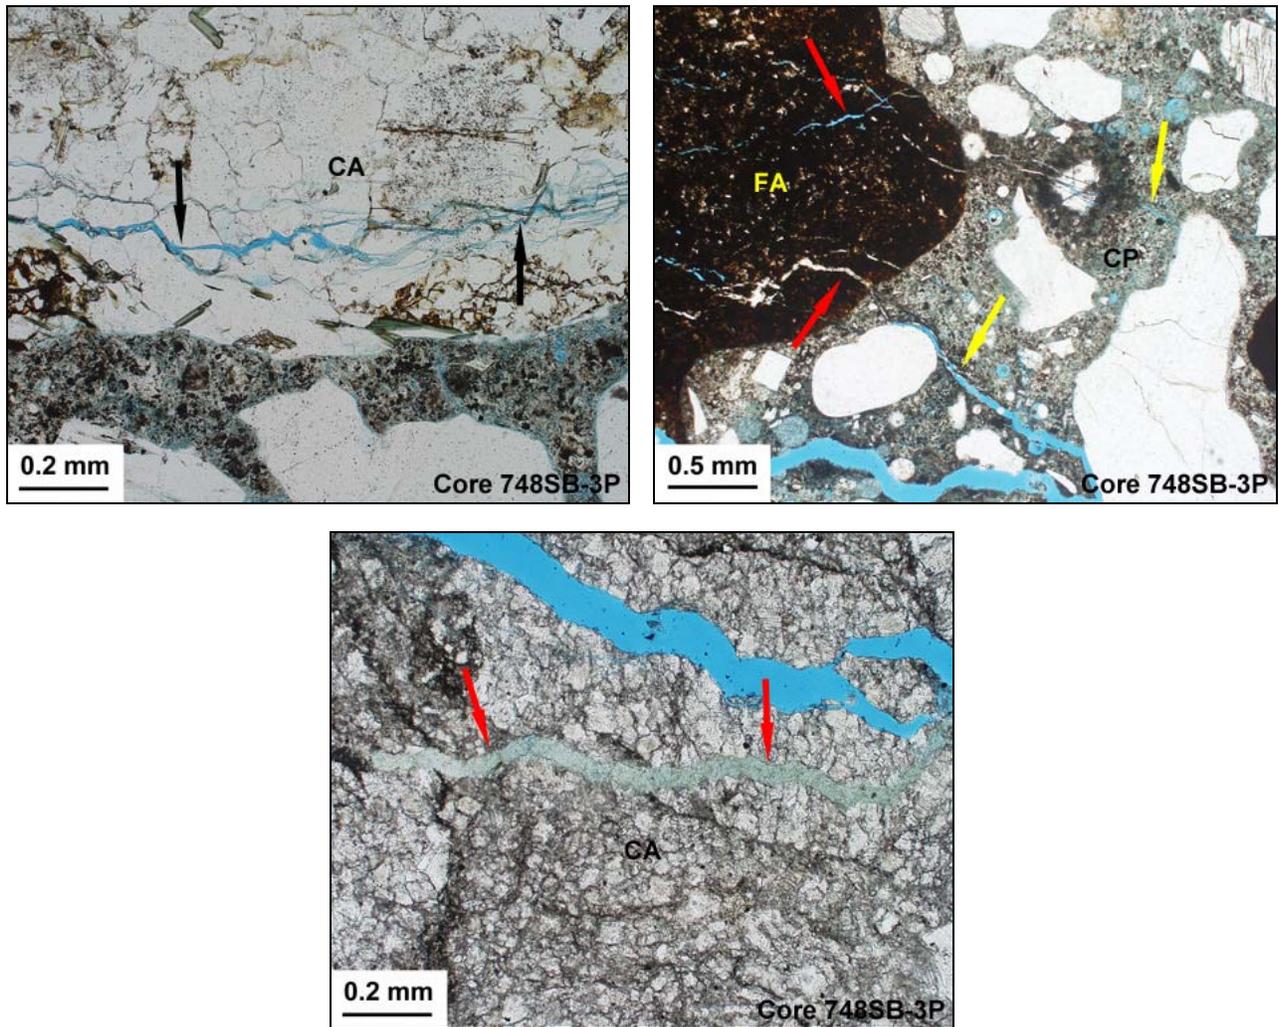
**Figure 25:** Only traces of alkali-silica reaction are detected in Core 748SB-3P and examples are shown in these PPL photomicrographs. (Upper left) The arrows indicate a microcrack that parallels a coarse aggregate surface (CA). The grain is a granitoid. (Upper right) The red arrows indicate reaction cracks within a chert fine aggregate (FA). The yellow arrows indicate where these have propagated into the adjacent cement paste (CP). (Lower) The arrows indicate a microcrack lined with a hydrous silica gel. This is a precursor to the ASR reaction. Surprisingly, this is found within a dolostone particle.

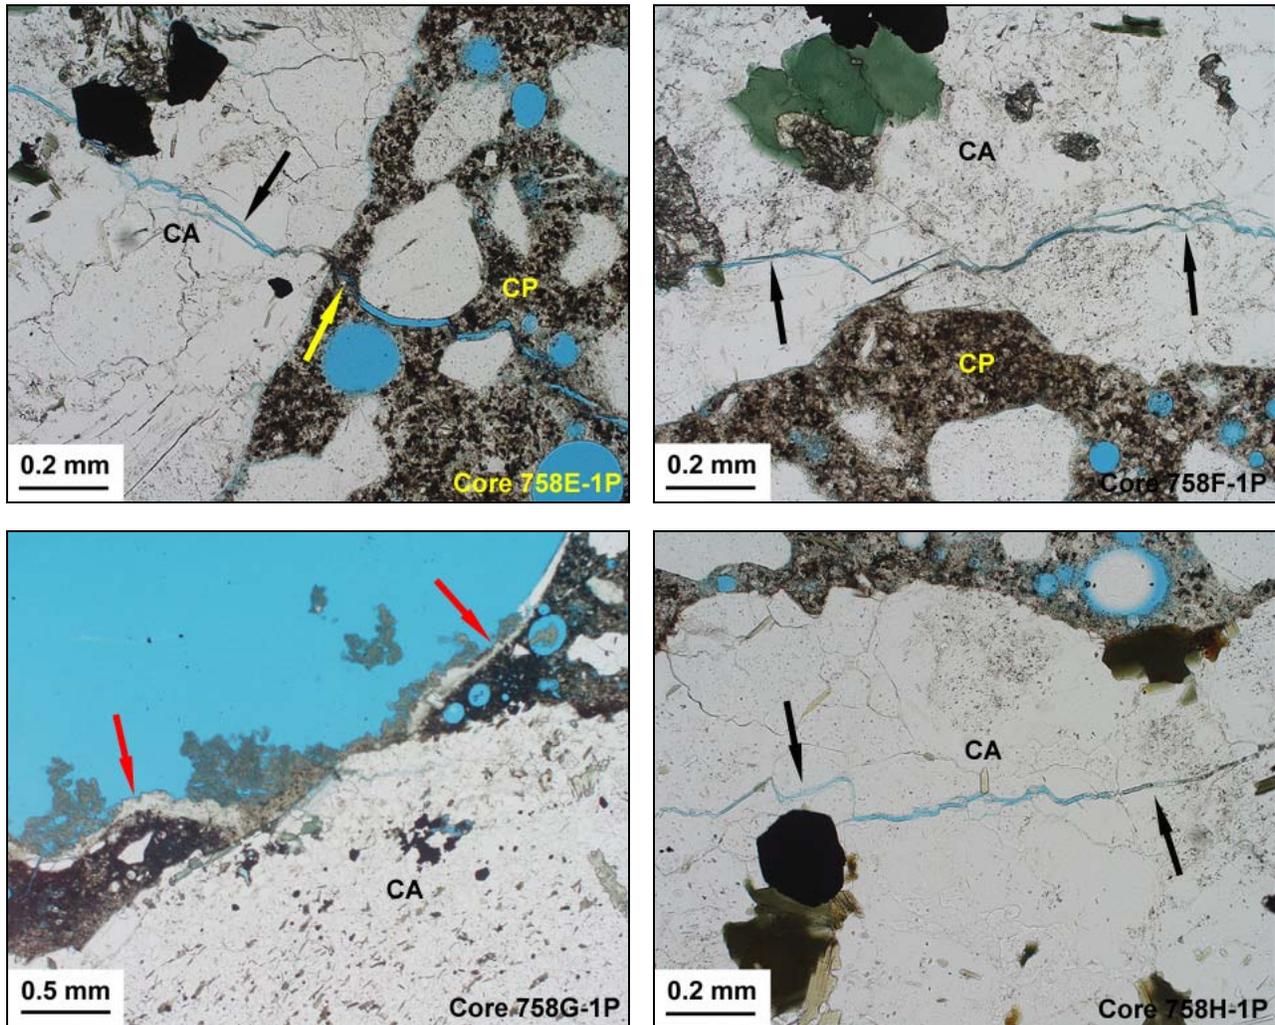
**Figure 27:** Evidence for ASR reaction is negligible in the 758 cores. Some of this minimal evidence is highlighted in these PPL photomicrographs. (Upper left) A granitoid coarse aggregate (CA) has a thin reaction crack (black arrow) that has propagated a short distance into the adjacent cement paste (CP and yellow arrow). (Upper right and lower right) The arrows indicate minor reaction cracks within coarse aggregate particles (CA). Granitoid is again the reactive stone. (Lower left) The arrows indicate the lining of a soft ASR gel deposit that was present adjacent to a granofels coarse aggregate particle (CA). The softer portion of the gel was likely eroded away during initial saw-cutting.

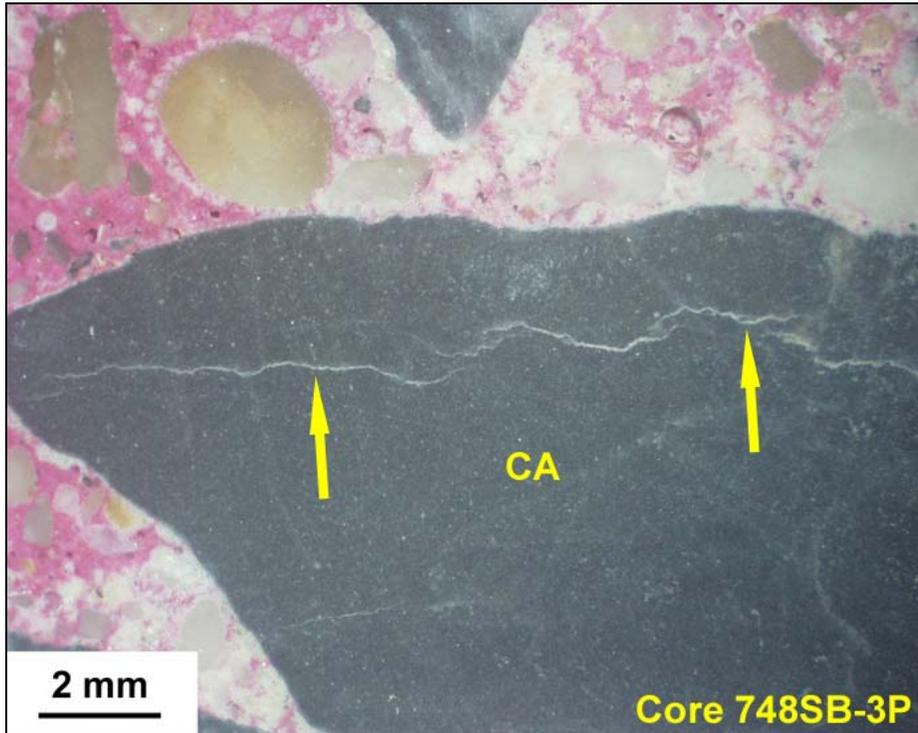
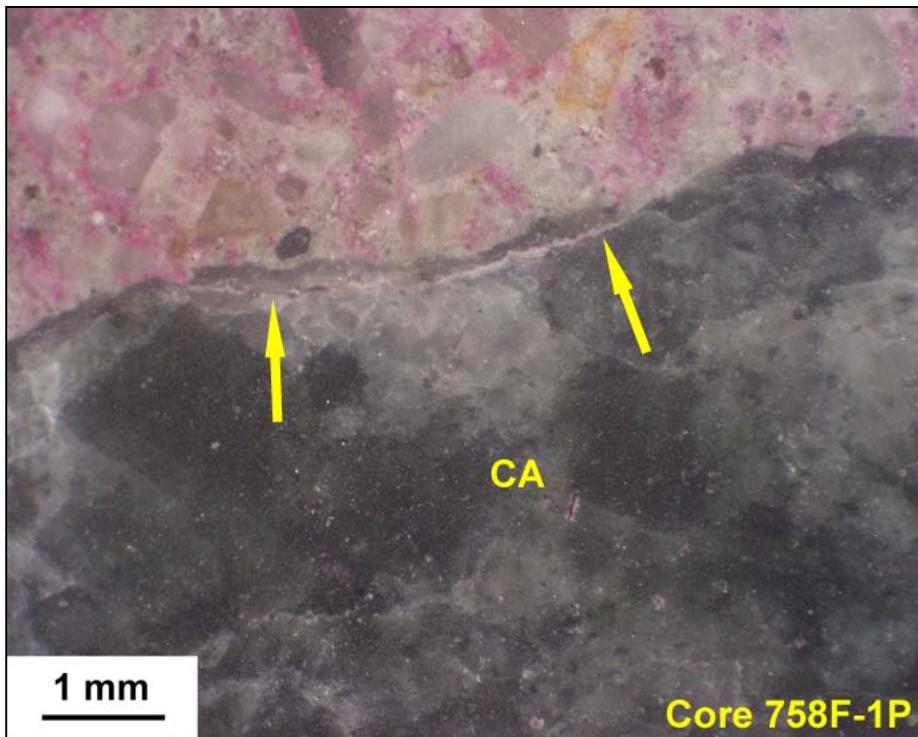
**Figure 28:** Reflected light photomicrographs taken of honed concrete core sections. The arrows indicate very fine internal microcracks within granitoid stone. While no ASR gel is found in association with these trace cracks, there are interpreted to represent a very early stage reaction.

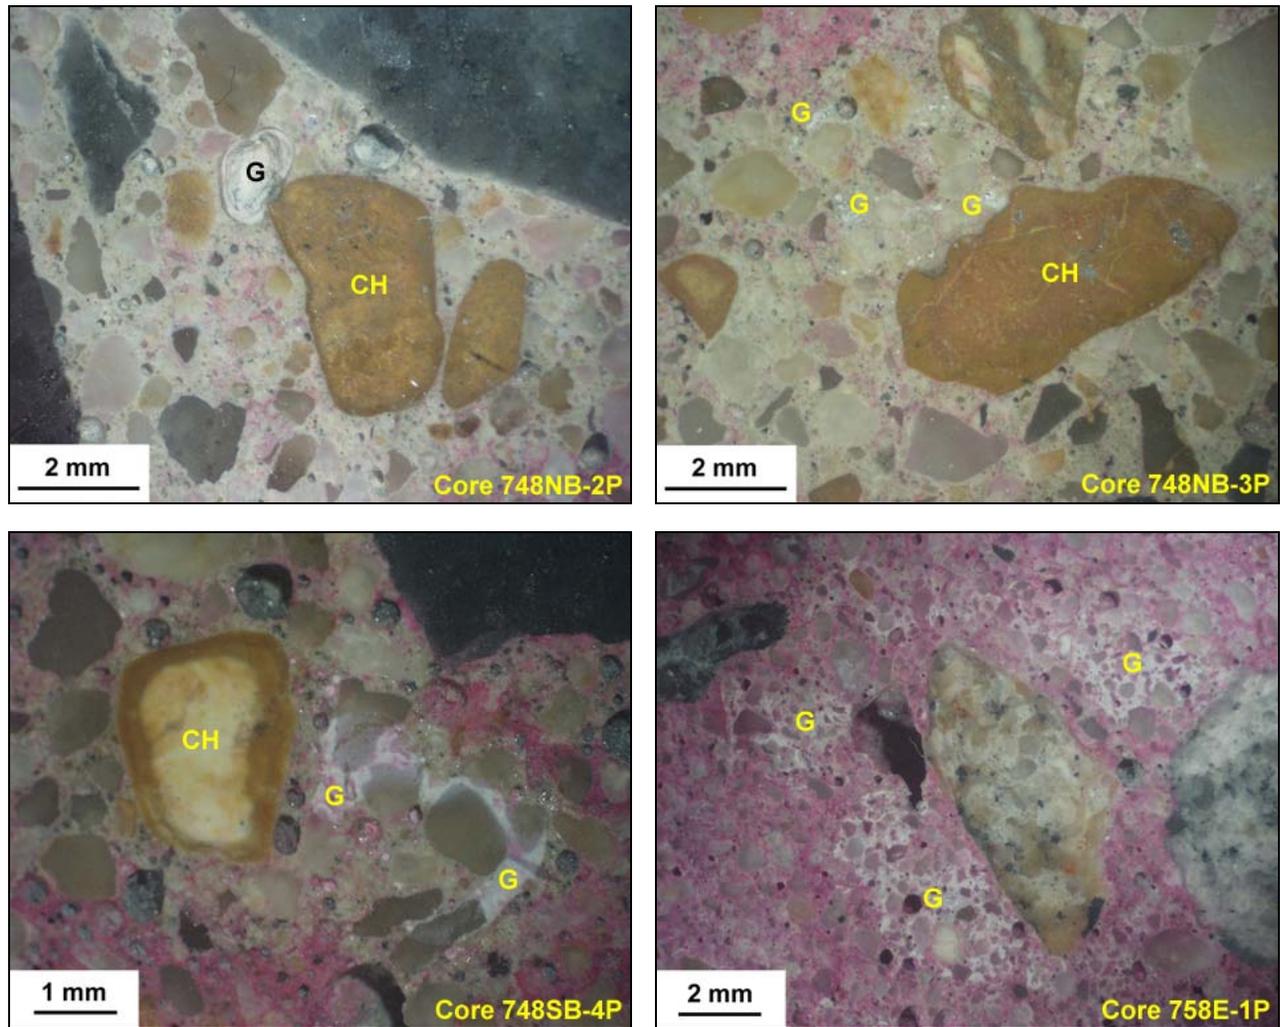
**Figure 29:** Reflected light photomicrographs taken of honed concrete core sections. A deposit of ASR gel (G) is shown adjacent to a reactive chert particle (CH) for Core 748NB-2P. In some cases, discrete gel deposits had not formed previously but rather exuded from the paste near reactive sand and stone after cutting and polishing the core section. Examples of this are shown in the other three images. This is not uncommon where the fine aggregate contains ferruginous chert (CH). In the image for Core 758E-1P, the source of the gel deposit appears to be outside the plane of the thin section.

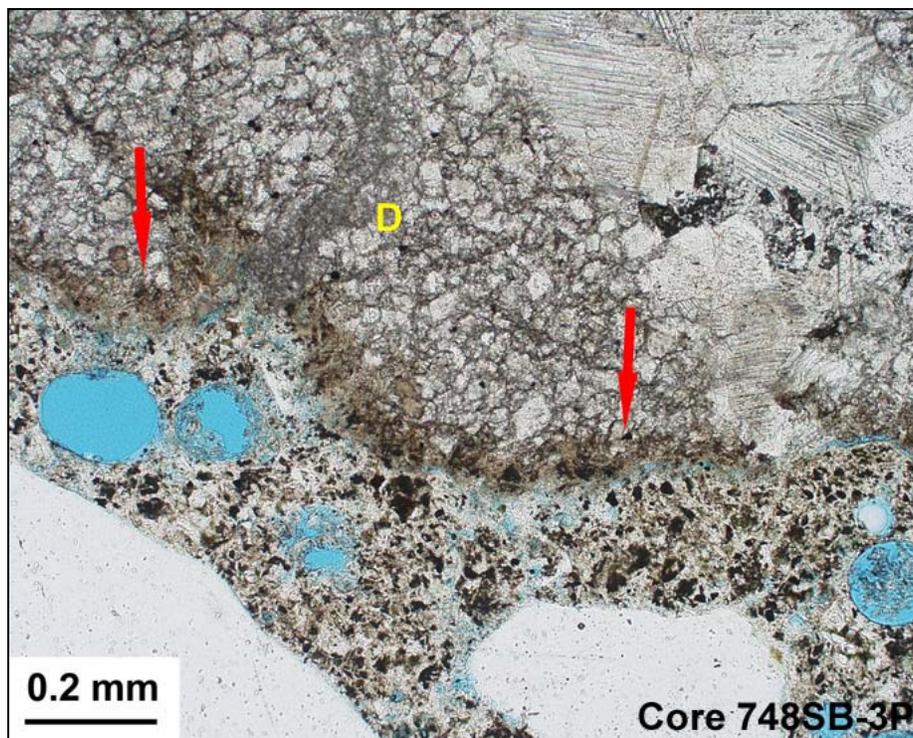
**Figure 30:** Evidence for alkali-carbonate reaction is detected in the dolomite aggregate (D) present in Cores 748NB-1P and 748SB-3P. In these PPL images, the arrows indicate corroded zone representing a dedolomitization reaction at the grain periphery. Microcracking along individual dolomite grain boundaries is shown for Core 748NB-1P. A continuous reaction rim of affected dolomite is shown for Core 748SB-3P.

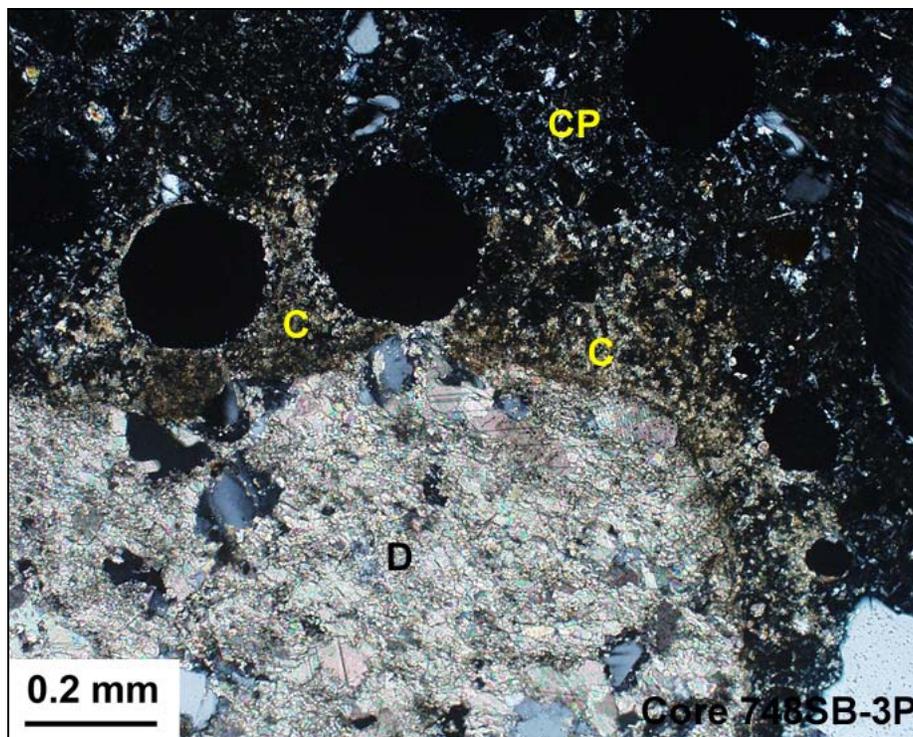
**Figure 31:** The dedolomitization reaction is also evidenced by a “bloom” of carbonation that emanates from the dolostone aggregate (D). Note the golden-color of the carbonated paste juxtaposed against the normal dark color of the cement paste (CP) in these XPL photomicrographs.

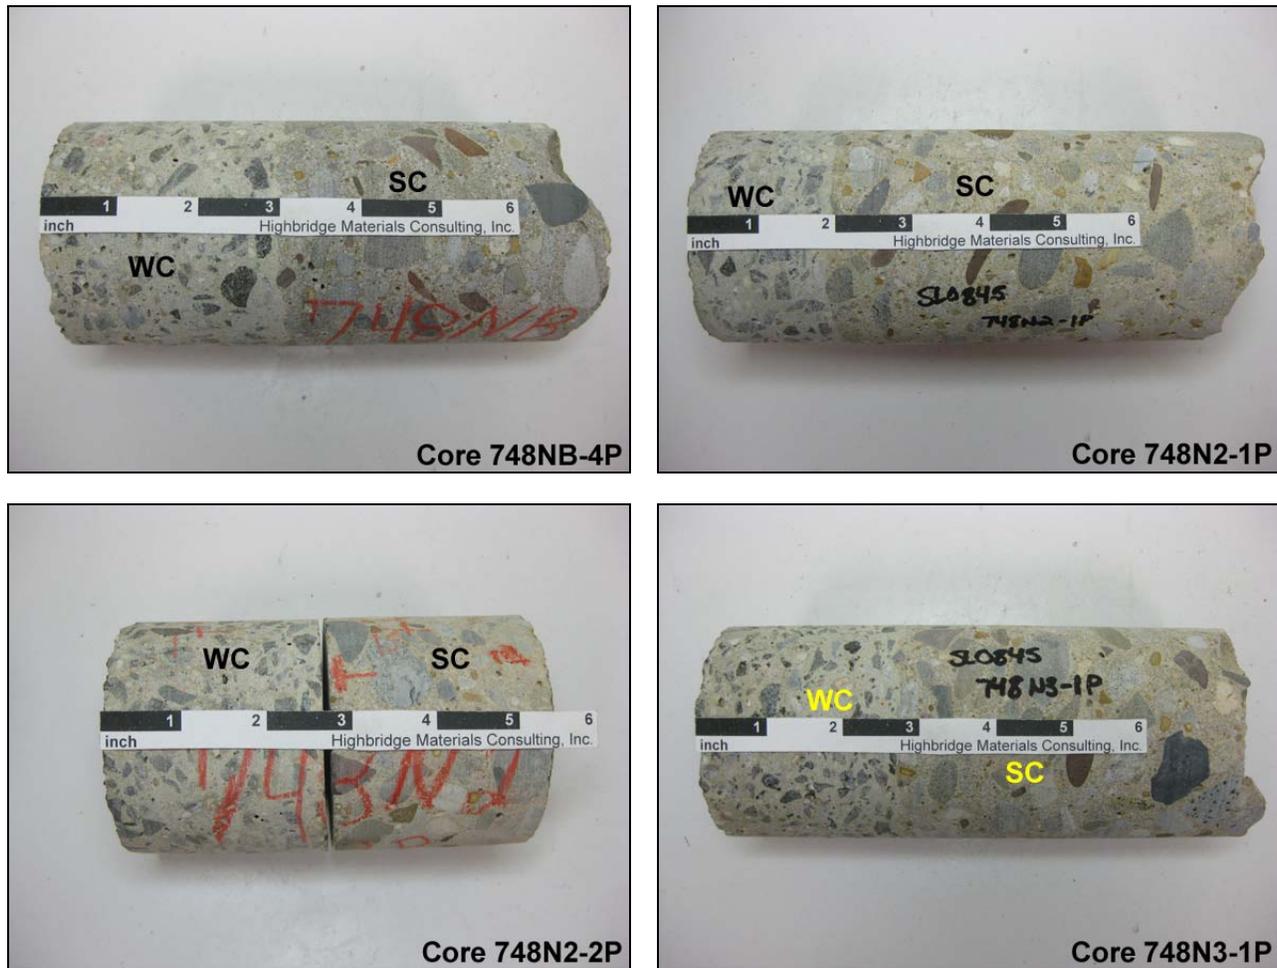
**Figure 1:** Photographs of the ten concrete core samples used for petrographic examination and air-void analysis of the structural concrete layers. All are shown with their upper surfaces toward the left of each image. All of the cores contain wear course layers (WC) overlying normal weight structural concrete (SC). Core 748N2-2P was saw-cut and does not contain any original finished surfaces and the wear course is not attached to the substrate in this sample. The black arrows in the images for Cores 748S-1P and 749-1P illustrate core breaks present in the samples as delivered. Only the one in Core 749-1P is attributed to alkali-silica reaction. The other one is likely an artifact of sample retrieval. The blue arrows in the images for Cores 749-1P and 758-1P illustrate cracks that did not fail through. Again, the one for Core 749-1P is attributed to aggregate reactivity. The basal cracks in Core 758-1P appear to be artifacts.
