## PETROGRAPHIC EXAMINATION REPORT

<b>Client:</b>	Pennoni Associates, Inc.	<b>Client ID:</b>	PENN003
<b>Project:</b>	I-95 Viaduct Project	<b>Report #:</b>	SL0845-01
<b>Location:</b>	Delaware	<b>Dates Received:</b>	12/15/14, 01/07/15, 01/14/15
<b>Sample Type:</b>	Concrete cores	<b>Report Date:</b>	02/14/15
<b>Delivered by:</b>	Client (M. Padula)	<b>Petrographer:</b>	J. Walsh
		<b>Analyst:</b>	M. Pattie

- This report presents the results of petrographic examination and air-void analysis on six concrete core samples taken from viaduct structures along I-95 near Wilmington, DE.

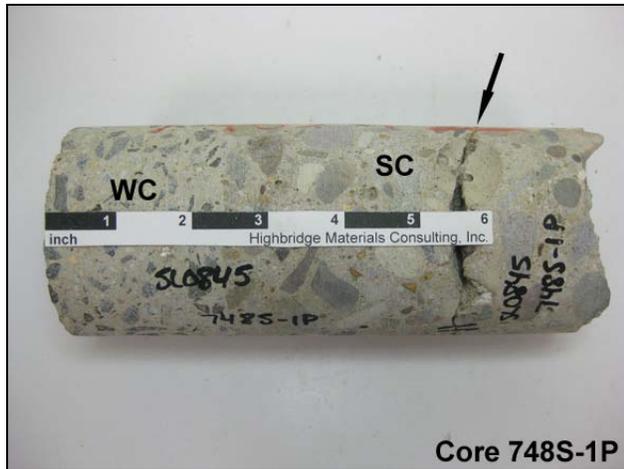
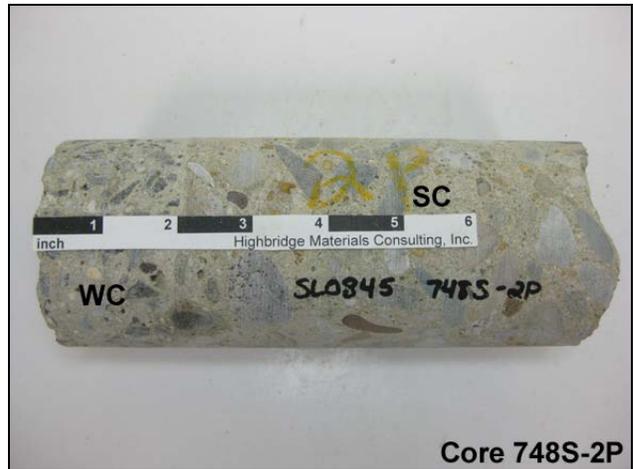
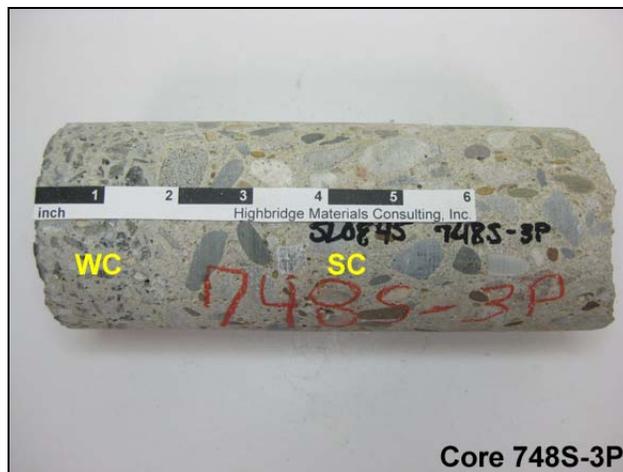
**Figure 1 (cont'd.):** Photographs of the ten concrete core samples used for petrographic examination and air-void analysis of the structural concrete layers.

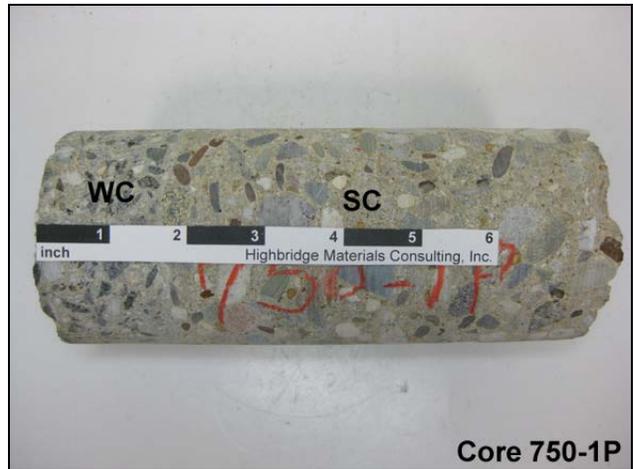
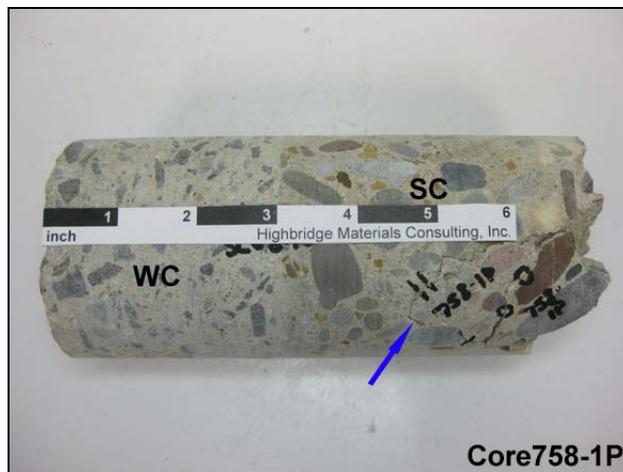
**Figure 1 (cont'd.):** Photographs of the ten concrete core samples used for petrographic examination and air-void analysis of the structural concrete layers.

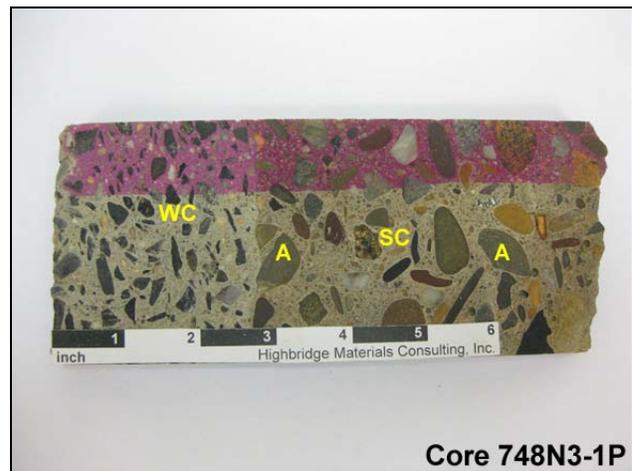
**Figure 2:** Photographs of honed concrete cross sections prepared for the full depth of each provided sample. The upper surfaces are shown to the left in each example. The black arrows indicate where core breaks were epoxied together prior to honing. Wear courses (WC) overlie structural concrete (SC). The size and gradation of the natural gravel aggregate (A) can be observed in the structural layers. Most cores have aggregate with a 3/4" nominal top size. Exceptions include Core 748NB-1P with a 1/2" top size and Core 748S-3P with a 1" top size. Variations in the particle size distributions are likely intrinsic to the original source and not necessarily intentional. The aggregate is well distributed and no segregations are identified. A portion of each core is treated with phenolphthalein indicator solution. The pink color indicates that the structural concrete is alkaline throughout all but a thin veneer along the upper surfaces. The high pH is indicative of the relative lack of carbonation within the structural layers. Steel embedded within the substrate concrete would not be at risk for depassivation at least within the upper portions represented here.

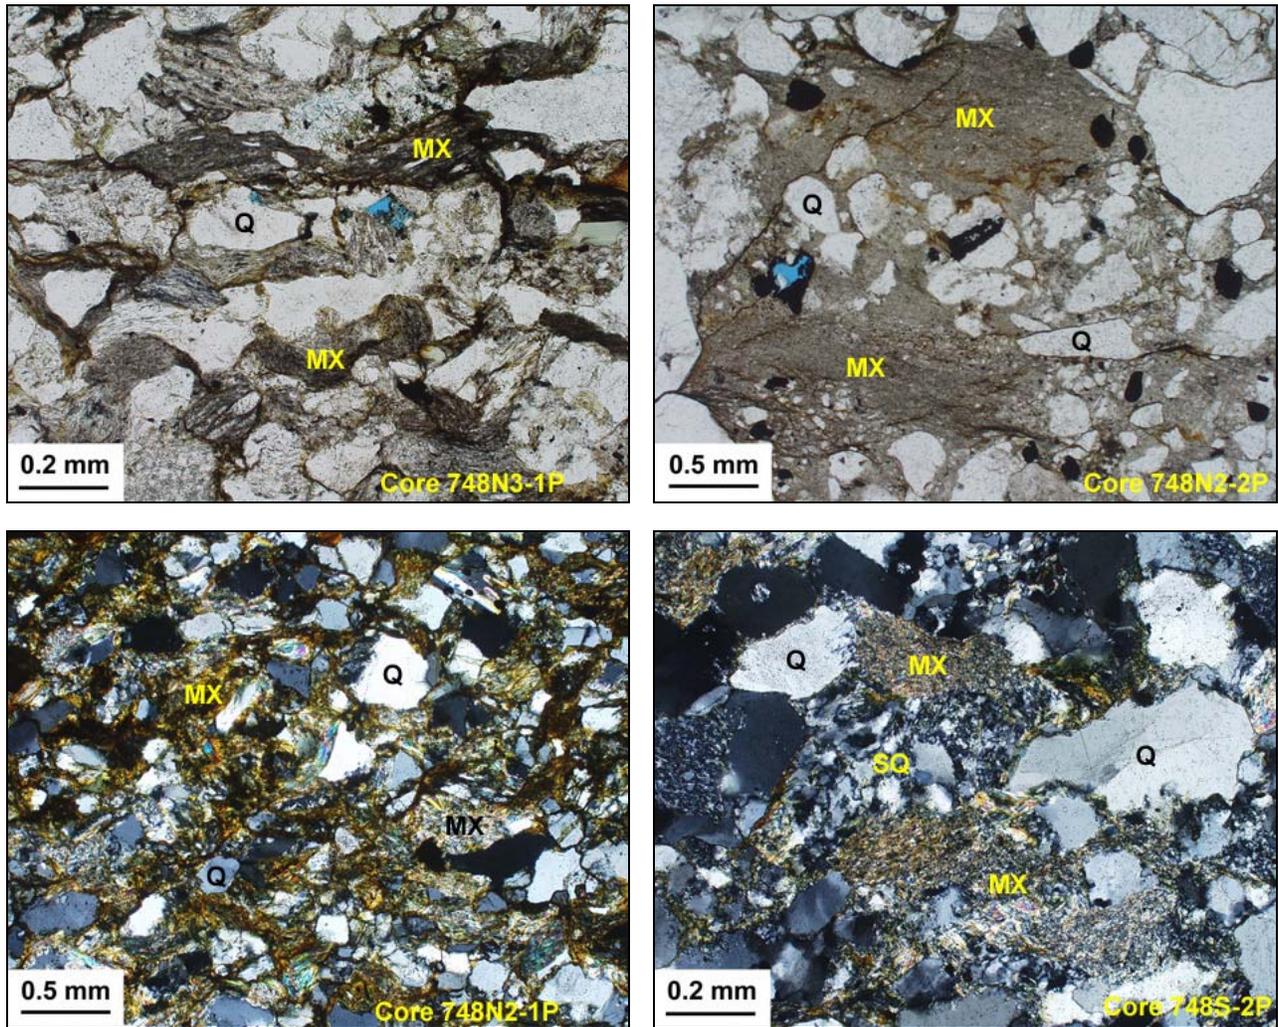
**Figure 5:** Quartz wackes are also a significant component of the sedimentary rock types in the aggregate assemblage. Examples are shown in the upper PPL images and lower XPL images. The wackes are distinguished by higher amounts of fine clay matrix (MX). The matrix tends to result in softer and more elastic particles and is also expected to increase the microporosity of the aggregate. Quartz sand (Q) is more or less abundant and strained quartzite (SQ) is also found as individual sand particles. The matrix is observed to be compacted and elongate in many of the grains as shown in the upper left image. Some particles are particularly rich in matrix as shown in the upper right image.

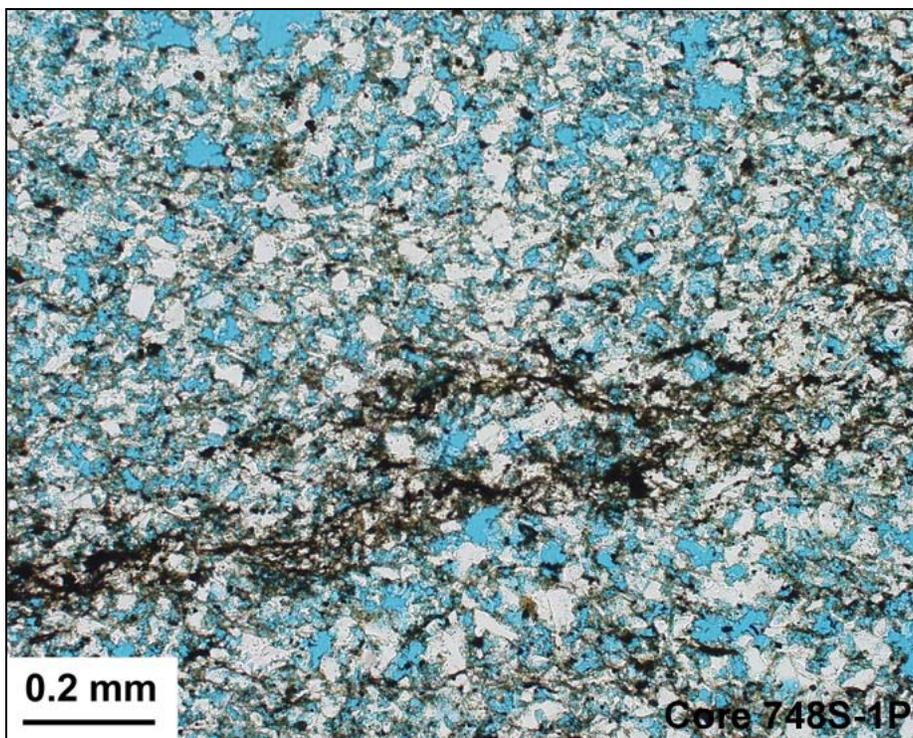
**Figure 6:** PPL photomicrographs. The quartz wackes tend to have a higher internal porosity than the quartz arenites. Again, the samples are impregnated with a blue-dyed epoxy to highlight the presence of pore spaces. Note the distributed porosity in these two examples. The larger pores in the upper image are likely connected by a submicroscopic porosity in the constituent clay matrix. In contrast, the fine interstitial pores in the lower image are fully interconnected on their own.

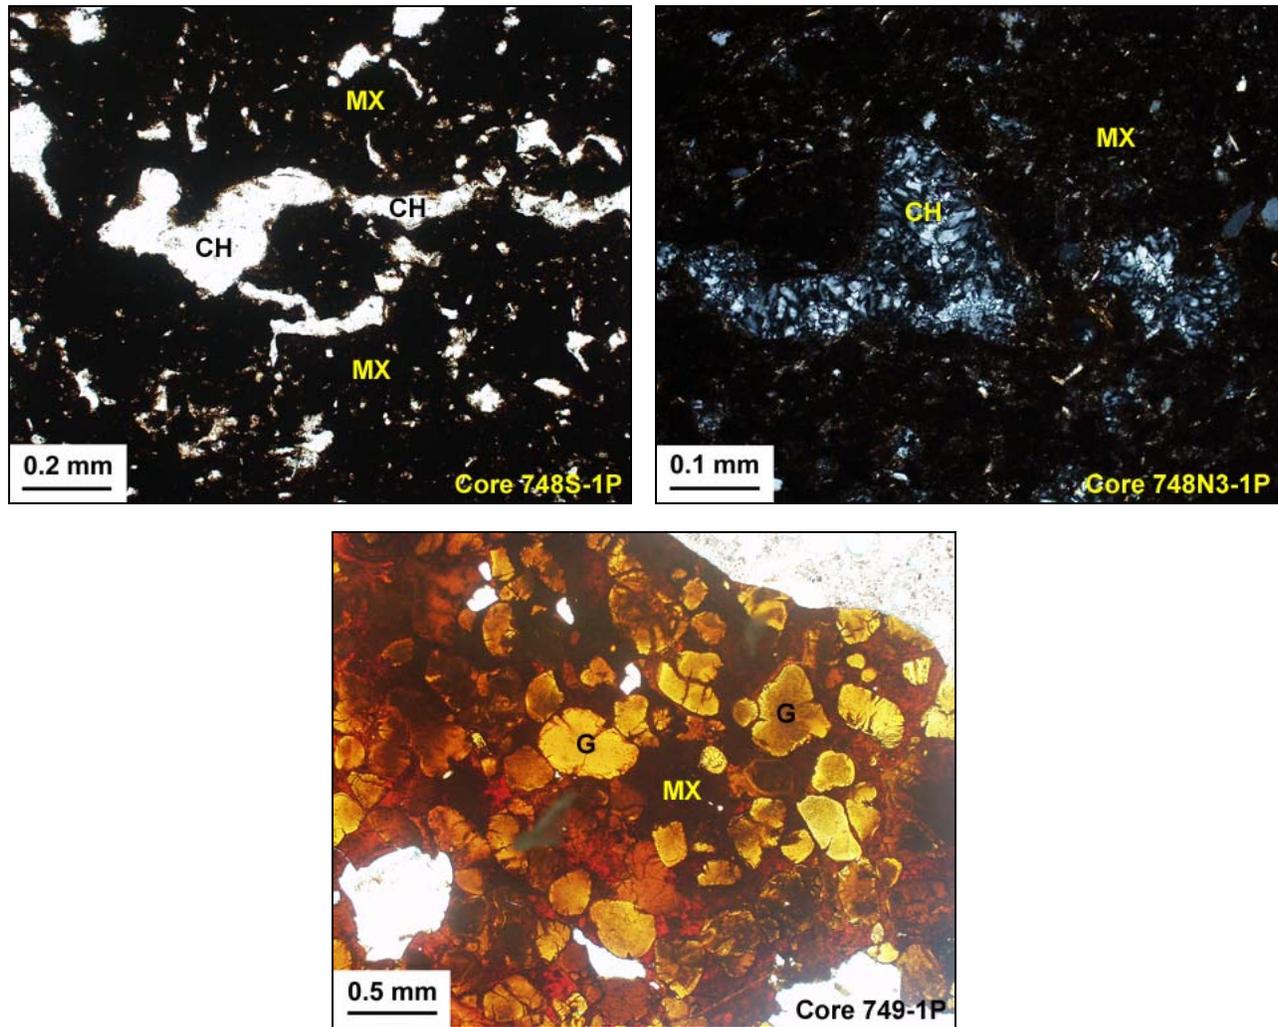
**Figure 8:** Other iron oxide rich aggregates are better classified as ironstones and some examples are shown here. In the upper images, pods of chalcidony (CH) are embedded in a matrix of iron oxide (MX). The left image is in PPL and the right image in XPL. Chalcedony is a cryptocrystalline variety of quartz that is susceptible to alkali-silica reaction. Another ironstone is shown in the lower PPL image. In this grain, altered glauconite pellets (G) are embedded in an iron oxide matrix (MX). Glauconite is an iron-rich clay commonly found in marine sediments.

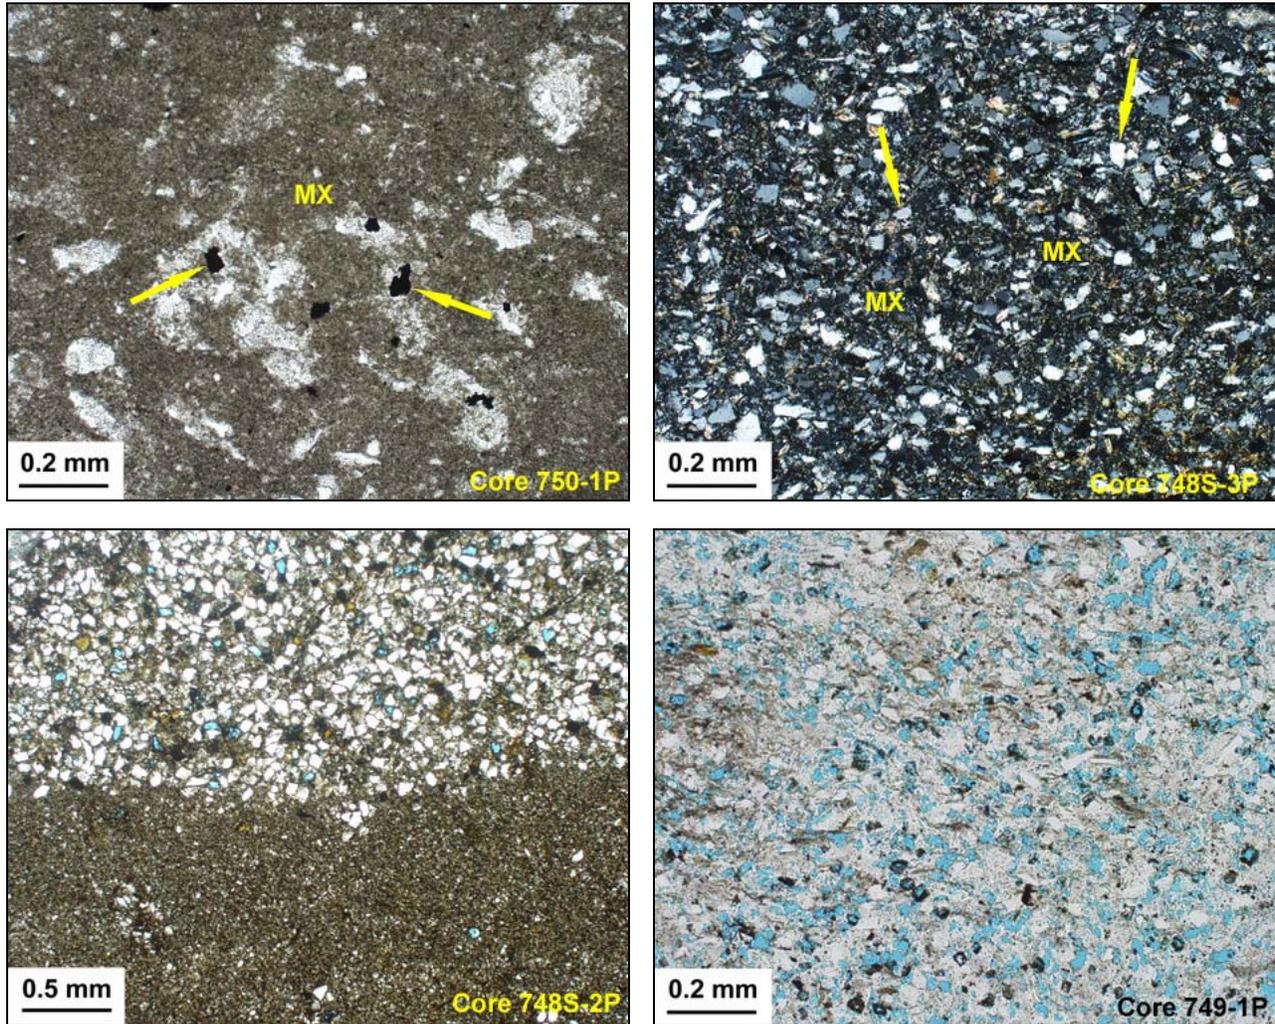
**Figure 9:** Some of the sedimentary rocks in the coarse aggregate are finer-grained than the arenites and wackes. These include rocks that range from siltstone to argillite with examples shown here. (Upper left PPL image) An argillite has a fine clayey matrix (MX). The arrows indicate sulfide phases detected in the argillite but these are too few to represent a durability or aesthetic issue. (Upper right XPL image) An argillaceous siltstone contains fine quartz silt (arrows) embedded in a fine argillaceous matrix (MX). (Lower left PPL image) The lower portion of this grain is a pure argillite. However, the upper portion contains quartz silt (appearing as white particulates). Note also that some porosity is indicated in this layer by the blue epoxy showing through the matrix. (Lower right PPL image) This cherty and silty argillite is even more porous. Blue pores are distributed evenly throughout the whole of the sample.

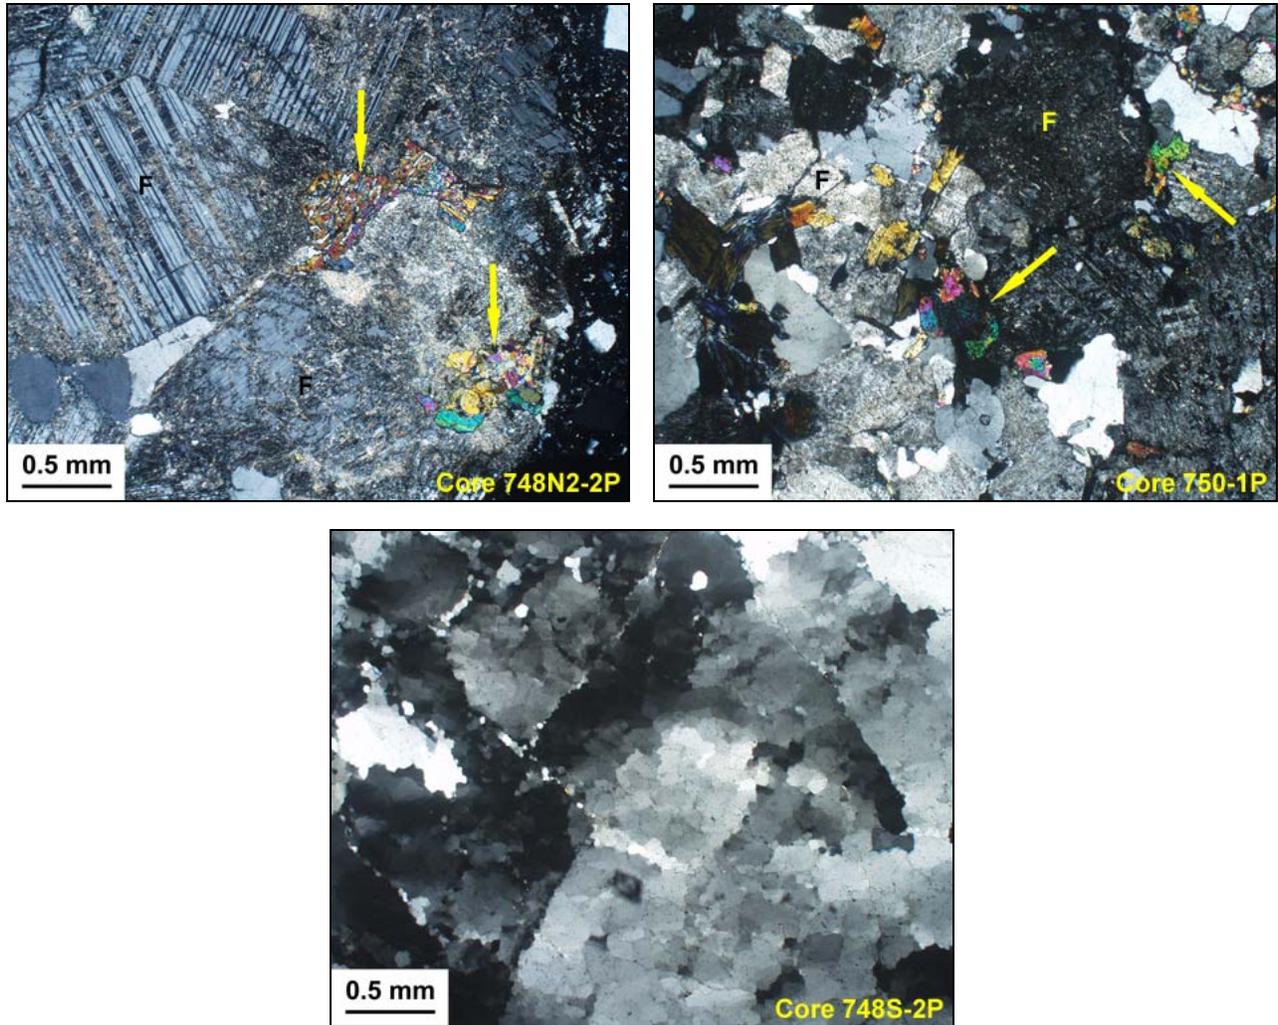
**Figure 11:** XPL photomicrographs illustrating examples of some of the minor rock types observed in the natural gravel coarse aggregate assemblage. The upper images display granites that contain mildly altered feldspar (F) along with some epidote (arrows). The mosaic of white and gray crystals in the lower XPL image consists of quartz grains that have undergone crystal plastic strain.

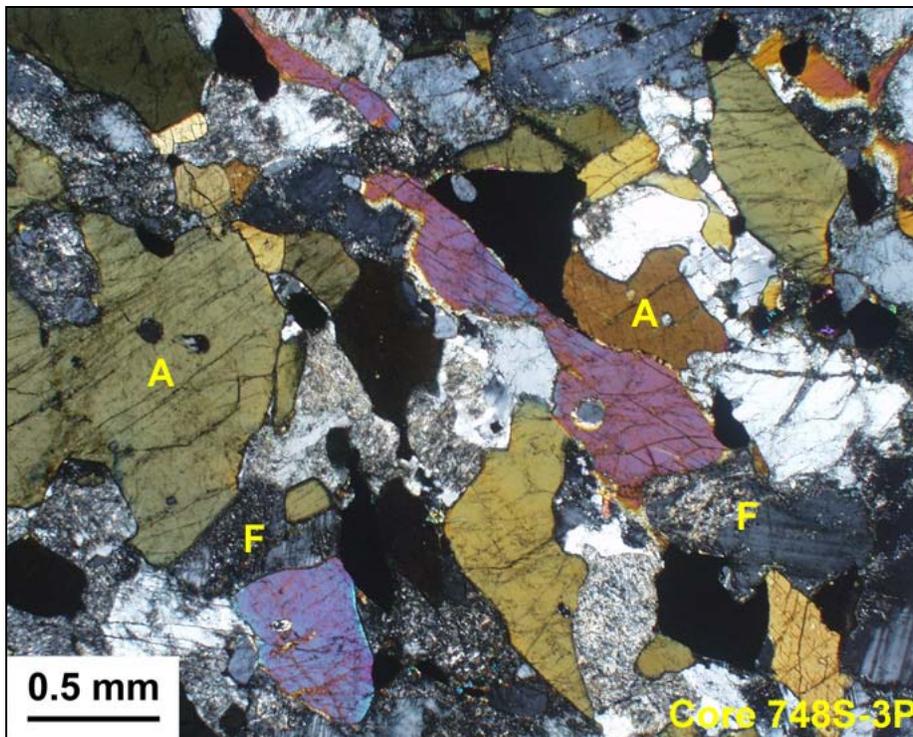
**Figure 12:** XPL photomicrographs illustrating trace grains of the coarse aggregate identified in two of the samples. (Upper image) A single grain of dolostone is detected in Core 748NB-4P. (Lower image) Amphibolite in Core 748S-3P consists of amphibole (A) and feldspar (F).

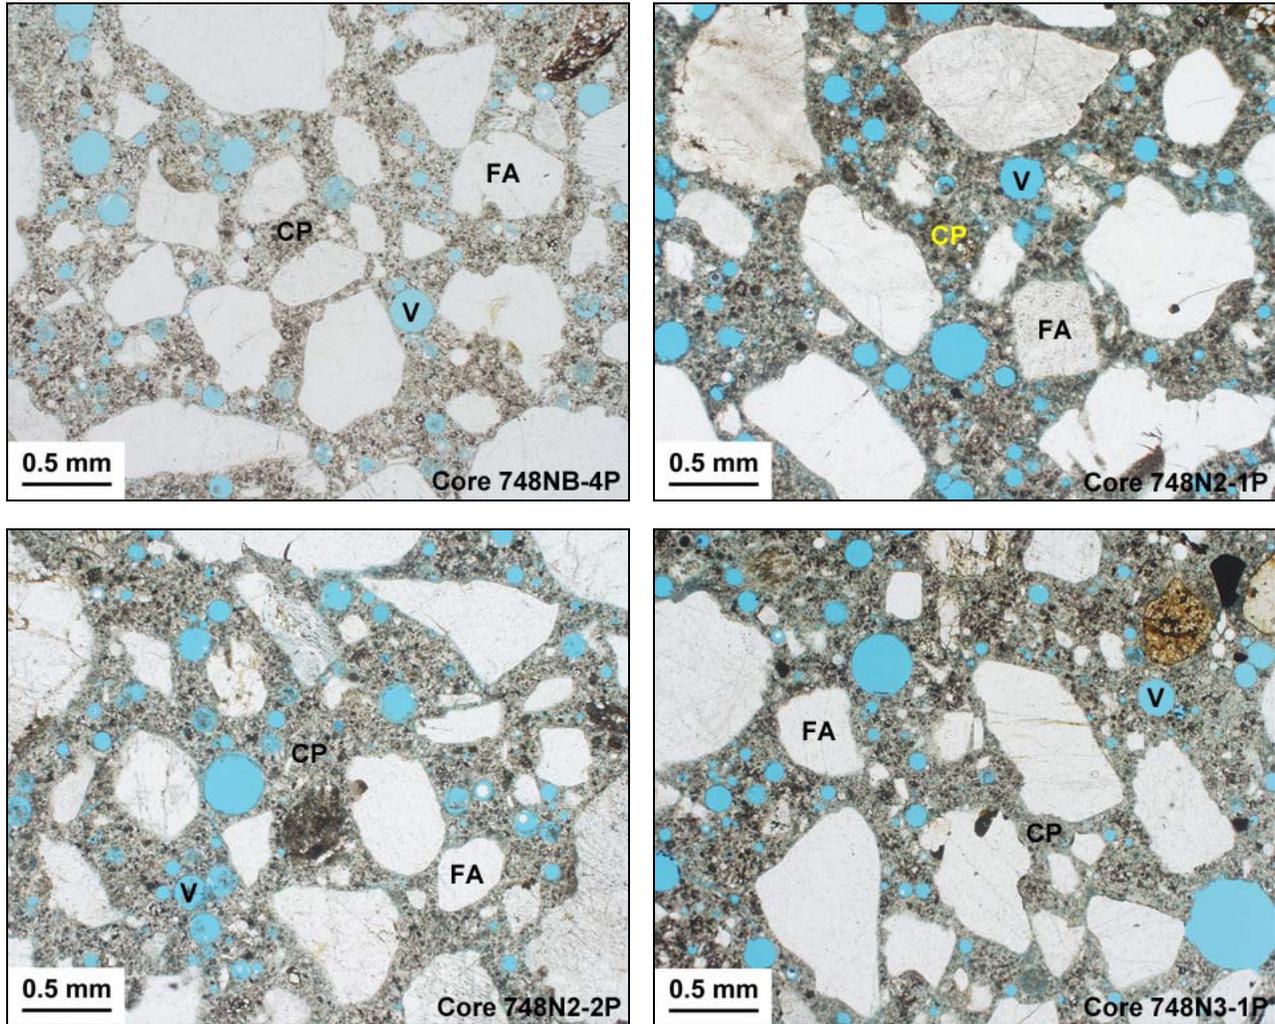
**Figure 14:** PPL photomicrographs illustrating the overall microstructure of the structural concrete. There is some variability in water contents and entrained-air development that result in some quality differences. In all of the examined samples, the cement paste (CP) is well-developed and relatively dense as indicated by the even brown coloration under plane light. The samples are impregnated with a low-viscosity, blue-dyed epoxy in order to highlight cracks, pores, and voids. There is a moderate absorption of the epoxy consistent with moderate mix water contents. The fine aggregate (FA) is well distributed throughout the matrix. The sand is somewhat coarse-grained but otherwise well-graded. Fine, spherical voids (V) indicate intentional air-entrainment in all cores though the air content is sparse in Core 748S-1P. In contrast, air volumes may be considered somewhat excessive in Cores 748S-3P, 750-1P and 758-1P.
