Underwater Inspection of
Main Street/ SR-299 over Appoquinimink River
Bridge No. 1-393-441
March 11 & 26, 2013

Mark A. Bostick, P.E.
Delaware P.E. No. 16696
Collins Project No. 35-6428.06

Bridge No. 1-393-441

Main Street/ SR-299 over Appoquinimink River

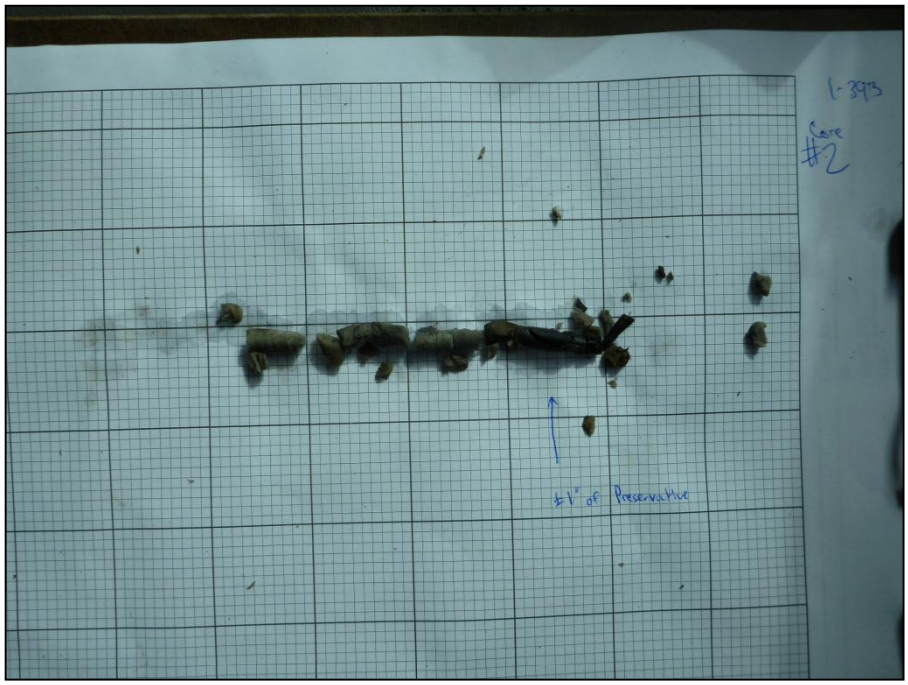
The fiberglass jacket/form on the pier extended from above the high water mark down to approximately 1 foot to 2 feet above the tremie seal. The tremie seal at the pier typically exhibited soft concrete and areas of rough and deteriorated concrete up to 1 foot deep. The east face of the tremie seal exhibited an area of concrete section loss which measured 3 feet high by 3 feet wide by 2 feet deep. The previous underwater inspection identified the top of a jagged timber pile within this area of concrete section loss; however, due to limited visibility and high currents the presence of the timber pile could not be verified. The concrete surfaces within the void were very rough. Two piles were cored at the request of the Department and the results showed that there was good penetration of the preservative and there were no indications of marine borer activity.

Photograph 6. View of Timber Core from Southwest Quadrant Perimeter Pile of Pier 1.

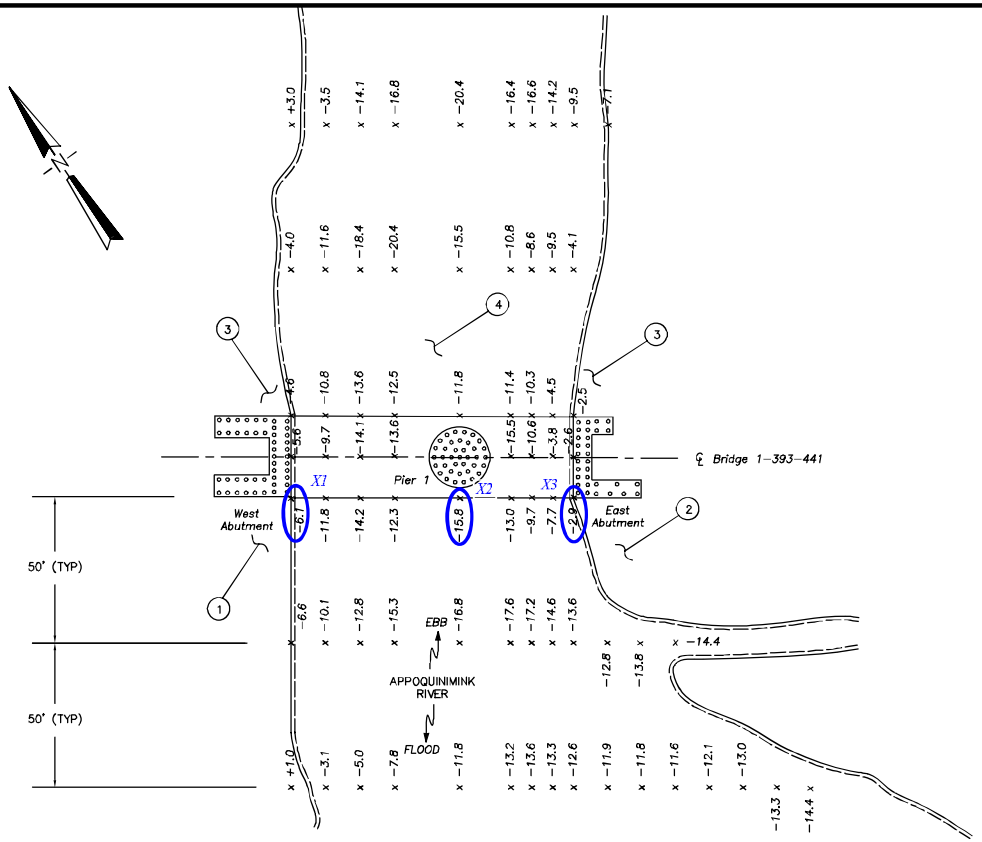
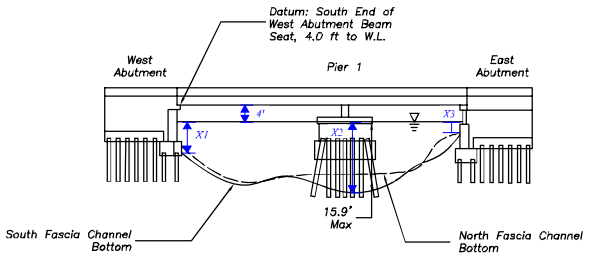
DRAWN BY: JMD	COLLINS ENGINEERS	DATE: 3/11/13
CHECKED BY: MAB	10201 Fairfax Boulevard Suite 330 Fairfax, VA 22030 www.collinseng.com	SCALE: N.T.S.
JOB NO.: 35-06428		FIGURE NO.: 1

The northwest and northeast embankments consisted of riprap which measured 6 to 12 inches on a side with scattered concrete construction debris which measured up to 3 feet on a side. The embankments above the riprap protection consisted of vertical cut banks up to 2 feet high with exposed tree roots. The southeast embankment extending from the bridge to 50 feet south of the bridge consisted of riprap which measured 6 to 18 inches in diameter. The southeast embankment extending from 50 feet south of the bridge to the south exhibited slumping banks with no significant erosion. The southwest embankment consisted of a steel sheet pile wall which exhibited heavy corrosion and areas of 100 percent section loss (localized small holes) along the channel bottom with no significant loss of fill observed. The channel had abandoned timber piles scattered throughout from previous fender systems. Refer to Photographs 9 through 15 in Appendix B for views of the embankments and Photographs 16 through 18 for channel views. Refer to Figure 1 in Appendix C for detailed inspection results showing the embankments and deficiencies noted.

The timber piles in the waterway do not constitute an effective fender system. At high tide, most of the timber piles are submerged and can pose a threat to the small boat traffic that use the waterway.

(1) *The southwest embankment consisted of a steel sheet pile wall which exhibited heavy corrosion and areas of 100 percent section loss along the channel bottom with no significant loss of fill.*

(2) *The southeast embankment extending from the bridge to 50 feet south of the bridge consisted of riprap which measured 6 to 18 inches on a side. The embankment extending from 50 feet south of the bridge to the south exhibited slumping banks with no significant erosion.*

(3) *The northwest and northeast embankments consisted of riprap which measured 6 to 12 inches on a side with scattered concrete construction debris which measured up to 3 feet on a side. The embankments above the riprap protection consisted of vertical cut banks up to 2 feet high with exposed tree roots.*

(4) *The channel had abandoned timber piles scattered throughout from previous fender systems.*

An NBI Rating of 5 for Item 61 (Channel and Channel Protection Code) is recommended. Although the channel bottom in the vicinity of the pier has not changed significantly since the previous underwater inspection in 2011, there has been significant scour since the bridge was constructed. In addition, there is some cut bank erosion exhibited in the northwest embankment. The abandoned timber piles from prior fender systems in the channel should be removed and consideration be given to installing a new fender system.

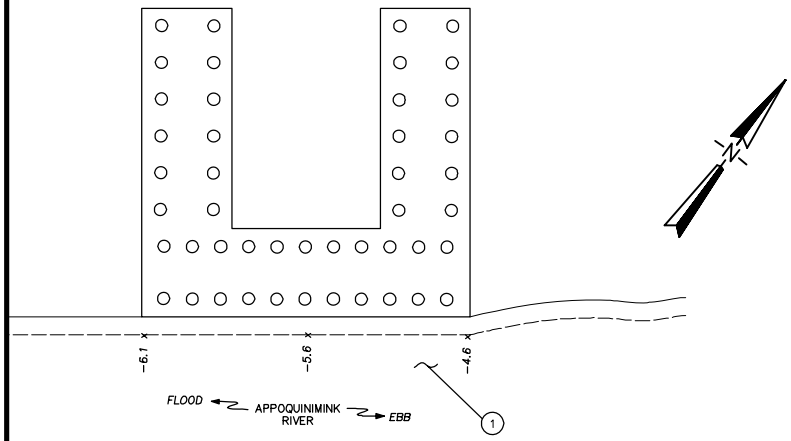
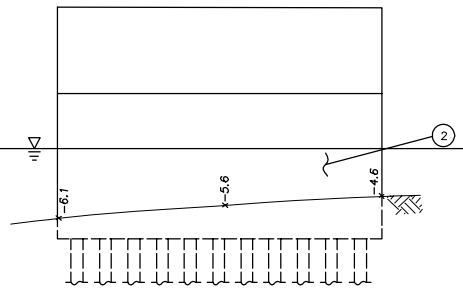
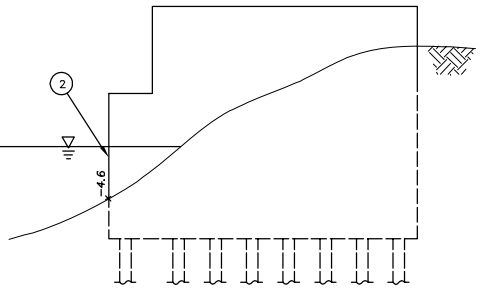
DRAWN BY: JMD	COLLINS ENGINEERS	10201 Fairfax Boulevard Suite 330 Fairfax, VA 22030 www.collinsengr.com	DATE: 3/11/13
CHECKED BY: MAB			SCALE: N.T.S.
JOB NO.:35-06428			FIGURE NO.: 2

Overall, the West Abutment was in good condition from the mean high waterline to the channel bottom. The channel bottom in the vicinity of the abutment consisted of riprap which measured 1.5 to 2 feet on a side and extended from the abutment out 10 feet on a steep slope. The concrete exhibited scaling up to 1/4 inch deep extending from 4 feet below the beam seat to the channel bottom. Refer to Photograph 3 in Appendix B for a view of the West Abutment. Refer to Figure 2 in Appendix C for detailed inspection results of the West Abutment.

(1) The channel bottom in the vicinity of the abutment consisted of riprap which measured 1.5 to 2 feet on a side and extended from the abutment out 10 feet on a steep angle.

(2) The concrete exhibited scaling up to 1/4 inch deep with random popouts up to 1/2 inch deep extending from 4 feet below the beam seat to the channel bottom.

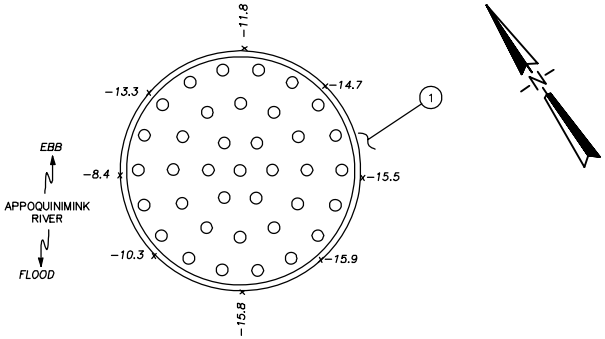
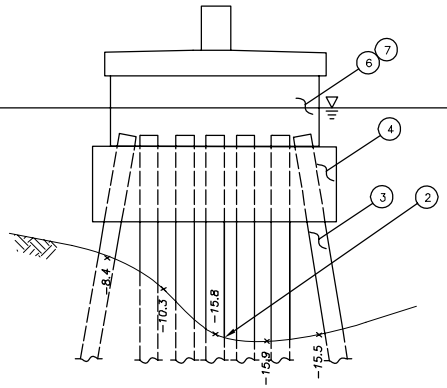
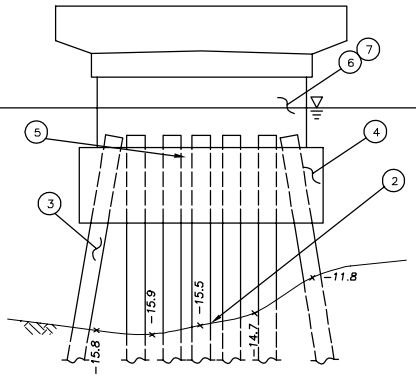
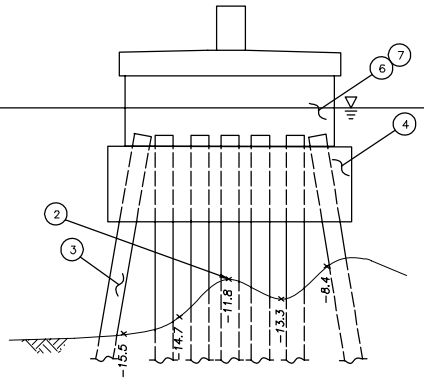
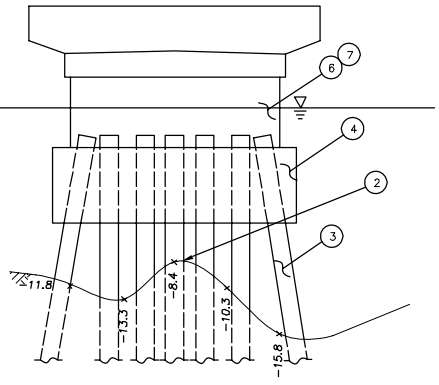
DRAWN BY: JMD	COLLINS ENGINEERS	10201 Fairfax Boulevard Suite 330 Fairfax, VA 22030 www.collinsengr.com	DATE: 3/11/13
CHECKED BY: MAB			SCALE: N.T.S.
JOB NO.:35-06428			FIGURE NO.: 3

to plans, the pivot pier was rehabilitated by encasing the original pier with a structural (reinforced) concrete jacket with a stay-in-place fiberglass jacket. The fiberglass jacket was still in place, was covered with a light barnacle growth, and was generally in satisfactory condition. The fiberglass jacket appeared to end approximately 1 to 1.5 feet above the top of the tremie seal. In general, the tremie seal was in poor condition. The tremie concrete typically exhibited soft concrete throughout, along with areas of rough and heavily deteriorated concrete up to 1 foot deep. The previous underwater inspection in 2011 identified a void in the east side of the seal measuring 3 feet high by 3 feet wide by 2 feet deep with an exposed jagged top of a timber pile. The presence of the void was verified; however, the top of the pile was not confirmed. The interior of the void was very rough and narrowed moving inward from the perimeter and the visibility was extremely limited. The seal/pier was completely undermined, exhibiting opening heights of 2.5 to 5.5 feet around the pier perimeter. The timber piles encountered under the pier were in satisfactory to good condition. Two of the outer (perimeter) piles in the southwest quadrant of the pier were approximately 9 inches in diameter. It is not known if the 9 inch diameter piles were originally larger and eroded over the years, but there was no widening evident in these piles at the juncture with the tremie seal or at the channel bottom. The interior piles were typically 12 to 14 inches in diameter. The timber piles appeared to be sound when struck with a hammer. Two piles were cored, one in the southwest quadrant (a perimeter pile) and one interior pile in the northwest quadrant. Both exhibited good penetration of the preservative and there were no internal (or external) indications of marine borers. The channel bottom in the vicinity of the pier consisted of riprap measuring 1.5 to 2 feet on a side. There appeared to be some timber formwork elements embedded in the channel bottom around the pier. The channel bottom appeared to deepen under the pier. Refer to Photographs 4 and 5 in Appendix B for views of the Pier. Also, refer to Photographs 6 and 7 in Appendix B for views of the timber cores. Refer to Figure 3 in Appendix C for detailed inspection results of the pier.

The tremie seal concrete is soft and will continue to erode over time, leaving the potential to expose more of the piles.

An NBI Rating of 4 for Item 60 (Substructure) is recommended. The tremie seal at Pier 1 was in poor condition and exhibited heavy deterioration throughout with voids up to 2 feet

deep. In addition, the pier is completely undermined with up to 5.5 feet of pile exposure beneath the tremie seal.

(1) The channel bottom in the vicinity of the pier consisted of riprap which measured 1.5 to 2 feet on a side and timber debris.

(2) The pier was undermined 5.5 ft on the south side, 4 ft on the east side, 2.5 ft on the north side, and 3 ft on the west side.

(3) Timber piles appeared to be sound.

(4) The seal typically exhibited soft concrete and areas of rough and heavily deteriorated concrete up to 1 foot deep.

(5) The east face of the seal exhibited an area of concrete section loss which measured 3 feet high by 3 feet wide by 2 feet deep and narrowed as it went inwards.

(6) The fiberglass form ended 4.7 ft below the top of the pier.

(7) The fiberglass form exhibited very light barnacle growth.

At this time, the structural stability of the pier does not appear to be significantly affected by the undermining; however, the scour void under the pier should be filled and scour countermeasures should be installed in the vicinity of the pier to prevent further scour and channel bottom degradation. A structural analysis may become necessary if the scour at the pier continues to progress.

The pier undermining should be repaired by filling the void with tremie concrete and scour countermeasures should be installed in the vicinity of the pier to prevent further scour and channel bottom degradation. Due to the soft nature of the concrete and the extent of the deterioration, the seal should be repaired/protected from further deterioration similar to the encasement that was done on the original pivot pier.

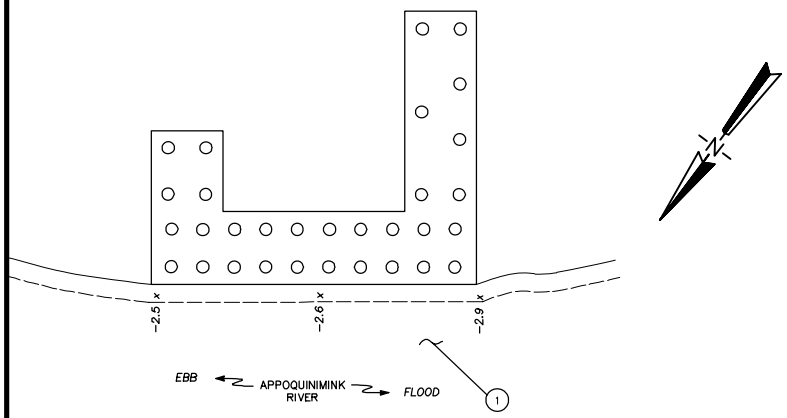
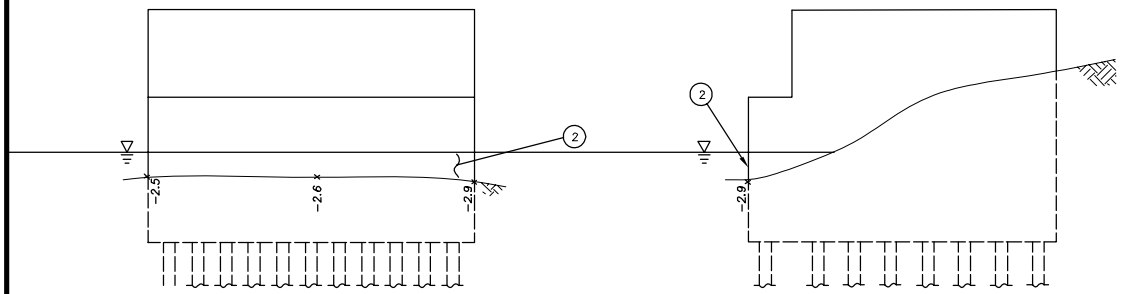
DRAWN BY: JMD	COLLINS ENGINEERS	10201 Fairfax Boulevard Suite 330 Fairfax, VA 22030 www.collinsengr.com	DATE: 3/11/13
CHECKED BY: MAB			SCALE: N.T.S.
JOB NO.:35-06428			FIGURE NO.: 4

Overall, the East Abutment was in good condition from the mean high waterline to the channel bottom. The channel bottom in the vicinity of the abutment consisted of riprap which measured 1.5 to 2 feet on a side and extended from the abutment out 10 feet on a steep slope. The concrete exhibited scaling up to 1/4 inch deep extending from 4 feet below the beam seat to the channel bottom. Refer to Photograph 8 in Appendix B for a view of the East Abutment. Refer to Figure 4 in Appendix C for detailed inspection results of the East Abutment.

(1) The channel bottom in the vicinity of the abutment consisted of riprap which measured 1.5 to 2 feet on a side and extended from the abutment out 10 feet on a steep angle.

(2) The concrete exhibited scaling up to 1/4 inch deep with random popouts up to 1/2 inch deep extending from 4 feet below the beam seat to the channel bottom.
