DELAWARE DEPARTMENT OF TRANSPORTATION

PRE-MONITORING INSPECTION REPORT

THE MILL BUILDING AT HEARNS POND DAM, SUSSEX COUNTY , DE

**PRE-MONITORING INSPECTION REPORT
MILL BUILDING AT HEARNS POND DAM
CITY OF SEAFORD
SUSSEX COUNTY, DE**

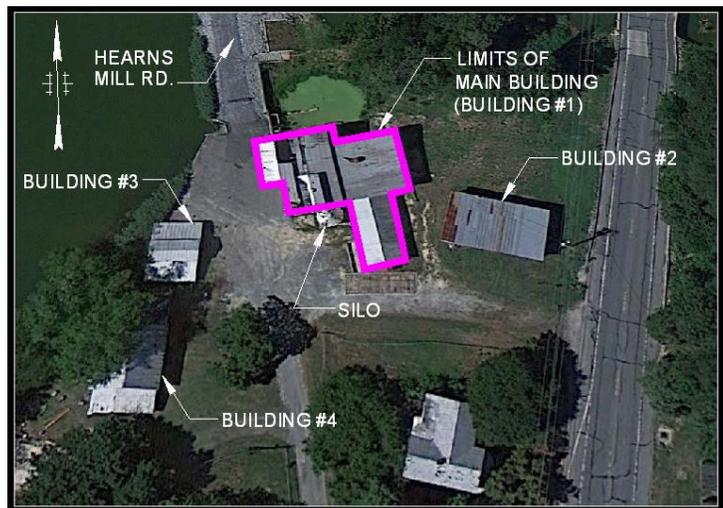
Figure 1A – Aerial view of the Mill Building

There are four (4) building structures identified as part of the Mill Building complex, but only the main building (Building #1, see *Figure 1A*) was inspected under this scope. The limits of the inspection are outlined in *Figure 1A*, which excludes the existing silo that is adjacent to the main building. Any reference to the Mill Building stated henceforth will be understood as the building #1 as highlighted in outline in *Figure 1A*.

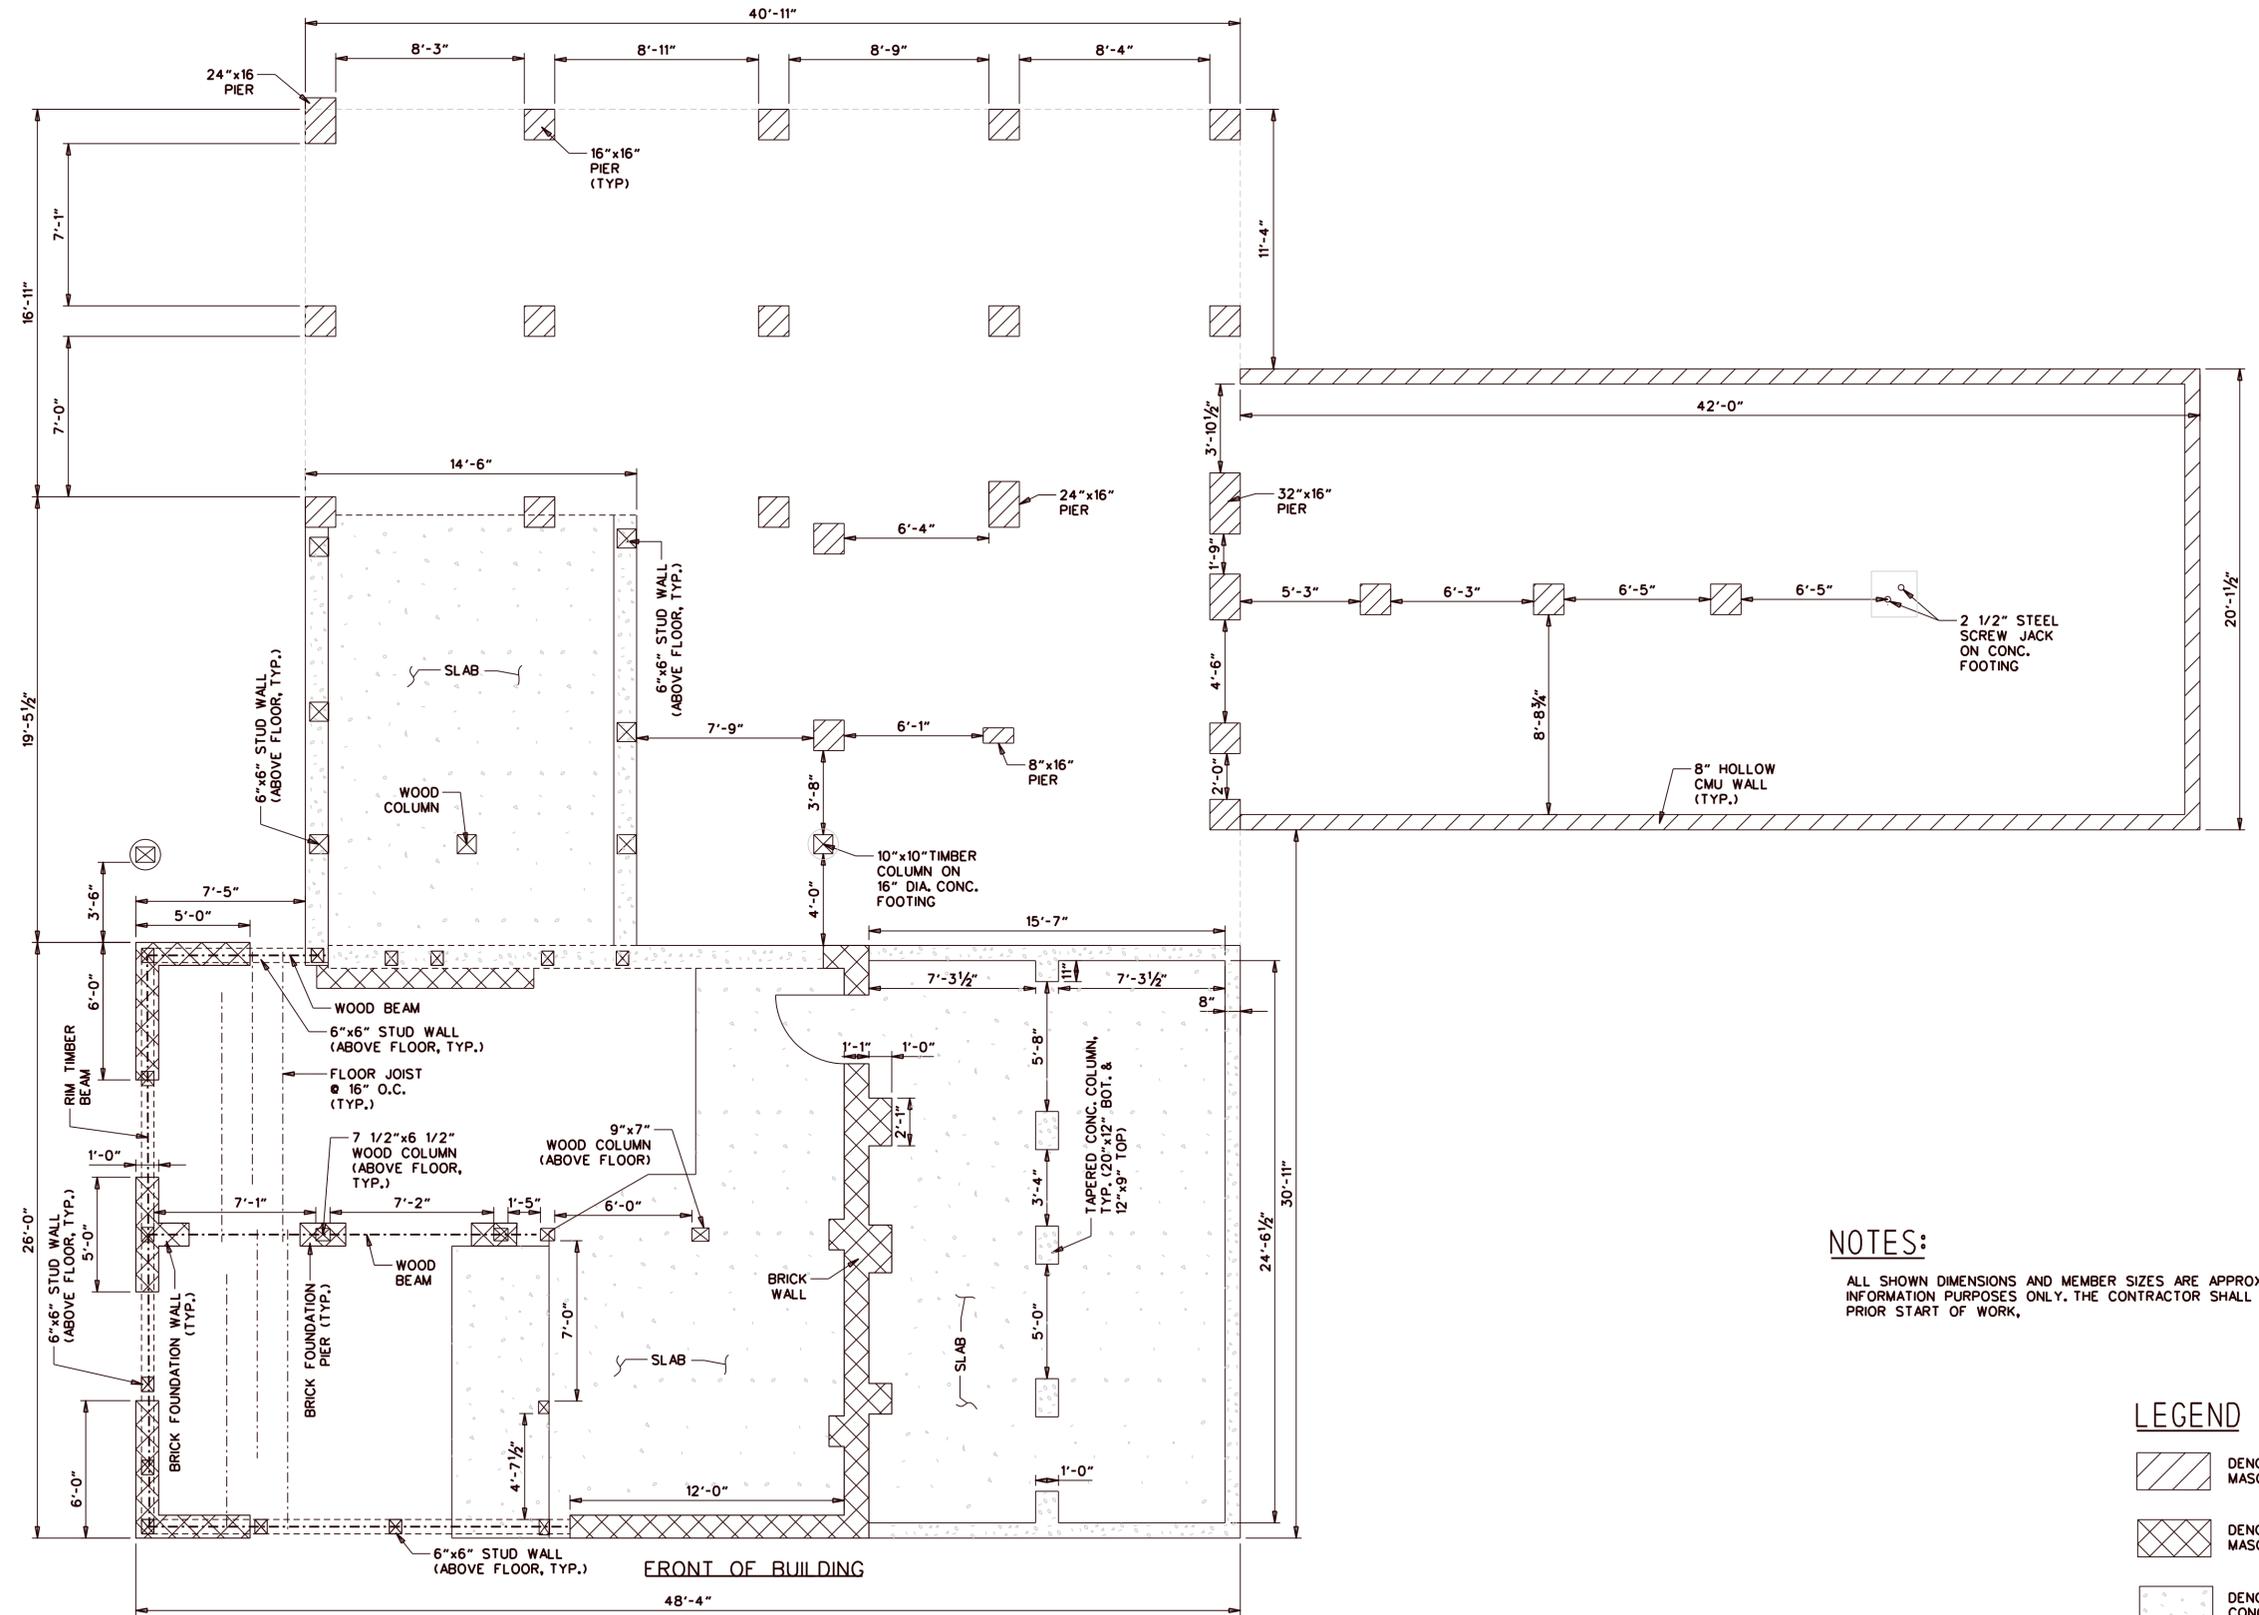
FIGURE 1

The Mill Building is founded on the following foundations types:

- Concrete wall and concrete pier foundation
- Brick masonry wall and brick masonry pier foundation
- Cement Masonry Unit (CMU) walls and CMU pier foundation

For foundation plan view and the above mentioned foundation type location, see *Figure 1* in *Appendix B* and Photos B1 through B25 in *Appendix C*. It appears that the original

building structure was founded on brick masonry walls and brick piers. Other foundation types appear to have been constructed at a later time as part of the building expansion.

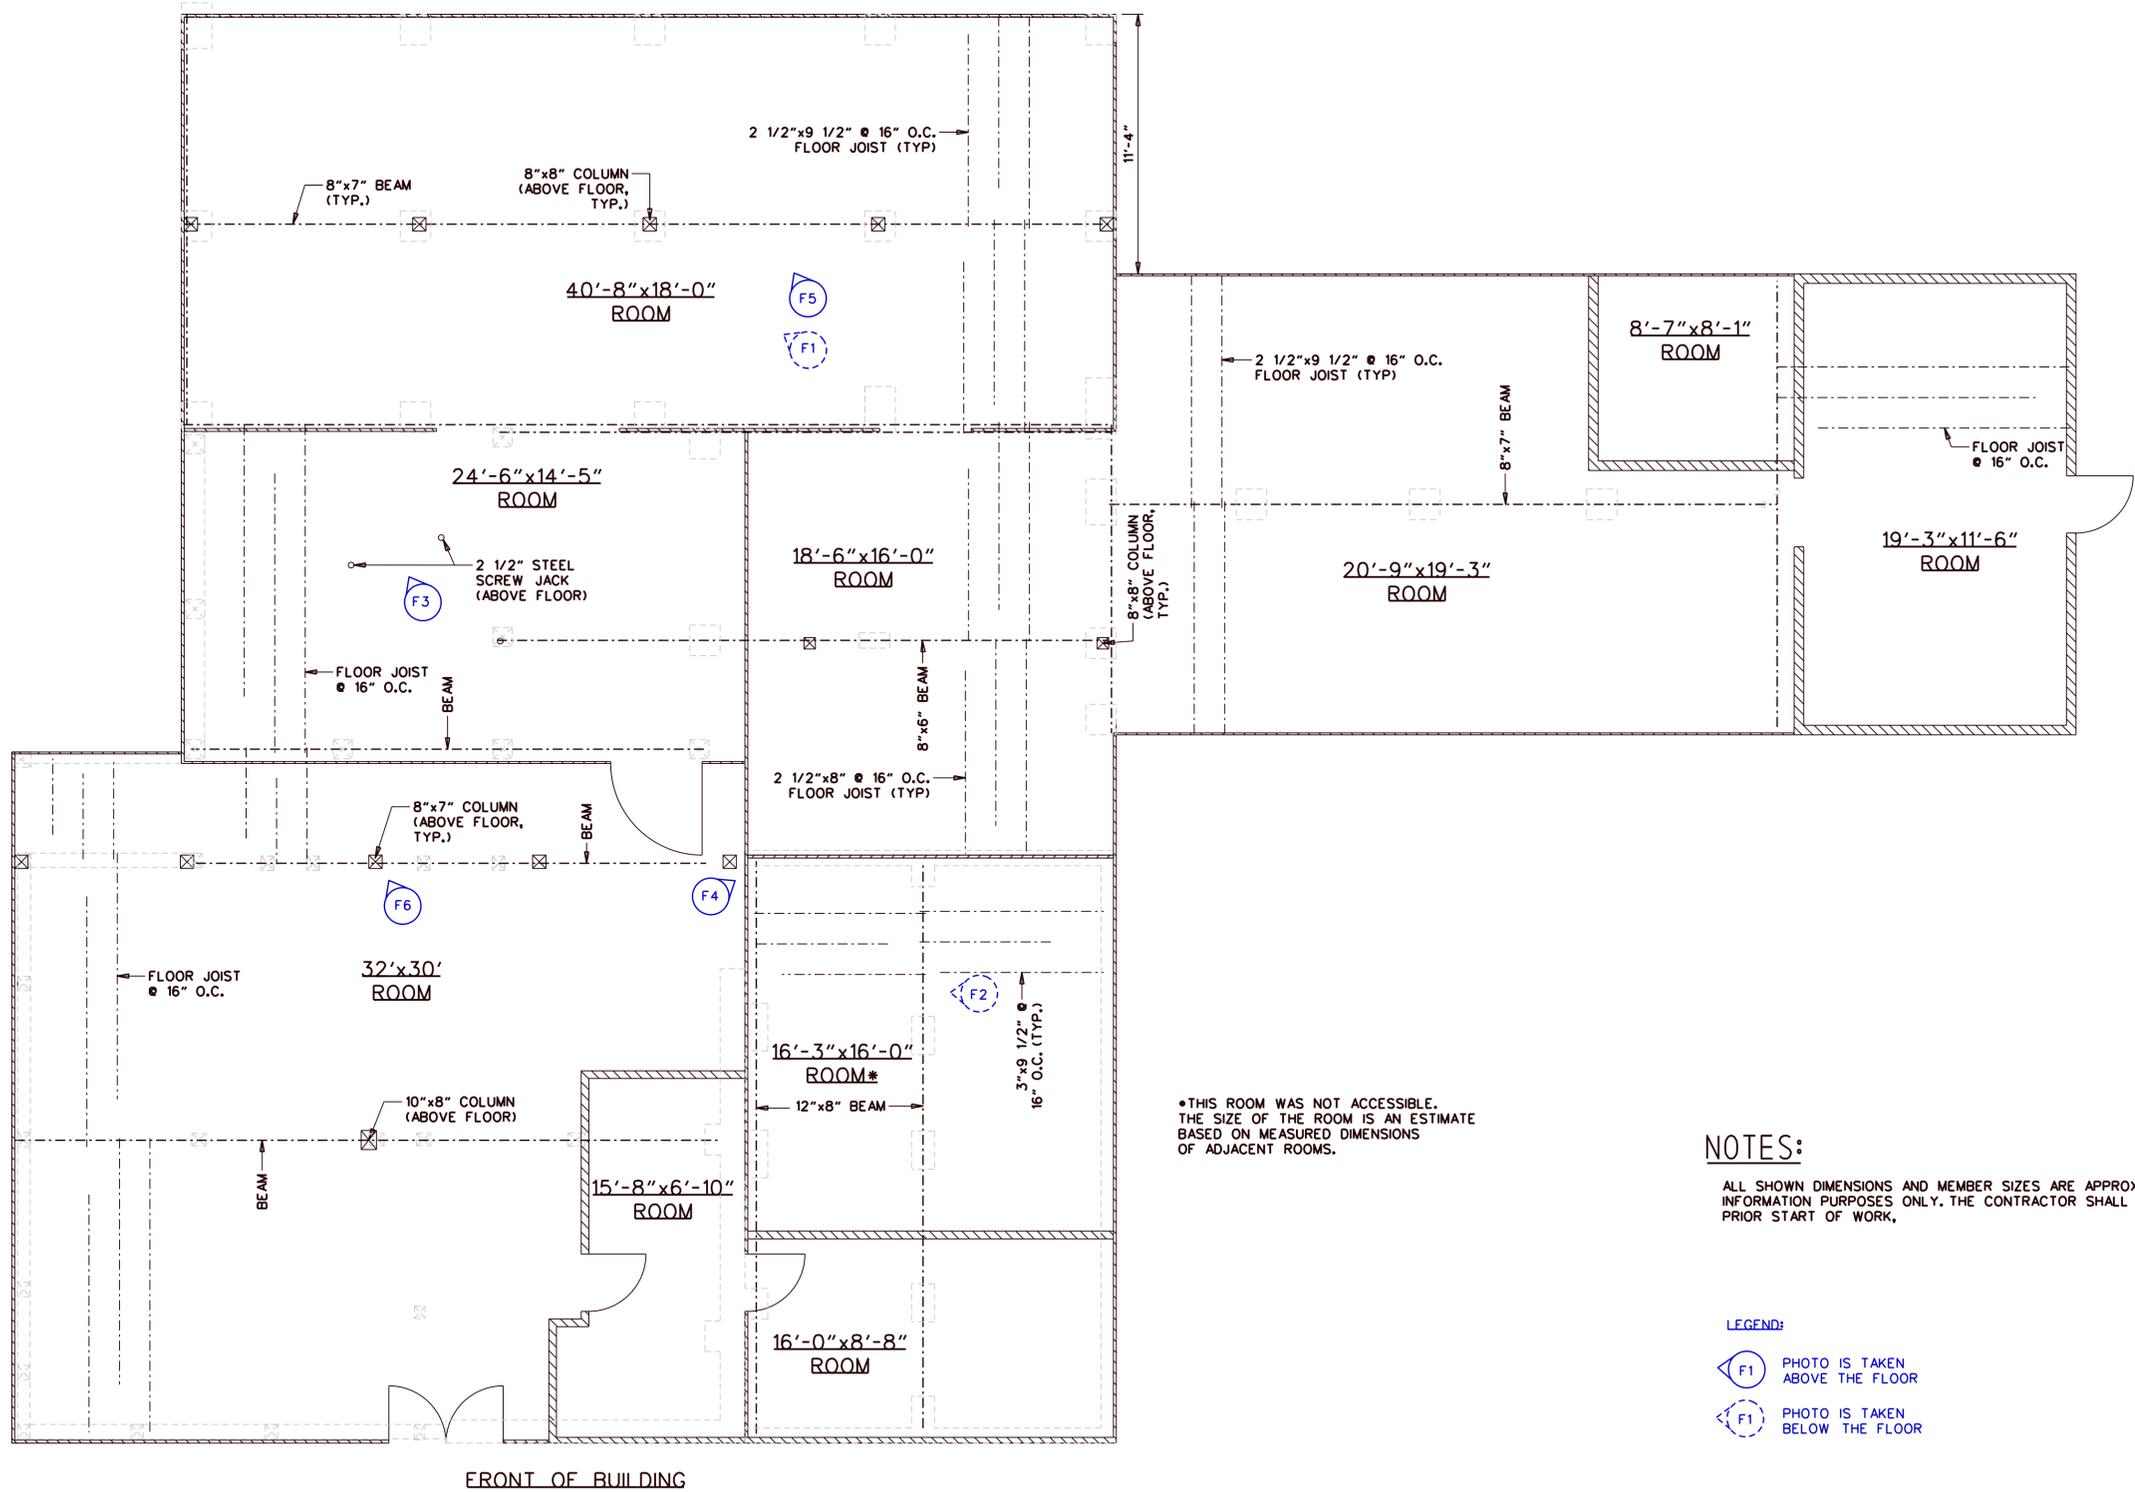
FIGURE 5

The overall condition of the timber structure appears to be in a fair condition. The following is a list of structural defects found on the first level of the building with photos (work with *Figure 5 = First Level Photo & Deficiency Location Plan* in *Appendix B* and Photos in *Appendix C*):

Based on the field observation, the overall condition of the timber structure appears to be in a fair condition due to various checks throughout the first level, joist cutouts and water damage.

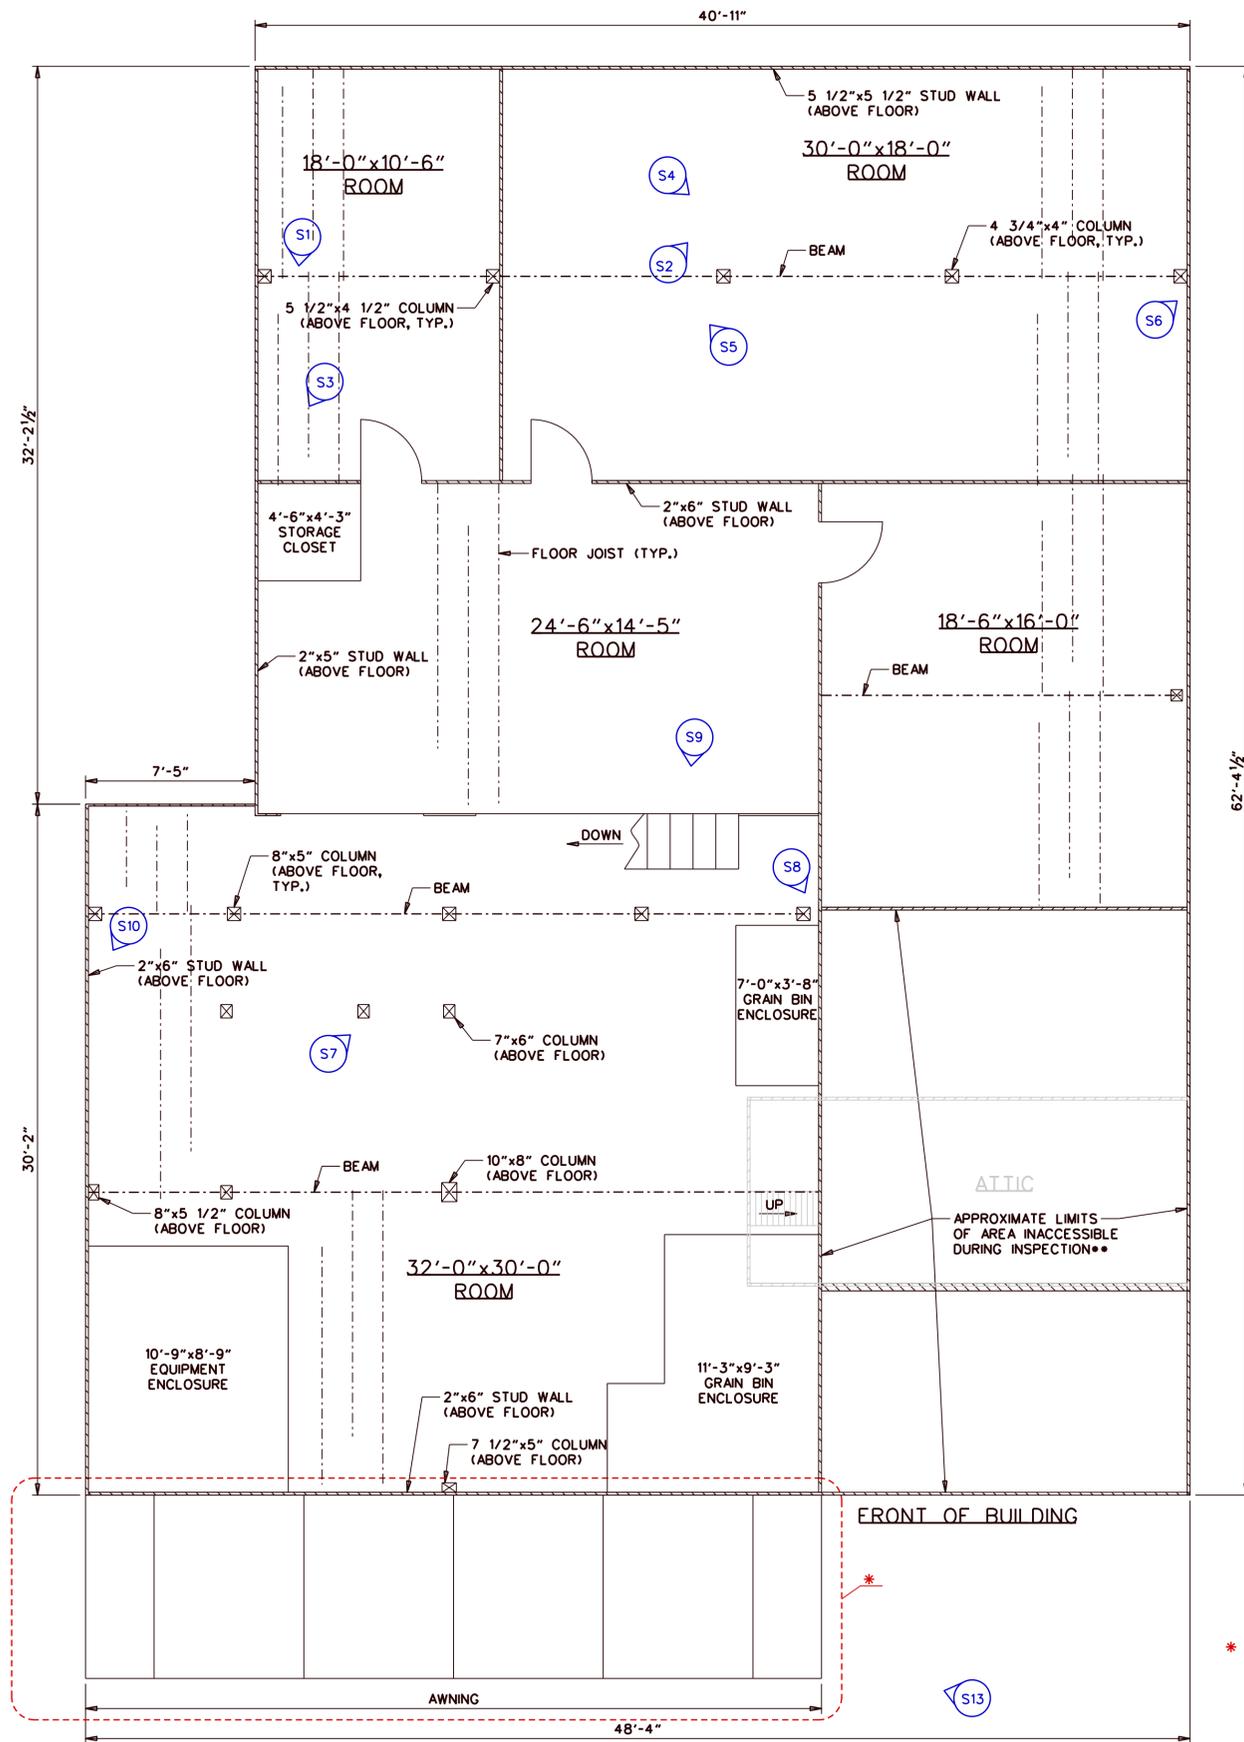
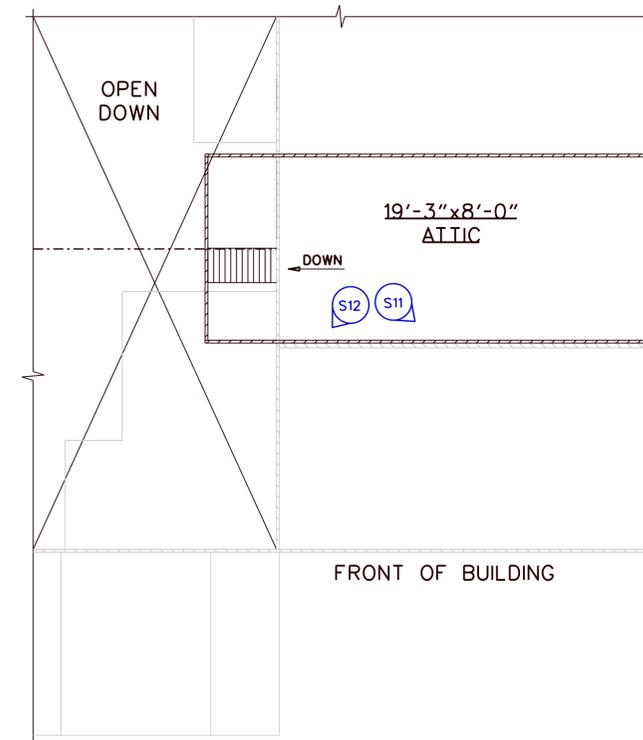
FIGURE 6

The overall condition of the timber structure appears to be in a fair condition. The following is a list of structural defects found on the second and attic levels of the building with photos (work with *Figure 6 - Second Level & Attic Photo & Deficiency Location Plan* in *Appendix B* and Photos in *Appendix C*):
