# ASBESTOS-CONTAINING MATERIALS SURVEY AND QUANTITY ESTIMATION REPORT

**“Hanger” Building**  
**Asbestos Agreement 1542 \*Task 27\***  
**800 Bay Road**  
**Dover, Delaware**  
**Agreement 1542**  
**Task No. 27 – Asbestos Management**

September 2012

**BrightFields File: 2680.27.74**

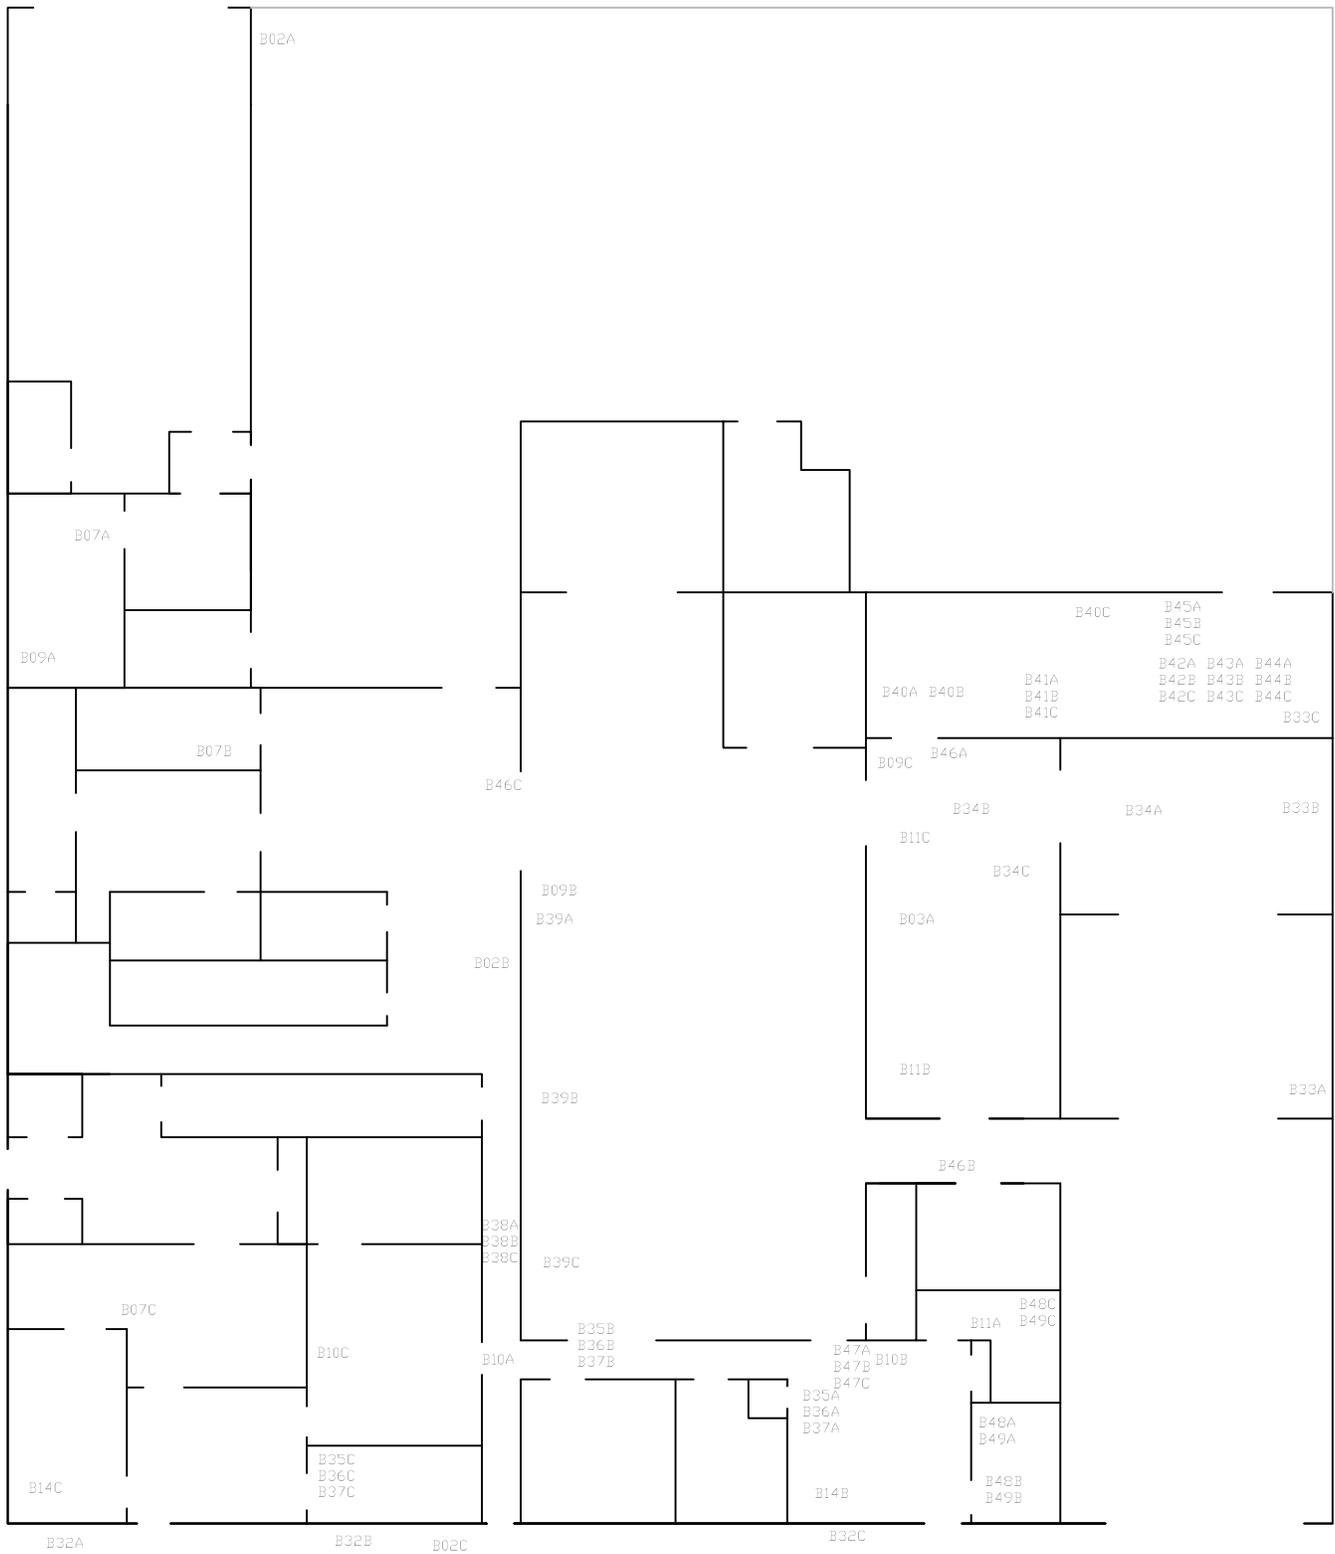
BY	DATE	SCALE:	AC FILE:
DRAWN	JWS	8-28-12	1:240	X
CHECKED	MWK	8-30-12	DWG. NO.	REV.
PROJECT #	2680.27.74		Figure 5	0

Table 1 contains BrightFields' sample numbers, material types and quantities, friability and condition of materials, and the percentage of asbestos (as reported by the analytical laboratory). Sample locations are shown on Figures 5 through 8 and the asbestos-containing materials identified in this survey report are shown on Figures 9 through 12. The results of the sampling indicate the following:
