Contract No.: T201707005

Title: Statewide Movable Bridge Preventative Maintenance  
Location: Bridges 1-687, 1-688, 1-693, 2-021A, 3-151, 3-153, 3-154, 3-164  
County: Statewide

Bridge 1-688

T201707005	SOUTH MARKET STREET
615606 - INITIAL REPAIRS AT BRIDGE 1-688	
REPAIRS S1 & S2

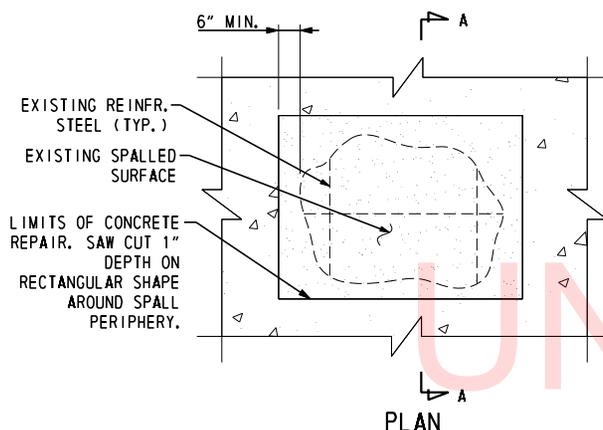
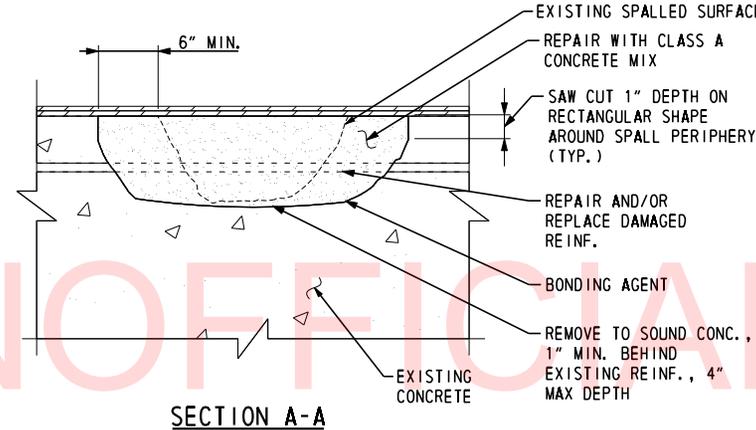
**DEEP SPALL REPAIR**

**SPALL IN THE SOUTH COUNTERWEIGHT**

1. ALL WORK INVOLVING METHODS OF DEEP SPALL REPAIR SHALL BE PERFORMED IN ACCORDANCE WITH SPECIAL PROVISION "615606 - INITIAL REPAIRS AT BRIDGE 1-688". PAID UNDER "ITEM 615606 - INITIAL REPAIRS AT BRIDGE 1-688."
2. ALL WORK INVOLVING METHODS OF CRACK REPAIR SHALL BE PERFORMED IN ACCORDANCE WITH SPECIAL PROVISION "615606 - INITIAL REPAIRS AT BRIDGE 1-688". PAID UNDER "ITEM 615606 - INITIAL REPAIRS AT BRIDGE 1-688."
3. THE CRACKS THAT ARE TO BE SEALED ARE LOCATED IN THE RACK SUPPORT NEAR THE TOP OF THE RACK AT EACH LEAF.
4. MATERIAL USED FOR CONCRETE REPAIRS AND CRACK SEALING SHALL CONFORM TO DELDOT STANDARD SPECIFICATION SECTION 628.

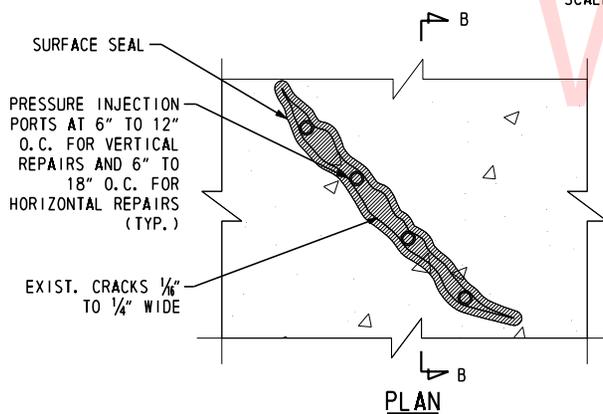
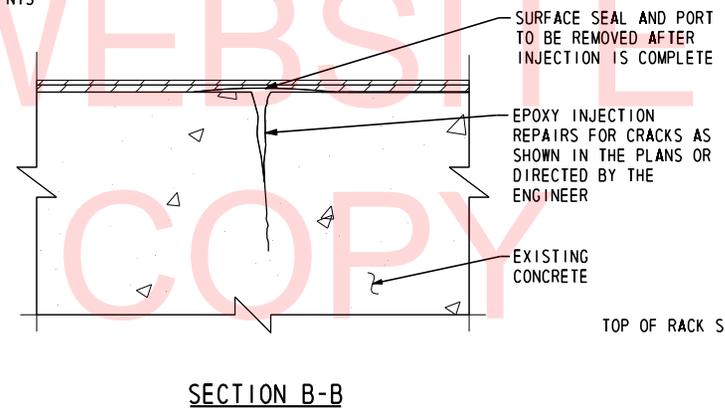
**CRACK REPAIR**

**TYPICAL CRACKS IN THE CONCRETE NEAR THE RACK SUPPORT**
