Contract No.: T201707005

Title: Statewide Movable Bridge Preventative Maintenance
Location: Bridges 1-687, 1-688, 1-693, 2-021A, 3-151, 3-153, 3-154, 3-164
County: Statewide

T201707005	THIRD STREET
615613 - INITIAL REPAIRS AT BRIDGE 1-693	
REPAIR S1

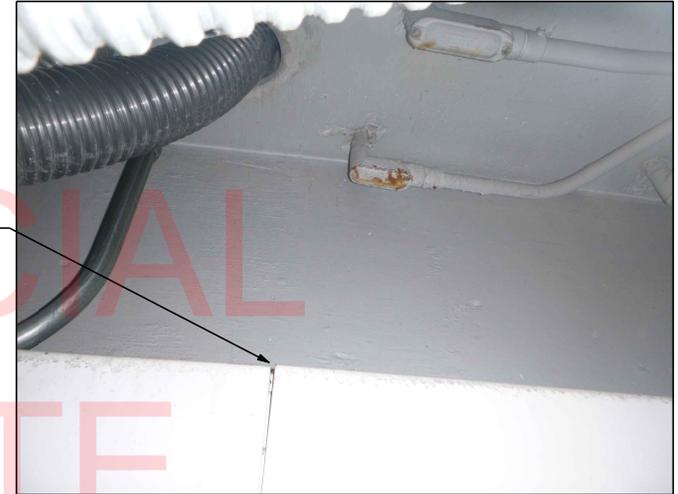
AREA ABOVE DRIVE AND CONTACTOR CABINET FOR PROPOSED SHIELD

CONTACTOR CABINET INTERIOR WITH SEALANT AND EVIDENCE OF WATER INFILTRATION

SEAL ALL CONDUIT ENTRANCES AND OPENINGS TO PREVENT WATER INFILTRATION

REPLACE EXISTING SEALANT ON ENCLOSURE ROOF

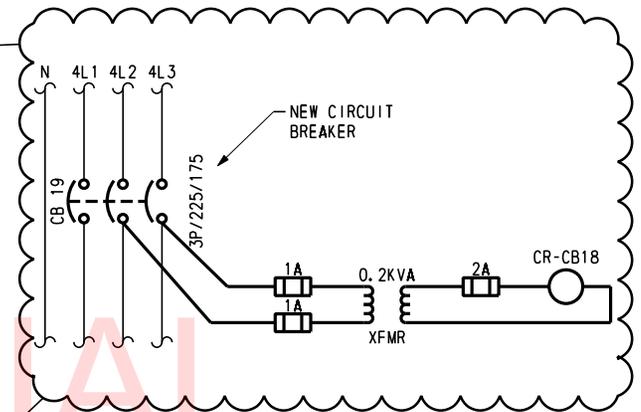
CB 19 MOTOR OPERATOR CONTROL SHOWN, CB 20 SHALL BE SIMILAR

REPLACE CONTACTOR IN KIND
