Contract No.: T201707005

Title: Statewide Movable Bridge Preventative Maintenance  
Location: Bridges 1-687, 1-688, 1-693, 2-021A, 3-151, 3-153, 3-154, 3-164  
County: Statewide

Bridge 2-021A

T201707005	REHOBOTH BOULEVARD
615619 - INITIAL REPAIRS AT BRIDGE 2-021A	
REPAIR S1

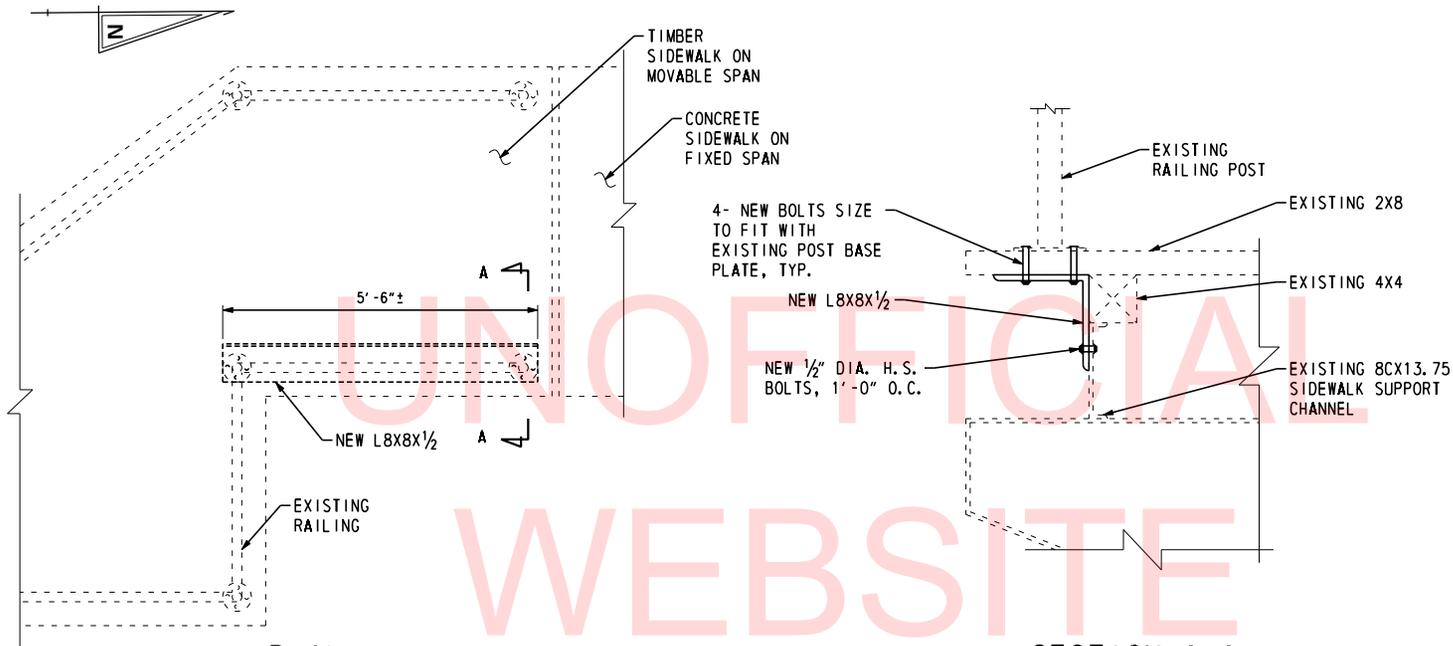
**PLAN**

NEW L8X8X1/2 TO CONNECT TO EXISTING DECKING AND SUPPORTING CHANNEL AT THE NORTH END OF THE BASCULE SIDEWALK

1. ALL WORK INVOLVING STRENGTHENING THE SIDEWALK POST CONNECTION SHALL BE PERFORMED IN ACCORDANCE WITH SPECIAL PROVISION 615619 - INITIAL REPAIRS AT BRIDGE 2-021A. PAID UNDER "615619 - INITIAL REPAIRS AT BRIDGE 2-021A."
2. NEW ANGLE AND BOLTS TO BE PAINTED TO MATCH EXISTING STEEL.

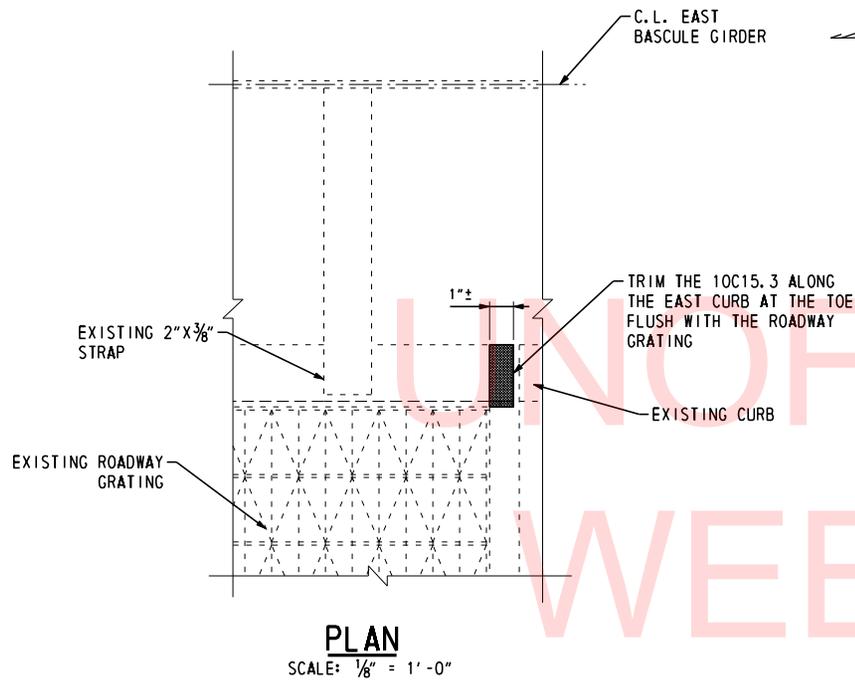
LOCATION OF  
HANDRAIL  
INTERFERENCE

LOCATION OF  
CHANNEL  
INTERFERENCE

1. ALL WORK INVOLVING TRIMMING THE CURB CHANNEL SHALL BE PERFORMED IN ACCORDANCE WITH SPECIAL PROVISION 615619 - INITIAL REPAIRS AT BRIDGE 2-021A. PAID UNDER "615619 - INITIAL REPAIRS AT BRIDGE 2-021A."
2. GRIND SMOOTH ANY ROUGH AREAS ON THE 10C15.3 AFTER TRIMMING IS COMPLETE.
3. APPLY TOUCH UP PAINT TO REPAIRED AREA. PAINT TO MATCH EXISTING.

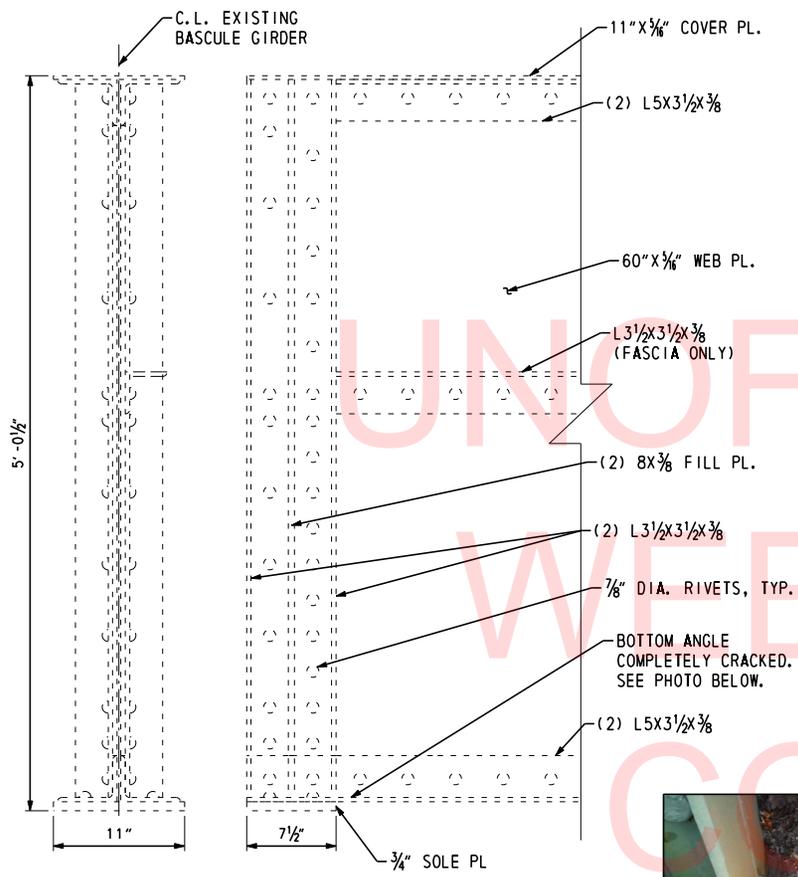
**EXISTING BASCULE GIRDER**  
 TOE SECTION OF THE EAST BASCULE  
 GIRDER SHOWN, WEST BASCULE GIRDER SIMILAR  
 SCALE: NTS

**CRACK IN BOTTOM FLANGE OF EAST  
 BASCULE GIRDER AT LIVE LOAD BEARING  
 (TYP.)**

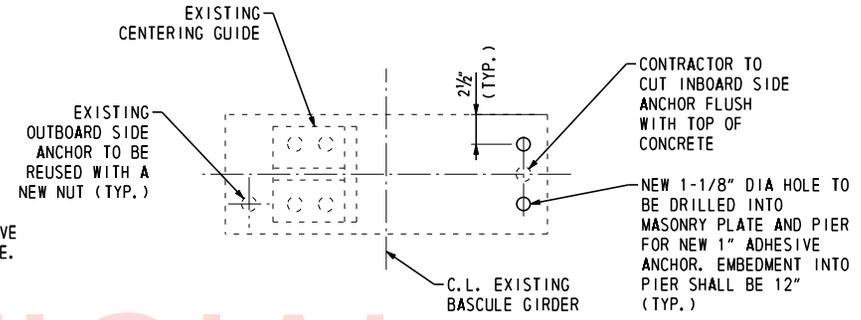
**EXISTING LIVE LOAD BEARING MASONRY PLATE WITH NEW ANCHOR LOCATIONS**

- FULLY SEATED LIMIT SWITCH TARGET (WEST L.L. BEARING LOCATION ONLY. SEE NOTE 5)
- EXISTING CENTERING GUIDE
- MISSING ANCHOR BOLT IN LIVE LOAD BEARING MASONRY PLATE. TWO NEW 1" DIA. ADHESIVE ANCHORS TO BE INSTALLED

3. ADHESIVE ANCHORS SHALL BE HILTI HAS-R STAINLESS STEEL ANCHOR USED WITH HILTI HIT-HY ADHESIVE. THE STAINLESS STEEL SHALL CONFORM TO ASTM F593 GRADE 316 SPECIFICATIONS.

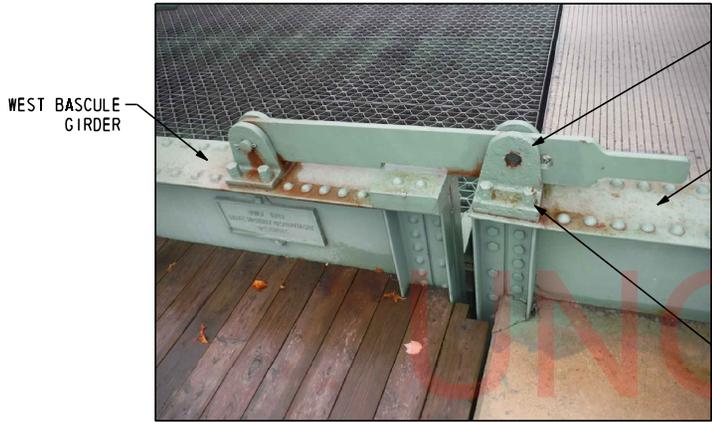
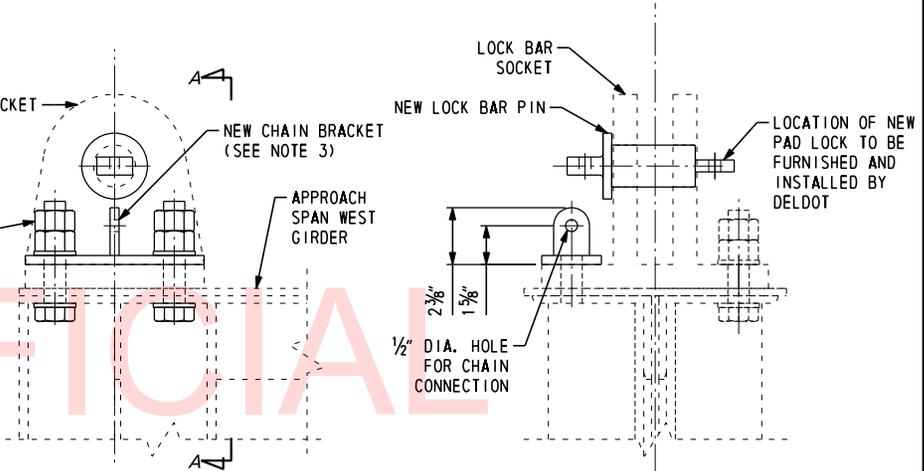
**SPAN LOCK (FACING EAST)**

M2 - REPLACE THE MISSING SPAN LOCK PIN.

SPAN LOCK BAR SOCKET  
 LOCK BAR SOCKET  
 APPROACH SPAN WEST GIRDER  
 2 NEW 7/8" DIA. H.S. BOLTS. HOLES IN CHAIN BRACKET TO MATCH SIZE AND LOCATION OF HOLES IN LOCK BAR SOCKET  
 LOCATION OF NEW SPAN LOCK CHAIN BRACKET

1. ALL ITEMS ON THIS DRAWING SHALL BE PAID UNDER SECTION 615619 "INITIAL REPAIRS AT BRIDGE 2-021A."
2. REFER TO THE SPECIAL PROVISIONS FOR ADDITIONAL REQUIREMENTS.
3. CONTRACTOR SHALL FURNISH AND INSTALL A STEEL CHAIN TO CONNECT THE LOCK BAR PIN TO THE CHAIN BRACKET.
4. PROVIDE 1/8" MAX. CLEARANCE BETWEEN THE HOLES IN THE LOCK BAR SOCKET AND THE NEW PIN.
