Contract No.: T201707005

Title: Statewide Movable Bridge Preventative Maintenance
Location: Bridges 1-687, 1-688, 1-693, 2-021A, 3-151, 3-153, 3-154, 3-164
County: Statewide

Bridge 3-151

T201707005	FRONT STREET
615625 - INITIAL REPAIRS AT BRIDGE 3-151	
REPAIRS S1 & S2

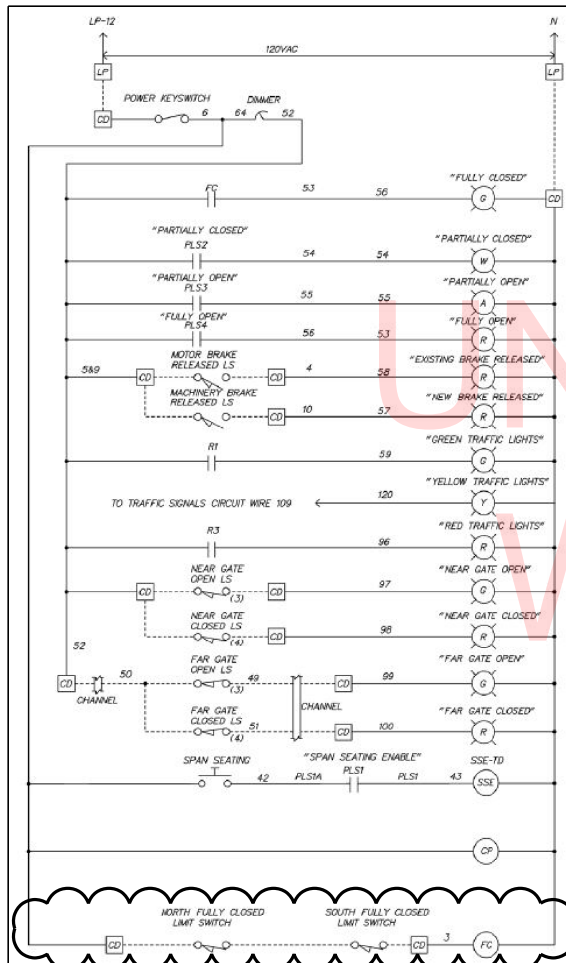
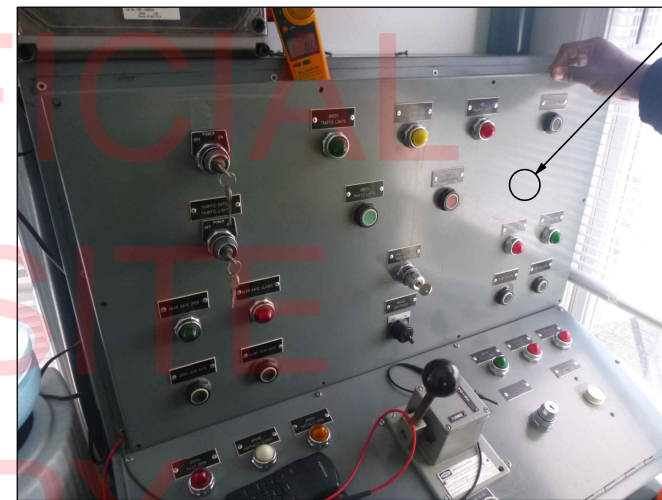
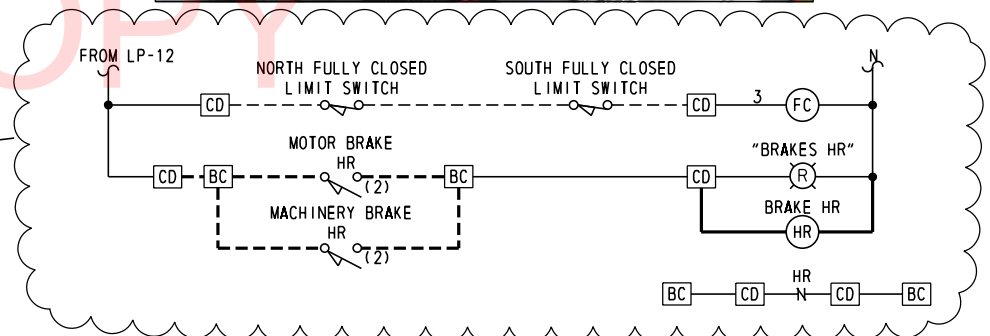
T201707005	FRONT STREET
615625 - INITIAL REPAIRS AT BRIDGE 3-151	
REPAIR E15 (2 OF 2)

LOCATION FOR THE NEW MOTOR BRAKES HAND-RELEASED INDICATING LIGHT

1. CONNECT THE EXISTING MOTOR BRAKE AND MACHINERY BRAKE HAND-RELEASED LIMIT SWITCHES AS SHOWN.
2. CONNECT BOTH EXISTING LIMIT SWITCHES TO THE NEW INDICATING LIGHT AND INTEGRATE THEM WITH THE EXISTING CIRCUITS AS SHOWN AND MODIFY WIRING AS REQUIRED.
3. FURNISH NEW RELAY AND CONNECT TO EXISTING CIRCUITS AS SHOWN.
4. FURNISH AND INSTALL NEW NAMEPLATE "BRAKES HAND-RELEASED" ABOVE THE NEW INDICATING LIGHT.
5. PERFORM OPERATIONAL TESTING TO CONFIRM THE INDICATING LIGHT ILLUMINATES WHEN EITHER N.O. HAND-RELEASED LIMIT SWITCH FOR THE BRAKES IS CLOSED.
