Bridge No: 1001 279  
 Date of Inspection: 04/23/2024  
 Load Rating Date: 03/25/2020

6) Feature Intersected: BRANDYWINE CREEK

7) Facility Carried: RISING SUN LANE

43 A & B) Main Span Mtrl/Design: 3 Steel 10 Truss-Thru

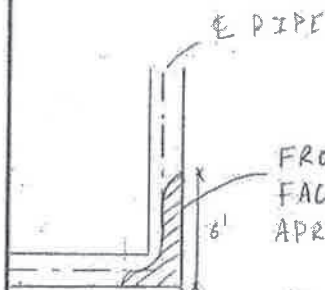
NORTH ABUTMENT - LOOKING NORTH

FRONT  
FACE  
APRON

1.5' H  
AND  
UP TO 2' D

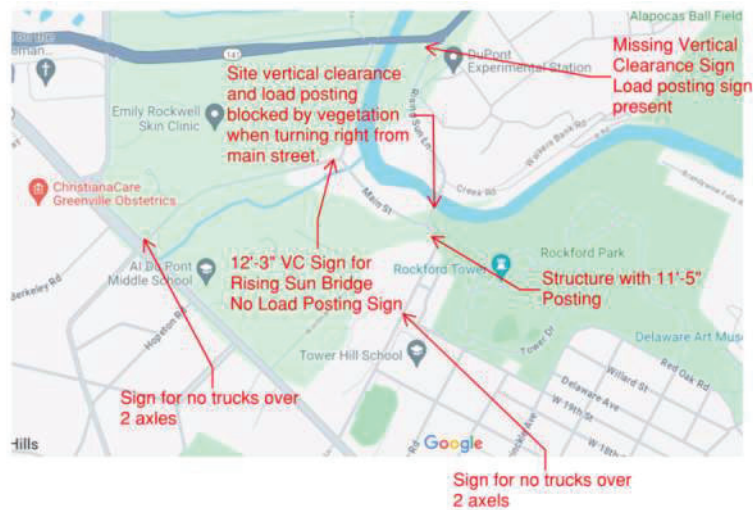
**Bridge 1-001 Signing Plan.pdf**

Please see the attached Photos of the missing vertical clearance sign at the 141 intersection as well as the south side sign blocked by vegetation and a Bridge Signage Plan for your reference.

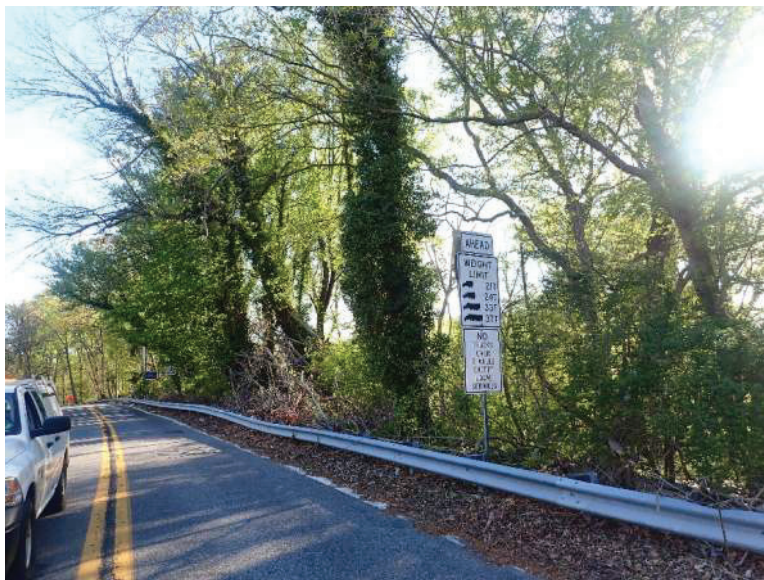
P4243479.JPG

During the inspection of the subject bridge, we noticed several trucks having to turn around on the north approach to the bridge. When we checked the signing for the structure we found that there is no vertical clearance sign posted at the SR-141 and Rising Sun Lane intersection (Photo P4243479).
